INSPECTION REPORT

Alaska Department of Environmental Conservation

Name and Location of Site/ Facility Inspected		Entry Time	Permit Effective Date
Tailings Treatment Facility (TTF) dam construction and Acid Rock Drainage area adjacent to LSL.	Loc: Lat: 58d 49' 58"N Long: 134d 57' 58"W	08:00	September 1, 2005
	Source: NPDES permit	Exit Time 11:30	Permit Expiration Date August 31, 2010
On-Site Representative		Additional Participants:	
Kevin Eppers, Env. Superintendent		Sarah Samuelson, USFS	
Responsible Official(s):		Yes No	
Clyde Gillespie, Surface Operations Manager, Kevin Eppers, Environmental Superintendent x Contacted	TTF: Nick Lewallen, Construction project manager, Chief Engineer, Jen Stetz, Tetra Tech	Samples Taken?	X
		Photos Taken?	X
		Analytical Results?	X
Clyde: 523-3309 Kevin: 523-3328

PHOTO ADDENDUM – KENSINGTON TAILINGS DISPOSAL FACILITY –DECEMBER 10, 2009

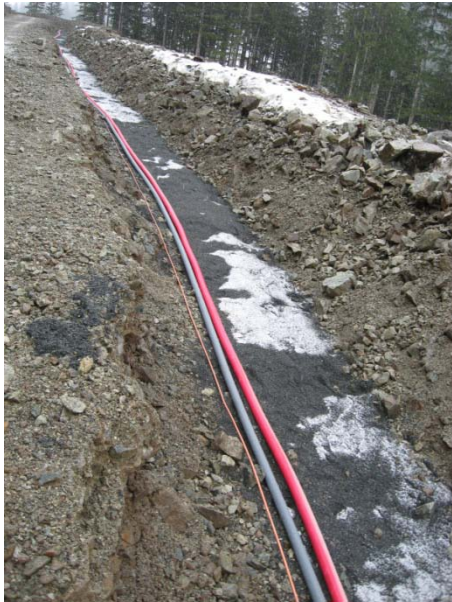
We initially looked at the trench adjacent to the road between the mill and Snowslide Gulch. The pipe has not yet been laid in the trench, however the optical and electrical lines are in the trench.

PHOTO 1. FIBER OPTIC AND ELECTRIC CABLES

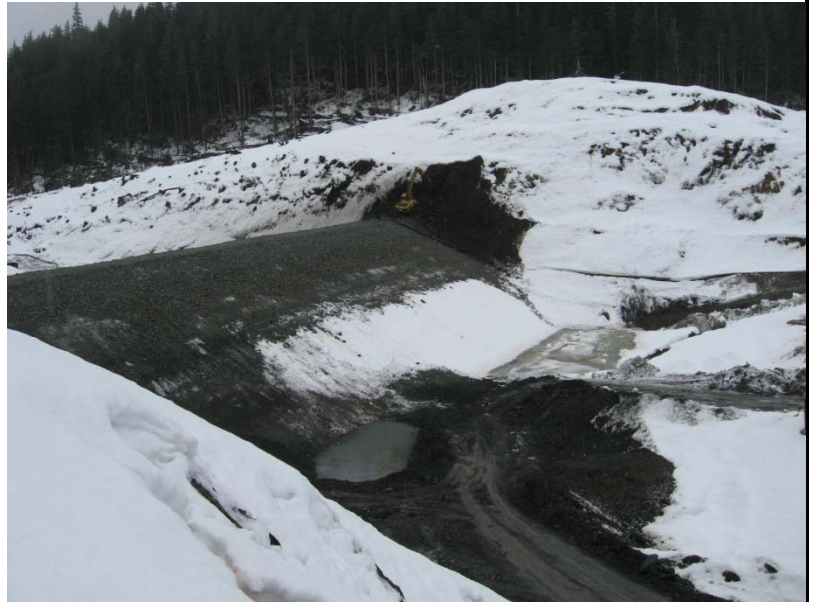
PHOTO 2. DAM FROM EAST EMBANKMENT

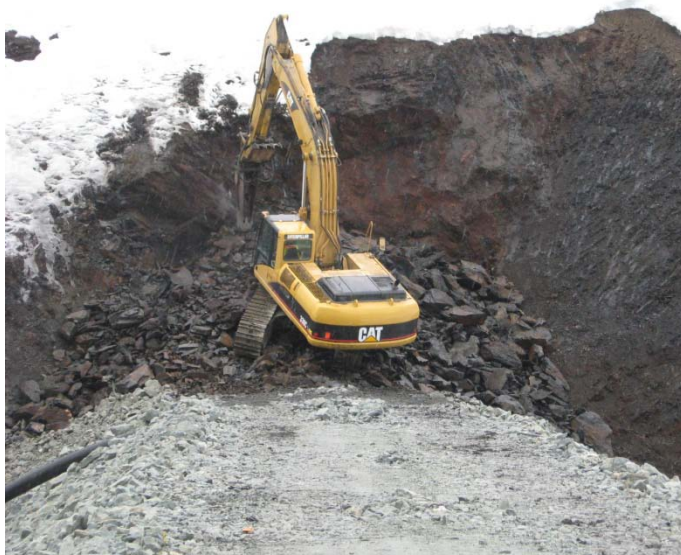
At the dam site preparatory work for the grout trench drill rig was under way. Rock was being cut away from the west embankment. This rock is to be checked to see if it is Graphitic Phyllite before ultimate disposal. The east abutment had been prepared for the drill rig and the graphitic phyllite material placed adjacent to the access road, at the bottom of the slope, until it can be moved to the temporary ARD storage site in Pit 4. This will occur after the tailings pipe has been laid and the road restored.

PHOTO 3. PREPARATORY WORK ALONG GROUT TRENCH

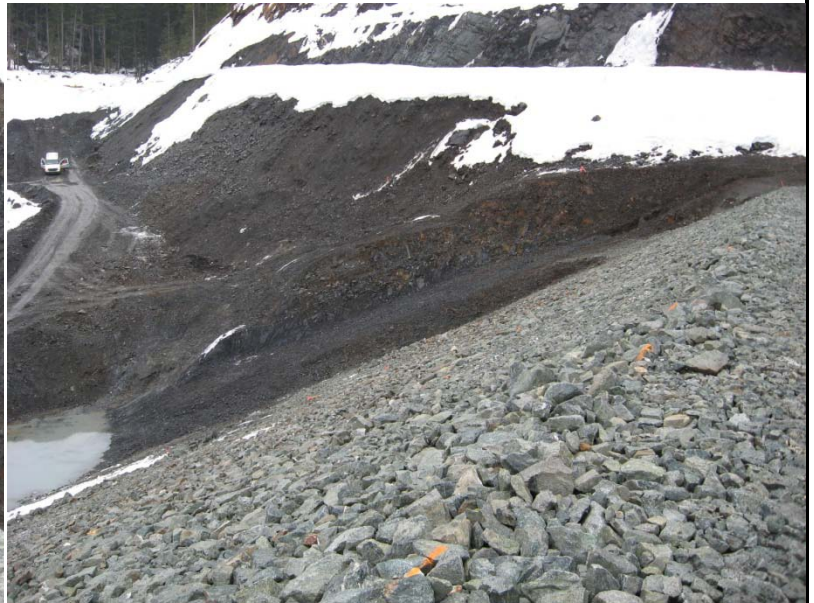
PHOTO 4. EAST EMBANKMENT PREPARED FOR DRILL RIG

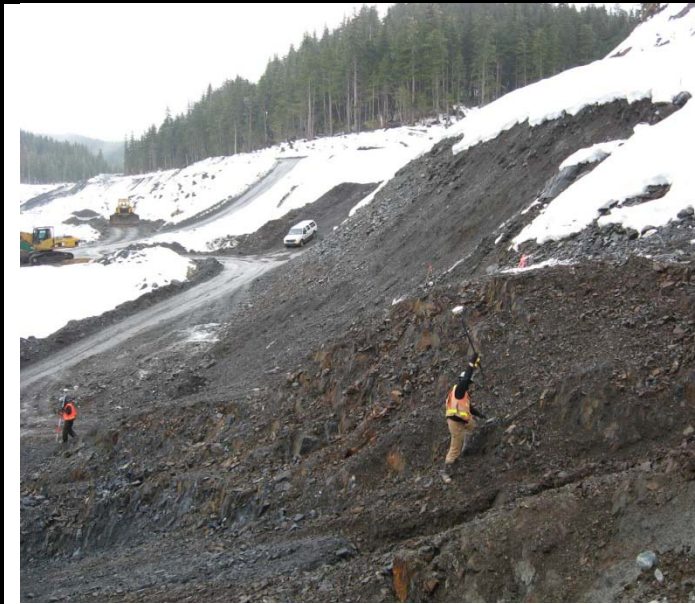
PHOTO 5. EAST EMBANKMENT, GRAPHITIC PHYLLITE TEMPORARY STORAGE WHERE THE TRUCK IS LOCATED.

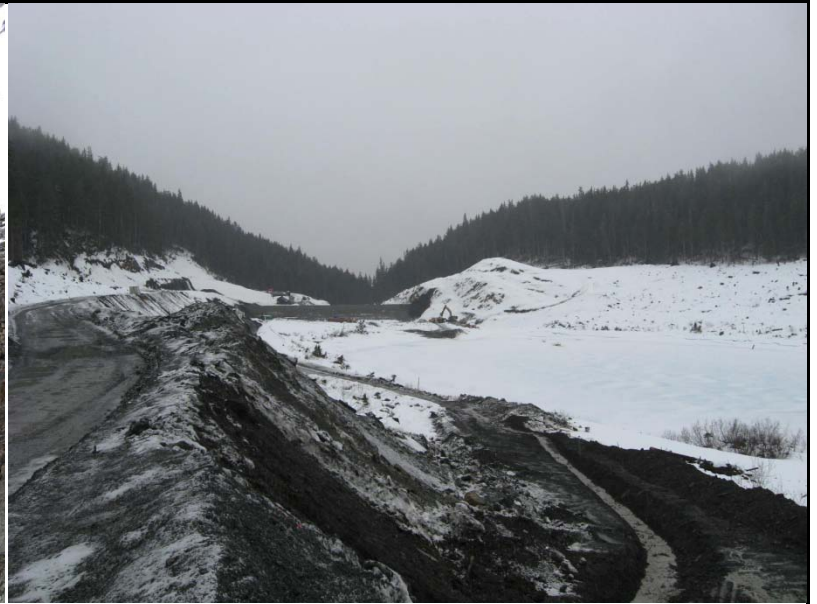
PHOTO 6. GENERAL VIEW OF THE TTF AND DAM AND THE LOCATION FOR THE TAILINGS PIPE IN THE TRENCH IN THE FOREGROUND.
