APDES INSPECTION REPORT

Alaska Department of Environmental Conservation

Inspection Date 05/13/2010	Permit # AK-005057 AKR05CA53 (Stormwater)	Borough N/A	Receiving Waters E. Fork Slate creek	Weather Current Conditions: +/- 50 partly cloudy	Facility Type Industrial
Discharges to: Surface Water <input checked="" type="checkbox"/> Ground Water <input type="checkbox"/>				ANNOUNCED Inspection

Name and Location of Site/ Facility Inspected		Entry Time	Permit Effective Date												
Kensington Project Tailings Treatment Facility		Exit Time	Permit Expiration Date												
On-Site Representative Kevin Eppers/ Coeur Alaska Jeff Stacy/ Coeur Construction		Additional Participants: Kevin Eppers / Coeur Alaska Jeff Stacy / Coeur Construction Chad Hood / USFS Tom Crafford/ ADNR													
Responsible Official(s): Tom Henderson Coeur Alaska 3031 Clinton Drive, Suite 202 Juneau, AK. 99801 Phone: (907)523-3300

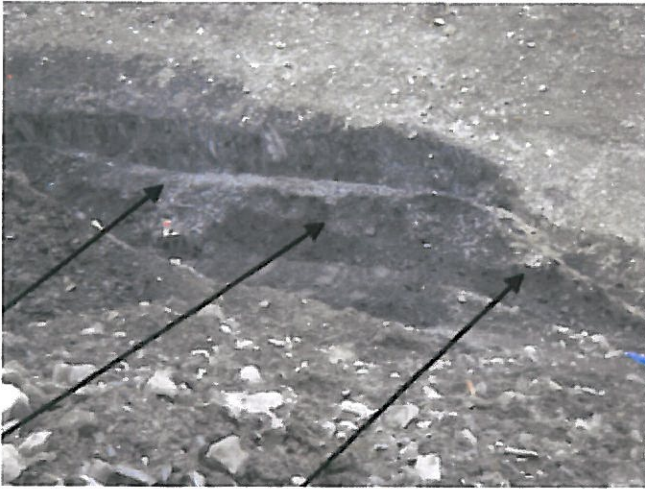
PHOTO 1: TRENCH WILL KEY-IN 100 MM HDPE LINER

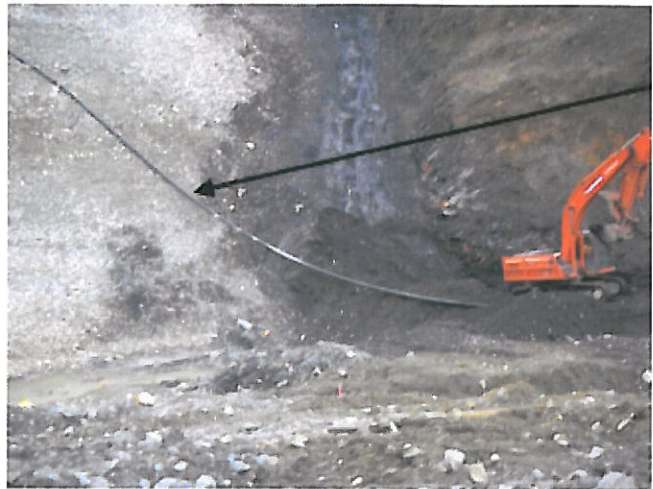
PHOTO 2: BLACK PIPE CONVEYS WATER FROM SEEP COLLECTION SYSTEM TO LOWER SLATE LAKE (TTF).

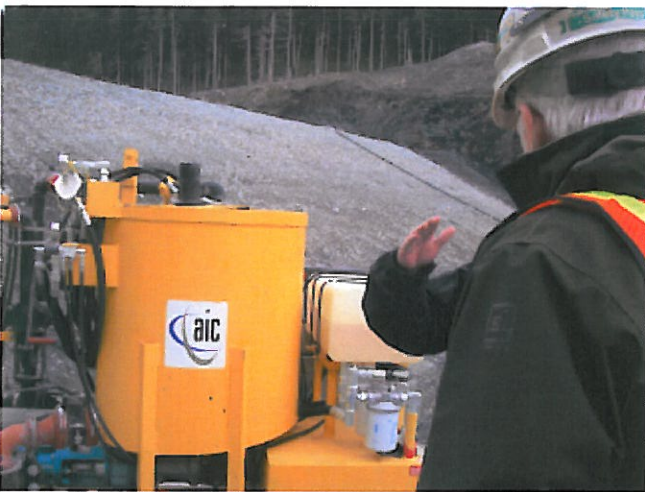
PHOTO 3: KNIGHT-PIESOLD PERSONNEL EXPLAIN GROUTING OPERATION TO MR. TOM CRAFFORD/ADNR

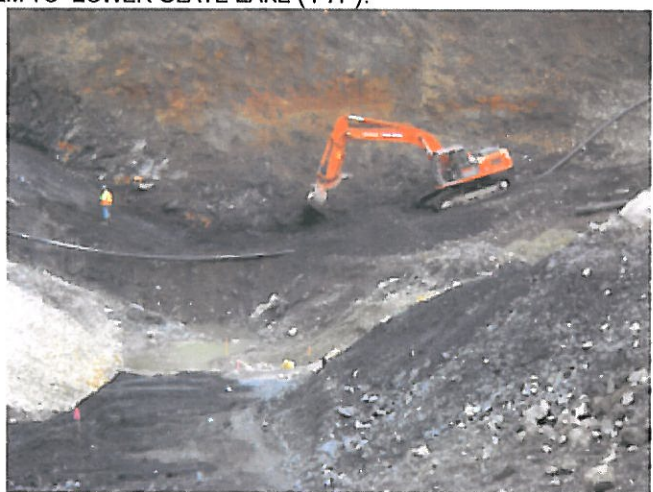
Inspection began at the cofferdam at the Tailings Treatment Facility (TTF). We observed large, portable Rain for Rent units for water treatment at the base of the dam. Following treatment in the Rain for Rent units, water is discharged through a series of two sediment bags. Phase I (of III) of the dam is complete. 100 mm HDPE liner will cover the face of the dam; the HDPE liner will be welded and keyed in via a grout trench. The grout trench is under construction (Photo 1). A spot where ponding occurs is thought to possibly have more fractures than expected. Return pipe which conveys water from the seep collection sump to the TTF was observed (Photo 2). We observed Knight-Piesold personnel conducting drilling and grouting operations (Photo 3). According to Mr. Stacy, two holes recently filled accepted 18,000 gallons of grout to fill fractures. Following a 24-hour curing period, core samples are collected and analyzed to determine whether grouting was successful. Holes are then pressure tested with water. We viewed the TTF grouting operation from the Parshall flume (Photos 4 and 5).

PHOTO 4: VIEW OF TRENCH FROM FLUME. NOTE LOW SPOT ON WEST SIDE OF TRENCH.

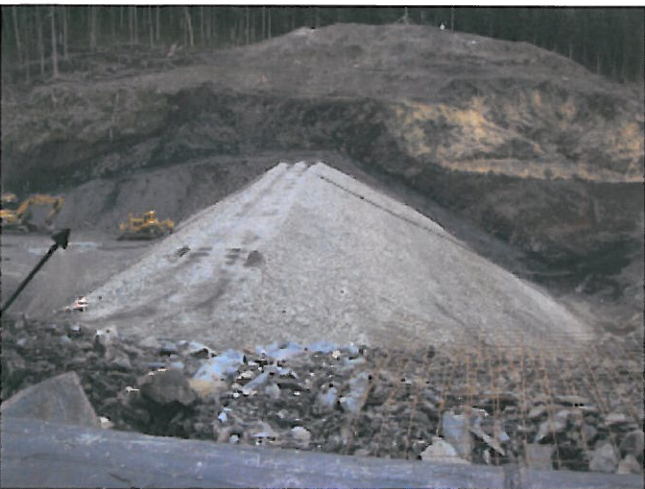
PHOTO 5: COFFERDAM AT TTF FROM FLUME.

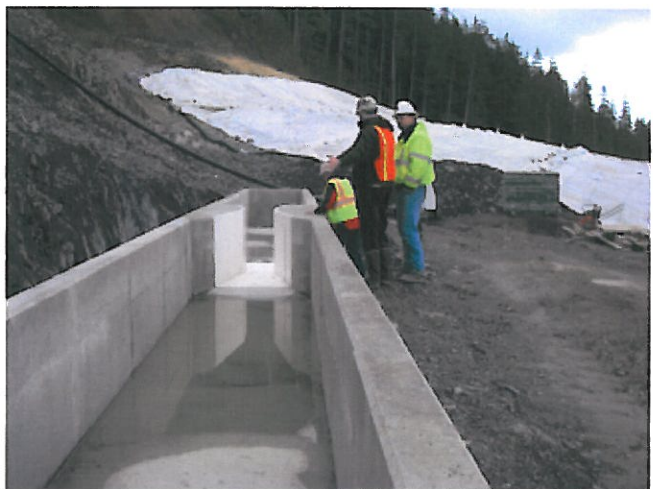
The Parshall flume (Photos 6 and 7) leads to a bypass plunge pool. A hydraulic hammer was chipping rock for the spillway on the west embankment (Photo 8).

PHOTO 6: PARSHALL FLUME WILL CARRY DIVERTED FLOW

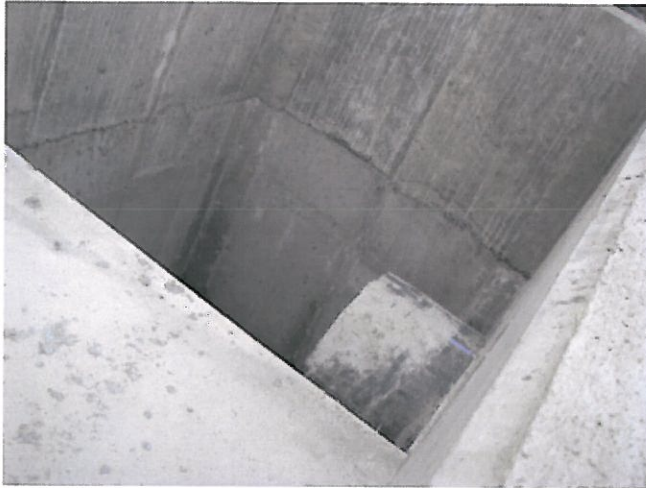
PHOTO 7: BYPASS PARSHALL FLUME OUTLET CHAMBER

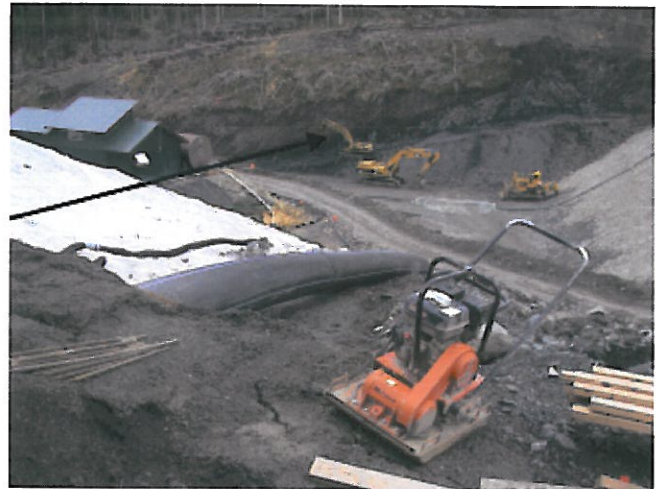
PHOTO 8: HYDRAULIC HAMMER CHIPS (LEFT ARROW) SPILLWAY; LARGE BLACK PIPE IS BYPASS PIPE COMING FROM FROM PARSHALL FLUME

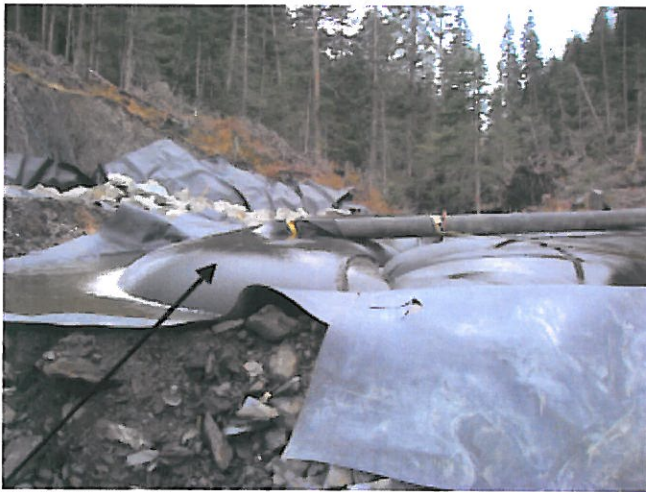
PHOTO 9: SEDIMENT BAG FILTERS WATER PRIOR TO DISCHARGE (UPSTREAM OF SAMPLE LOCATION # 5)

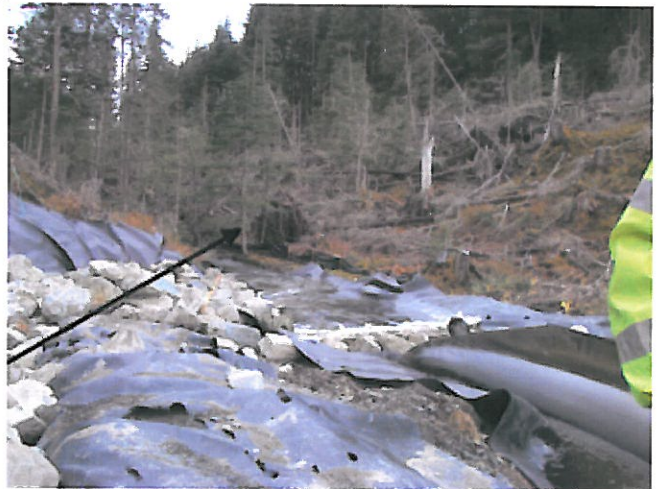
We drove down near the discharge location and observed a large sediment bag that filters water prior to release. Mr. Eppers pointed out sample location # 5, adjacent to a flagged tree and downstream of the discharge (Photo 8). February and March data analysis from sample site # 5 indicated high metals values (manganese, cadmium, and aluminum). Blackish material on the ledge face above the run-down liner is graphitic phyllite (Photo 11), which will be removed, then capped. The dam seepage sump (Photo 12) was observed prior to leaving the area.

PHOTO 10: SAMPLE LOCATION # 5 IS ADJACENT TO TREE WITH FLAG (AT TERMINUS OF ARROW)

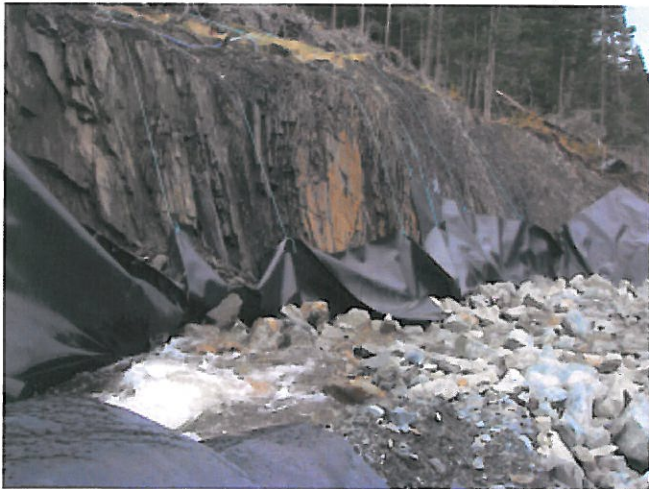
PHOTO 11: BLACKISH MATERIAL ON FACE ABOVE LINER IS GRAPHITIC PHYLLITE WHICH WILL BE REMOVED, THEN CAPPED

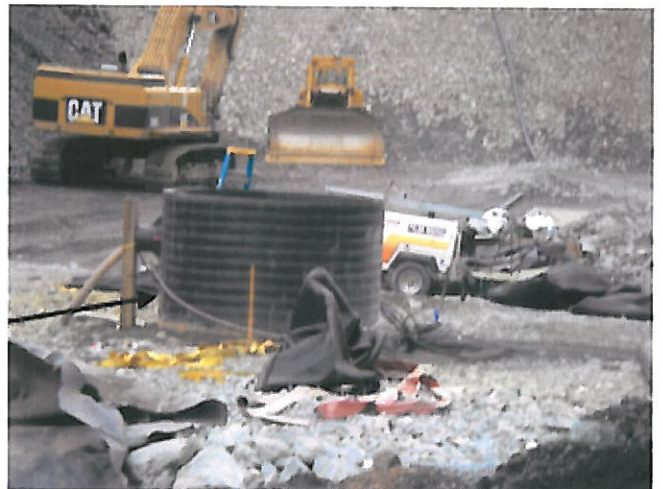
PHOTO 12: SEEP COLLECTION SYSTEM

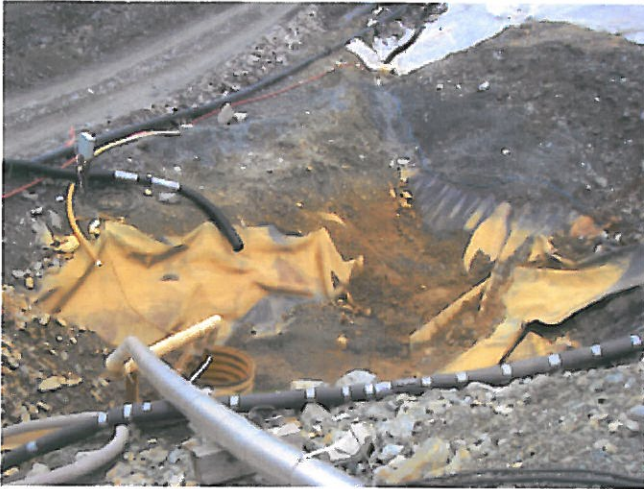
Water was not present in the sump (Photo 13). The liner has not been modified recently. The ARD site water treatment plant

PHOTO 13: ARD SEEPAGE COLLECTION SUMP WAS EMPTY

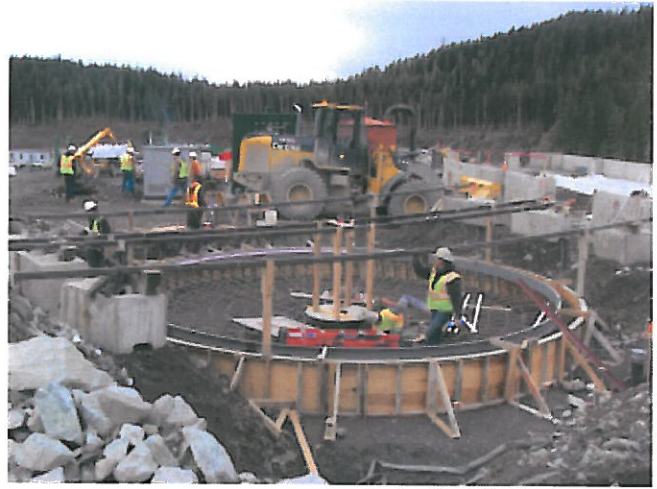
The TTF Water Treatment Plant is under construction (Photo 14).

PHOTO 14: TTF WATER TREATMENT PLANT. FOUNDATION FOR CLARIFIER IN FOREGROUND

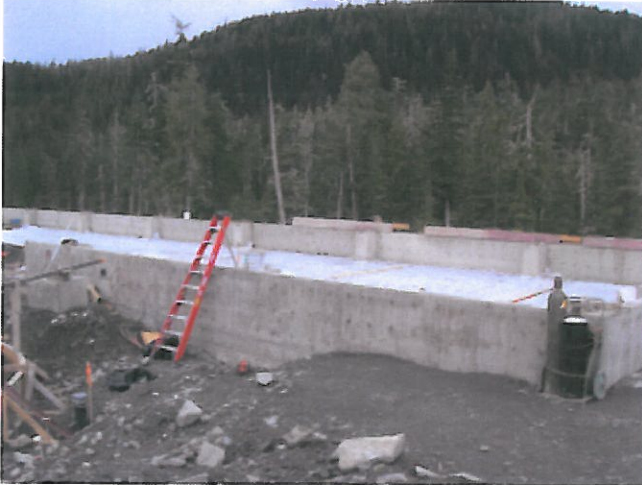
PHOTO 15: TTF WATER TREATMENT PLANT UNDER CONSTRUCTION

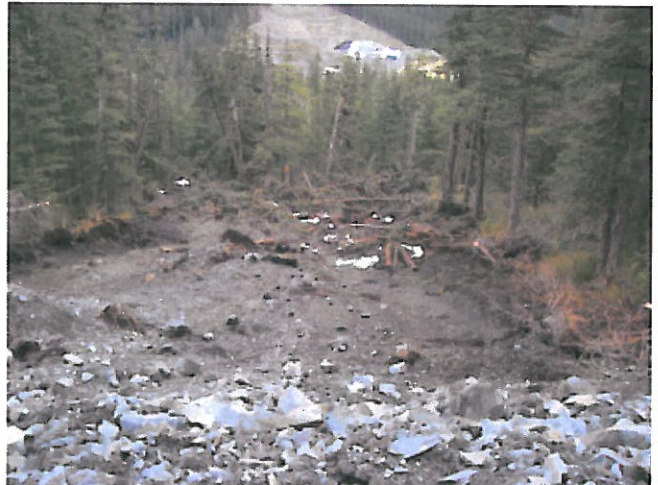
PHOTO 16: SITE OF AVALANCHE ALONG PIPELINE ROAD
