# INSPECTION REPORT

Alaska Department of Environmental Conservation

Name and Location of Site/ Facility Inspected		Entry Time	Permit Effective Date
<b>Kensington Lower Slate Lake (LSL)</b> Dam construction and Acid Rock Drainage area adjacent to LSL.	<b>Loc:</b> Lat: 58d 49' 58"N Long: 134d 57' 58"W	08:00	September 1, 2005
	<b>Source:</b> NPDES permit	<b>Exit Time</b> 13:00	<b>Permit Expiration Date</b> August 31, 2010
On-Site Representative		Additional Participants:	
Clyde Gillespie (Surface Ops Mgr), Pete Strow, (Env. Coord.)			
Responsible Official(s):			
Clyde Gillespie, Surface Operations Manager  x Contacted	LSL: Jen Stetz, AIC Construction Civil Superintendent	Yes No Samples Taken? X Photos Taken? X Analytical Results? X	
Clyde: 523-3309 Kevin: 523-3328

**PHOTO ADDENDUM – KENSINGTON LOWER SLATE LAKE – OCTOBER 8, 2009**

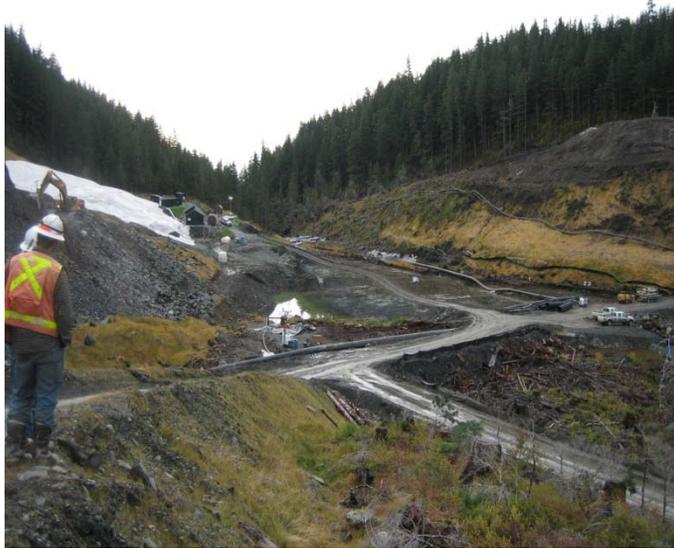
Excavation of the Phase 1 dam construction had progressed such that the graphitic phyllite material had been removed from the "Big Hole" (Photos 1 and 6) and transported to the temporary storage pad. Other unsuitable material (soils) had been removed from the dam foundation area and transported to the west side of the lake at the head of the lake. Bedrock had been struck at a depth of around 10 feet below the natural surface; however it was expected to be up to 30 feet below the natural ground level in other places. The majority of the diorite material from adjacent to the mill had been transported to the storage areas alongside the dam access road. A crusher was set up and soon to be ready for crushing rock for the dam construction.

**PHOTO 1. EXCAVATION OF DAM FOUNDATION**

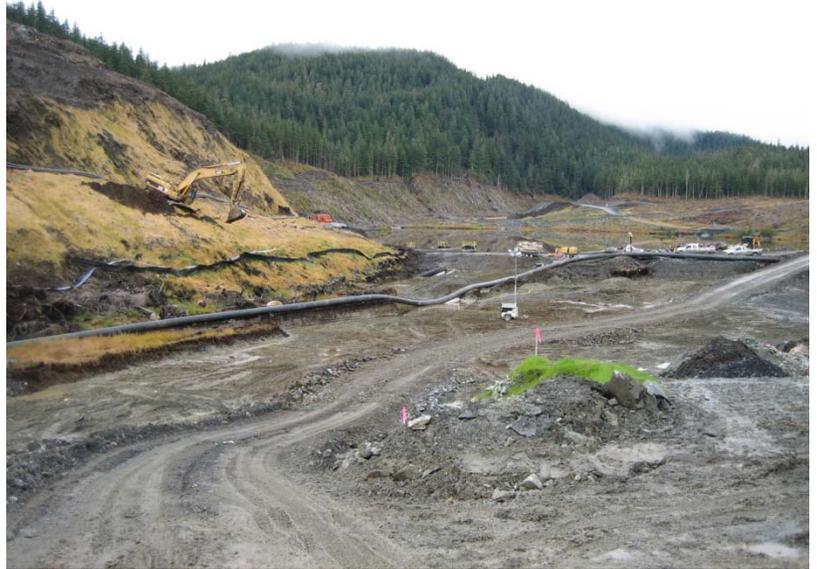
A tracked excavator was preparing the USL bypass pipe route on the east side of the dam. It traversed across to the opposite embankment where pits were dug (Photo 2) for the geologist (Clint Degenhart/Henry Follman are two of the three geologists on site) to make a determination as to whether there was graphitic phyllite present at that location.

**PHOTO 2. EXCAVATOR DIGGING EXPLORATORY PITS**

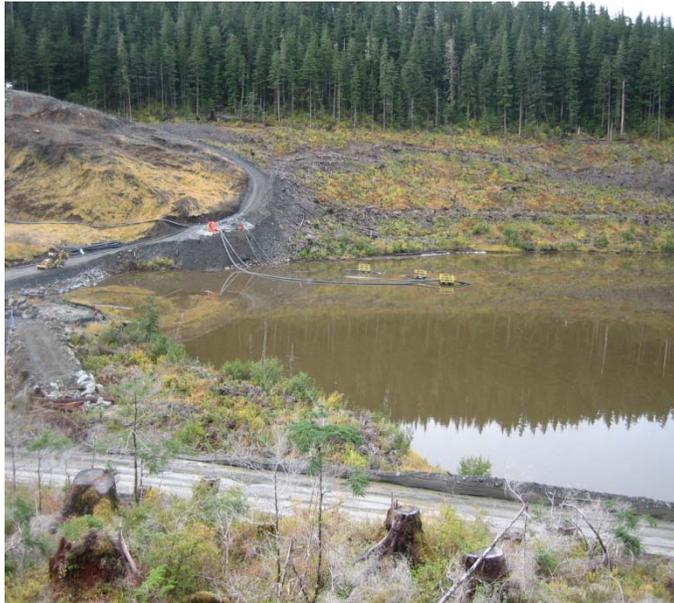
Approximately October 1st the lake / TDF experienced what appeared to be a turn-over event. The water went overnight from being clear to brown and turbid (Photo 3). Pumping had been cut back to around 1000 gpm to reduce turbidity impacts to East Fork Slate Creek, and the sediment loading to the dirt bags into which the pumps discharge prior to the water going to East Fork Slate Creek. Additional pumps and fine mesh filter bags were being installed to allow additional discharge of this turbid water. Because the sediment is very fine colloidal material, it will take some time to settle again within the impoundment. The water from Upper Slate Lake was running clear, with a turbidity of 2 NTU.

**PHOTO 3. TURBID LAKE/TDF WATER**

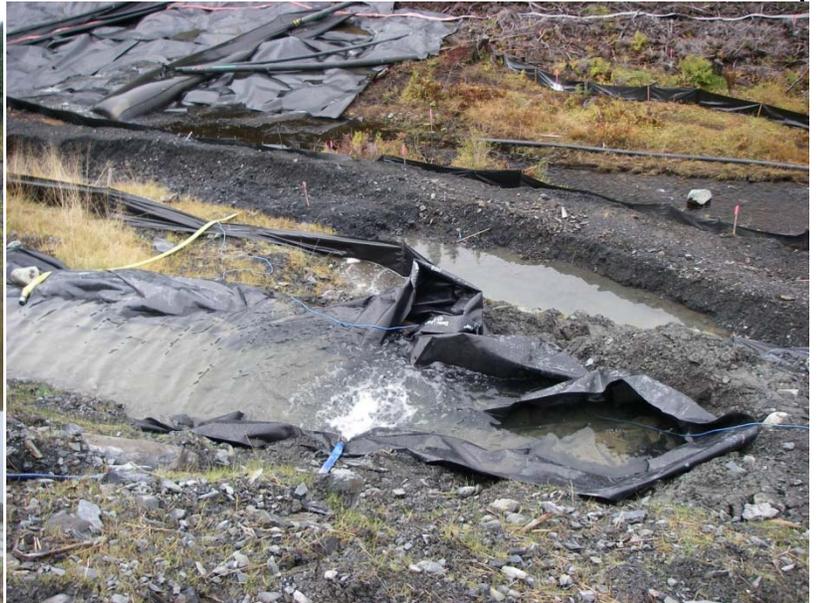
Contractors were in the process of moving the treated water storage tank and flocculent tank to an elevation above and beyond the dam footprint. Due to a contractor misunderstanding, water from the storage tank was being discharged over the bank (Photos 4 & 5). The normal discharge location for this water was into the "Big hole". Since the discharge location was incorrect the contractor closed the valve at the time of the site visit and they were directed by Clyde Gillespie that the water from the tank must be placed on the roads. Water from the plant is used to water the roads when possible or piped to the Big Hole. Coeur informed ADEC that the water flowing over the bank was captured in ponds in the diversion pipe excavation and pumped back to the plant for treatment and discharge to the "Big Hole".

Treated seep water has elevated Cadmium (when using receiving water hardness), sulfate and TDS.

**PHOTO 4. DISCHARGE OF TREATED SEEP WATER**

1. Prevention and ensuring no additional treated seep water flows directly to East Fork Slate Creek.
2. Submittal by Coeur of plan for the disposal of treated ARD seep water to the land around and adjacent to the TDF.

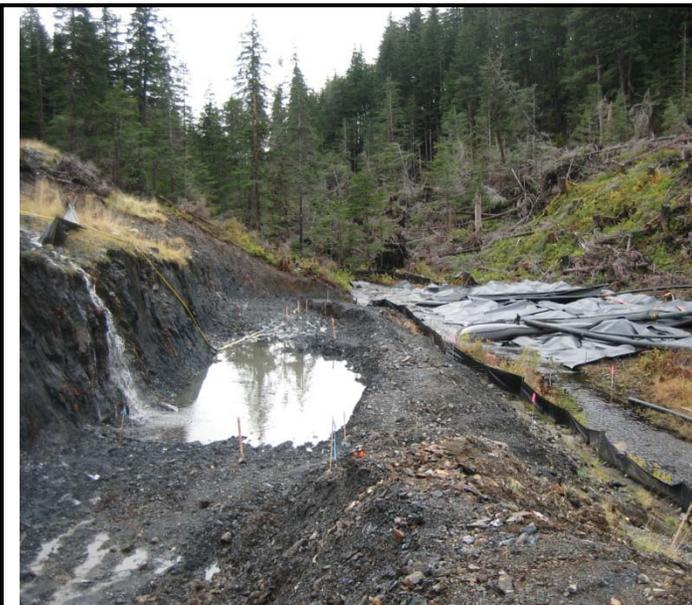
**PHOTO 5. TREATED SEEP WATER. PLUNGE POOL BEYOND, NEXT TO DIRT BAG.**

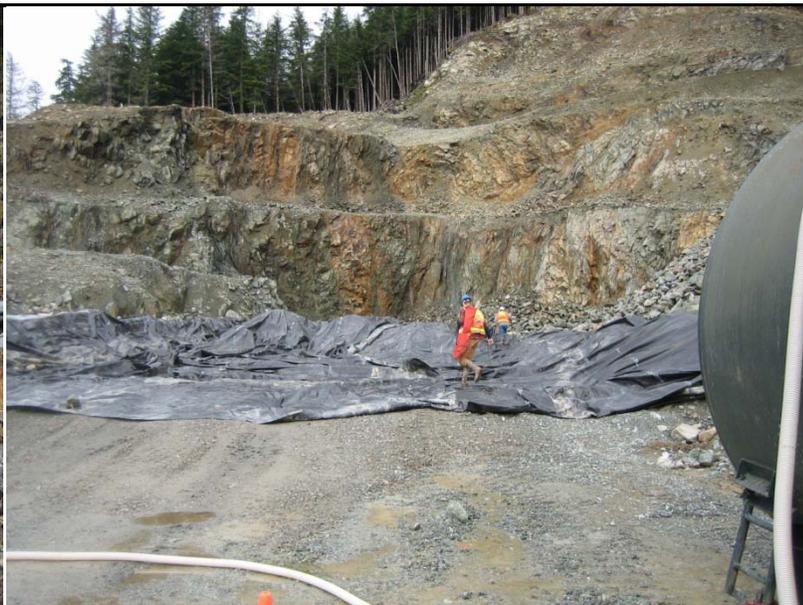
This cell is in Pit 3 (as it is called in the POO, otherwise called Pit 4 by surface operators). Material had been placed here from the "Big Hole" and from the road access to the plunge pool adjacent to East Fork Slate Creek. Approximately 200 cy of material had been placed on the pad. The water drains from the pad into a covered sump (Photo 7), thence to a 20,000 gallon storage tank prior being transported to the seep water treatment plant at the TDF. Adjacent to this cell is another cell where hydrocarbon contaminated soil is stored for future remediation. This cell also drains to the same sump as the graphitic phyllite cell, however there is no water draining from it, and the contaminated soils have been covered over with polyethylene to keep rainwater off the pad. The remediation cell, which requires circulating water, will not be used while water is draining from the graphitic phyllite pad for transportation to the seep treatment plant. Also, should a hydrocarbon sheen form within the sump, the hydrocarbons will not be pumped into the storage tank because the suction in the sump is below the water surface. A polyethylene cover had been placed over the graphitic phyllite pad and material. The seal at the liner/drain contact from the pad appeared in good condition such that one would not expect a leak where the pipe passed through the liner.

**PHOTO 6. STORAGE PAD FOR GRAPHITIC PHYLLITE**

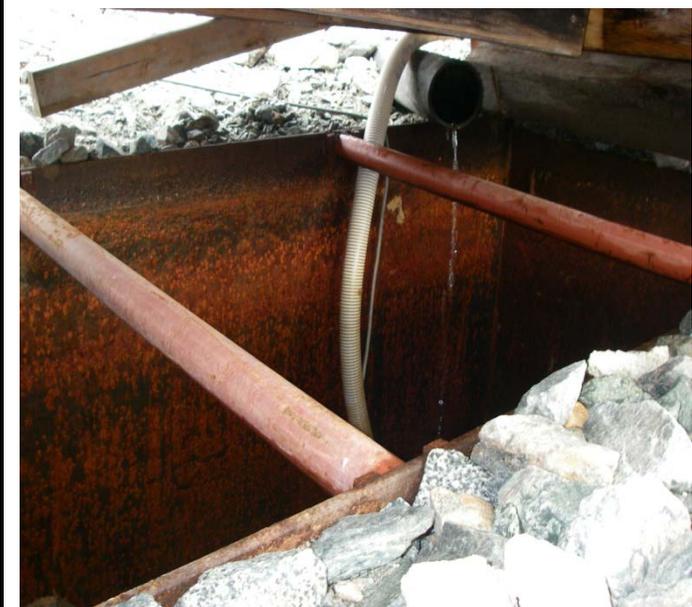
**PHOTO 7. SUMP AT PAD / FLOW FROM PAD.**

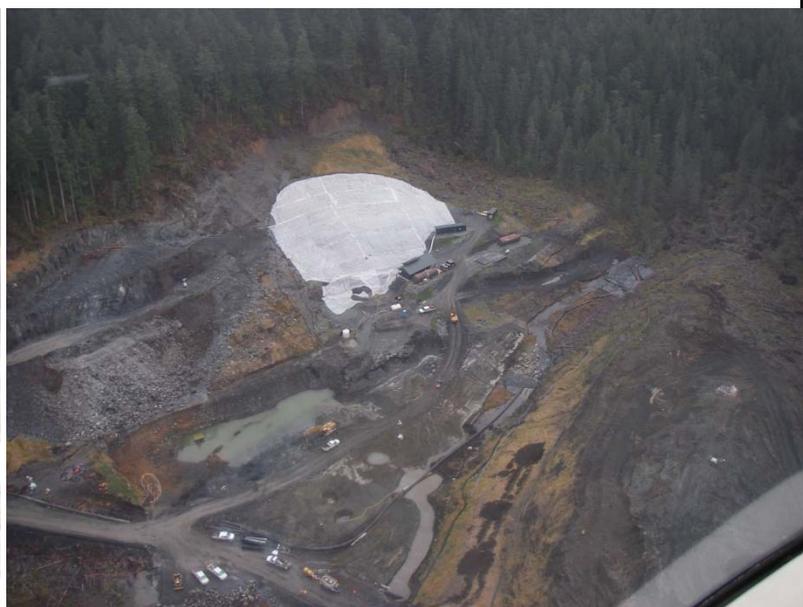
**PHOTO 6. ARIAL VIEW OF DAM SITE AND COVERED ARD AREA.**
