INSPECTION REPORT: KENSINGTON GOLD MINE

Tongass National Forest Minerals Group
8510 Mendenhall Loop Rd
Juneau, AK 99801
(907) 789-6275– office
(907) 586-8808 – fax

Date of Inspection: Wednesday, July 12, 2017
Date of Report: Thursday, July 20, 2017
USDA Forest Service Inspector: Richard Dudek

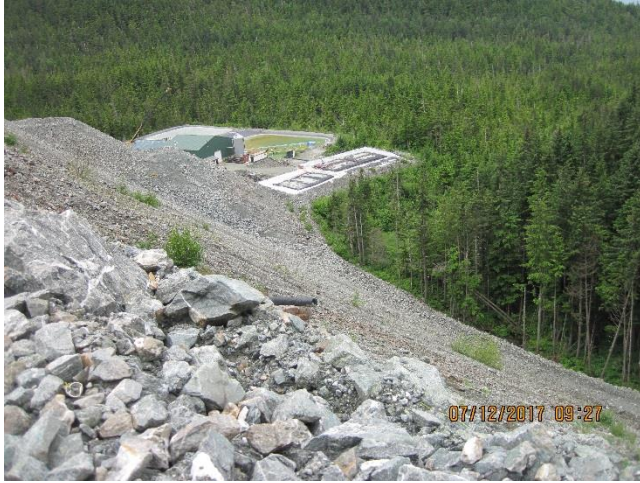
Coeur Alaska continues to stockpile waste rock from the Raven drift at the southwest end of the development pile (Photos 1-2).

Photo 1 Comet Development Pile.

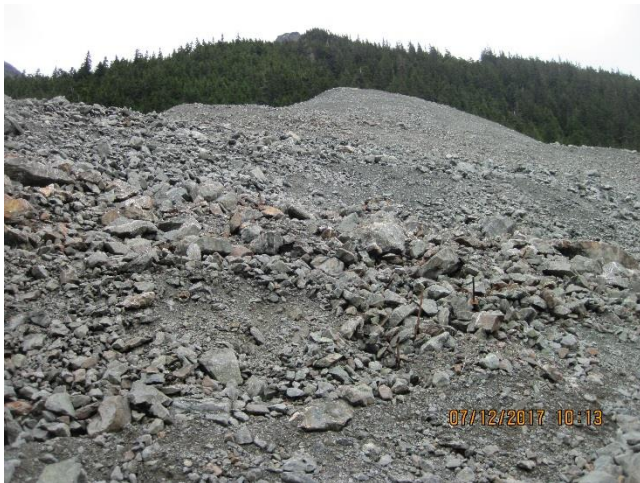
Photo 2. Comet Development Pile's southwest toe.

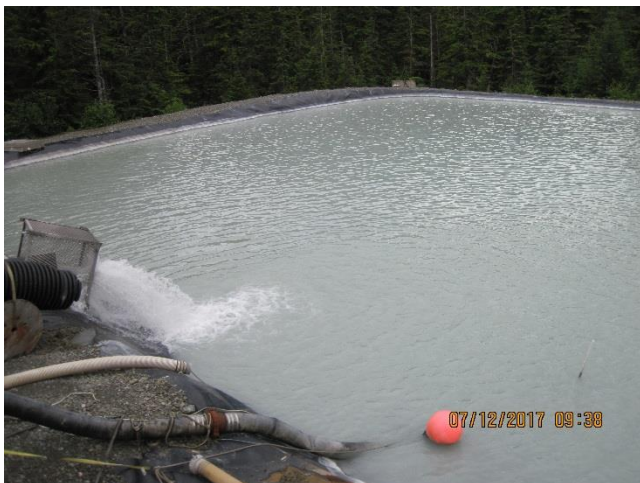
The water treatment personnel recently installed a trash screen (Photo 3) at the inlet for Pond 1. The cage will capture underground foreign material that could enter the pond and potentially block the water pump. Pond 2 (Photo 4) was receiving backwash from the treatment plant. Coeur Alaska will begin dredging Pond 2 in the next couple of weeks. The dredging for settling ponds 1 and 2 typically takes three to four weeks.

Photo 3. Comet Water Treatment Plant's Pond 1.

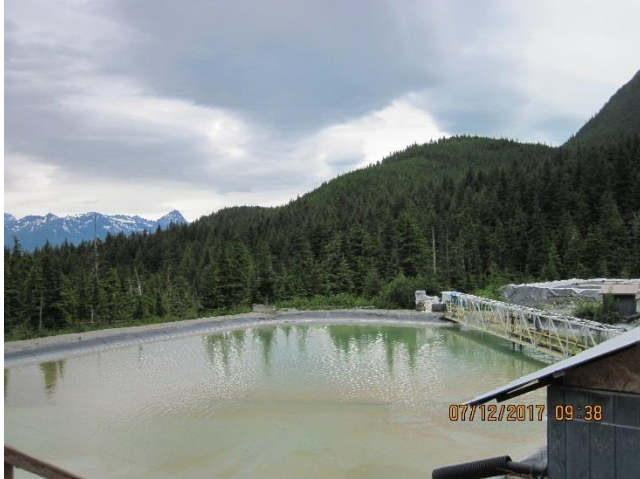
Photo 4. Comet Water Treatment Plant's Pond 2.

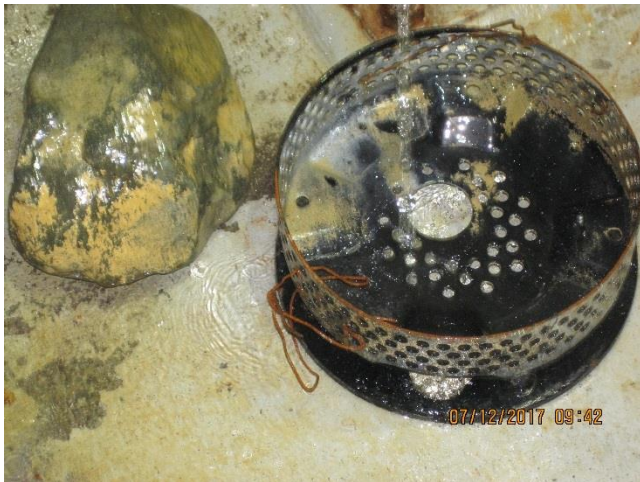
Below the discharge turbidity meter for treated mine site water, a small amount of white material was observed on the test rock (Photo 5). Coeur Alaska has submitted a proposal to the Alaska Department of Environmental Conservation (ADEC) to use Calcium Chloride (CaCl_2) as a coagulant to help remove the white material out of solution.

Photo 5. The test rock and metal screen used for white material accumulation.

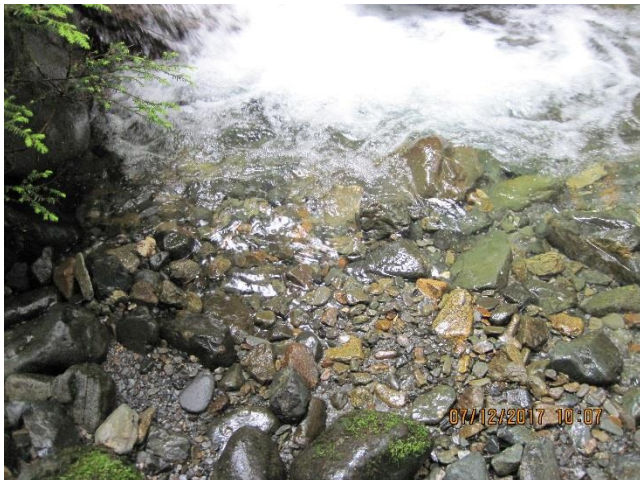
White material was not observed in Sherman Creek during this inspection (Photo 6).

Photo 6. Sherman Creek Outfall.

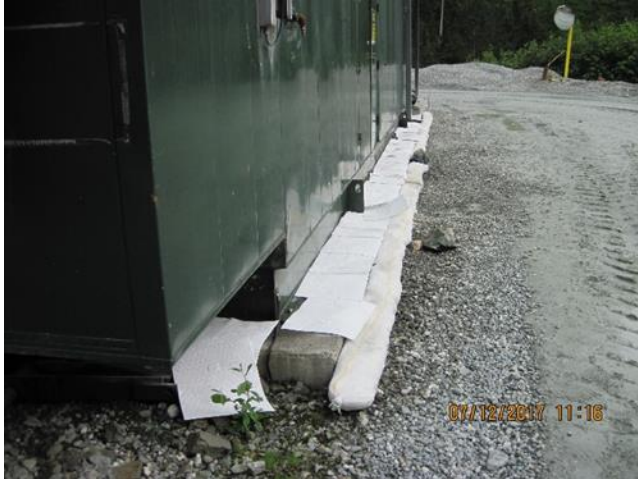
On July 8 2017, fifty-five gallons of diesel fuel leaked inside the housing unit for generator number seven (Photos 7-8) with approximately five gallons of diesel fuel reporting to land. The leak was caused by a faulty fuel filter's gasket, which failed and allowed fuel to be leaked inside the housing unit. Coeur Alaska personnel heard an alarm due to generator seven not receiving any fuel. Coeur Alaska personnel observed fuel flowing from the filter, and immediately placed hydrocarbon containment booms and absorbent pads on the concrete pad inside and outside of the generator. Contaminated gravels and soils (Photo 8) were removed and shipped off site to Clean Harbors for disposal. The spill was reported to ADEC due to the quantity of fifty-five gallons spilled inside the housing unit and five gallons reporting to land (2016 Coeur Alaska Plan of Operations pages 104-105). As a precaution, absorbent pads and hydrocarbon containment booms remain in place until the area can be thoroughly inspected for any residual fuel.

Photo 7. Generator 7 is where 5 gallons of diesel fuel leaked out onto the ground (Image 1 of 2).

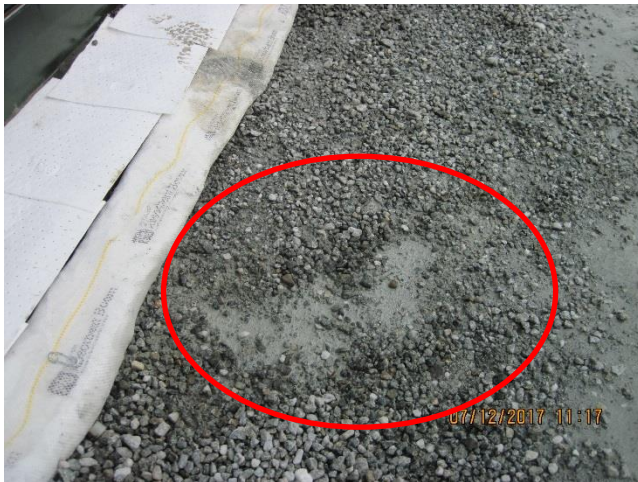
Photo 8. The area circled in red is where the 5 gallons of fuel reported to land.

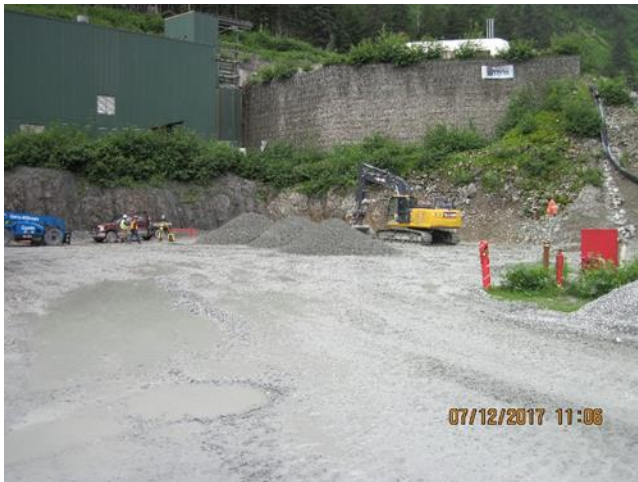
Contractors have begun excavation for the four new generator's concrete foundation pad (Photo 9). The current seven generators are near the end of their ten-year operating life.

Photo 9. Contractors have begun construction of the foundation pad for the four generators at the mill.

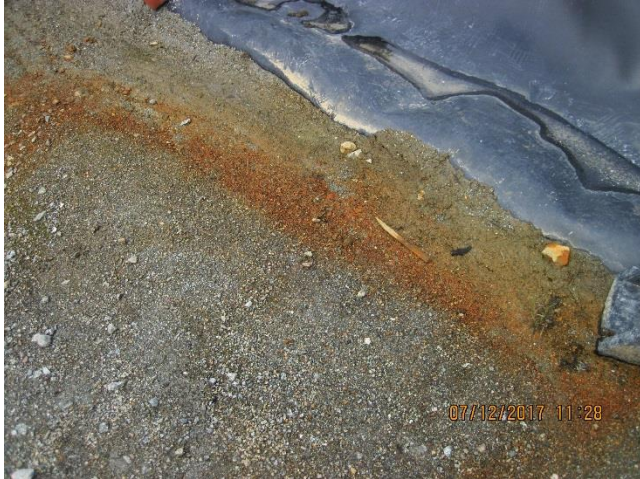
During the previous inspection on 6/8/2017, reddish water was observed on the surface near the edge of an HDPE liner used to contain a Graphitic Phyllite (GP) stockpile. During this inspection, no leaks were observed in the liner. However, there is water under the liner, which should be pumped out. A minor spill may have occurred during the last pumping of water from the liner, which may be why reddish water was observed on the ground (Photo 10). The HDPE liner for the GP stockpile has two water collection drains that collect water above and below the liner.

Photo 10. The reddish-stained ground may be a result of ARD water spillage.

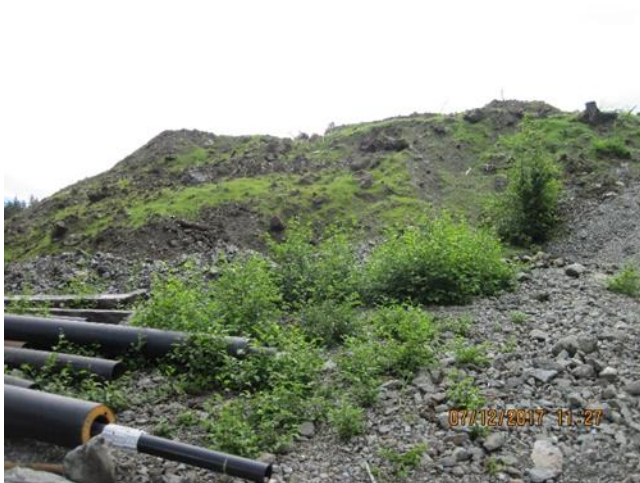
The 8,000 yd^3 of reclamation soil stockpiled at this location was hand seeded and grass is germinating (Photo 11).

Photo 11. 8,000 yd³ of reclamation soil was hand seeded at the Mud dump.

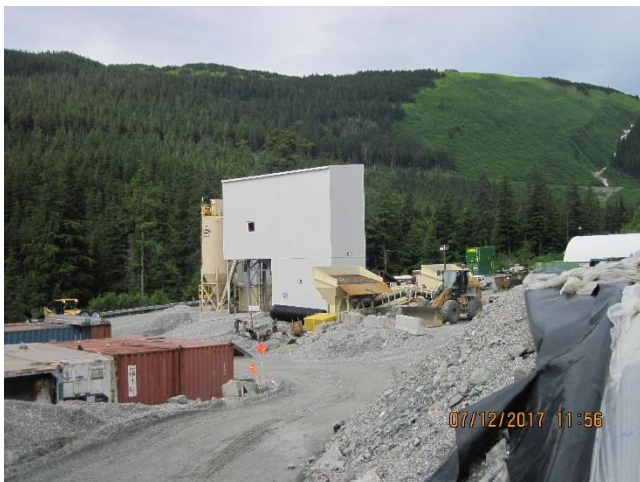
The Pug plant (Photo 12) is currently offline due to mechanical problems. The parts have been ordered and once the repairs are made, the Pug plant and all other ancillary equipment will resume operations for the remainder of the summer season.

Photo 12. Pug plant at Pit 4.

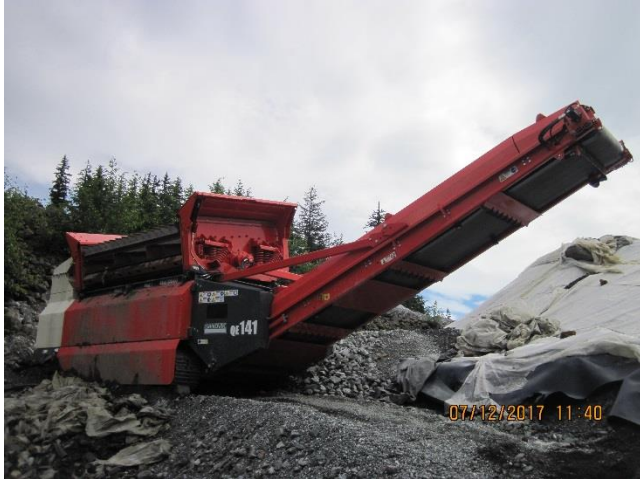
To prevent rocks greater than 5 inches in diameter from getting stuck in the Pug plant’s grizzly, Coeur Alaska is using a screen-deck shaker plant (Photo 13) to separate large rocks (greater than 5 inches in diameter) from smaller rocks (five inches in diameter or less). The smaller rocks are loaded into the Pug plants hopper with the larger rocks being stockpiled next to the rock shaker and later incorporated directly into the trucks of cement paste for disposal underground. Since the last inspection on 6/8/2017, the volume for a GP stockpile (Photo 14), located behind the Pug plant, has been reduced. The GP material is being encapsulated in cement at the Pug plant. When the GP material is not being utilized as an aggregate for cement backfill, the temporary liner should completely cover the remaining material to prevent oxidation/acid generation.

Photo 13. The rock shaker at Pit 4.

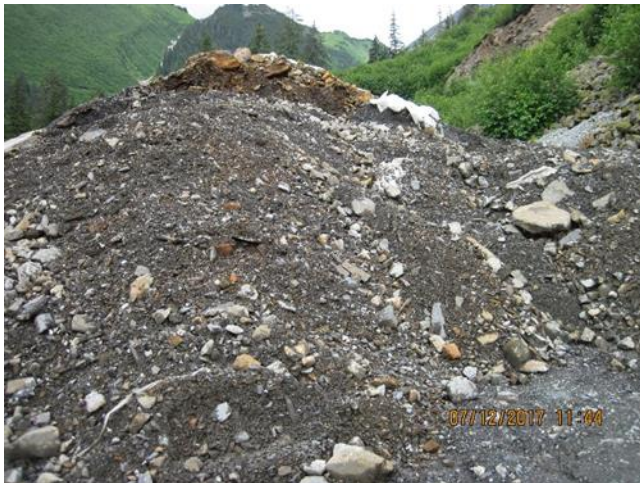
Photo 14. The GP stockpile that is currently being used for aggregate at the Pug plant.

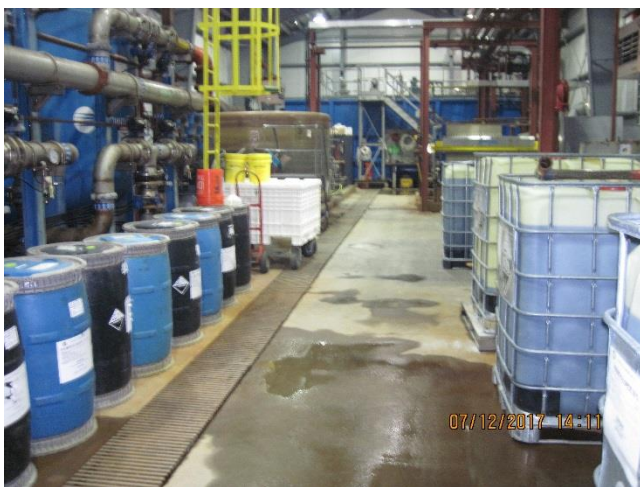
The water level for the TTF on 7/12/2017 was 697.9 feet. The TTF water treatment plant was treating 1370 gallons of water per minute. The water treatment plant was tidy and in order (Photo 15).

Photo 15. TTF water treatment plant.

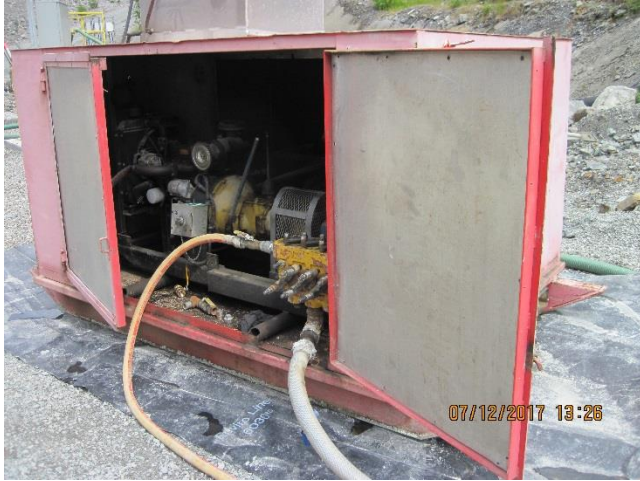
Coeur Alaska will begin geotechnical drilling (Photos 16-18) in the TTF area beginning in mid-July.

Photo 16. A generator for a geotechnical drilling pad is staged in the southern TTF area.

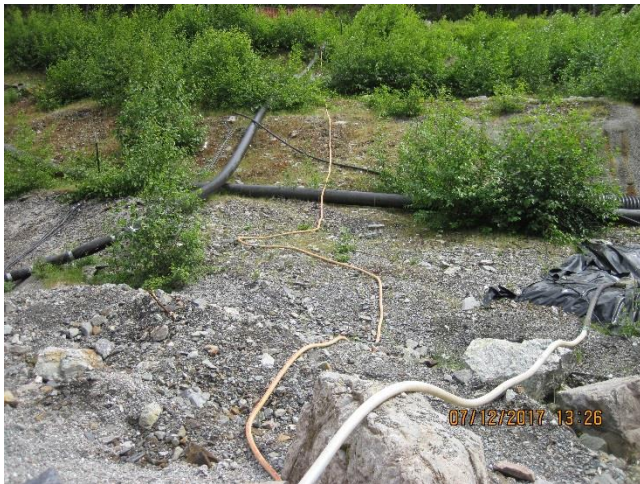
Photo 17. Water hoses for the geo-tech drilling pad located in the southern TTF area.

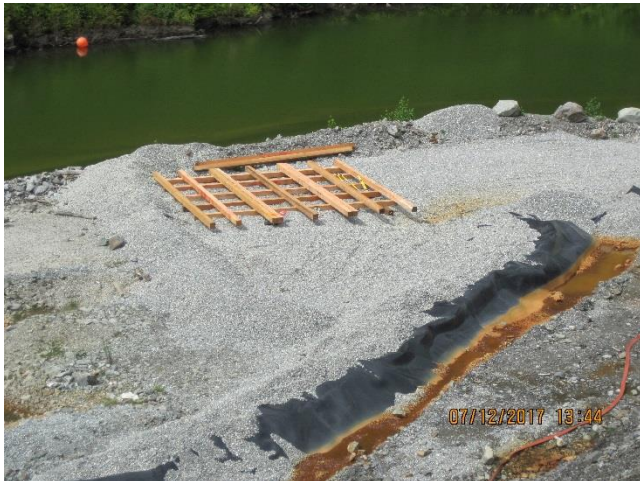
Photo 18. Staged lumber for a geotechnical drilling pad in the northern TTF area.

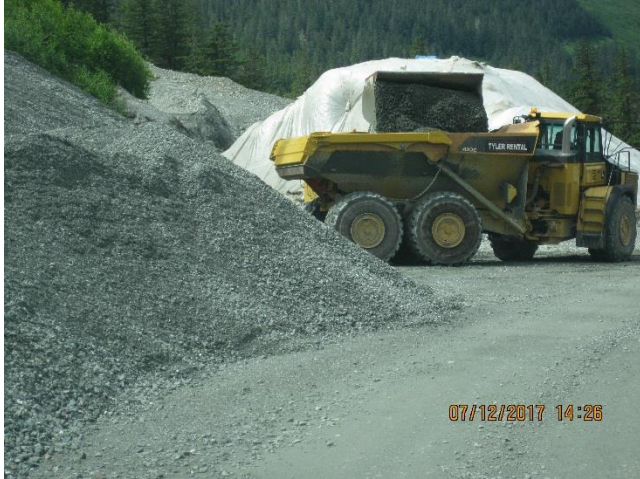
The gravel that is being loaded into a haul truck in Photo 19 will be utilized as the subbase for the construction of the four new generator’s concrete foundation pad.

Photo 19. Gravel from Pit 7 is being utilized as a subbase for construction at the Mill.

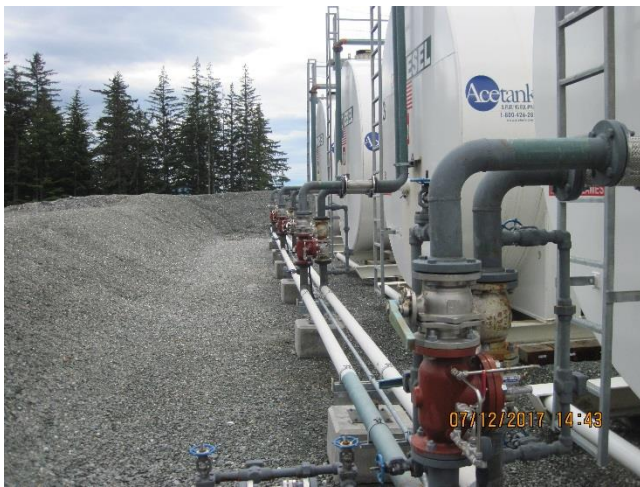
The fuel depot was well kept and orderly (Photos 20-21).

Photo 20. Fuel depot (Image 1 of 2).

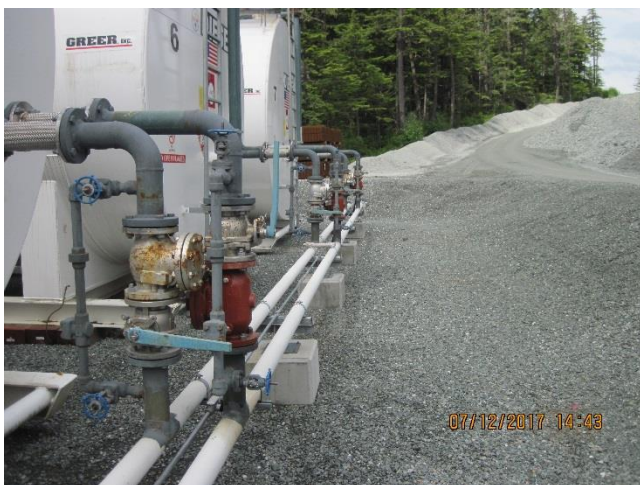
Photo 21. Fuel depot (Image 2 of 2).
