INSPECTION REPORT: KENSINGTON GOLD MINE

Date of Inspection: Tuesday November 28, 2017
Date of Report: Monday December 11, 2017
USDA Forest Service Inspector: Richard Dudek

Ranger District: Juneau Ranger District
Weather Conditions: Partly cloudy. Temperature: Low 30's °F.

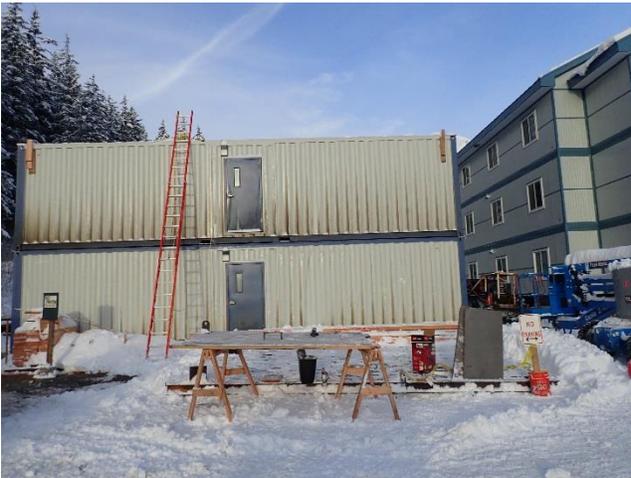
Coeur Alaska began staging a modular housing complex to be constructed at main (upper) camp (Photo 1). This will increase the living quarter's capacity by an additional eighty people.

Photo 1. New stackable living quarters located at the Kensington camp.

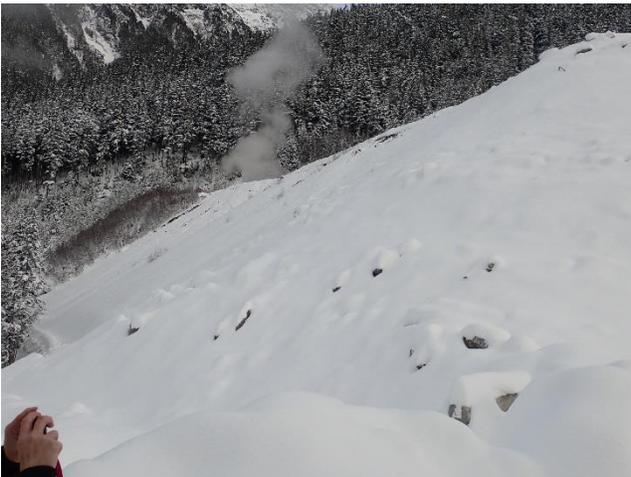
No additional waste rock has been stockpiled at this location (Photos 2).

Photo 2. The Comet development pile.

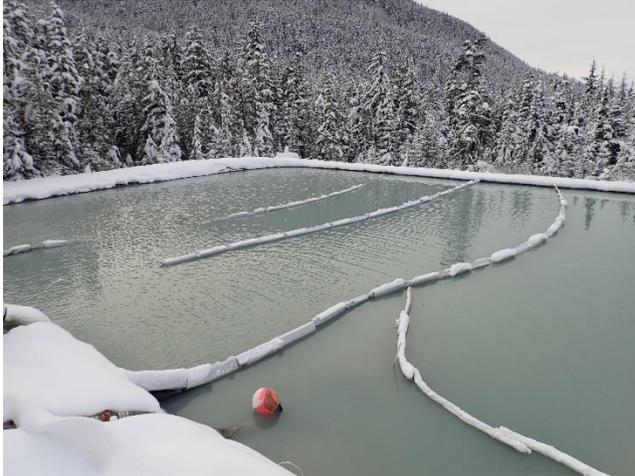
On the day of the inspection, the CWTP was treating 1,000 gallons of water per minute (gpm), and the monthly average is 1300 gpm. Pond-1 (Photo 3) was receiving mine site water, and Pond-2 (Photo 4) was receiving backwash from the CWTP. Good housekeeping practices (2016 BMP plan Table 4-1) were observed inside the CWTP (Photo 5).

Photo 3. CWTP Pond-1

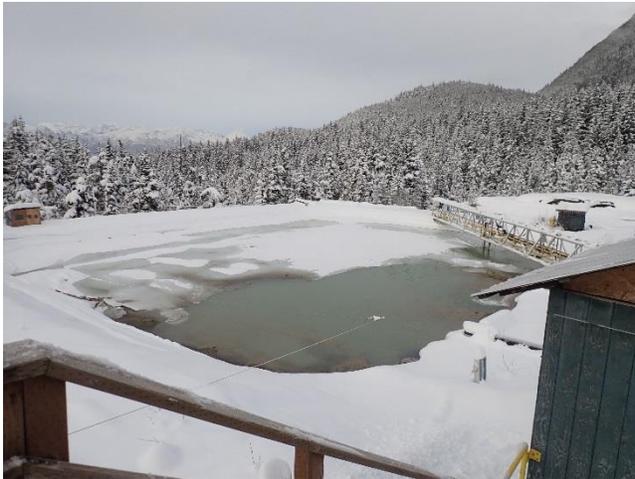
Photo 4. CWTP Pond-2

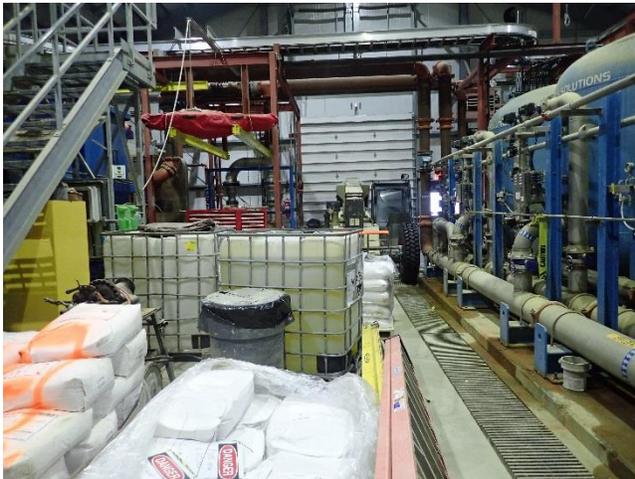
Photo 5. The Comet water treatment plant.

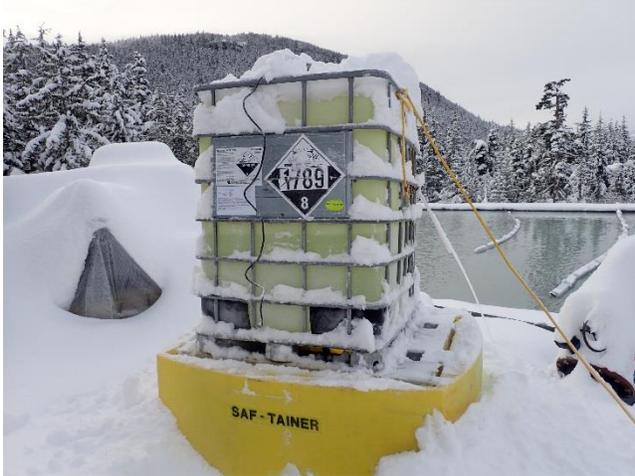
While grouting the Jualin exploration adit, some shotcrete accidentally entered the water pipeline that reports to Pond-1, which caused the water's pH to increase. Coeur Alaska self-reported a water quality 10-hour exceedance for high pH to the Alaska Department of Environmental Conservation (ADEC). To lower the water's pH in Pond-1, CWTP personnel applied hydrochloric acid (HCl) to Pond-1 (Photo 6). The pH levels have lowered to near neutral levels and HCl is no longer being applied to Pond-1.

Photo 6. A 300-gallon tote of hydrochloric acid staged within secondary containment.

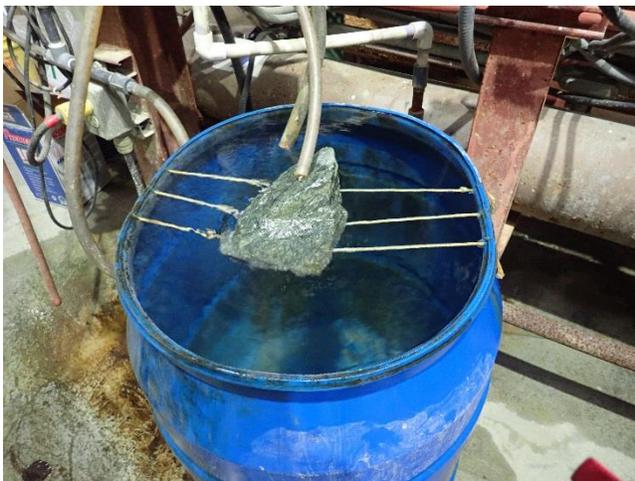
There was no white material on the test rock/barrel used for monitoring white material in treated mine site water (Photo 7).

Photo 7. The test rock/barrel for monitoring white material accumulation.

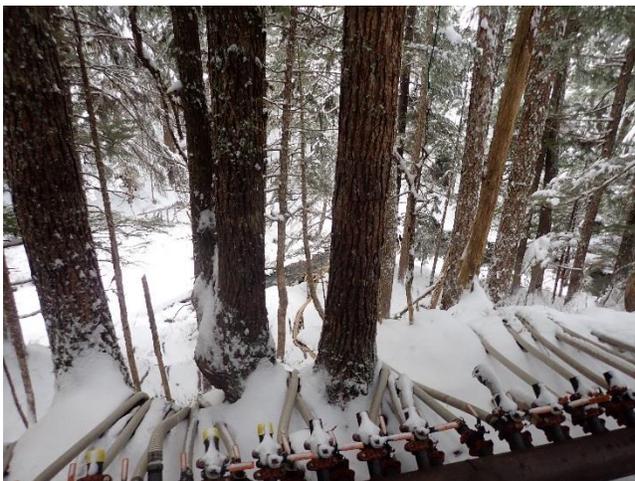
No white material was observed in Sherman Creek (Photo 8). These observations were made from the water discharge manifold for outfall 001 because the lower footpath was unsafe.

Photo 8. Sherman Creek outfall (Outfall 001).

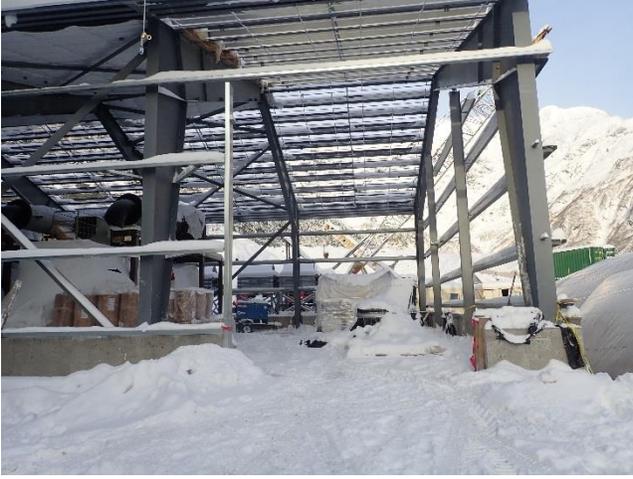
Contractors continue with the construction of the new powerhouse station (Photo 9). Coeur Alaska anticipates that the powerhouse will come online in the spring of 2018.

Photo 9. Contractors continue with the construction of the powerhouse steel structure.

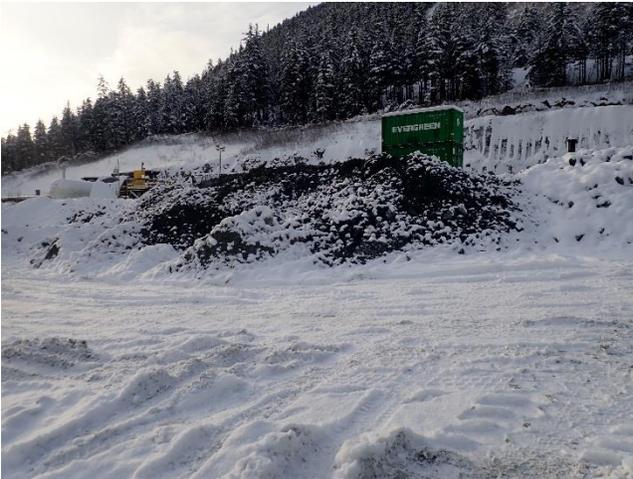
All waste rock generated from the underground workings is currently being deposited at the Kensington development pile (Photo 10).

Photo 10. The Kensington development pile.

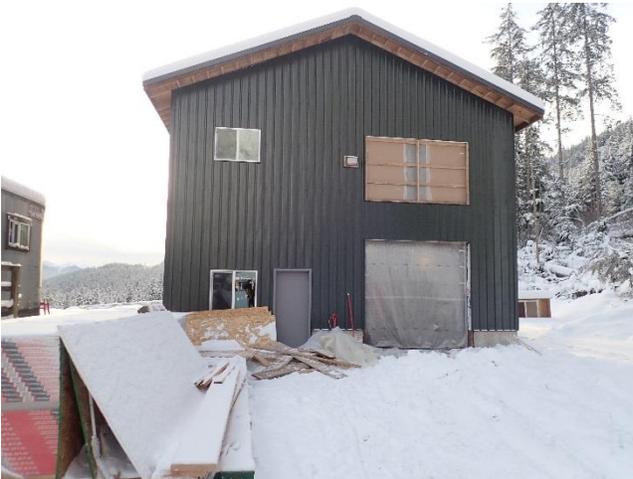
Contractors continue with construction of the new carpenters shop (Photo 11).

Photo 11. The new carpenters shop.

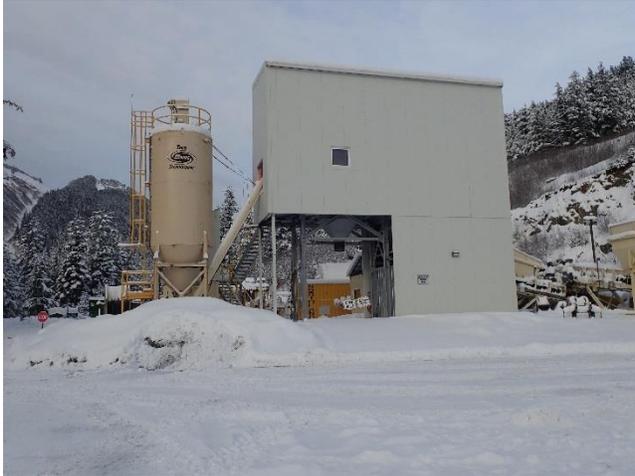
The Pug plant and X-ray sorter are inactive for the winter months (Photos 12-13). All pebble rock generated from milling is currently staged at the Kensington mill bench. A temporary liner covers the graphitic phyllite (GP) stockpile at Pit 4 (Photo 14).

Photo 12. The Pug plant at Pit 4.

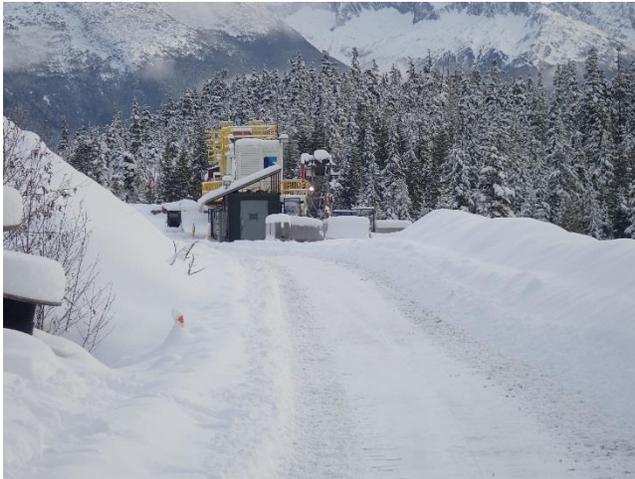
Photo 13. The X-ray sorter at Pit 4.

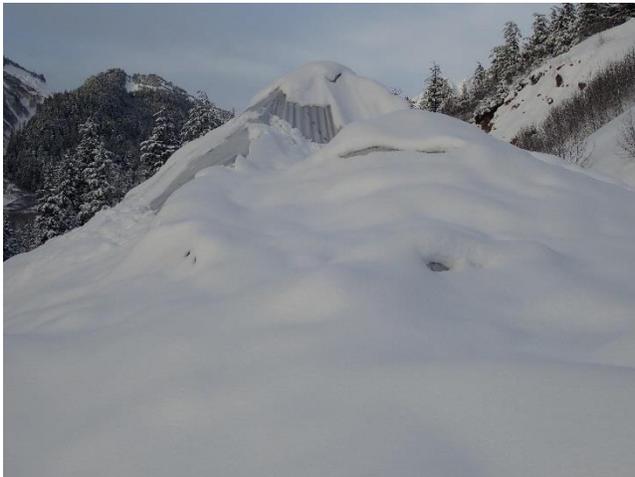
Photo 14. Snow covering the GP stockpile at Pit 4, which is covered by a temporary liner.

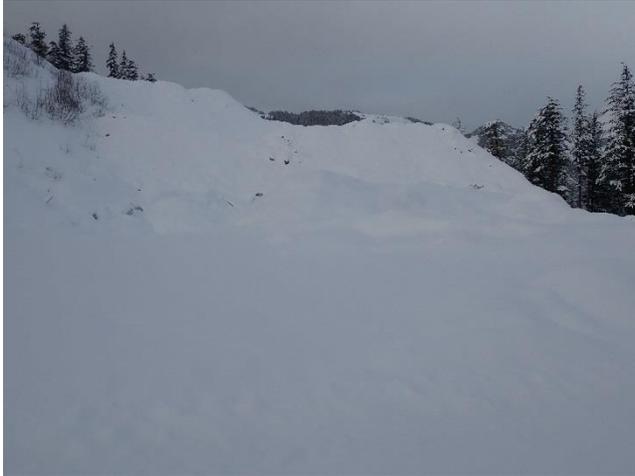
This site is inactive for the winter months. The GP stockpile is covered with a temporary liner (Photo 15), and the waste rock stockpiled at this location will be utilized for the 2018 TTF dam construction.

Photo 15. The remaining GP material is covered by a polyethylene liner and the separately stockpiled waste rock are both covered in snow at pit 7.

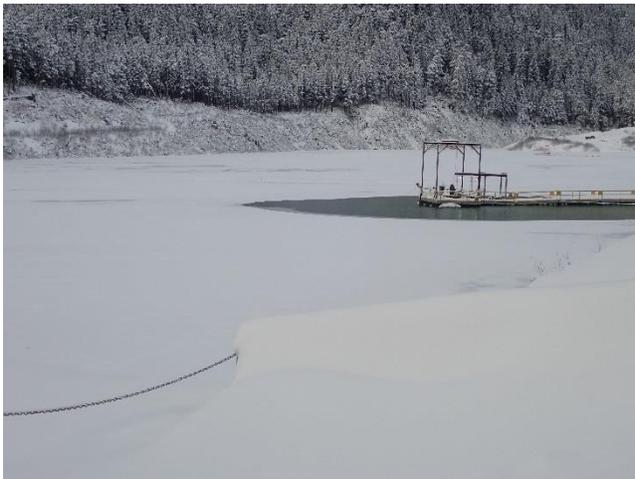
The TTF was mostly frozen over and the recorded water level on 11/28/2017 was 700.6 feet (Photo 16). The day of this inspection, the water treatment plant was treating 738 gpm and the monthly average is 695 gpm. Good housekeeping practices (BMP plan Table 4-1) were observed inside the water treatment plant (Photo 17). At the northern TTF area, the ARD collection sump was mostly frozen over and covered in snow (Photo 18).

Photo 16. The TTF with the water reclaim barge in the background.

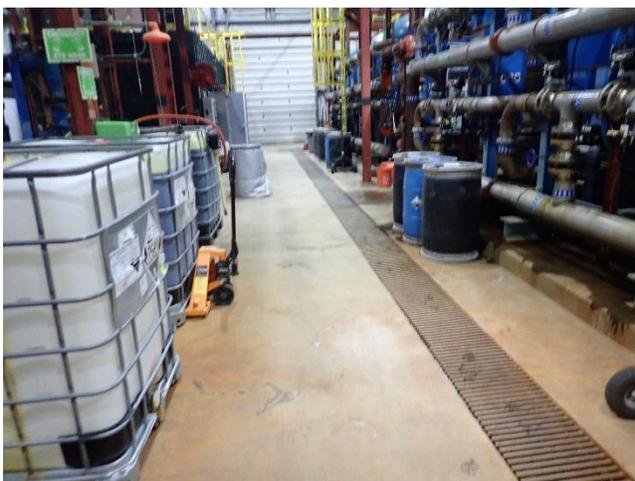
Photo 17. The TTF water treatment plant was tidy and in order.

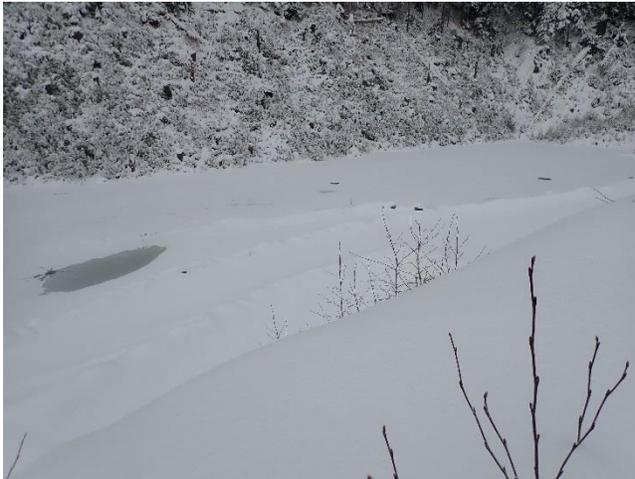
Photo 18. The ARD collection sump was frozen over and covered in snow.

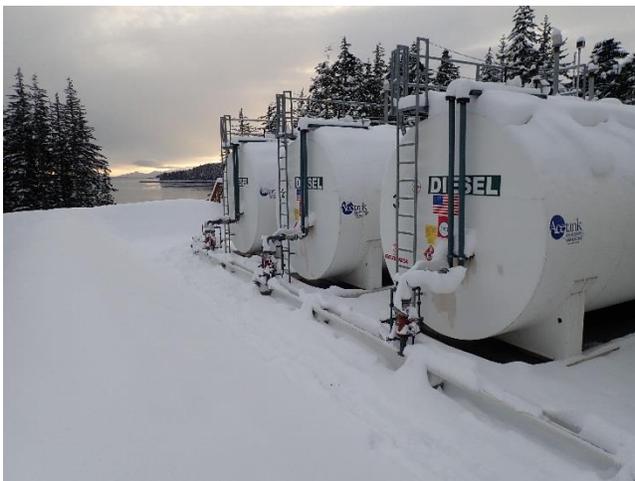
This site was tidy and in order (Photo 19-21).

Photo 19. The 50,000 gallon tanks at the fuel depot.

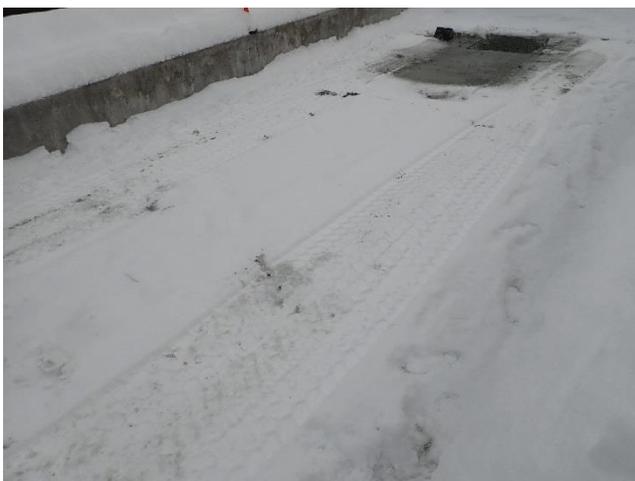
Photo 20. There were no apparent fuel spills on the concrete refueling pad.

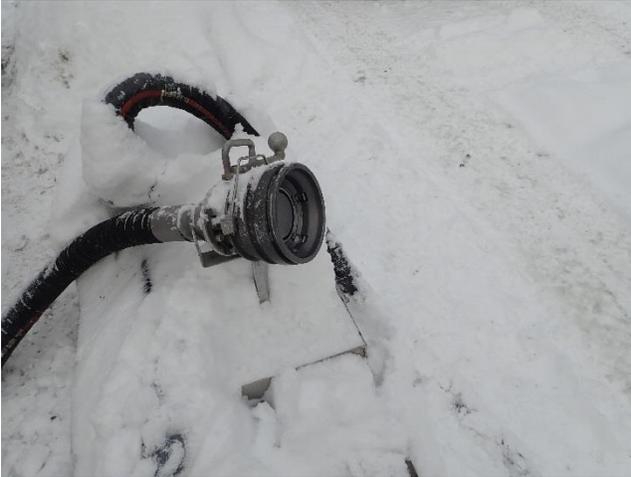
Photo 21. No small fuel spills were observed at the fuel transfer line.
