INSPECTION REPORT: KENSINGTON GOLD MINE

Tongass National Forest Minerals Group
8510 Mendenhall Loop Rd
Juneau, AK 99801
(907) 789-6275– office
(907) 586-8808 – fax

Date of Inspection: Thursday March 29, 2018
Date of Report: Friday April 20, 2018
USDA Forest Service Inspector: Richard Dudek

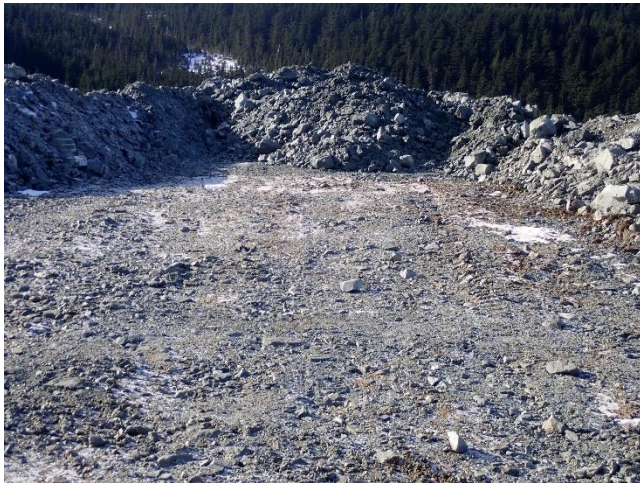
Waste rock from the Raven drift was recently deposited at this location (Photos 1-2).

Photo 1. The Comet development pile.

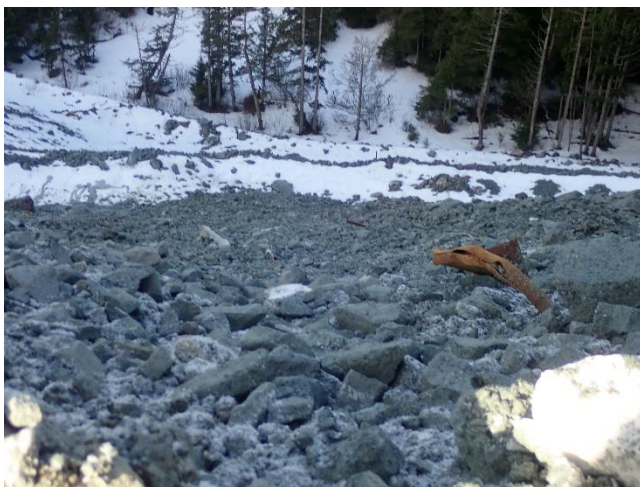
Photo 2. Recently deposited waste rock from the Comet side underground mine activities.

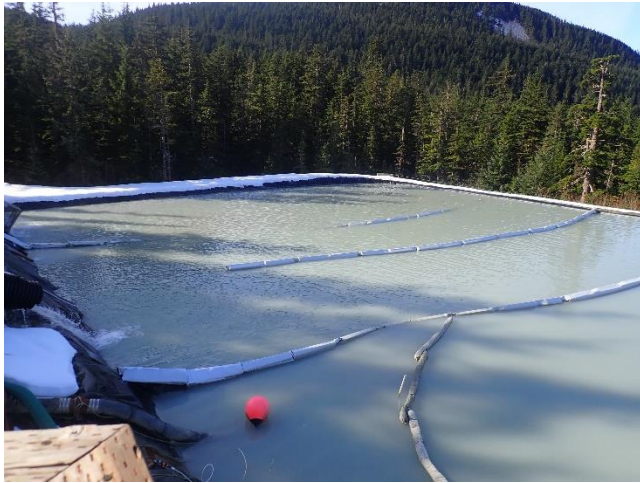
On 03/29/2018, the CWTP was treating 1,300 gallons per minute. Pond-1 (Photo 3) was receiving mine site water, and Pond-2 (Photo 4) was receiving backwash from the CWTP. It was observed that water was spilling over into Pond-2 (Photo 5). Both ponds require dredging, and Pond-1 will need new silt curtains installed. Coeur personnel frequently monitor Pond-2 to ensure the crest has at least 12 inches of freeboard. Good housekeeping practices (2016 BMP plan Table 4-1) were observed inside the CWTP.

Photo 3. CWTP's Pond-1 requires dredging and installation of new silt curtains.

- **The GP test barrels hoses need to be connected to the ARD collection barrels.**
- **Comet water treatment plant pond's 1 and 2 require dredging.**

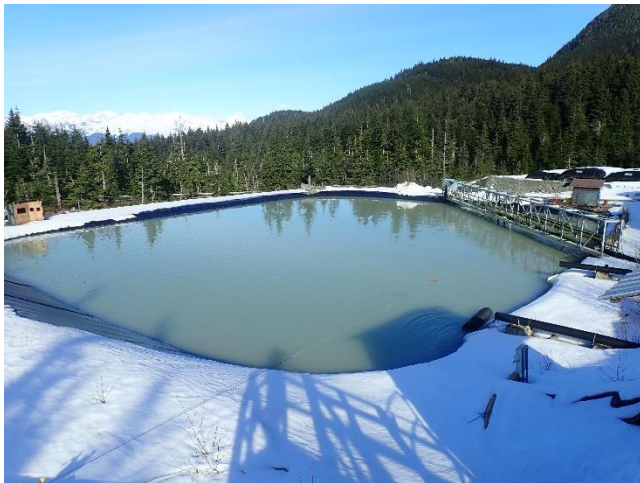
Photo 4. The CWTP's Pond-2.

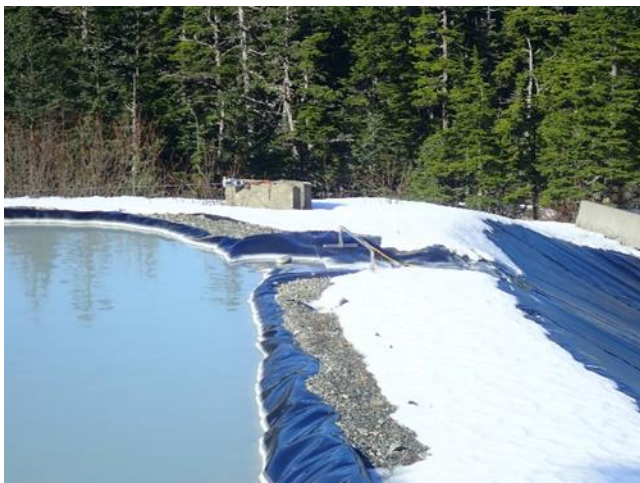
Photo 5. Water flowing over Pond-1's spillway and into Pond-2.

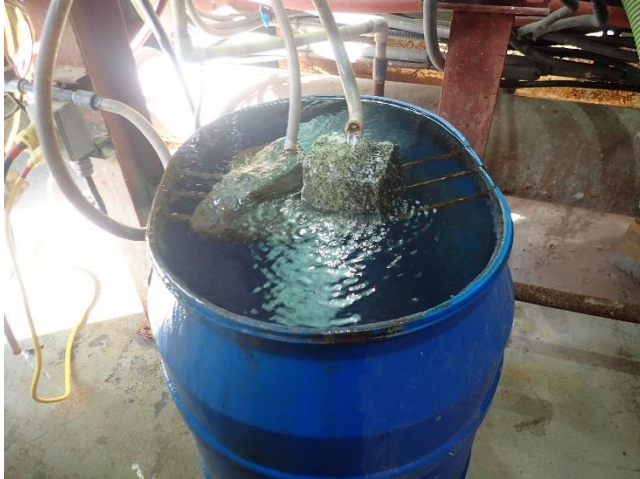
White material was not observed on the test rocks used for monitoring white material in treated mine site water (Photo 6).

Photo 6. The CWTP's test rocks for white material accumulation.

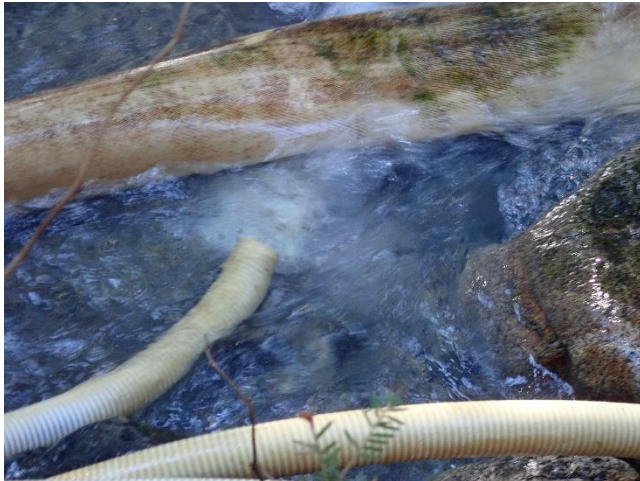
White material was observed in Sherman Creek (Photo7). However, since the inspection, Coeur Alaska has reported that there has been no white material observed in Sherman Creek.

Photo 7. White material observed at one outfall discharge hose.

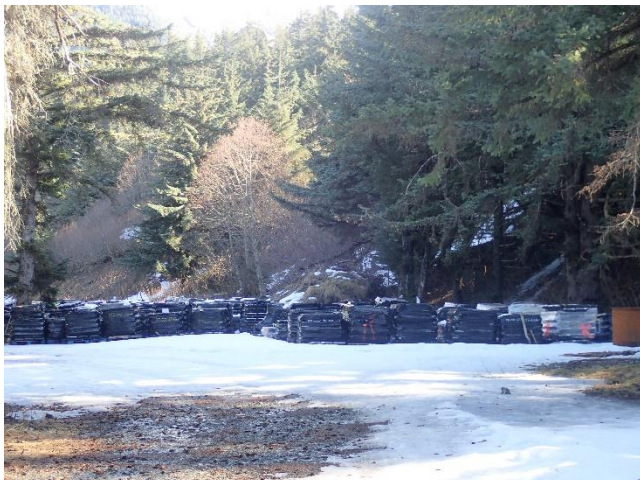
The area where rock core is being stored is on patented property (Photo 8).

Photo 8. Rock core from geotechnical drilling is staged at this location.

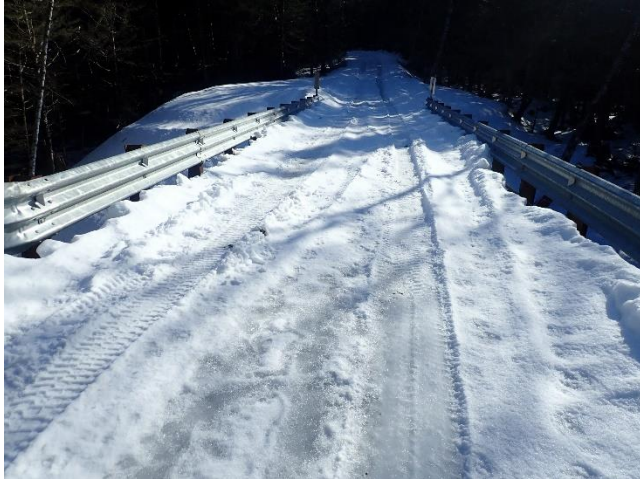
As warmer temperatures persist, both Sherman Creek and the South Fork of Sherman Creek Bridge abutments (Photos 9-10) will need to be frequently monitored for sediment loading caused by meltwater runoff.

Photo 9. The South fork Sherman Creek Bridge.

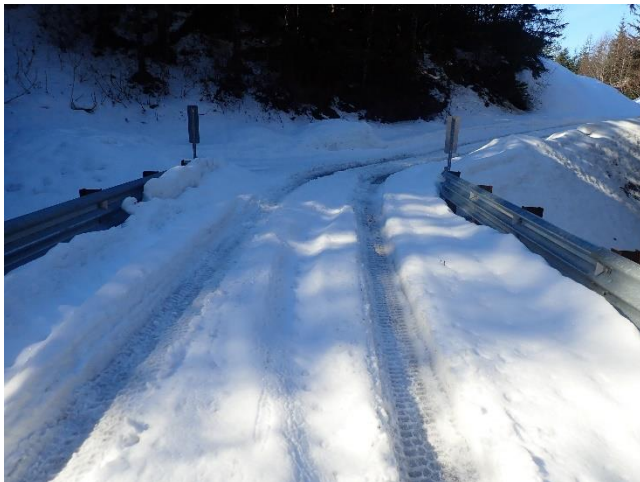
Photo 10. Upper Sherman Creek Bridge.

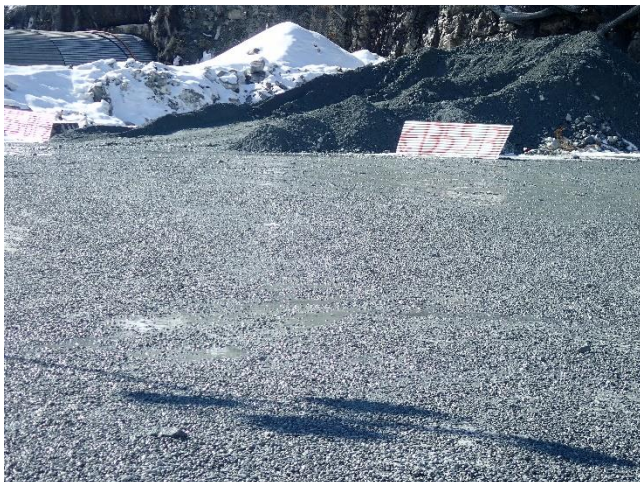
At the time of the inspection, ore from the 1355 level was being separately staged at the Kensington ore pad (Photo 11).

Photo 11. Ore from the 1355 level is being staged separately at the Kensington ore pad.

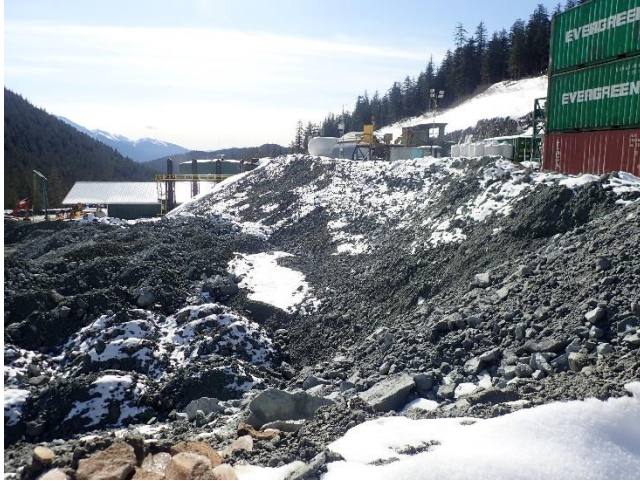
The waste rock (Photo 12) from this location is being temporarily staged at Pit 7, and will be used as fill material for the TTF stage 3 dam construction activities.

Photo 12. Coeur continues to remove waste rock from the Kensington development pile for the TTF dam expansion.

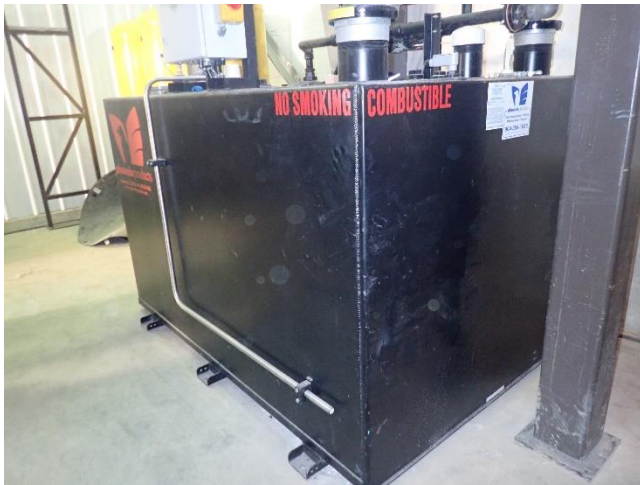
Contractors continue with the construction of the new powerhouse station. The 1,000 gallon tanks for the four generators have been staged inside the powerhouse (Photo 13).

Photo 13. 1,000-gallon fuel tanks are now staged behind all four new generators.

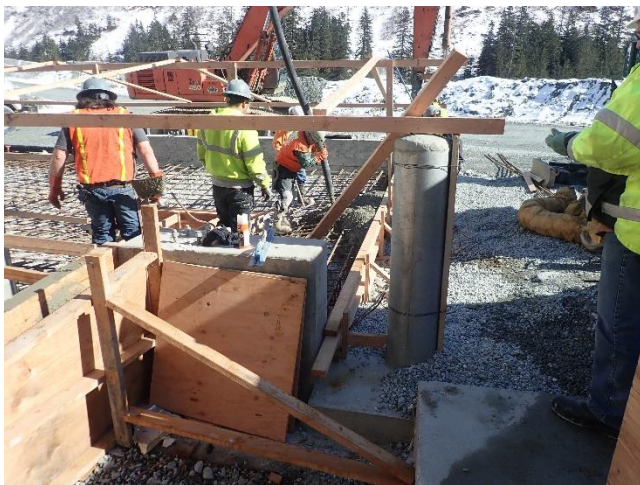
Site contractors were in the process of pouring cement for the new refueling pad (Photo 14).

Photo 14. Contractors pouring cement for the new refueling pad.

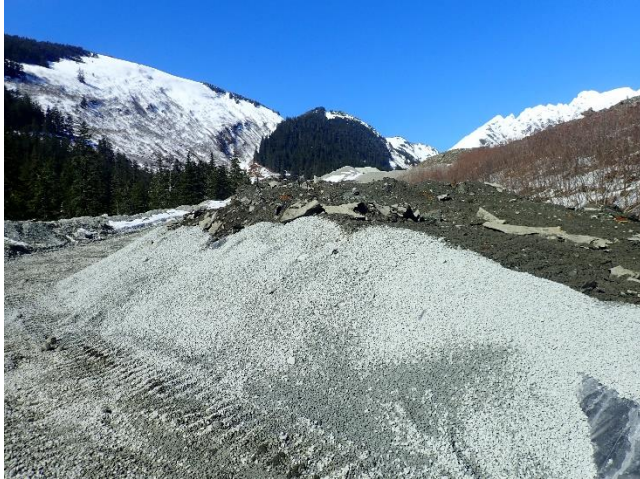
Coeur Alaska removed all of the Graphitic Phyllite (GP) material from Pit 7 and staged it at the Mud Dump (Photo 15). The GP material was placed on a layer of pebble rock that covers an HDPE liner.

Photo 15. GP material staged at Mud Dump's southern end.

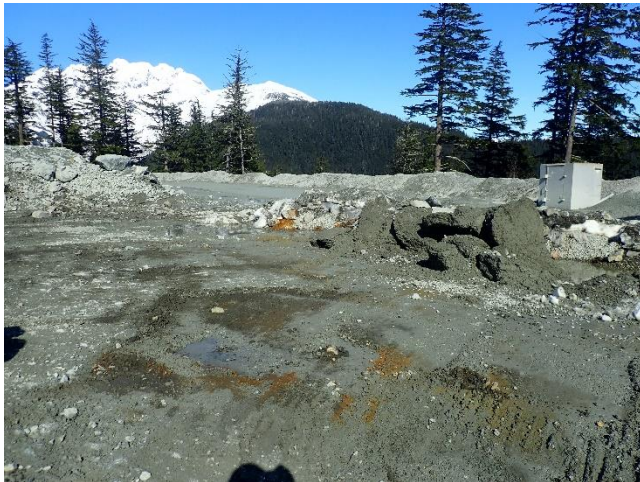
Additional waste rock will be staged at this location, and will be utilized as fill material for the stage 3 dam construction activities (Photo 16).

Photo 16. Additional waste rock for the stage 3 dam construction activities will be staged at Pit 7.

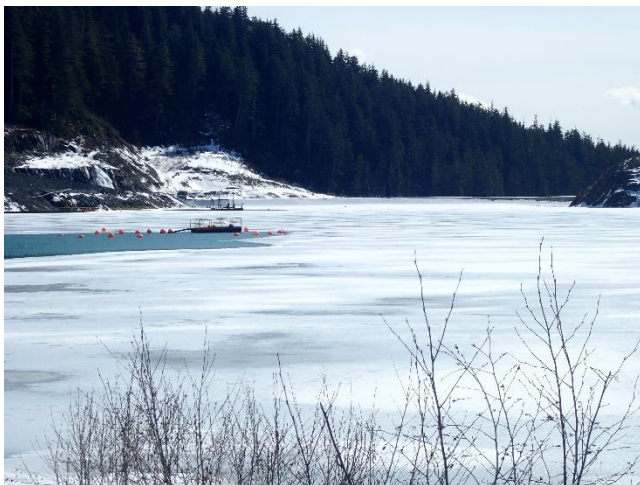
The TTF was partially frozen over and the recorded water level on 03/29/2018 was 702.8 feet (Photo 17).

Photo 17. The TTF.

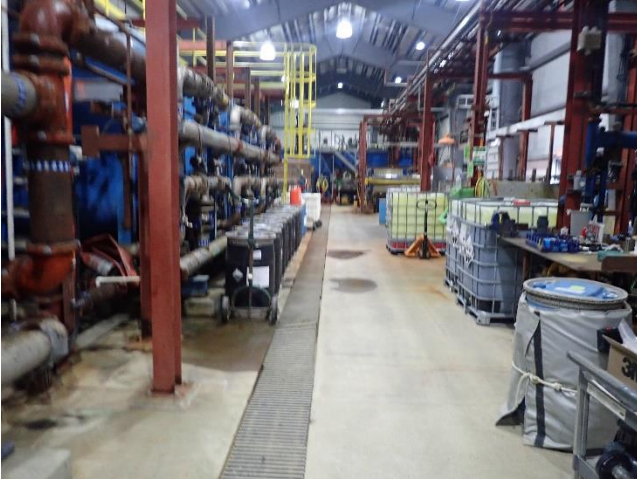
Good housekeeping practices (BMP plan Table 4-1) were observed inside the water treatment plant (Photo 18).

Photo 18. The TTF water treatment plant.

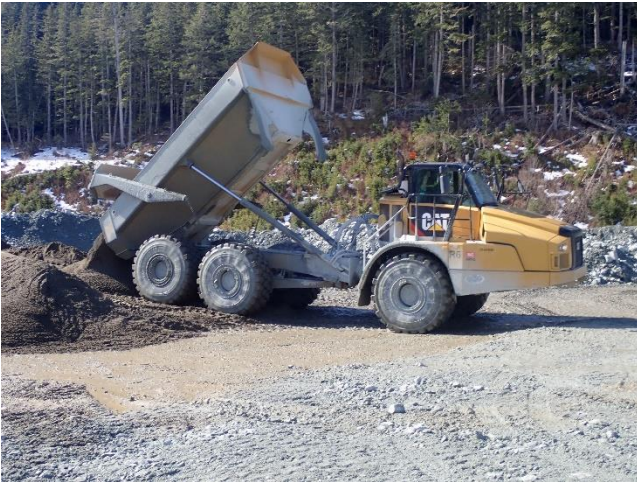
In the northern TTF laydown area, site contractors have begun staging sand and gravel (Photo 19) to be utilized as an aggregate for cement required for the Stage 3 dam construction. The lined ditch, which contains acid rock drainage (ARD) was frozen over and covered in snow.

Photo 19. Cement aggregates staged at the TTF laydown yard.

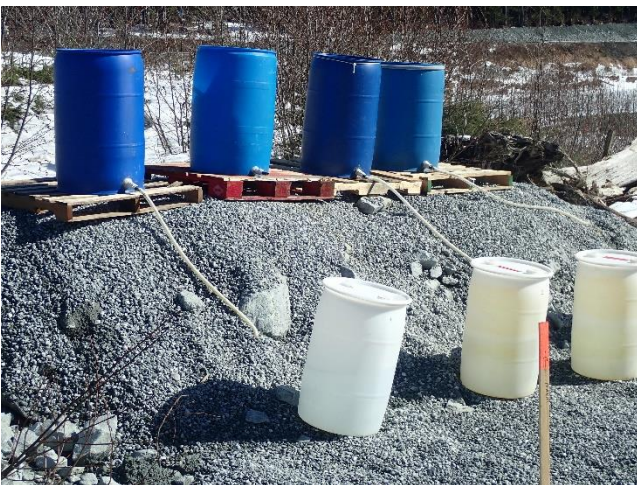
The Graphitic Phyllite (GP) cells (ARD test barrels) hoses were not connected to the ARD collection barrels (Photo 20). The hoses need to be connected to prevent ARD from escaping the barrels and flowing into the environment.

Photo 20. The ARD test barrels.

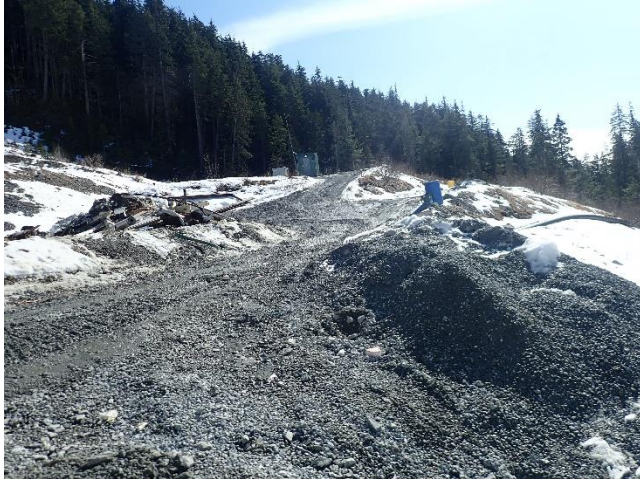
Below the dam, the decommissioned seep plant has been removed (Photo 21) for the preparation of the TTF dam's construction expansion.

Photo 21. The decommissioned seep plant was removed for the TTF's dam construction.

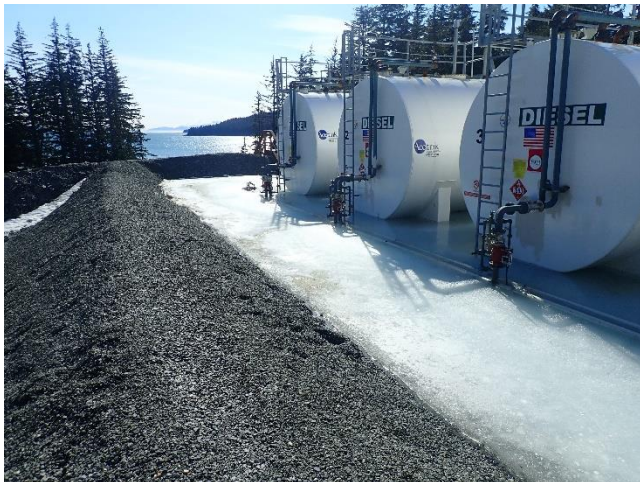
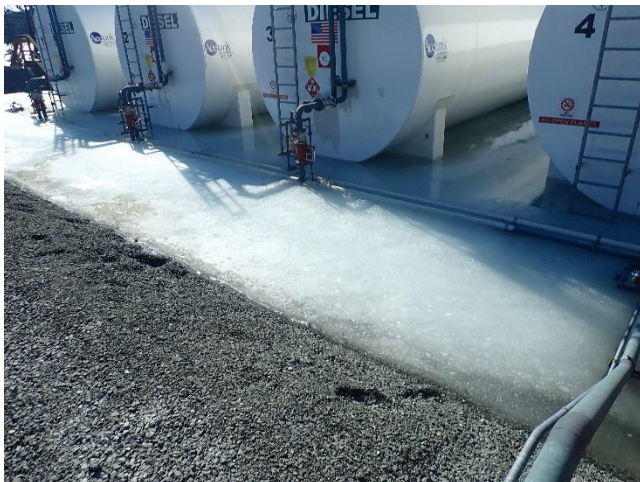
The fuel tank's structural gravel pad was covered by approximately three feet of melt water and ice (Photos 22-25). The Fuel Depot Operators will remove the accumulation when it is impacting the capacity to store 110% of the volume from a single tank.

Photo 22. The fuel depot.

Photo 23. Melt water and some ice covering the gravel pad.

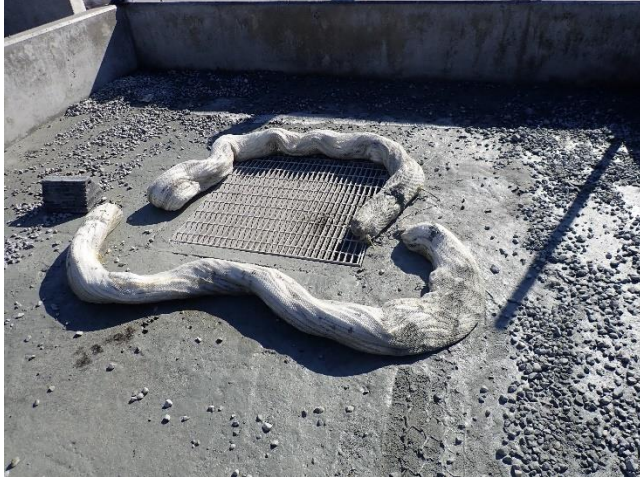
Photo 25. A hydrocarbon contamination boom was placed around the fuel depot's refueling pad's drain to capture small fuel spills.
