INSPECTION REPORT: KENSINGTON GOLD MINE

Date of Inspection: Wednesday April 24, 2019
Date of Report: Monday May 13, 2019
USDA Forest Service Inspector: Richard Dudek

Ranger District: Juneau Ranger District

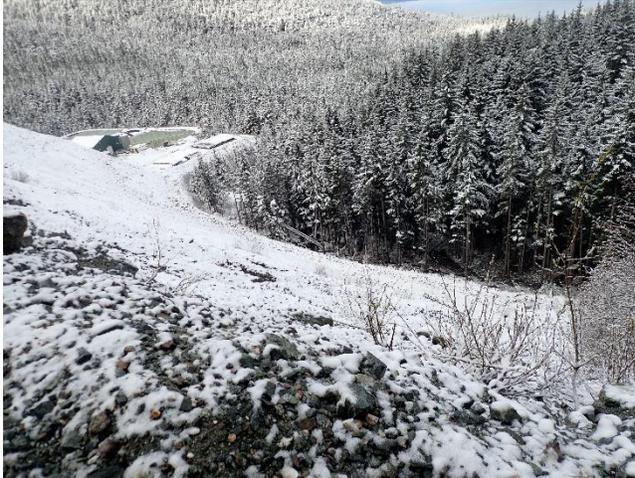
Photo 1. The Comet development pile.

Coeur Alaska continues to deposit waste rock from the Raven drift at this location (Photo 1).

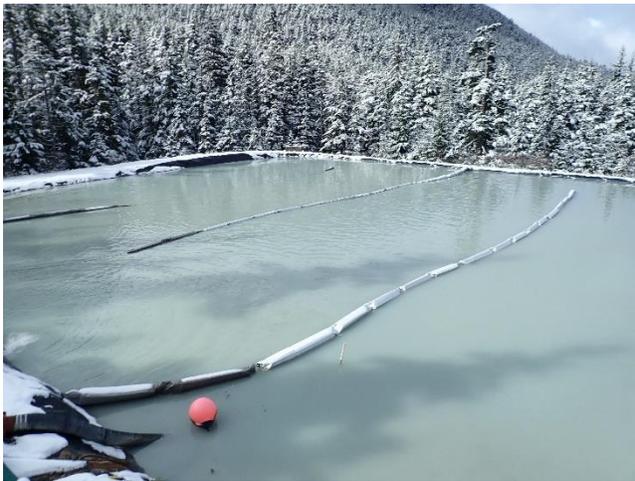
Photo 2. Pond-1.

On 4/24/2019, the CWTP was treating 1,438 gallons per minute (gpm). Pond-1 (Photo 2) was receiving mine site water. Pond-2 (Photo 3) was receiving backwash from the water treatment plant, and some overflow water from Pond-1.

Coeur Alaska will be dredging the settling ponds once temperatures at night stay above freezing and the old dewatering bags are replaced.

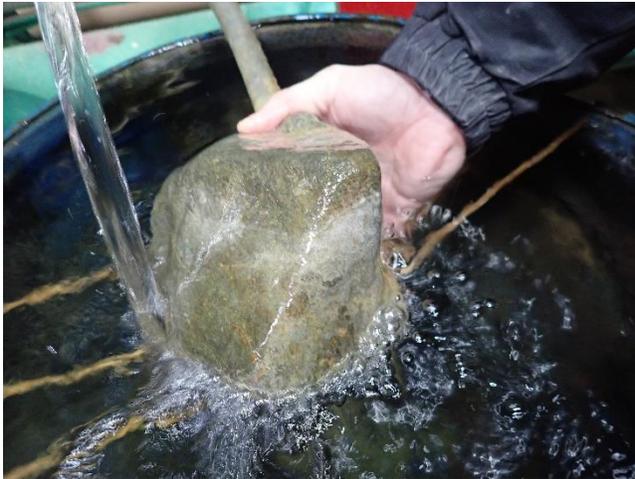
Photo 4. CWTP test rock.

White material was observed on the test rock used for monitoring white material in treated mine water (Photo 4).

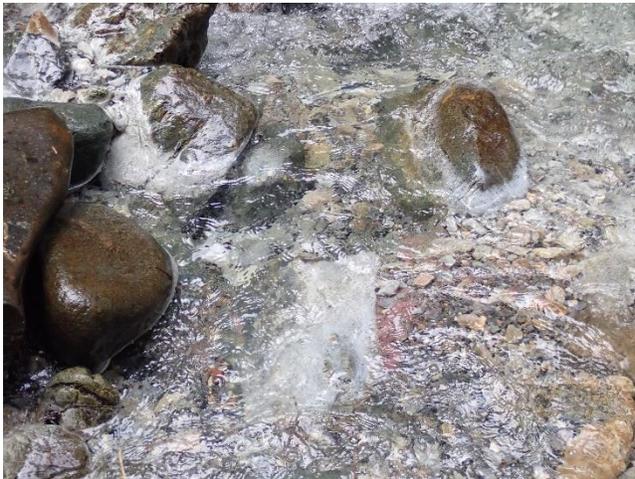
Photo 5. Sherman Creek.

White material was observed in the creek (Photos 5).

Inspect for white material in Sherman Creek.

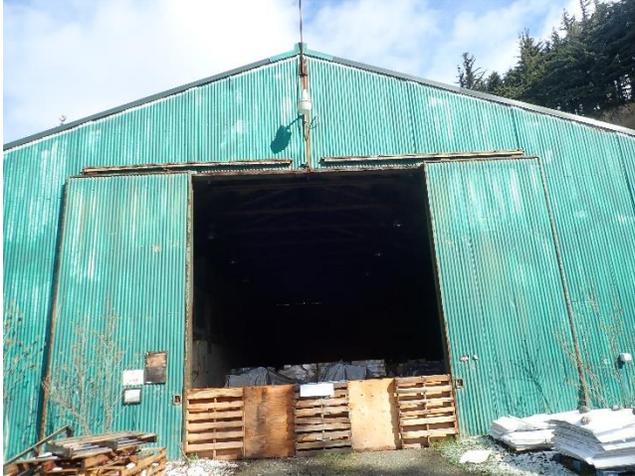
Photo 6. The Comet Beach core shed.

Coeur Alaska has started storing drilling cores at the Comet Beach warehouse (Photo 6-7).

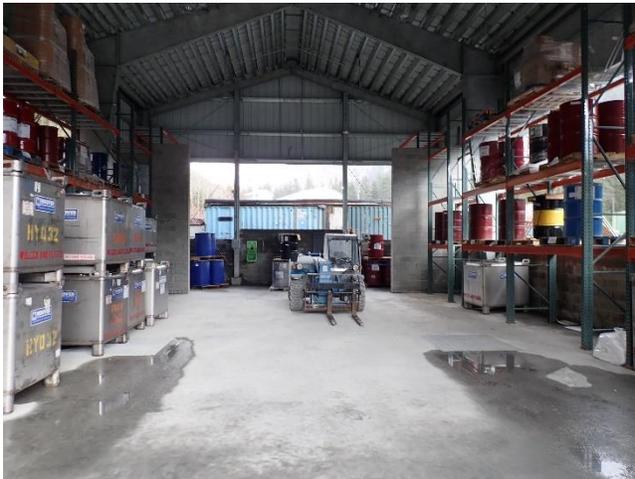
Photo 8. Cold storage facility.

The facility was tidy and in order (Photo 8).

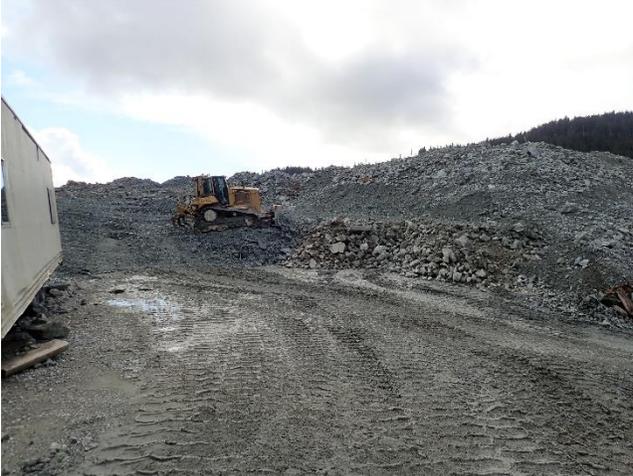
Photo 9. Pit 4 waste rock storage.

Approximately 59,000 cubic yards of waste rock is stockpiled at this location (Photo 9).

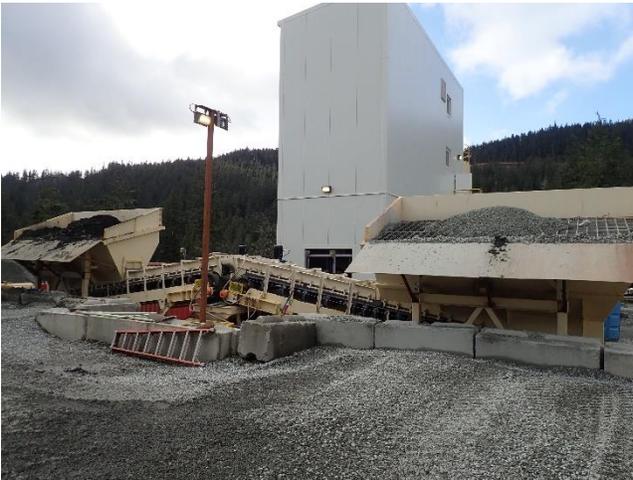
Photo 10. The pug plant.

In 2019, the pug plant has generated 7,500 tons of GP/cement underground backfill (Photos 10).

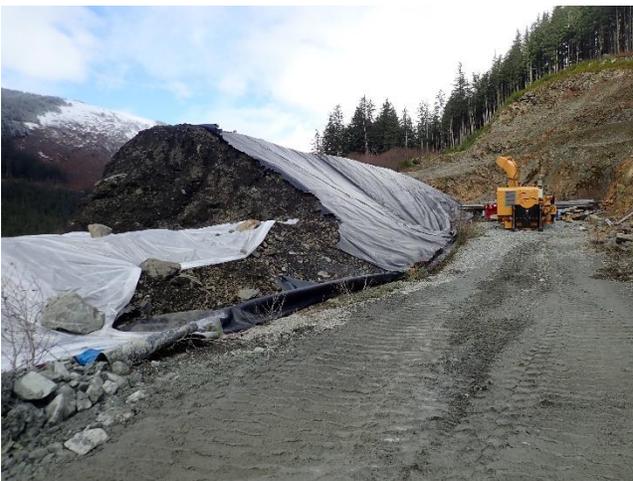
Photo 11. GP stockpile at pit 4.

The graphitic phyllite (GP) stockpile staged at Pit 4 is being utilized at the pug plant for cement underground backfill (Photo 11).

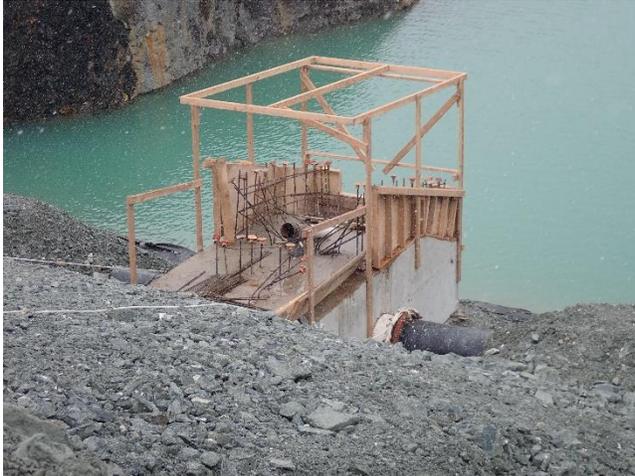
Photo 12. The TTF's dam low-level structure.

At the time of the inspection, contractors were prepping to pour concrete for the TTF dam's low-level structure (Photo 12).

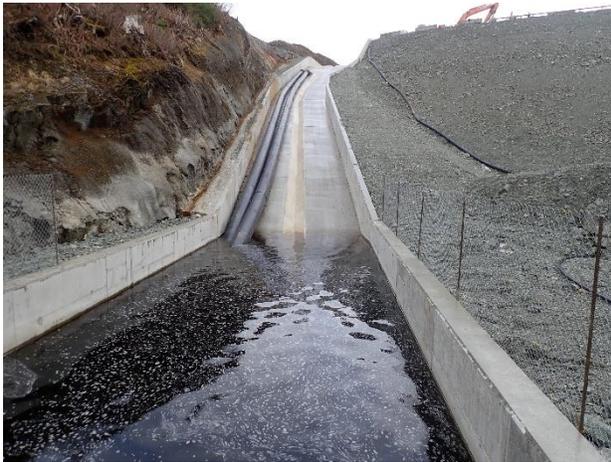
Photo 13. The dam plunge pool.

The dam spillway/plunge pool and the ARD seepage collection drain are working as intended (Photos 13-14).
