INSPECTION REPORT: KENSINGTON GOLD MINE

Date of Inspection: Wednesday July 17, 2019
Date of Report: Thursday July 25, 2019
USDA Forest Service Inspector: Richard Dudek

This inspection included the Access roads, Comet Development Pile, Comet Water Treatment Plant (CTWP), Sherman Creek Outfall 001, Kensington Mill area, Kensington lower camp, Pit 4, and the TTF area.

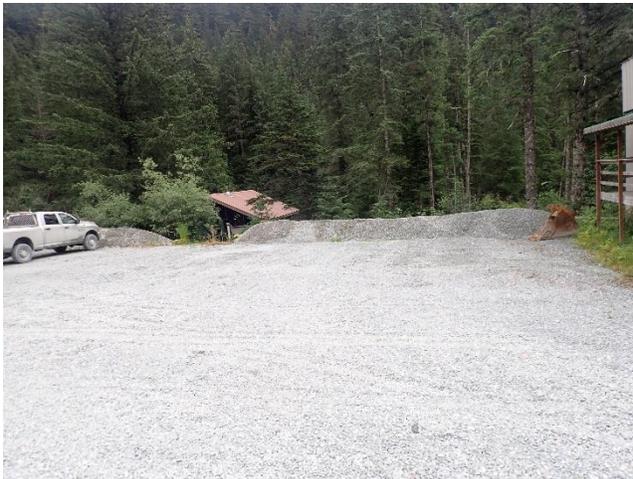
- **Coeur Alaska recently removed housing units (Photo 1) that were located at the lower camp to make room for the maintenance shop. These housing units will be shipped off site and refurbished by another company in Juneau.**

Photo 1. Housing units removed from the lower camp area.

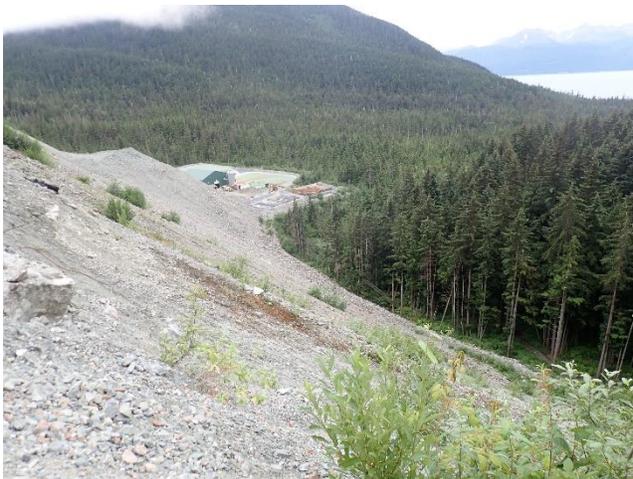
Waste rock from the Raven drift is being deposited at this location (Photo 2).

Photo 2. The Comet development pile.

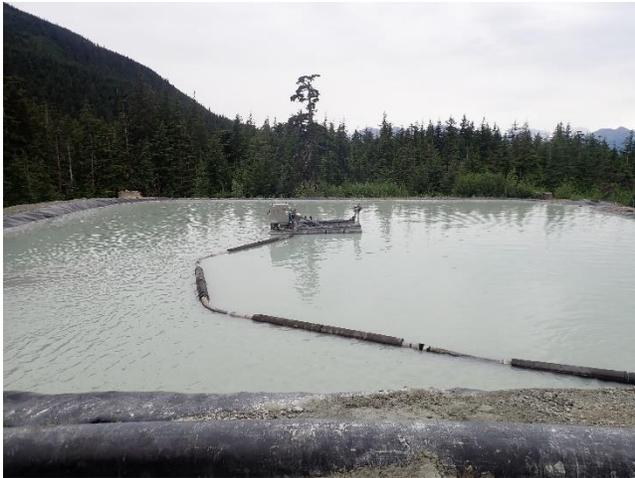
On 7/17/2019, the CWTP was treating 1261 per minute (gpm). Pond-1 (Photo 3) was receiving mine site water. CWTP operators were in the process of dredging Pond-1. This process takes about two to three weeks. Once the dredging for Pond-1 is complete, Coeur Alaska personnel will begin dredging Pond-2.

Photo 3. The dredge in operation at Pond-1.

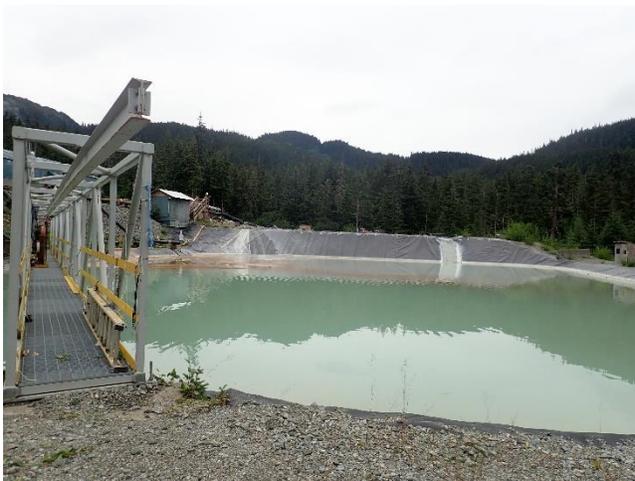
Pond-2 (Photo 4) was receiving backwash from the water treatment plant, and some overflow water from Pond-1.

Photo 4. Pond-2 receiving backwash from the treatment plant.

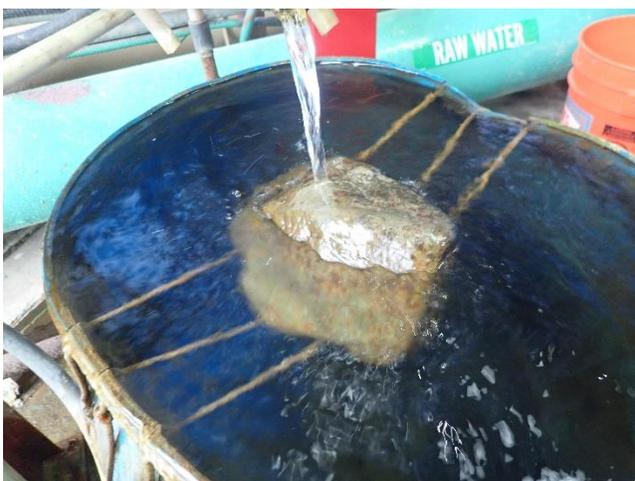
White material was not observed on the test rock used for monitoring white material (Photo 5).

Photo 5. The test rock for monitoring white material.

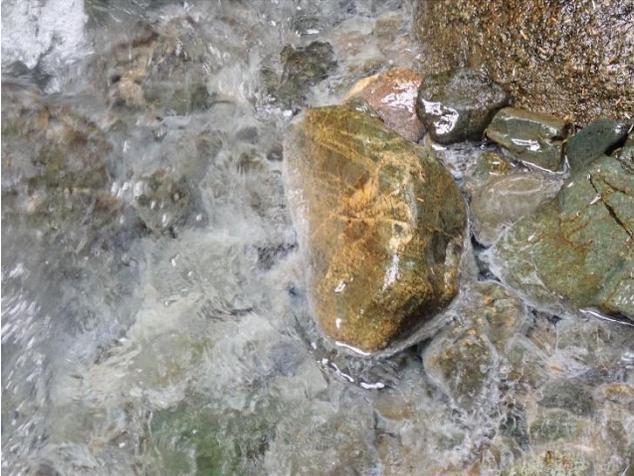
White material was observed in the creek bed (Photos 6-7). Coeur Alaska personnel continue to use calcium chloride (CaCl_2) as part of the treatment process for removing white material out of solution.

Photo 6. White material adhering to rocks.

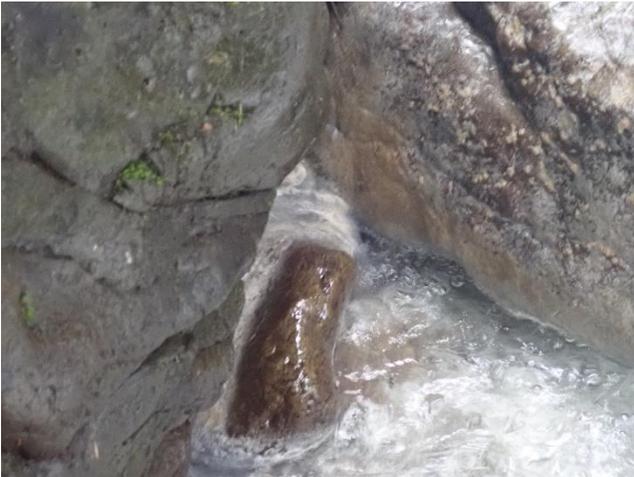
Photo 7. White material accumulation just downstream of outfall 001.

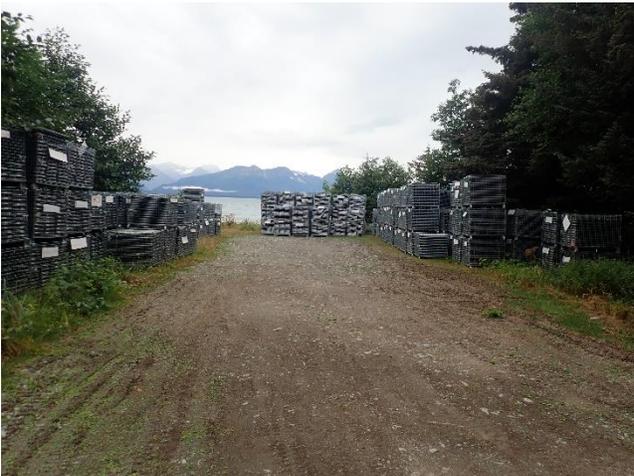
Coeur Alaska continues to stage surface exploration drilling core at this location (Photo 8).

Photo 8. Staged drill core at the Comet Beach area.

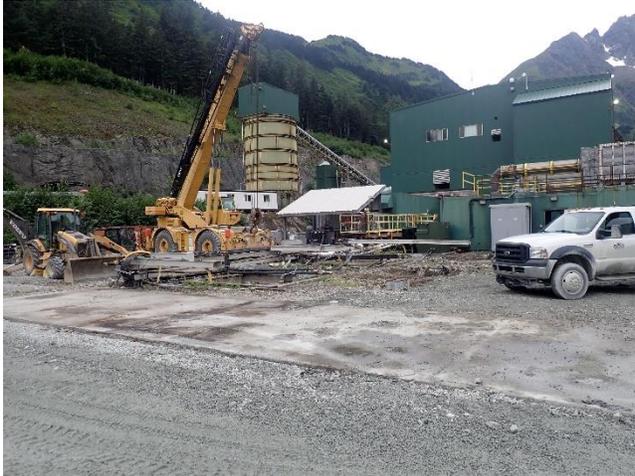
Coeur Alaska personnel have begun removing the old generators and the associated equipment from the site (Photo 9).

Photo 9. The removal of the decommissioned generators.

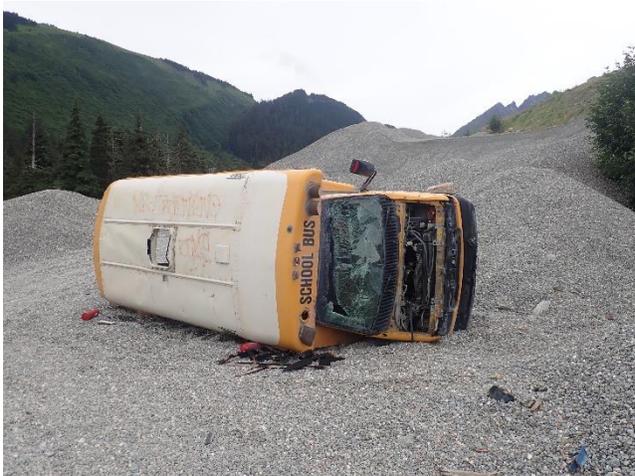
Mine Rescue staff are using an old out of commission school bus for emergency training exercises (Photo 10). It was also observed that all fluids were removed prior to staging the bus for training.

Photo 10. A mini-bus staged for emergency rescue training.

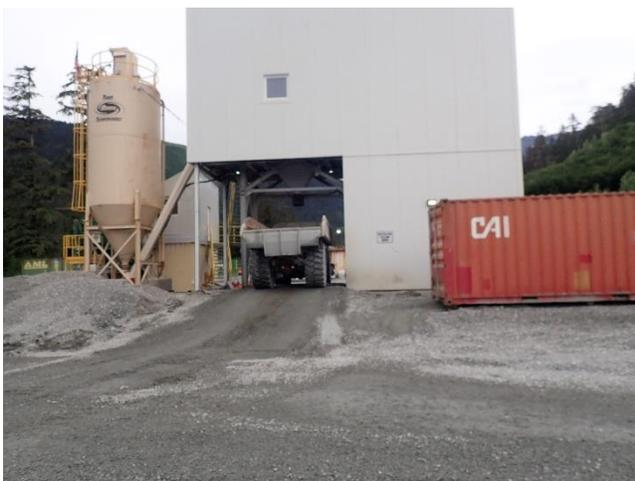
Coeur personnel continue to use the graphitic phyllite (GP) stockpile that is staged at Pit 4 for cement underground backfill (Photo 11). Approximately 7,500 tons of GP/cement mix has been generated for underground backfill.

Photo 11. A parked haul truck waiting for a batch of GP cement mix.

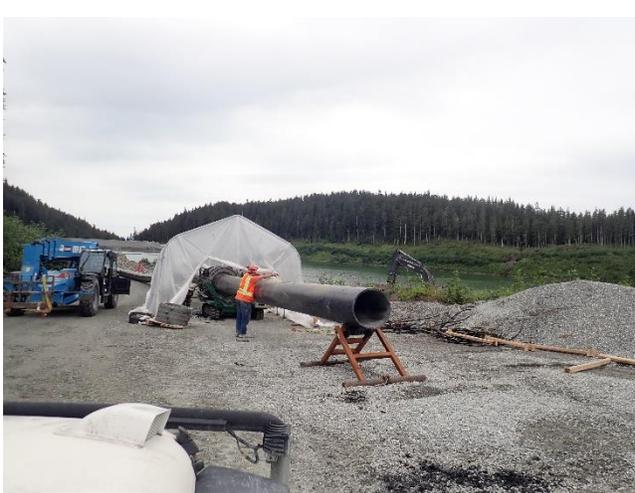
At the time of the inspection, Coeur Alaska personnel were fusing together sections of HDPE pipe that will be used as the second diversion pipeline (Photos 12-13).

Photo 12. Coeur Alaska personnel fusing together sections of HDPE pipe.

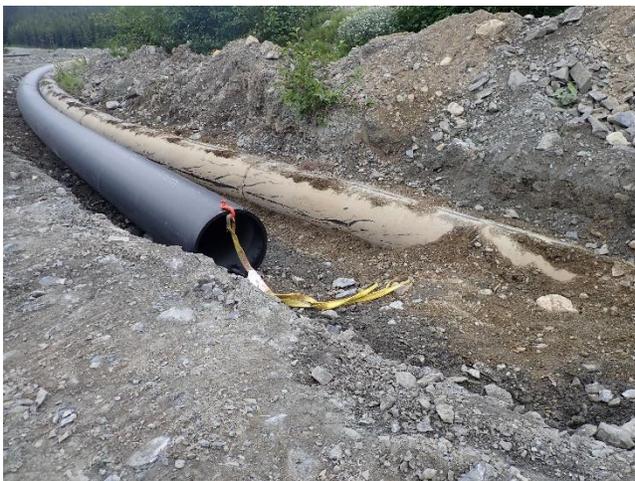
Photo 13. The fused HDPE pipe is being routed to the stage 3 dam.

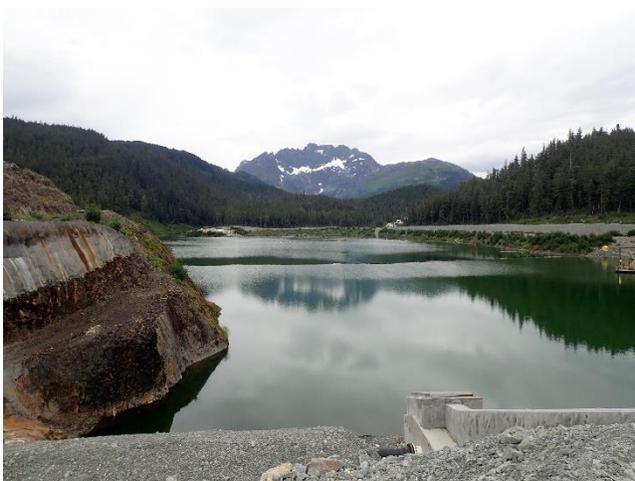
The TTF's recorded water level on 7/17/2019 was 704.85 feet (Photo 14).

Photo 14. The TTF.

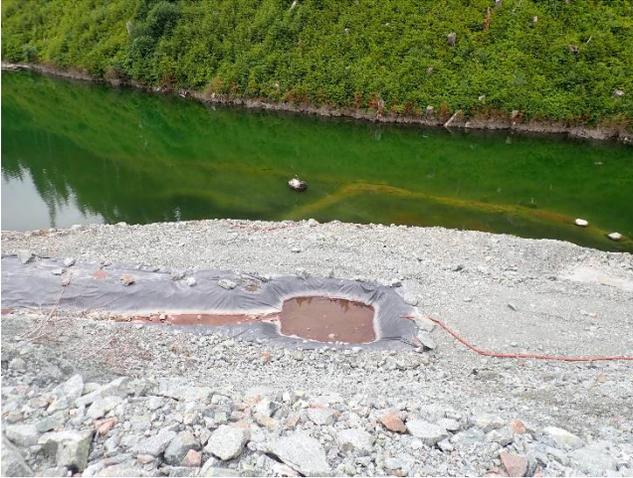
The acid rock drainage (ARD) collection sumps located at northern TTF laydown yard were functioning as intended (Photo 15). The ARD that is collected will be treated at the seepage treatment plant, and then discharged into the TTF's infiltration gallery.

Photo 15. The northern TTF area ARD collection sump.
