## INSPECTION REPORT: KENSINGTON GOLD MINE

Date of Inspection: Thursday November 14, 2019  
Date of Report: Tuesday December 3, 2019  
USDA Forest Service Inspector: Richard Dudek

This inspection included the Access roads, Comet Development Pile, Comet Water Treatment Plant (CTWP), Sherman Creek Outfall 001, Comet Bridges, Pit 4, Bridge 1 ponds, and the TTF area.

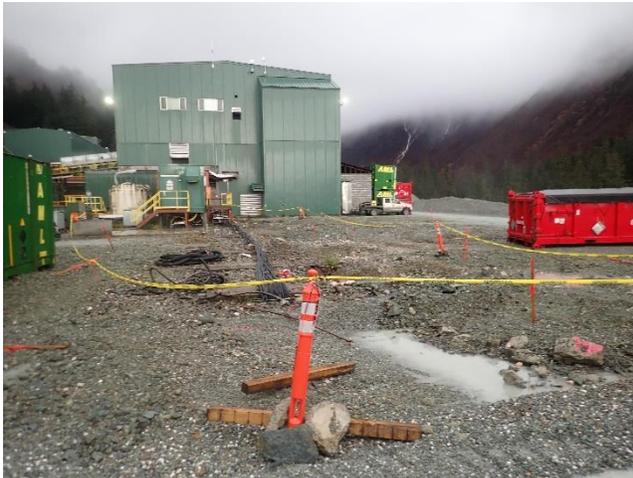
**NOTEWORTHY ITEMS: Coeur Alaska personnel are currently excavating the contaminated soils from where the old diesel generators were located (Photo 1).**

**Photo 1.** The location where the old generators once stood.

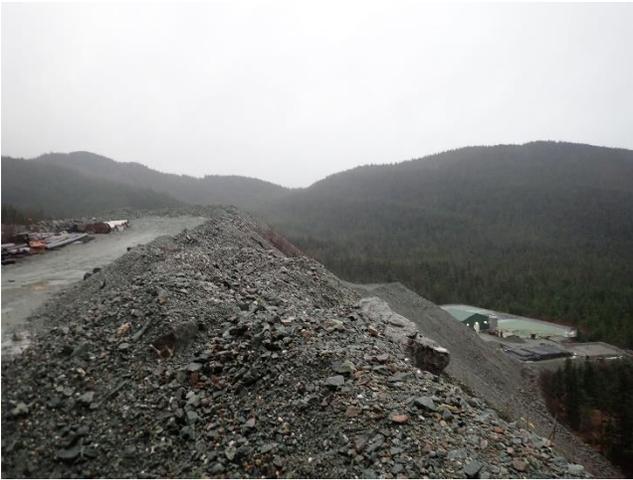
Waste rock from the Raven drift is currently being deposited at this location (Photo 2).

**Photo 2. The Comet development pile.**

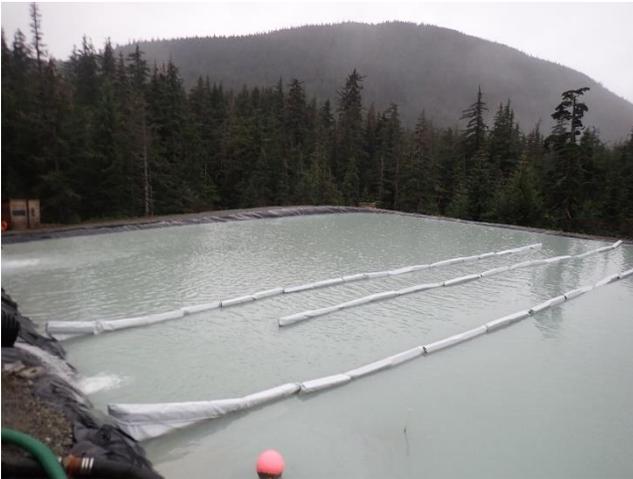
On 11/24/2019, the CWTP was treating 1,900 gallons per minute (gpm). Pond 1 was receiving mine site water (Photo 3). Pond 2 was receiving back wash from the water treatment plant (Photo 4).

**Photo 3. Pond 1 at the Comet Water Treatment Plant.**

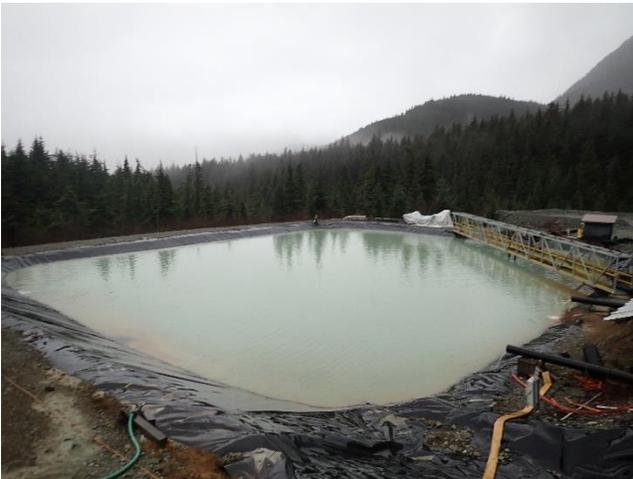
**Photo 4. Pond 2 at the Comet Water Treatment Plant.**

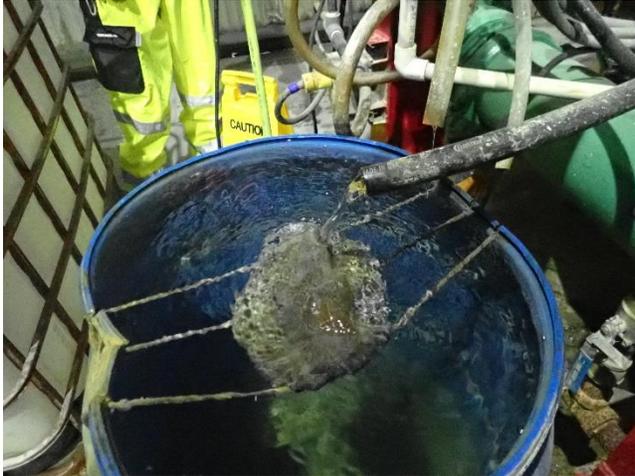
White material was observed on the clean test rock used for monitoring its accumulation (Photo 5). Personnel at the CWTP continue to use calcium chloride (CaCl<sub>2</sub>) to help remove white material out of solution.

**Photo 5. The test rock used for monitoring white material accumulation.**

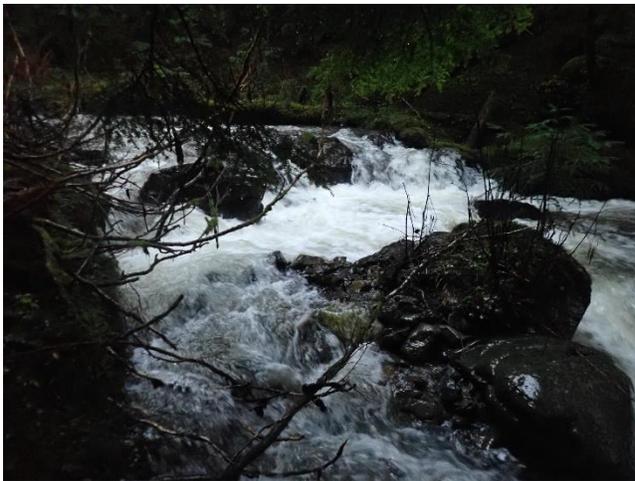
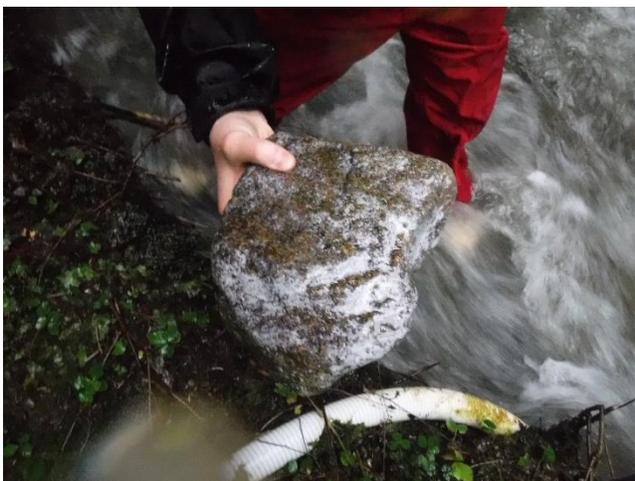
White material was observed on the rocks in the creek bed (Photo 6-7).

**Photo 6. Sherman Creek outfall 001.**

**Photo 7. A rock pulled from Sherman Creek with white material on it.**

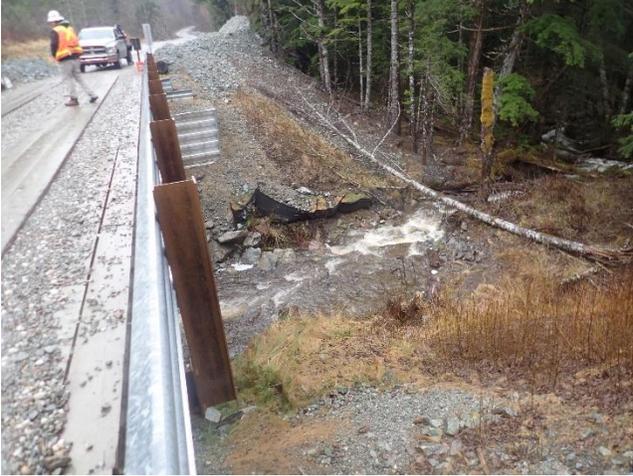
Both of the Comet Bridges silt fencing are working as intended (Photos 8-9). A stormwater cutout by the No Name Bridge end needs to be moved to prevent the gravel road from eroding (Photo 10).

**Photo 8. No Name Creek Bridge (Comet Beach access road system).**

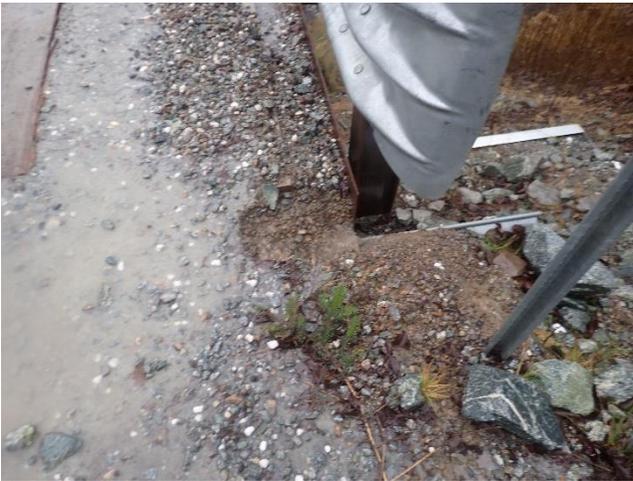
**Photo 9. Concern here is the increased potential for erosion at the bridge end.**

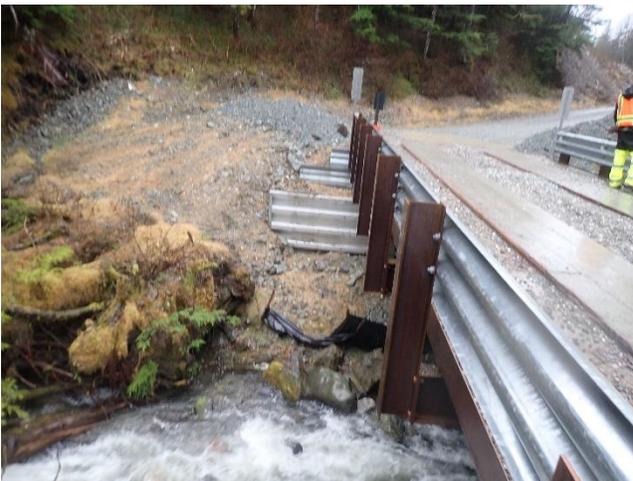
**Photo 10. Sherman Creek Bridge (Comet Beach access road system).**

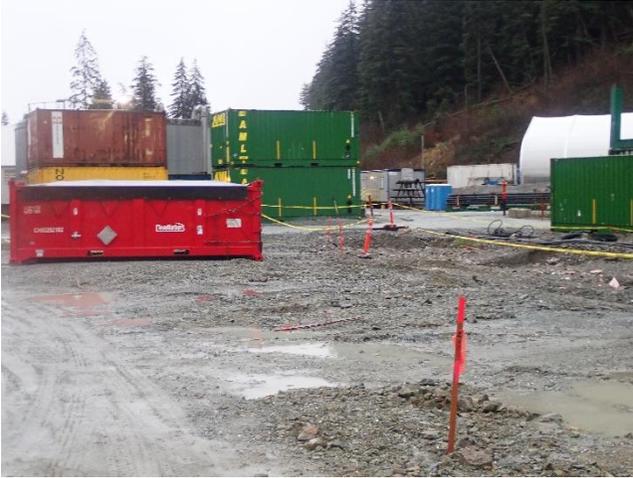
Coeur Alaska personnel are currently excavating contaminated soils from where the old diesel generators were located (Photo 11). These soils will then be shipped off site to an appropriate facility for disposal. Coeur Alaska will then remove the generators remaining support infrastructure, and then construct a ramp from the Julian portal down through to where generators 1 and 2 were located.

**Photo 11. The location where the old diesel generators were located.**

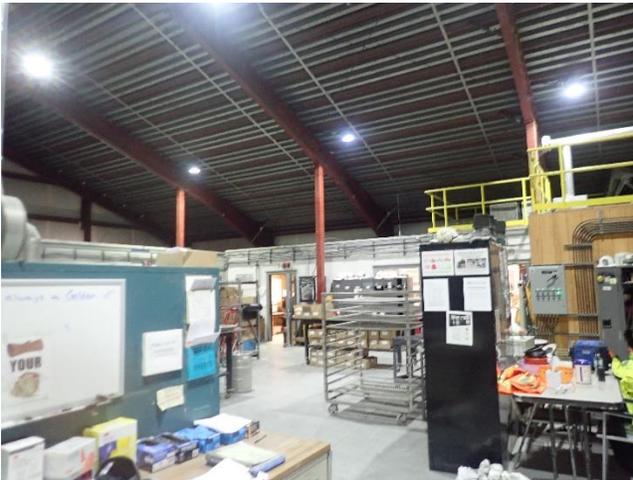
Good housekeeping practices were observed at the assay laboratory ((Photo 12) (Appendix 4g BMP Plan; Table 4-1)).

**Photo 12. The Kensington assay laboratory.**

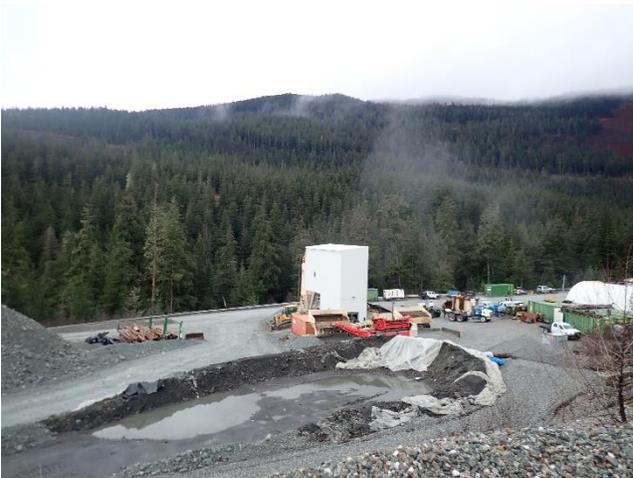
Coeur personnel continue to use the graphitic phyllite (GP) stockpile (Photo 13) staged at pit 4 for GP/cement underground backfill. The x-ray sorter was offline the day of this inspection (Photo 14).

**Photo 13. The pug plant at pit 4.**

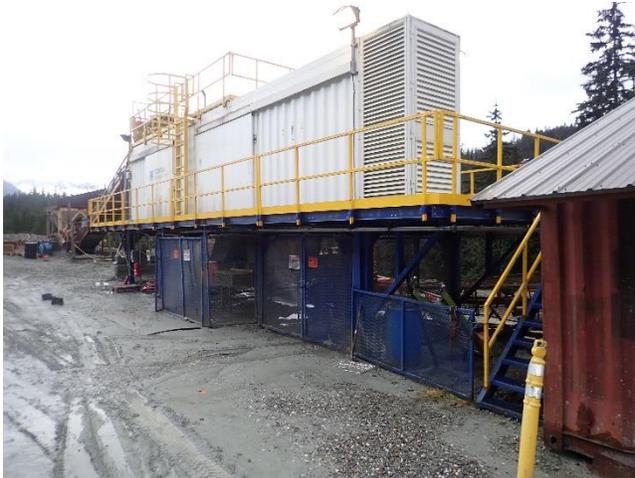
**Photo 14. The x-ray sorter for reject pebbles at pit 4.**

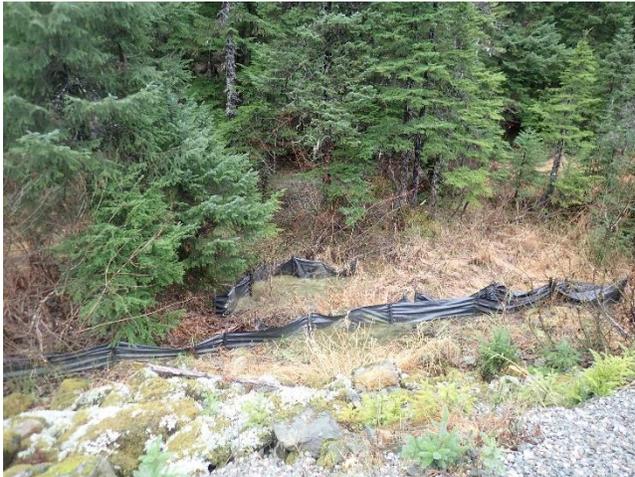
The small tire that was documented in IR 177 has been removed, and the secondary silt fencing was repaired (Photo 15).

**Photo 15. The tire has been removed and new secondary silt fencing was installed.**

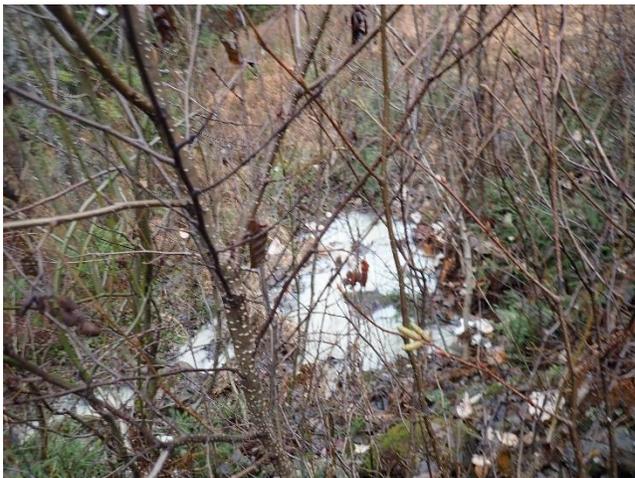
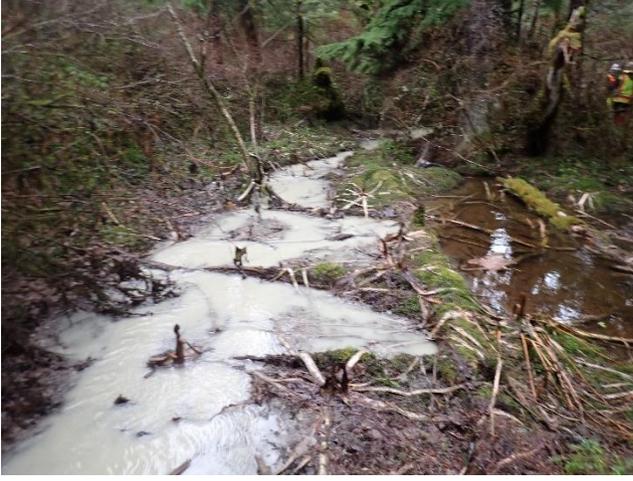
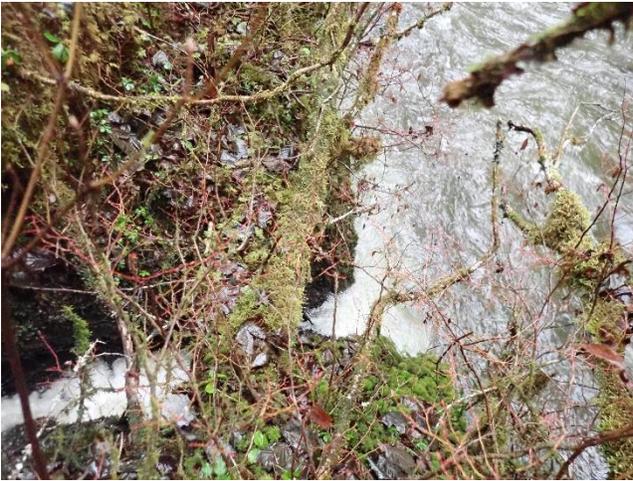
During the site inspection it was observed that turbid water had breached a settling pond's wall and was flowing into Johnson Creek (Photos 16-18). Additional mitigations for stormwater management and sediment controls are required at this location.

**Photo 16. Turbid water was observed breaching the settling pond and flowing into the forest.**

**Photo 17. Turbid water flowing towards Johnson Creek.**

**Photo 18. Turbid water from the settling pond flowing into Johnson Creek.**

- **Additional BMPs for stormwater management and sediment controls are required at Bridge 1. Turbid water was observed flowing from a pond into the forest, then into Johnson Creek.**

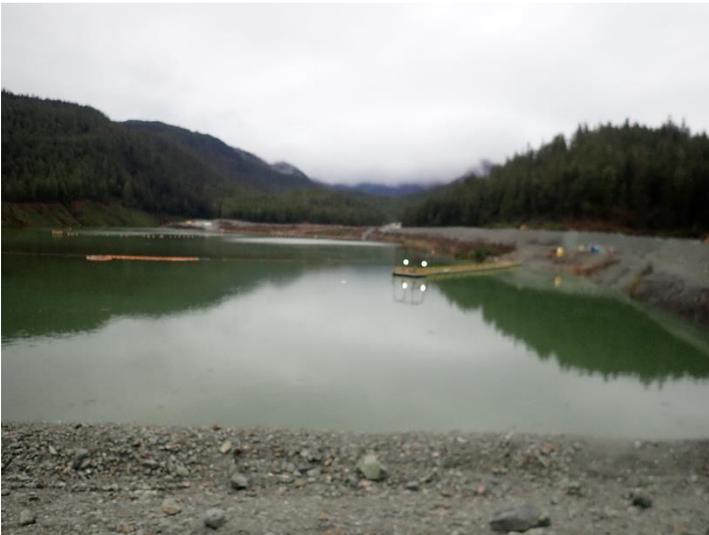
The TTF's recorded water level on 11/24/2019 was 707 feet (Photo 19). The tailings barge has been moved central area of the TTF.

**Photo 19. The Tailings Treatment Facility.**

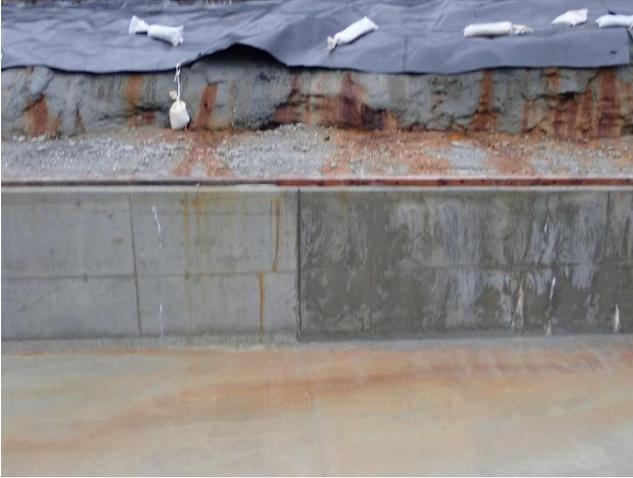
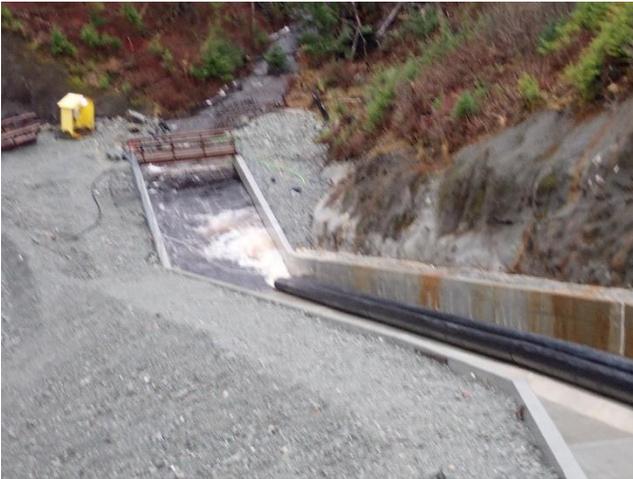
**Photo 20. Coeur personnel recently applied additional cement to the spillway walls to indicate if any new ARD generation has breached the wall.**

**Photo 21. ARD staining**

Coeur Alaska is currently exploring additional BMPs and/or modifications to prevent future ARD from flowing into the dam spillway (20-21).

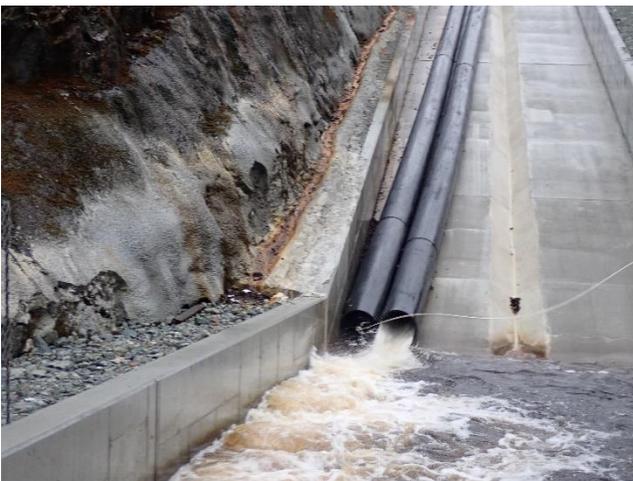
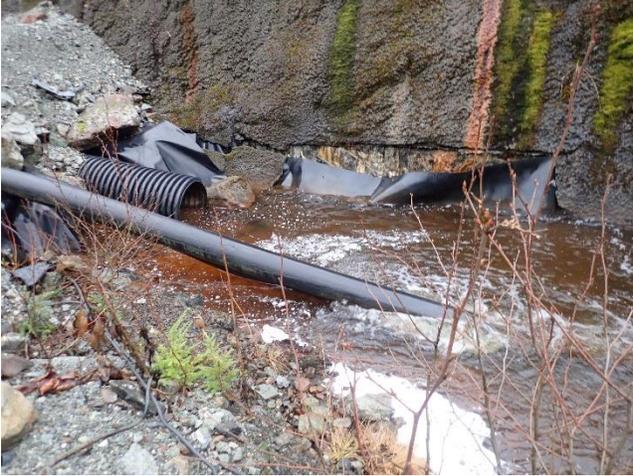
The dam spillway and the effluent spillway were functioning as intended (Photos 22-23). No ARD plumes were observed in the northern TTF area (Photo 24).

**Photo 22. The diversion pipeline discharging into the dam spillway.**

**Photo 23. The TTF water treatment plant effluent spillway.**

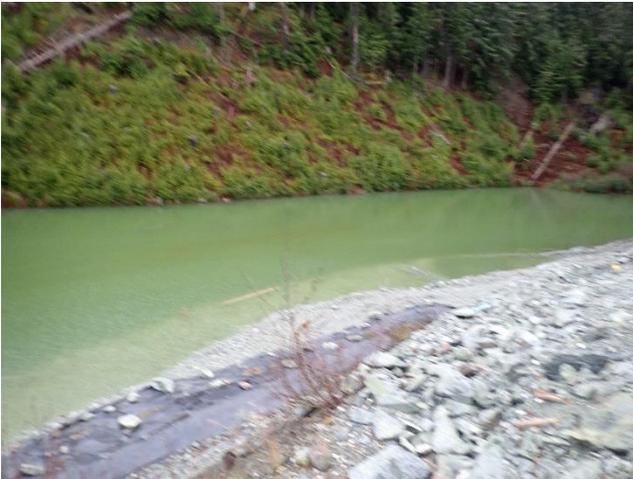
**Photo 24. The northern TTF laydown area.**
