INSPECTION REPORT: KENSINGTON GOLD MINE

Date of Inspection: Thursday February 27, 2020
Date of Report: Tuesday March 10, 2020
USDA Forest Service Inspector: Richard Dudek

Ranger District: Juneau Ranger District

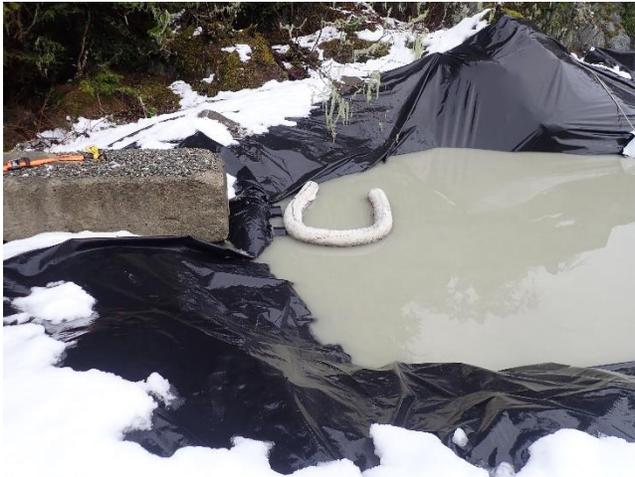
- **The silt sock for the port facility stormwater collection ditch needs to be cleaned out (Photos 1-3). Additional mitigations for sediment controls are required at this location. Since the inspection, Surface Operations have installed a new slit sock, and new silt curtains to the stormwater ditch.**

Photo 1. The Kensington Beach settling pond.

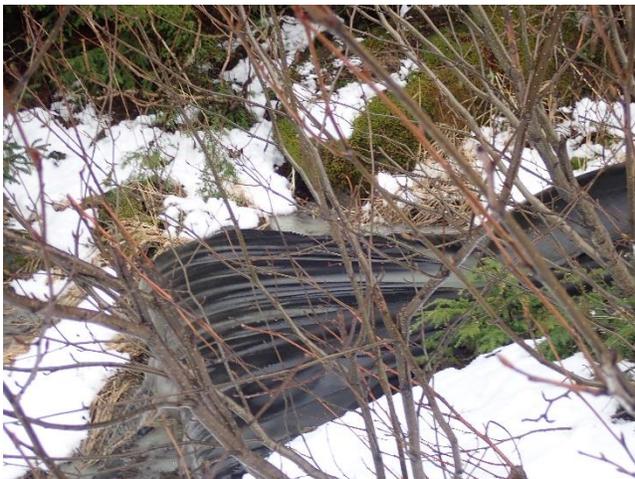
Photo 2. Discharging water from the settling pond.

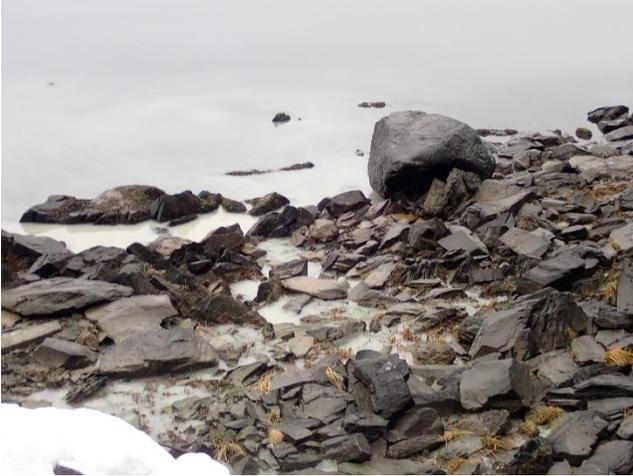
Photo 3. The turbid water flowing into Slate Cove.

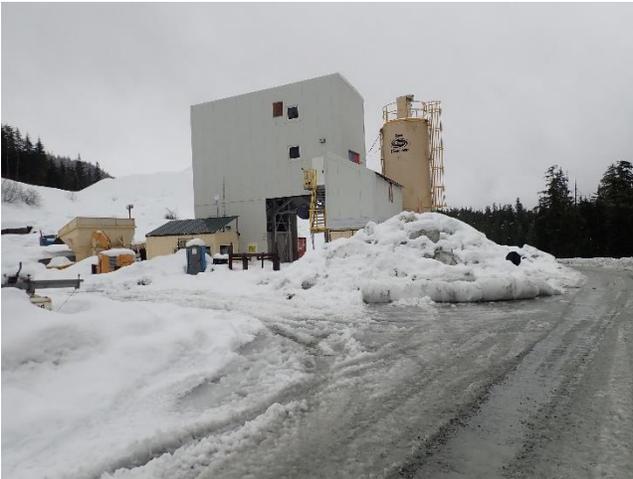
NOTEWORTHY ITEMS: The pug plant is currently offline for the winter months (Photo 4).

Photo 4. The pug plant at pit 4.

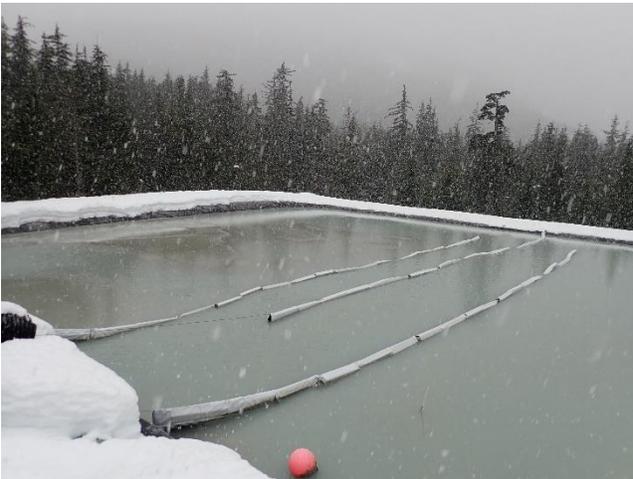
Photo 5. Comet settling pond-1.

On 2/27/2020, the CWTP was treating 1,000 gallons per minute (gpm). Pond 1 was receiving mine site water (Photo 5). Pond 2 was receiving back wash from the water treatment plant (Photo 6).

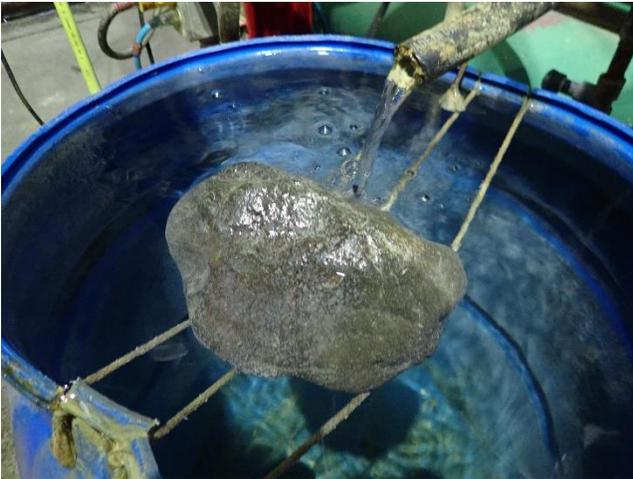
White material was observed on the clean test rock used for monitoring its accumulation (Photo 7).

Photo 7. The test rock for white material accumulation observations.

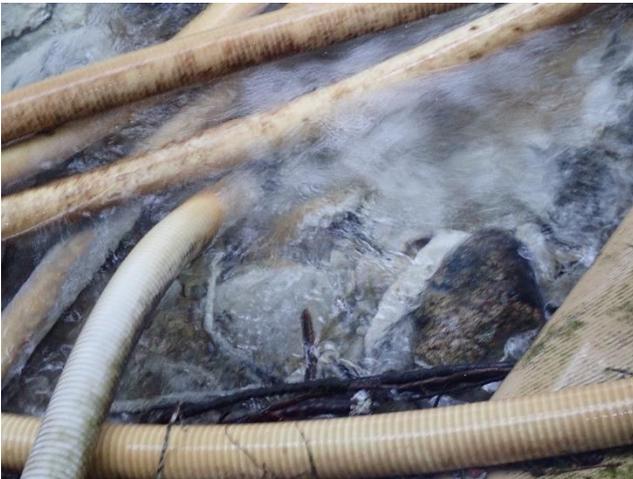
White material was observed on the rocks in the creek bed (Photos 8-9).

Photo 8. White material adhering to rocks in the creek bed.

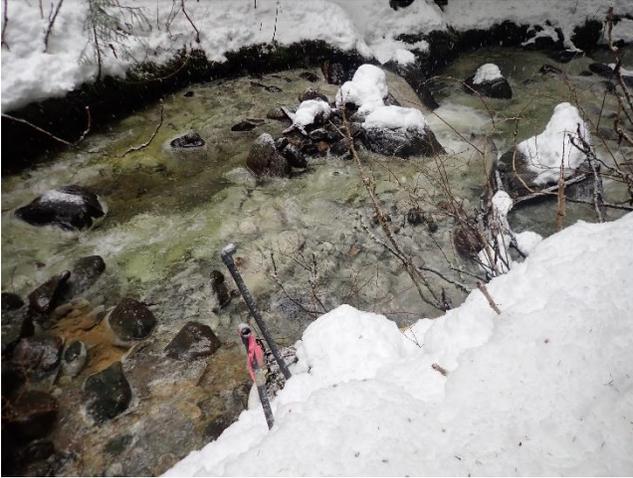
Photo 9. White material observed in Sherman Creek.

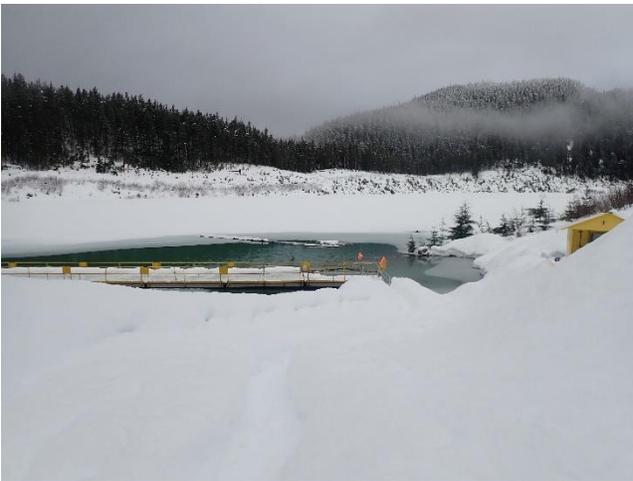
The TTF is mostly frozen over and covered in snow (Photo 10). The TTF's recorded water level on 2/27/2020 was 712.4 feet.

Photo 10. The TTF was mostly frozen over and covered in snow.

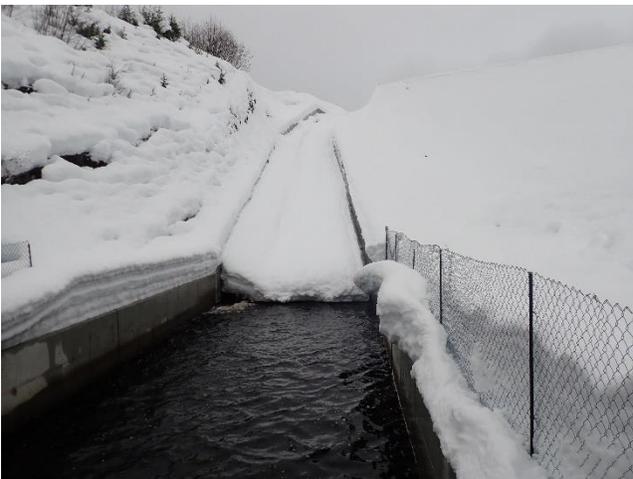
Photo 11. The TTF Dam Spillway.

The TTF dam spillway (Photo 11) and the effluent spillway were functioning as intended.

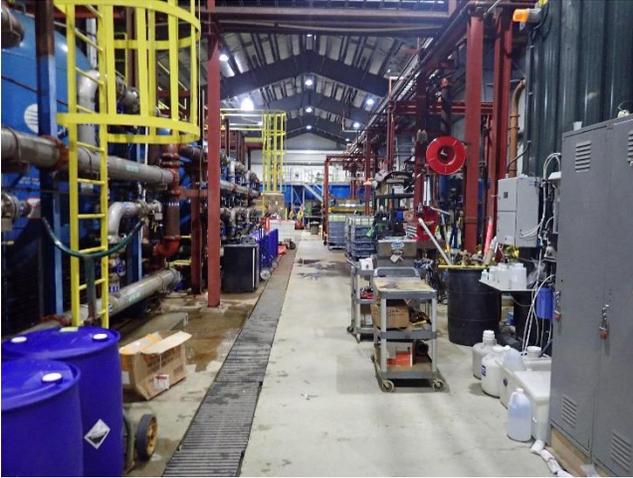
Photo 12. The TTF water treatment plant.

Good housekeeping practices were observed at the TTF water treatment plant ((Photo 12) (Appendix 4g BMP plan; Table 4-1)).

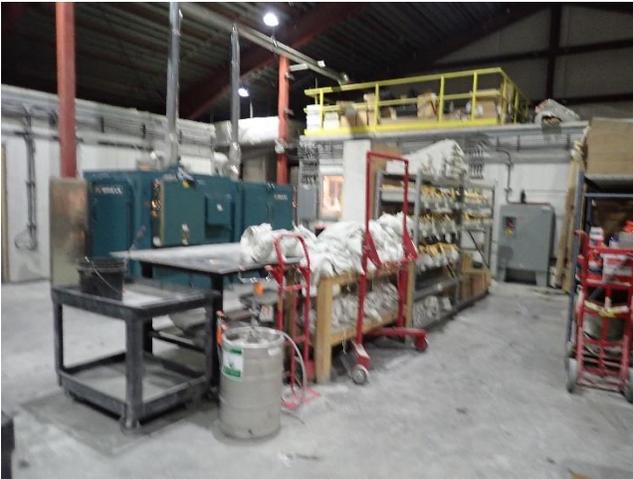
Photo 13. The fire assay laboratory.

Good housekeeping practices were observed at the assay laboratory ((Photo 13) (Appendix 4g BMP plan; Table 4-1)).

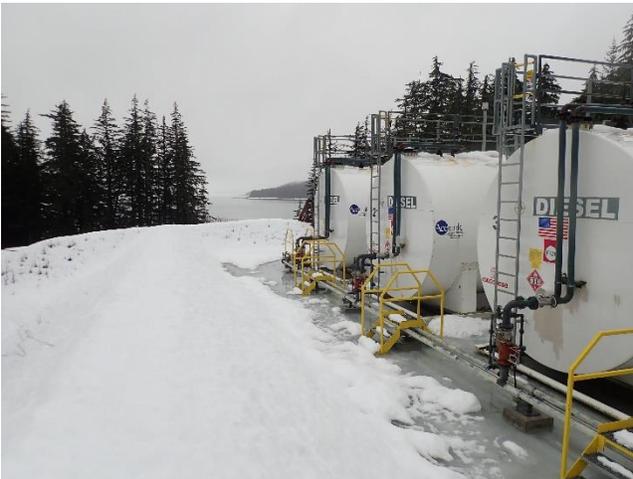
Photo 14. The fuel depot.

There was no observed fuel sheening, and/or spills at the facility (Photo 14).

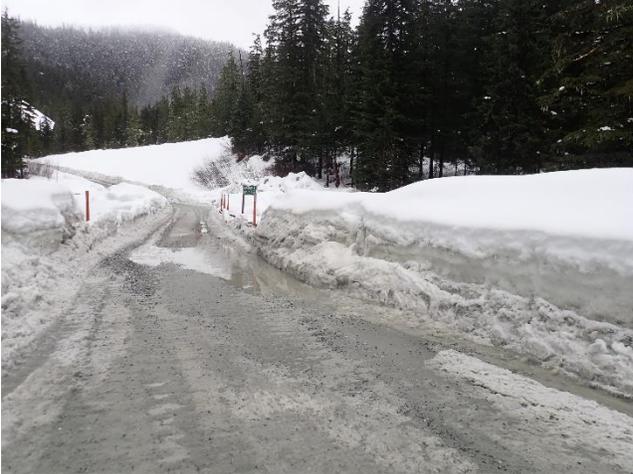
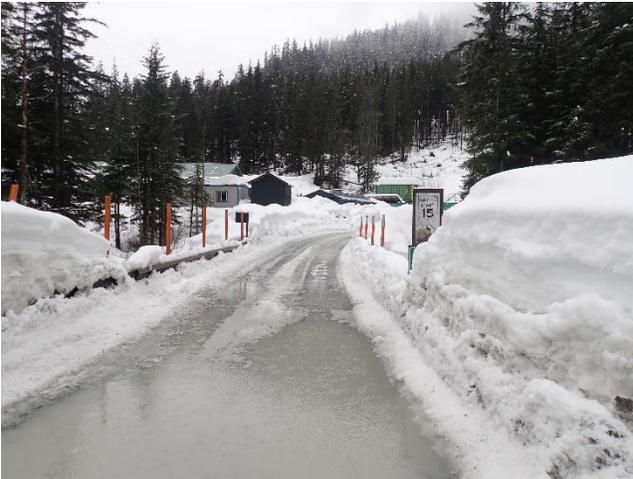
There were no sediments observed along the abutments of the bridges from vehicular splash over (Photos 15-16). Additional cutouts and other BMPs are required at the bridges for snowmelt management.
