INSPECTION REPORT: KENSINGTON GOLD MINE

Date of Inspection: Thursday May 6, 2021
Date of Report: Friday, May 14, 2021
USDA Forest Service Inspector: Casey Loofbourrow

Ranger District: Juneau Ranger District

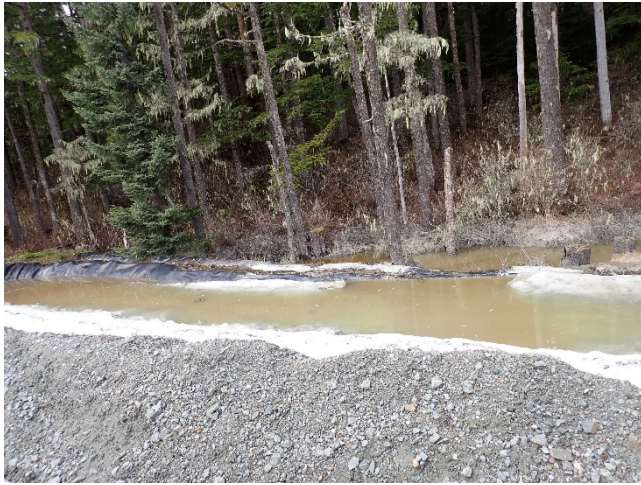
During the inspection, the access roads were in adequate condition (2016 BMP Plan; Table 4-4). Approximately 0.75 miles north of the TTF a contact water collection ditch along the uphill side of the road was obstructed by deep snow which allowed the discharge of turbid water into a small area of undisturbed ground adjacent to the ditch (Photo 1). The water appeared to be contained within a natural depression and was not mobile to other areas. This is expected to resolve as snow continues to melt but should be monitored to ensure the structure functions as intended during normal flows.

Photo 1. Overflow on TTF Spur Road.

- **A culvert at the port facility stormwater collection ditch requires cleaning.**
- **A blocked drainage ditch on the spur road should be monitored for functionality once snow has melted.**

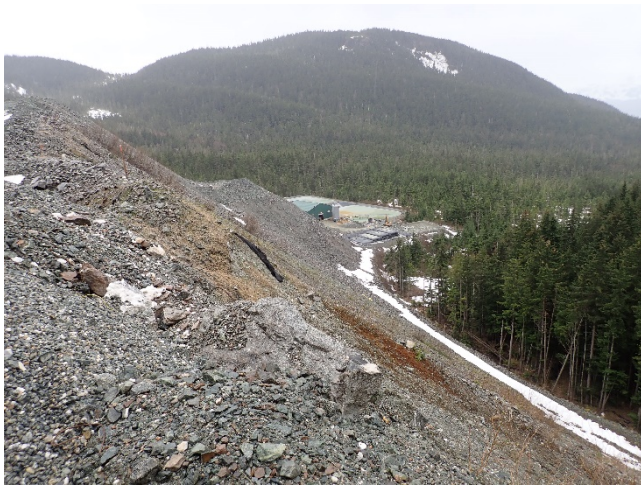
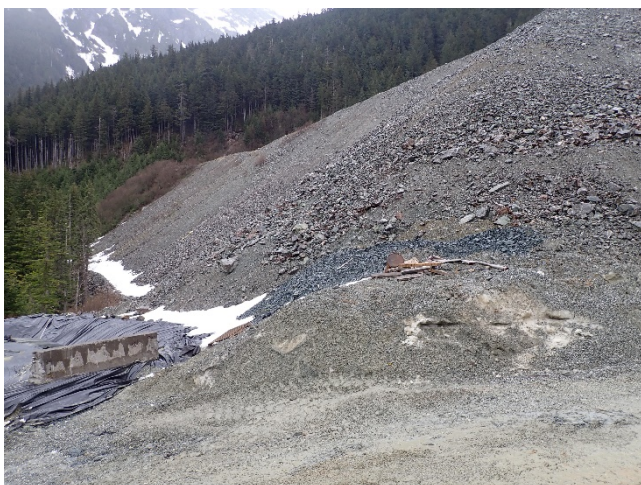
This site was inactive during the winter months. The slopes appear stable (Photos 2-3). A landslide occurred during heavy rain on December 2, 2020 which impacted the Comet Road (Photos 4-5, courtesy of Coeur Alaska). The road has been cleared of debris and the landslide scarp is visible above the site (Photo 6).

Photo 2. Comet Development Pile looking south.

Photo 3. Comet Development Pile looking north.

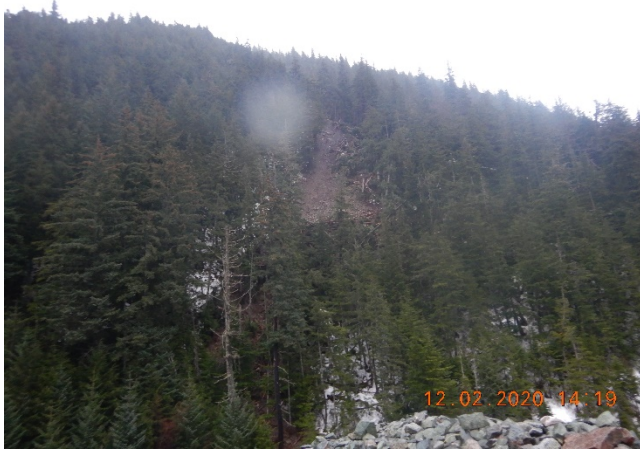
Photo 4. Landslide scarp above Comet Road on December 2, 2020. Image courtesy of Coeur Alaska.

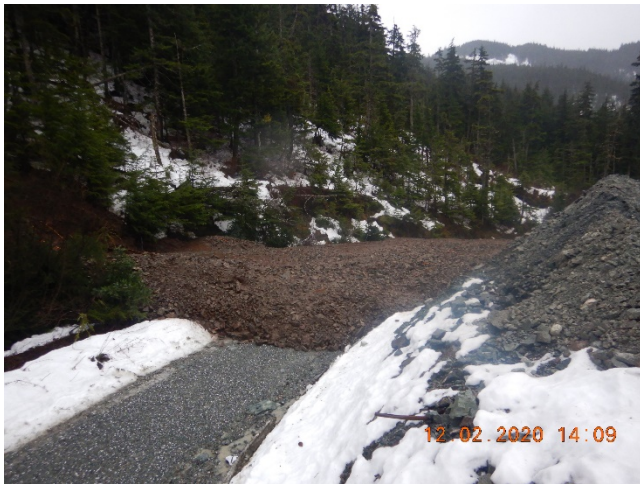
Photo 5. Landslide covering Comet Road on December 2, 2020. Image courtesy of Coeur Alaska.

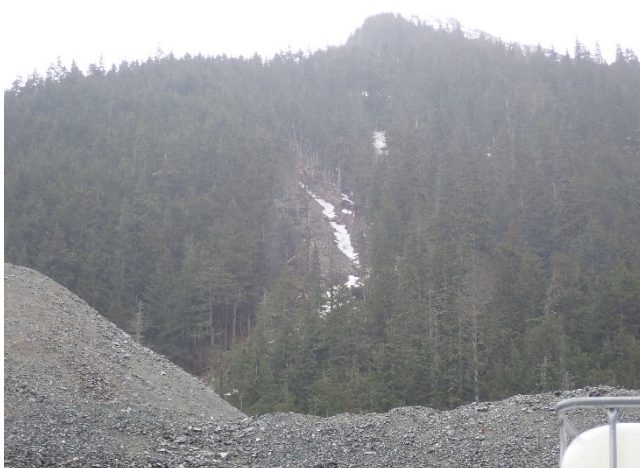
Photo 6. Landslide scarp above Comet Road.

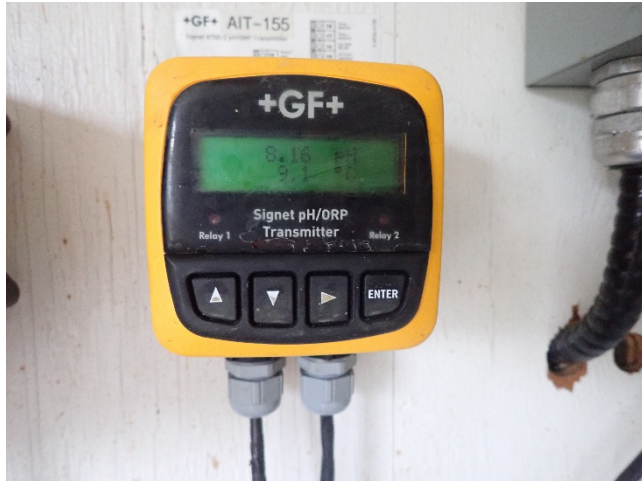
On 05/06/2021, the CWTP was treating 1,743 gallons per minute (gpm). Ponds 1 and 2 were in good condition and functioning as designed. Water being discharged to the Sherman Creek Outfall measured 8.16 pH, 9.1 degrees Celsius (Photo 7), and .446 nephelometric turbidity units (NTU) (Photo 8). The mobile water treatment plant is still on site but is not yet operational from winter cessation (Photo 9).

Photo 7. Measured temperature and pH of water being discharged to Sherman Creek.

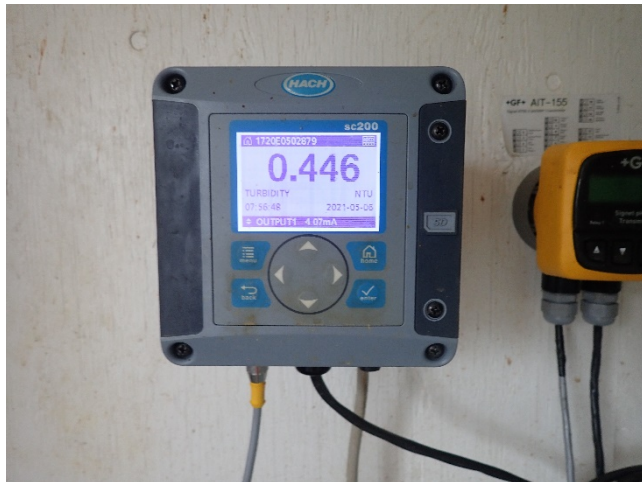
Photo 8. Measured turbidity of water being discharged to Sherman Creek.

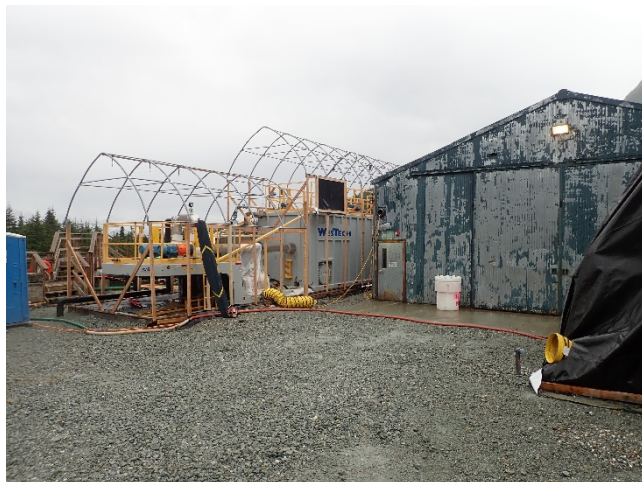
Photo 9. Mobile wastewater treatment plant.

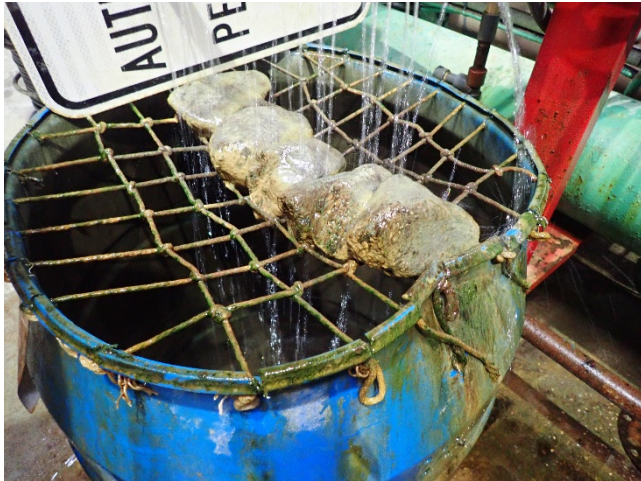
White material was observed on the test rocks used for monitoring its accumulation in the CWTP (Photo 10).

Photo 1. White material test apparatus.

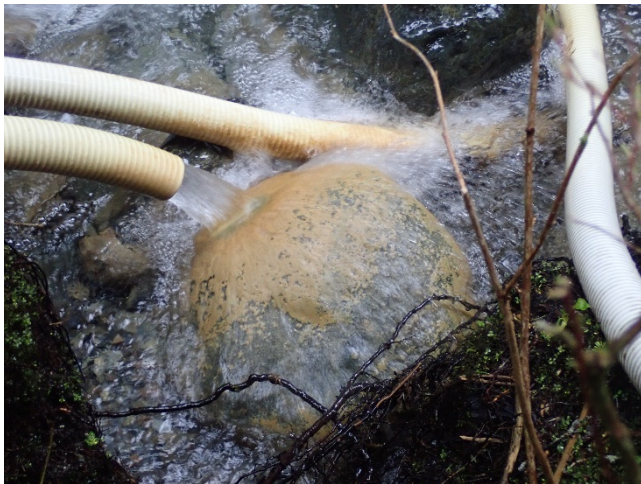
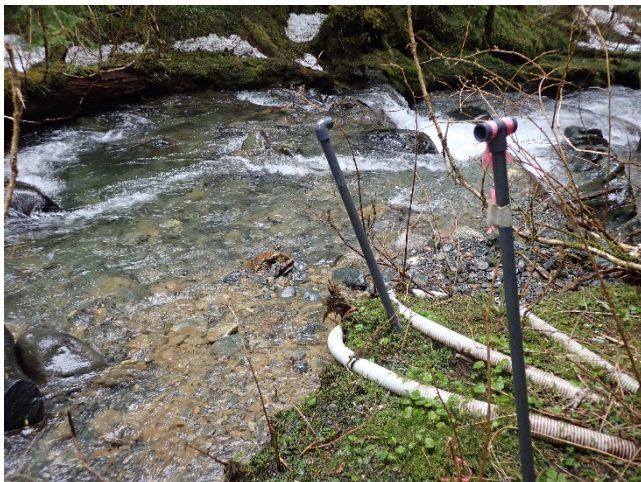
White material was observed on the substrate in Sherman Creek in close proximity to the hoses actively discharging treated water (Photos 11-12). In the underground workings Z-Clear 129 was observed being added to seepage water at the lowermost sump (Photo 13). This coagulant is used in an attempt to remove flocculants and polymers used as underground drill additives that Coeur suspects contribute to the white material observed at the Sherman Creek Outfall.

Photo 2. Sherman Creek Outfall and white material.

Photo 3. Sherman Creek Outfall and white material.

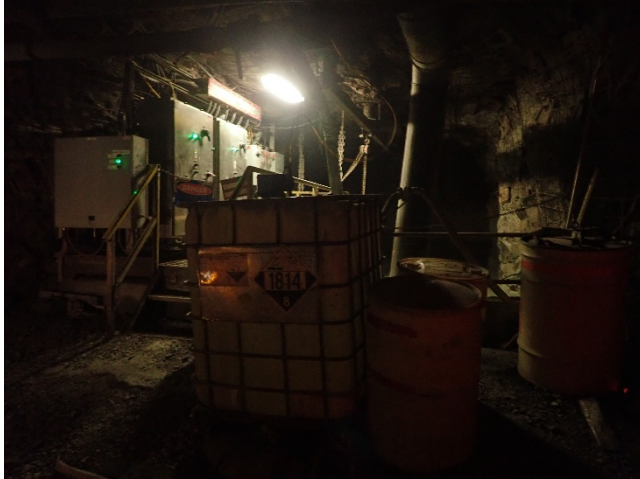
Photo 4. Z-Clear 129 being added to mine water at sump.

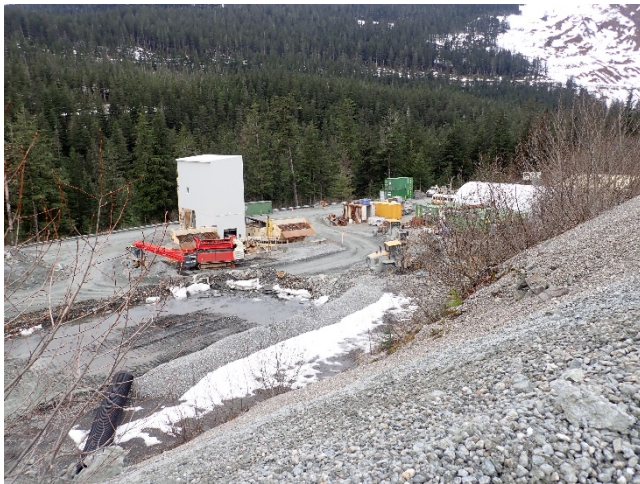
The pug plant is not currently operational and is being de-winterized (Photo 14). When functional, the pug plant is used to mix ARD-generating graphitic phyllite with concrete in preparation for underground backfill and storage to prevent impacts to surface resources.

Photo 5. The pug plant.

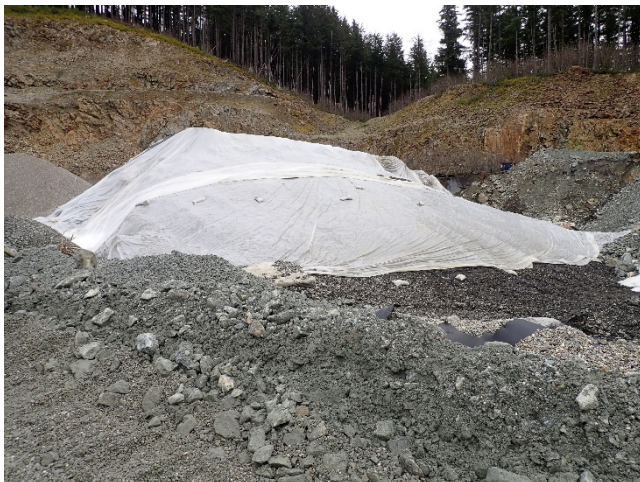
Graphitic phyllite is stored at this location and is covered and lined underneath to manage contact water (Photo 15). The waste rock stockpile at this location appeared stable (Photo 16).

Photo 6. Graphitic Phyllite stored at Pit 4.

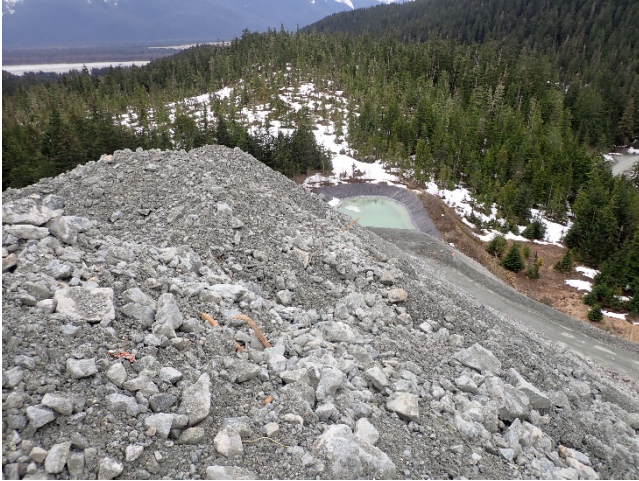
Photo 7. Pit 4 waste rock stockpile.

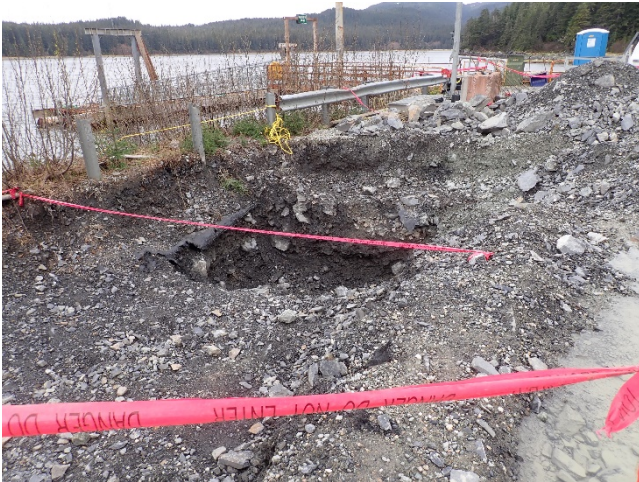
On April 18, 2021 a diesel spill at the port facility during a fuel transfer by Petro Marine Services resulted in approximately 50 gallons of diesel unintentionally released into the environment including approximately 2 gallons that entered the ocean in Slate Cove. Fuel spilled into in the water was contained and removed with absorbent fuel booms. The contaminated soil has been removed and stockpiled in Pit 1 (Photo 17). Coeur Alaska is currently awaiting test results to determine whether additional soil must be removed. Coeur Alaska requested additional containers to dispose of the excavated materials and some of the excavated soil is temporally stockpiled at Pit 1 (Photo 18). This material will be loaded into containers for disposal when containers arrive onsite. This spill was previously reported to regulatory agencies by Coeur Alaska.

Photo 17. Excavated soil at site of fuel spill.

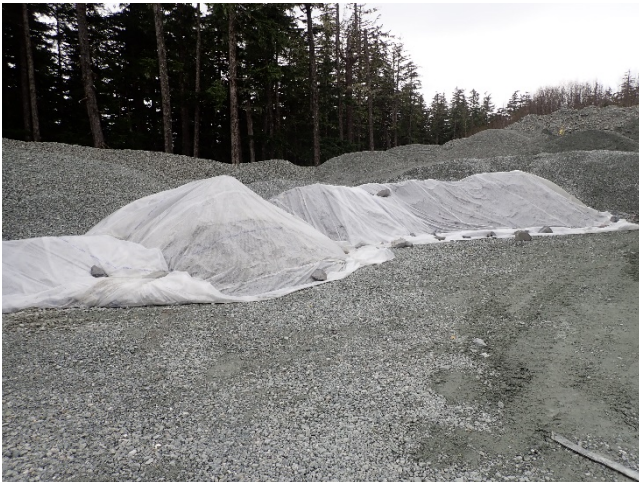
Photo 18. Stockpiled fuel-contaminated soil.

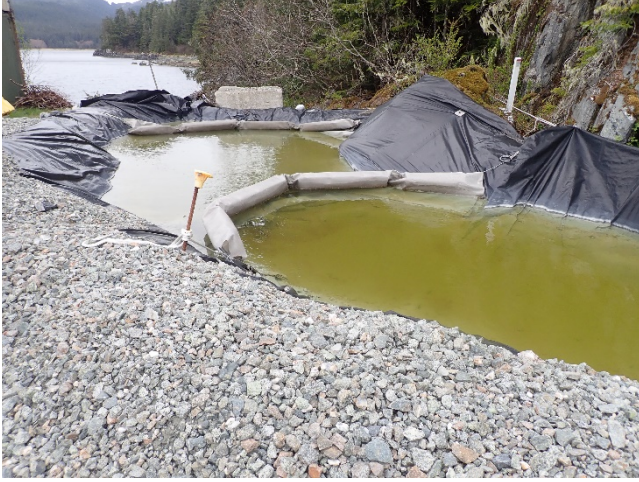
An action item from the previous inspection on February 26, 2020 was to fix a problem with the settling ponds at the port facility that was allowing turbid water to enter the ocean. This action item has been resolved and clear water was observed flowing in the lower settling pond system (Photo 19). However, a small culvert is nearly blocked with accumulated sediment and should be cleaned out (Photo 20).

Photo 19. Settling pond system with clear running water.

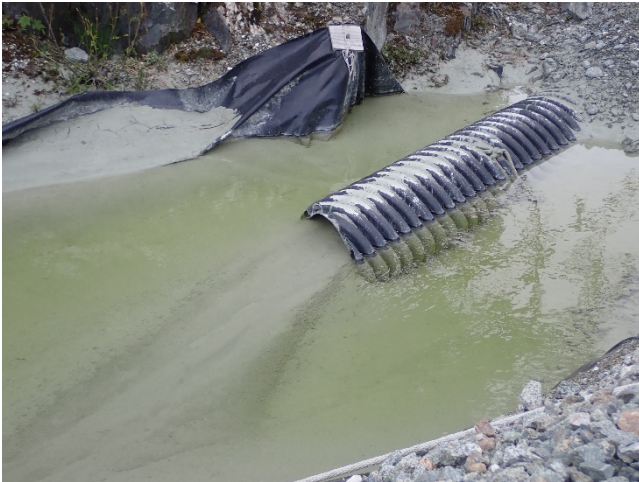
Photo 20. Nearly blocked culvert at port facility settling ponds.

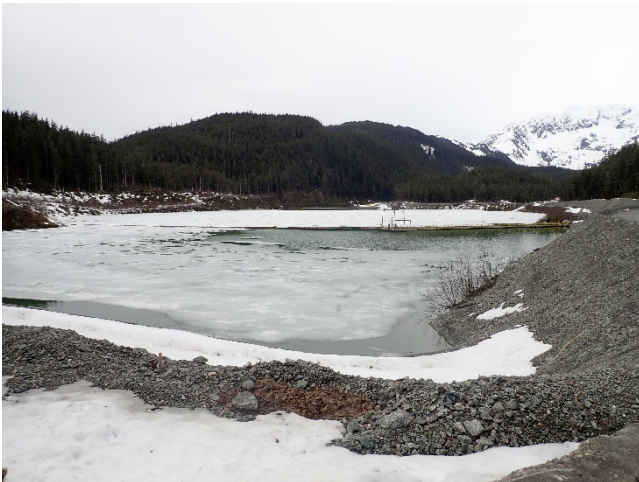
The TTF is partially frozen over (Photo 21). The TTF's recorded water level on 5/6/2021 was 716.2 feet. Tailings placement was occurring in the northwest area of the TTF.

Photo 21. TTF looking north from dam.

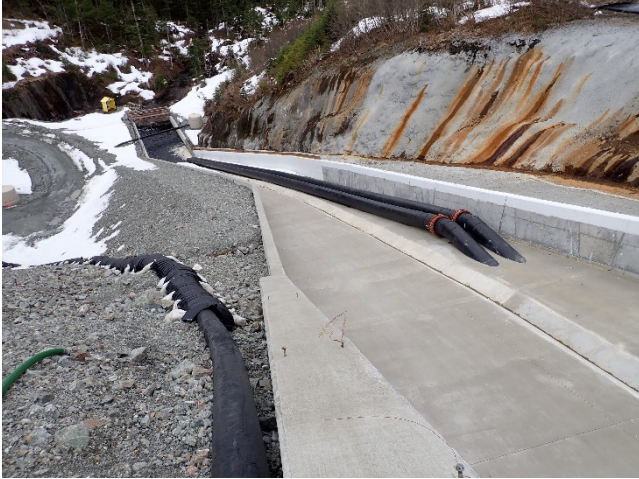
The TTF dam spillway was functioning as intended and free of debris (Photo 22). The acid rock drainage (ARD) diversion sill appeared to be allowing only minor seepage of ARD into the dam spillway (Photos 23-24).

Photo 22. TTF dam spillway.

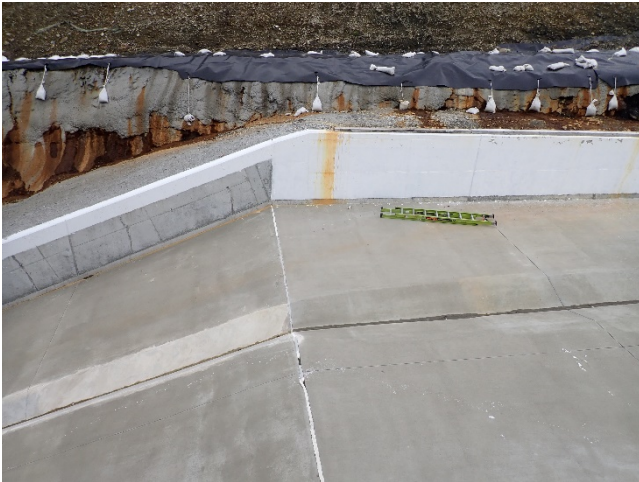
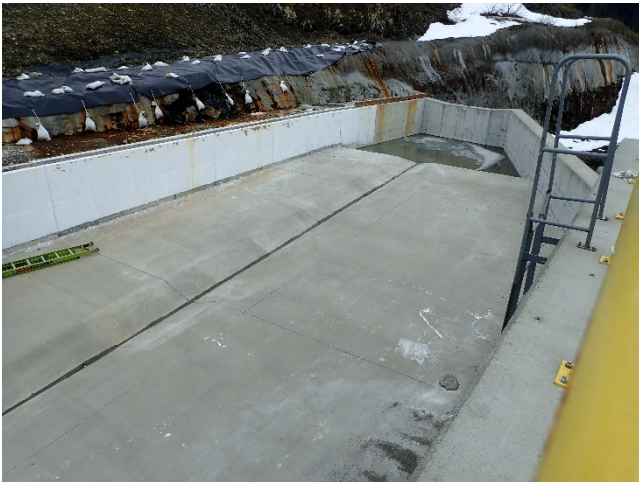
Photo 23. ARD seepage into spillway.

Photo 24. ARD seepage into spillway.
