INSPECTION REPORT: KENSINGTON GOLD MINE

Date of Inspection: Wednesday, January 12, 2022
Date of Report: Wednesday, January 19, 2022
USDA Forest Service Inspector: Casey Loofbourrow

Sites visited during the inspection included: access roads, Comet Development Pile, Comet Water Treatment Plant (CWTP), Sherman Creek Outfall 001, Pit 4, the Tailings Treatment Facility (TTF) area, and the Fuel Depot.

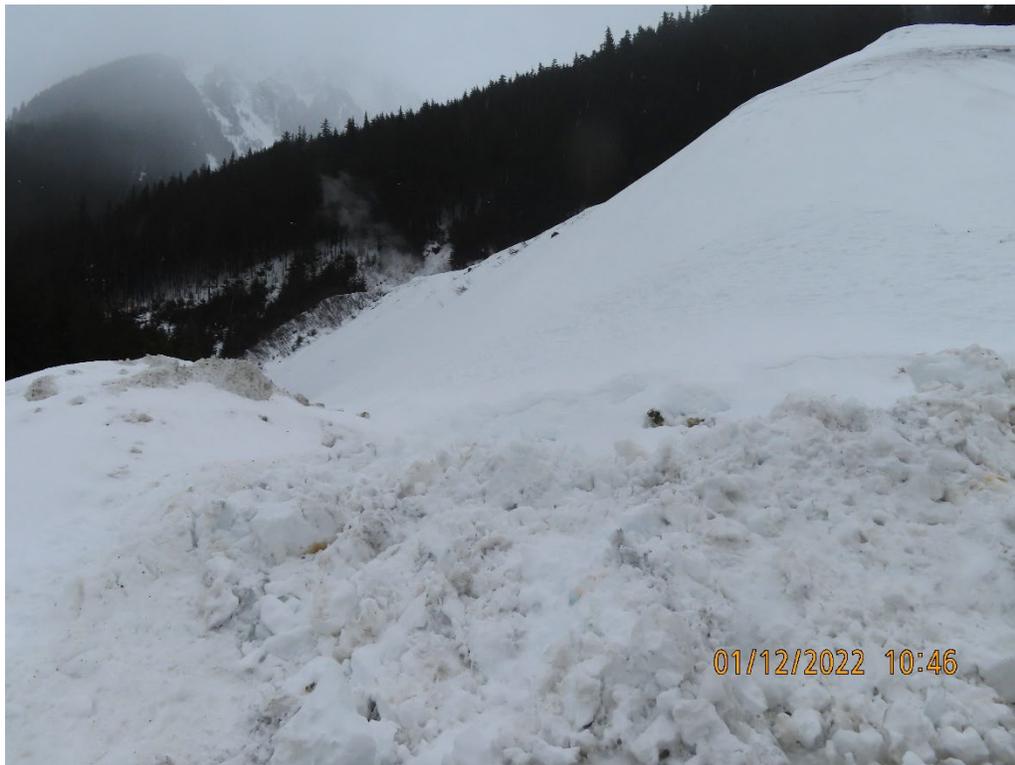
The slopes of the Comet waste rock storage area appear stable (Photo 1). Explosives were used following recent heavy snowfall to reduce the avalanche hazard above the CWTP (Photo 2).

Photo 1. Comet waste rock stockpile.

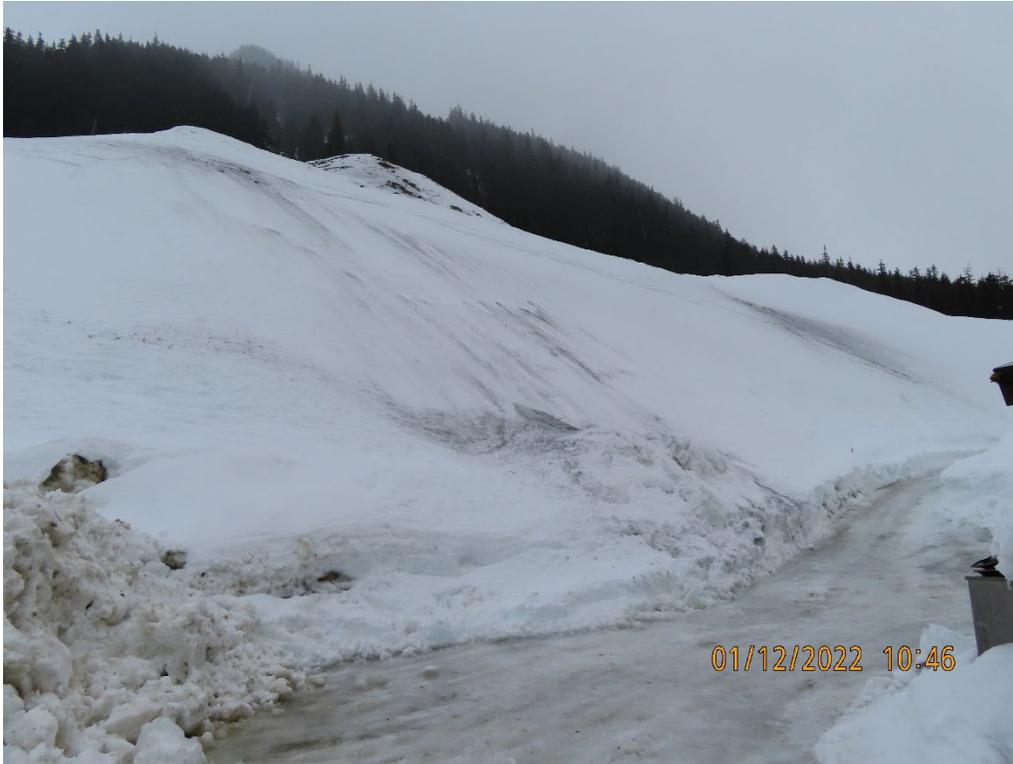
Photo 2. Comet waste rock stockpile above CWTP. Dark areas are where explosives were used for avalanche hazard reduction.

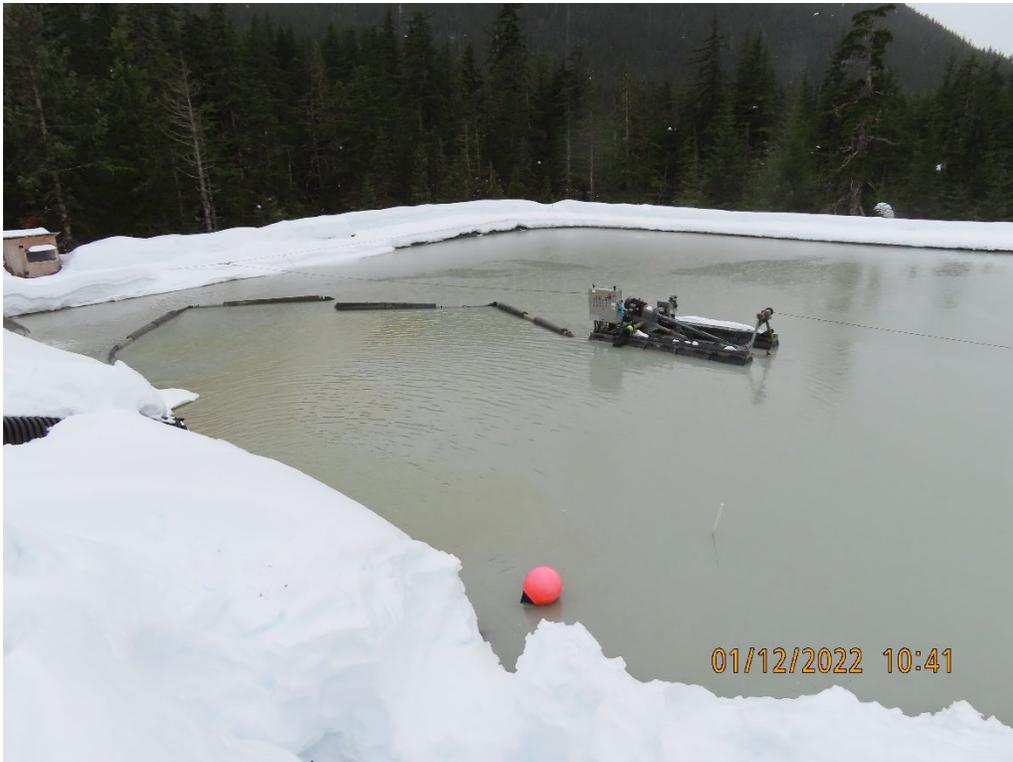
The CWTP was treating approximately 1050 gallons per minute (gpm). Ponds 1 and 2 were receiving mine site water and functioning as intended (Photos 3-4). The mobile water treatment plant (CWTP plant 2.5) has been idled and winterized (Photo 5).

Photo 3. Pond 1 at CWTP.

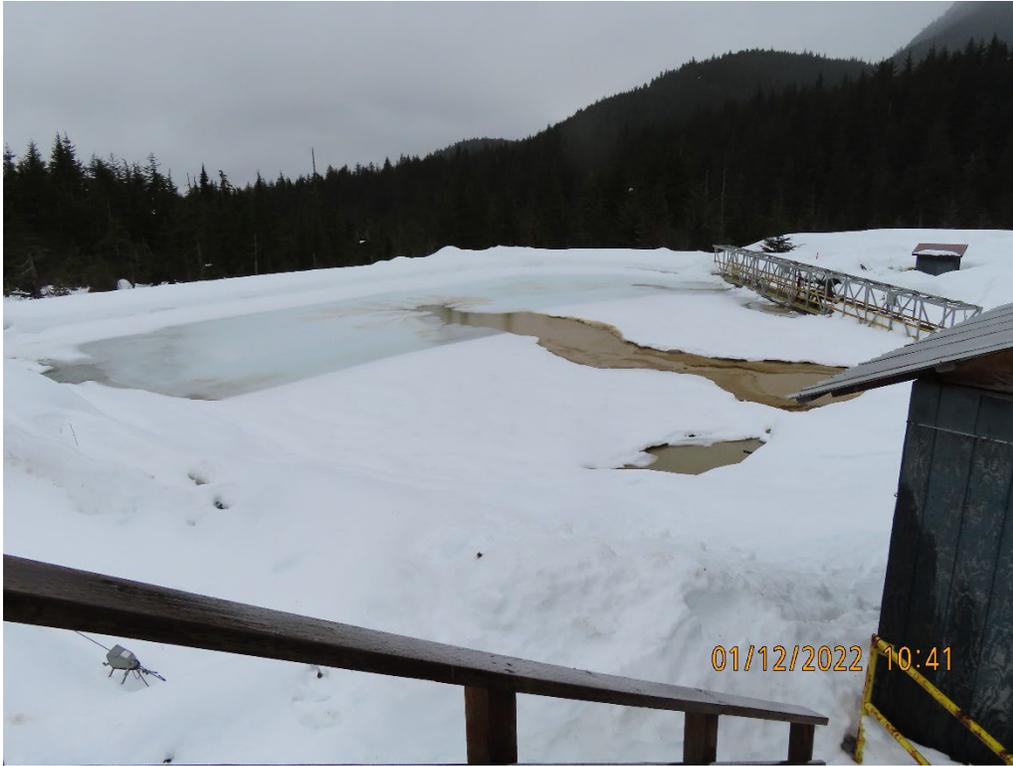
Photo 4. Pond 2 at CWTP.

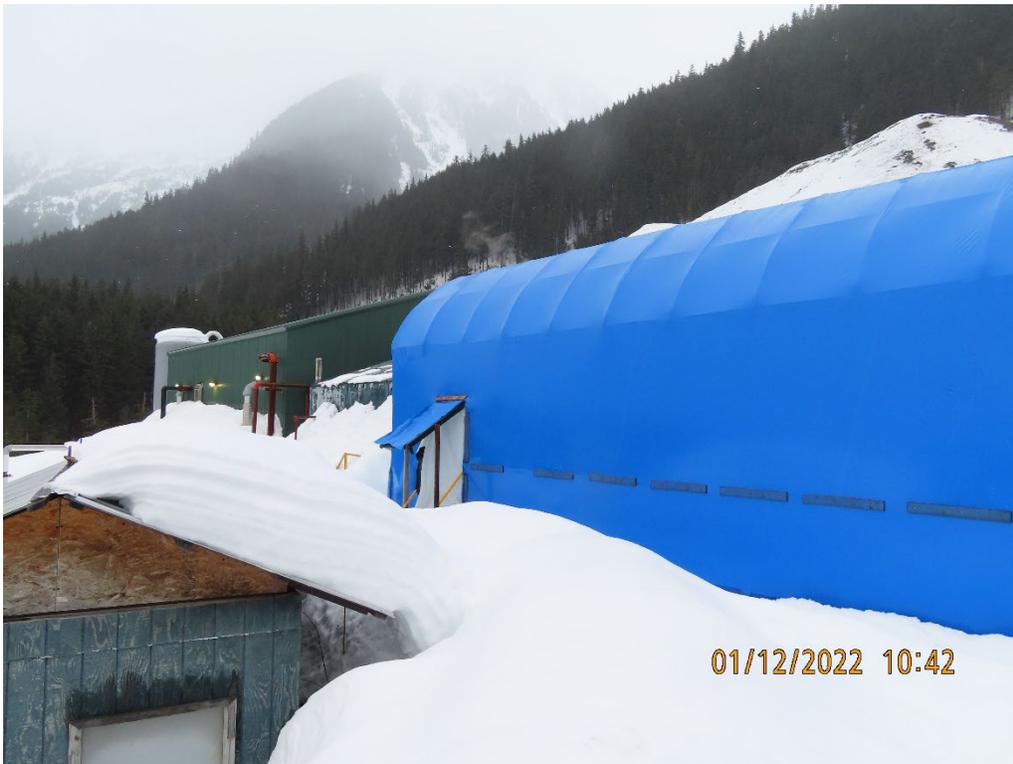
Photo 5. Winterized CWTP 2.5.

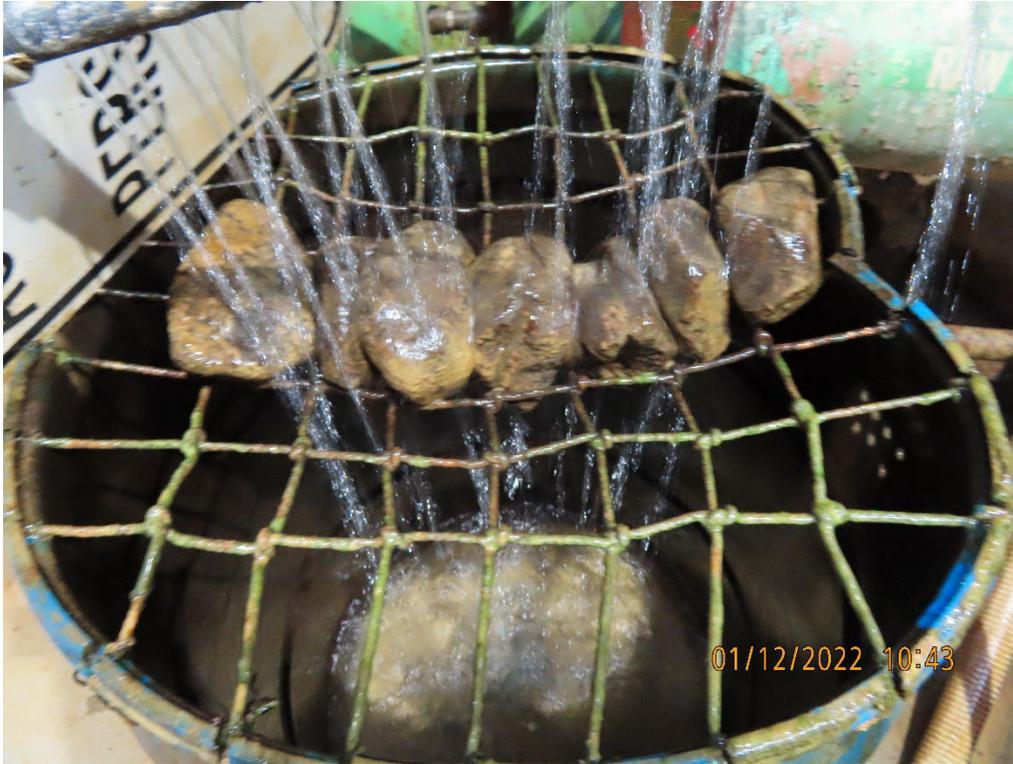
White material was not observed on the test rocks used for monitoring in the CWTP (Photo 6).

Photo 6. Test rocks in CWTP.

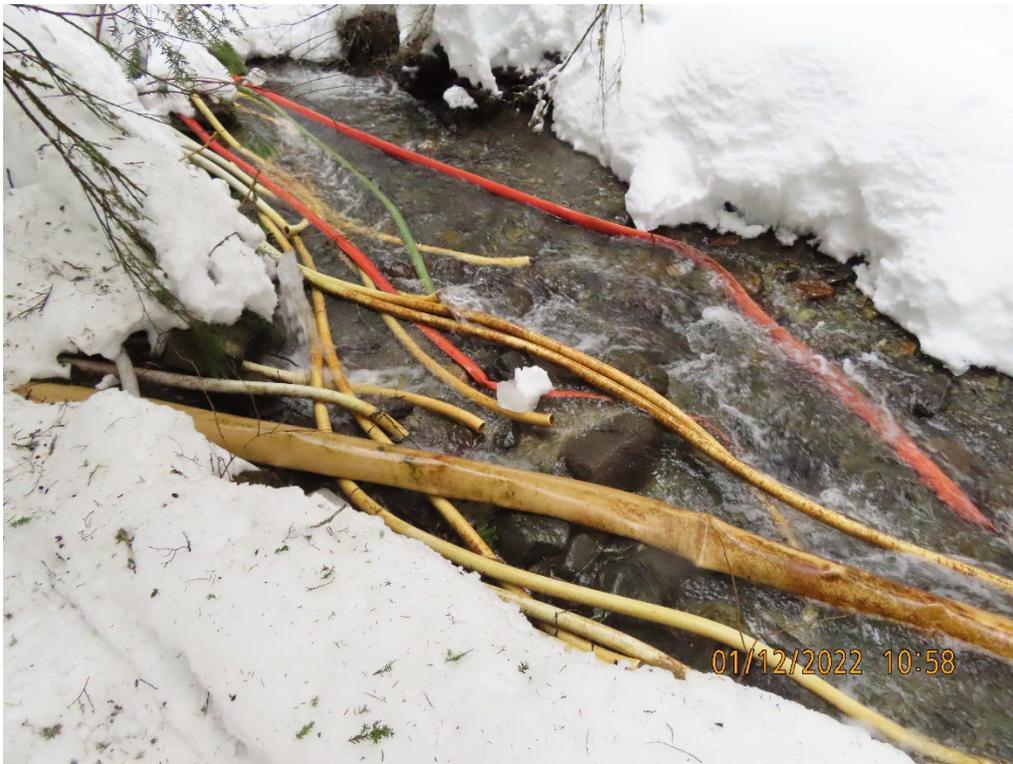
White material was not observed in Sherman Creek at Outfall 001 (Photo 7).

Photo 7. Sherman Creek Outfall 001.

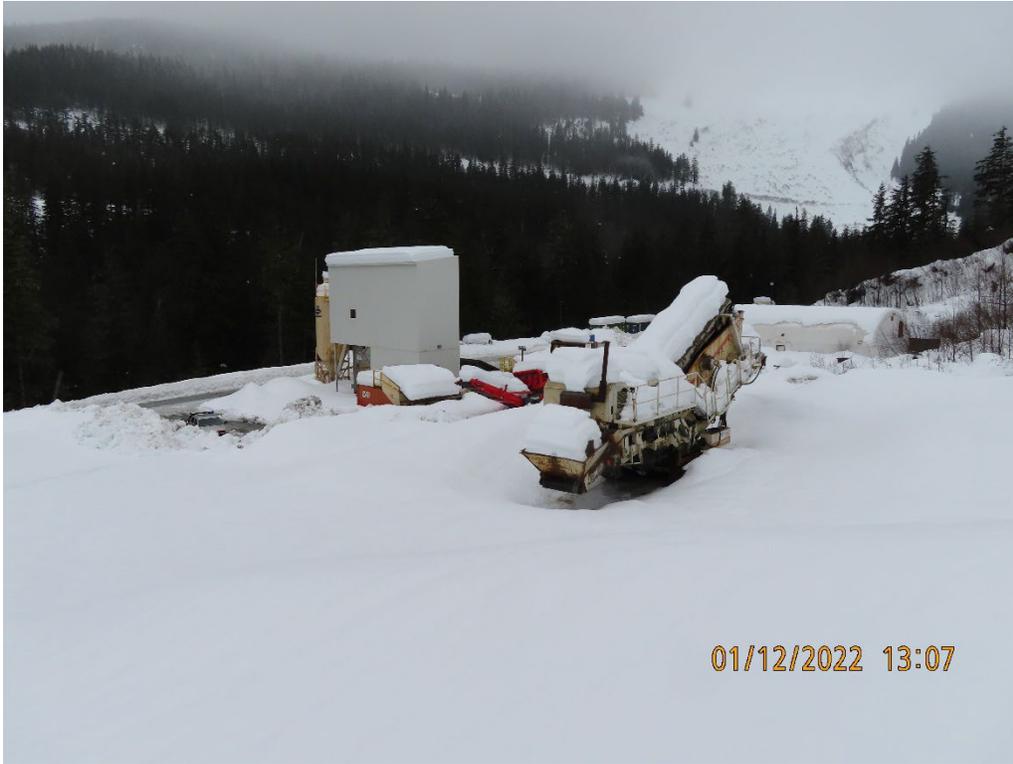
The pug plant has ceased operation for the winter (Photo 8). The graphitic phyllite at this location was covered with an impermeable liner before snowfall (Photo 9).

Photo 8. Idled pug plant in Pit 4.

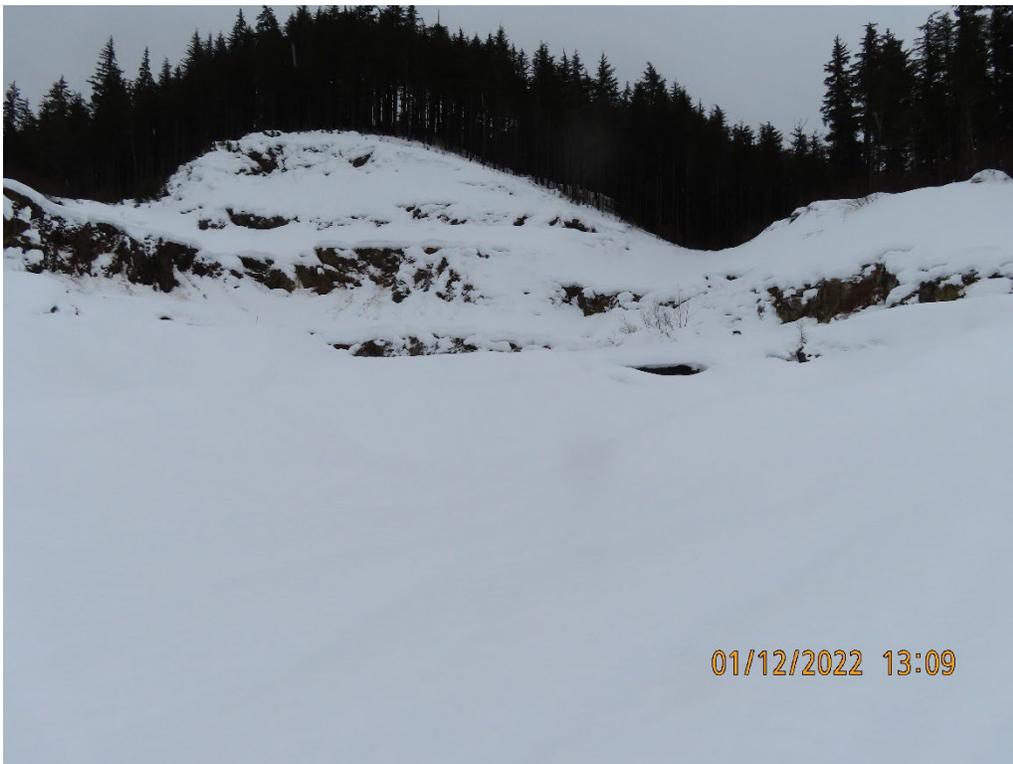
Photo 9. Graphitic phyllite stockpile in Pit 4.

ID	Action Item	Status
183-2	ARD seepage at the TTF SE abutment.	Pending. Shotcrete or other mitigation measures will be applied, as needed, once snow melt and ground conditions permit access and ability to perform the work (Photo 14).
185-1	The graphitic phyllite (GP) stockpile at Pit 4 was not adequately covered to prevent rainwater infiltration and potential ARD generation.	Resolved. Stockpile was covered with impermeable liner before snowfall (Photo 9).

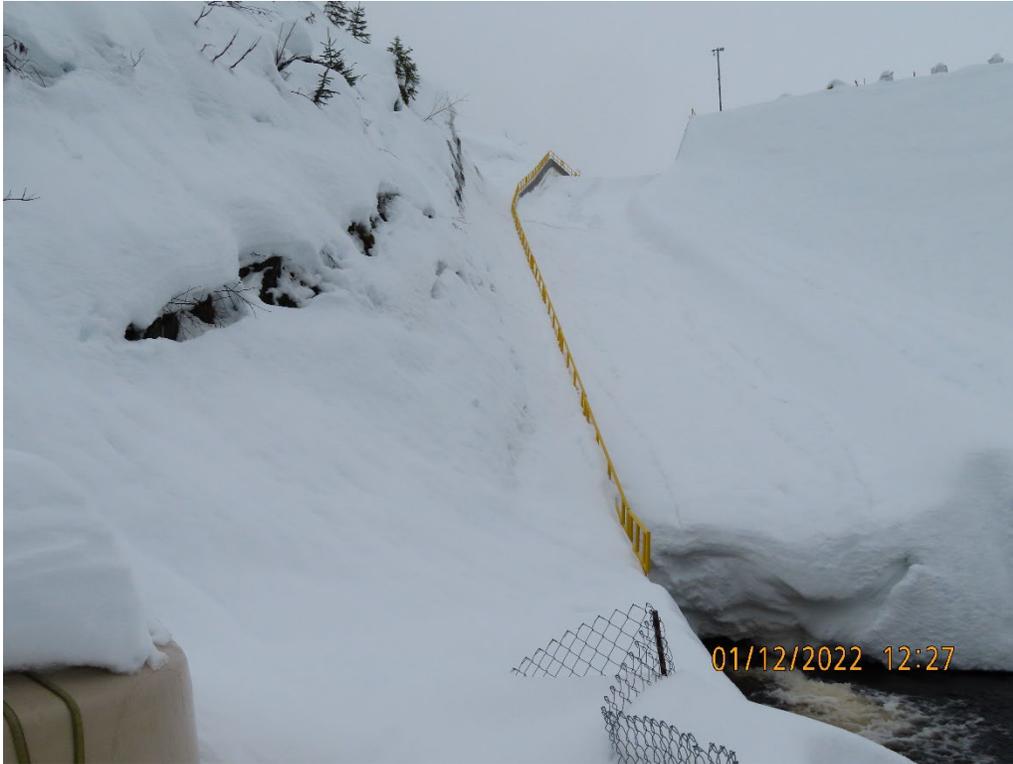
The TTF dam spillway was covered with deep snow (Photo 10). Coeur has installed a handrail along the new raise above the spillway to facilitate safe inspection and maintenance (Photo 11)

Photo 10. TTF dam spillway.

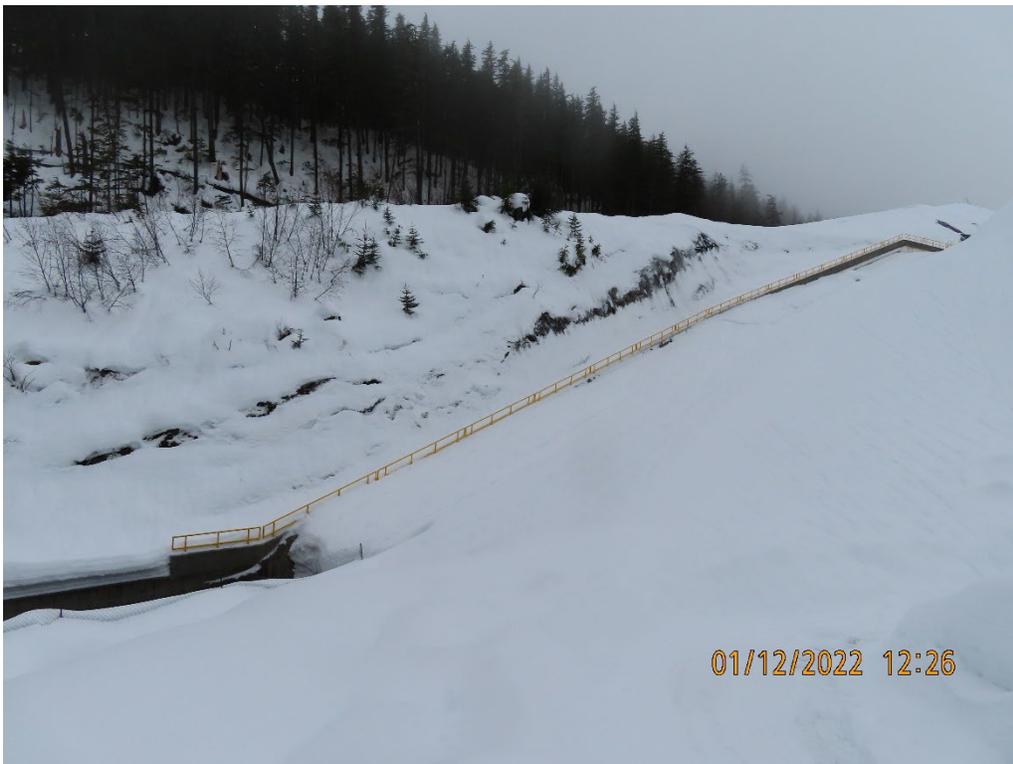
Photo 11. TTF dam spillway with new handrail.

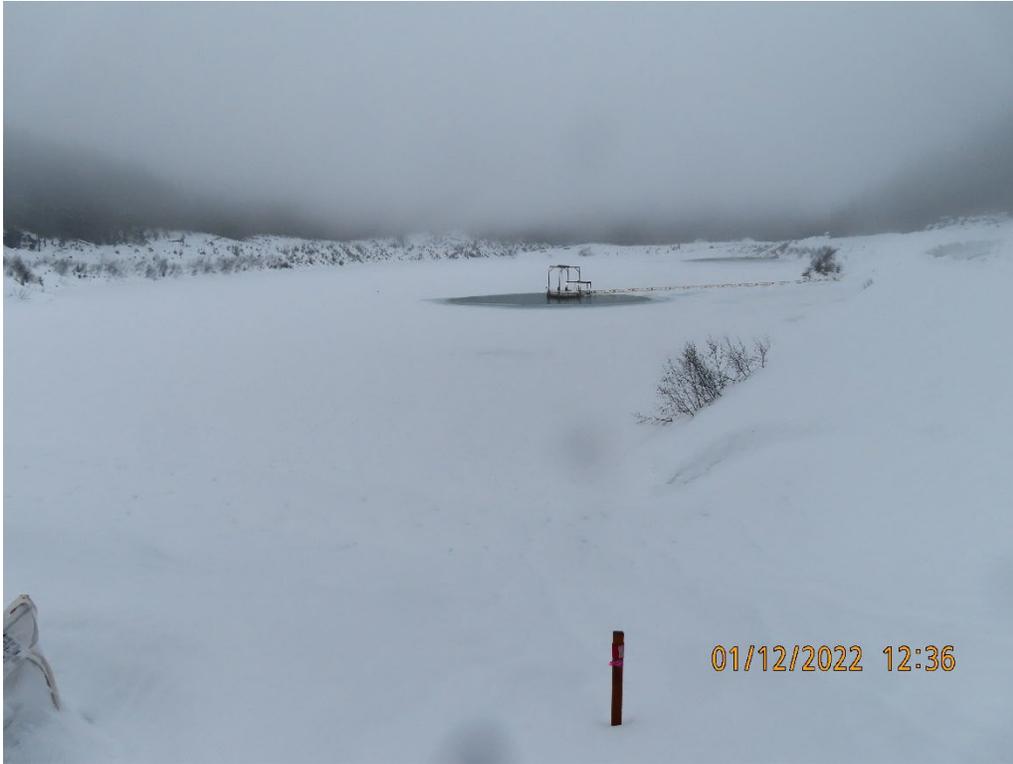
The TTF was mostly frozen, and tailings were being deposited in the northeast area of the facility (Photo 12). At that location water is being sprayed to maintain an unfrozen area to allow the tailings deposition barge to move as needed (Photo 13).

Photo 12. TTF lake. Dark area with open water in foreground is the reclaim barge, tailings deposition area is dark area up and to the right of reclaim barge.

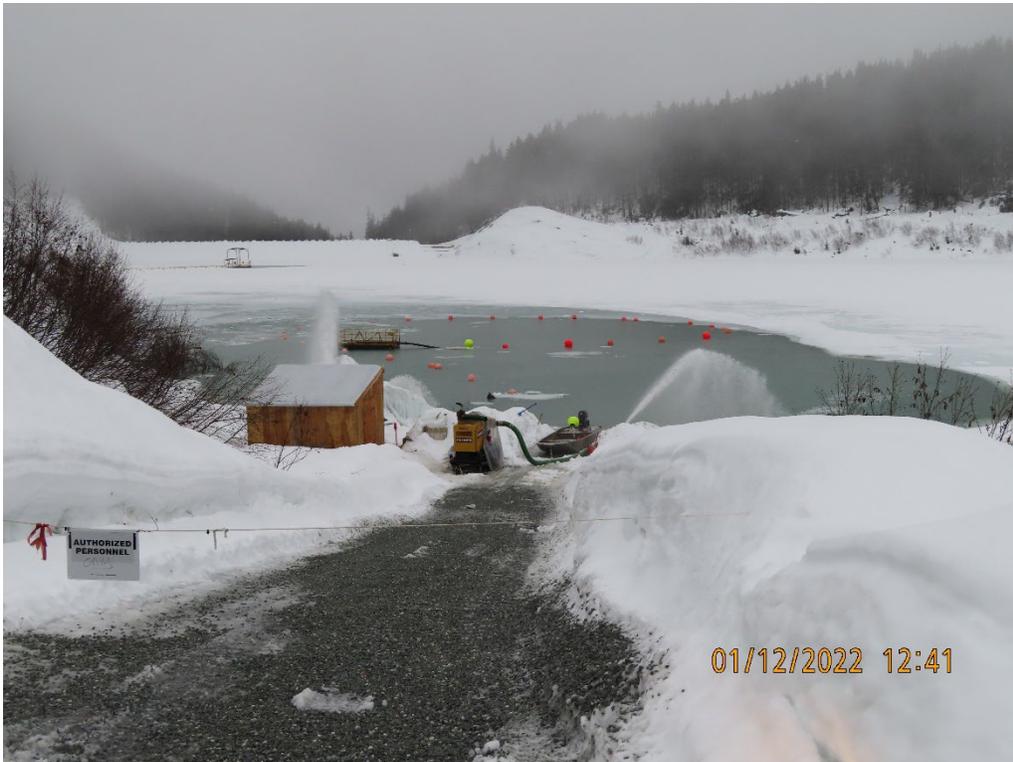
Photo 13. Tailings deposition area showing spraying water used to maintain open water for deposition barge maneuverability.

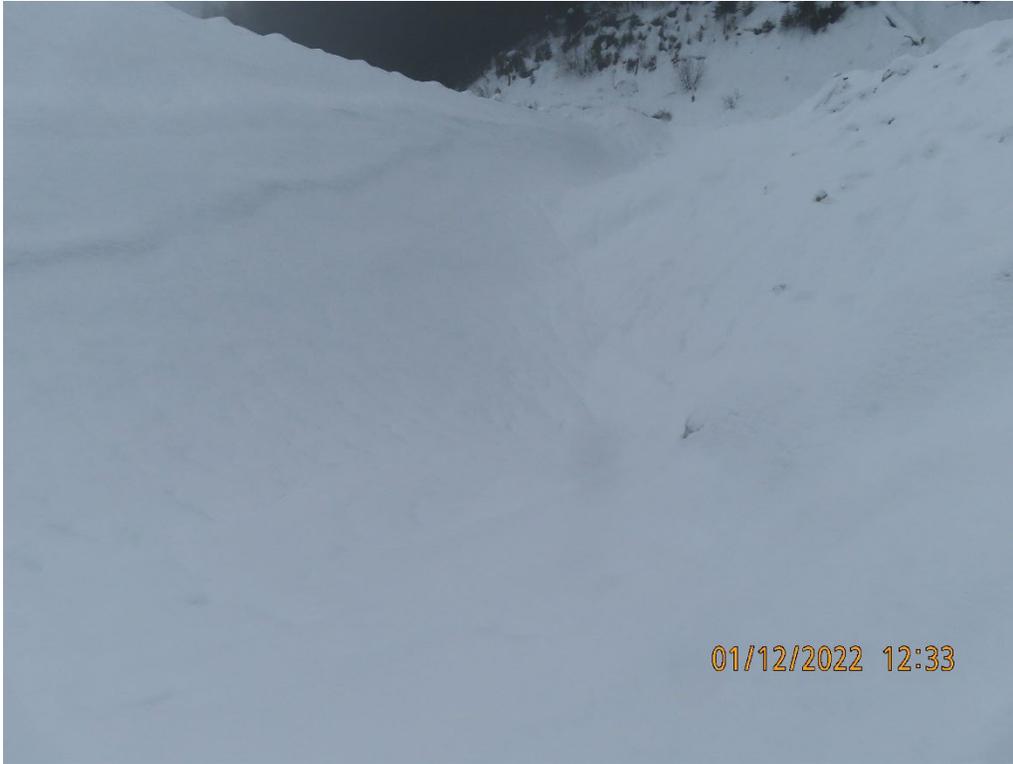
Pending action item 183-2: The ARD seep observed below the TTF dam in previous inspections is under deep snow (Photo 14). Once this area is accessible, Coeur will evaluate the need for additional mitigation measures and implement those as needed.

Photo 14. Location of ARD seep below TTF dam covered in snow.

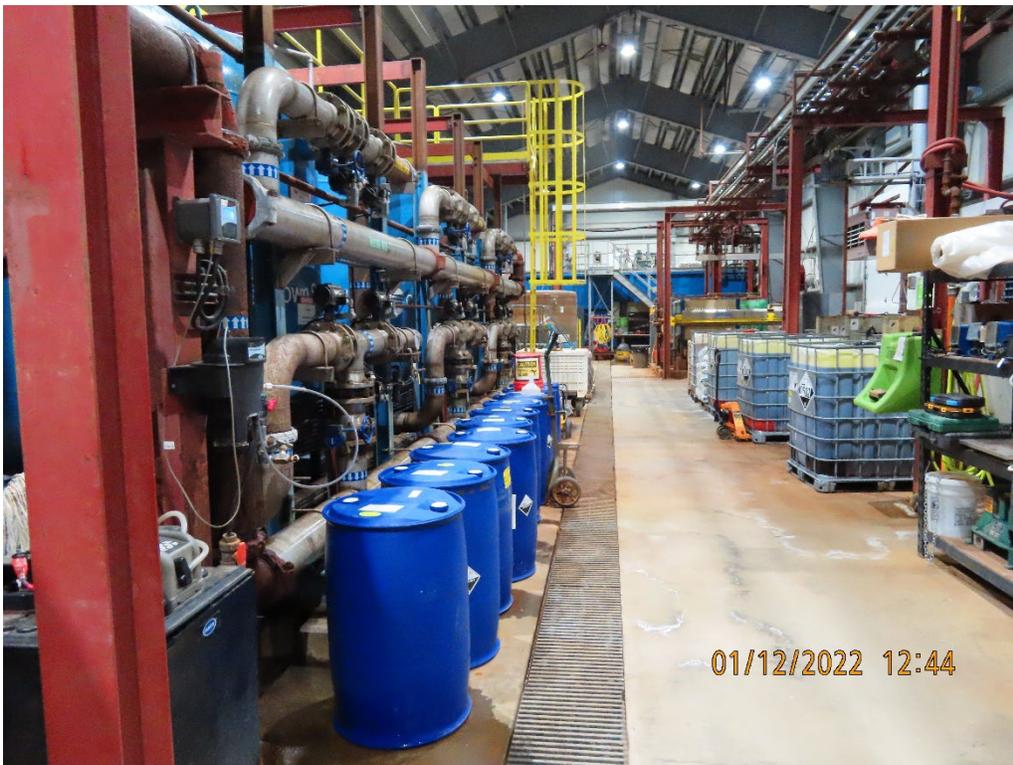
Good housekeeping practices were observed at the TTF water treatment plant (Photo 15)(Appendix 4g BMP plan; Table 4-1).

Photo 15. TTF WTP interior.

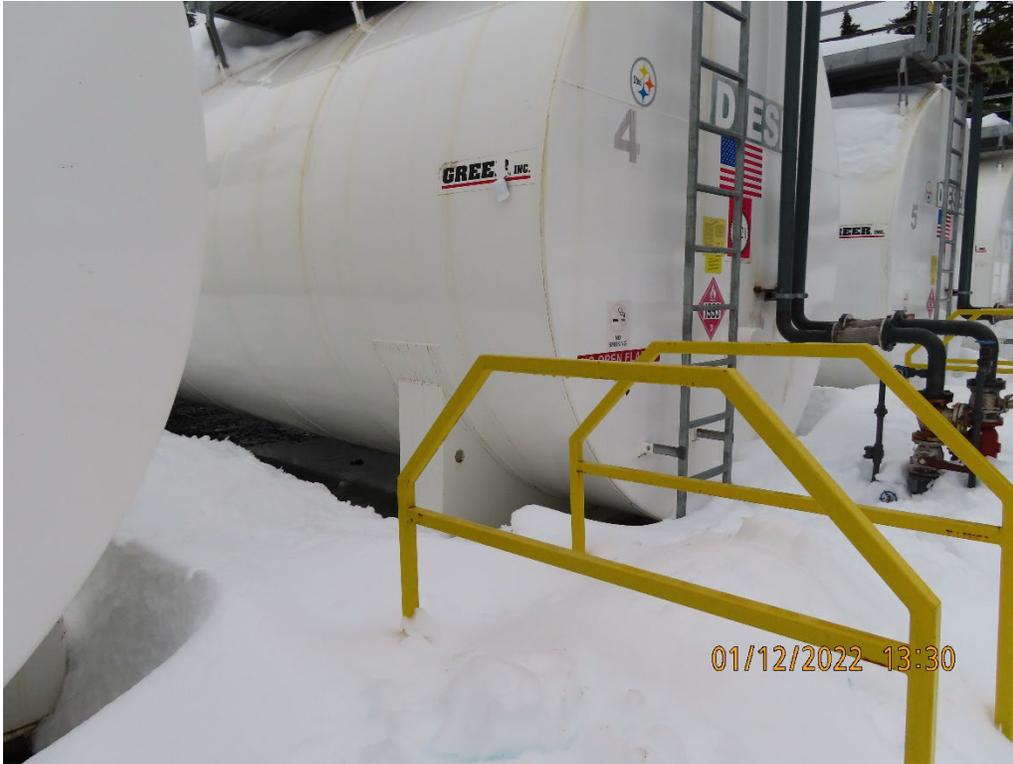
The fuel depot was in good condition and no sheen was observed. Deep snow was present which limited the extent of the facility that was visible (Photo 16).

Photo 16. Fuel depot showing deep snow.
