INSPECTION REPORT: KENSINGTON GOLD MINE

Date of Inspection: Wednesday, March 8, 2022
Date of Report: Wednesday, March 15, 2022
USDA Forest Service Inspector: Casey Loofbourrow

Ranger District: Juneau Ranger District
Weather Conditions: Sunny. Temperature: 30's °F.

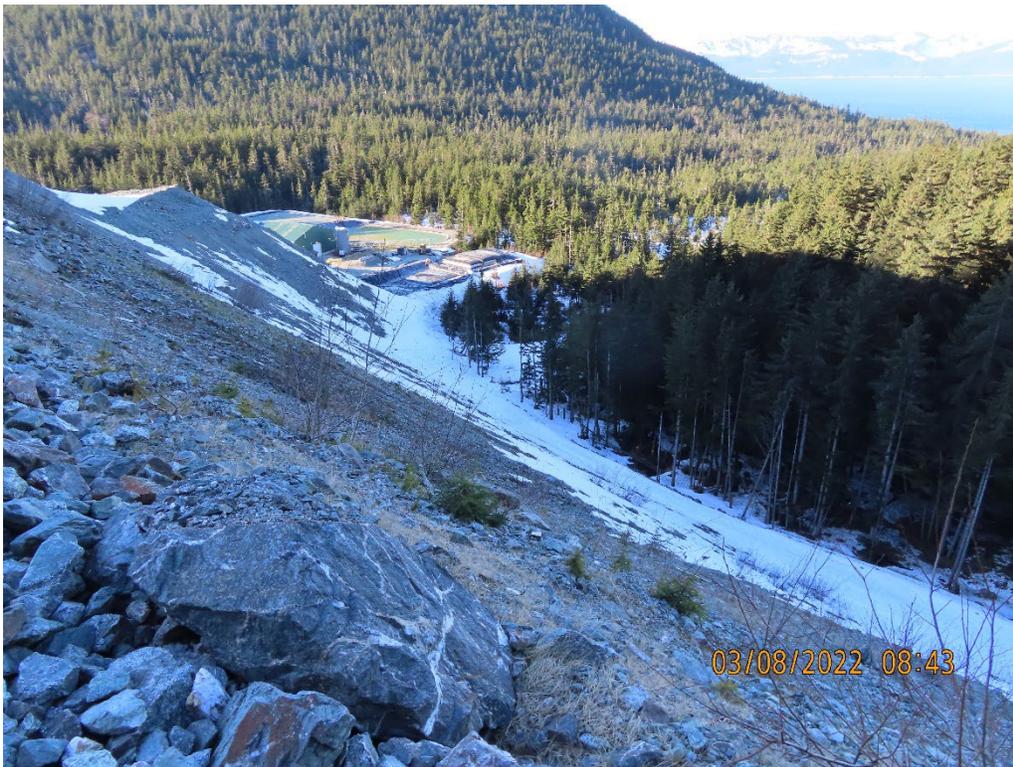
The slopes of the Comet waste rock storage area appear stable (Photo 1). Recent waste rock placement has not occurred.

Photo 1. Comet waste rock stockpile.

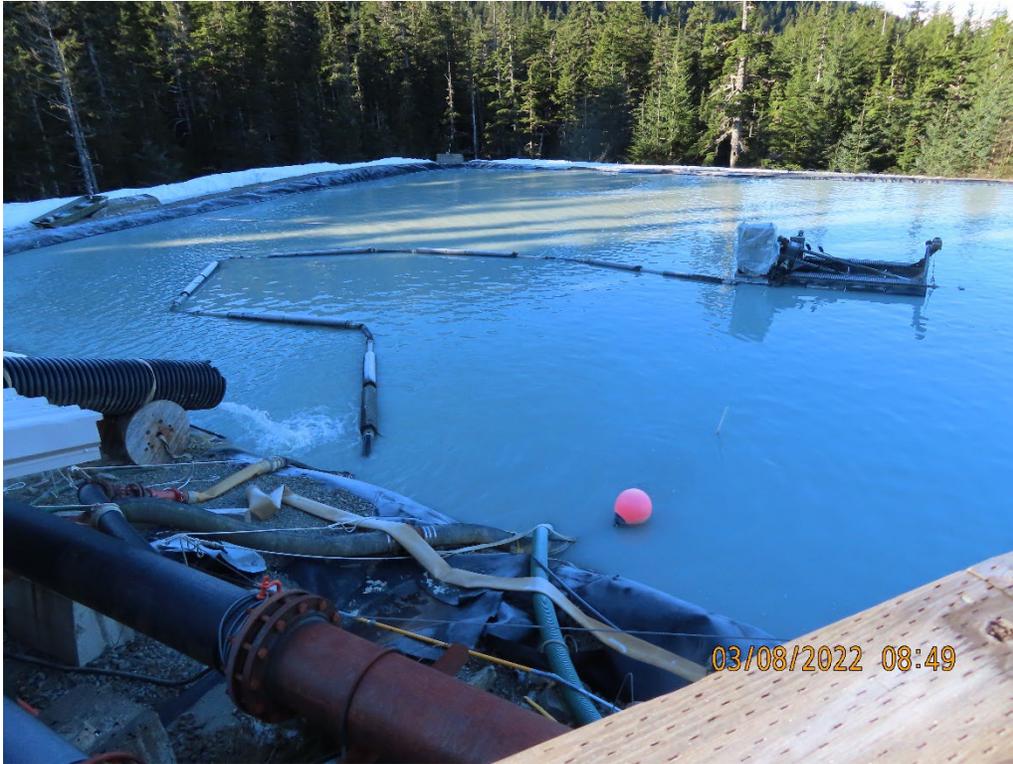
The CWTP was treating approximately 1750 gallons per minute (gpm). Turbidity of the received water measured 168 nephelometric turbidity units (NTU), and discharged treated water measured 0.4 NTU. Ponds 1 and 2 were receiving mine site water and functioning as intended (Photos 2-3). The mobile water treatment plant (CWTP plant 2.5) has been idled and winterized.

Photo 2. Pond 1 at CWTP.

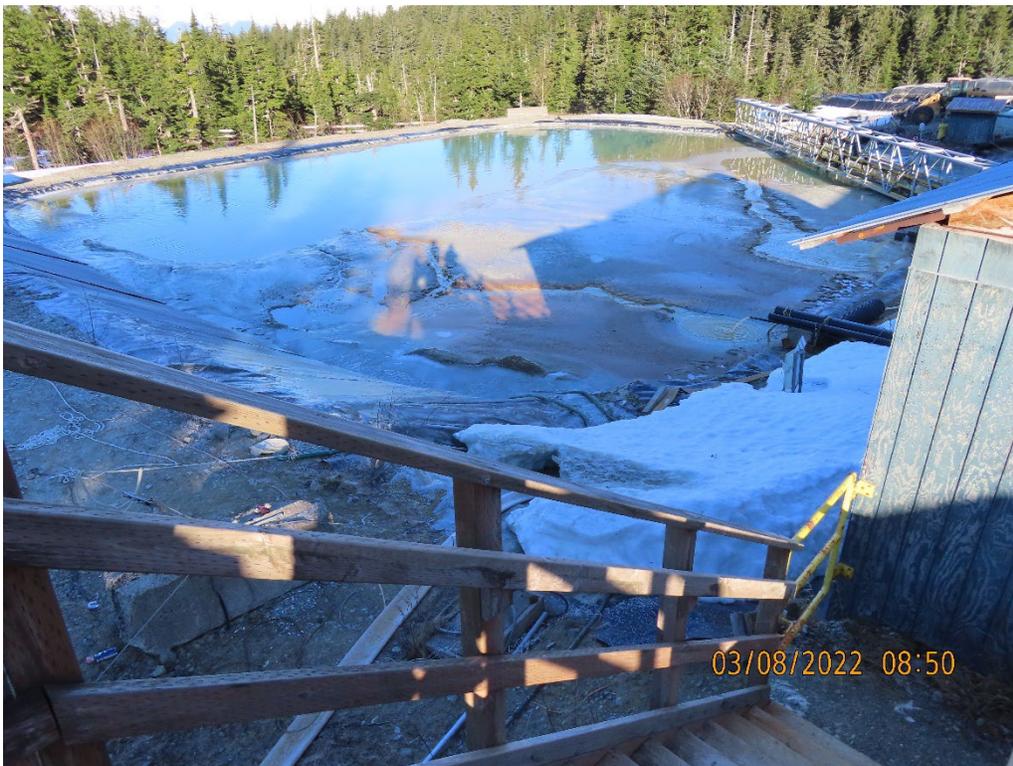
Photo 3. Pond 2 at CWTP.

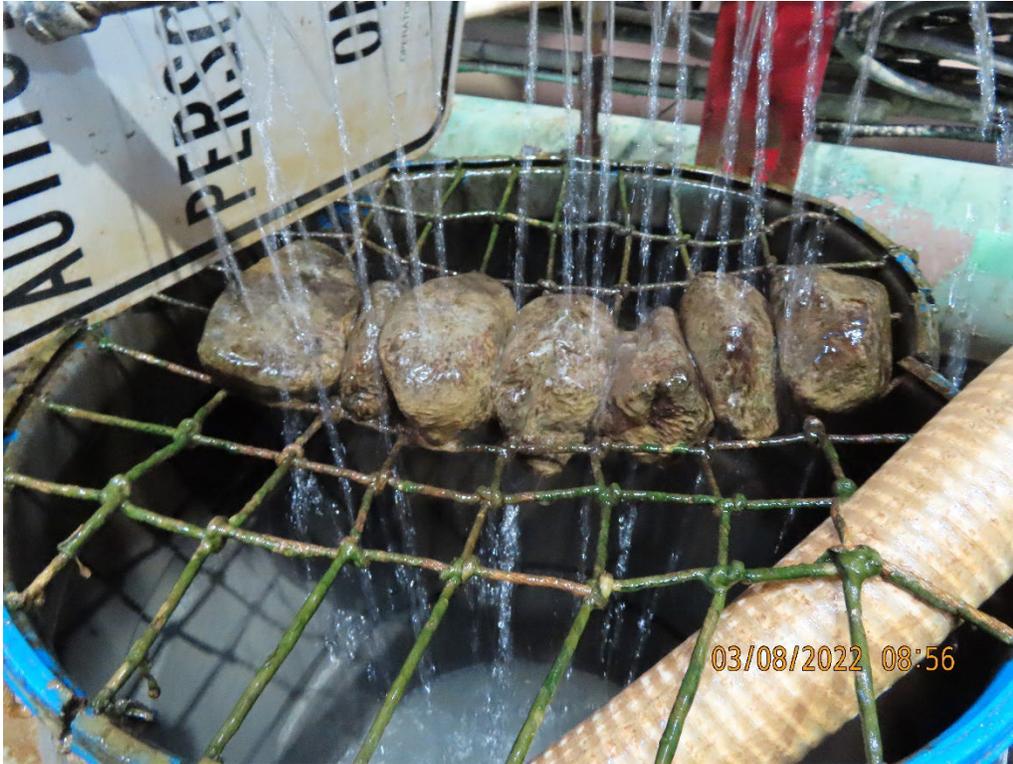
White material was not observed on the test rocks used for monitoring in the CWTP (Photo 4).

Photo 4. Test rocks in CWTP.

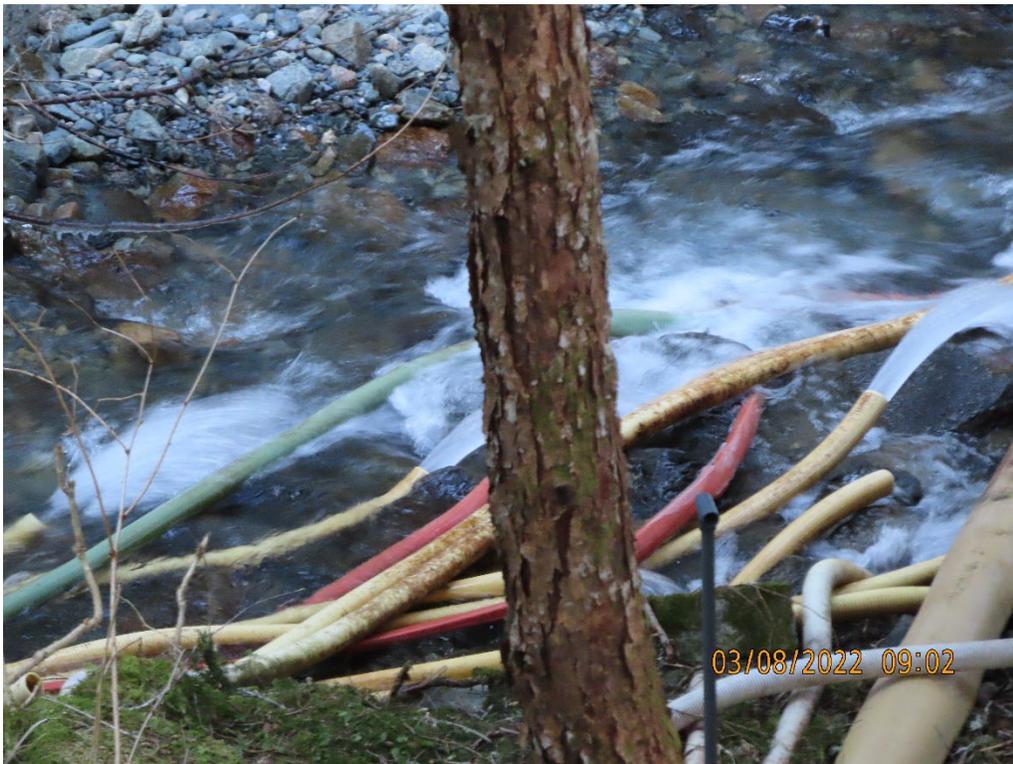
White material was not observed in Sherman Creek at Outfall 001 (Photo 5).

Photo 5. Sherman Creek Outfall 001.

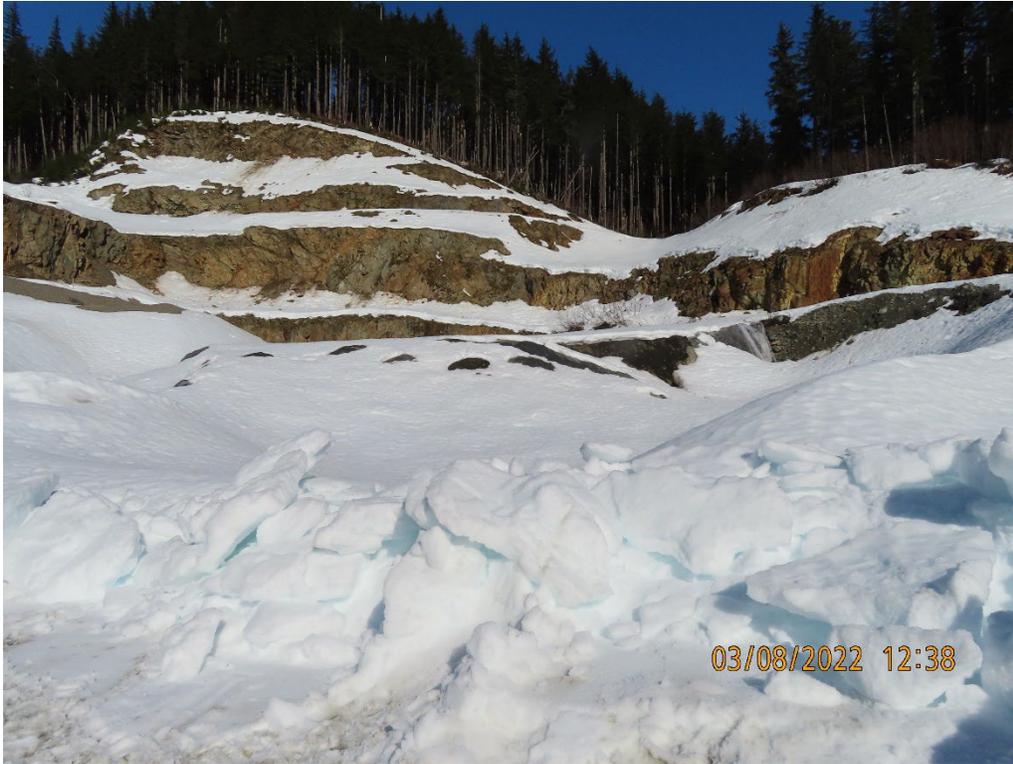
The graphitic phyllite at this location is covered with an impermeable liner to minimize rain and meltwater infiltration and potential generation of acid rock drainage (Photo 6).

Photo 6. Graphitic phyllite stockpile in Pit 4.

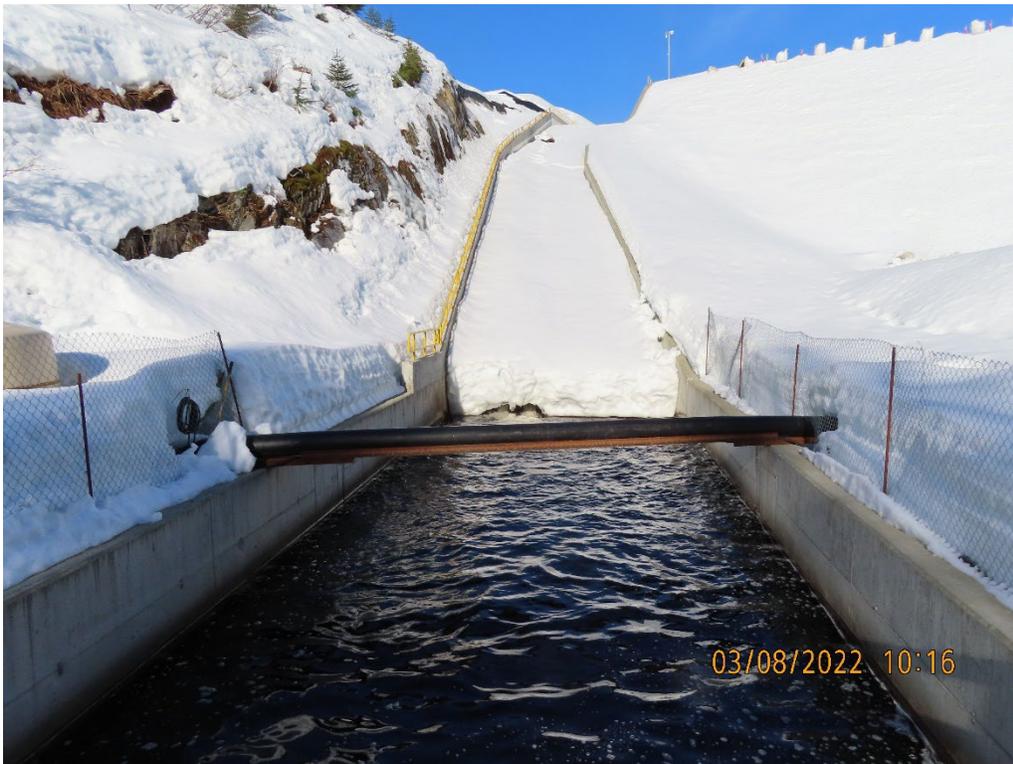
The TTF dam spillway was covered with deep snow. No visual indication of active acid rock drainage seeps entering the spillway past the recently constructed concrete raise was observed (Photo 7).

Photo 7. TTF dam spillway.

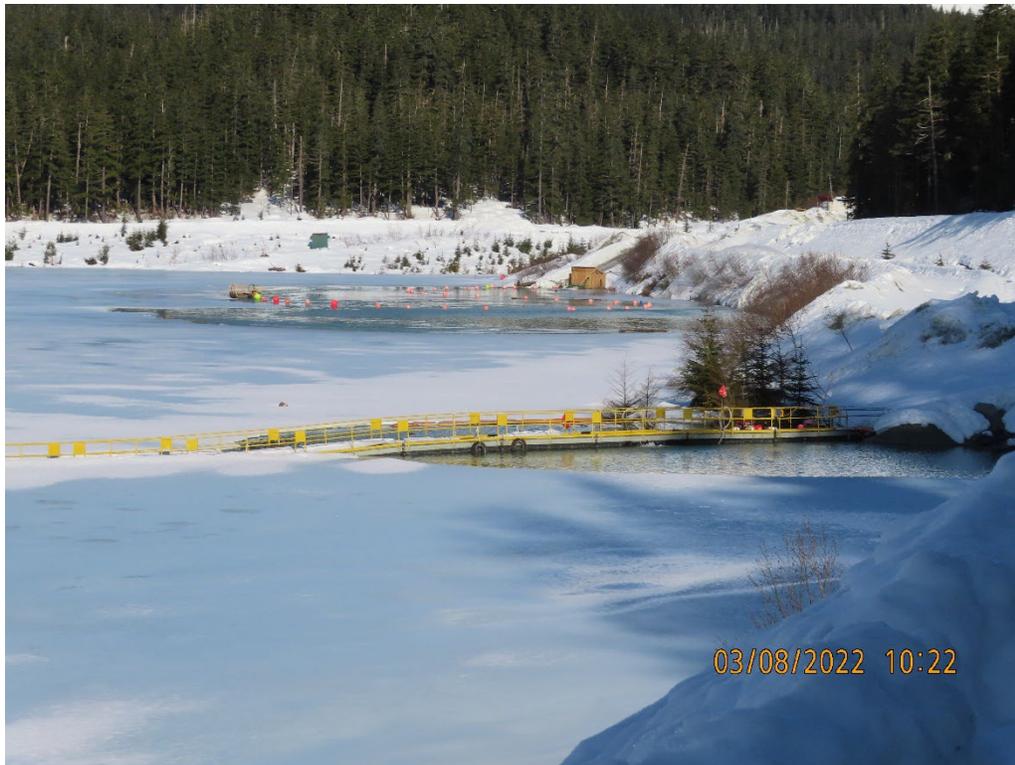
The TTF was mostly frozen, and tailings were being deposited in the northeast area of the facility (Photo 8). At that location water is being sprayed to maintain an unfrozen area to allow the tailings deposition barge to be relocated as needed.

Photo 8. TTF lake. Dark area with open water in foreground is the reclaim barge, tailings deposition area is in the background.

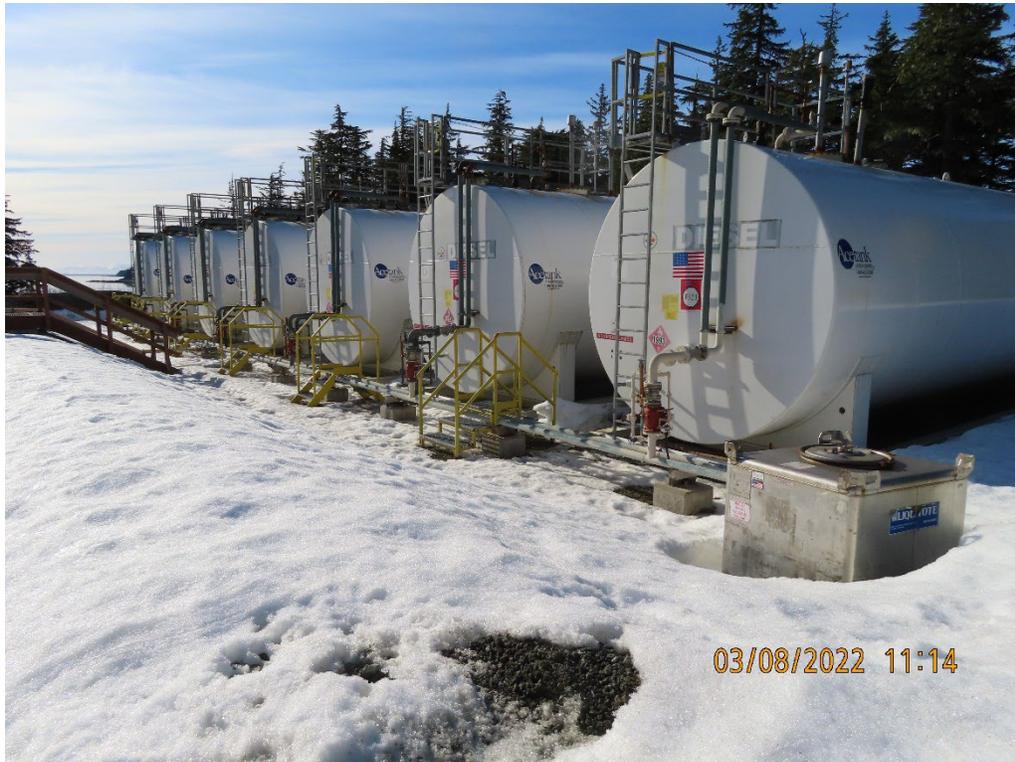
The fuel depot was in good condition and no sheen was observed. Snow was present which limited the extent of the facility that was visible (Photo 9).

Photo 9. Fuel depot with deep snow present.

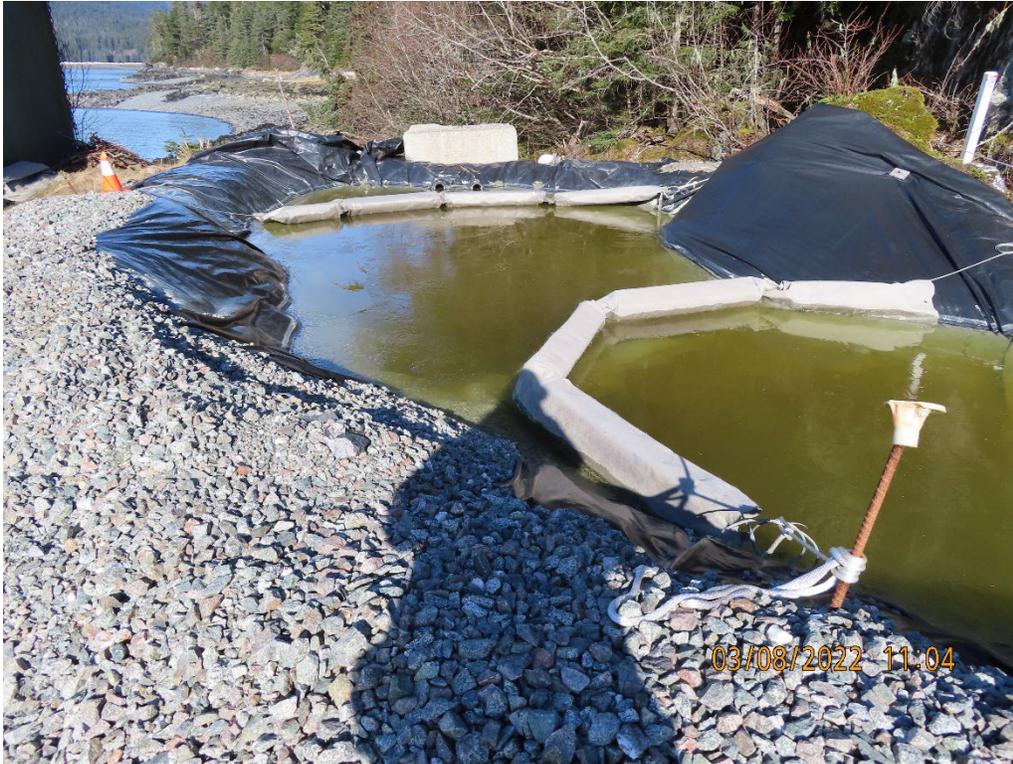
The stormwater BMPs at the marine facility were functioning as intended, with discharged water observed to be clear (Photo 10).

Photo 10. Slate Cove marine facility stormwater sediment BMPs.
