INSPECTION REPORT: KENSINGTON GOLD MINE

Tongass National Forest Minerals Group
8510 Mendenhall Loop Rd
Juneau, AK 99801
(907) 789-6276 – office
(907) 586-8808 – fax

Date of Inspection: Thursday, July 14, 2022
Date of Report: Monday, July 25, 2022
USDA Forest Service Inspector: Casey Loofbourrow

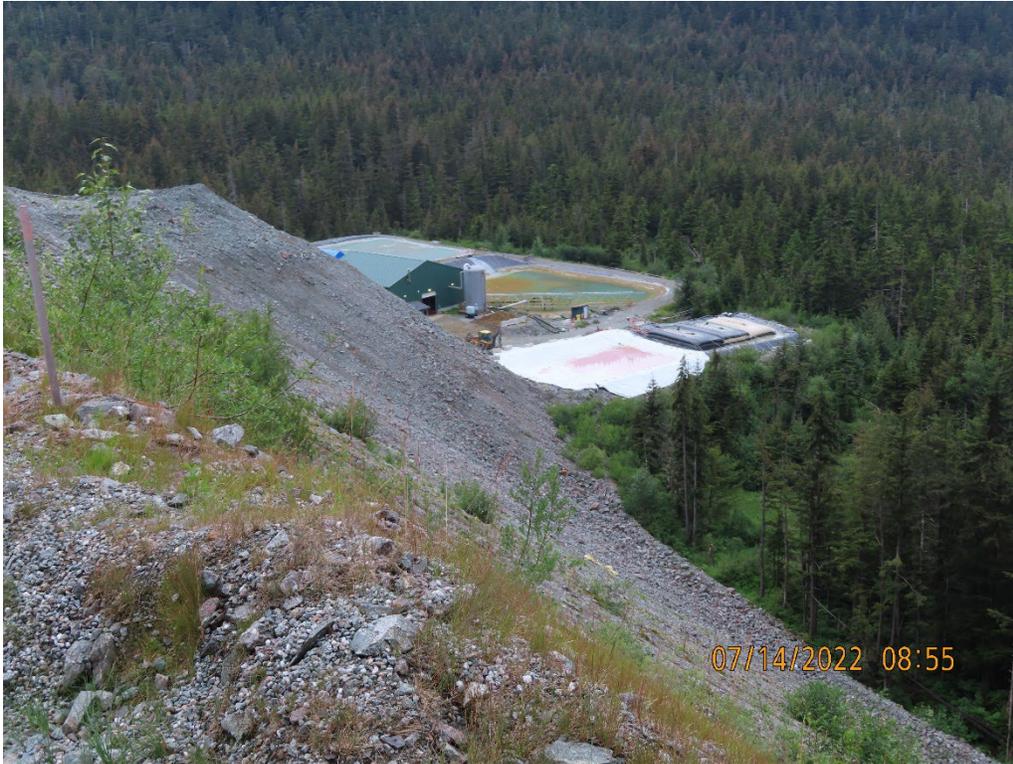
The slopes of the Comet waste rock storage area appear stable (Photo 1). There has been no recent waste rock placement at this site.

Photo 1. Comet waste rock storage area.

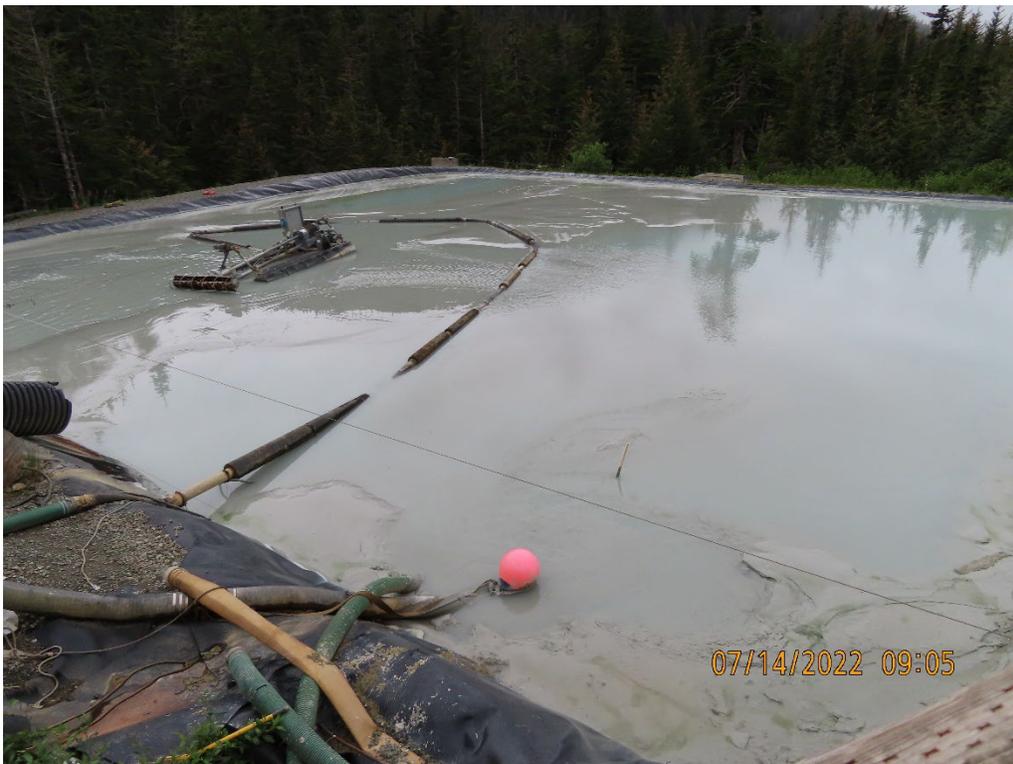
The CWTP was treating approximately 2,590 gallons per minute (gpm). A dredge was located in Pond 1, which at the time of inspection was nearly filled with sediment (Photo 2), and Pond 2 had a water level lower than observed in recent inspections (Photo 3). Pond 1 was draining into Pond 2 via the connecting spillway.

Photo 2. Comet Water Treatment Plant (CWTP) Pond 1.

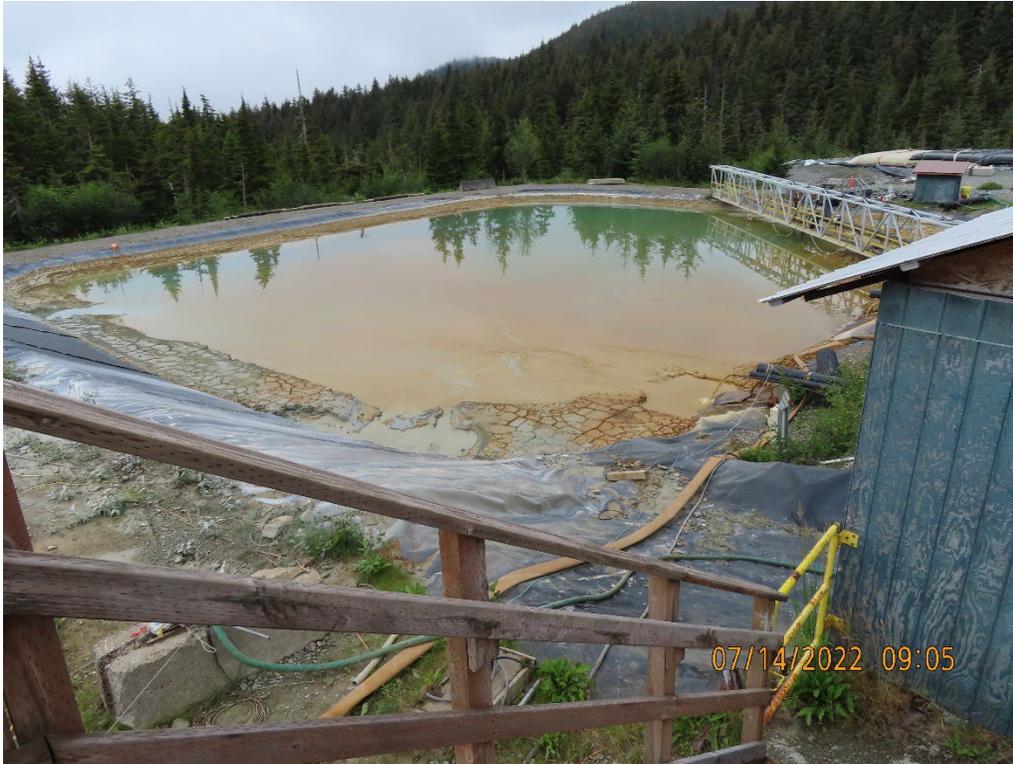
Photo 3. CWTP Pond 2.

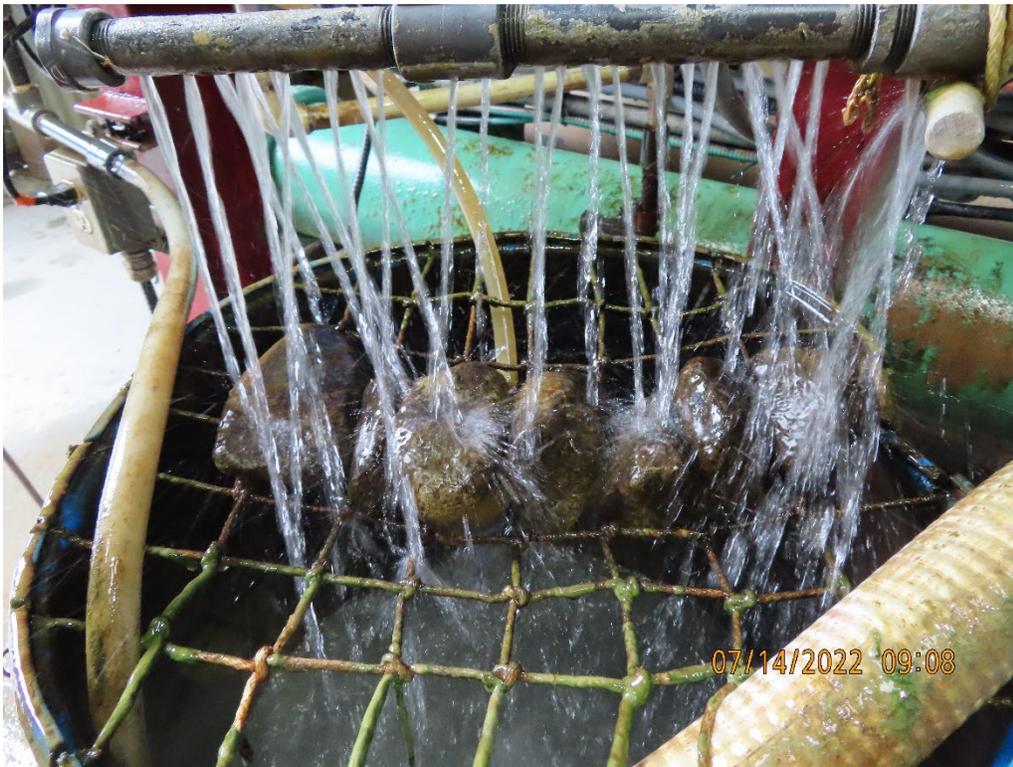
White material was not observed on the test rocks used for monitoring in the CWTP (Photo 4).

Photo 4. CWTP white material test rocks.

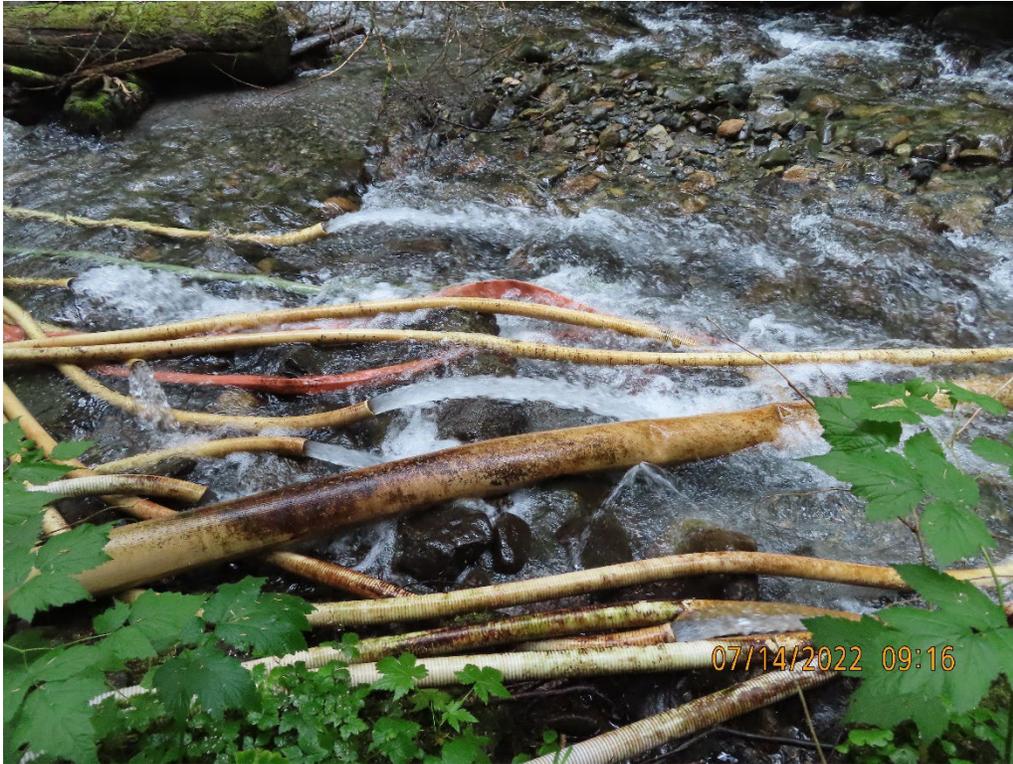
No white material was observed at Outfall 001, where treated water from the CWTP is discharged (Photo 5).

Photo 5. Sherman Creek Outfall 001.

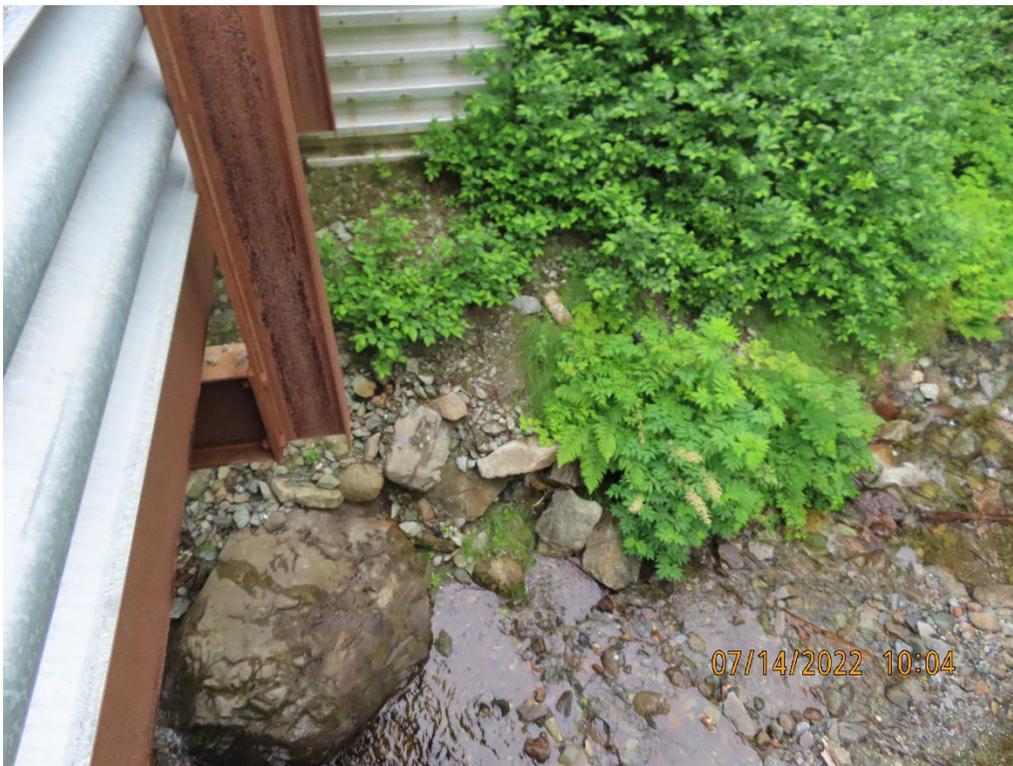
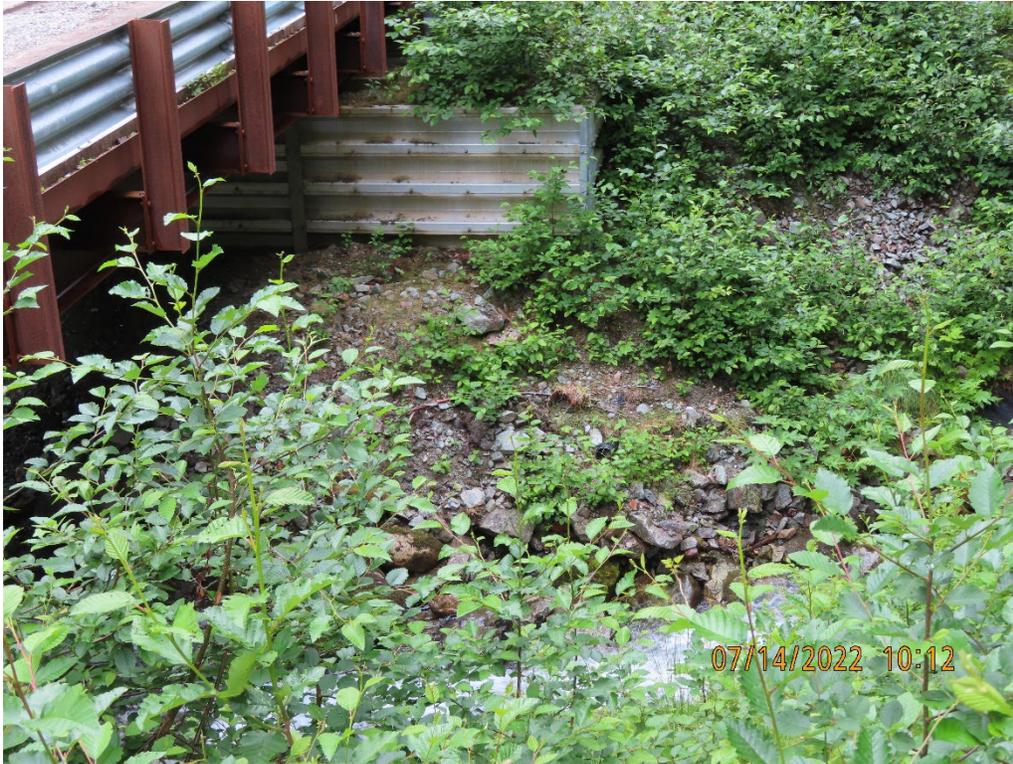
RESOLVED ACTION ITEM 189-2: Silt fencing installed during construction to reduce fine sediment discharge to the streams was no longer needed and has been removed (Photos 6-7).

Photo 6. No Name Creek abutment, location of removed silt fencing.

Photo 7. Upper Sherman Creek bridge abutment, location of removed silt fencing.

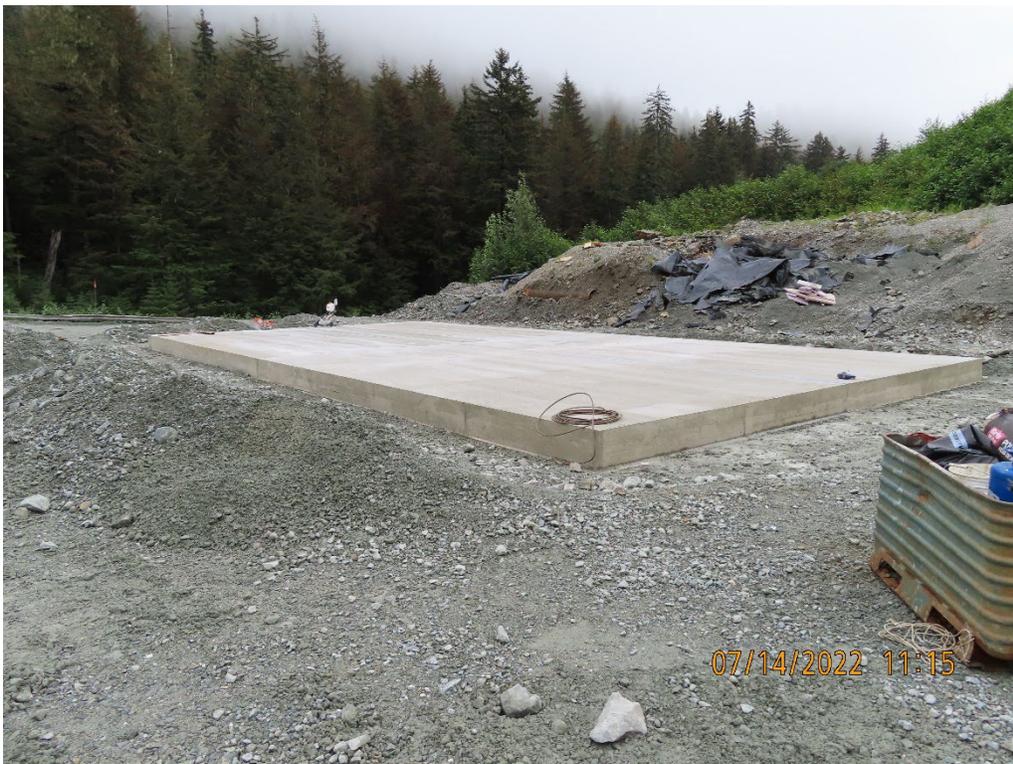
A concrete slab foundation has been poured at this location (Photo 8), where the surface equipment shop currently at Pit 4 (Photo 9) will be relocated. This slab is located on private land.

Photo 8. Concrete slab at the north end of the Mud Dump, where the equipment maintenance shop currently located at Pit 4 will be relocated.

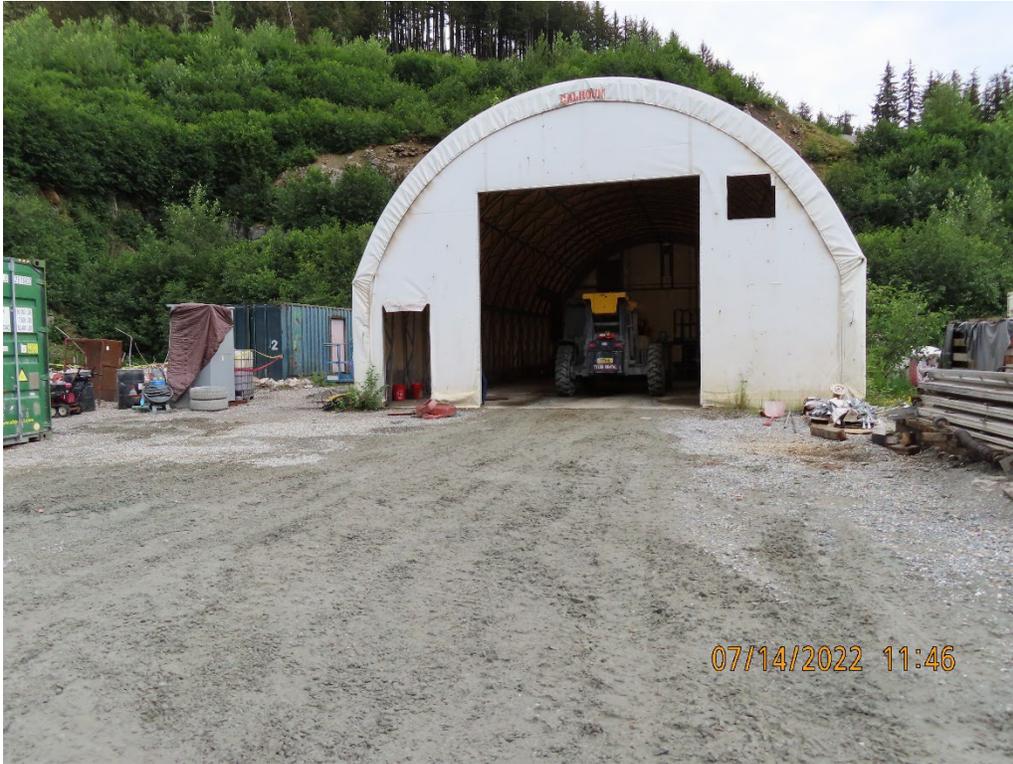
Photo 9. Equipment shop at Pit 4 that will be moved to the concrete foundation at the Mud Dump.

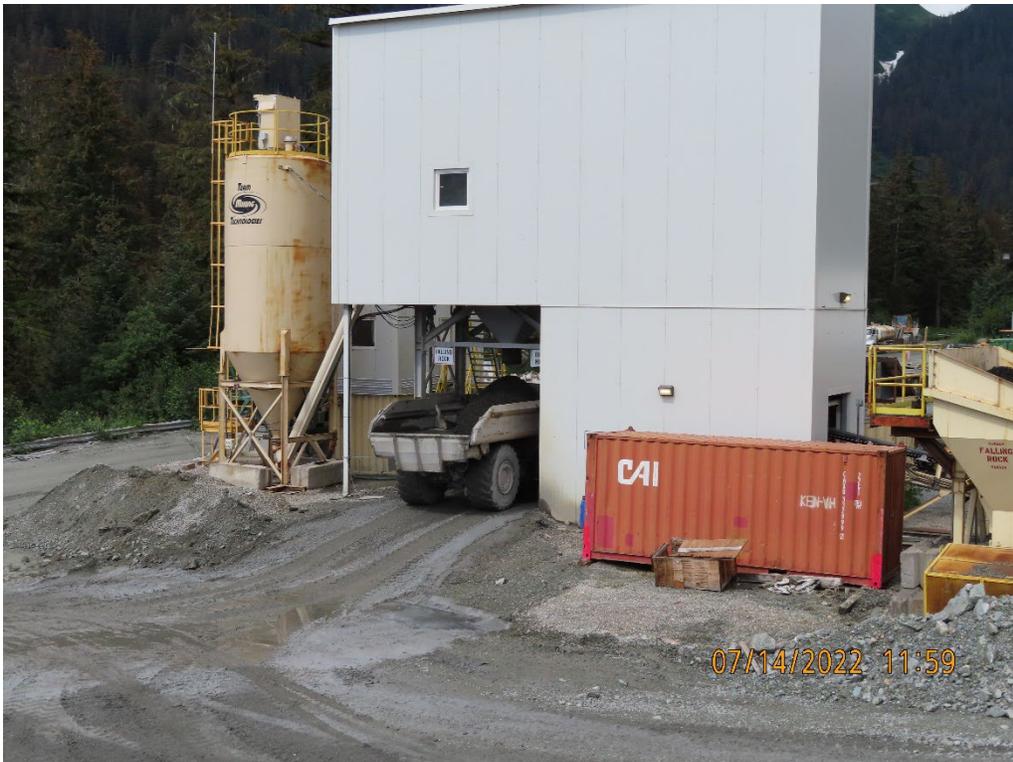
The Pug Plant (Photo 10) was operational and processing graphitic phyllite stockpiled in Pit 4 (Photo 11) for underground backfill.

Photo 10. Pug Plant loading an underground haul truck with graphitic phyllite mixed with concrete and aggregate for backfill underground.

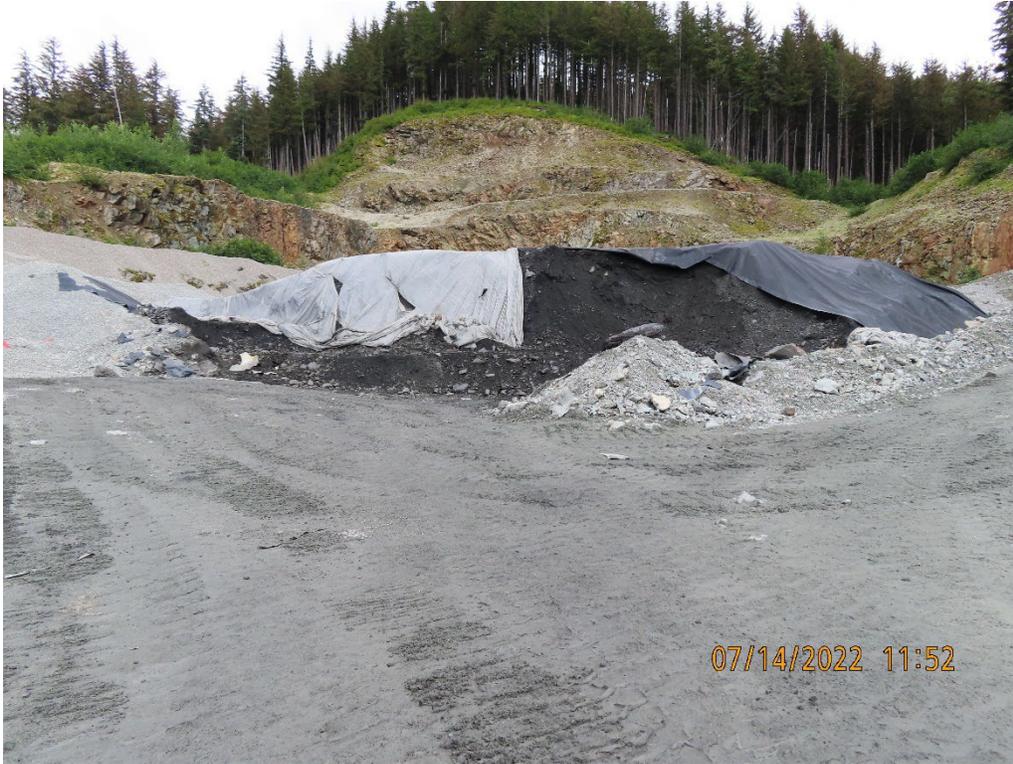
Photo 11. Graphitic phyllite stockpile at Pit 4.

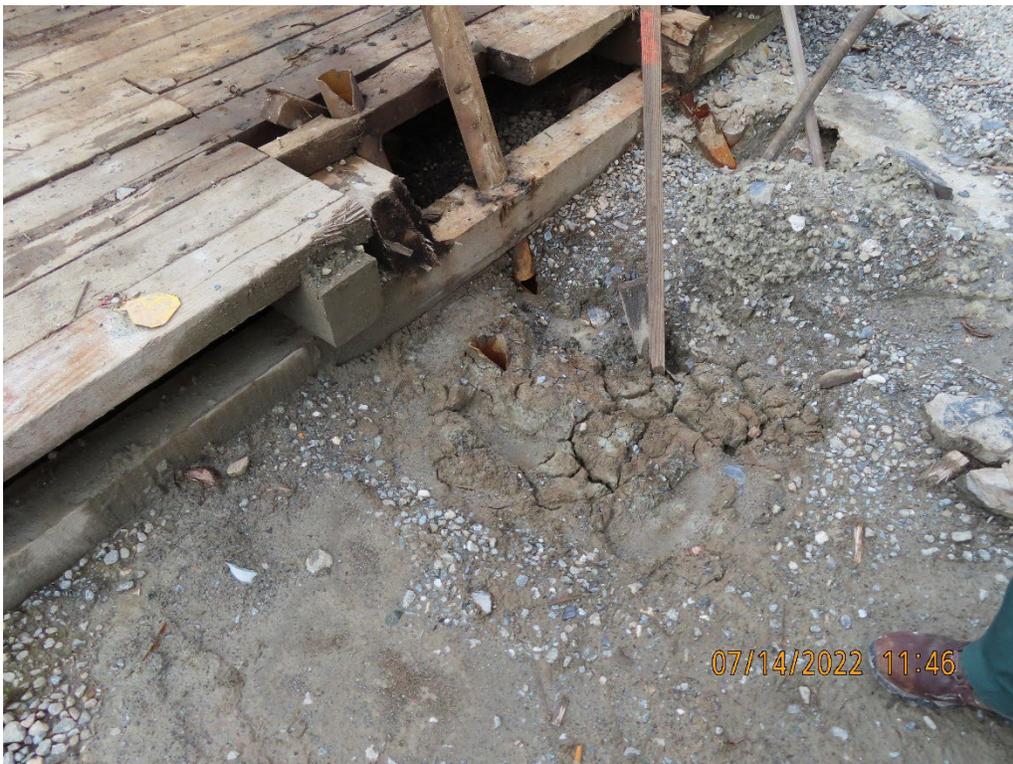
RESOLVED ACTION ITEM 189-3: In the previous inspection, an exploration drill hole appeared to have intercepted groundwater, resulting in water discharging to the surface. Coeur has plugged the hole and surface flow of water has ceased (Photo 12).

Photo 12. Borehole location at Pit 4 where groundwater had previously been flowing to the surface.

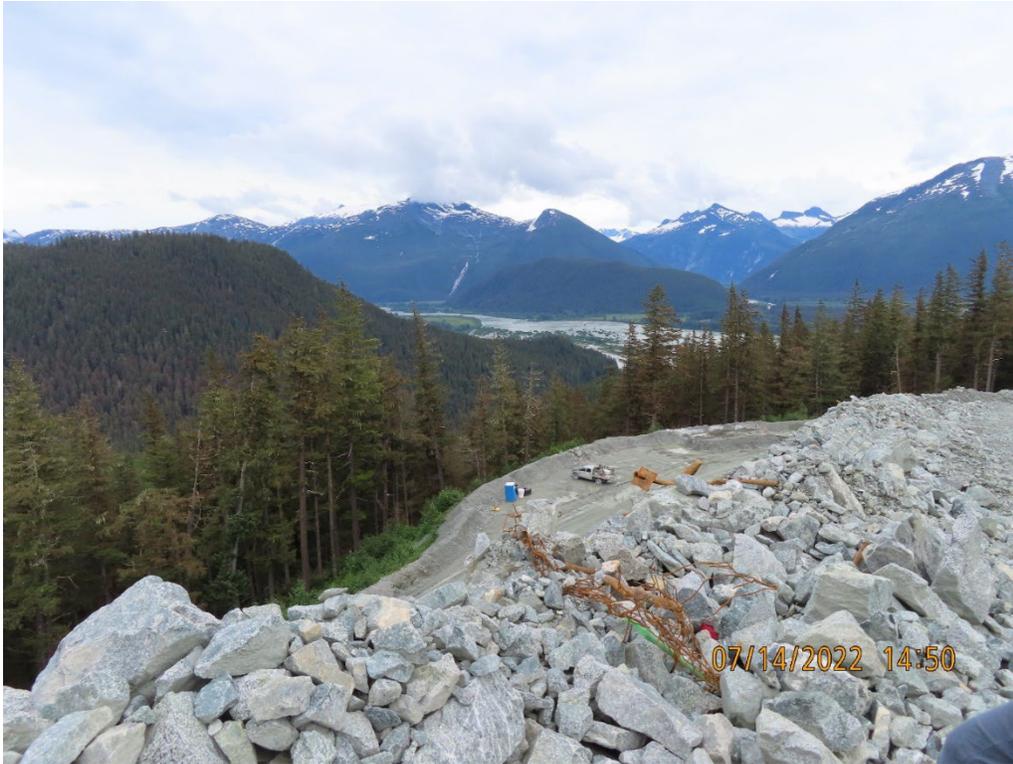
Coeur continues to transport and store waste rock at Pit 7 (Photo 13). Coeur intends to use this material as fill for POA1 Stage 4 dam construction.

Photo 13. Looking from top of waste rock stockpiled at Pit 7 down to the TTF access road.

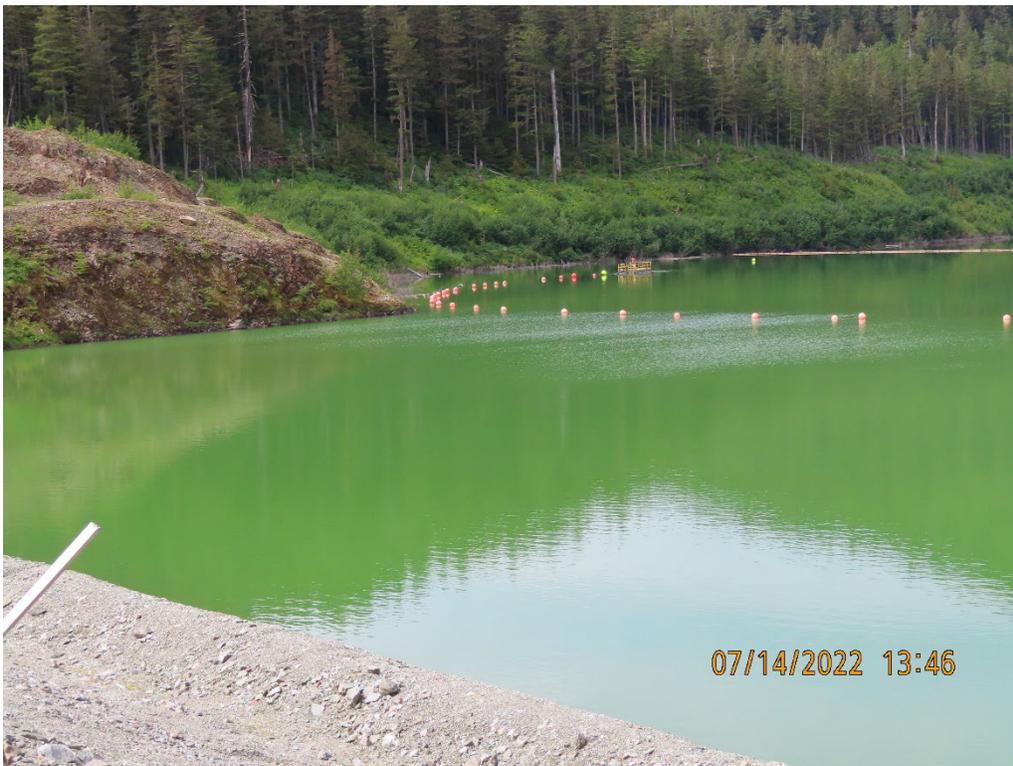
Since the previous inspection, the tailings deposition barge and water treatment reclaim barge have been relocated. Tailing deposition is currently occurring in the southern area of the TTF near the dam (Photo 14). The reclaim barge is located to the north (Photo 15).

Photo 14. TTF tailings deposition barge located at the southwest of the facility.

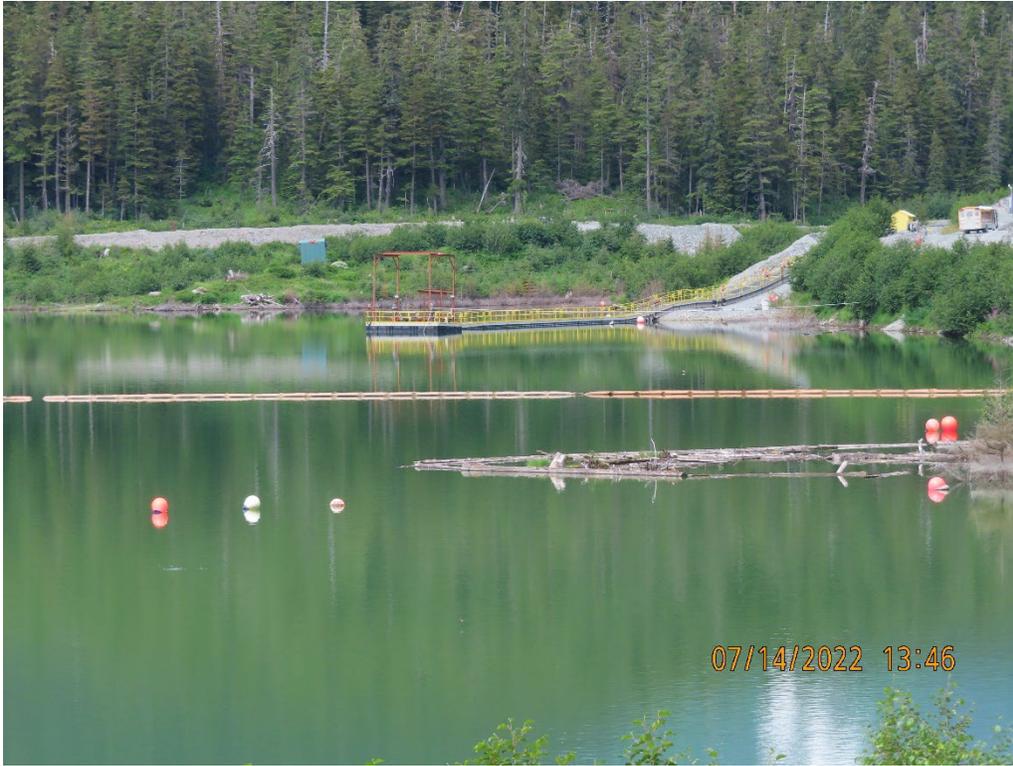
Photo 15. TTF reclaim barge located at the northeast of the facility.

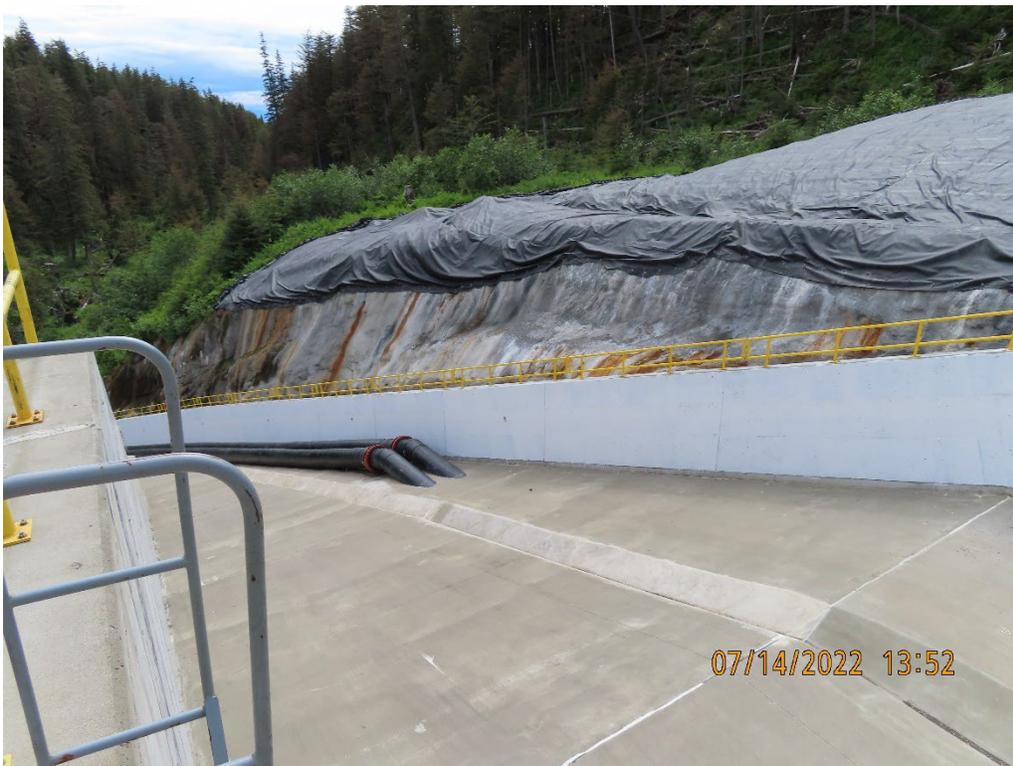
The TTF dam spillway appeared in good condition and there was not visual indication of ARD entering the spillway (Photo 16).

Photo 16. TTF dam spillway.

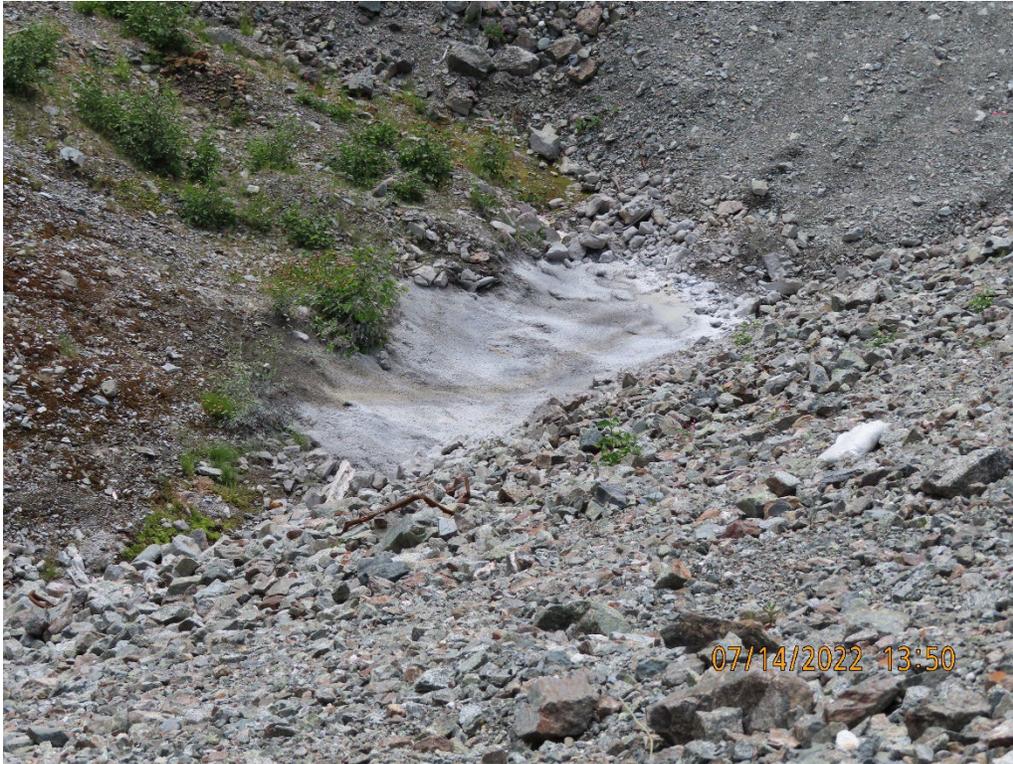
RESOLVED ACTION ITEM 183-2: Coeur has applied shotcrete to the source of the ARD seepage located by the east TTF dam abutment. No additional seepage was visible at the time of inspection (Photo 17).

Photo 17. Shotcrete covering ARD seep by east TTF dam abutment.

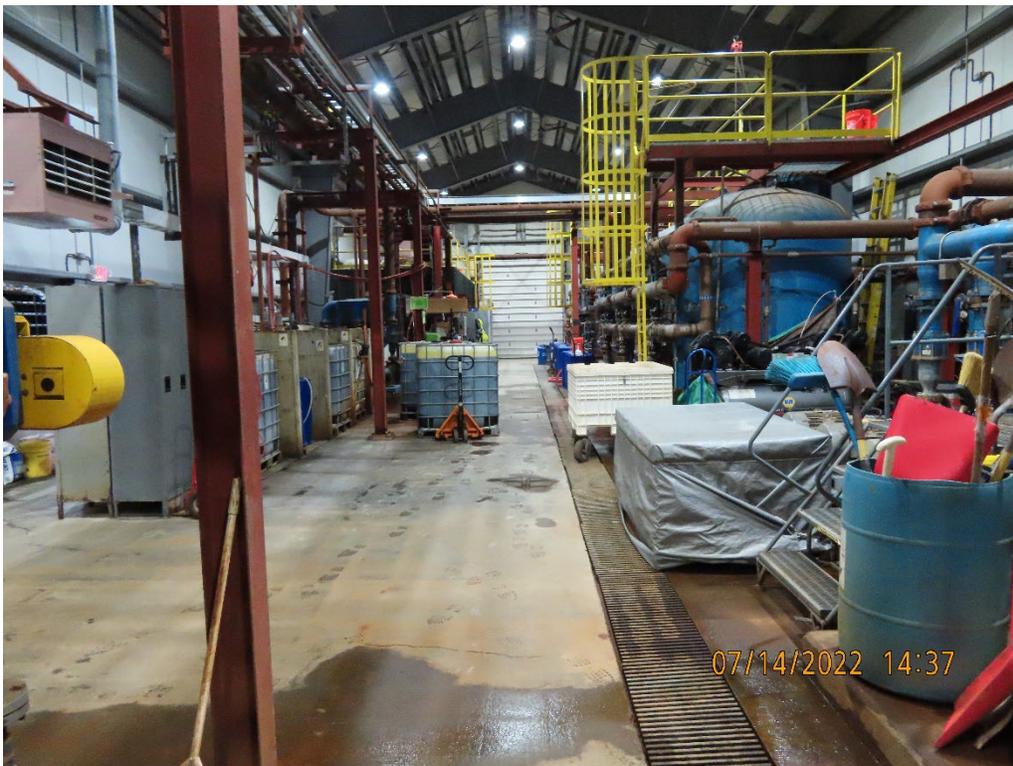
Good housekeeping practices were observed inside the TTF water treatment plant (Photo 18, Appendix 4g BMP plan; Table 4-1). The TTF water treatment plant was treating 980 gpm, and the water discharged to Outfall 002 measured 7.58 pH and .323 NTU.

Photo 18. TTF water treatment plant interior.

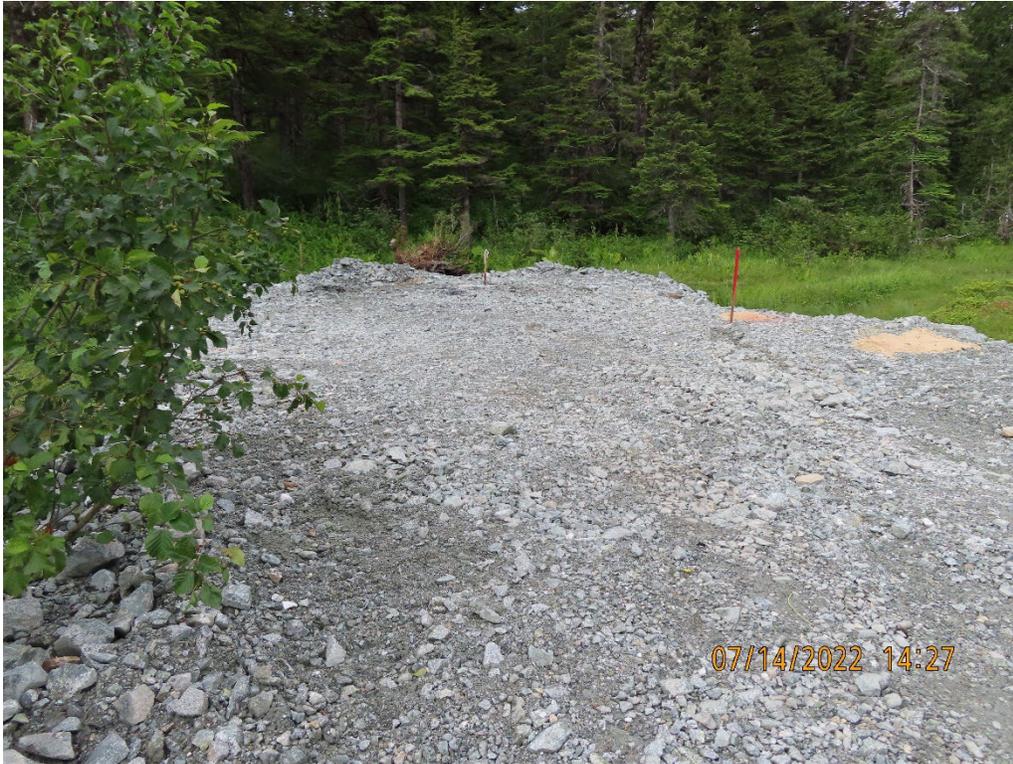
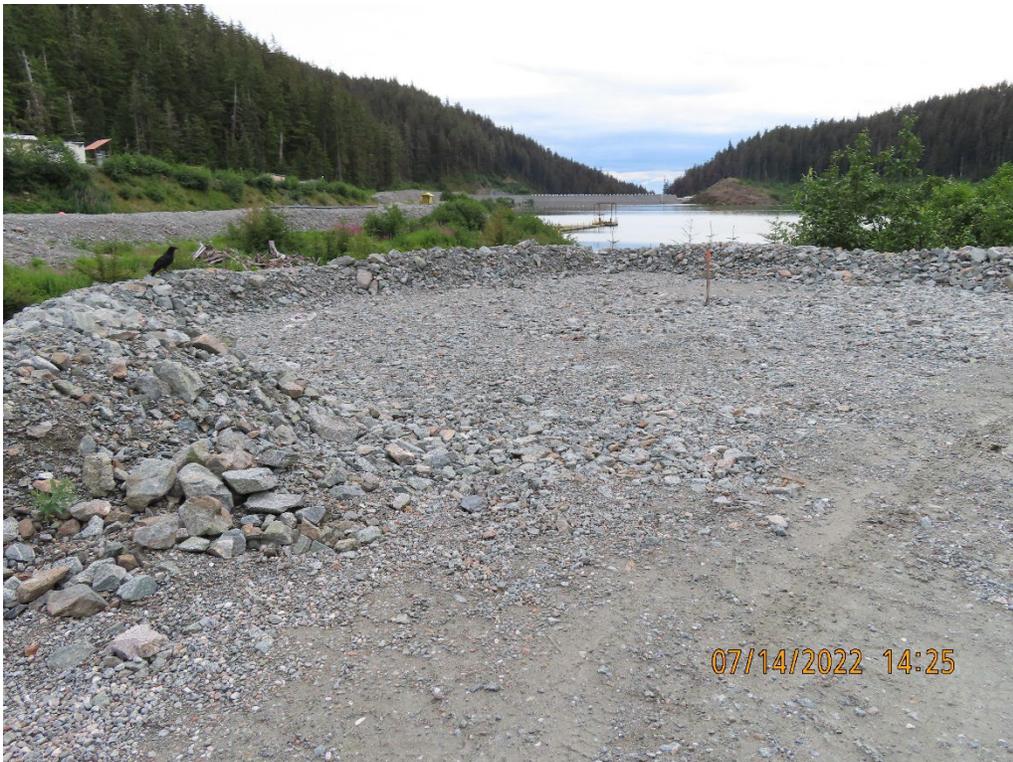
Coeur recently completed geotechnical drilling near the Upper Slate Lake diversion intake, in support of engineering the back dam as described in POA1 (Photos 19-20).

Photo 19. Drill pad constructed for geotechnical drilling near the Upper Slate Lake bypass intake.

Photo 20. Second drill pad constructed for geotechnical drilling near the Upper Slate Lake bypass intake.

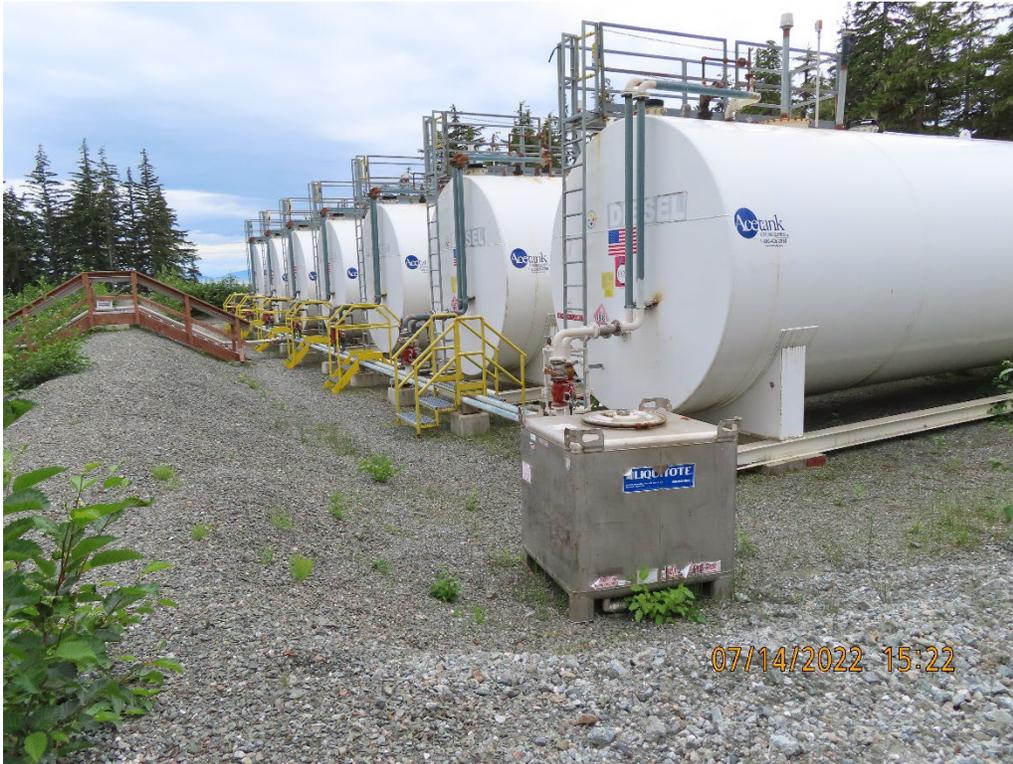
The fuel depot was in good condition with no sheen or spills observed (Photo 21).

Photo 21. Fuel depot.

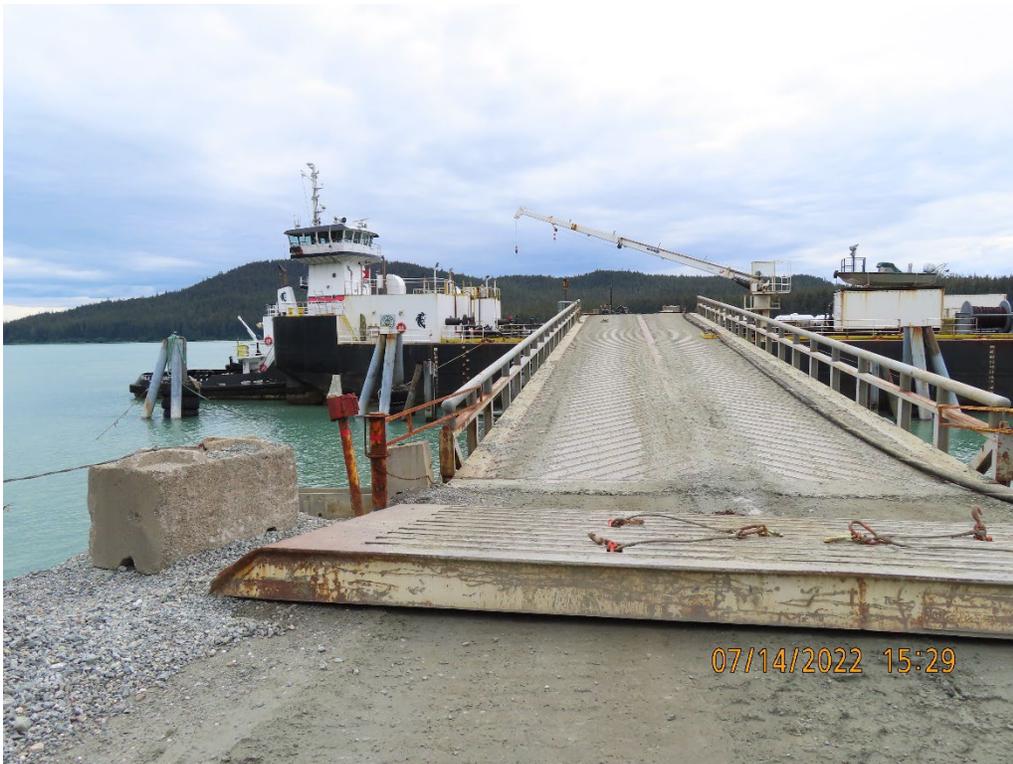
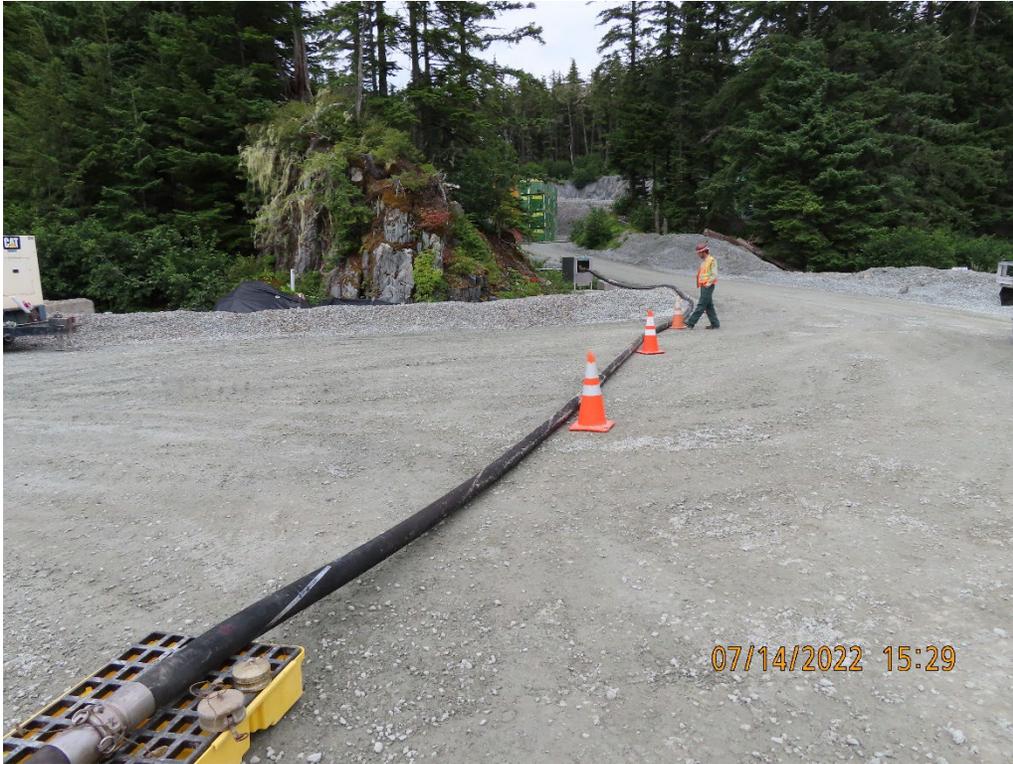
At the time of inspection, the fuel barge was refilling the tank farm (Photos 22-23).

Photo 22. Fuel barge.

Photo 23. Line connecting the fuel barge to the fuel depot header.
