## INSPECTION REPORT: KENSINGTON GOLD MINE

Date of Inspection: Wednesday, September 21, 2022  
Date of Report: October 12, 2022  
USDA Forest Service Inspector: Pat Dryer

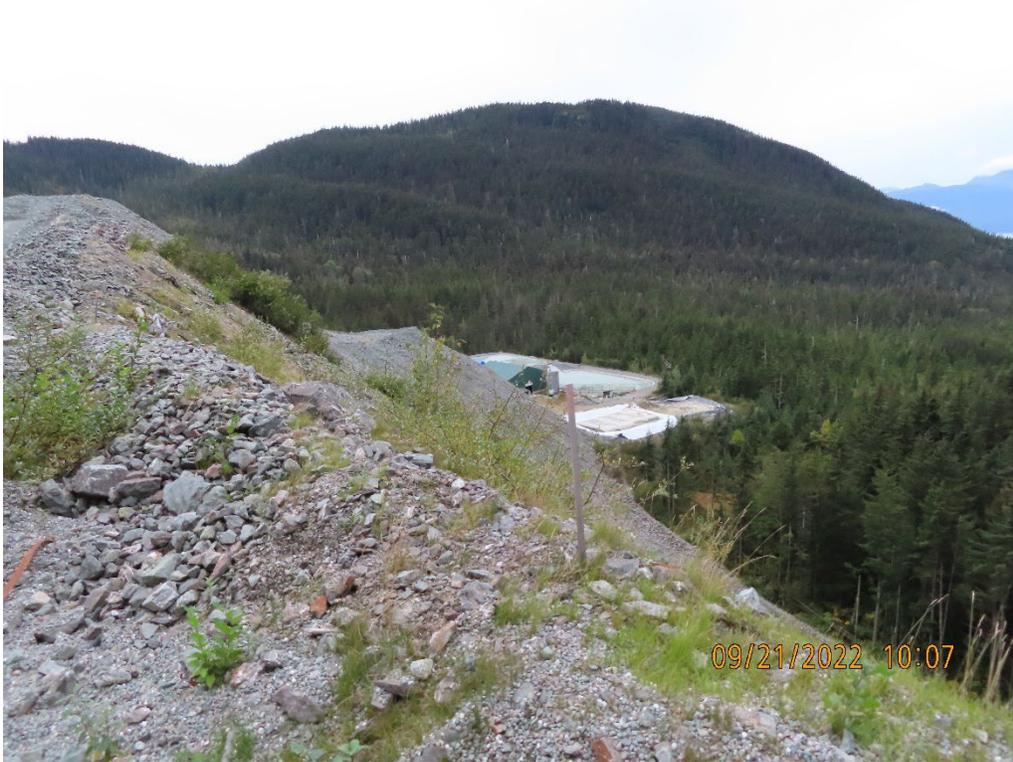
The slopes of the Comet waste rock storage area appeared stable (Photo 1). There has been no recent waste rock placement at this site. On this inspection the USFS and Coeur personnel walked the perimeter of the Comet development pile to determine if BMP's at the toe of the pile were functioning as designed. The Comet development pile appeared stable and BMP's appeared to be functioning as intended (Photos 2 and 3). This was conducted as part of the quarterly BMP inspection as specified in the POA1 ROD.

**Photo 1. Comet waste rock storage area.**

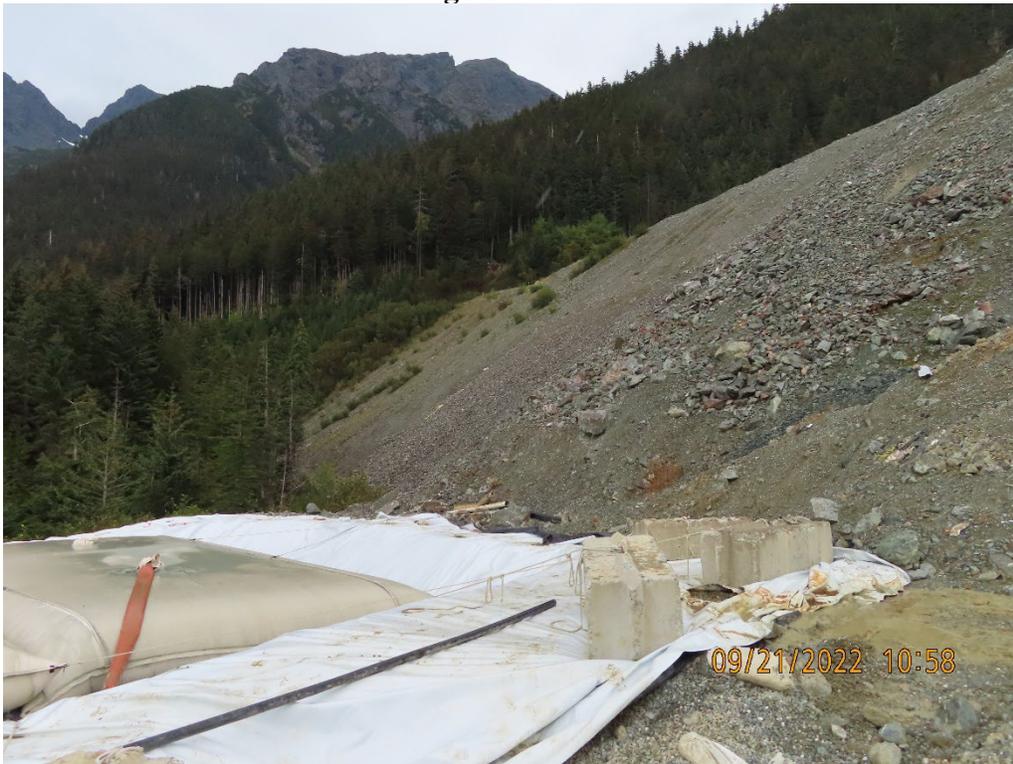
**Photo 2. View of the slope of the Comet Development pile looking north from the Comet Water Treatment Plant.**

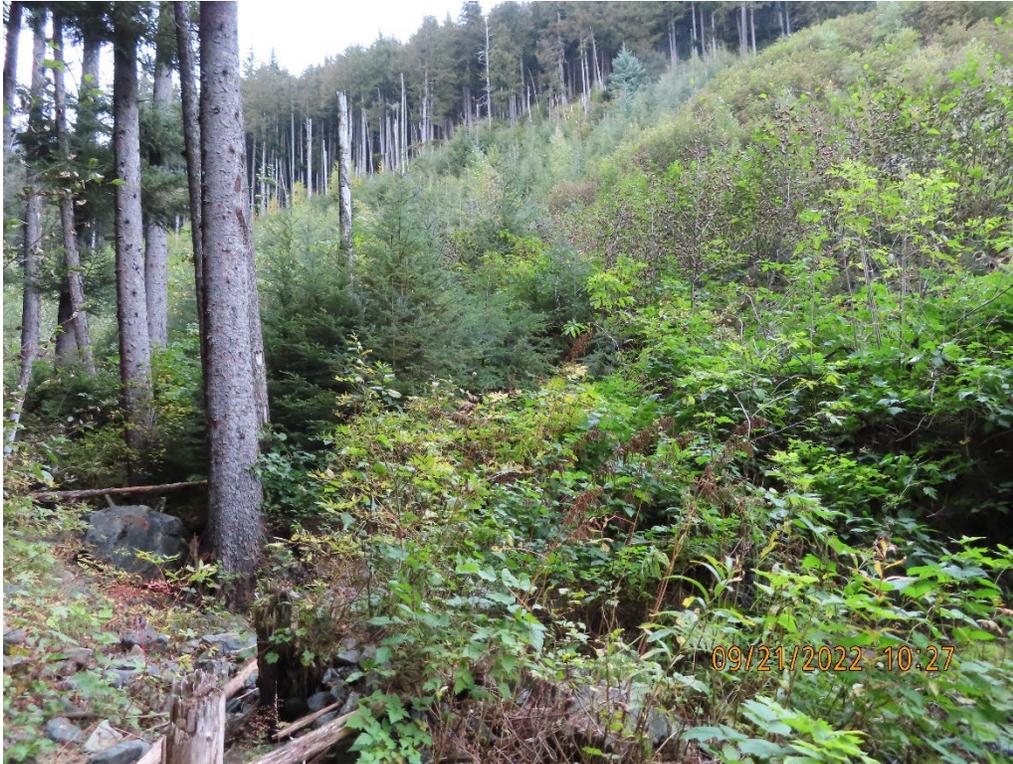
**Photo 3. View from the toe of the Comet Development pile looking north.**

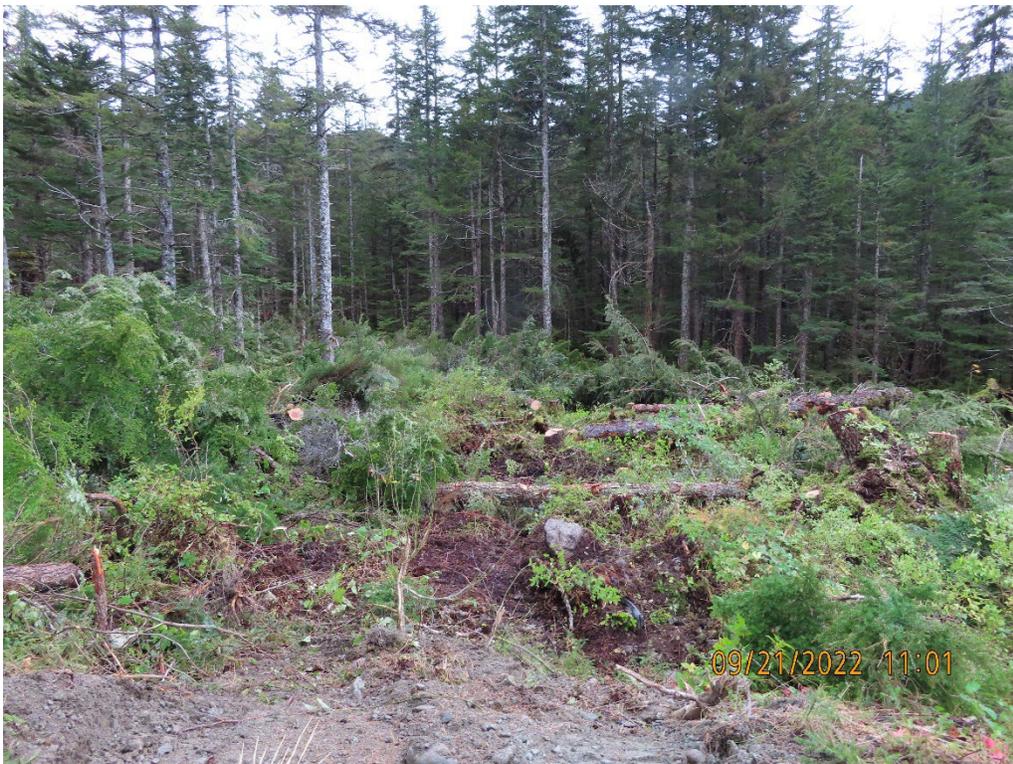
Timber clearing has commenced following the timber sale contract adjacent to Pond 1 (Photo 4) for the Comet waste rock storage expansion of POA1. Coeur plans to construct stormwater BMP's once grubbing has started.

**Photo 4. Tree clearing has commenced as part of approved activities under POA1 near Pond 1 of the Comet Water Treatment Plant.**

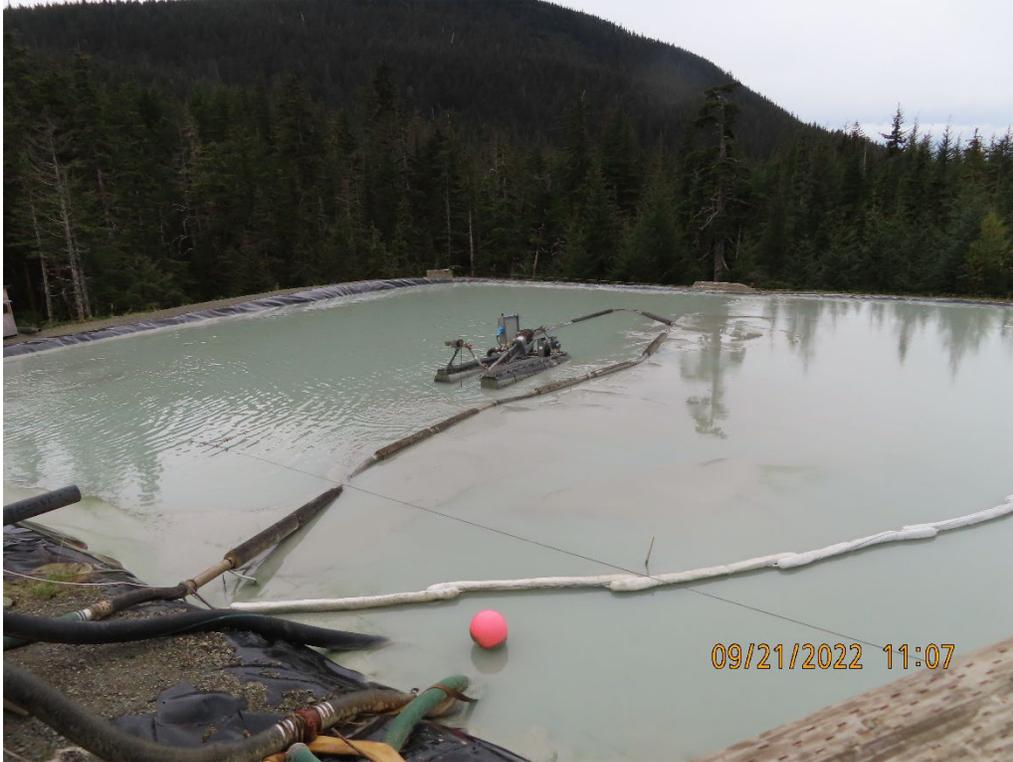
The CWTP treatment rate was approximately 2433 gpm. A dredge was located in Pond 1 (Photo 5) and was operating at the time of the inspection. Pond 2 was receiving waters pumped from Pond 1 (Photo 6).

**Photo 5. Comet Water Treatment Plant (CWTP) Pond 1.**

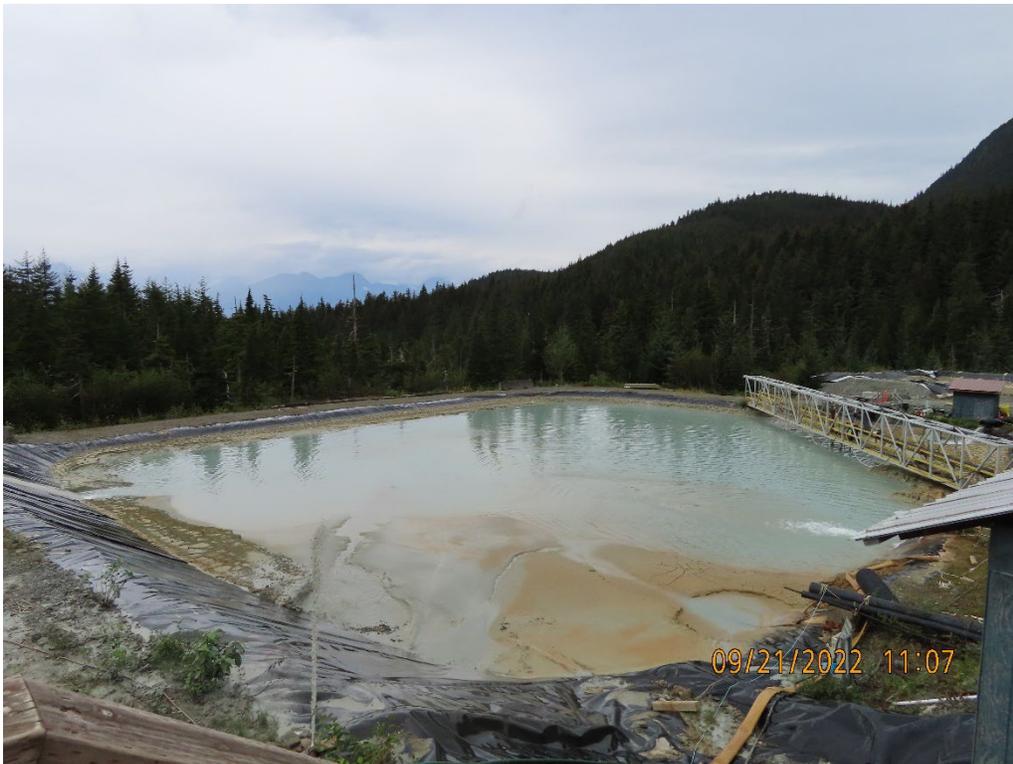
**Photo 6. CWTP Pond 2.**

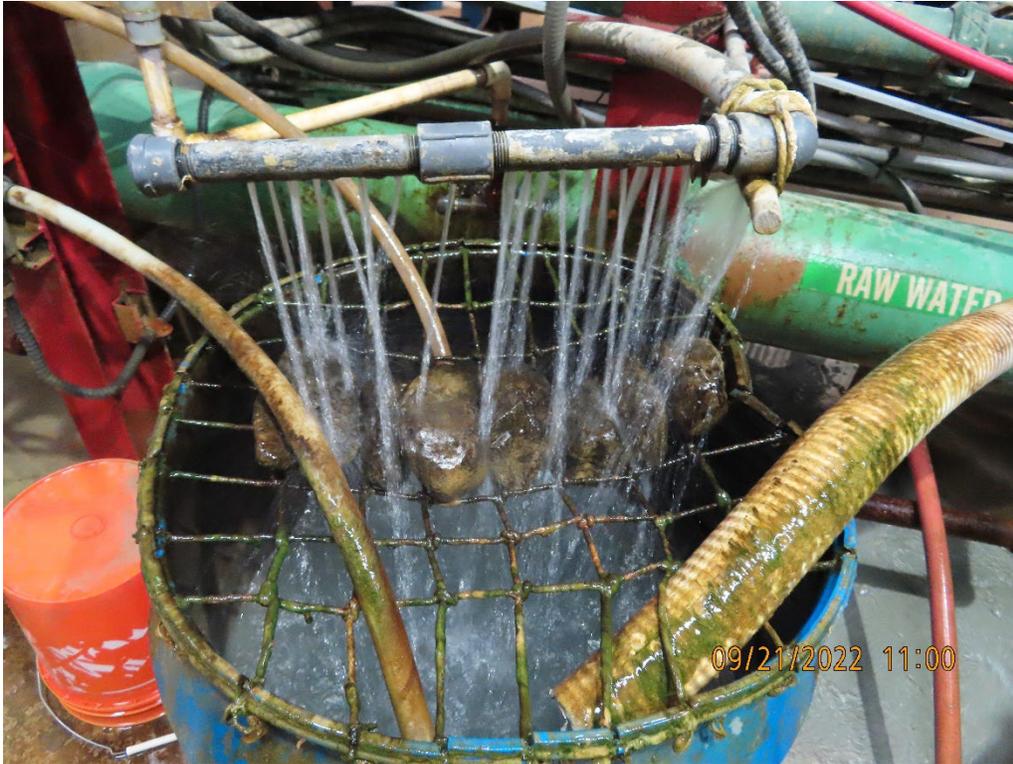
White material was not observed on the test rocks used for monitoring in the CWTP (Photo 7).

**Photo 7. CWTP white material test rocks.**

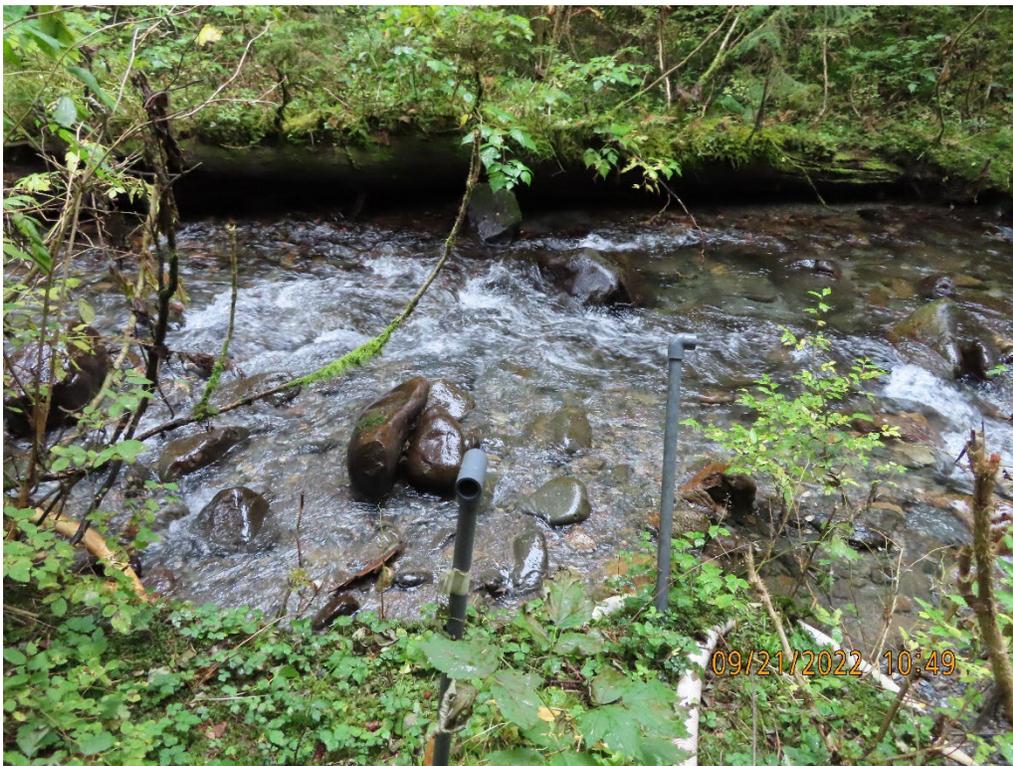
No white material was observed at Outfall 001, where treated water from the CWTP is discharged (Photo 8).

**Photo 8. Sherman Creek Outfall 001.**

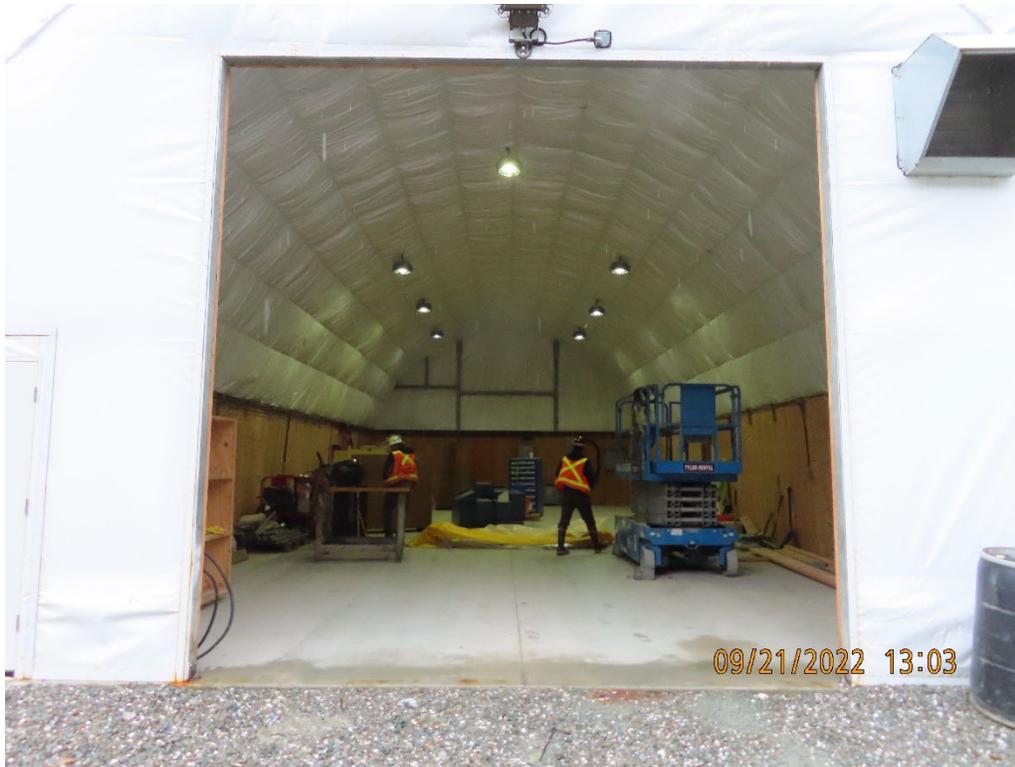
The surface equipment shop has been relocated from Pit 4 to the north end of the Mud Dump (Photo 9).

**Photo 9. Surface equipment shop relocated from Pit 4 to the Mud Dump.**

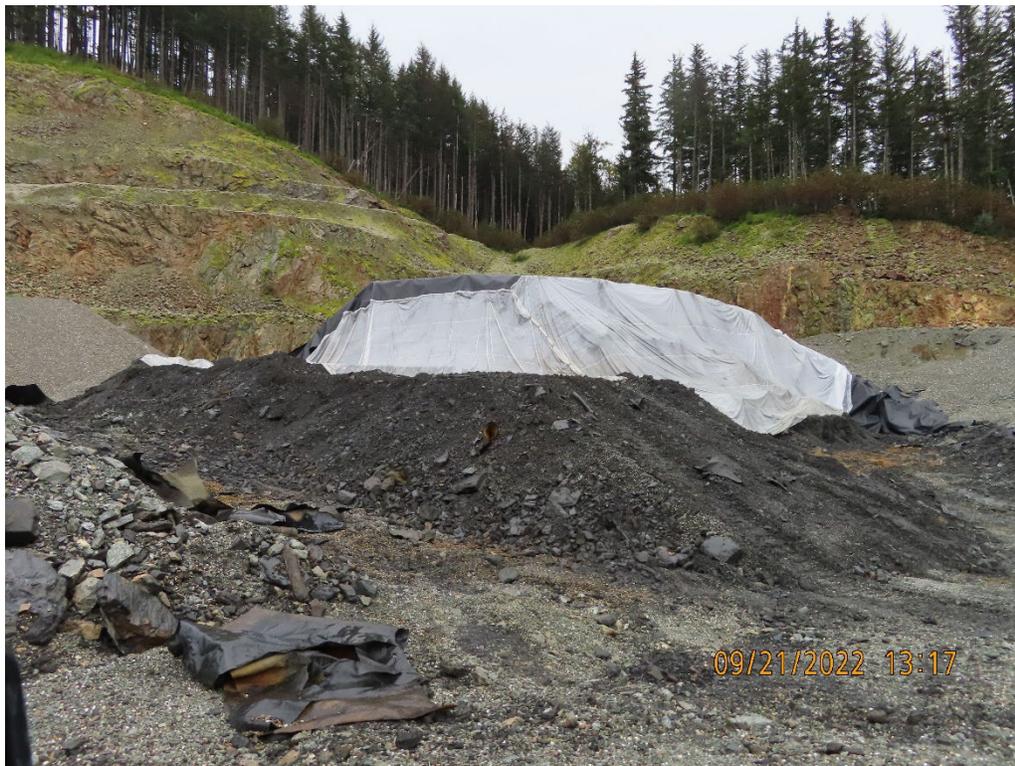
The Pug Plant was not operational during our visit and was in the process of being repaired. The graphitic phyllite stockpiled in Pit 4 was covered as required to prevent water infiltration into the stockpile (Photos 10 and 11).

**Photo 10. Graphitic phyllite stockpile at Pit 4.**

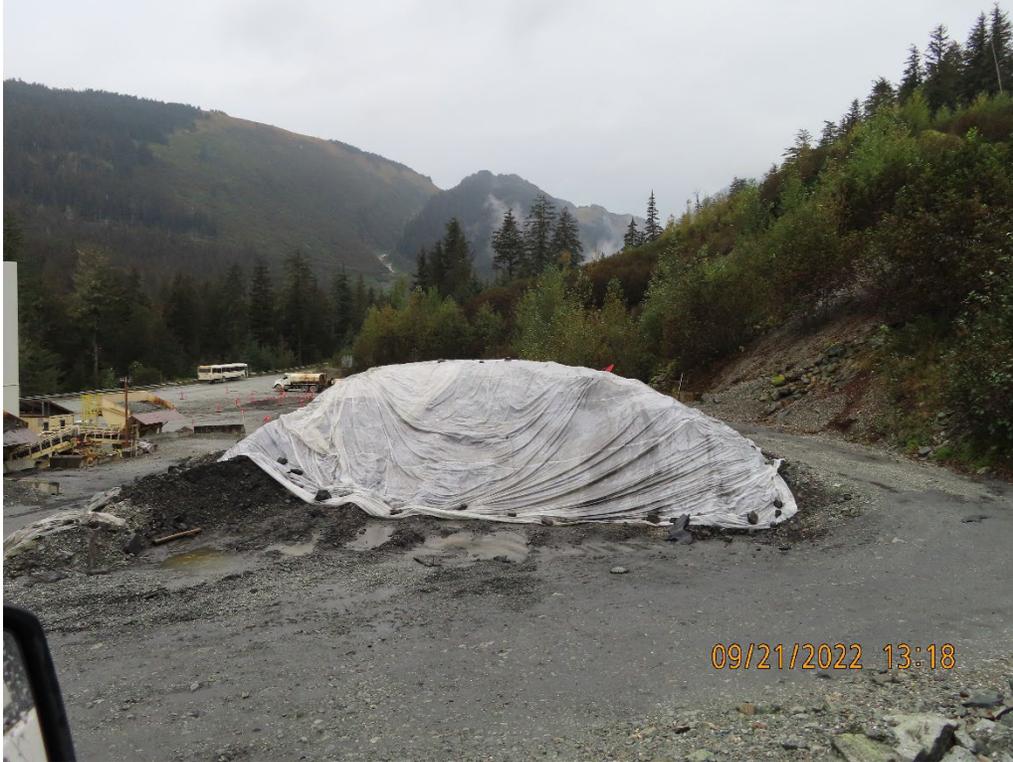
**Photo 11. Graphitic phyllite day use stockpile at Pit 4**

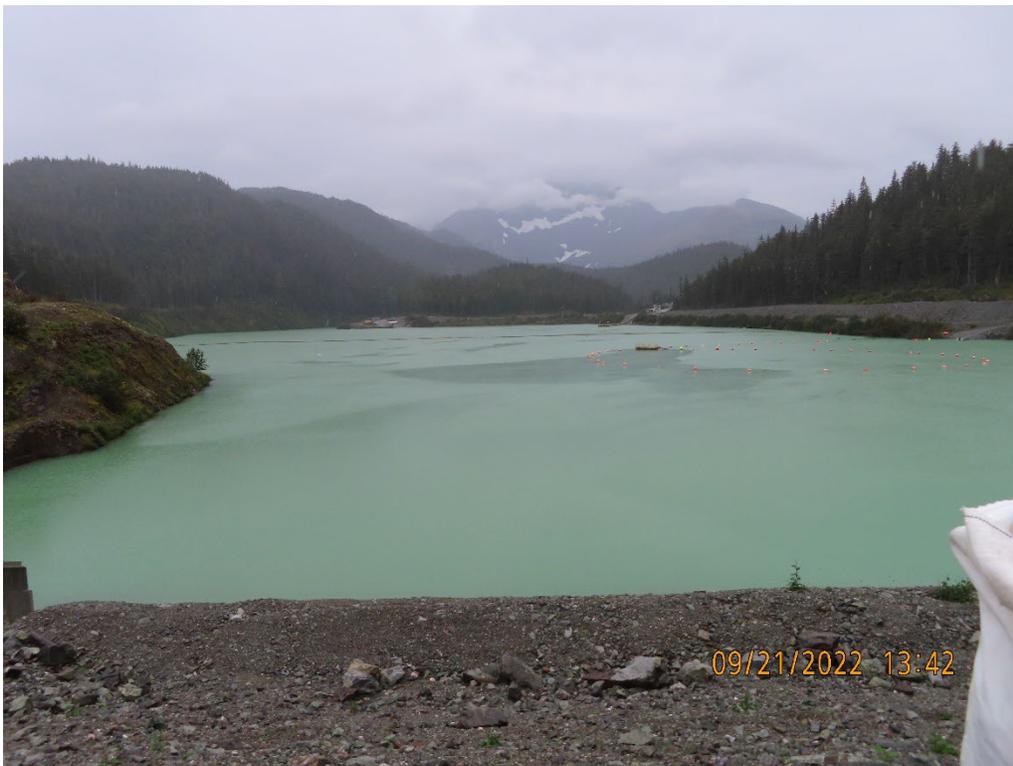
The water level for the TTF (Photo 12) was 715.75 feet.

**Photo 12. TTF looking north**

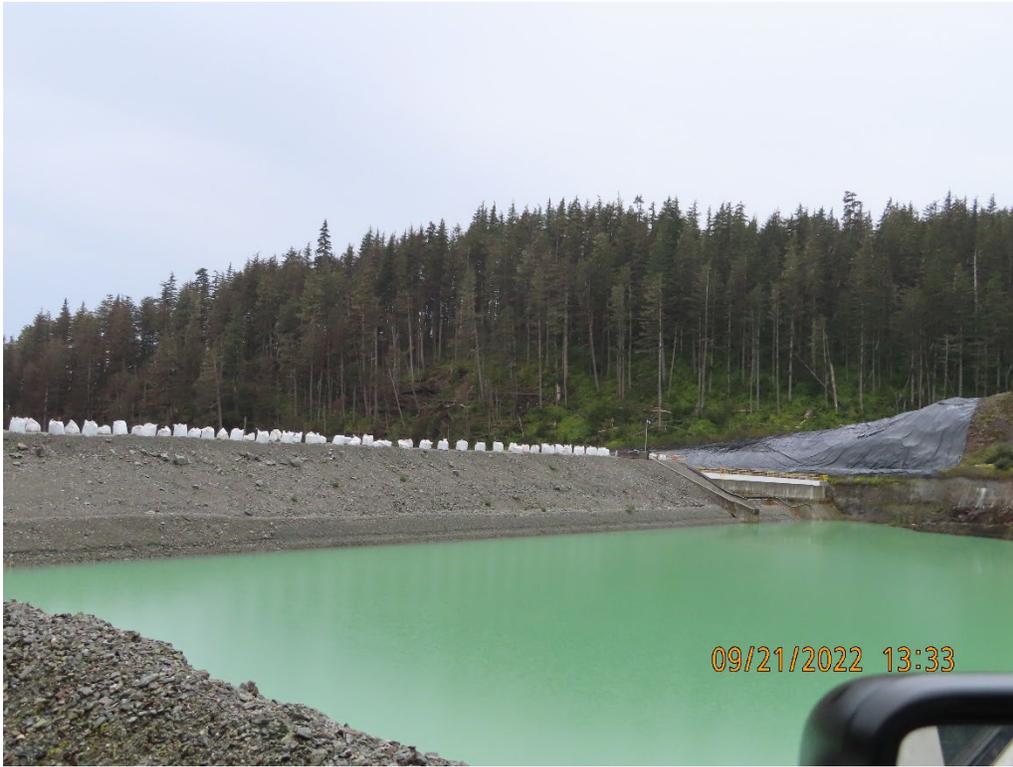
The TTF dam spillway appeared in good condition and there was no visual indication of ARD seepage reaching the spillway (Photo 13). The face of the dam was free of debris (Photo 14).

**Photo 13. TTF dam face.**

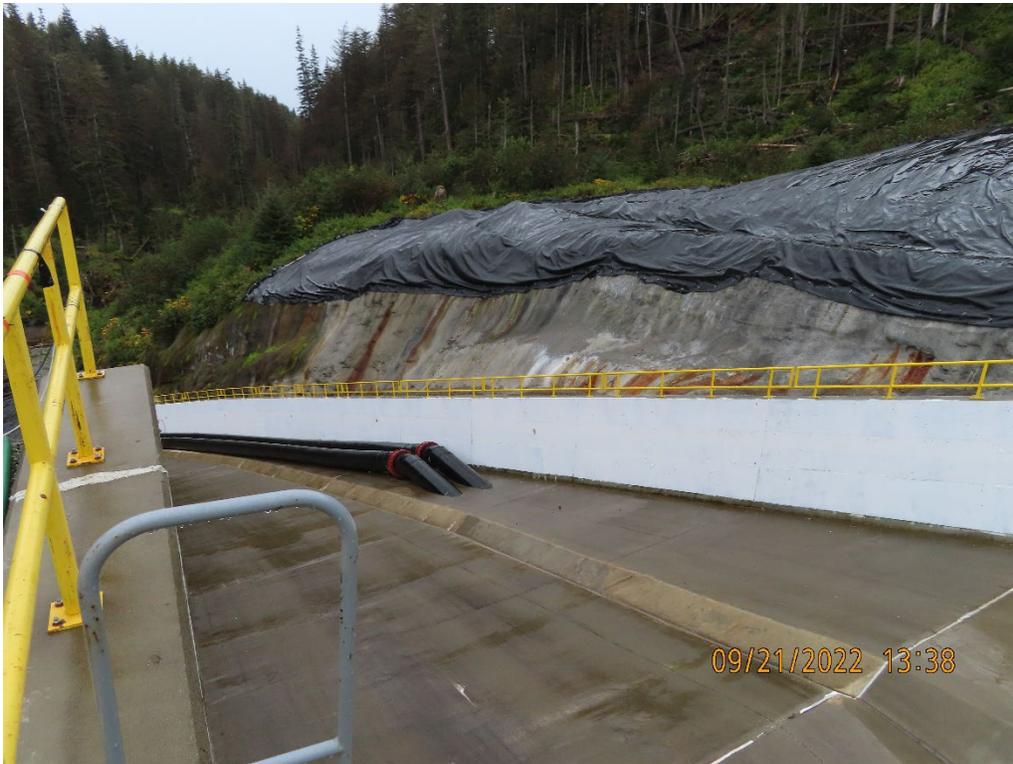
**Photo 14. TTF dam spillway.**

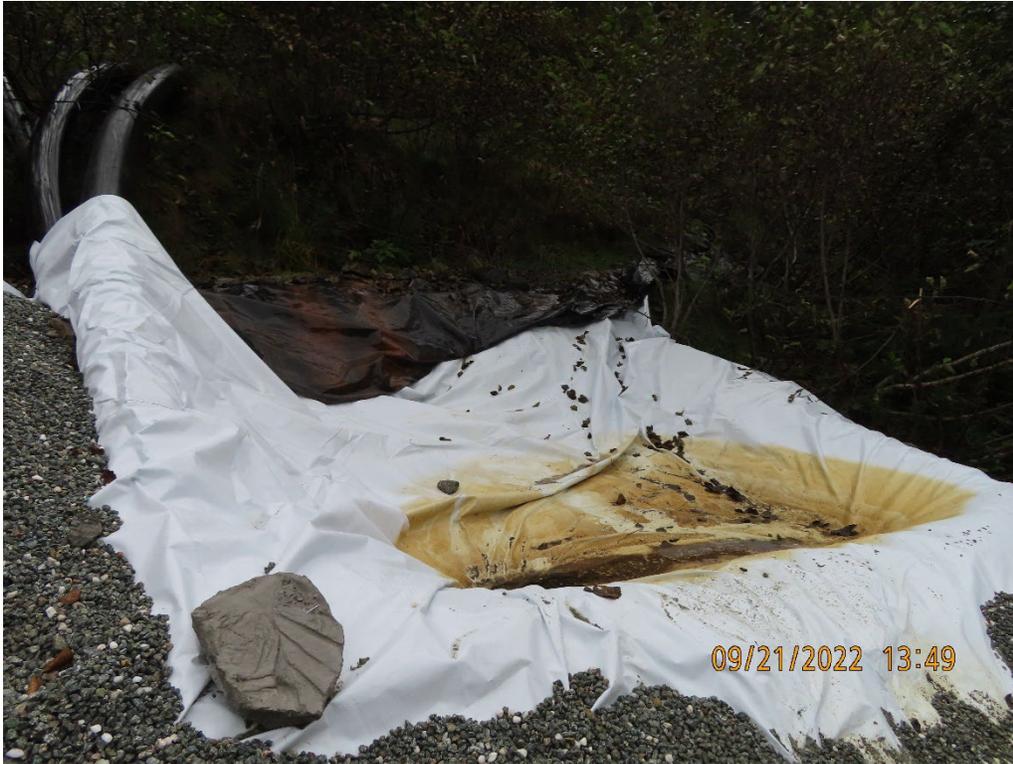
| ID | Action Item | Status |
|---|---|---|
| 191-1 | Staining on the TTF dam lower access road will be investigated to determine source and if additional mitigation measures are necessary. | <b>Pending.</b> Coeur has constructed catchment sumps and taken water quality samples. Coeur is waiting on results from water quality sampling to determine source of staining. |

**PENDING ACTION ITEM 191-1:** Adjacent to and running across the lower TTF dam access road, reddish staining from a seepage is present. Due to the presence of ARD-generating graphitic phyllite, groundwater in this vicinity is captured in wells and transported to the ARD seepage treatment plant. Additionally, Coeur has constructed a containment sump (Photo 15) and collected water quality samples for which results have not yet been received. Preliminary field sampling indicates the seep may not be ARD, as the pH is above 7.0. This location will be monitored, and water quality testing results summarized, in a subsequent inspection report.

**Photo 15. Seepage staining adjacent to lower TTF dam access road and constructed containment sump.**

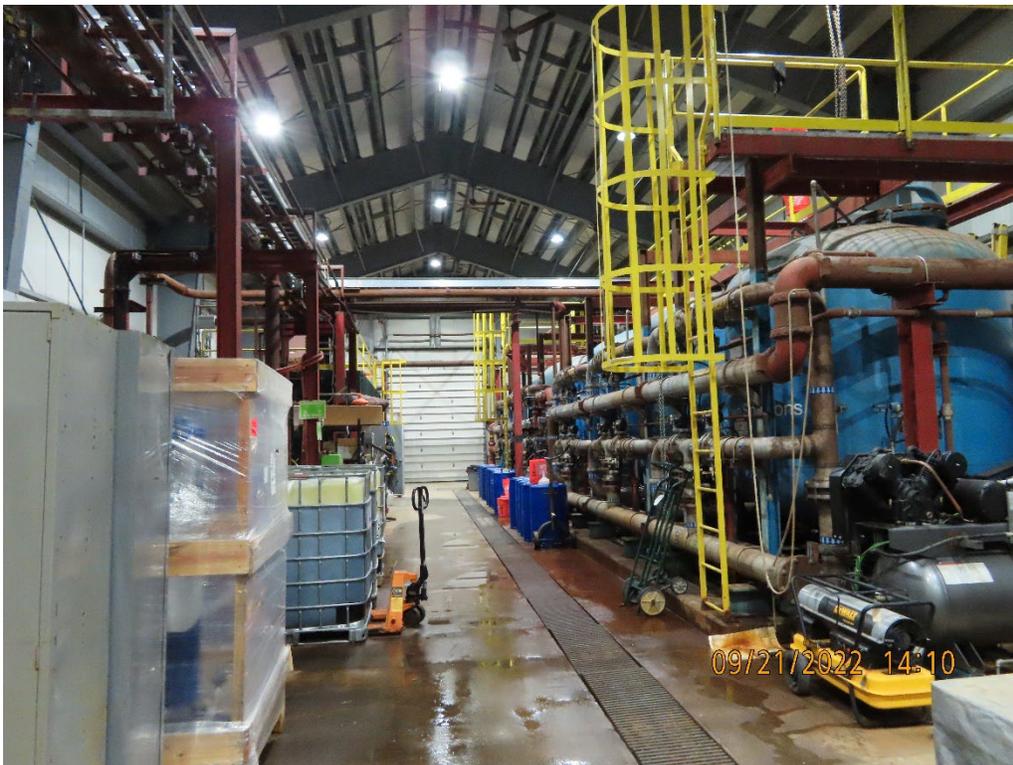
Good housekeeping practices were observed inside the TTF water treatment plant (Photo 16, Appendix 4g BMP plan; Table 4-1). The TTF water treatment plant was treating 730 gpm, and the water discharged to Outfall 002 measured 7.39 pH and .285 NTU.

**Photo 16. TTF water treatment plant interior.**
