INSPECTION REPORT: KENSINGTON GOLD MINE

Date of Inspection: Wednesday, December 21, 2022
Date of Report: Tuesday, January 10, 2023
USDA Forest Service Inspector: Richard Dudek

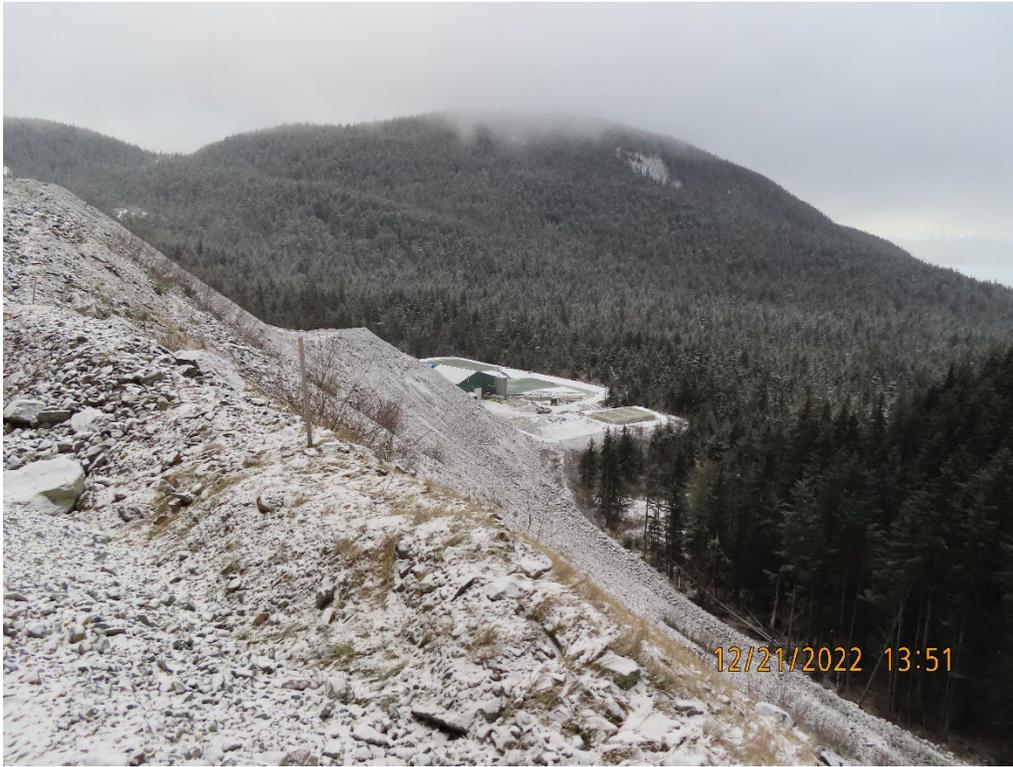
The Comet waste rock storage pile was stable (Photo 1) and there has been no recent waste rock placement at this site.

Photo 1. The Comet development pile.

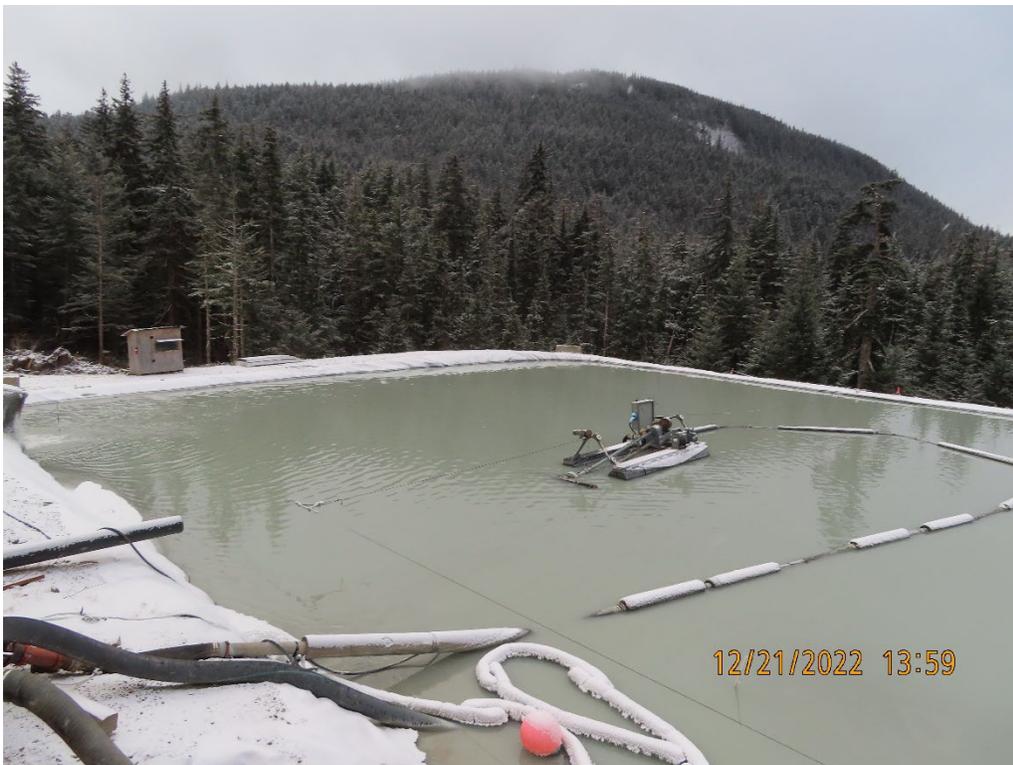
The CWTP treatment rate was approximately 1,734 gpm. A dredge was observed in Pond 1 (Photo 2) and was not operating at the time of this inspection. Pond 2 was receiving backwash water from the CWTP (Photo 3).

Photo 2. CWTP pond 1.

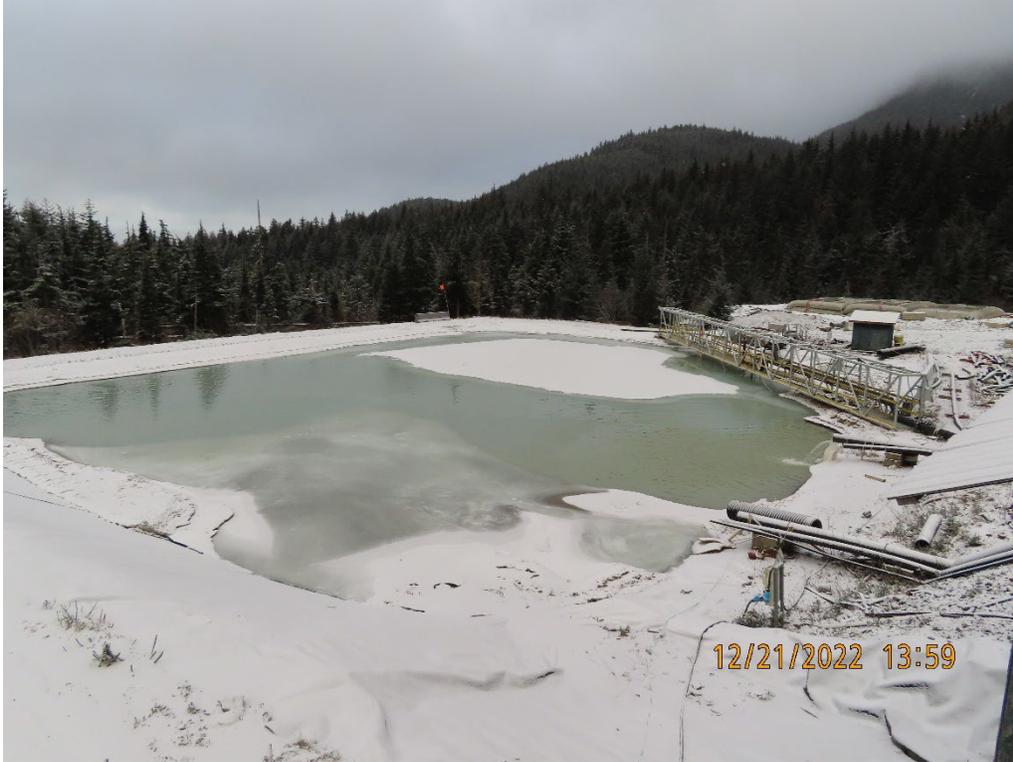
Photo 3. CWTP pond 2.

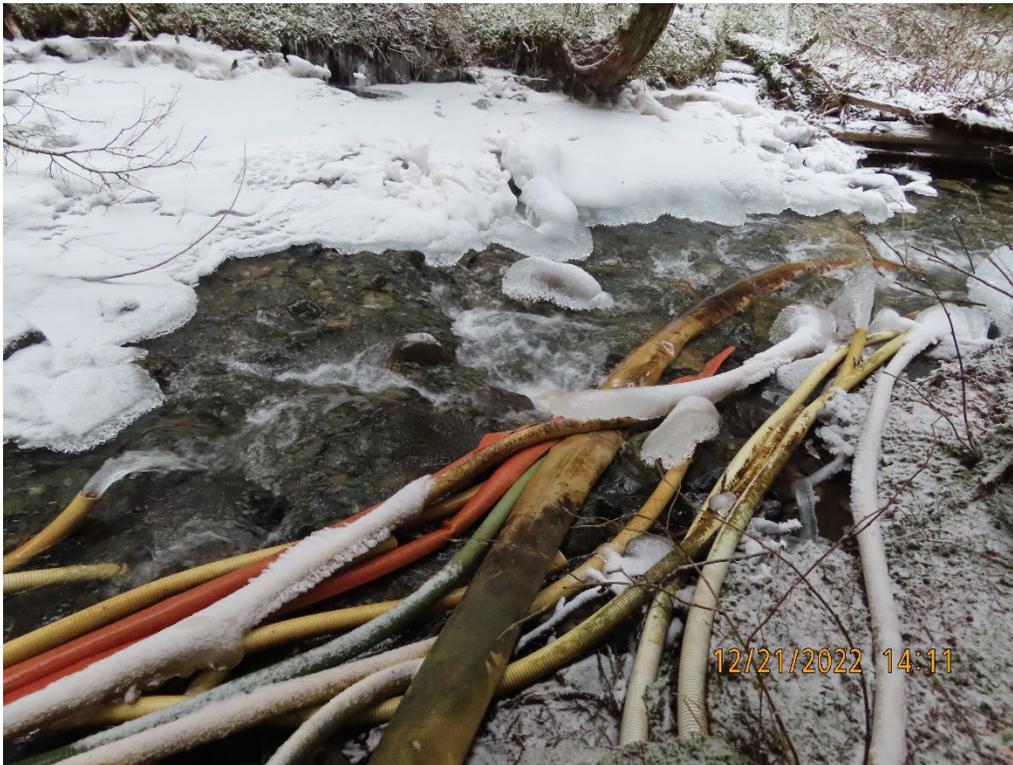
No white material was observed at Outfall 001 (Photo 4).

Photo 4. The Sherman Creek Outfall 002.

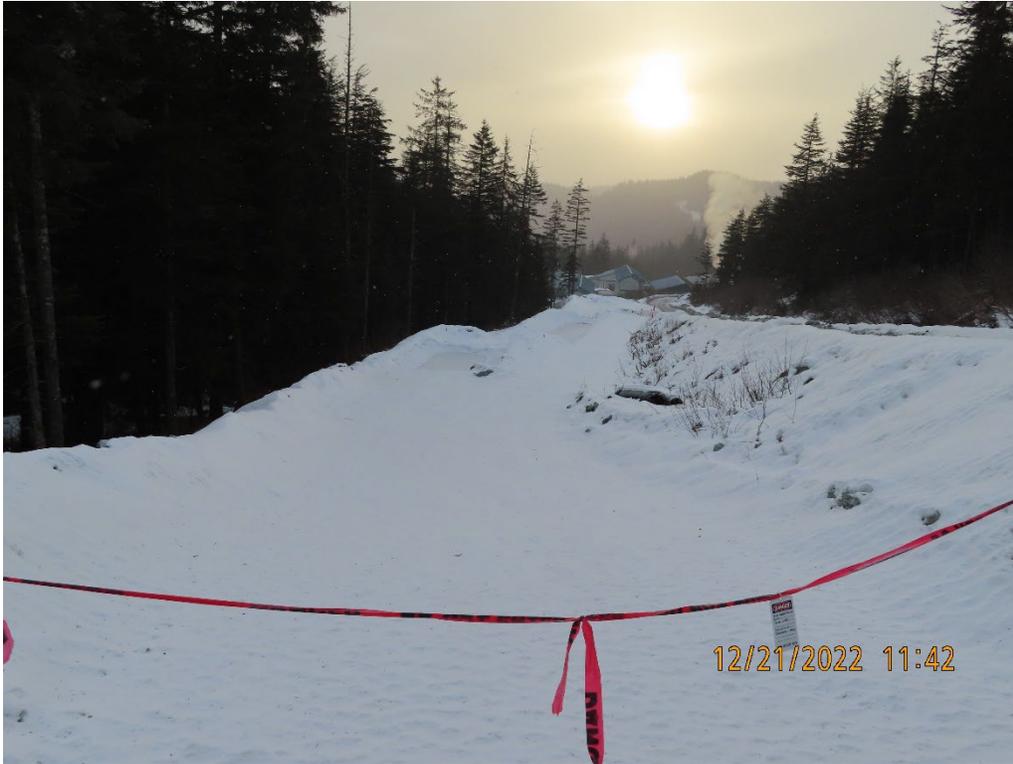
As stated in IR 194 11/16/2022, a fuel spill had occurred at the Mill benches 30,000-gallon diesel fuel tank, which overwhelmed the fuel/water separator with fuel/water mix entering the Mill ponds (Photo 5). ADEC was informed that a spill had occurred at this location. During the reclamation process, the excavated contaminated soils were covered and staged at Pit 4. The contaminated soils are currently being evaluated by Coeur Alaska to determine the most cost-effective way for disposal (Photo 6).

Photo 5. The Mill ponds (Wolf Ponds).

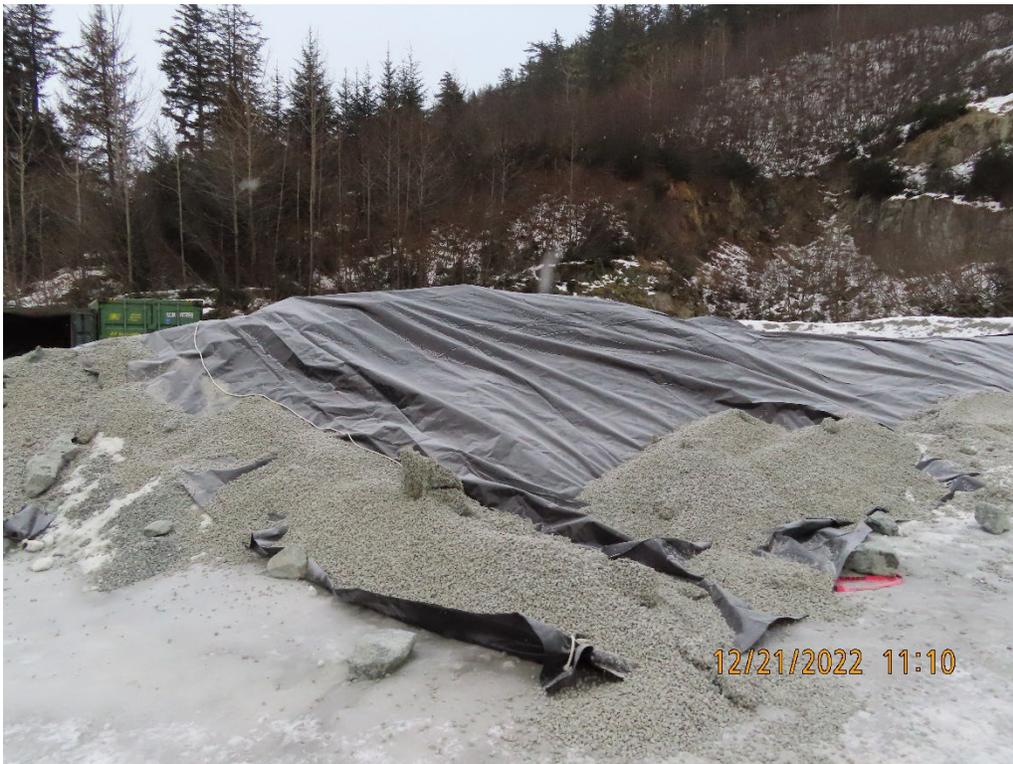
Photo 6. The contaminated soils stockpiled at pit 4.

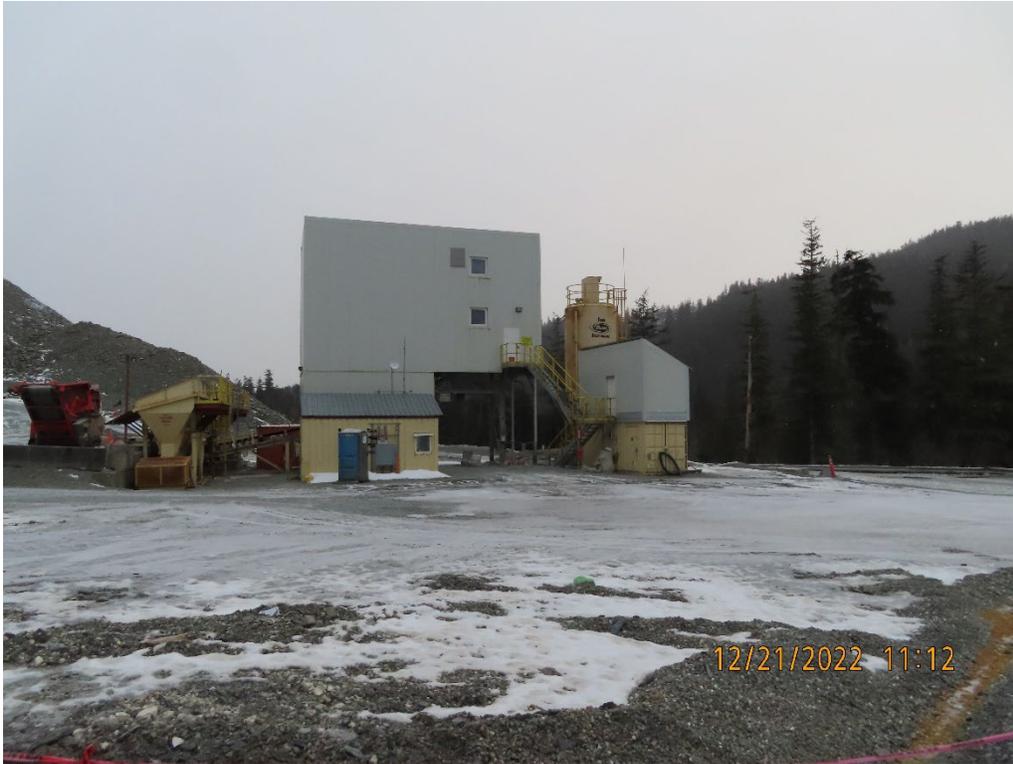
The Pug Plant is currently offline during the winter months (Photo 7).

Photo 7. The pug plant at pit 4.

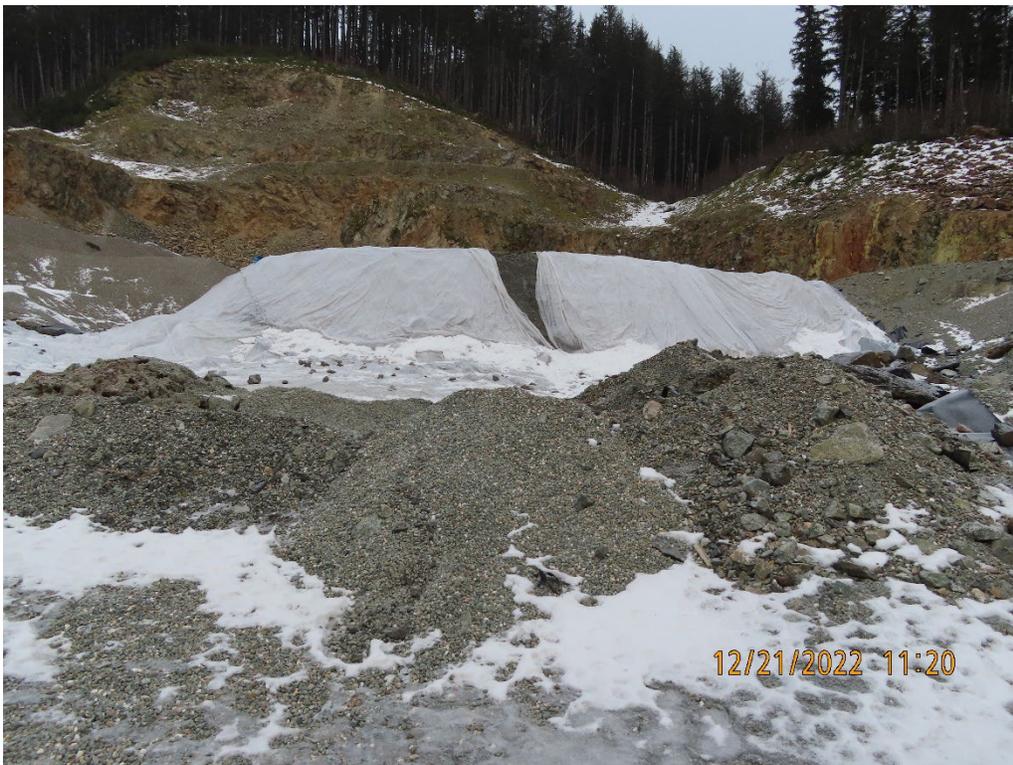
PENDING ACTION ITEM 194-1: Graphitic phyllite stockpiled at Pit 4 was partially uncovered. The pile needs to be covered as required to prevent ARD generation (Photo 8).

Photo 8. GP pile at pit 4.

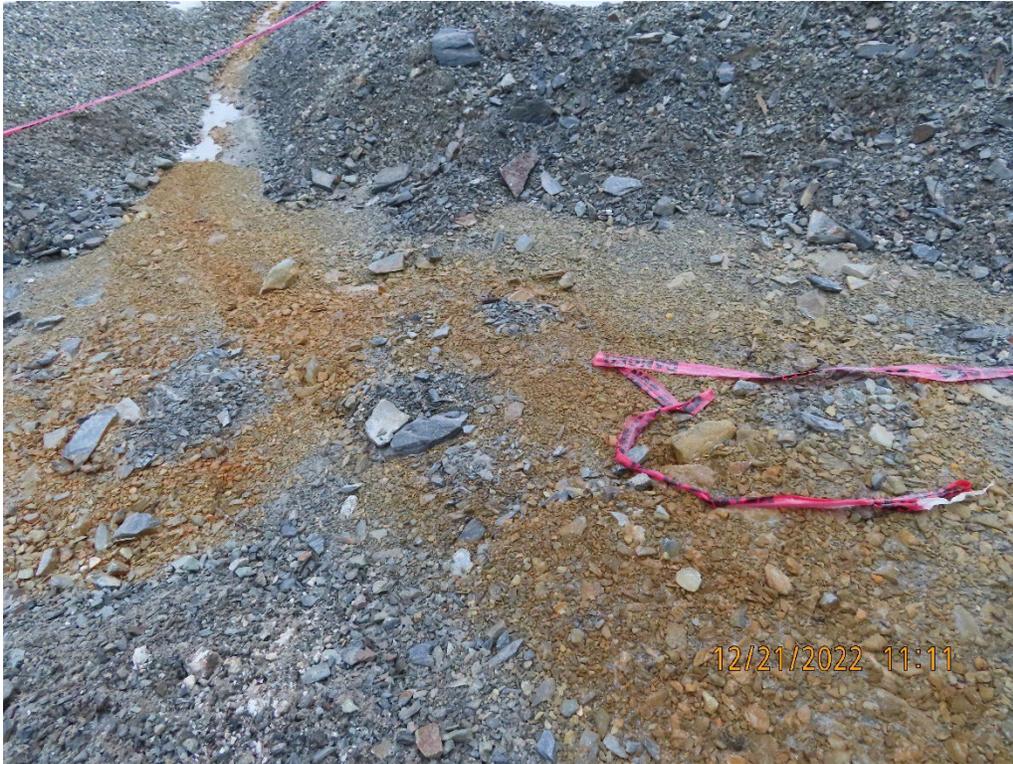
192-2	Investigate source of surface discharge near abandoned borehole in Pit 4.	Pending. Further investigation is necessary to determine if source of groundwater.
194-3	Large woody debris was observed along the face of the TTF dam.	Pending. The woody debris is currently frozen in the TTF.

PENDING ACTION ITEM 194-2: To determine the source of upwelling near abandoned borehole in Pit 4. Currently due to freezing conditions, no upwelling was observed (Photo 9).

Photo 9. The location of the abandoned borehole where upwelling took place.

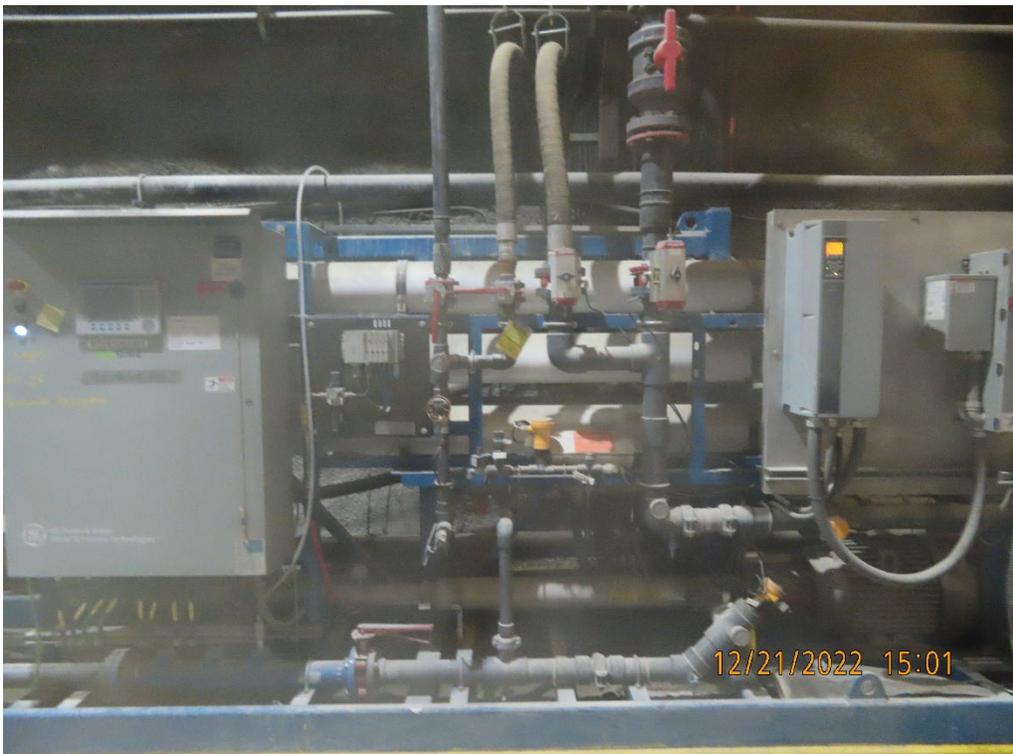
The RO system is currently online to help reduce the concentration of sulfates in mill water entering the TTF (Photo 10). Coeur Alaska will dispose of the brine waste in the underground stopes.

Photo 10. The reverse osmosis (RO) system for removing sulfates out of mill water.

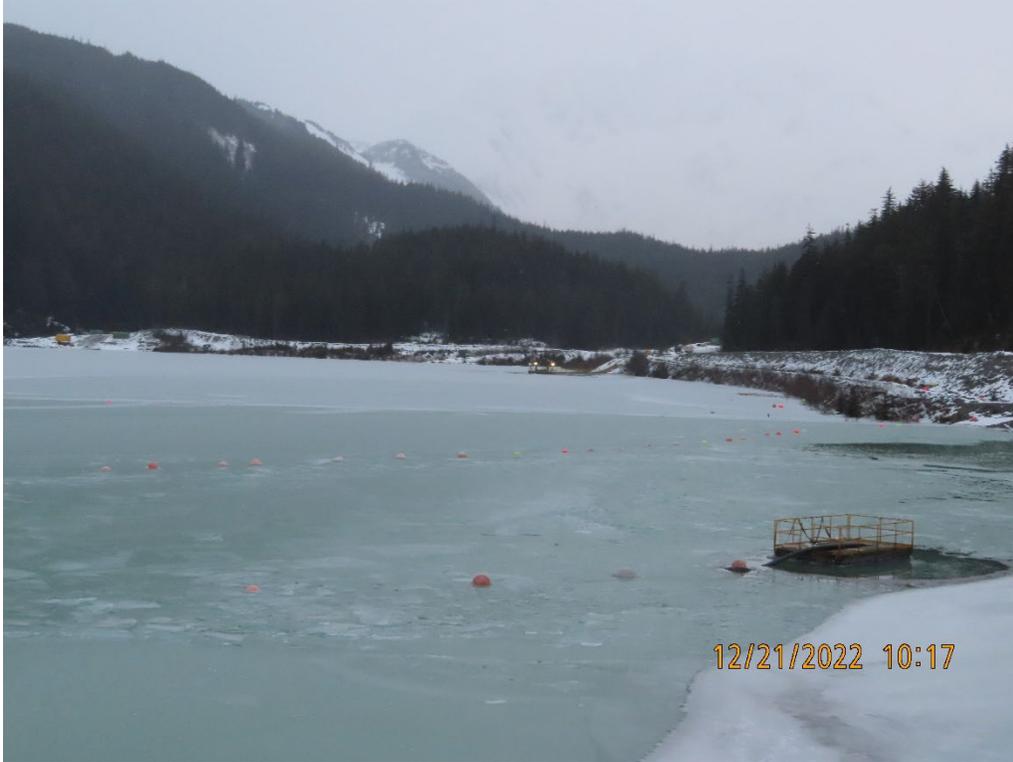
The water level for the TTF (Photo 11) was 720.5 feet. TTF Operators were breaking up the ice to create a path to access the tailings barge.

Photo 11. The TTF.

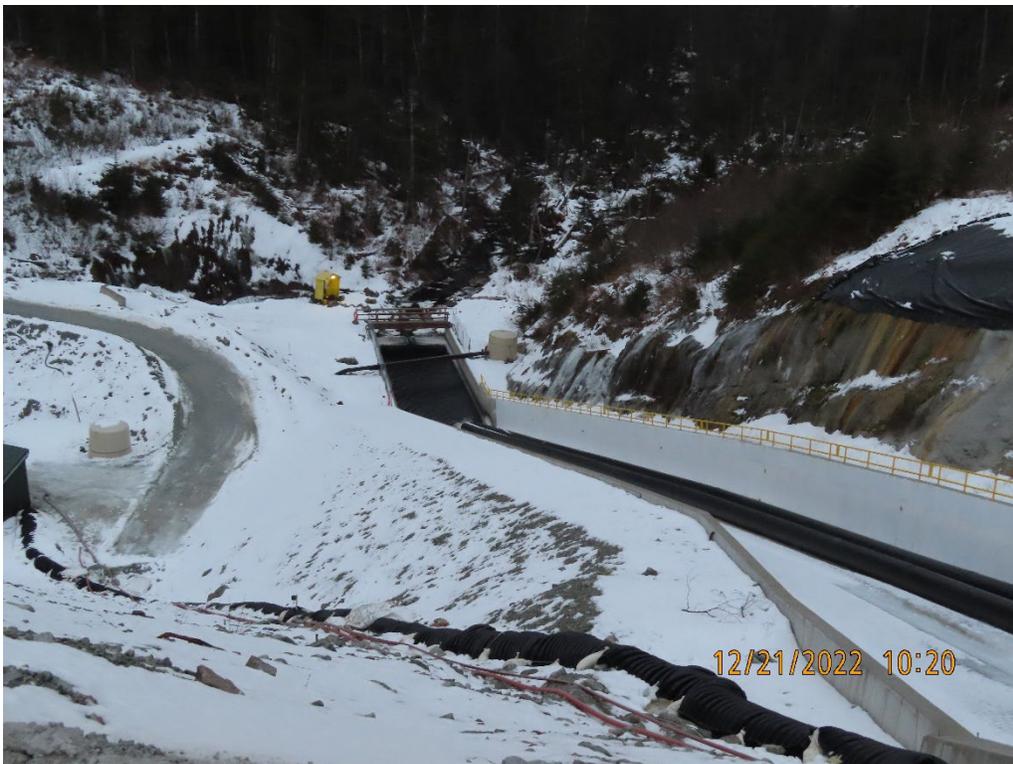
The TTF dam spillway appeared in good condition and is covered with snow and ice. There were no visual signs of ARD seepage in the spillway (Photo 12).

Photo 12. TTF dam spillway and bypass.

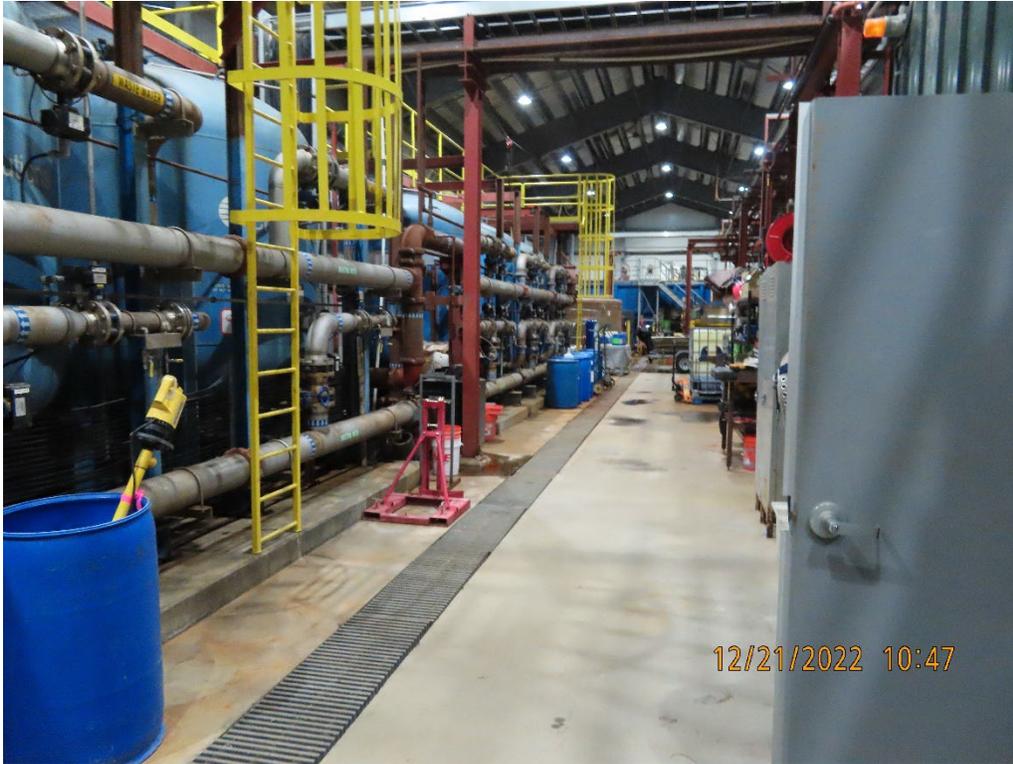
Good housekeeping (Appendix 4g BMP plan; Table 4-1) practices were observed inside the TTF water treatment plant (Photo 13).

Photo 13. The TTF water treatment plant.

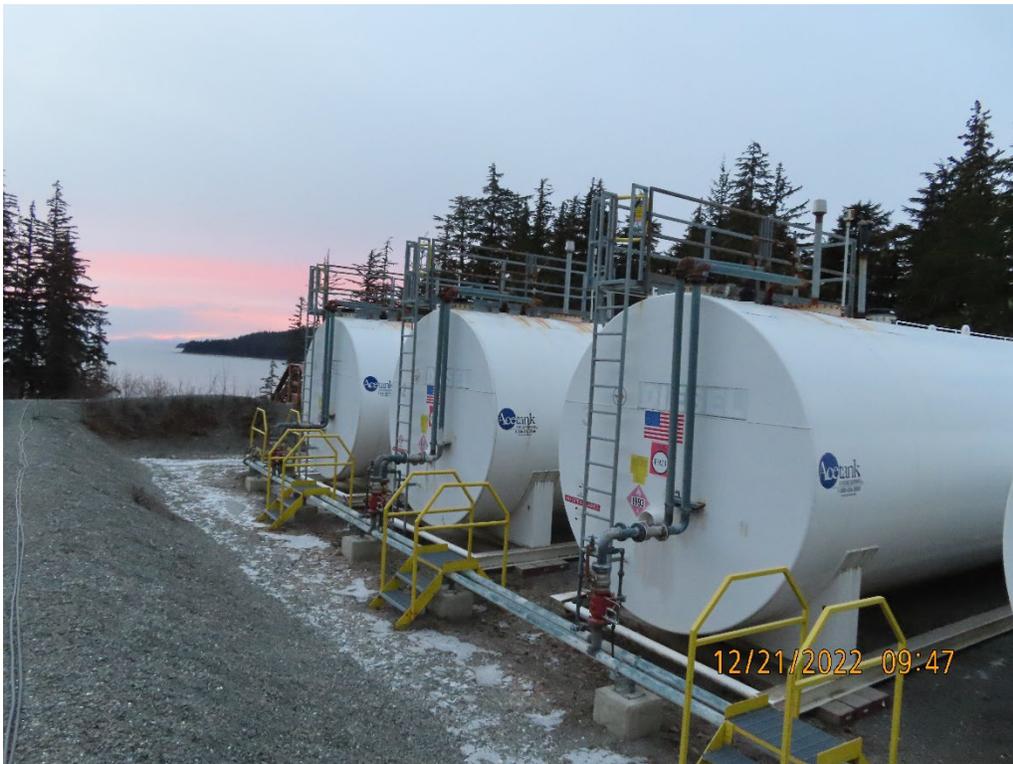
The fuel depot was in good condition with the BMPs functioning as intended. No fuel sheening was observed inside the fuel containment area (Photo 14).

Photo 14. The fuel depot.

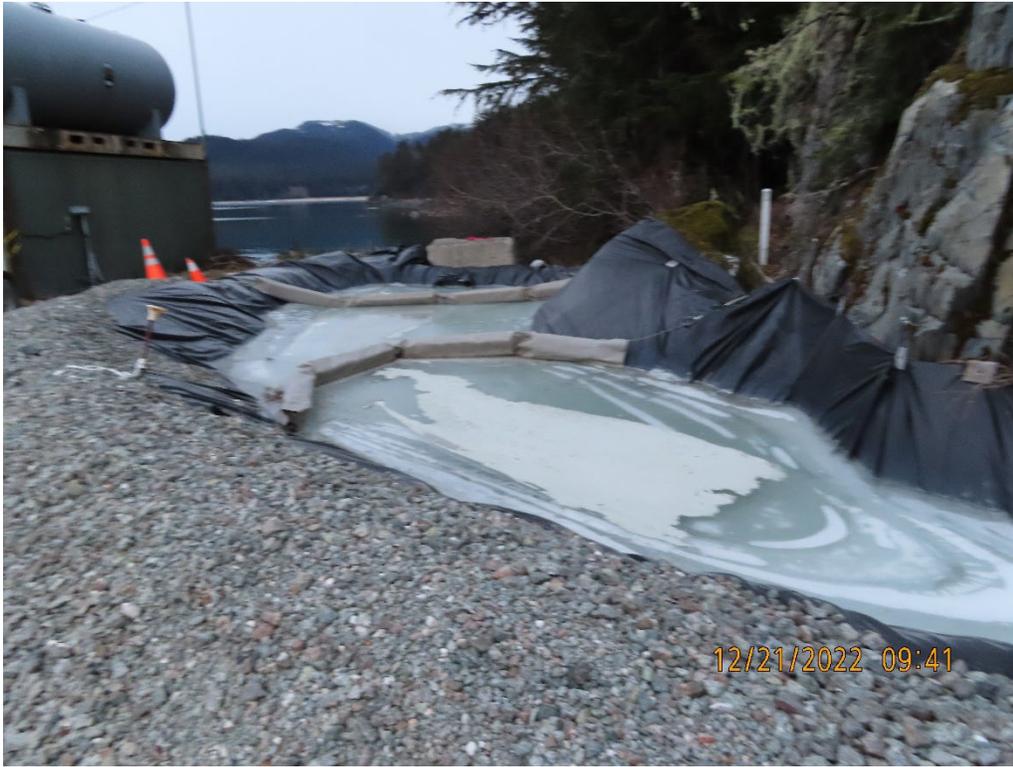
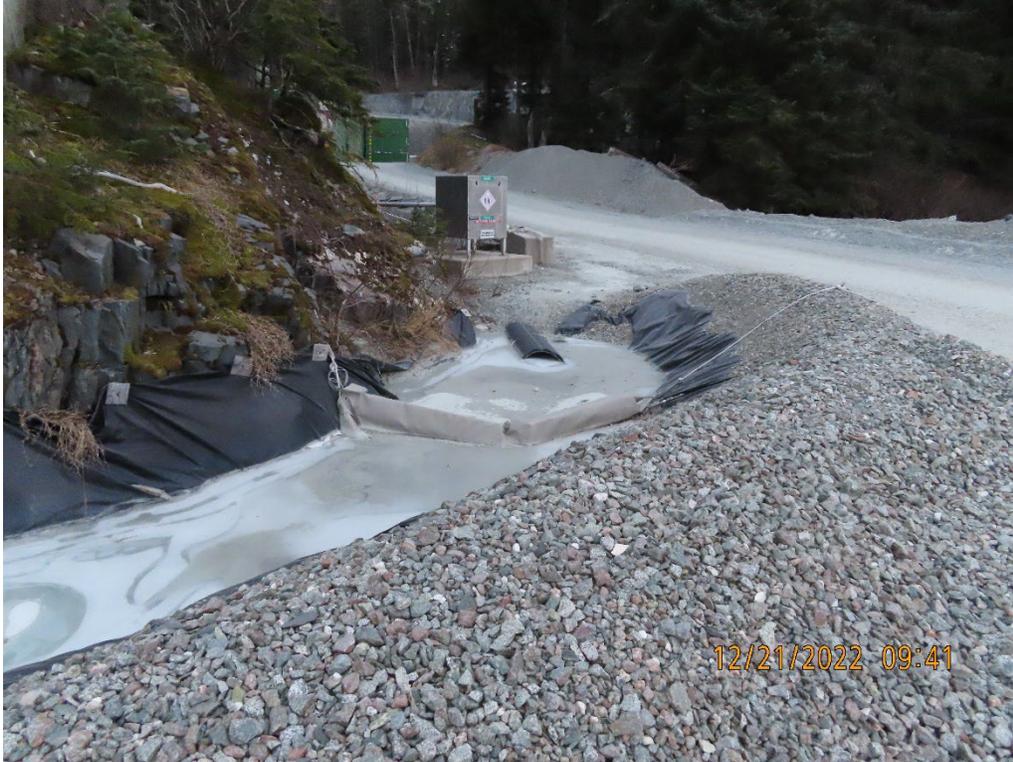
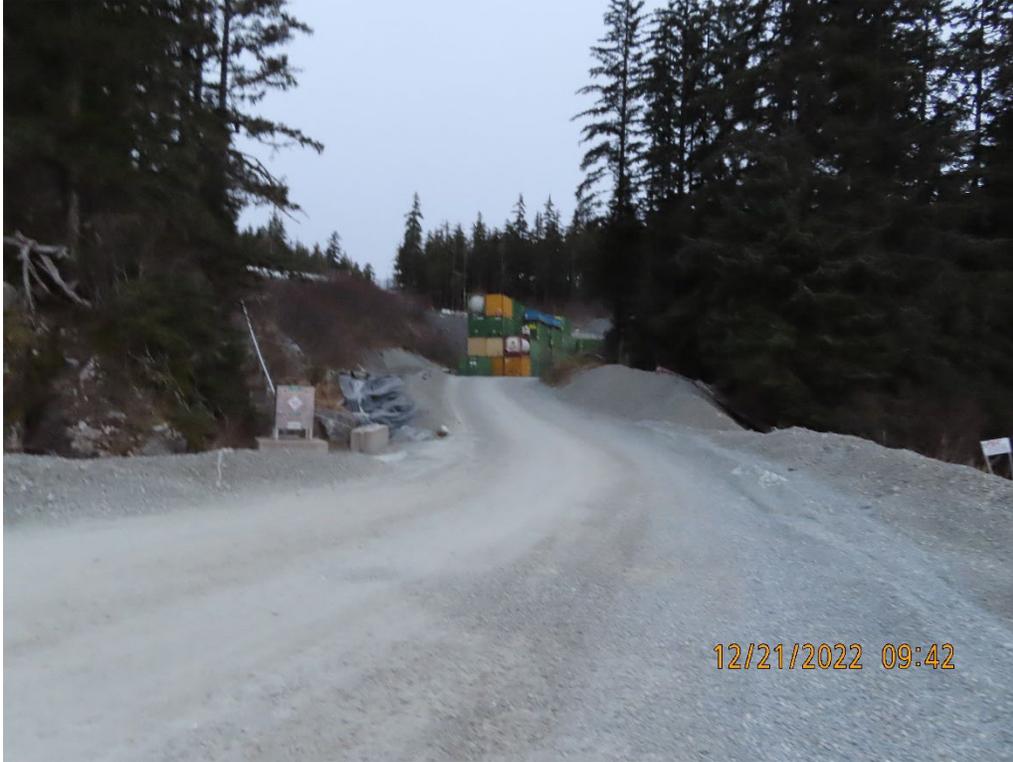
The port facility appeared in good condition with stormwater BMPs were frozen over (Photos 15-17).
