## INSPECTION REPORT: KENSINGTON GOLD MINE

Date of Inspection: February 15, 2023  
Date of Report: March 7, 2023  
USDA Forest Service Inspector: Casey Loofbourrow

Ranger District: Juneau Ranger District  
Weather Conditions: Snowy. Temperature: mid 20's °F.

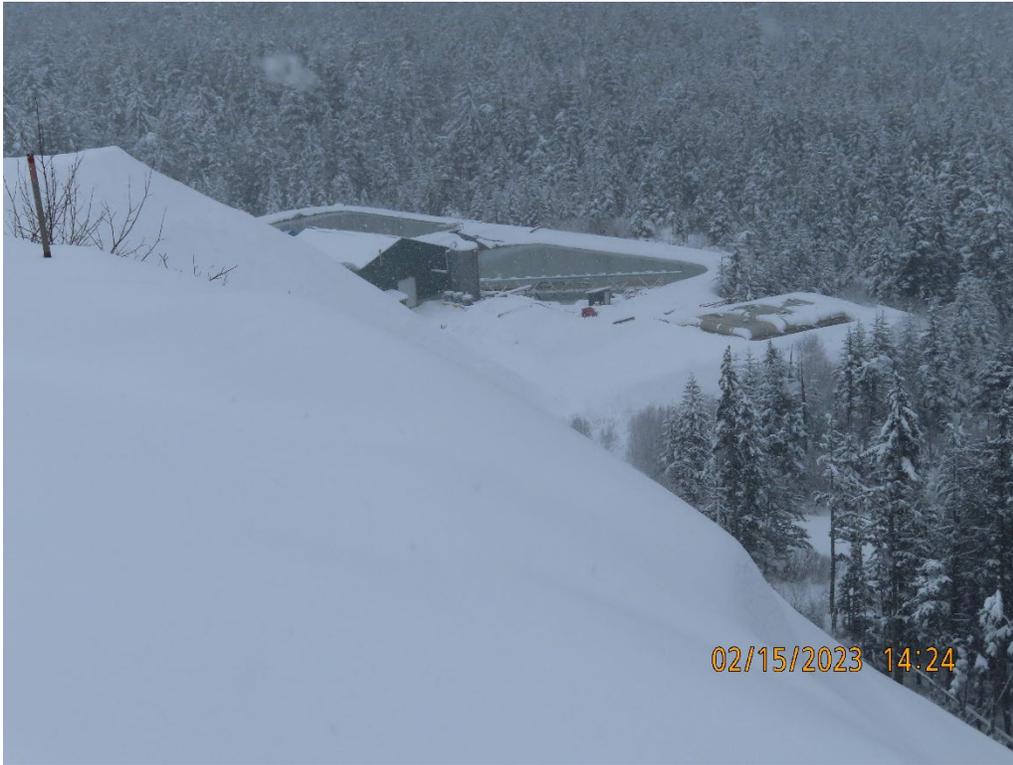
The Comet waste rock storage pile was stable (Photo 1) and there has been no recent waste rock placement at this site.

**Photo 1. The Comet development pile.**

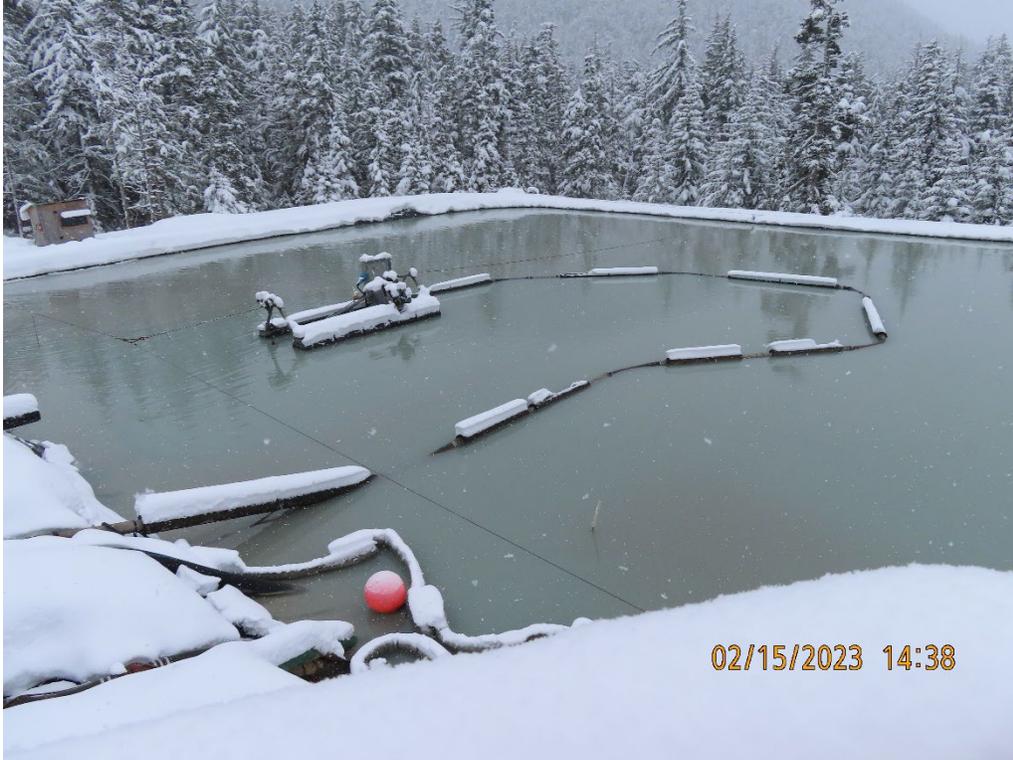
The CWTP treatment rate was approximately 1,760 gpm. A dredge was observed in Pond 1 (Photo 2) and was not operating at the time of this inspection. Pond 2 was receiving backwash water from the CWTP (Photo 3).

**Photo 2. CWTP pond 1.**

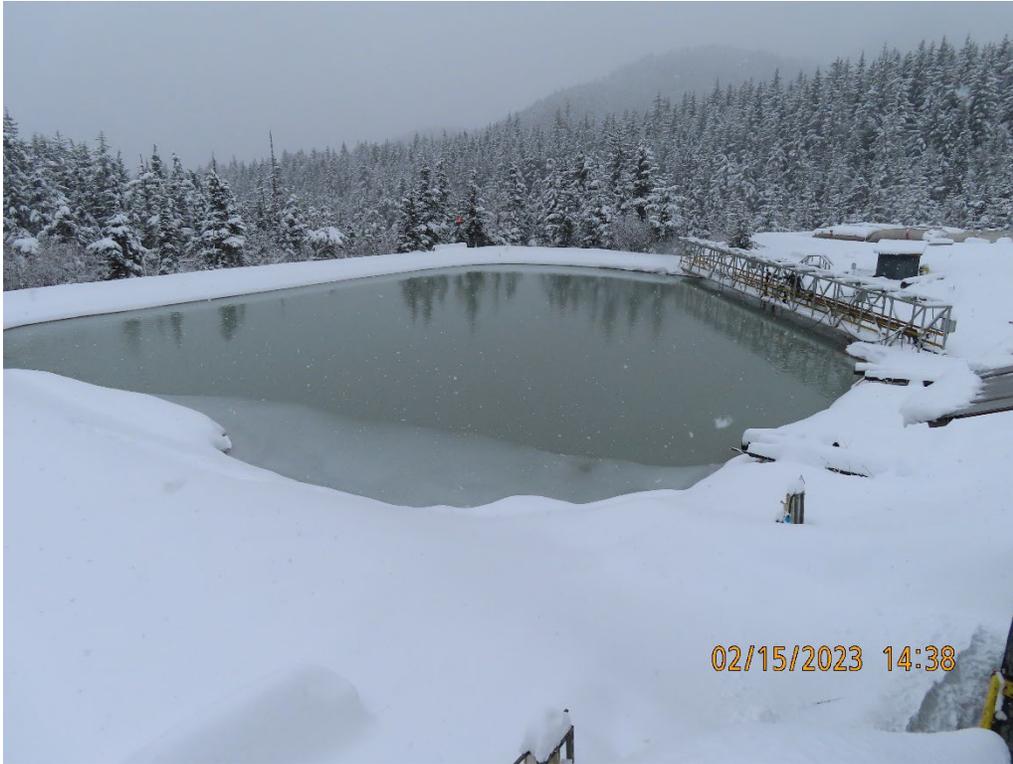
Photo 3. CWTP pond 2.

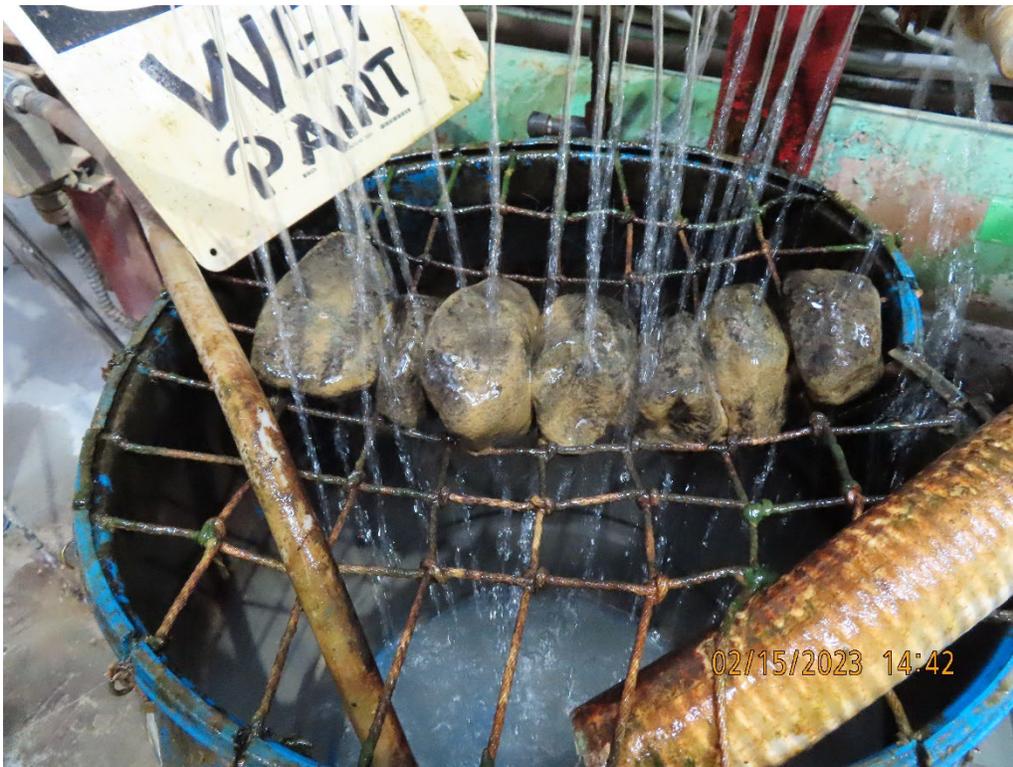
White material was observed on the test rocks used for monitoring in the CWTP (Photo 4).

Outfall 001 was not observed beyond the manifold (Photo 5) due to deep snow. The white material on the test rocks in the CWTP suggested it might be present in Sherman Creek as well, but this was not confirmed in this inspection. Coeur Alaska believes colloidal sulfur generated by acidification of sodium thiosulfate following breakpoint chlorination is likely the white material and is evaluating the use of soda ash to prevent its formation.

Photo 4. White material test rocks in the CWTP

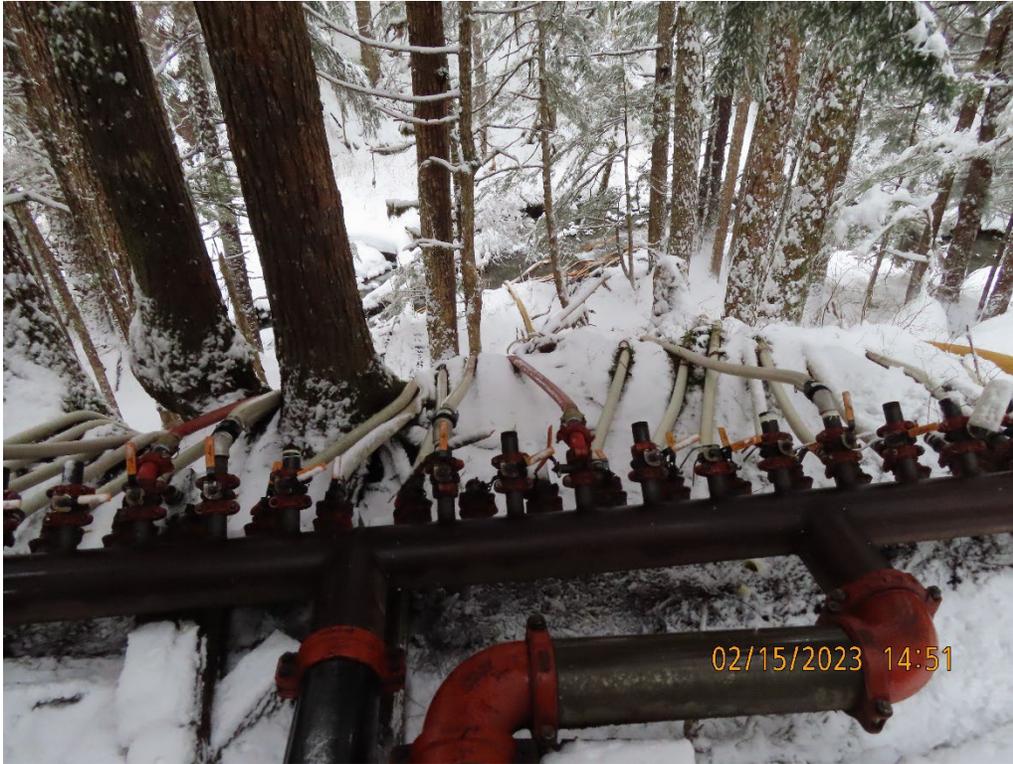
**Photo 5. Outfall 001 manifold.**

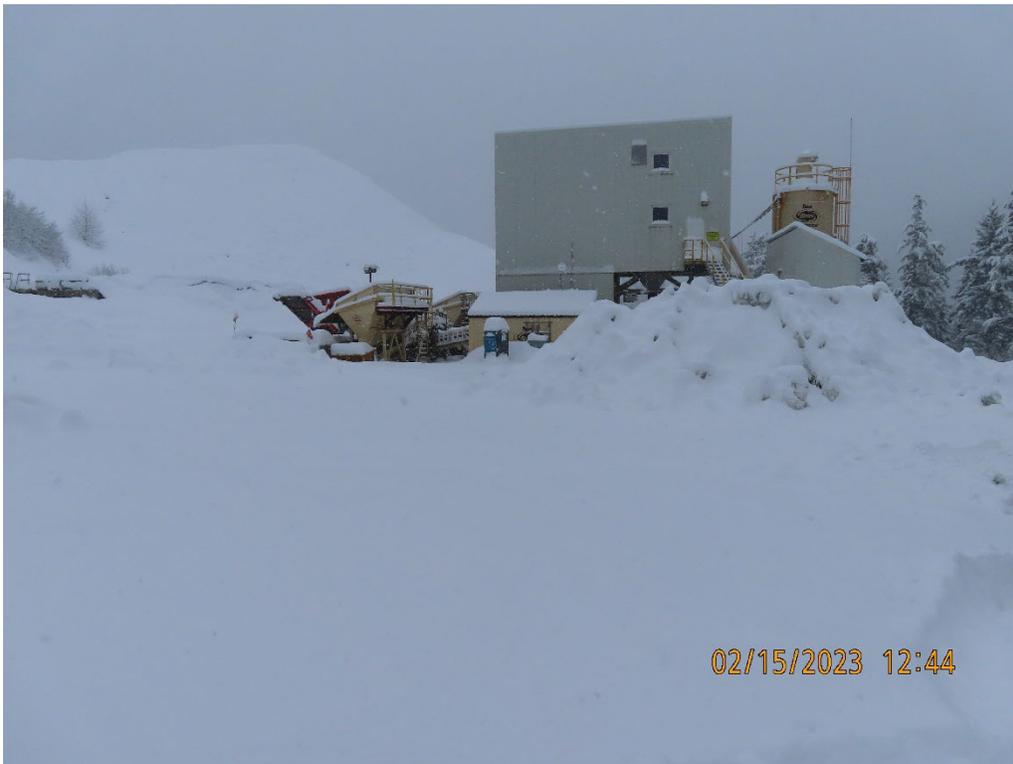
The Pug Plant is currently offline during the winter months (Photo 6).

**Photo 6. Pug Plant.**

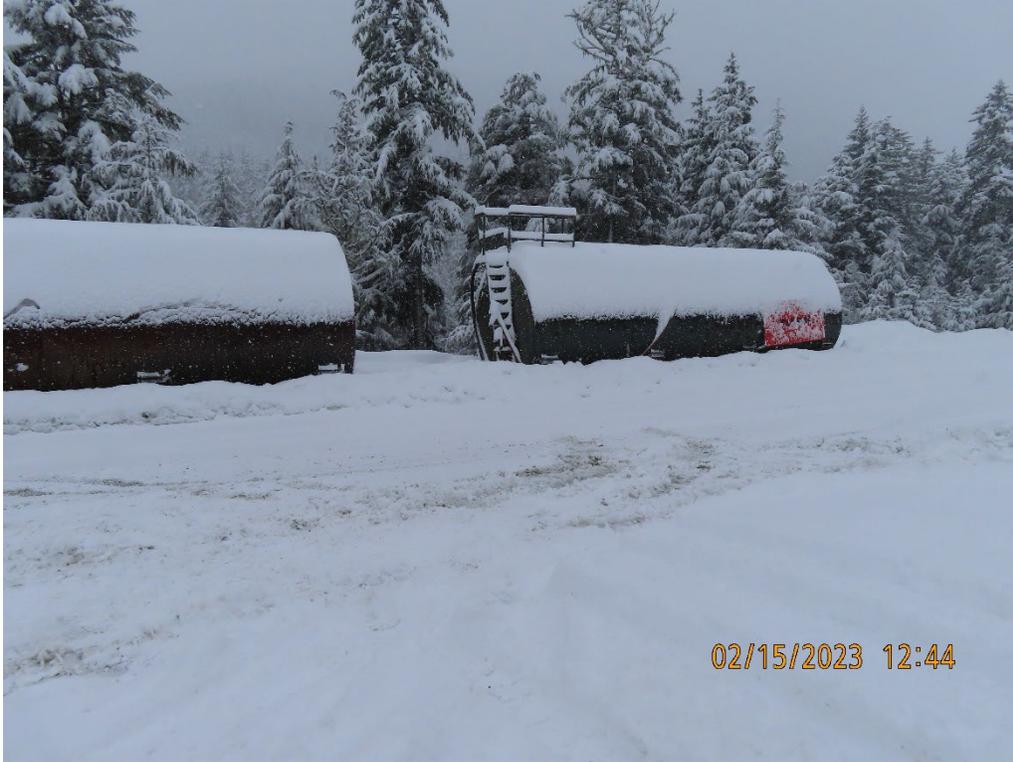
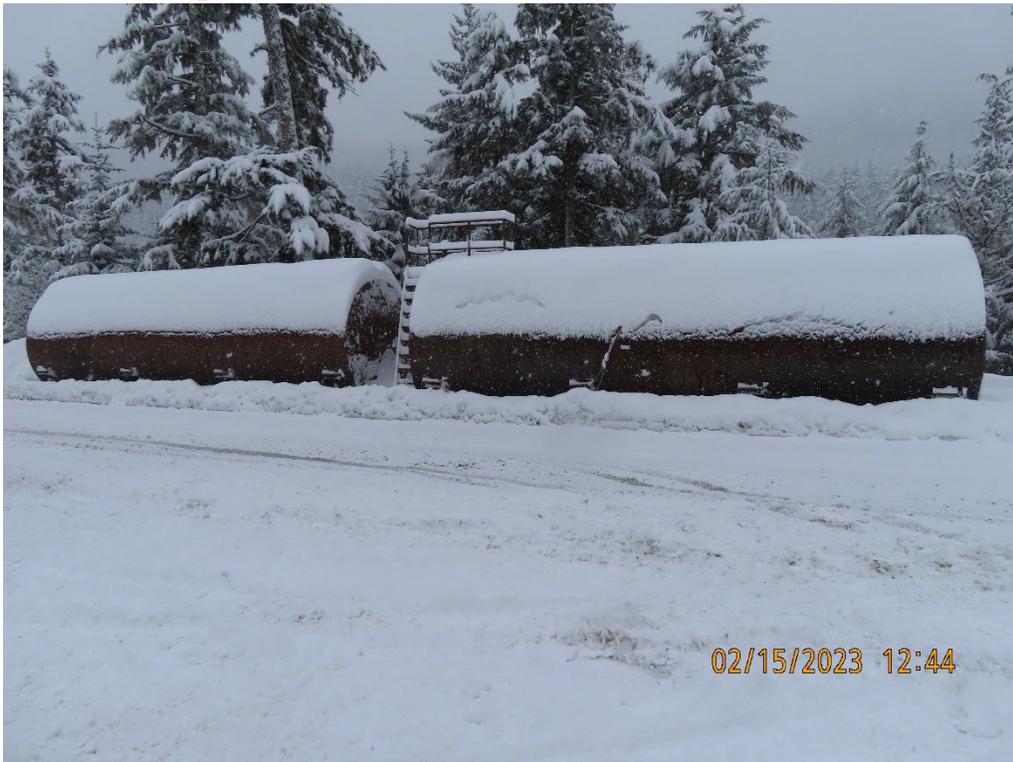
Adjacent to Pit 4 along the access road, four large tanks that previously contained contaminated water from a fuel spill near the upper camp stormwater ponds are staged (Photos 7-8). A contained stockpile of contaminated sediment from that spill is also located at Pit 4 (Photo 9). Coeur is evaluating options for safe disposal of this material.

**Photo 7. Tanks previously used to contain diesel-contaminated water at Pit 4.**

**Photo 8. Tanks previously used to contain diesel-contaminated water at Pit 4.**

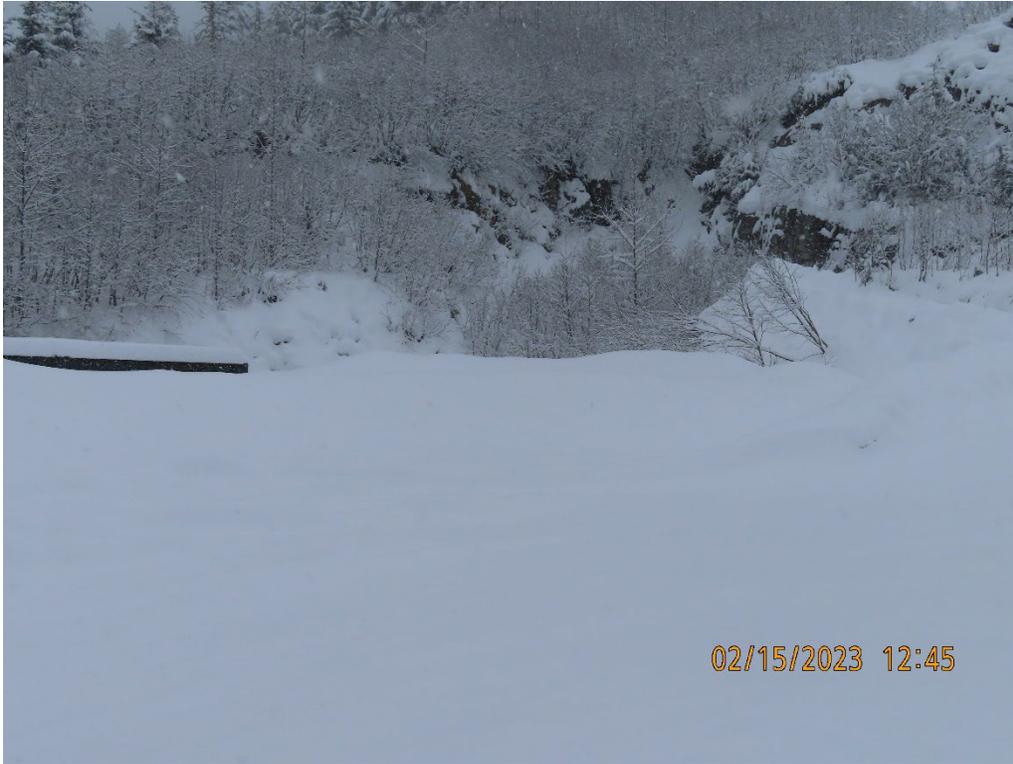
**Photo 9. Diesel-contaminated soil stockpile at Pit 4.**

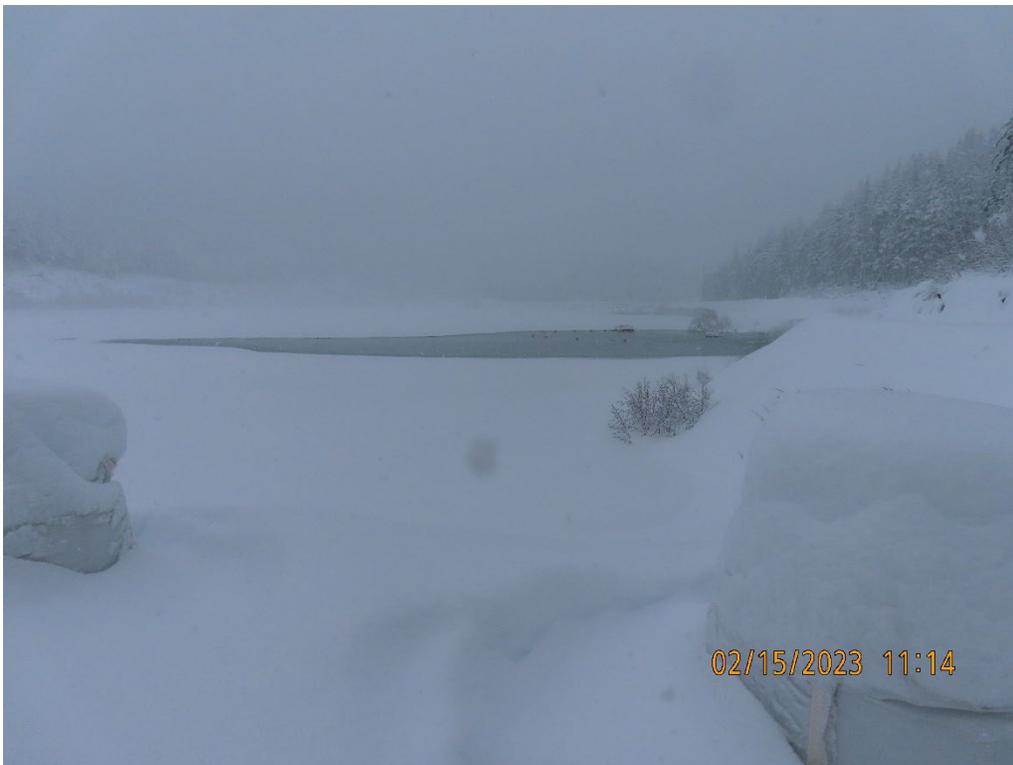
Tailings deposition was occurring near the southeast portion of the TTF (Photo 10).

**Photo 10. TTF Lower Slate Lake.**

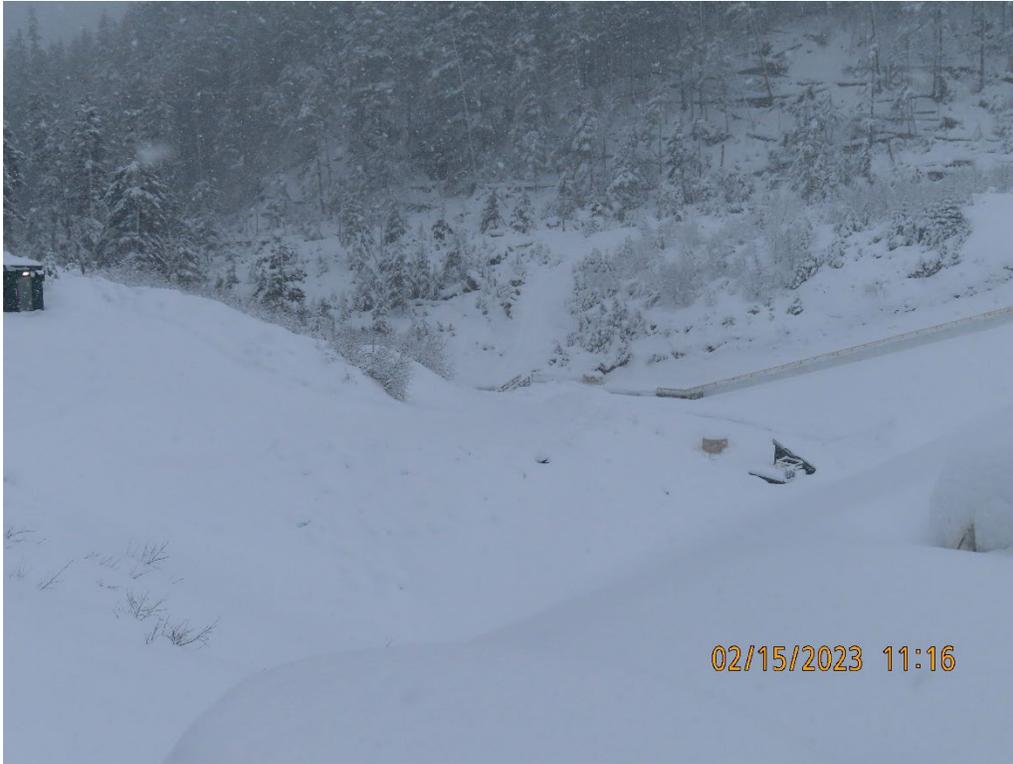
The TTF dam spillway appeared in good condition and was covered with snow and ice. There were no visual signs of ARD seepage in the spillway (Photo 11).

**Photo 11. The TTF spillway.**

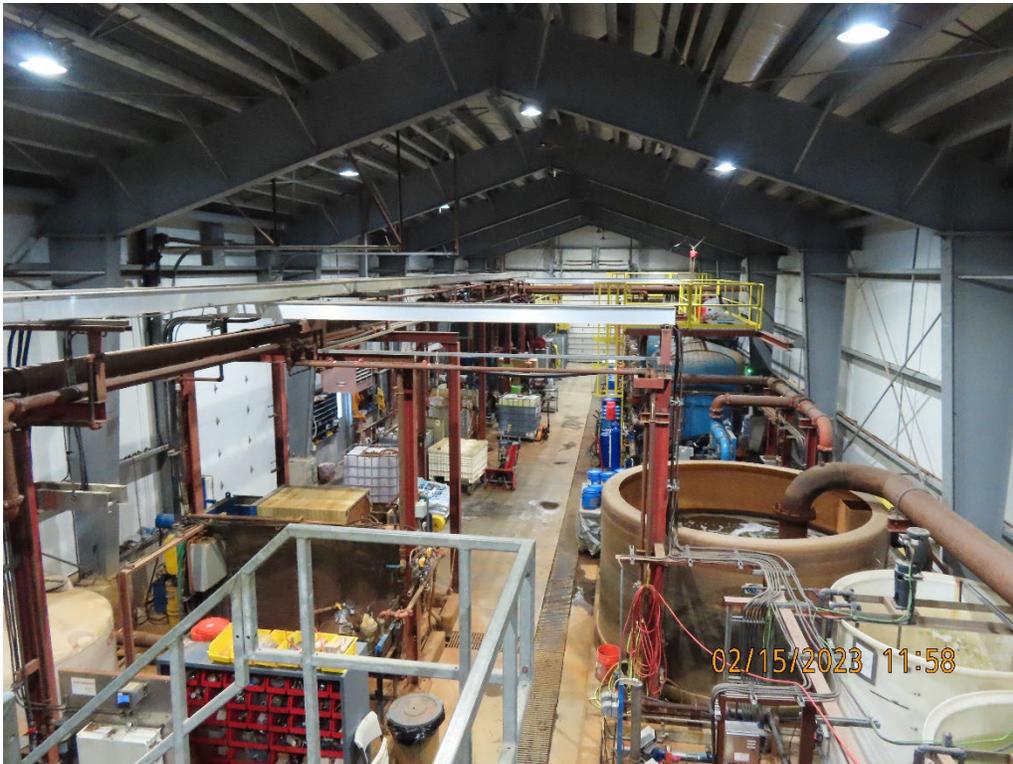
Good housekeeping (Appendix 4g BMP plan; Table 4-1) practices were observed inside the TTF water treatment plant (Photo 12).

**Photo 12. TTF Water Treatment Plant.**

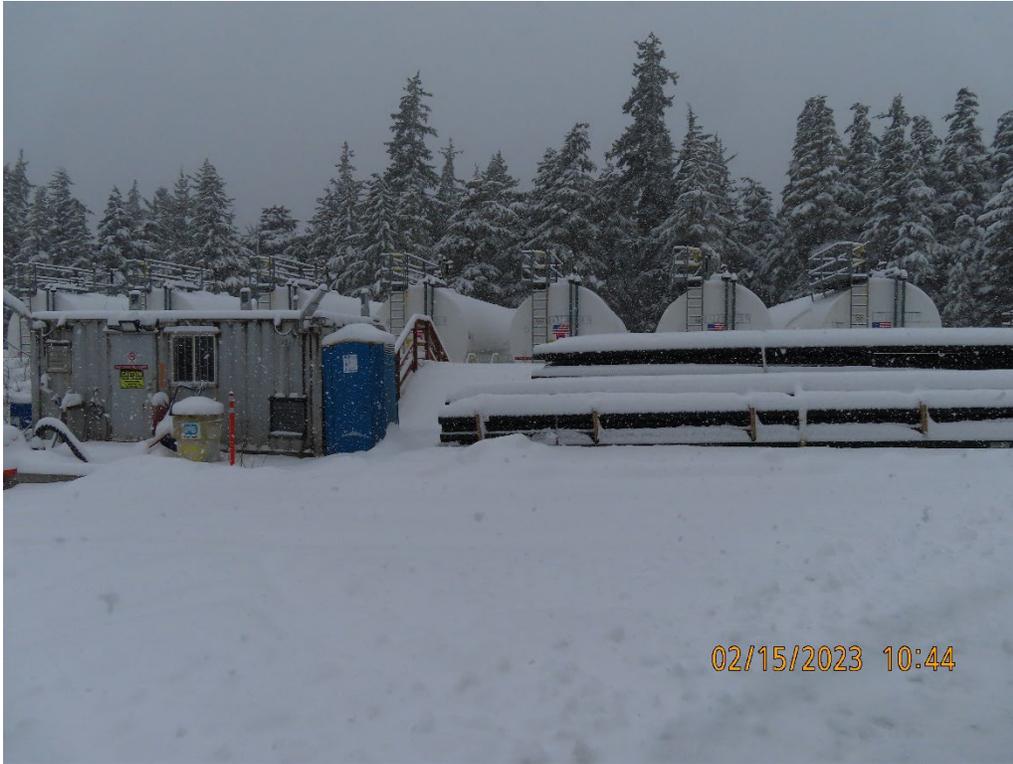
The fuel depot was in good condition with the BMPs functioning as intended. No fuel sheening was observed around the fuel containment area (Photo 13).

**Photo 13. Fuel Depot.**

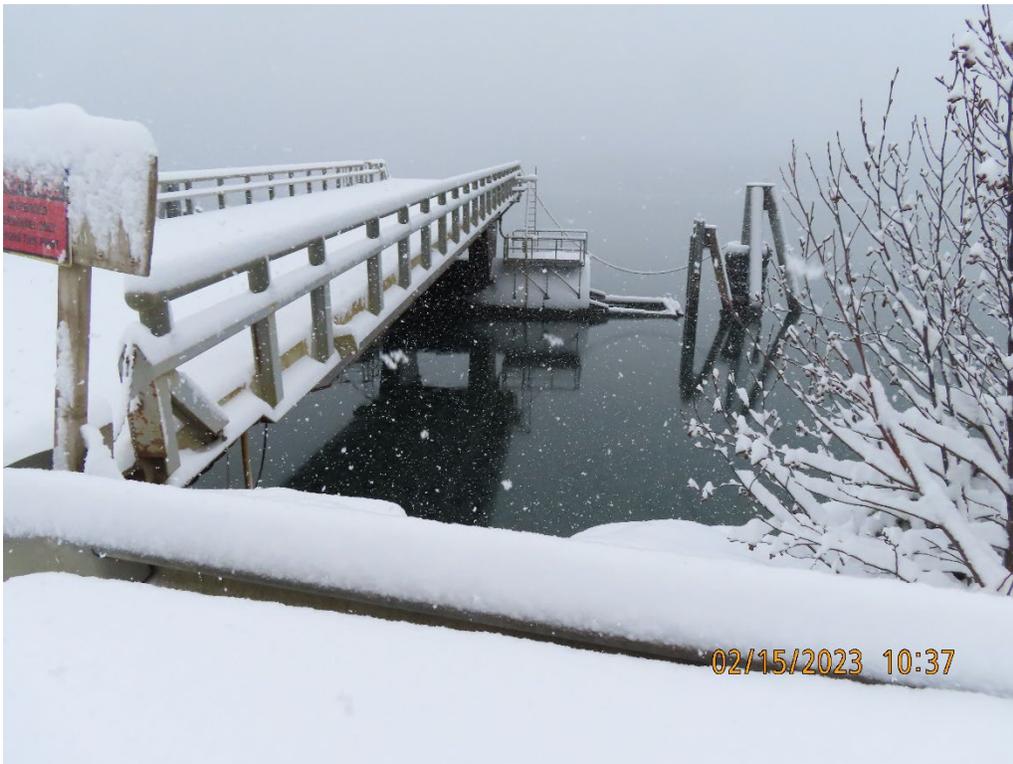
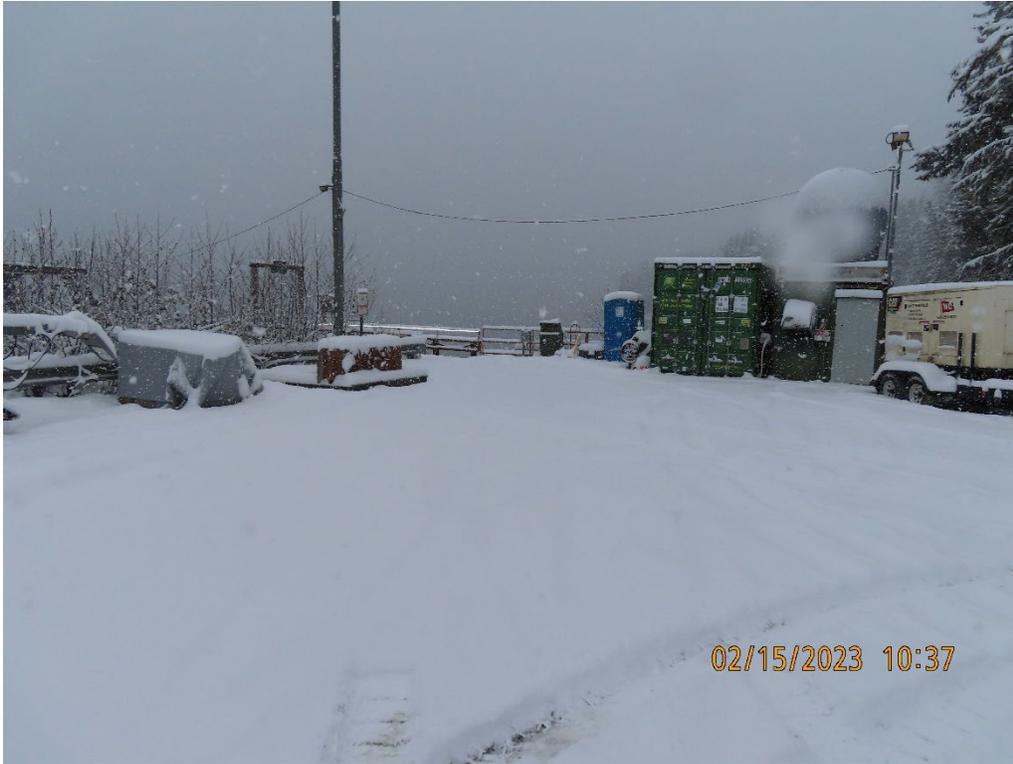
The port facility appeared in good condition (Photos 14-15). Stormwater BMPs were frozen and covered in snow (Photo 16).

**Photo 14. Slate Cove Port Facility.**

**Photo 15. Slate Cove Port Facility.**

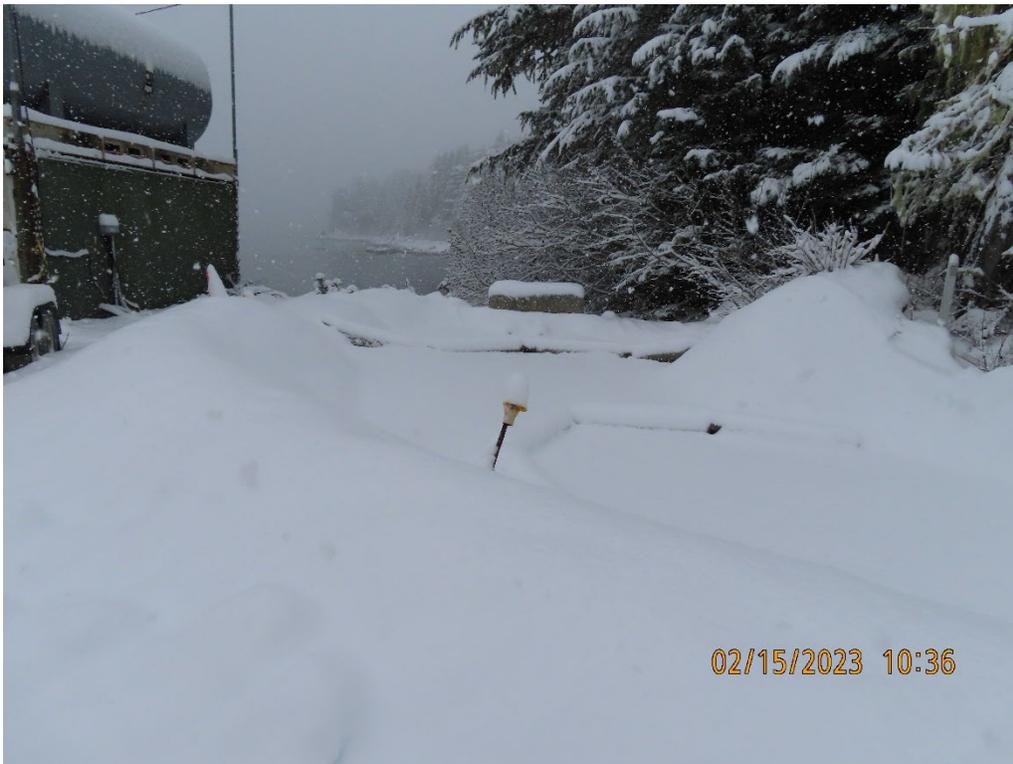
**Photo 16. Port facility stormwater BMP's.**
