Kensington Mine Field Inspection Report

Inspection Date: September 11, 2024
Time: 8:00 AM to 3:00 PM
Weather: Mostly cloudy with fog in the morning. Clearing to sun in the afternoon with an average temperature of 50°F.
Agency Personnel: DNR: Jesse Garnett White, William Groom, and Carolyn Curley
Operator Contact: Coeur Alaska: Sierra Lammers
Inspection Objectives: Site Inspection

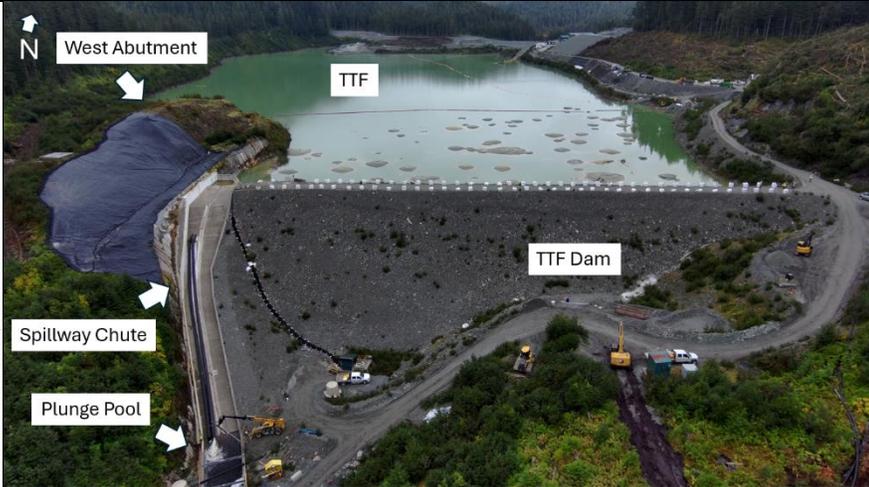
The spillway chute (Photos 1-3) was in good condition with water flowing out of the spillway pipe into the plunge pool. The seepage pump area was tidy and accessible. Disturbance below the dam is associated with construction of the new spillway location. The crest of the dam was walked in its entirety to the western abutment where it was noted that the graphitic phyllite cover was in good condition (Photo 1-4). The TTF had exposed tailings in the form of mounds from the upstream slope of the dam to the boom (Photos 1-2 and 4-5). Trees were cut down but not removed along the east side of the TTF from the new WTP Area to the main dam and beyond to the new plunge pool area for the expansion to construct the next dam lift and elevate the access road. The trees had not been removed at the time of inspection. The area of disturbance for the new WTP is about 5.76 acres (Photos 6 and 8). The new WTP Area was in good condition, graded, and sloped to contour. After completing the TTF drone flight we travelled to the Back Dam (see Section 2.3) area to view the completed construction, organics stockpile, WTP and new WTP Area.

Photo 1: Tailings Treatment Facility (TTF) and TTF Dam with views of tailing mounds above the water surface at time of inspection. Disturbance in the form of clearcutting east of the TTF. Disturbance below the dam is associated with construction of the new spillway location.

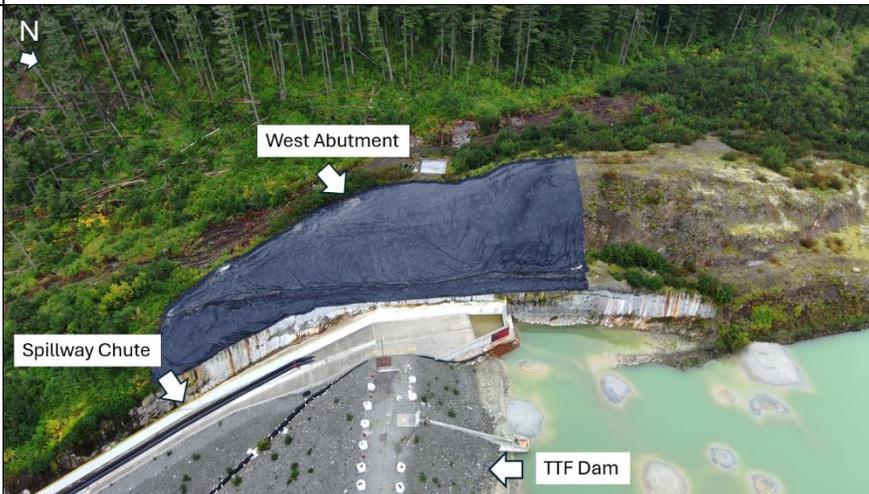
Photo 2: View of the TTF Dam West Abutment including cover of graphitic phyllite (exposed during original excavation), TTF Dam Crest, Spillway Chute, and tailing mounds above the water surface.

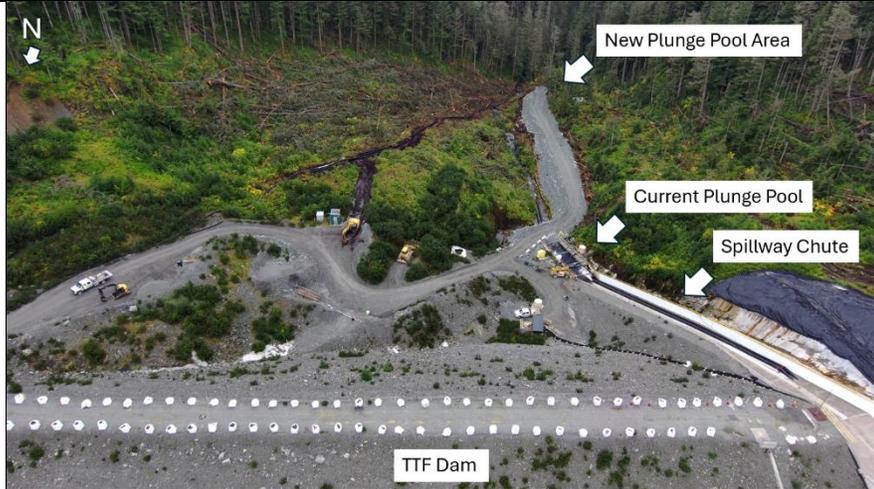
Photo 3: Southerly downstream view of the TTF Dam, New Plunge Pool Area, Current Plunge Pool, Spillway Chute, and clearcut, disturbed land. Note the seepage pump at the toe of the dam.

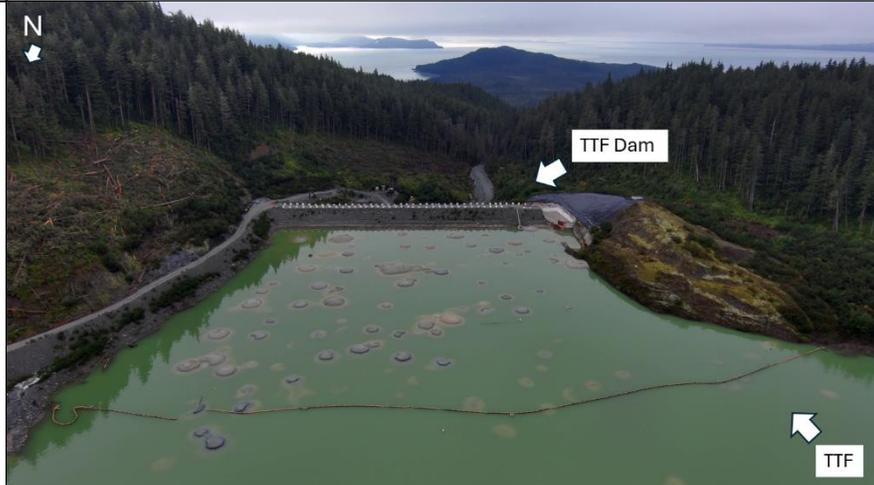
Photo 4: Wider southerly view of the TTF Dam, TTF, and tailing mounds above the water surface. Note the clearcut, disturbed land to the east of the TTF and below the dam. Trees were cut down but not removed along the east side of the TTF from the new WTP Area to the main dam and beyond to the new plunge pool area for the expansion to construct the next dam lift and elevate the access road.

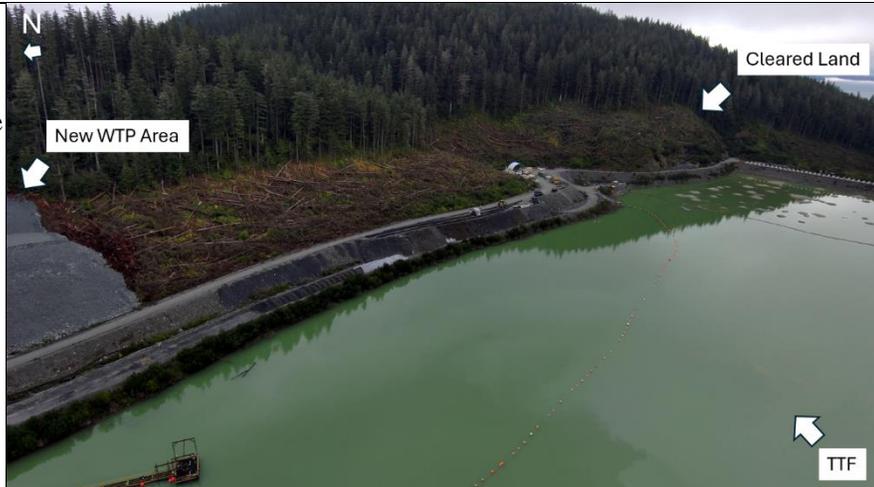
Photo 5: Another view of clearcut, disturbed land east of the TTF for the expansion to construct the next dam lift and elevate the access road.

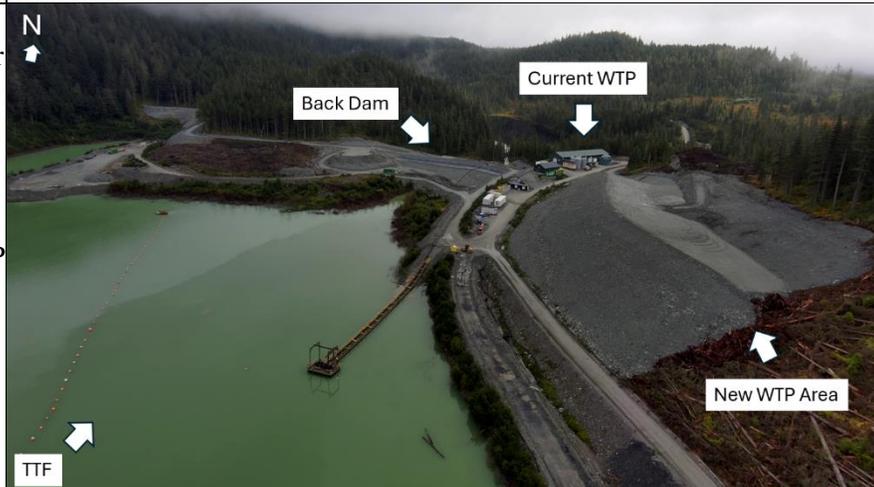
- 2.3. Tailings Treatment Facility Back Dam (Photos 6-7): The drone was deployed to view the completed Back Dam and initial phase of the new WTP area. Immediately to the west is an organics stockpile and to the east the WTP and new WTP Area. Upper Slate Lake from drone view looked clean and pristine (Photo 7). The crest of the Back Dam was walked from end to end after which we drove the entirety of the gravel road along the north end of the TTF and Northwest Diversion Structure before leaving for SCMT.

Photo 6: View of the Back Dam, Current Water Treatment Plant (WTP), and New WTP Area. Note the organic material stockpile to the west of the Back Dam. The footprint of the New WTP Area has changed considerably since the June 2024 inspection.

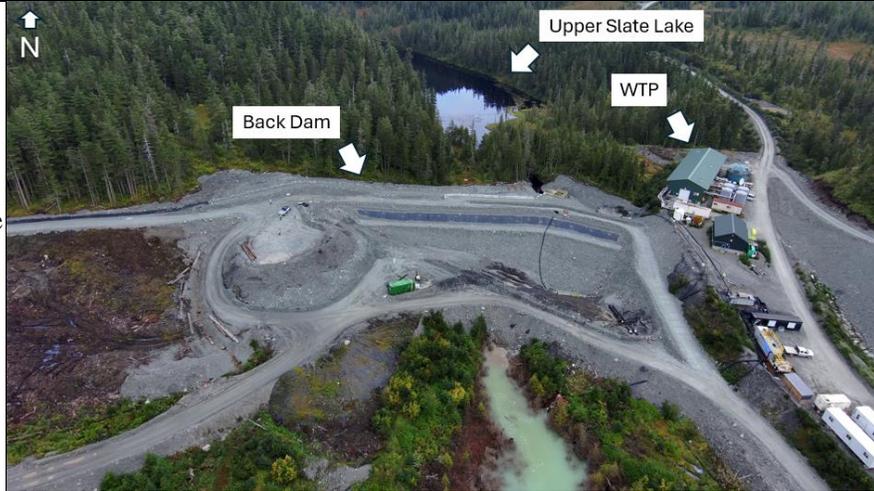
Photo 7: A closer view of the Back Dam and WTP including Upper Slate Lake in the background. To the west of the Back Dam is an organic material stockpile. To the south is the TTF.

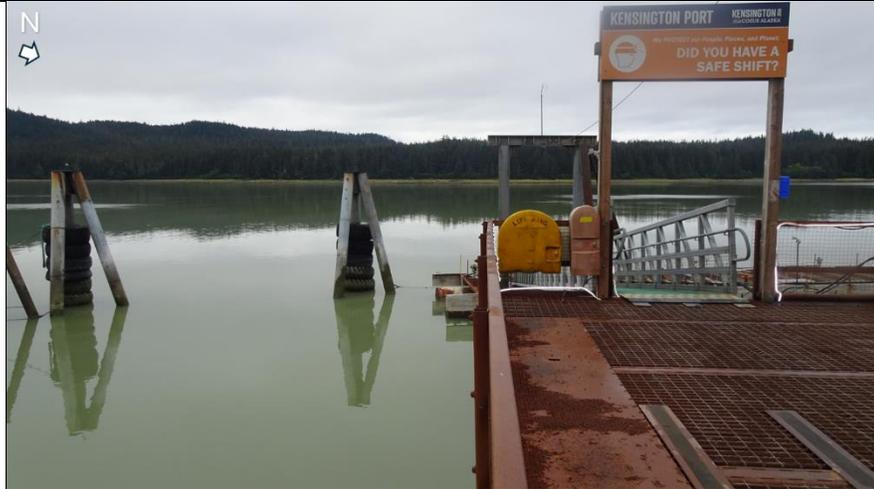
- 1.1. Slate Cove Marine Terminal, Lower Port Laydown Yard, and Bulk Fuel Depot: DNR Staff traveled from the TTF Area (see Section 2.2) to the SCMT (Photo 9) via the TTF Pipeline and Jualin roads. Everything was in good order. The LPLY and BFD were not inspected in detail as Coeur personnel were working in those areas at the time. We then traveled to Pit-4 via the Jualin Road.

Photo 9: Slate Cove Marine Terminal (Kensington Port) staging area, gangway, and various breasting dolphins.

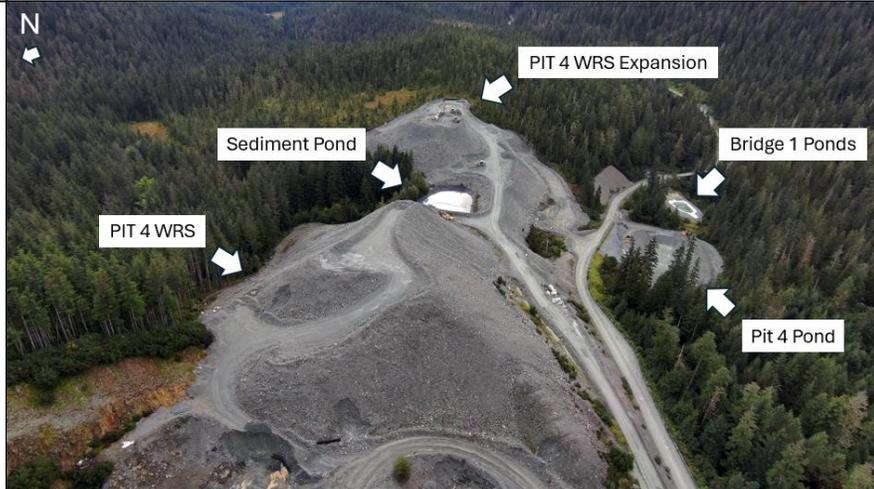
Photo 10: Pit 4 Waste Rock Storage (WRS) including views of the Sediment Pond, Pit 4 WRS Expansion Area, Bridge 1 Ponds, and Pit 4 Pond.

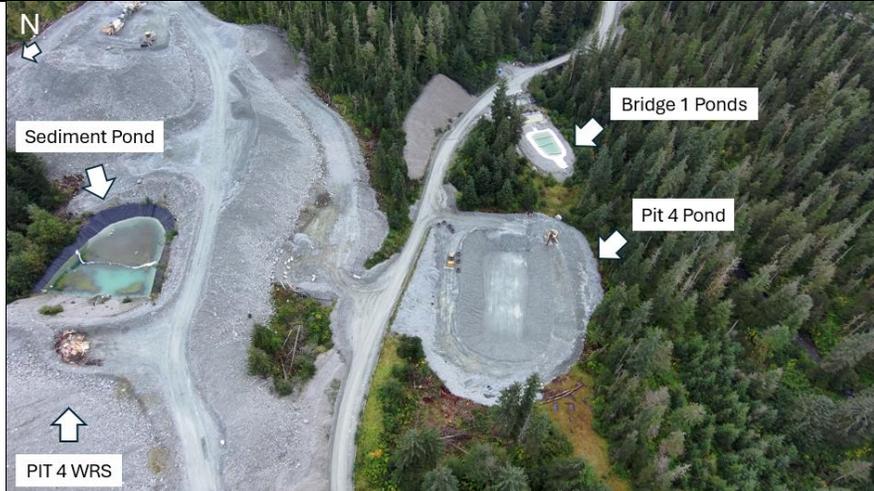
Photo 11: A different view of Pit 4 WRS, Bridge 1 Ponds and Pit 4 Pond.

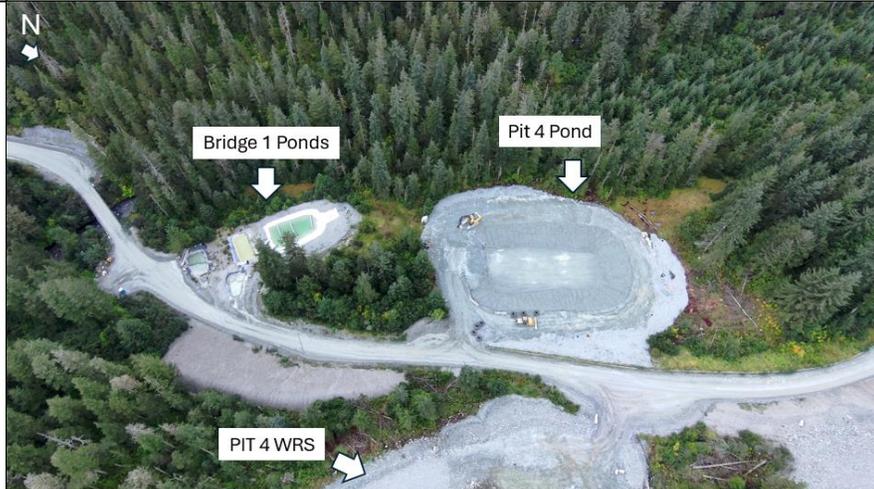
Photo 12: Another view of Bridge 1 Ponds and Pit 4 Pond from above Pit 4 WRS. Johnson Creek flows under Bridge 1.

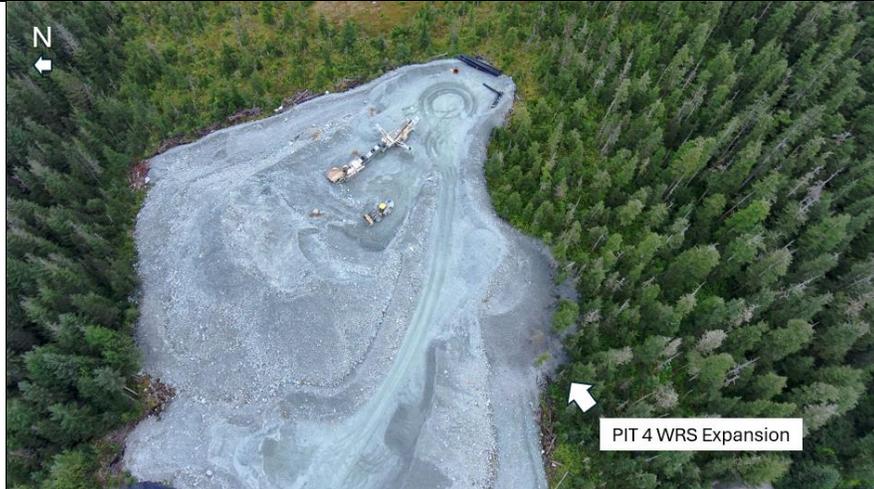
Photo 13: Activity at the Pit 4 WRS Expansion Area.

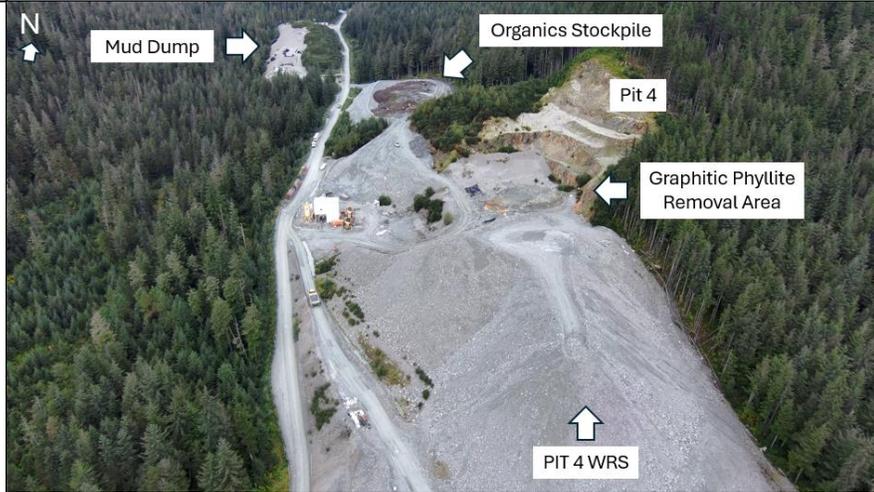
Photo 14: Pit 4 WRS, with views of the Mud Dump, Organics Stockpile, Pit 4 highwall, and where Graphitic Phyllite is/was being stored/removed.

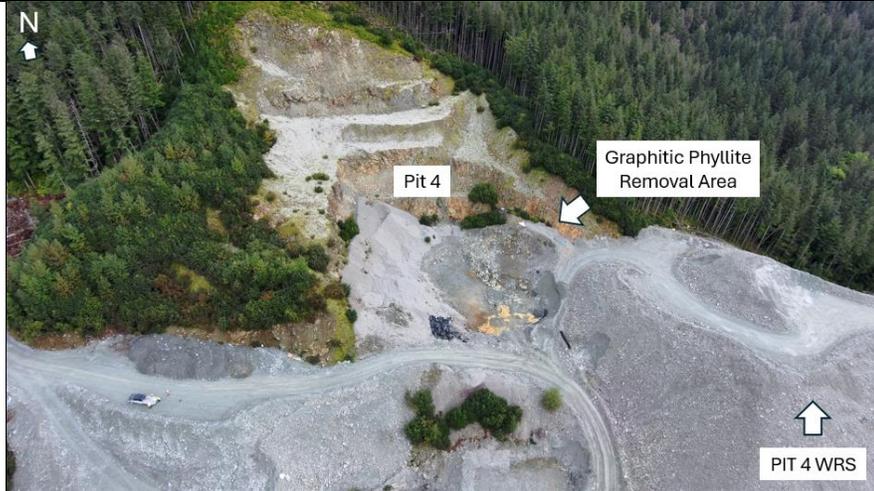
- 1.2. Pit-4 WRS (Photos 10-16): DNR Staff deployed the drone at Pit-4 to view the organic stockpile, GPSC, WRS, WRS Expansion, and pond. The WRS Expansion was active at the time of inspection. Approximately 99% of the ARD has been removed from the GPSC. Coeur personnel continue to excavate the remaining 1% to the southeast. Once this is completed, waste rock will be deposited over the current shallow layer of waste rock pebbles on the floor of the GPSC. Everything in and around Pit-4 was in good working order at the time of inspection. The drone flight also documented

Photo 15: Graphitic Phyllite Removal Area. Very little of this material is left at time of inspection. Almost all this material has been transported underground for disposal.

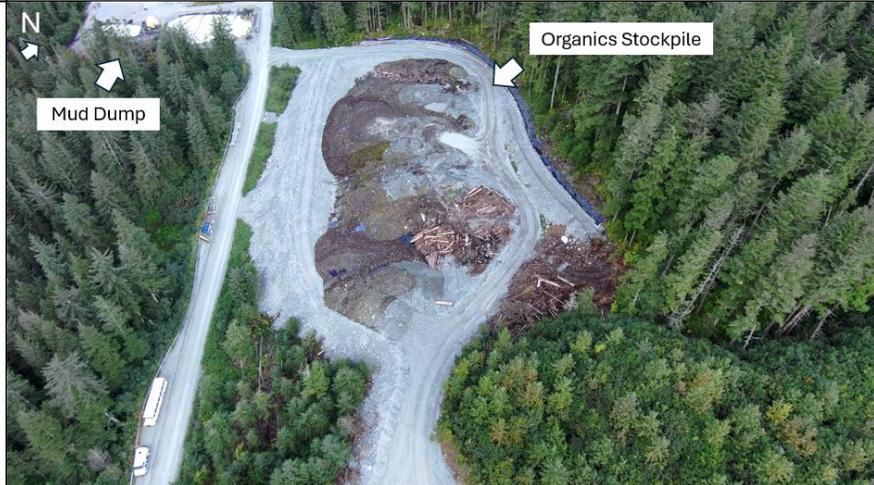
Photo 16: Organics Stockpile near Pit 4.

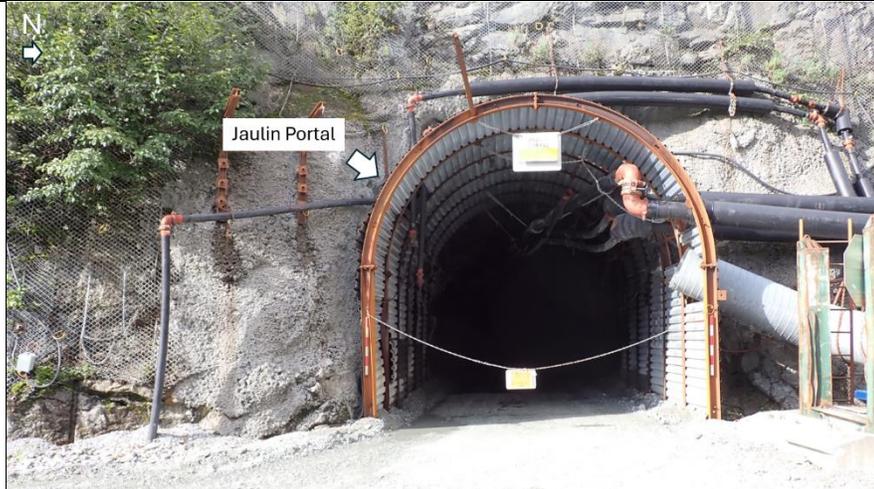
Photo 17: Jaulin Portal

3.1. Jaulin Portal, Tailings Pipeline, and Snowslide Gulch (Photos 17, 18, and 19 respectively): DNR Staff viewed the inactive Jaulin Portal then visited the remediated pipeline. The area around the Jaulin Portal was tidy and accessible. The pipeline was repaired and covered with reject pebble from the mill. DNR staff inspected the site and found it to be in good condition. Coeur staff continue to monitor the site weekly. Up the road, we viewed the Snowslide Gulch Avalanche Control Area which was in good order.

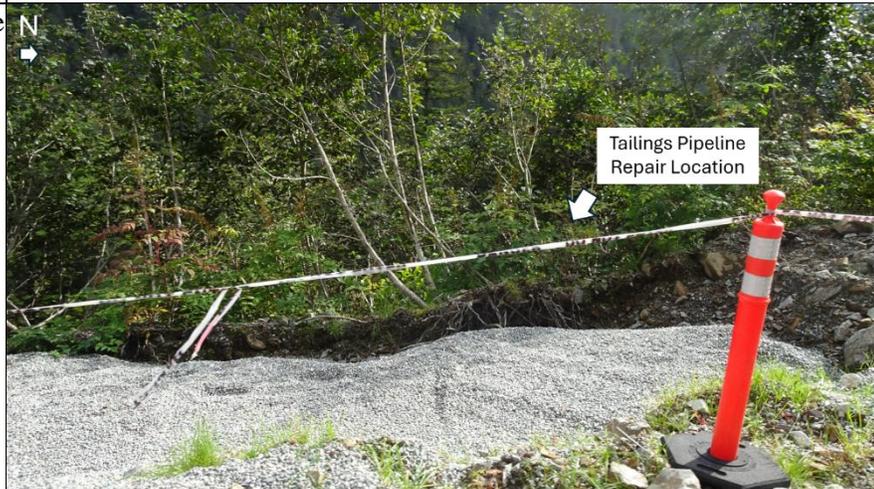
Photo 18: Tailings Pipeline Repair

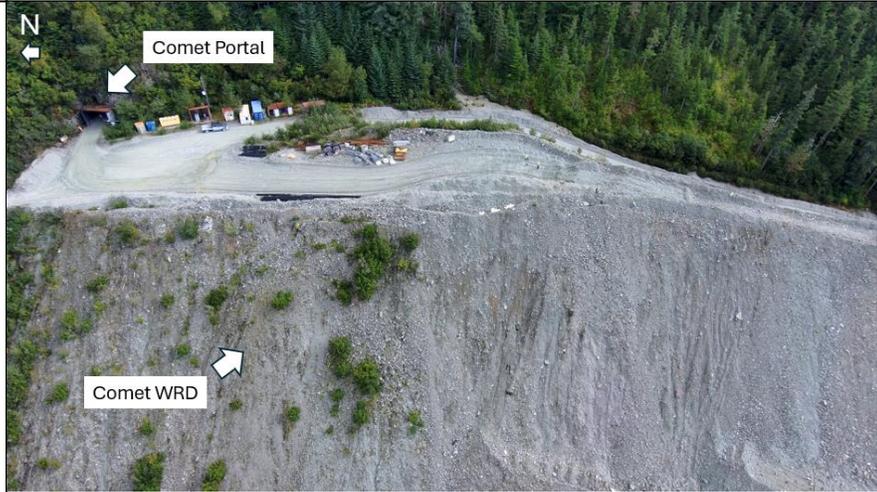
- 1.3. Comet Area (Photos 20-21): DNR Staff travelled underground from Kensington Portal to Comet Portal. Once at the CLY, the drone was deployed. The WRS was in good condition and the WTP, clarifier, treatment ponds, and sediment filtration storage area were operating normally reviewing the area, we walked to Outfall 001 (see section 2.1). Our final stop of the day was CBC and Core Storage (Photos 25-27). The drone was deployed from the beach. There was a significant increase in core boxes as compared to DNR's last inspection in June 2024.

Photo 20: Comet Portal and WRD.

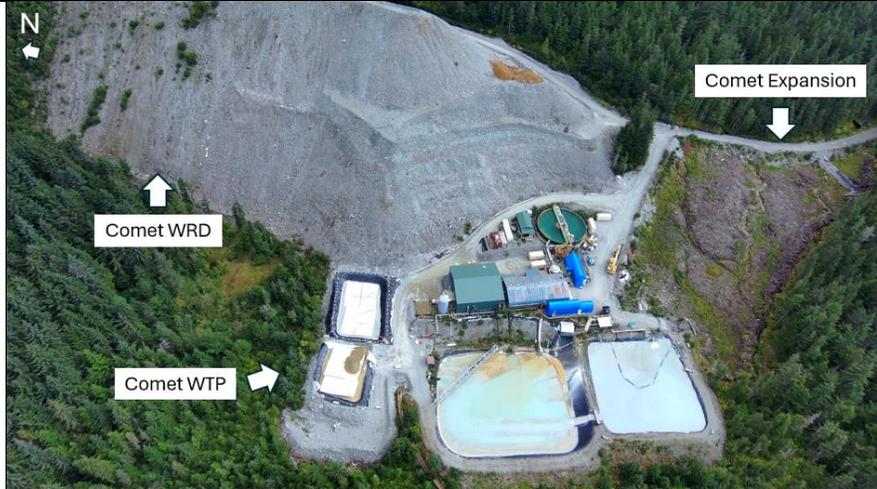
Photo 21: Comet WRD, WTP, and cleared Expansion Area.

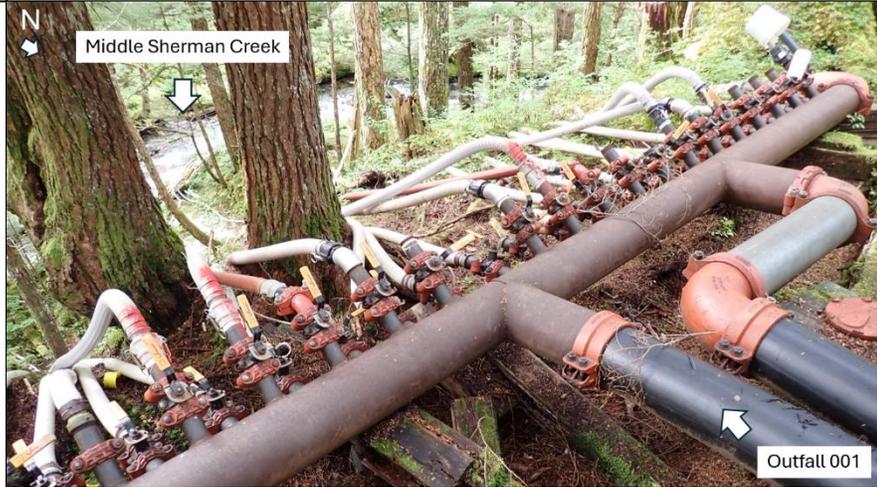
- 2.1. Sherman Creek Outfall (Outfall 001): DNR Staff observed Outfall 001 (Photos 22-24) at the end of the raised walkway and at creeks edge. Outfall 001 is monitored weekly and sampled monthly. The outfall was operating normally and there were no concerns by DNR staff.

Photo 22: Outfall 001 effluent discharge hoses.

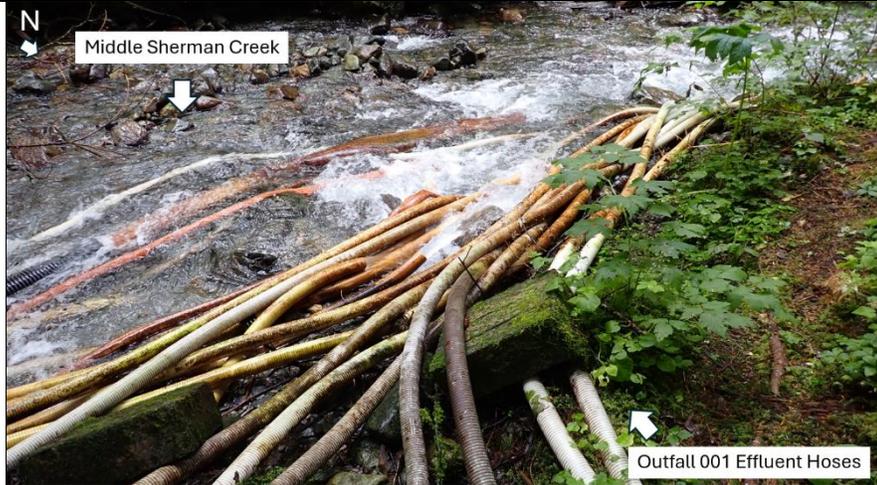
Photo 23: Outfall 001 effluent discharging directly into Middle Sherman Creek.

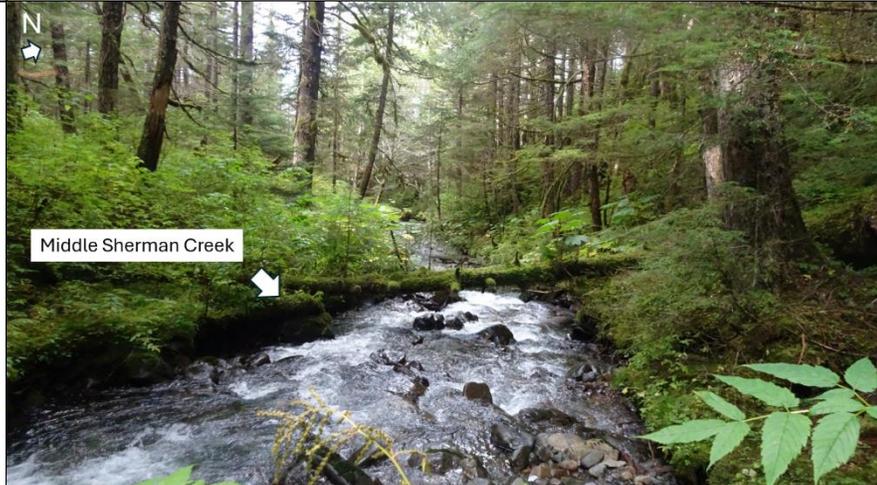
Photo 24: Middle Sherman Creek below Outfall 001 effluent discharge.

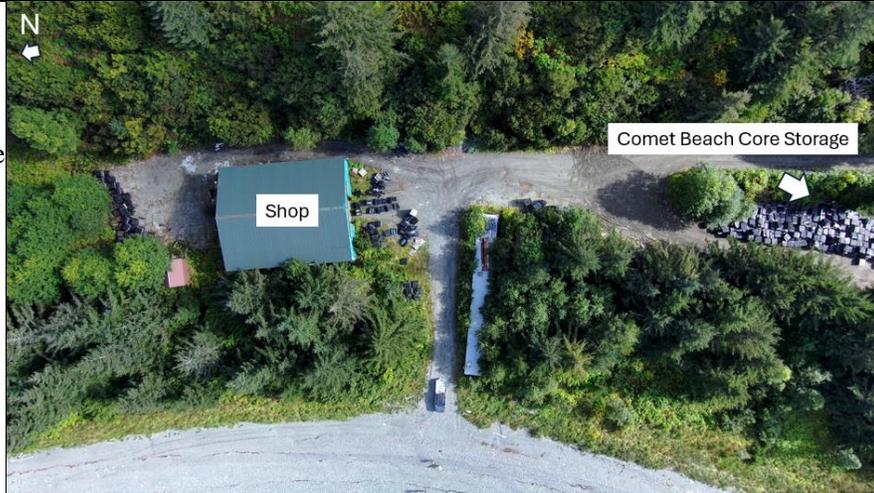
Photo 25: Comet Beach Camp and Core Storage. There is a significant increase in core boxes being stored in the storage yard than in the last inspection.
