KENSINGTON GOLD MINE INSPECTION REPORT

Inspection Date: February 1, 2012
Weather: Cloudy 36° F. No wind. 6-12 feet of snow on the ground.
Time of Inspection: 5:00 am to 2:30 pm
Operator Contact: Kevin Eppers – Coeur Mining
Agency Personnel: David Wilfong – ADNRR, Joe Manning, David Schmerge - USFS
Inspection Objectives: General Inspection

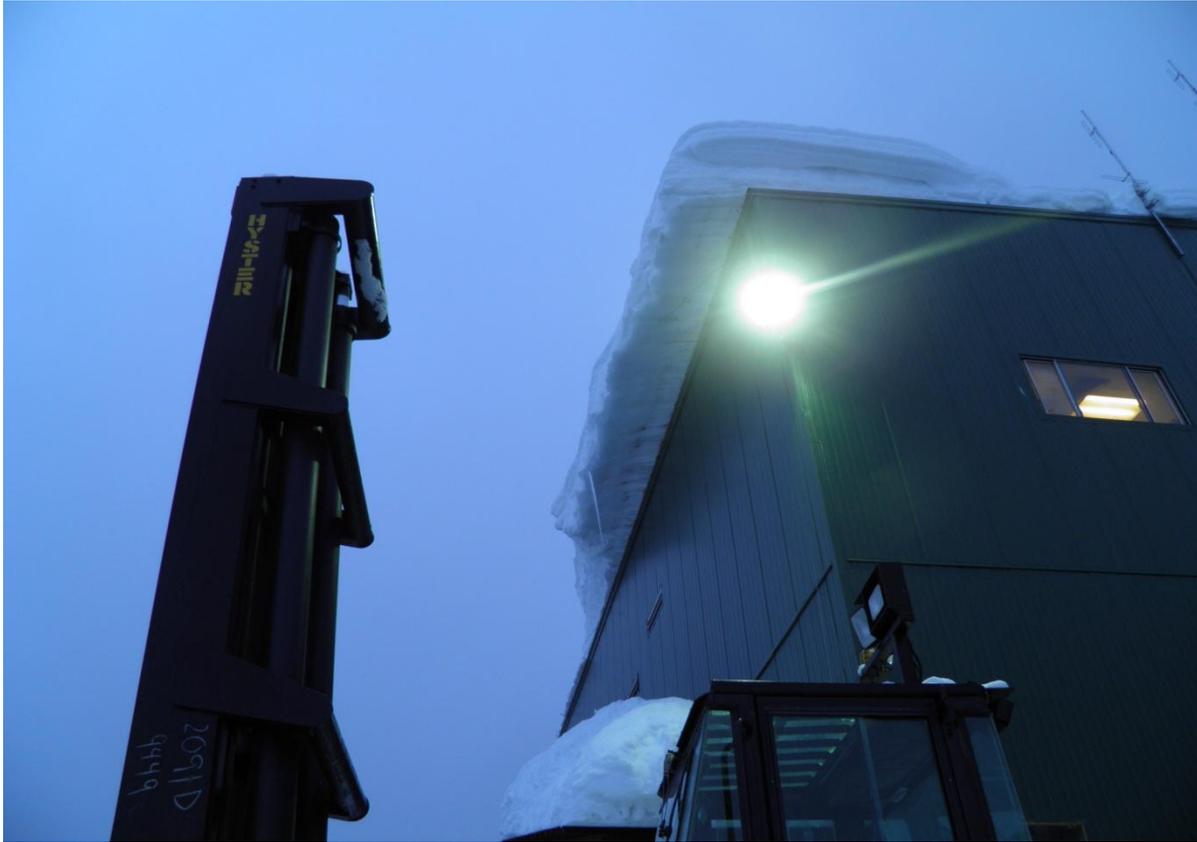
Agency personnel were greeted by Kevin Eppers, the environmental superintendent at Coeur Inc. Two short videos were viewed concerning safety precautions for above and below ground visitors. At the Jualin Portal shop building, snow had begun to slide off the roof (Figure 1). The falling snow was not directly over any access doors, and does not fall in any areas that are accessible to personnel.

Figure 1 Snow Hanging from Roof

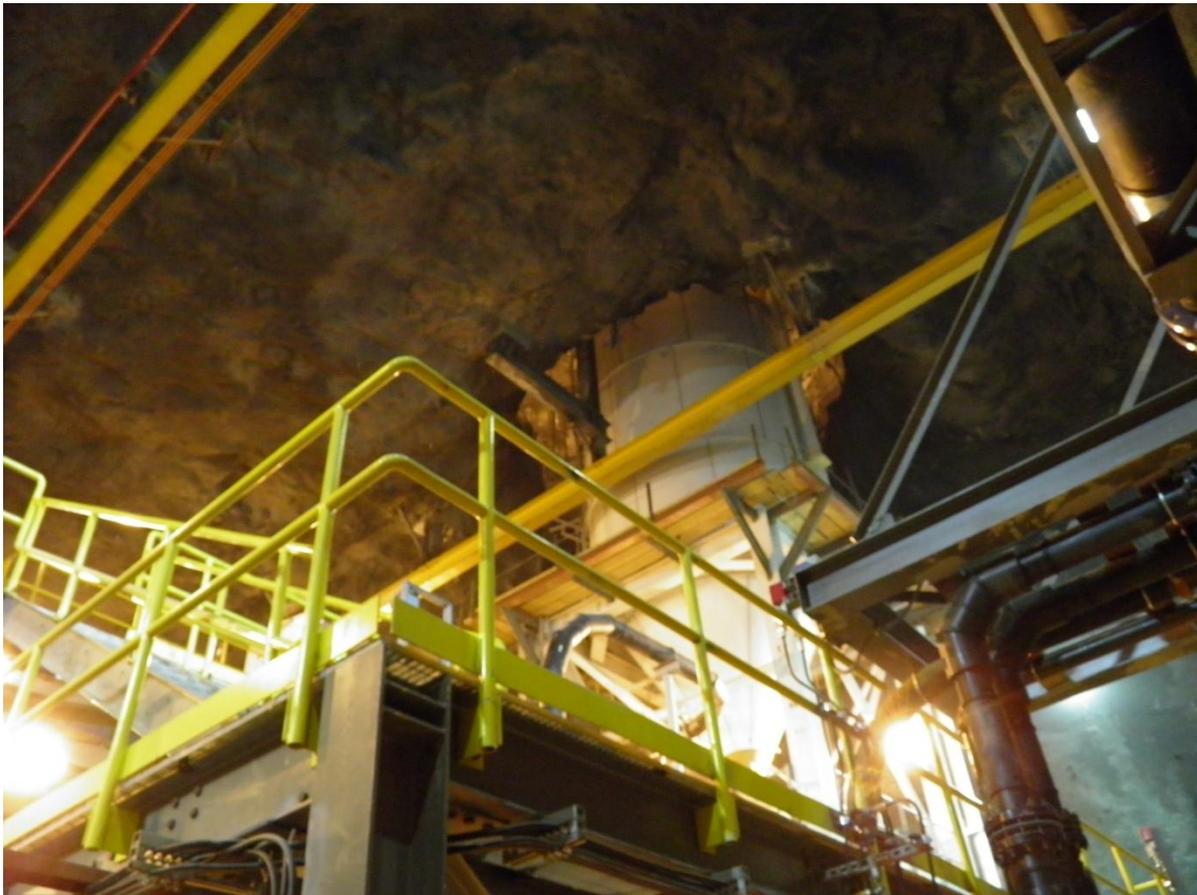
Underground access is currently restricted to Wednesdays while infrastructure construction and maintenance activities continue. The construction on camp facilities has been completed, and the work on the underground paste plant continues (Figure 2). The walls of the cavern that the paste plant is built in are covered with 3-4 inches of Shotcrete. Staining is evident at some of the seeps leaking through the Shotcrete (Figure 3). Underground development work continues, and enough ore is removed to run the mill at approximately 50% of its capacity. DYWIDAG rock bolts were being installed in the main tunnel connecting the Jualin and Comet portals. The bolts are being installed to support a High Density Polyethylene (HDPE) mine dewatering pipe needed to replace a leaking pipe. Full mine dewatering is maintained with treatment occurring at the Comet portal Water Treatment Plant (WTP).

Figure 2 Underground Paste Plant

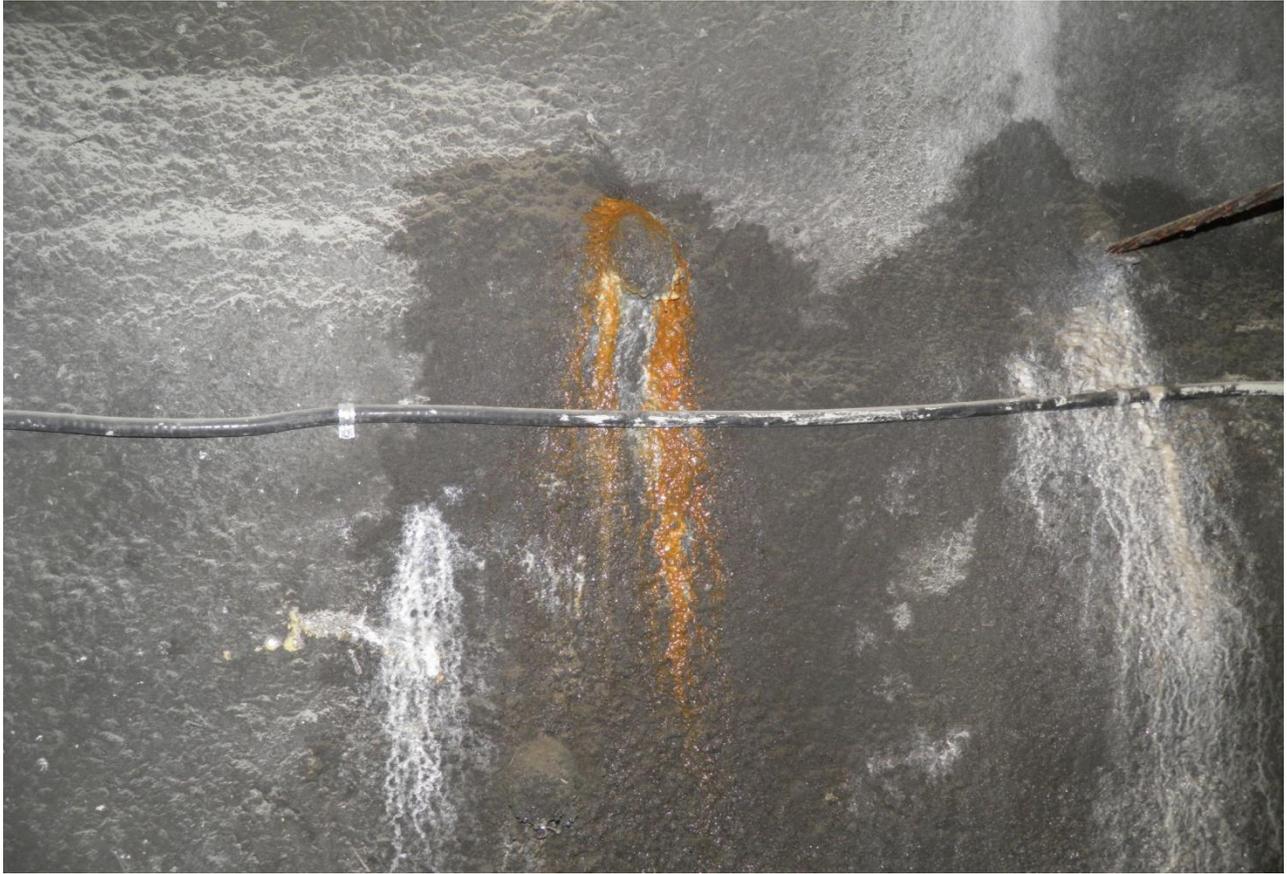
Figure 3 Staining in the Underground Paste Plant room

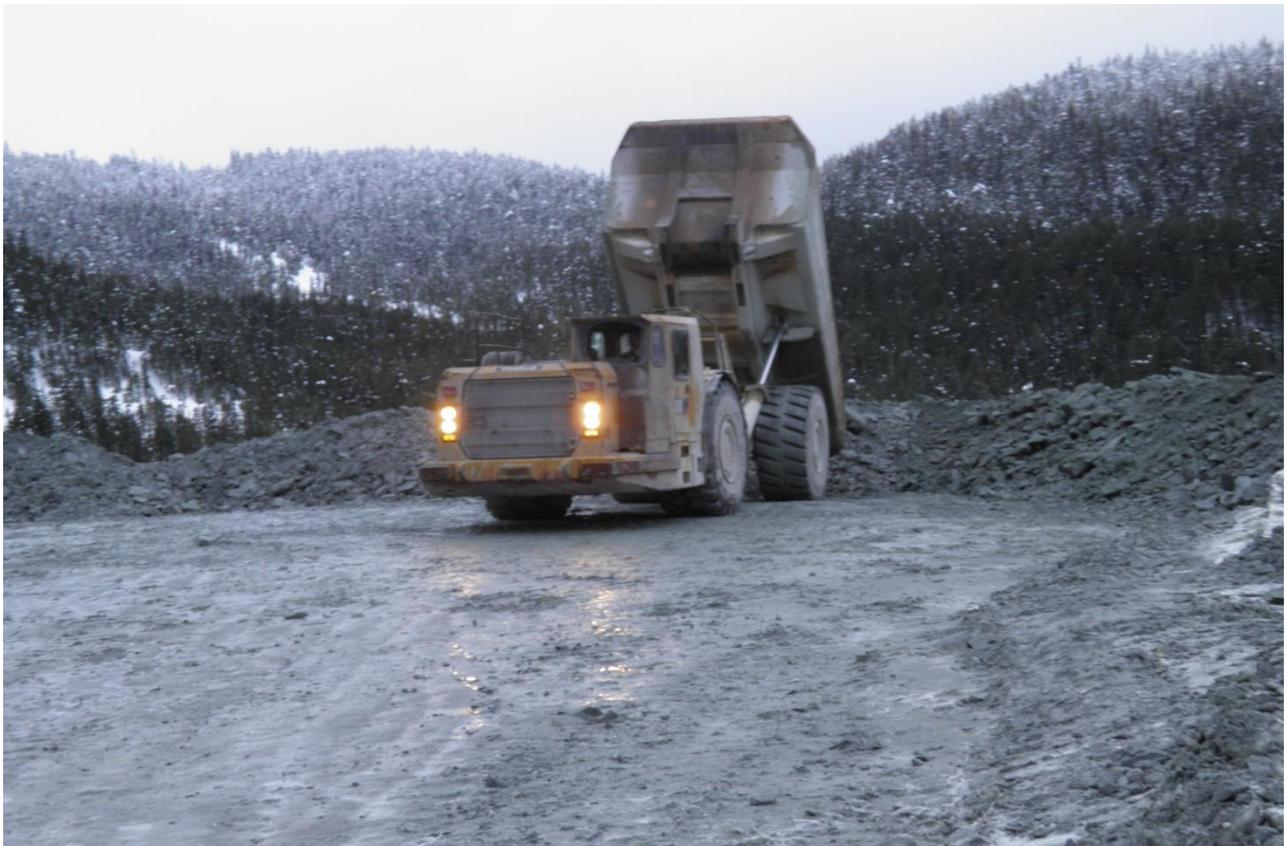
Waste rock is being disposed of at the permitted site near the Comet portal. Waste rock is dumped by underground haul trucks (Figure 4), and then pushed over the side by bulldozer (Figure 5). Much of the pile was covered under a blanket of snow, however the exposed portions did not show any signs of instability or excessive erosion.

Figure 4 Haul Truck Dumping Waste Rock

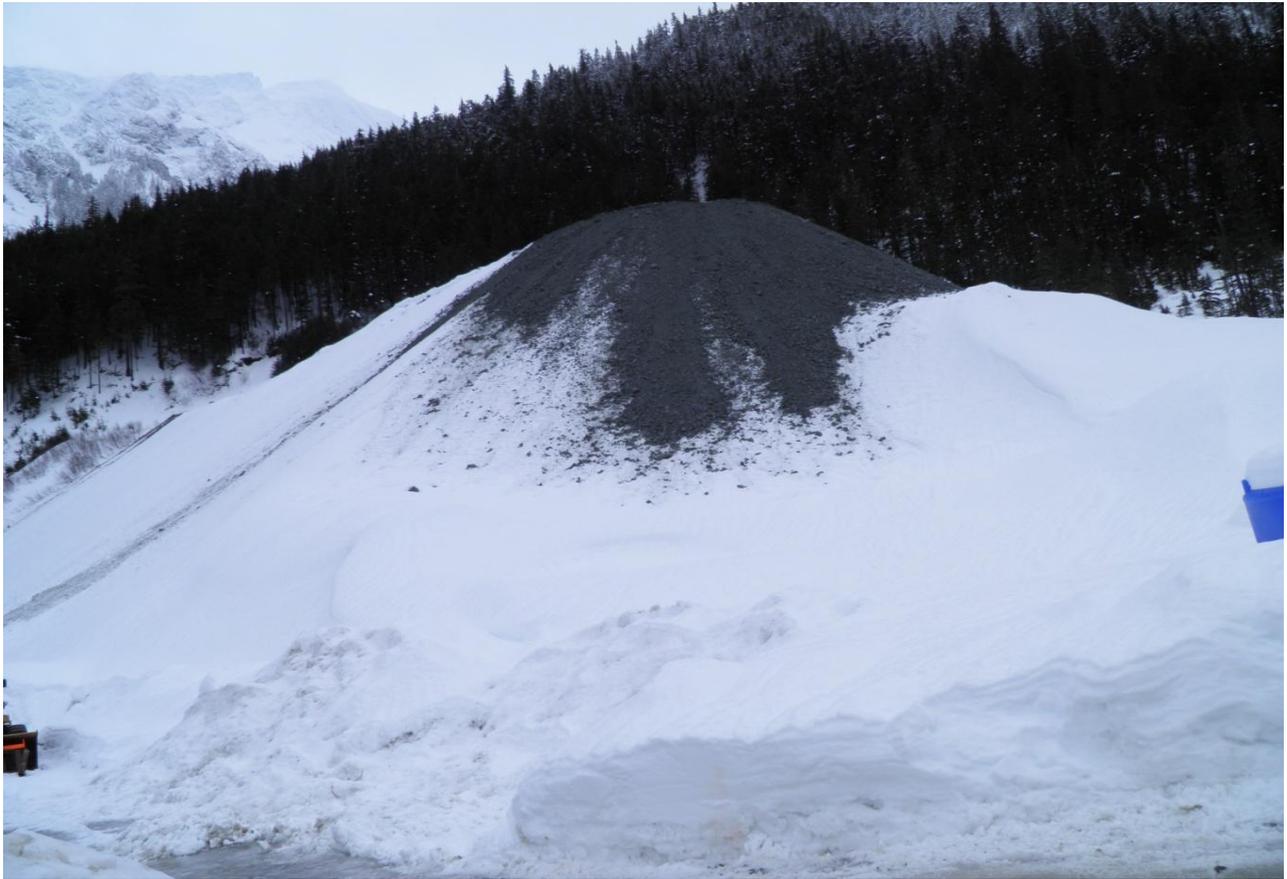
Figure 5 Waste Rock Pile as seen from the Water Treatment Plant

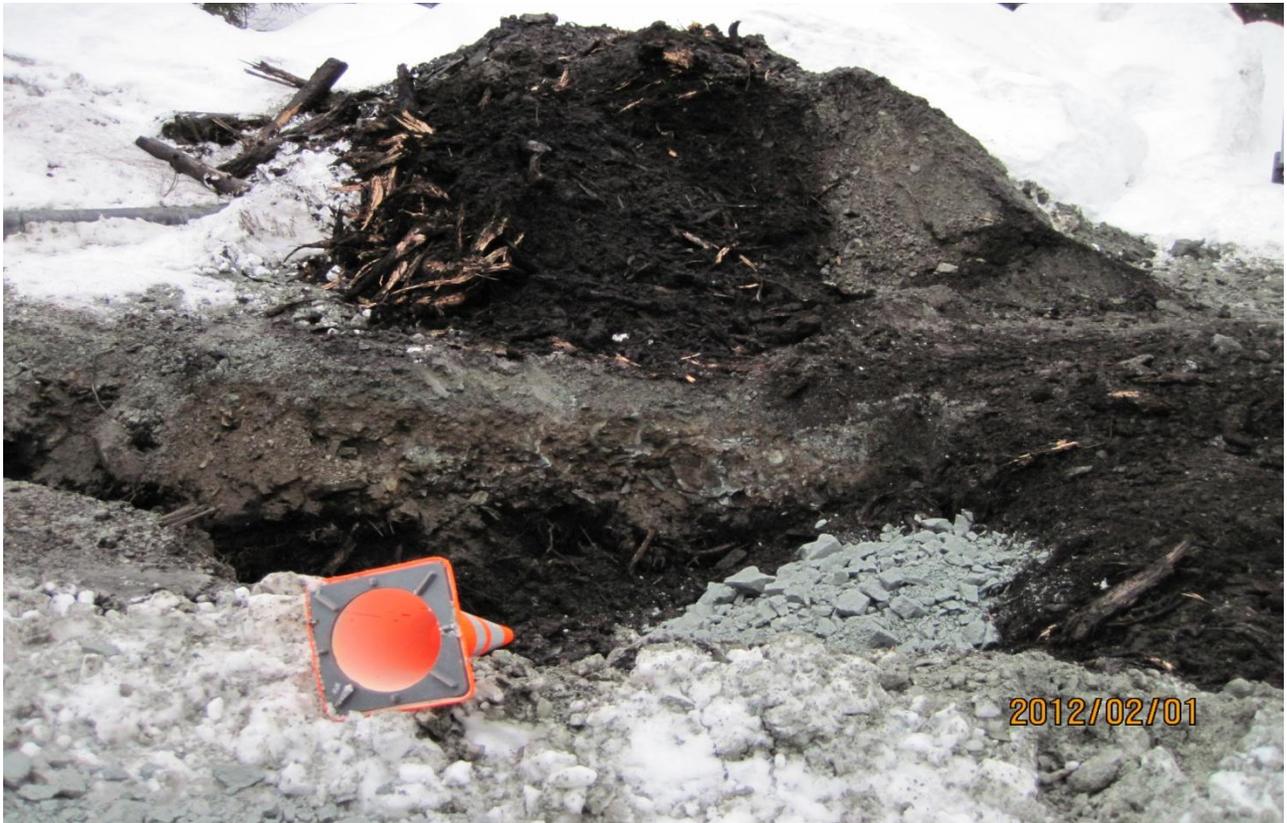
The buried portion of the mine dewatering pipe between the Comet portal and the WTP was in the process of being replaced (Figure 6). The current configuration consists of an 8" HDPE pipe which is near capacity with an 8" iron backup pipe. The new configuration will consist of one 12" HDPE pipe, and will use the old 8" pipes as a back up. Kensington is utilizing concurrent reclamation where practicable during the pipe laying project by separating topsoil from the inorganic soil, and then while backfilling, replacing the top layer (>12") with growth media (topsoil) only. This process will allow natural revegetation of the disturbed area.

Figure 6 Trench for the New Dewatering Pipe

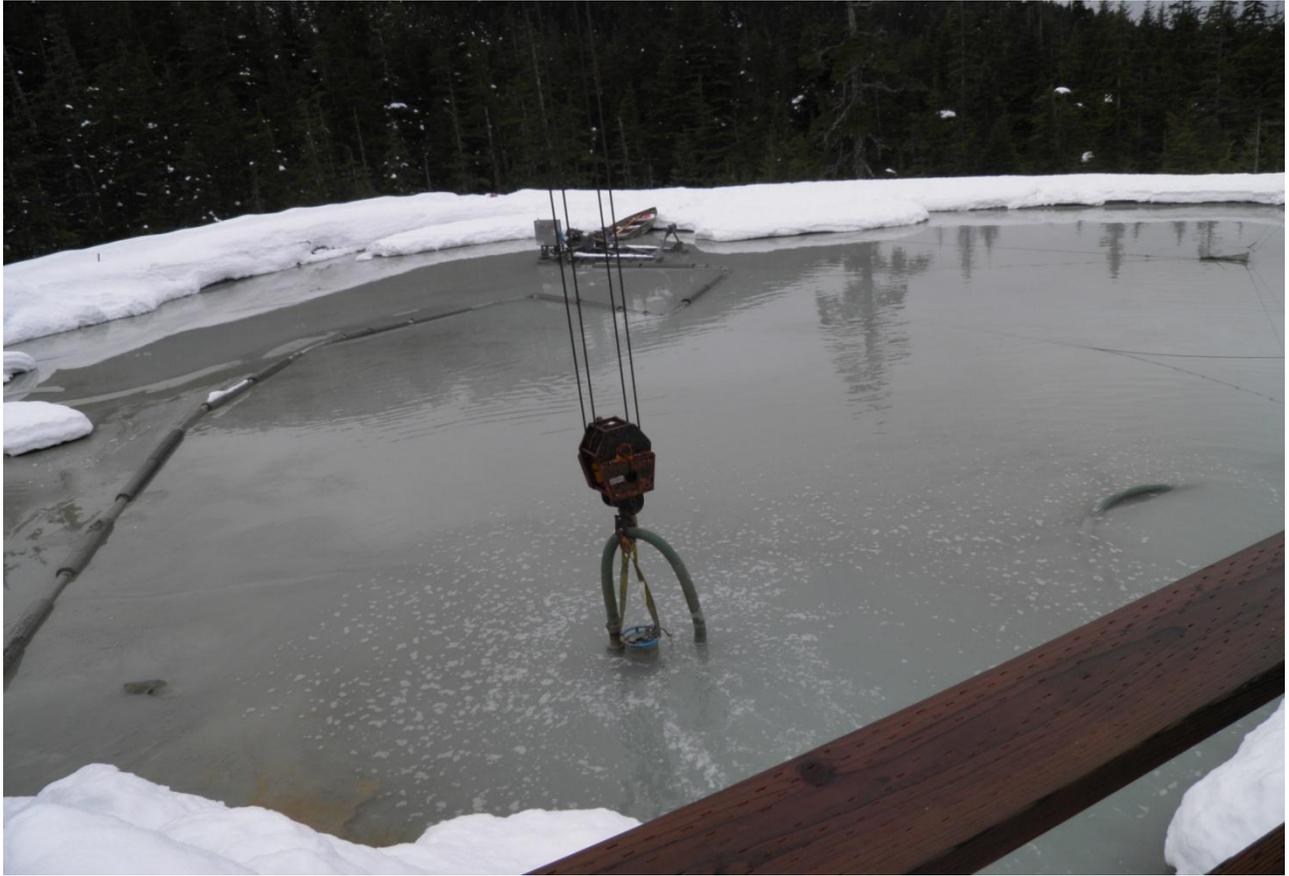
Figure 7 Pond 1

The mine dewater WTP near the Comet portal was running at approximately half of its capacity (~600GPM), so only 1 of the 2 treatment systems were operating. Sediment from the mine dewatering system continues to be dredged from pond 1(Figure 7) and transferred to sediment bags in a nearby lined basin (Figure 8). The sediment bags are made of a porous material with a ~2 micron size that is designed to let the water escape and leave the sediment inside the bag. Once the bag is full, it is allowed to dewater, and the disposable bags are then broken apart and the sediment is transferred to the waste rock facility. Water from the bags is pumped back to pond 1 for treatment. Water continues to flow through a tear in the liner of pond 1. The water is captured and pumped back to the pond. The piping for pond 2 was near completion. Once completed, mine dewater will be pumped to pond 2 so that the liner in pond 1 can be repaired.

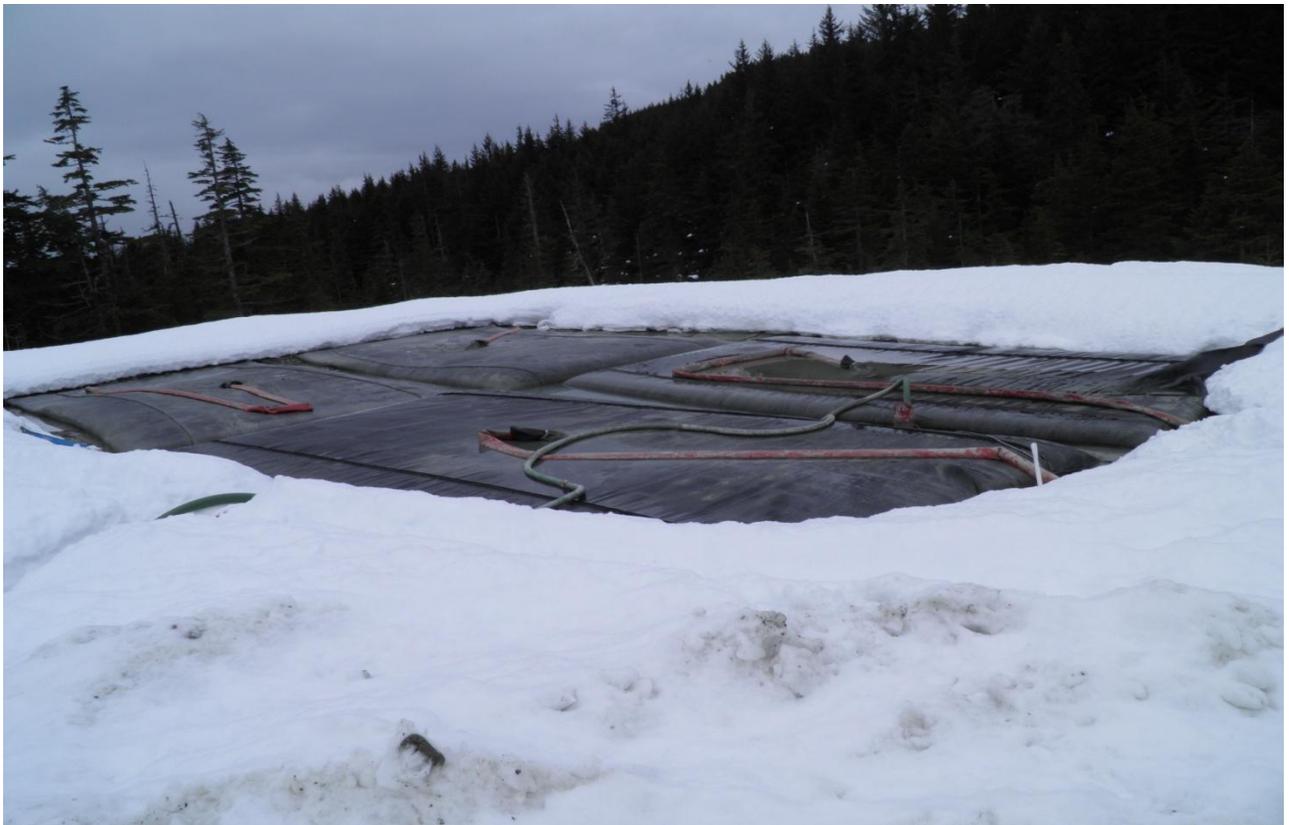
Figure 8 Sediment Bags

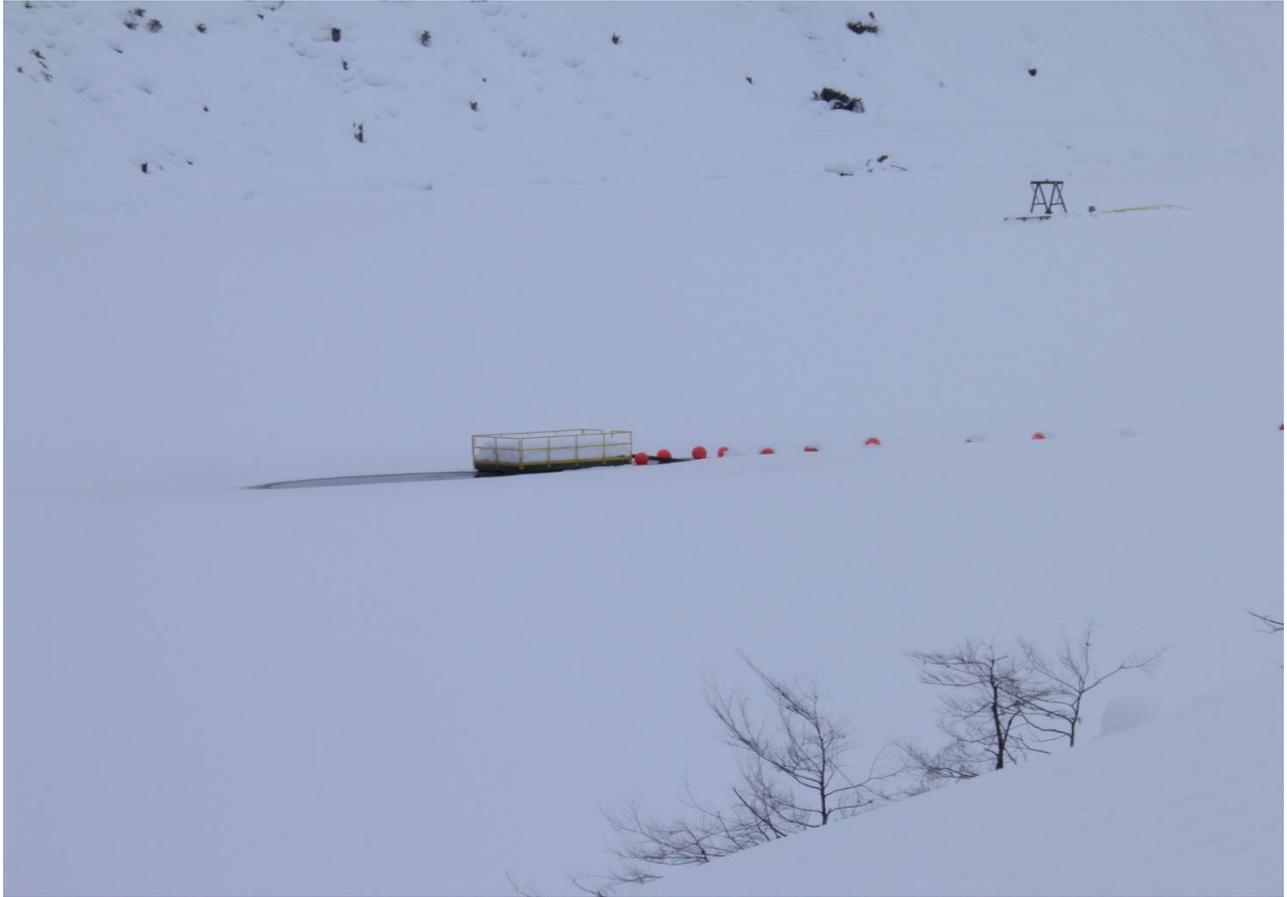
The Tailings Treatment Facility (TTF) was mostly inaccessible due to the deep snow cover. About 24 inches of ice covers the TTF, except at the tailings slurry outfall, where an aerator keeps the surface mostly ice free (Figure 9). The access road to the TTF Water Treatment Plant is plowed to within walking/snowshoeing distance of the plant. The WTP was functioning as designed during our visit. The TTF surface was at an elevation of 667.6 feet, and the Lower Slate Lake bypass had a flow of 1448 gallons per minute (gpm). All water monitoring stations were being monitored on schedule, and were being accessed by snow machine or snowshoes.

Figure 9 Aerator on Lower Slate Lake
