### KENSINGTON GOLD MINE INSPECTION REPORT

**Inspection Date:** June 5, 2012  
**Weather:** Overcast, approximately 60°F, light wind, no precipitation  
**Time of Inspection:** 8:30 am to 2:30 pm  
**Operator Contact:** Kevin Eppers – Coeur Alaska  
**Agency Personnel:** David Wilfong – ADNR, Joe Manning – USFS, Kenwyn George  
ADEC  
**Inspection Objectives:** General Inspection

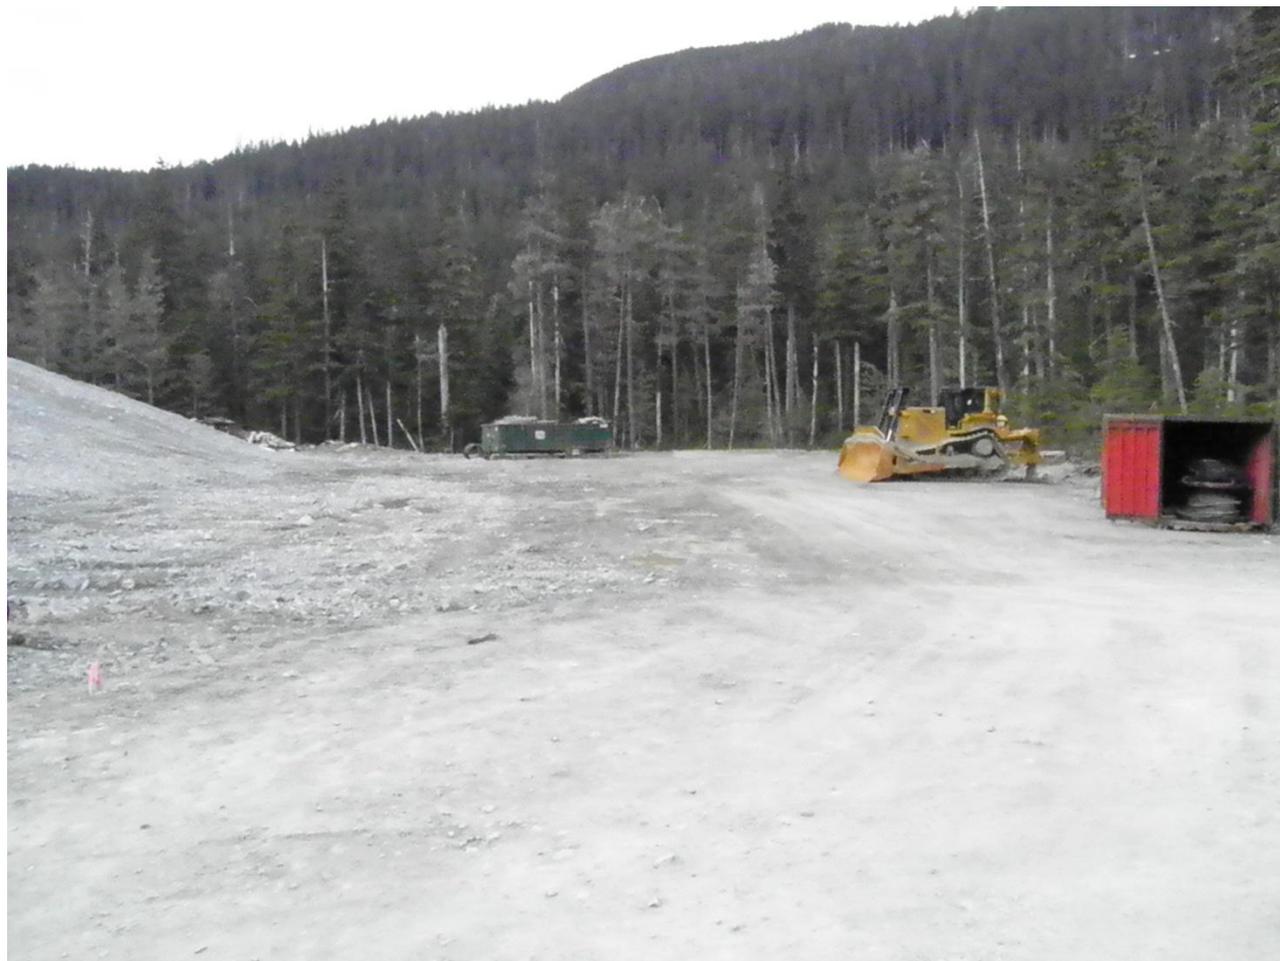
**Figure 1 North Mud Dump**

The first site visited was the “North Mud Dump” (Figure 1). Construction of this engineered site was to begin shortly and will include a liner to contain the graphitic phyllite that will be excavated from the dam abutments during the Stage 2 dam raise. Contact water from the facility will be contained and treated until an engineered cover is installed.

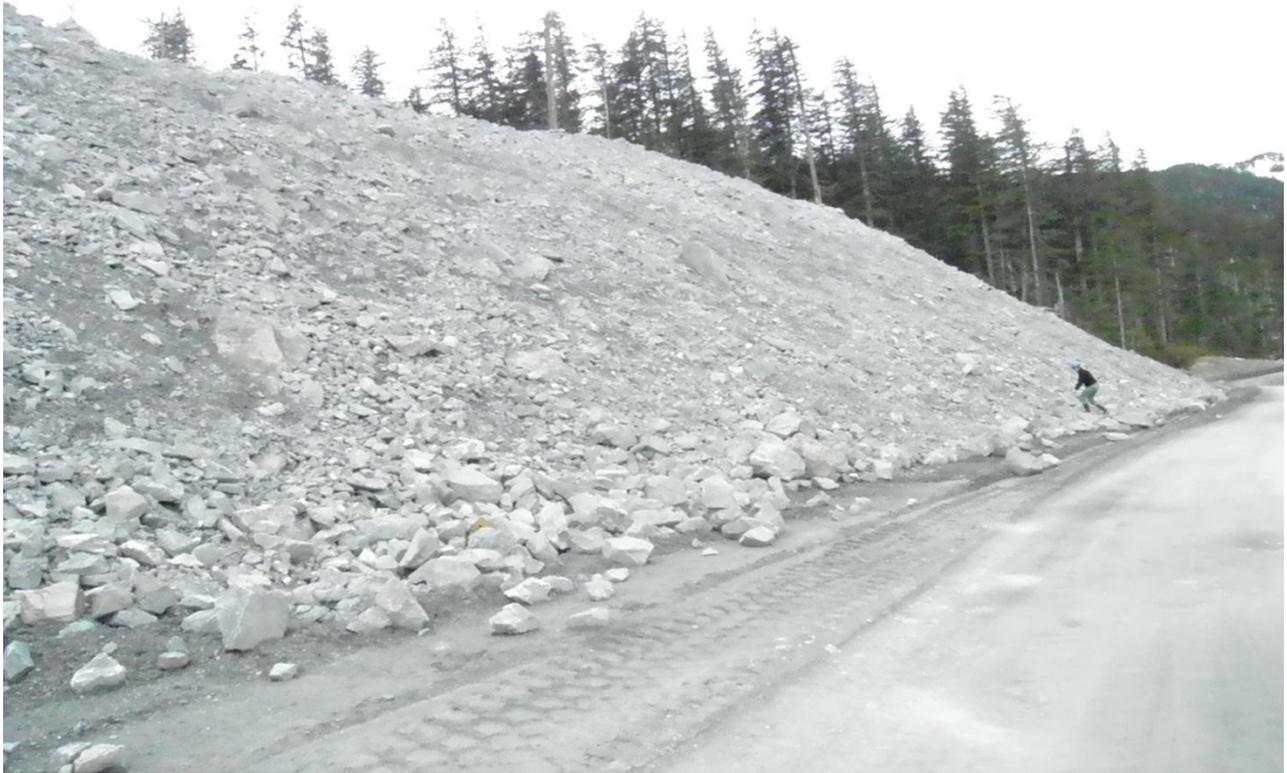
**Figure 2 Stage 2 Dam Raise Material**

The next site to be visited was a storage area for material needed for the Stage 2 dam raise (Figure 2). The area contained approximately 35,000 yds<sup>3</sup> of an expected 66,000 yds<sup>3</sup>, and material continued to be added to the site. Iron pyrite was visible in the waste rock, but had been found to be non-acid generating.

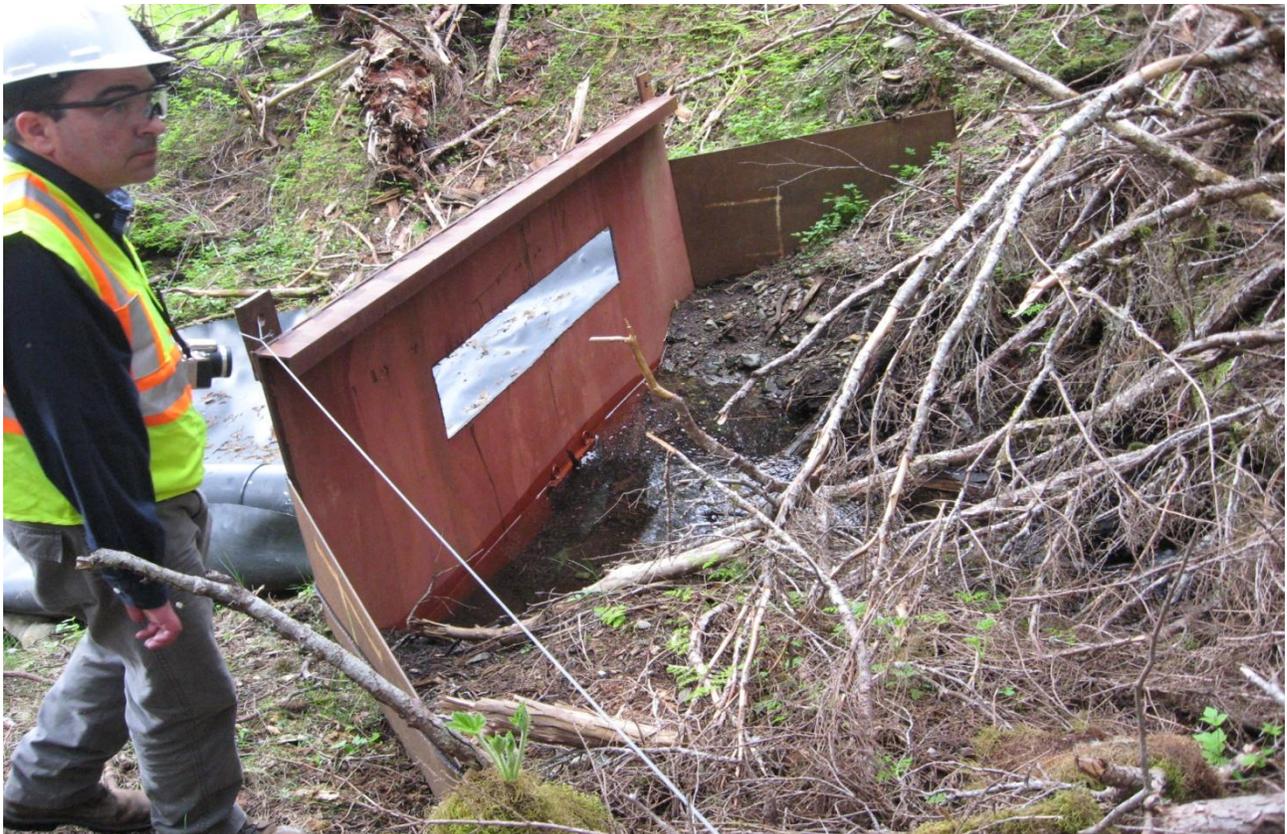
**Figure 3 Diversion Head Gate**

After a brief stop to examine a windfall area of trees, we continued on to the Tailings Treatment Facility (TTF). During the construction phase of the Stage 2 dam raise, the existing Emergency Spillway will be filled in and remain non-functional. Diversion tubes are in place to divert the major inflows into the TTF, but two of the diversion pipes at the northern end of the facility were found to have obstructions at the head gates (Figure 3). During a high flow precipitation event, the obstructions would lessen the ability of the tubes to divert clean water around the TTF, and could cause an unnecessary rise in the water level in the facility. Kenwyn George recommended that the obstructions be cleared before construction begins. Kevin Eppers agreed and said that the cleaning would be done.

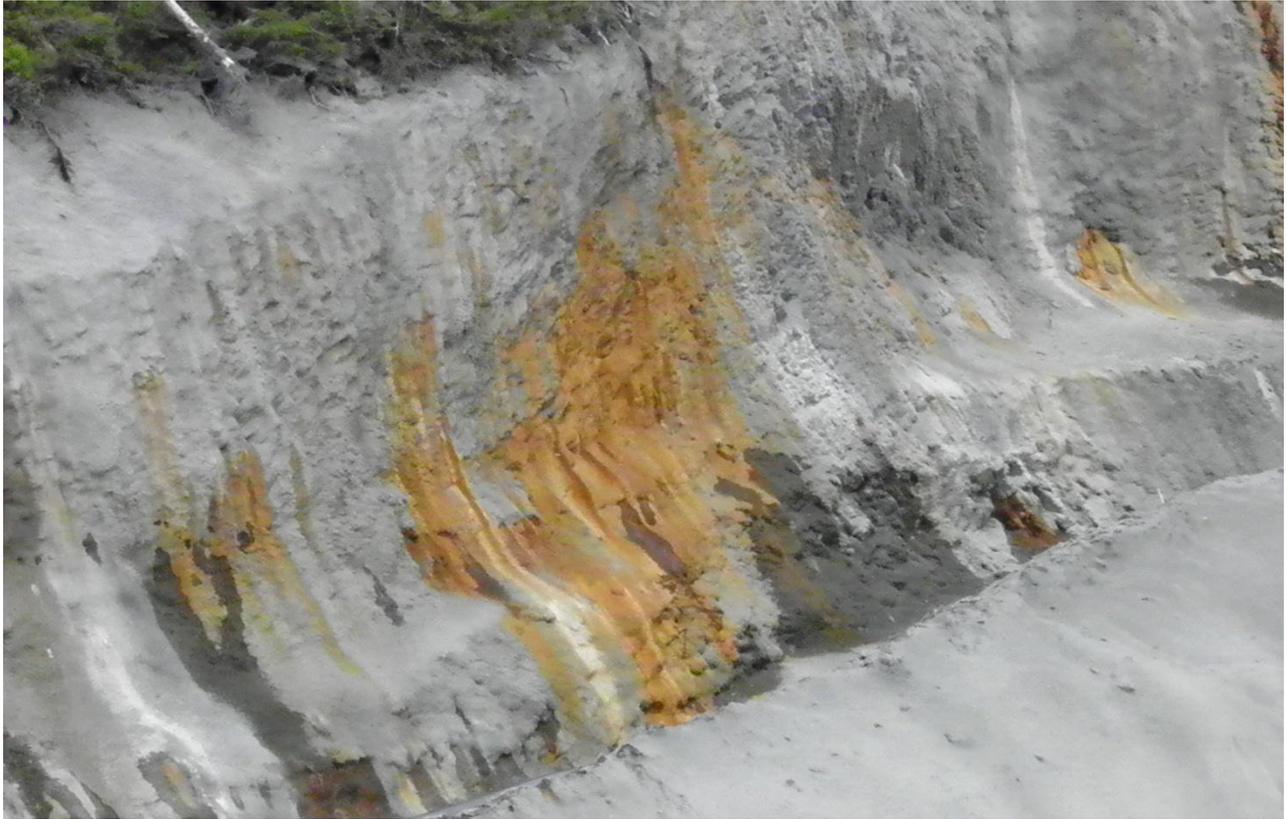
The next stop was the TTF Dam. Construction of the Stage 2 dam raise is planned to begin this summer. The planned 25 foot raise of the dam will accommodate the placement of more tailings in the TTF. The new spillway is required to be installed in solid bedrock, and it will be necessary to excavate a substantial amount of acid producing graphitic phyllite from the western dam abutment. The acid producing material will be placed in the yet-to-be constructed site that was visited earlier in the inspection. The graphitic phyllite material was exposed during the initial dam construction. Shotcrete was sprayed onto the exposed surface of the graphitic phyllite to lessen its exposure to oxygen and water infiltration. After several attempts to stop water from passing through the Shotcrete, staining which can signify metals leaching can be seen on the Shotcrete surface (Figure 4). Water that has come into contact with the graphitic phyllite is routed to a pool where it is pumped to the water treatment plant, then treated and discharged. Joe Manning tested the pH of the water in the pool, and the results came back neutral (about 7), but precipitate in the pool signifies that metals leaching is still occurring.

**Figure 4 Staining on Shotcrete**

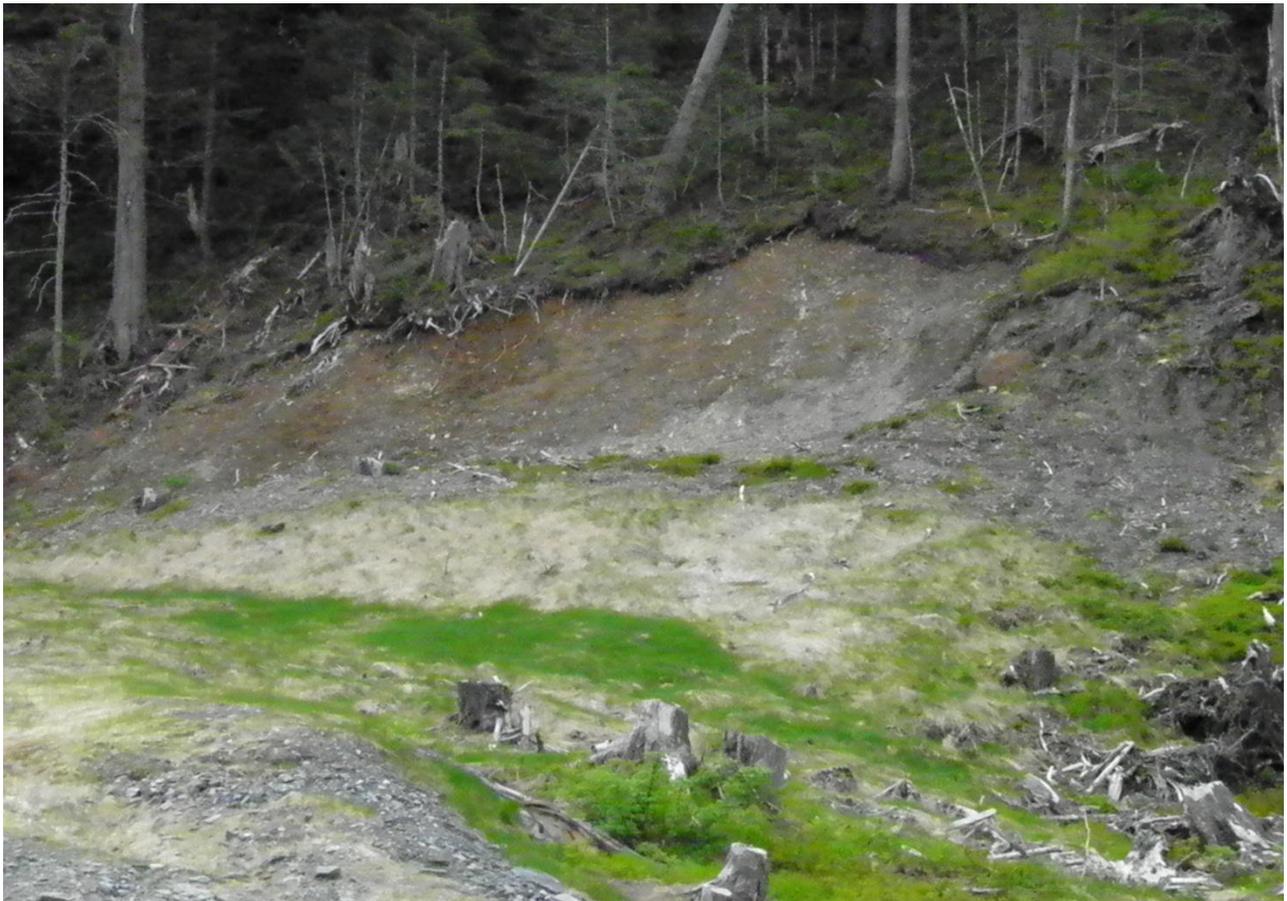
**Figure 5 Erosion Near the Eastern Side of the Dam**

Some slope instability and erosion can be seen above the eastern dam abutment (Figure 5). The instability is not endangering any facilities at this time. Before leaving the TTF, the inspection team stopped at the TTF Water Treatment Plant (WTP). According to Mr. Eppers, the water in the TTF generally meets Water Quality Standards (WQS) except for sulfate concentrations. Outside the WTP, we visited the filter cake storage area (Figure 6). Filter cakes are a byproduct of the water treatment process. When the TTF water is treated, a flocculent is added to help settle out suspended solids. The settled solids are run through a filter press to remove excess water. The end product is a densely pressed “cake”, containing very fine silty material that is high in metals content and low in moisture. The cakes are removed from the WTP building and temporarily placed in a lined storage area. It is a small lay down area lined with HDPE to prohibit infiltration of contact water. It is planned to mix the filter cakes in with tailings material at the underground paste plant and store it in mined out stopes as part of a concrete mixture for underground support.

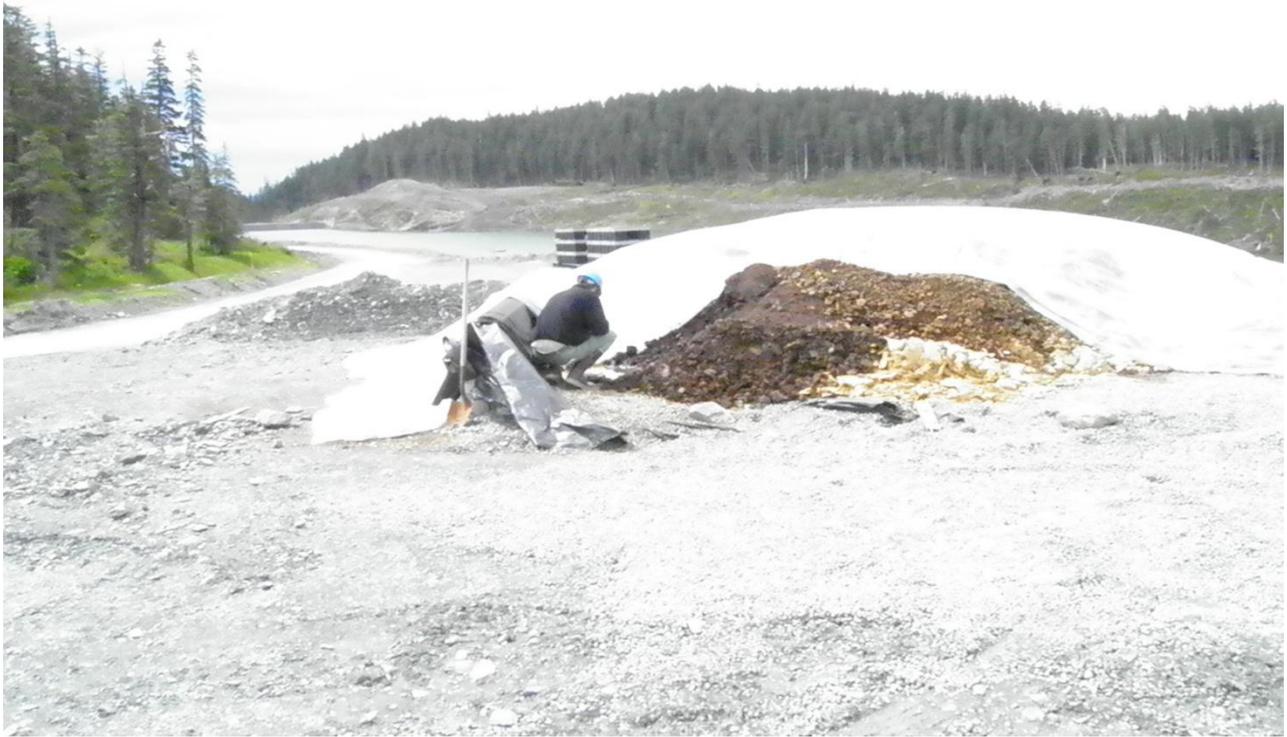
**Figure 6 Filter Cake Storage Area**

As seen in Figure 6, the top of the filter cakes are partially exposed. There is some slight discoloration around the front of the storage area that suggests that water overflowed from it during a precipitation event. Joe Manning (USFS) tested a puddle of contact water within the storage area for pH, and the results came back neutral (about 7). Kenwyn George (ADEC) suggested that a structure with a rigid roof be built over the filter cake storage area to prevent precipitation from contacting the material.

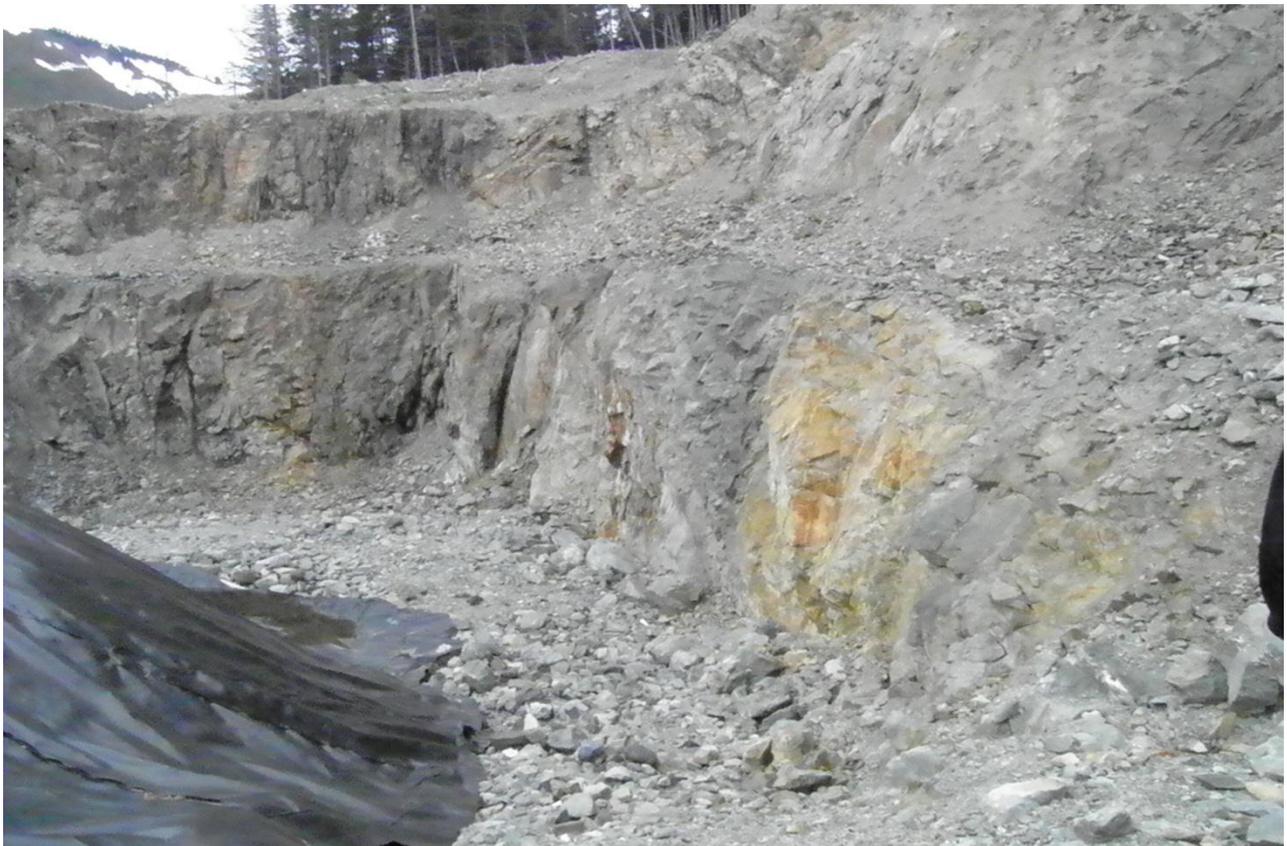
**Figure 7 Pit 4, Also Known as Pit 3**

After the WTP, the inspection team stopped at pit 4; aka pit 3 (Figure 7). This pit was a borrow site from which material was used to build a road on the mine site. The borrow material was later found to be acid generating. Steve McGroarty with the ADNR Mining Section had asked Coeur to dig some test pits in the borrow pit and have the material Humidity Cell Tested (HCT) for Acid Generating Potential. Mr. Eppers had stated that the site would be extremely difficult to access with the equipment needed to dig the test pits. During this inspection, Pit 3 was free of snow, and we confirmed that it would indeed be difficult to access the site with equipment. However we determined that the face of the pit wall has not yet significantly weathered, and that a variety of samples from just behind the face would be satisfactory. A test plan is expected to be forthcoming.

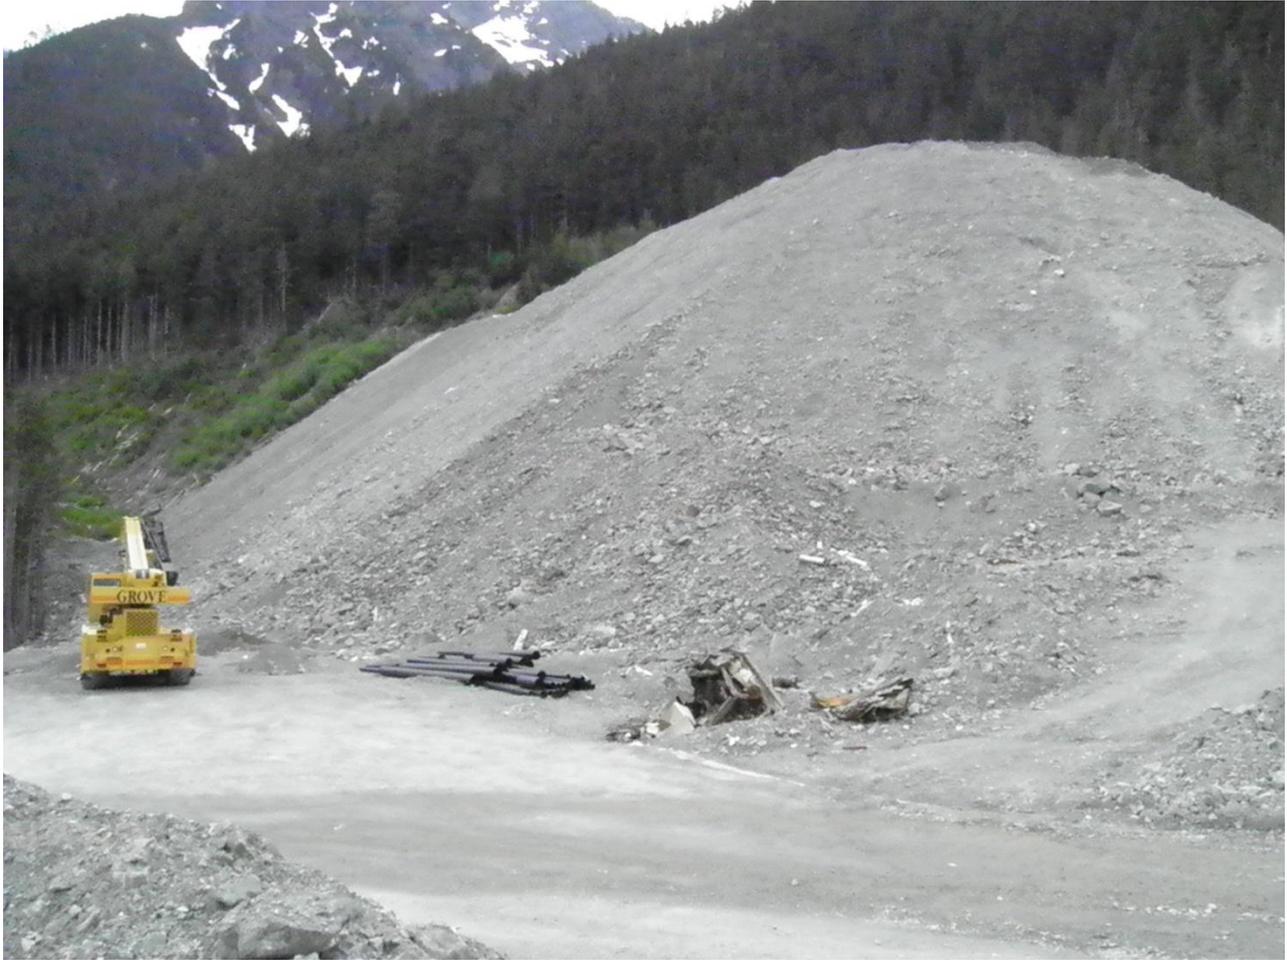
**Figure 8 Waste Rock Pile Near the Comet Portal**

After a quick trip through the main tunnel that runs between the Jualin portal, and the Comet Portal, we stopped briefly at the Comet Waste Rock Pile, and Water Treatment Plant where mine dewater is treated. Figure 8 shows the Comet Portal waste rock pile. The top of the boom on the Grove crane is approximately 25 feet tall for scale. Non-acid generating waste rock is dumped by underground haul trucks at the top of the pile and is pushed over the side by a bulldozer. A partial stick of unexploded emulsion type explosive was found protruding from a drill hole in a boulder at the bottom of the pile. Mr. Eppers was alerted to the situation, and it was properly disposed of.
