The April 1, 2015 Inspection of the Kensington Gold Mine

This report covers the April 1, 2015 inspection of the Kensington Gold Mine. The multi-agency inspection team (team) consisted of Curtis Caton (Geologist) and Matt Reece (Minerals Program Manager) from the United States Forest Service (USFS), and David Wilfong (Engineer) from the Alaska Department of Natural Resources (ADNR). Transportation to and from the mine that was provided by a United States Forest Service chartered Cessna floatplane operated by Ward Air. The team was accompanied by Kevin Eppers (Environmental Manager) from Coeur Alaska for the duration of the inspection.

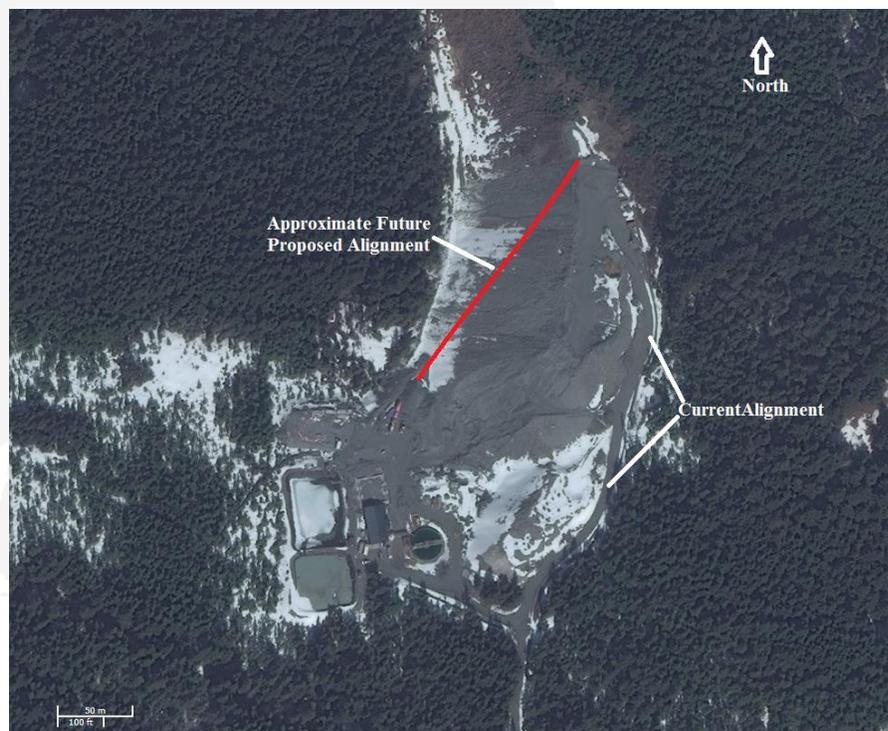
Figure 1 Comet Wasterock Pile Showing the Approximate Alignment of the New Road

Plant access road to run down the west side of the pile (Figure 1), thereby allowing for additional waste rock to be placed on the uphill (eastern) side of the pile. The toe of the west embankment of the pile is already very close to the seasonal channel of Ophir Creek, and construction of the road would need to be handled very carefully to ensure that no wasterock enters the creek. The new road would be of similar construction and length as the current road, and will likely not require an authorization from the ADNR.

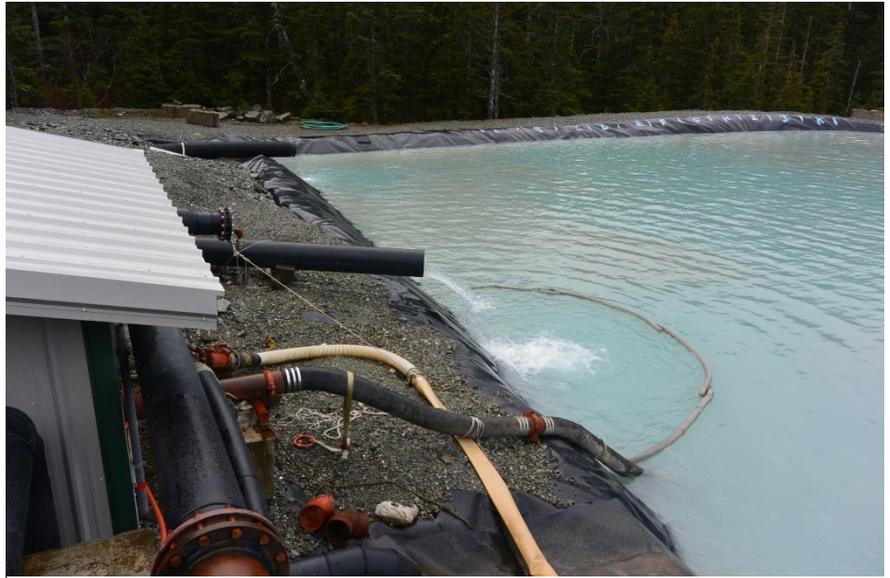
Figure 2 Pond 1

possible before reaching the water treatment plant. Coeur has been improving the efficiency of settling the sediment and cleaning the sumps, and the product of the improvements is evident at the outfall (Figure 2). While walking around the exterior of the WTP, the team spotted two pallets with four black 55 gallon barrels strapped to each (Figure 3). The two pallets containing the barrels were not within secondary containment, and several of the barrels showed minor damage to the exterior, likely caused by a forklift. One of the barrels was visibly leaking a polyacrylamide flocculant called Z-Flocc. Z-Flocc is a very viscous fluid with a consistency similar to automotive grease. According to the Material Data

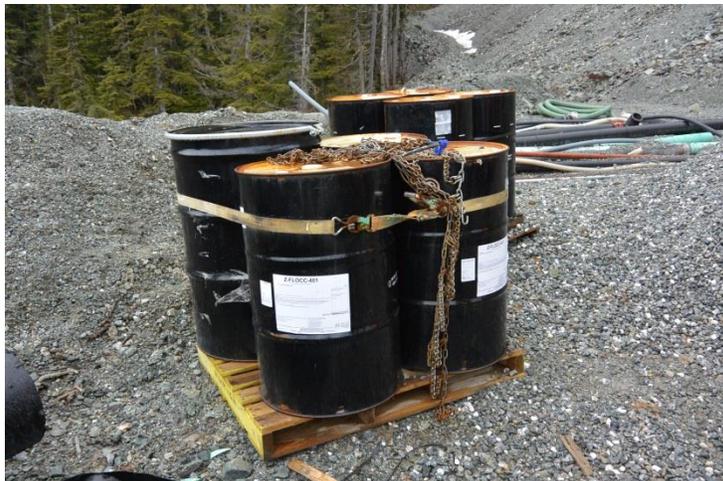
Figure 3 Barrels outside of secondary containment.

- Place barrels and containers in secondary containment at the Comet Wastewater Treatment Plant.
- Clean up the “spill” of Z-flocc at the Comet Wastewater Treatment Plant.
- Pull and fold the liners in the old storm water ponds near the Mill.
- Correct the minor pooling near the new storm water ponds.
- Inspect the tailings discharge pipe and ensure that it deposits tailings properly.

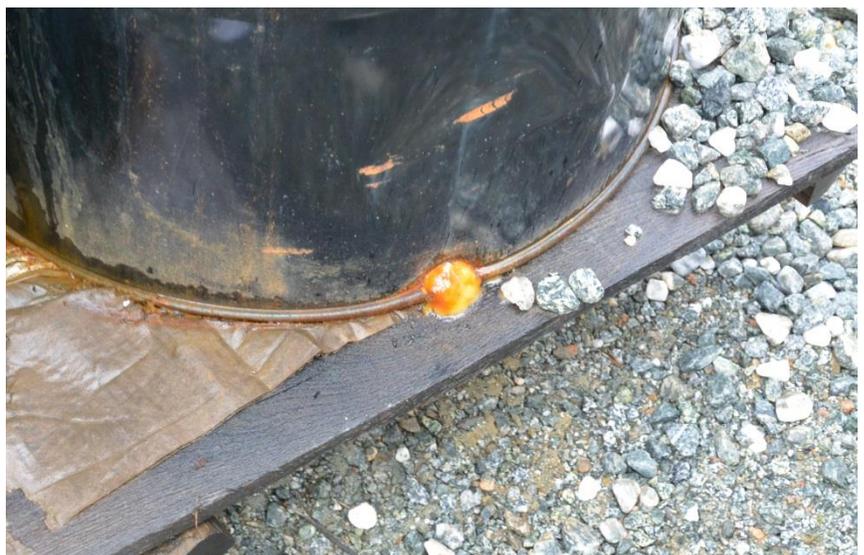
Safety Sheet (MSDS), the flocculant is not toxic to humans or animals. The viscous liquid was running from a hole near the seam at the bottom of the barrel (Figure 4). It appeared to have stopped flowing, and it was not an imminent danger. Pond Two was not operating and was nearly dry. The water flow rate from the mine was very low for April, when spring runoff normally creates the highest annual flow for the WTP.

Figure 4 Barrel leaking Z-flocc

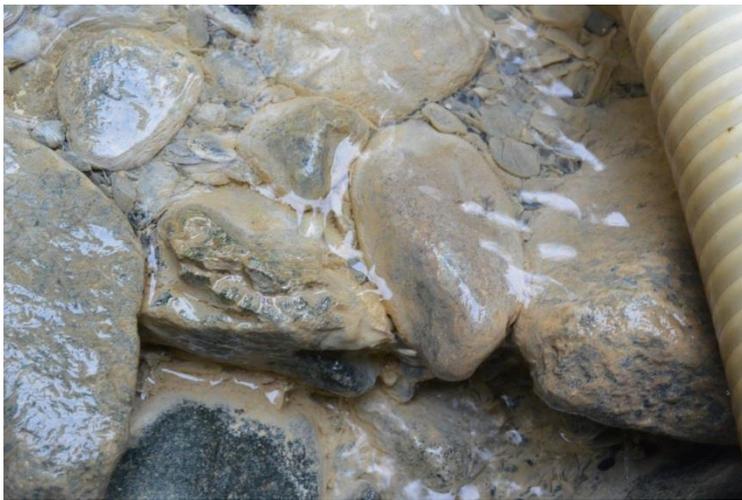
Figure 5 White residue coating rock in Sherman Creek

The team moved down the wooden walkway to the water outfall manifold, and then on to the discharge point in Sherman Creek. A dirty white “residue”¹ was clearly visible on the rocks within the Creek at, and downstream of the outfall (Figure 5). The residue appears to be caused by the water treatment process, however it is not clear why it occurs, or exactly what it is. Testing shows that it may have an organic nature, and does not appear to be the same material (gypsum) that was found in Slate Creek in 2014.

Testing also shows very low toxicity, and it does not appear to pose an immediate threat. The residue cannot be found upstream of the outfall lines, but continues downstream for about 100 yards. Recent water quality tests show the water in the WTP and in Sherman to be within Alaska’s Water Quality Standards. Testing by Coeur and the Alaska Department of Fish and Game continues to occur on the residue to better understand the residue and its source.

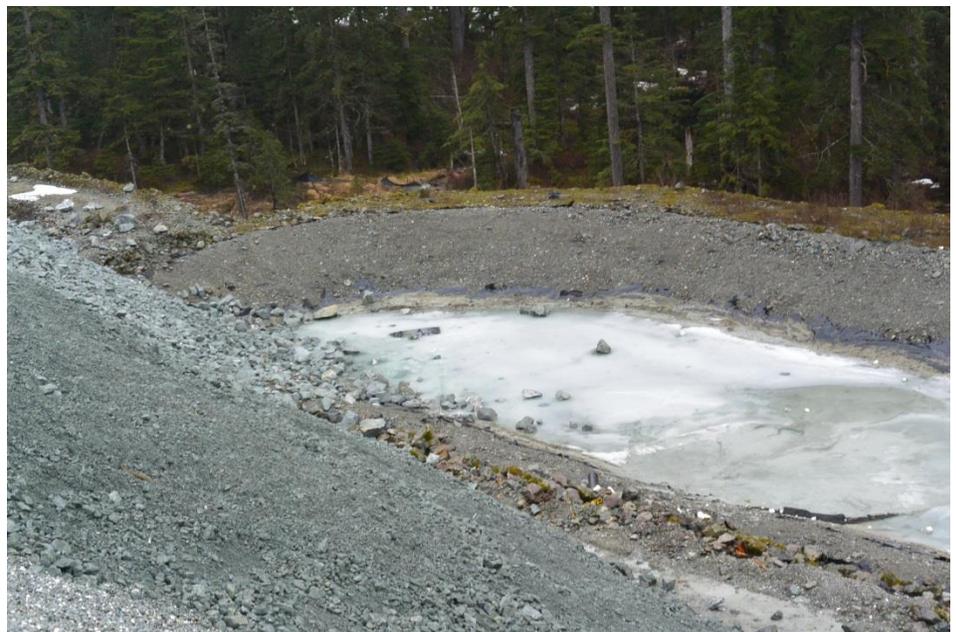
Wasterock from the mine continues to be placed on the east side of the Mill Bench access road trending southward. The area was prepped to receive the wasterock in December, 2014 and seems well suited for its disposal. However, the toe of the wasterock pile is encroaching on the old and inoperable storm water runoff ponds (Figure 6). The approved Reclamation Plan requires the pond liners to be

Figure 6 Wasterock is beginning to cover up the liner in the old pond

removed and folded prior to burial so the pond will no longer retain water after being covered with wasterock.

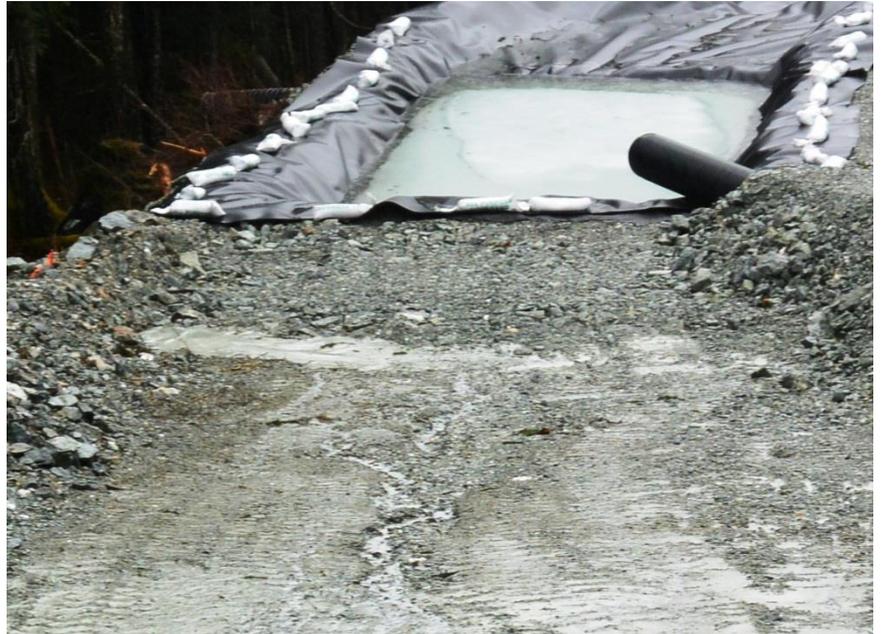
The newly built storm water runoff ponds are now in operation, and were full of water. Water from the Mill area is routed through a series of pipes and ditches to an outfall pipe located at the top pond. Storm water subsequently flows through the series of ponds which creates sufficient resident time for solids to settle out. A small preferential flow path has developed on the road leading to the ponds. Water flows along the Mill Bench access road, and then down the short pond access road where it pools near the head of the pond (Figure 7). The flow was low during our visit, but may be higher during heavy rain events. Grading should be performed to divert the water into the ponds.

Figure 7 Water pooling near the head on the upper pond

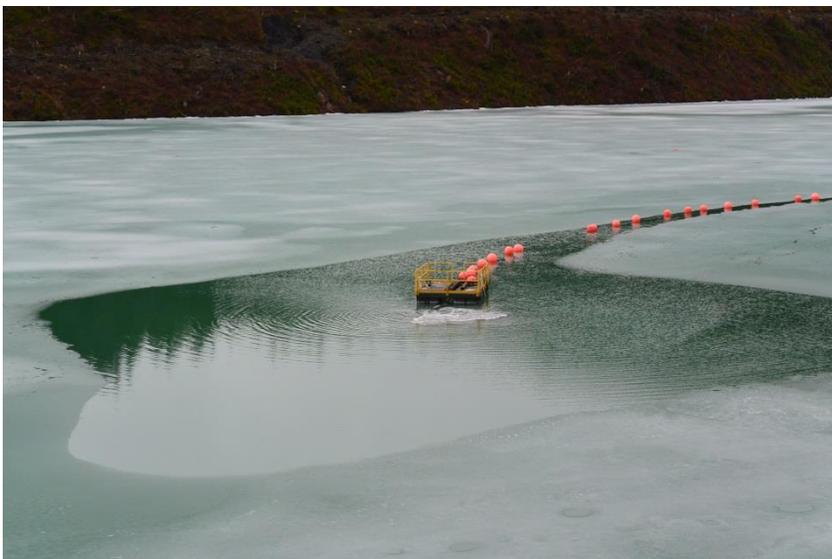
After breaking for lunch, the team moved to the Tailings Treatment Facility (TTF). Upon arriving, it was immediately noticed that the tailings discharge pipeline was discharging to the surface of the TTF (Figure 8). The pipe's outlet is typically submerged beneath the surface of the water as required by the Integrated Waste Management and Disposal Plan. Much of the surface of the TTF was covered by a thin sheet of ice, but open water was seen near the banks and surrounding the tailings placement barge and pipeline.

Figure 8 The tailings slurry was discharging to the surface of the TTF

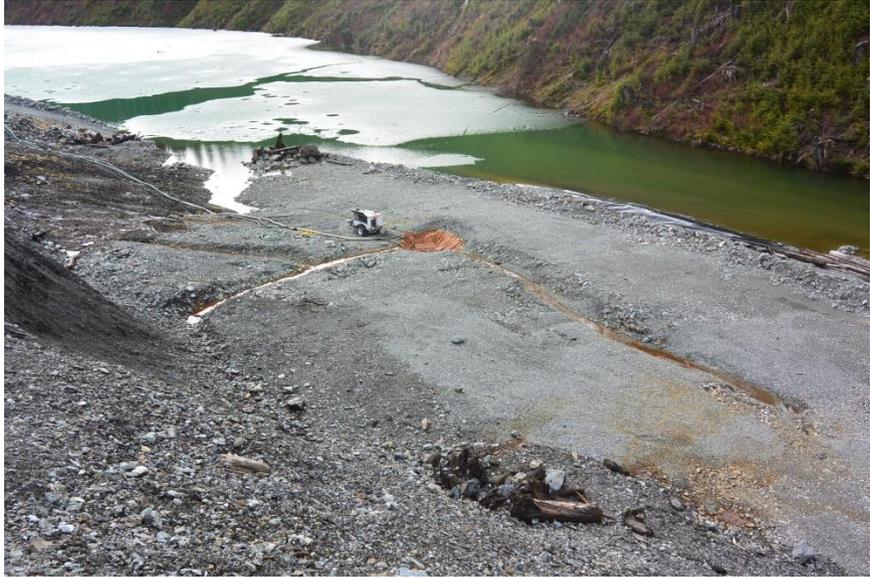
The team then turned around and headed back to the north end of the TTF where the graphitic phyllite (GP) had accidentally been placed and the barrel tests are located. Due to the very mild and rainy winter, water samples were recovered every month, unlike the previous winter when the barrels overflowed with ice. The team walked to the area where the GP was placed and staining could still be seen at the base of the pile. Water flowing from the seeps continues to be collected and tested and Kevin mentioned that more of the black colored rock

Figure 9 Water collection sump

may be excavated during the upcoming summer (Figure 9). The water collected from the sump at the bottom of the pile is taken to the small WTP near the dam for treatment. The containment cell remains in the center of the gravel pad to hold the excavated material until loaded into a haul truck and driven underground for disposal. The access road to the area has not been realigned yet, and the water level may not rise enough to require its movement for some time due to the lack of snowmelt.

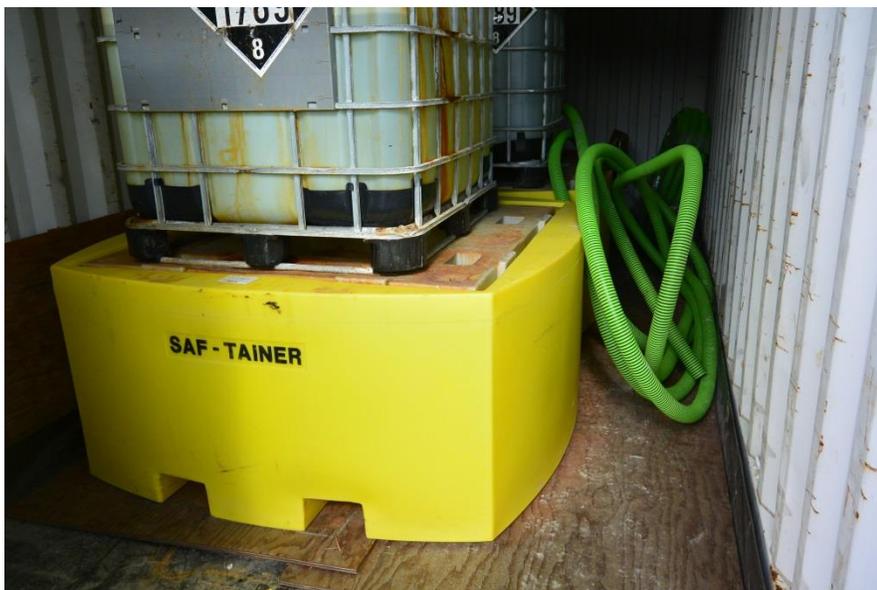
The team drove to the main TTF WTP and inspected the inside of the plant and surrounding area. At one container, the double redundant secondary containment liners were rendered ineffective

Figure 10 A tote on secondary containment

due to rain water filling them, but there were no chemicals inside the container. Coeur is using individual containment for the containers that have liquids inside (Figure 10). As for the secondary containment structures made from “heavy timbers” that were featured in a previous report... Machinery operators have once again defied the impossible, and destroyed the indestructible design.
