DAM SAFETY AND CONSTRUCTION UNIT

FIELD INSPECTION REPORT LOWER SLATE LAKE TAILINGS DAM KENSINGTON MINE, ALASKA

Inspection Date: June 14, 2018
Report Date: July 11, 2018
Weather: 50° Rain
Inspection Objectives: Observe the Lower Slate Lake Tailings Dam construction and sediment ponds around the Kensington Mine site
Operator Contact: Kevin Eppers, Couer
State Personnel: Charlie Cobb, ADNR, Eli Ward, ADNR
Documentation: Photos and field book notes may be reviewed at DNR-Anchorage

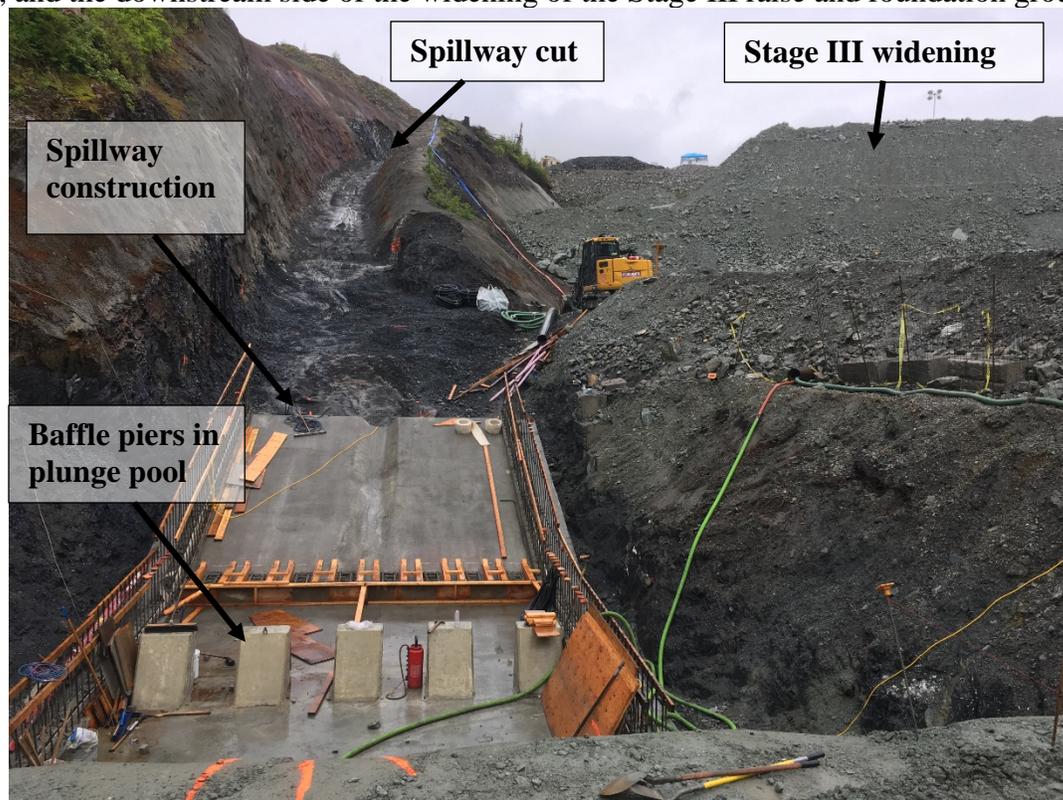
Figure 1. Lower Slate Lake Tailings Dam spillway and fill.

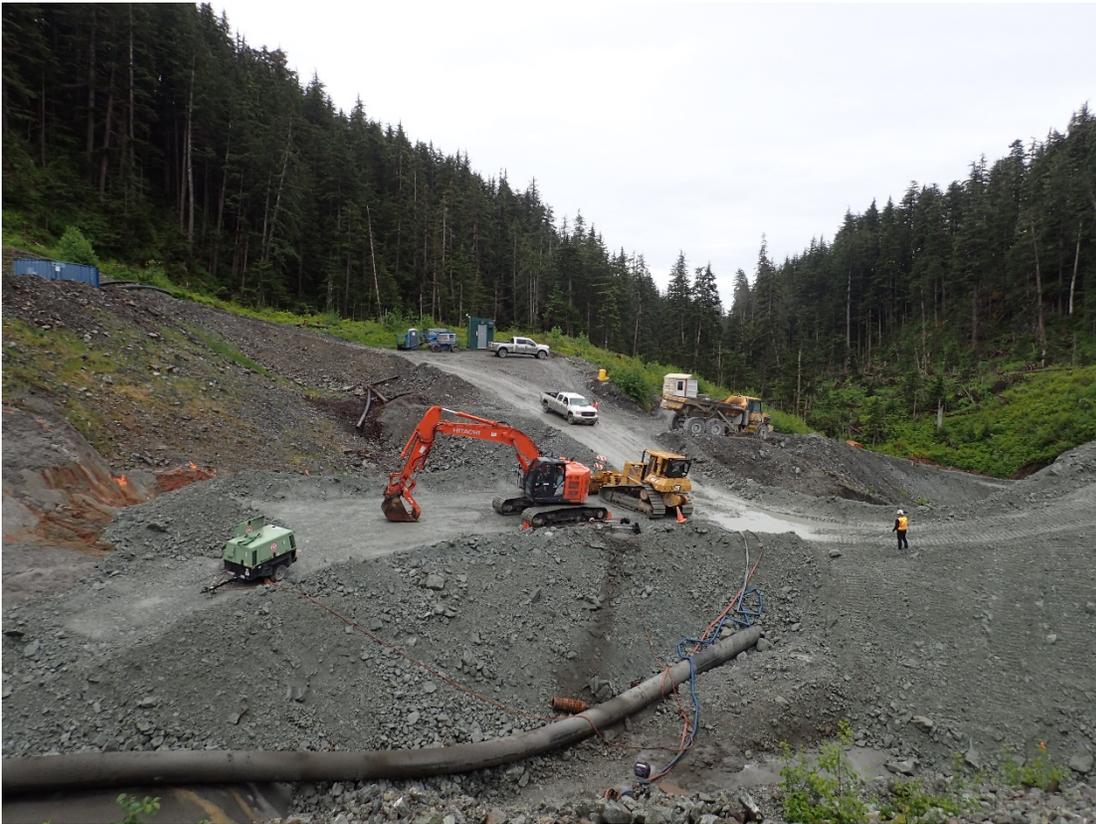
Figure 2. Construction downstream of dam.

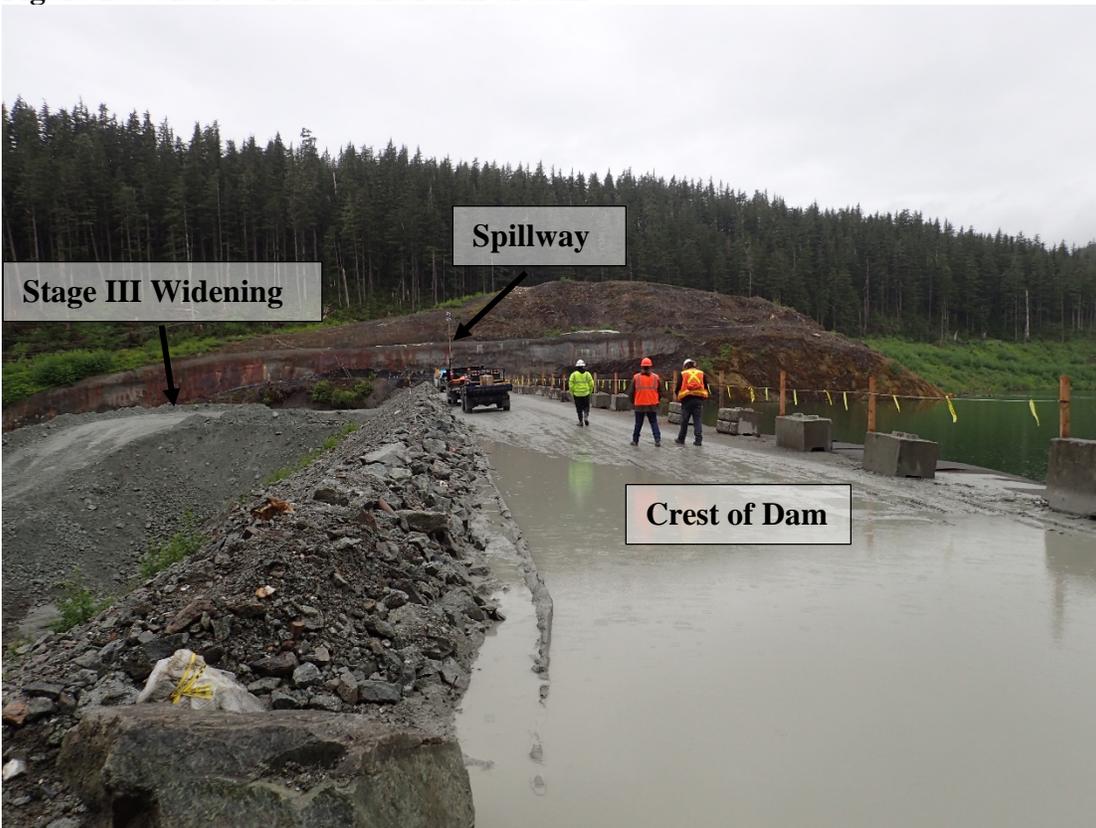
Figure 3. Crest of dam and downstream slope, looking west

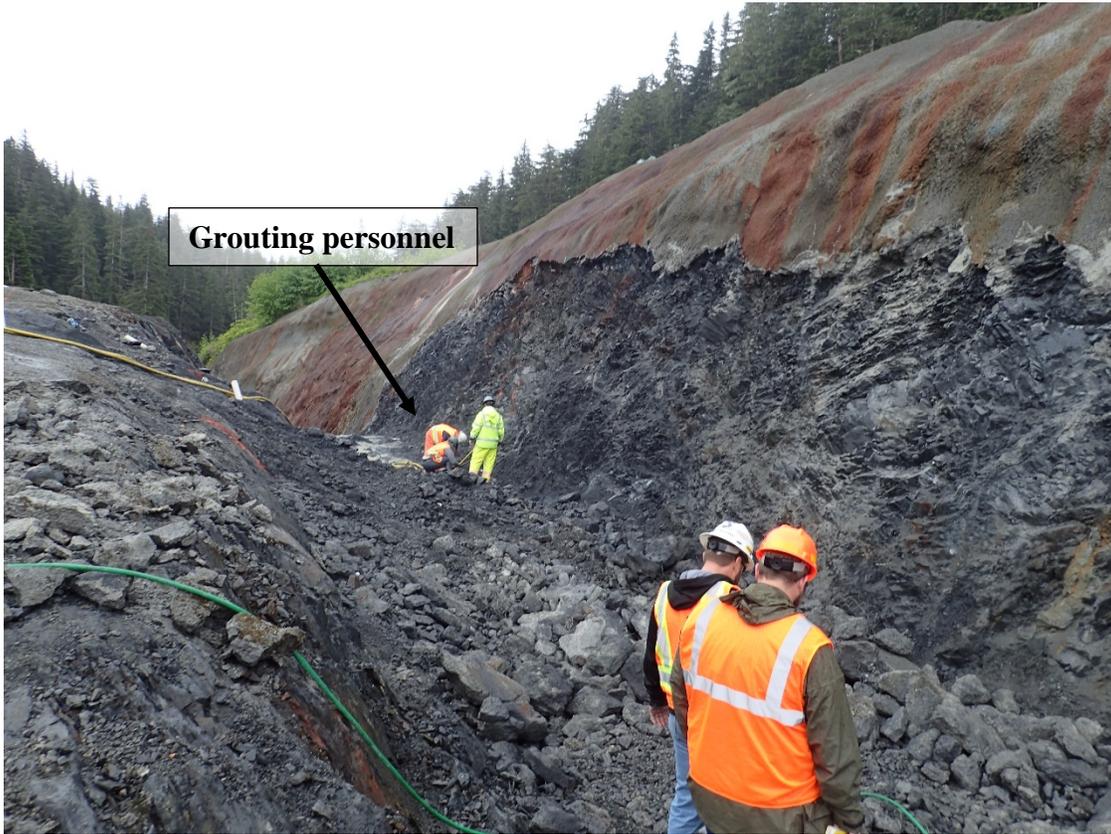
Figure 4. Grouting efforts in spillway cut.

Construction efforts at the tailings dam were focused on the grouting, fill for the Stage III widening of the crest, and preparing the spillway flume for roller compacted concrete (RCC) application. The grouting program (Figure 4) and fill placement appeared to be progressing according to the schedule provided by Alaska Aggregate Products LLC (AAP) on April 30, 2018. Dam Safety was not able to observe any RCC application during the site inspection, but were able to view the test pad by AAP next to their gravel plant.

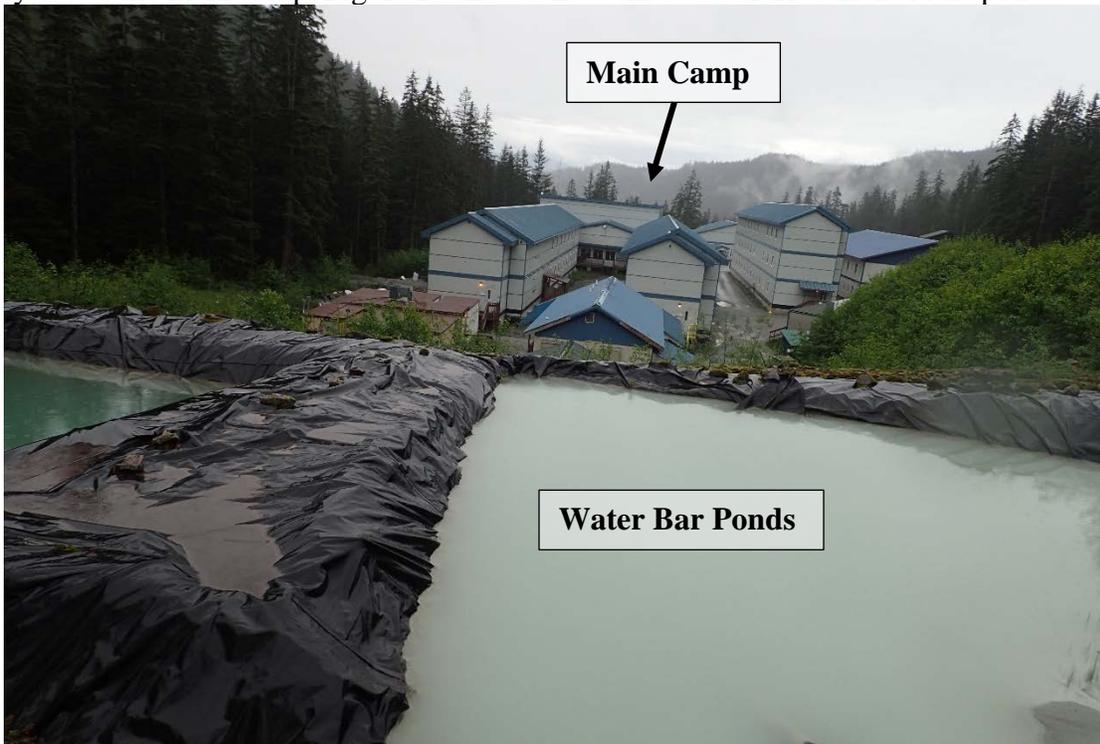
Figure 5. View downstream from Water Bar Ponds

ADNR Dam Safety observed that the Water Bar and Avalanche pond series are situated directly above the camp facilities, as seen in Figure 5 through Figure 9, may not be safe as designed and constructed and could threaten personnel and structures at the main camp of the Kensington Mine. The potential for a cascading failure of the Avalanche and Water Bar pond embankments amplifies the risk.

1. Complete an ADNR *Hazard Potential Classification and Jurisdictional Review* form for the embankments of all sediment ponds upstream of the Mile 4/Bridge 1 area, including the Comet Water Treatment Plant ponds, while clear of snow, and submit to ADNR before October 31, 2018.

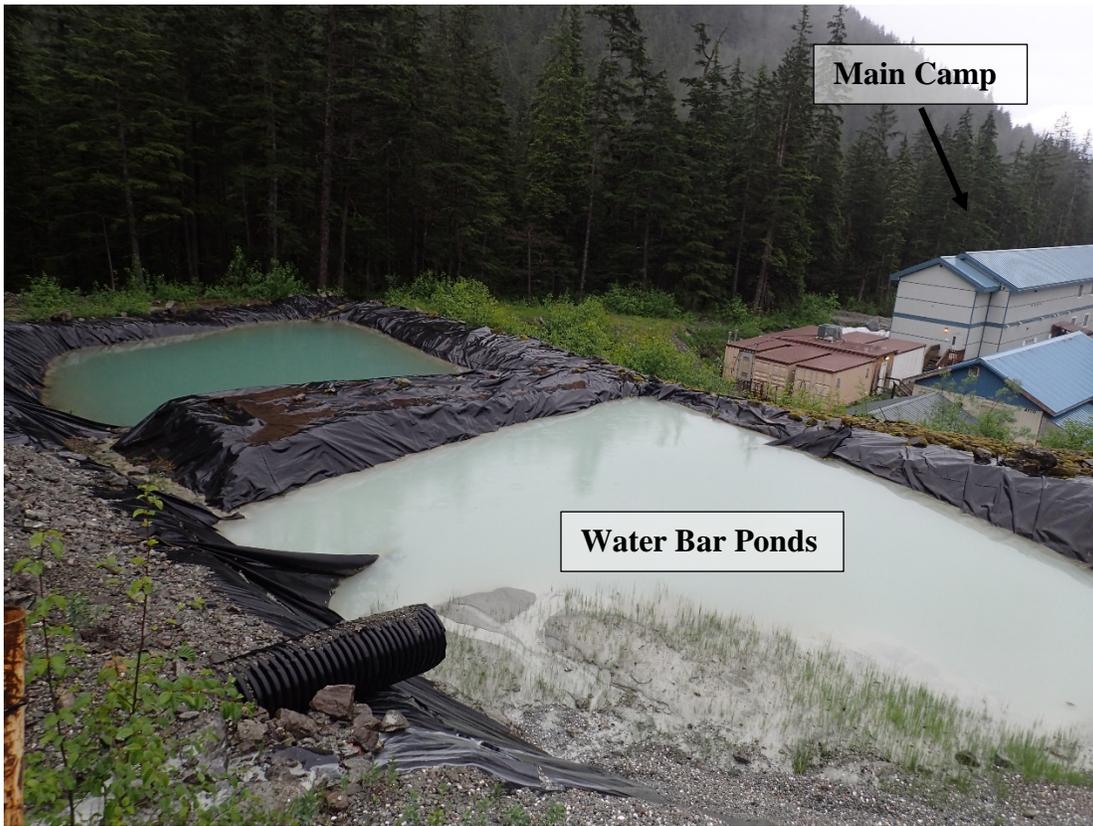
Figure 6. Water Bar Ponds, camp facilities in the background.

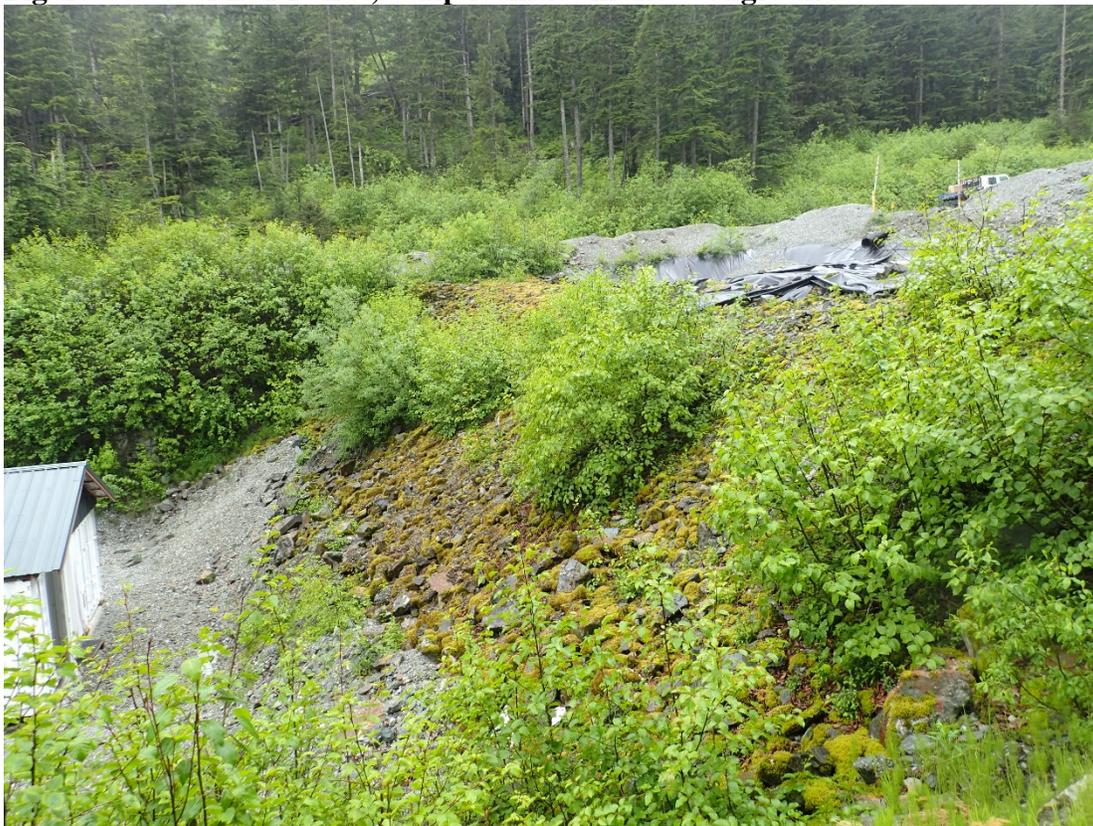
Figure 7. Water Bar Ponds downstream embankment.

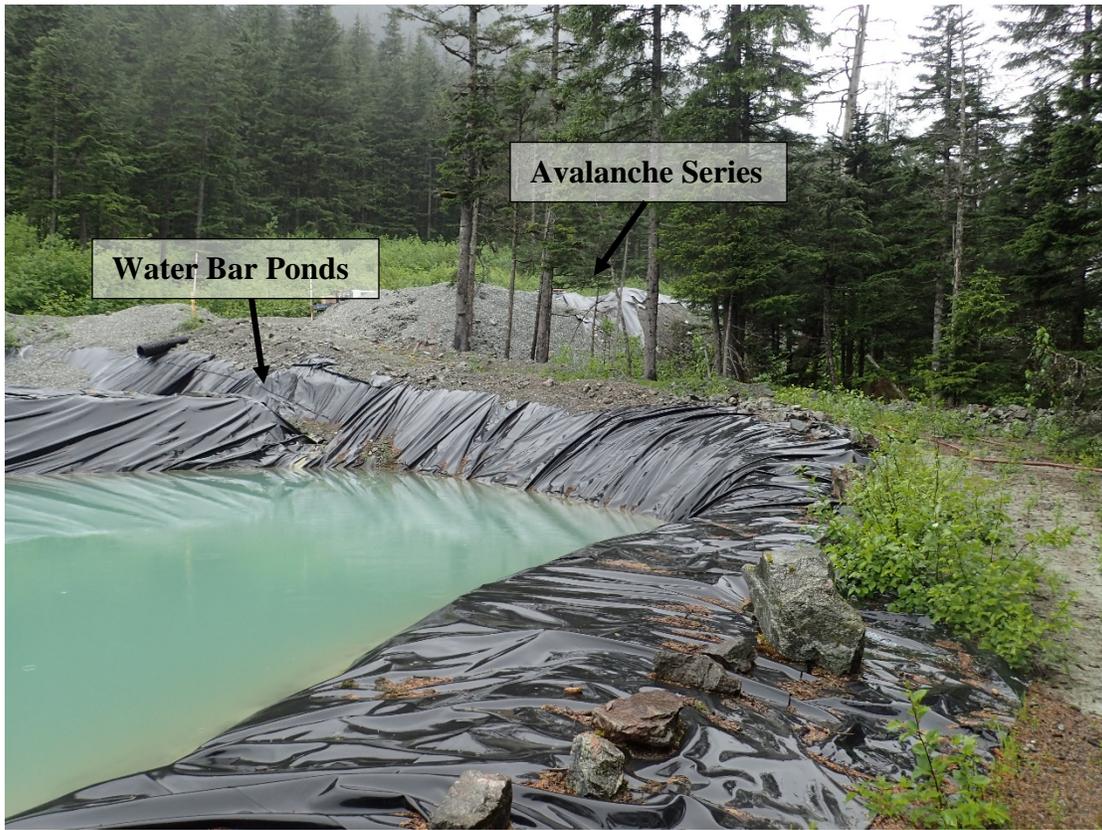
Figure 8. Water Bar Ponds and Avalanche Series.

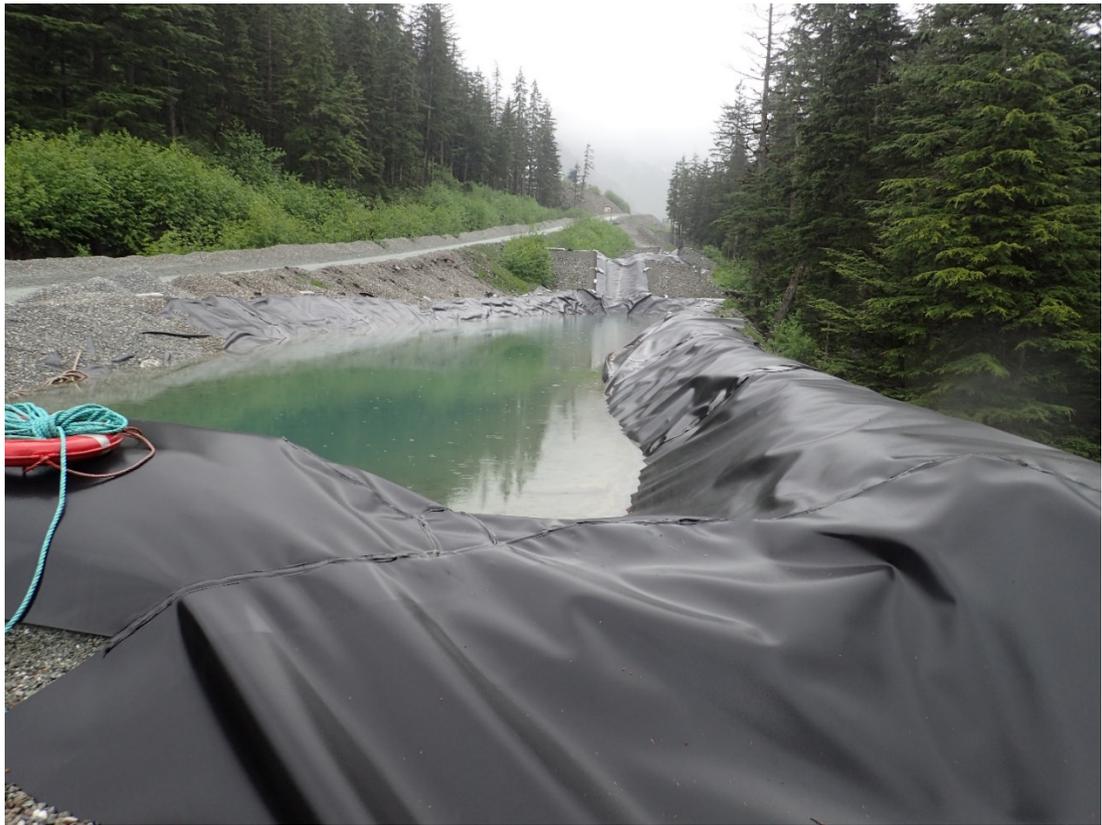
Figure 9. Avalanche Ponds, directly upstream of Water Bar Ponds.

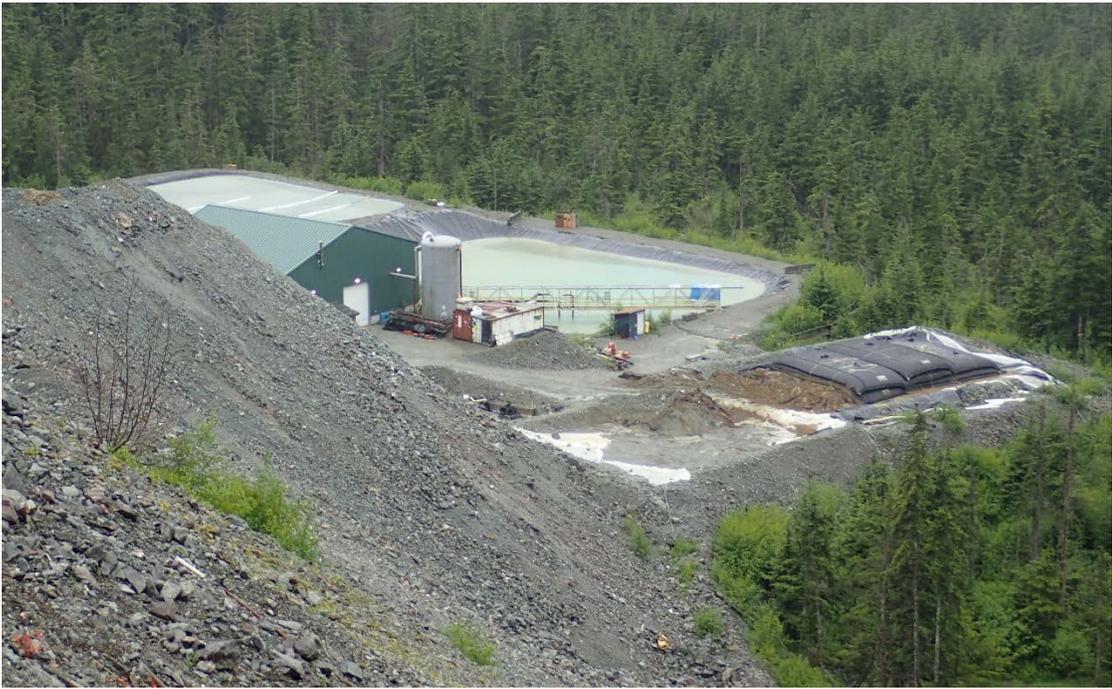
Figure 10. Comet Water Treatment Plant ponds.
