July 23, 2015

## **The June 17, 2015 Inspection of the Kensington Gold Mine**

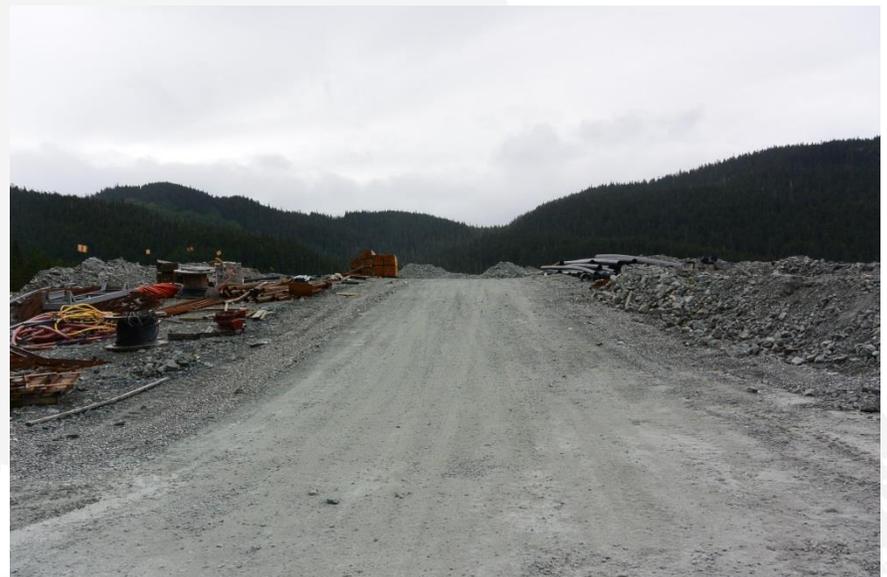
The team stopped by the camp area for short time before driving to the mill to gather the extra Personal Protective Equipment (PPE) needed to travel underground, and traveled through the mine to the Comet Wasterock Pile. The southern part of the wasterock pile is built in lifts from the bottom up, and piles (Figure 1) are pushed off the top to meet the lifts. Pipes, lumber, hoses and other mine infrastructure parts are stored on the pile for easy access. The road realignment mentioned

**Figure 1** The top of the Comet Wasterock Pile. The piles in the distance are waiting to be pushed off the end

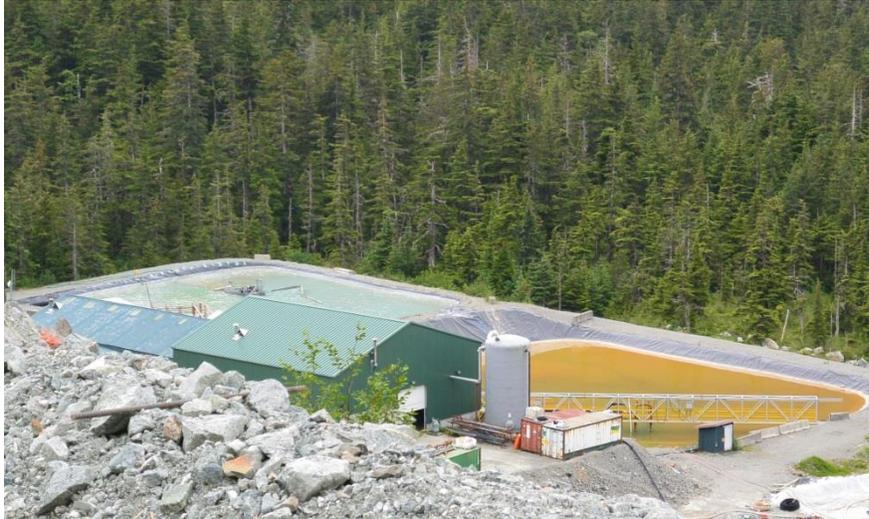
Figure 2 Pond 1 and Pond 2 as seen from the Comet Wasterock Pile. Note the difference in Color of the two ponds.

The quantity of water flowing from the mine was very low for this time of year. The low flow is likely due to the very low snowpack received during the winter of 2014-2015. A sediment dredge was floating in Pond One, but was not actively dredging at the time of the inspection. Kevin stated that dredging has historically occurred on an almost constant basis.

The new Triple Sumps in the mine retain the majority of the sediment, and dredging operations should be required on a less frequent basis. The water in Pond One was much less turbid than in previous years' inspections, likely due to the efficiency of the Triple Sumps. The water level in Pond Two was very low at the time of the inspection, but was higher than the inspection performed on April 1, 2015. The sediment in Pond Two was orange in color, and distinctly different than the gray-blue color of the sediment in Pond One (Figure 2). The orange color was likely due to high iron content in the sediment, possibly due to pyrite oxidation after being exposed to air. The water in both Ponds are treated to meet Alaska Water Quality Standards, and then discharged into Sherman Creek.

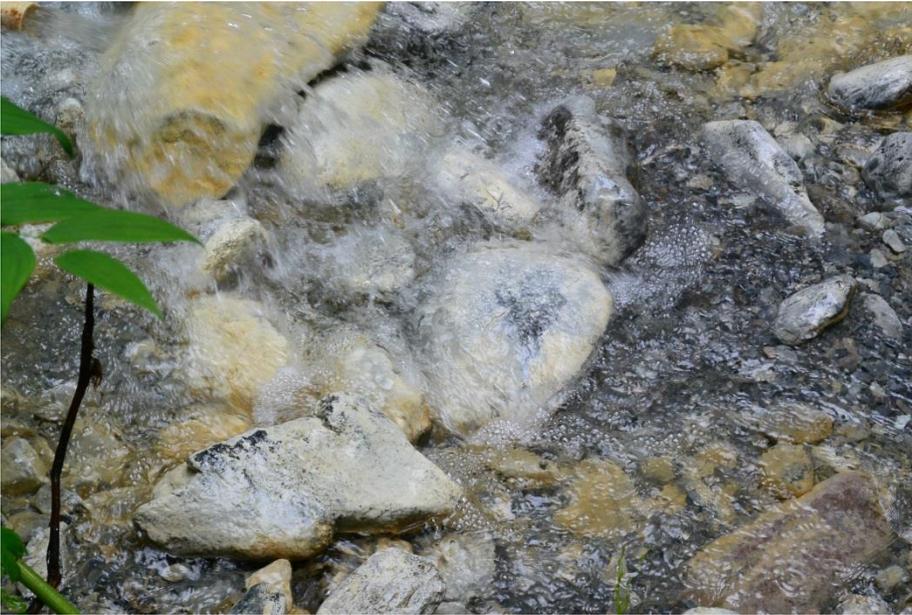
Figure 4 White residue in Sherman Creek

The team traveled around the WTP and down the length of the wooden walkway leading to the treated water discharge point in Sherman Creek. The walkway felt firm underfoot, and appeared to be in good shape. Upon arriving at Sherman Creek, the white residue<sup>2</sup> that has been noted in previous inspections unmistakably persists in the creek bed (Figure 4). The residue has been vigorously tested in an attempt to identify what it is and what is causing it. The

water treatment plant can safely be identified as the source, due to the discoloration starting at the discharge point and continuing downstream, but the discharged water meets Alaska water quality standards. Coeur has contracted with the University of Montana to conduct deoxyribonucleic acid (DNA) tests to further classify the substance. However, there has been a significant delay in receiving the results of the DNA testing. Golder Associates, a consulting firm hired by Coeur Alaska, used a modeling program called PHREEQC and found that under a very narrow range of conditions, it would be possible to precipitate a substance similar to what has been found coating the rocks in Sherman Creek. It is apparent that the substance in Sherman Creek is not the same as the white gypsum precipitate that occurred in Slate Creek in 2014. Testing on the residue continues in an attempt to track down its cause.

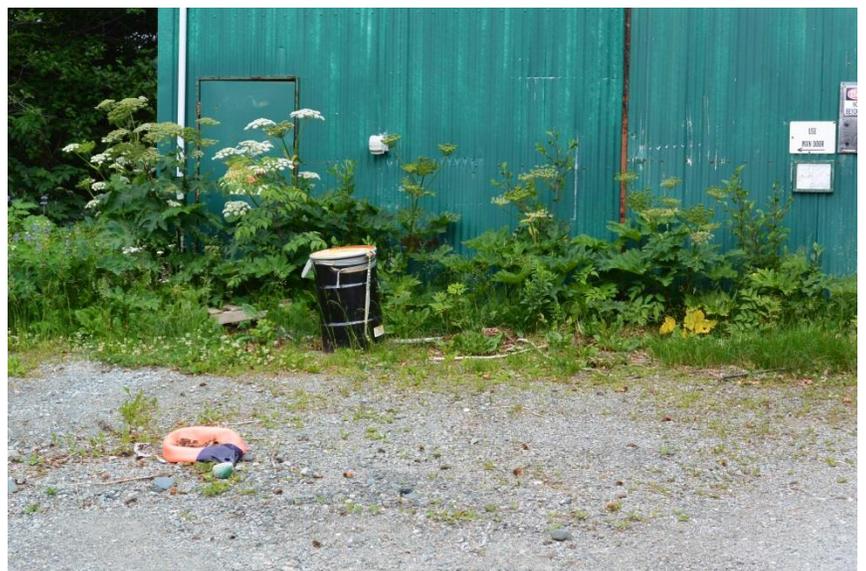
Figure 5 Refuse outside of the Comet Beach Warehouse

barrel, various pieces of scrap steel, pallets, and a large flattened buoy were most notable (Figure 5). The building is rarely used due to weight restrictions imposed on some of the log stringer bridges leading from the warehouse up to the WTP. At this time, vehicles no larger than pickup trucks can drive across the bridges, and Coeur is working with Forest Service engineers to rebuild the bridges so that the road can be used again for the transfer of media and parts from the Comet Beach to the Comet WTP.

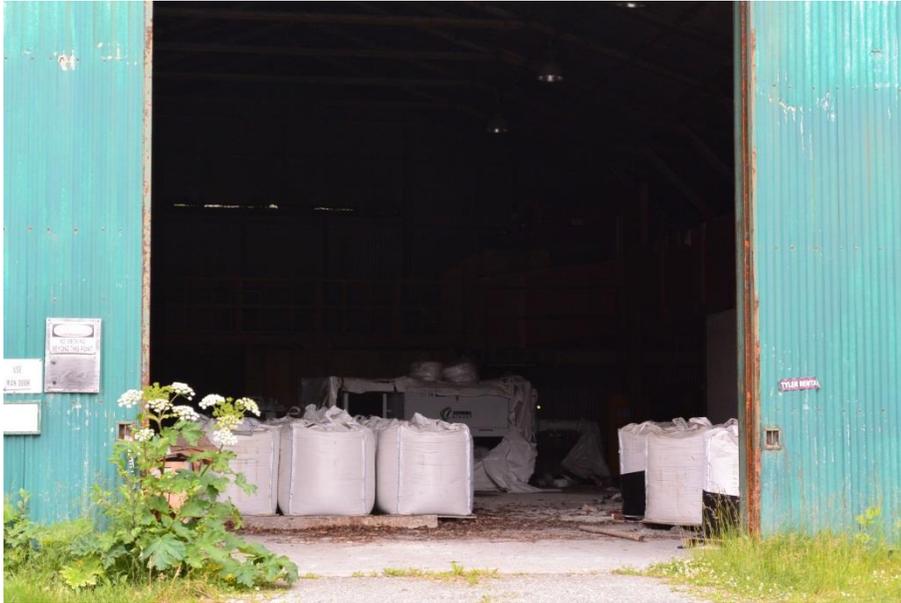
Figure 6 The Comet Beach Warehouse with the leaking pump in the background

Although the road cannot be used, several super sacks of Filter media for the WTP, and a large Schwing Bioset piston pump, for use in the paste plant, were stored inside the warehouse (Figure 6). In the past, media for the WTP was transferred via landing craft from the Marine terminal in Slate Creek Cove, around Point St. Mary, and northward up Lynn Canal to Comet Beach. The landing craft would beach itself, lower the front gate, and its cargo would be offloaded. Inside the warehouse, the piston pump

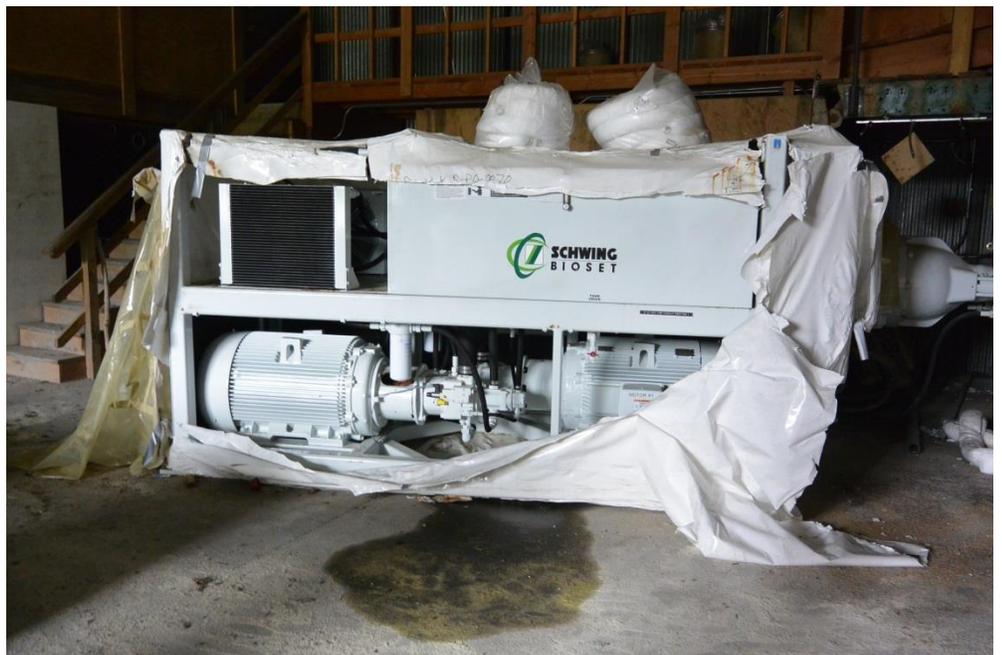
was found to be leaking hydraulic oil (Figure 7), and the oil was slowly spreading across the concrete floor. It appeared as though the slow leak had been occurring for some time, and there was no imminent release to the environment. Kevin spread some floor dry on the stained concrete floor in an attempt to soak up the oil. The team returned to the pickup, and drove back through the mine.

Figure 7 Piston pump leaking a small amount of hydraulic oil

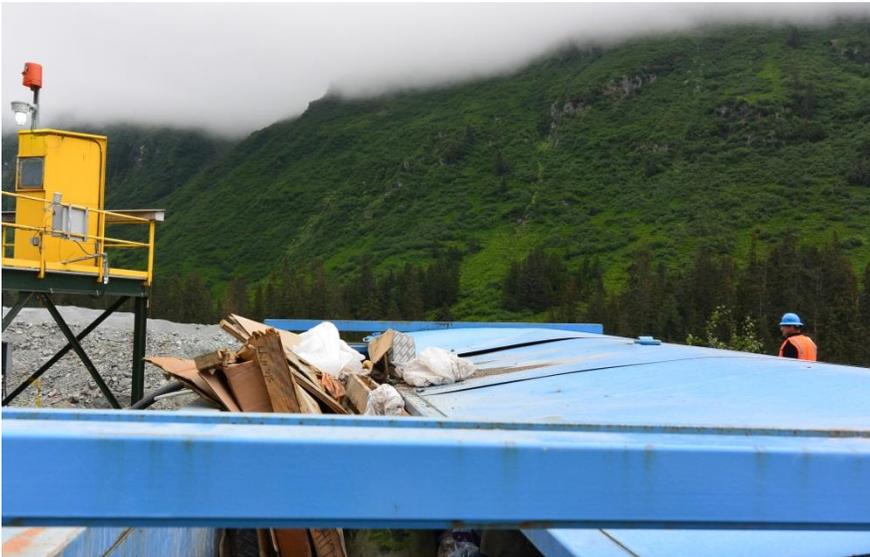
Figure 8 Garbage receptacle with a damaged lid that prevents closure

damaged, likely by a large piece of equipment. Some of the contents of the dumpster were protruding from the top, and hanging over the side of the repository (Figure 8). The dumpster should be repaired or replaced to prevent wildlife, especially bears, from accessing it and retrieving food.

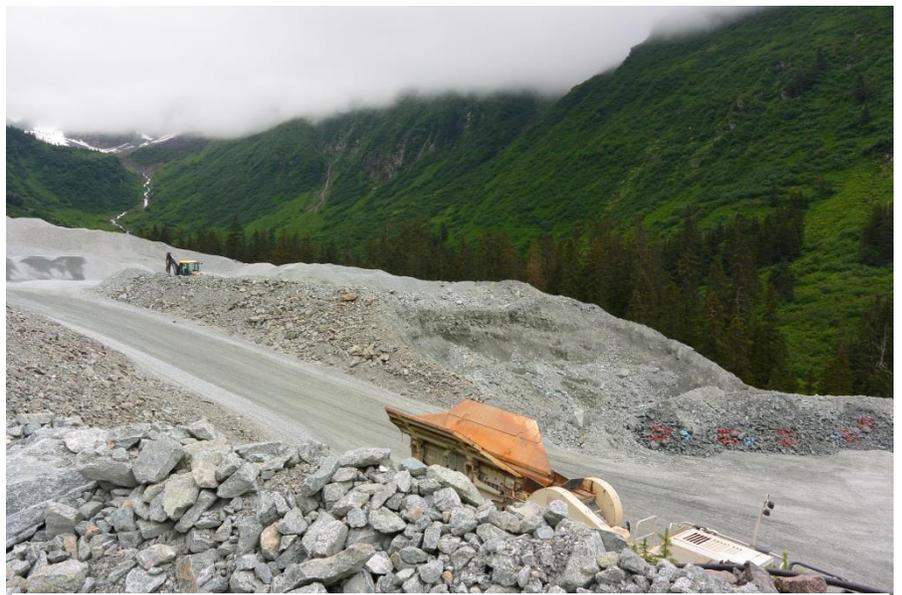
The edge of the bench that the dumpster was located on was a good vantage point to observe the placement of wasterock. Some of the freshly placed piles had paint on them to identify the slope that the uneconomical rock originated from (Figure 9). The current wasterock disposal areas are approaching their capacity, and Coeur has been expanding the pile footprint where possible. The Jualin wasterock pile continues to be built south along the access road that connects the camp to the mine area. The pile began to

Figure 9 Wasterock with paint identifying the slope of origin

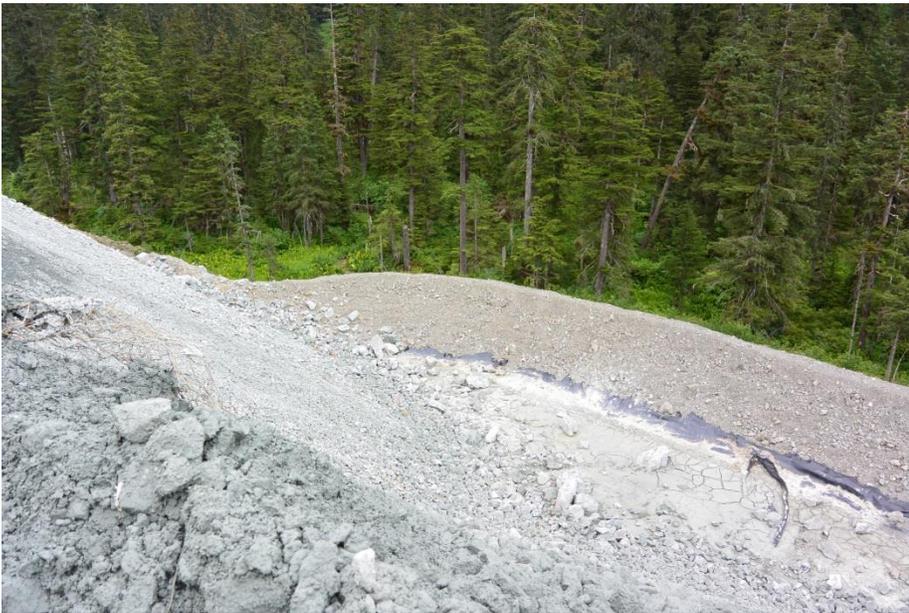
Figure 10 Wasterock covering about half of the liner

As the team moved the short distance down to the mill building, the truck skirted around the ever-growing “pebble reject<sup>4</sup>” pile and pulled to a stop at the Mill Building. Walking across the mill bench access road gave the team a good vantage point to see the detailed placement of the wasterock as it is piled along the road. Looking over the edge, it was clear that additional wasterock had been placed in one of the previously used settling ponds (Figure 10) that had been noted during an earlier inspection. The high density polyethylene (HDPE)

sheet that lined the bottom of the pond was still in place. Page 32 of the approved Reclamation Plan states that the area of the ponds will be reclaimed as a wetland area, and also says “The pond liner system would be folded and buried during grading. The treatment pond will be regraded to remove the berm along the east side of the pond”. Filling the area with wasterock may prohibit the approved post-mining land use as a wetland area. If the pond is filled and covered with large amounts of wasterock without removing the liner, water could fill the pond beneath the pile. The increased water level may cause pore pressures to rise and could cause the slope to be unstable, possibly causing a failure. The unreclaimed liner was noticed during the April 1, 2015 inspection when the toe of the pile had just started encroaching on the pond’s liner. The liner was pointed out to Kevin during the 4/1/15 inspection, and he was informed that the liner must be removed to remain in compliance with the approved Plan of Operations and Reclamation Plan. That same information was included in the ensuing report for that inspection as an action item, as well as photo documentation, and as text in the body of the report stating that the liner must be removed. During the 6/17/15 inspection, the toe of the wasterock pile had moved to cover about half of the settling pond and liner. The liner must be immediately removed or follow-up action may be taken by the regulatory agencies<sup>5</sup>.

<sup>5</sup> By the time this report was written, the liner had been removed and no follow-up action was required.

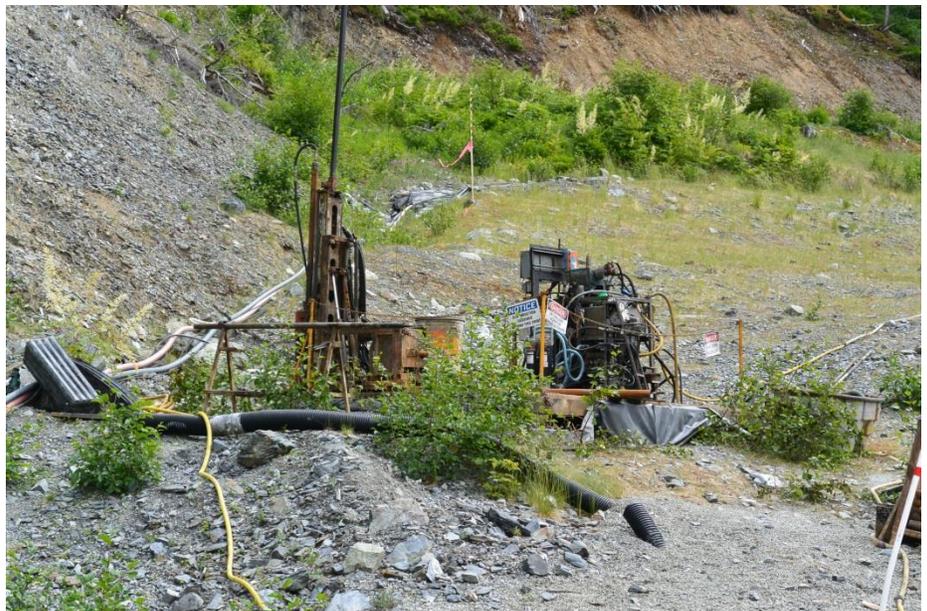
Figure 11 Geotechnical drill rig

After breaking for a short lunch, the team traveled to the Tailings Treatment Facility (TTF). Golder Associates (Golder) has been contracted to design Stage III of the TTF dam, and the consultant had a geotechnical drill rig on site, but it was not working (Figure 11). The drill will be used to further delineate the type and strength of the bedrock in the area of the dam. Stage III will be the final design of the dam and much work is to be done before a design is chosen. The geotechnical drilling is mainly performed beneath the footprint of the future development of Stage III, but may also be used to investigate different options for the spillway. The design and placement of the spillway is important due to the potentially acid generating graphitic phyllite bedrock that underlies parts of the dam and both of its abutments.

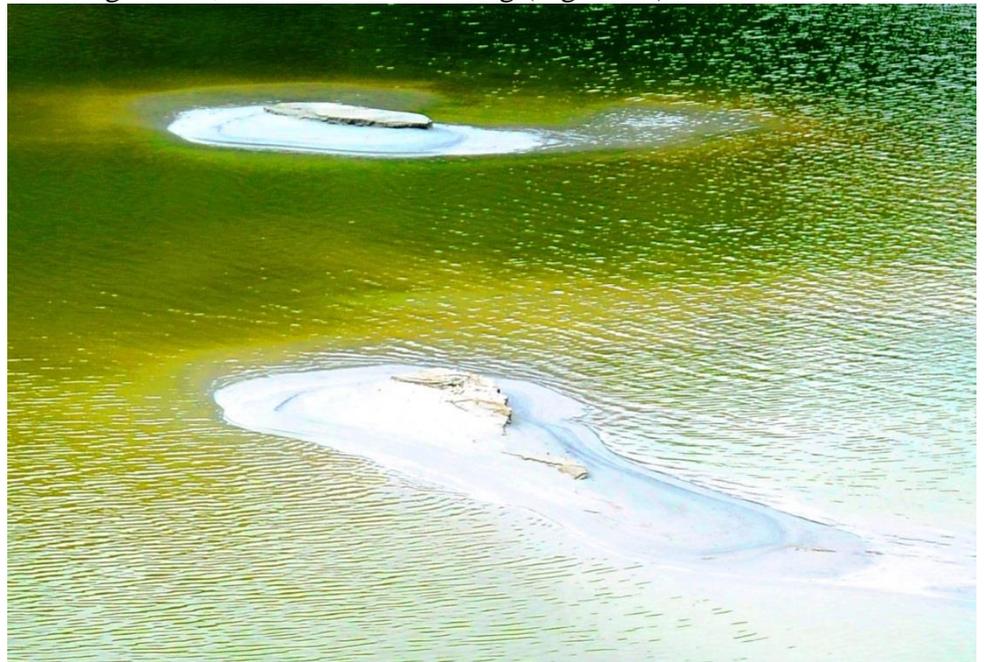
Figure 11 Tailings daylighting from the water at the TTF

Near the upstream face of the dam, two piles of tailings were protruding above the water's surface (Figure 12), and more tailings were seen just below the surface (Figure 13). During operations, the approved Plan of Operations (POO) and Reclamation Plan require at least 9 feet of water cover over the tailings as an interim reclamation measure. During the October 1, 2014 inspection, the shallow water cover was noticed for the first time by the agencies. The resulting ADNR Inspection Report stated "it [was] estimated that a cover of 4-6 feet of water was atop the tailings at the time of [the] inspection". The water cover limits oxidation of the tailings, inhibits terrestrial animals from accessing the tailings, and prevents wind blown tailings from leaving the facility.

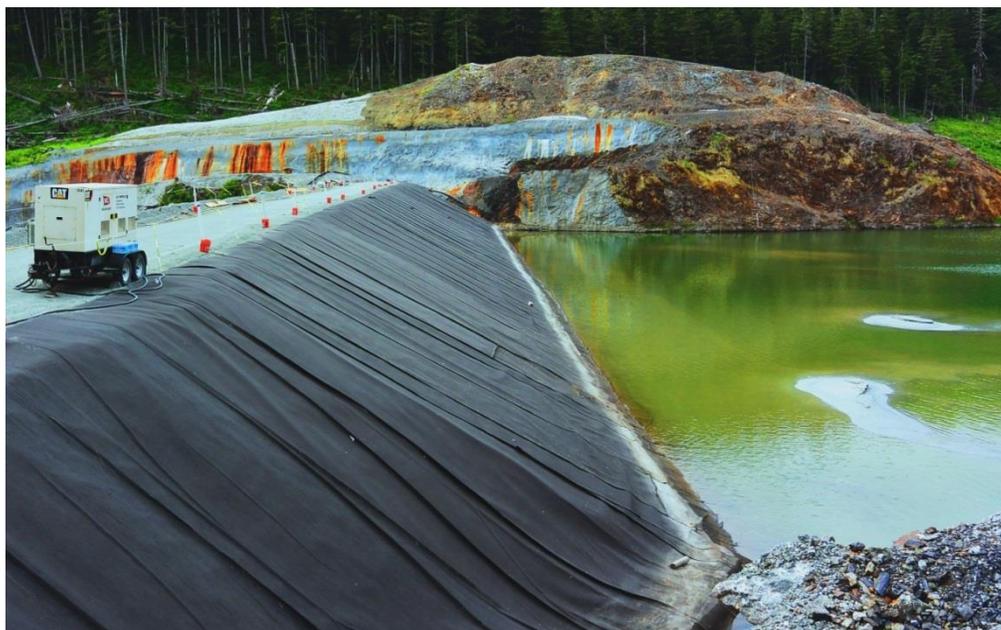
Figure 12 Exposed tailings with shallow cover over other piles. The crest of Stage I is visible under the water's surface

At the time this report was written, the peak elevation of the tailings was unknown. However, as seen in Figure 13, the tailings are piled higher than the crest of the Stage I dam (the crest of Stage I can be seen below the water’s surface running parallel to the crest of Stage II). The crest elevation of Stage I is about 690 feet. It is very important that the tailings remain underwater, and immediate measures must be taken to ensure that 9 feet of water cover is reestablished. Until the cover is restored, Coeur is out of compliance with the approved Reclamation Plan and Plan of Operations and further action may be taken by the Agencies.

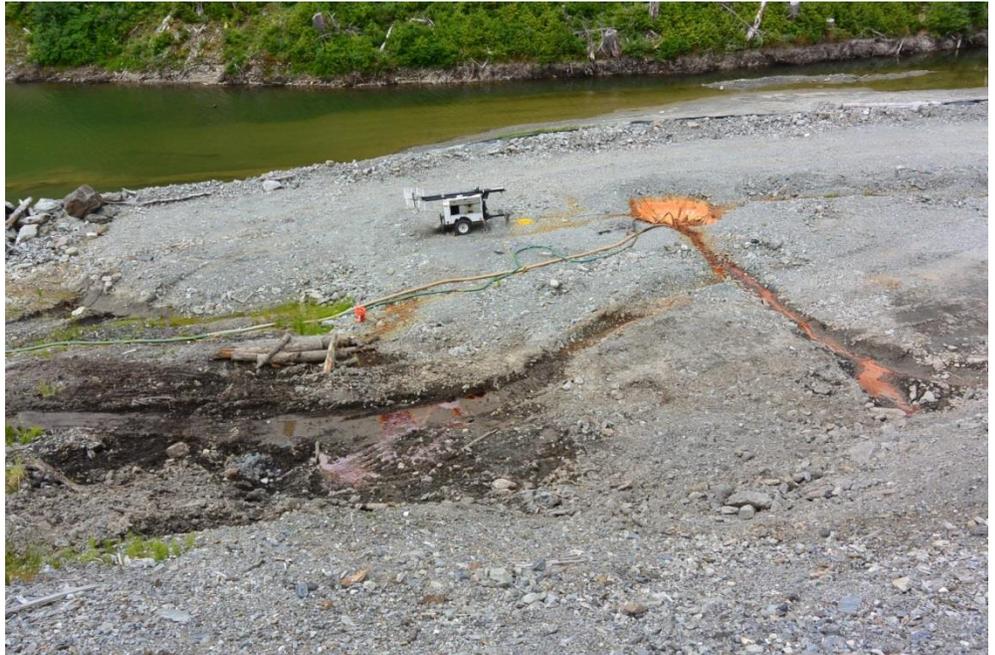
Figure 13 Staining at the toe of the pile.

The team moved to the north end of the TTF and checked the area where the graphitic phyllite was mistakenly placed during the construction of the Stage II dam raise. Visible staining lingers at the base of the stockpile embankment (Figure 14), and water continues to be collected,

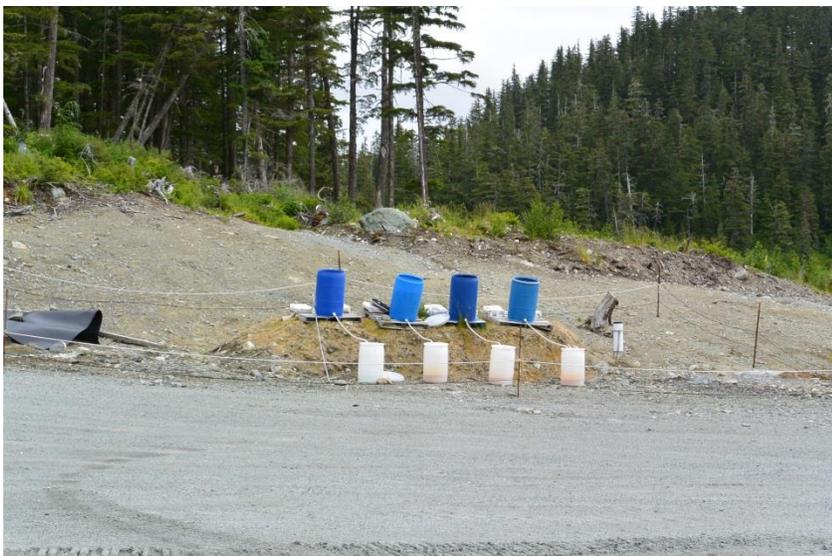
Figure 14 Barrels containing graphitic phyllite

pumped, and hauled to the treatment plant at the opposite end of the TTF where it is treated and discharged into an infiltration gallery. The Barrel Tests continue to run, and appeared to be in good condition (Figure 15). The second barrel from the left end, as seen in Figure 15, is leaning awkwardly, but does not appear to be in danger of tipping over. Samples were collected throughout the winter months because the mild temperatures did not freeze the water in the collection containers
