Report Date: July 30, 2015

Inspection Team David Wilfong – ADNR , Matt Reece and Curtis Caton – USFS

Inspection Objectives: General Inspection

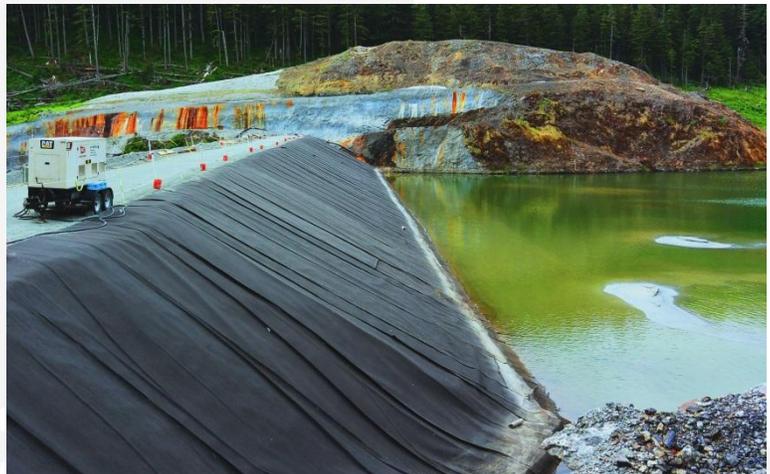
Tailings exposed to the air were observed by the agencies during a regular inspection performed on June 17, 2015¹. At that time, only two piles of tailings had daylighted about 1 foot above the surface of the water (Figure 1). The approved Plan of Operations and Reclamation Plan require at least 9 feet of water cover. During an earlier inspection in October 2014, water cover was estimated to be only 4-6 feet as stated in the resulting Inspection Report². During the months occurring between October 2014 and June 2015, the TTF water level had dropped several feet to expose the tailings located near the upstream face of the Dam. The unusual drop in the water level is likely due to an abnormally low snowpack during the winter of 2014-2015. Typically, the level of the water rises during the spring breakup. But, in 2015, the rate of water discharged from the water treatment plant (WTP) exceeded the infiltration of water into the TTF. The resulting drop in the water level exposed the tailings that were seen under the water's surface in October.

Figure 1 Exposed tailings during the June 17, 2015 inspection.

- **Continue efforts to establish a water cover over the tailings as described in the reclamation plan.**
-

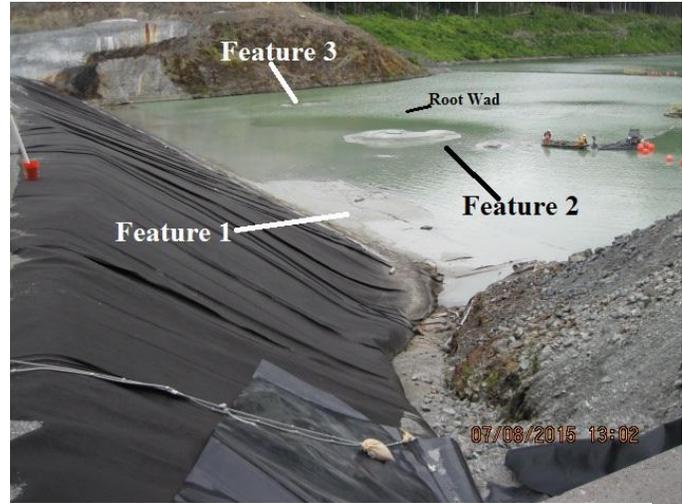
Upon arriving at the TTF on July 8, the team observed that a substantially larger volume of tailings had become exposed in the three weeks since June 17 when the exposed tailings were first observed by the agencies. The larger volume of exposed tailings was due to a drop in the water level, and Coeur was actively dredging tailings on July 8 to redistribute them to deeper areas of the TTF in an effort to establish 9 feet of water cover. Due to the dredging operation, the water was too turbid in the area of the dam to ascertain whether or not more piles of tailings would become exposed if the TTF water level continued to be drawn down. However, what appeared to be a lone root-wad of a small tree, was sticking above the surface indicating that another tailings pile may be lurking just below the surface.

Figure 2 Exposed tailings on July 8, 2015

Six different mounds of tailings were protruding above the surface, but were limited to 3 main areas near the dam (Figure 2).

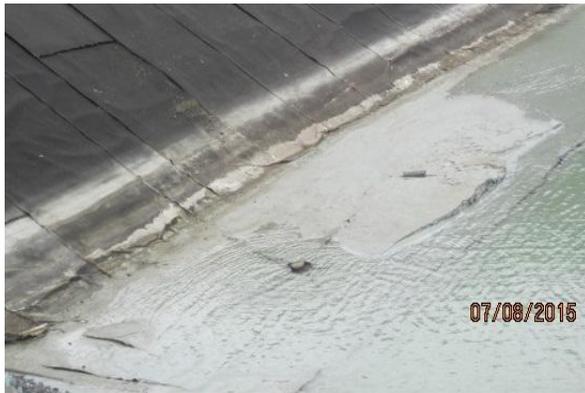
Figure 3 Tailings on the Crest of Stage 1

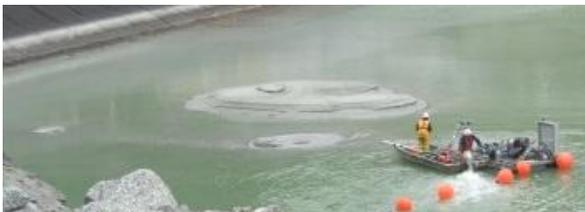
Figure 4 Tailings undergoing dredging operations

A bathymetric survey performed in May 2015 shows a depression in the tailings not far to the north, and watching the operation, it appeared that Coeur was attempting to settle the dredged tailings in that area. The dredge was a floating suction device with a rotating agitator on the front. The agitator contacts the tailings and “breaks up” the particles, which are sucked into a tube as a slurry. The tailings slurry is pumped through a pipe suspended below floating buoys, and deposited in a deeper area of the TTF. It is unknown how much volume of tailings must be moved, and it can change as the water elevation in the TTF rises or falls.

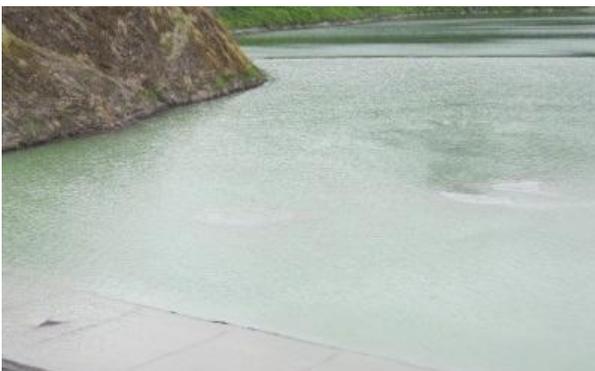
Figure 5 Exposed tailings near the west abutment

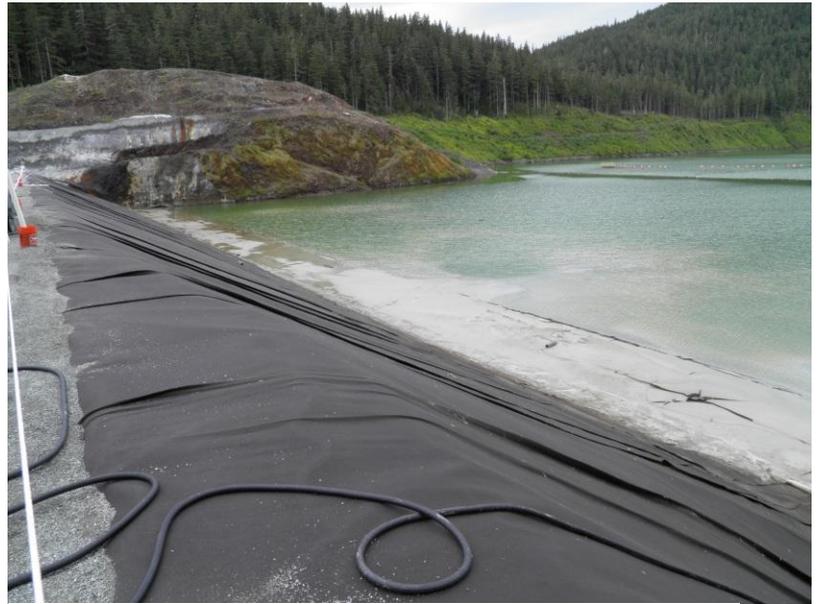
Upon arriving at the mine site during an inspection on July 20, the team was driven straight to the TTF. Upon arriving at the dam, exposed tailings could be seen on the crest of Stage I (Figure 6), but the “islands” of tailings that had been exposed during the July 8 trip were not visible. However, mounds of tailings could be seen just under the surface of the translucent water (Figure 7). Significant progress had been made to inundate the exposed tailings with water, but no active dredging was occurring. Kevin stated that the dredge was damaged, and a part was being expedited so it could be repaired and return to work. Although the water level in the TTF had dropped even further during the previous 12 days, the mounds of tailings

Figure 6 Tailings on the Stage I crest on July 20

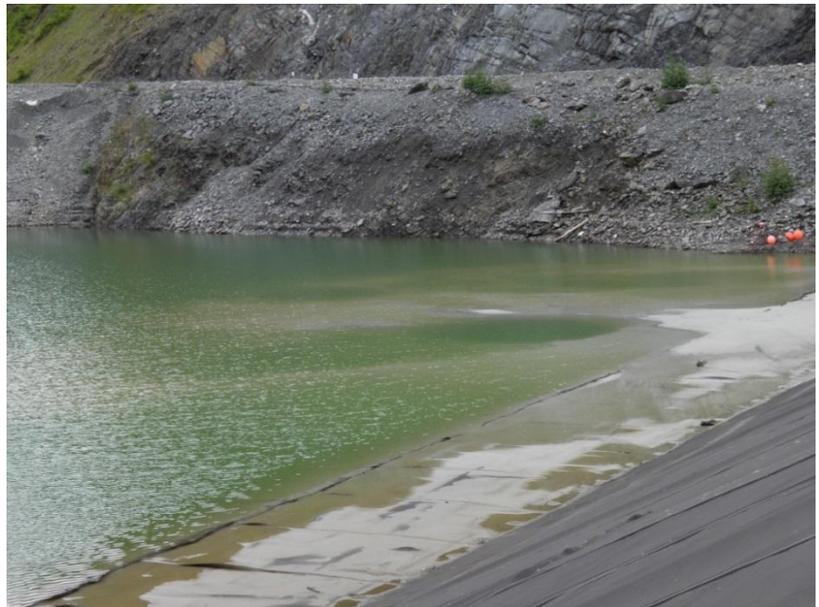
that had been exposed on July 8 were now underwater. Kevin stated that Coeur had focused on getting exposed tailings re-submerged before working to move the bulk of the material.

Figure 7 Tailings under the water's surface

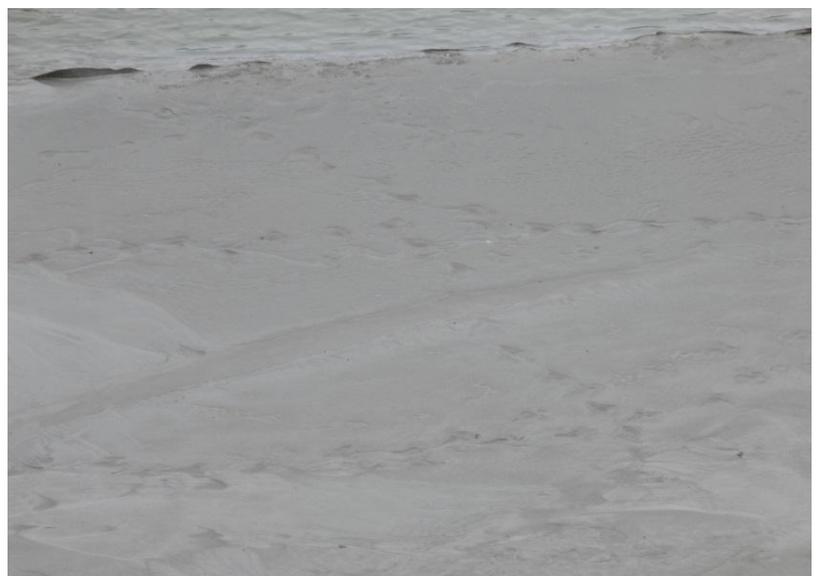
Impressions of what appeared to be bird tracks could be seen in the tailings resting on the crest of Stage I (Figure 8). It was suggested that a fire hose could be used to wash the tailings back into the water so terrestrial and airborne animals could not access the tailings easily. After discussing the situation and photo documenting the area, the team loaded into the pickup and drove toward the north end of the TTF. The team moved on to the north end of the TTF where the potentially acid generating graphitic phyllite was placed during the construction of Stage II of the dam. The water seeping from the toe of the pile was distinctly orange in color, and testing shows that it continues to have a low pH. The water is pumped to a storage area where it is transferred to a WTP,

Figure 8 Animal tracks in the tailings

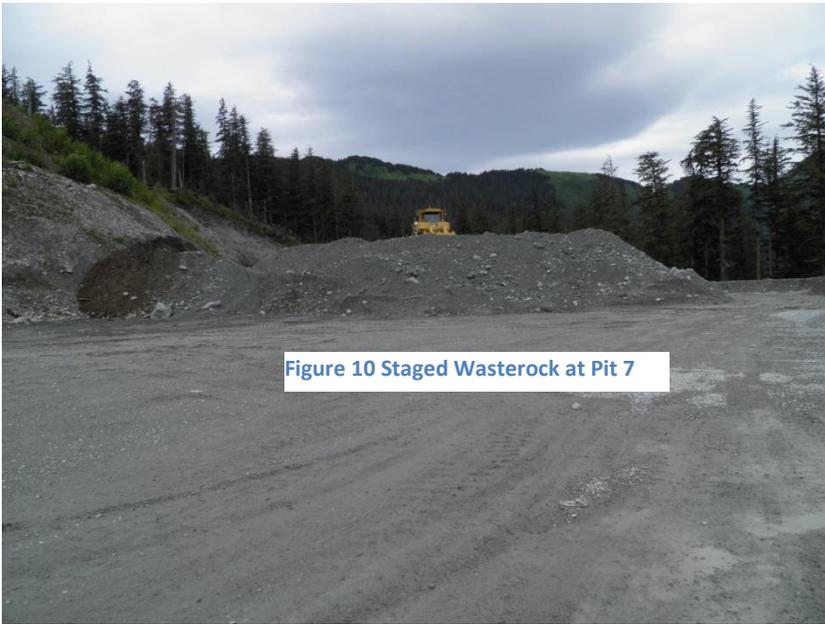
The team left the TTF and stopped at Pit 7 for a short time. Wasterock from the mine is now being staged at Pit 7 for the upcoming construction of Stage III raise of the dam (Figure 10). 160,000 tons of the diorite wasterock is needed for the construction, and a significant effort is needed to move it from the mine and place it in Pit 7. Coeur has hired a contractor to do the work, haul trucks bring the rock to Pit 7 where it is dumped, and spread in lifts with a dozer.

Figure 10 Staged Wasterock at Pit 7
