December 11, 2012

## October 10, 2012 Inspection of the Kensington Gold Mine

The purpose of this inspection was a general examination of the Kensington Mine with particular attention paid to the Tailings Treatment Facility Dam. This was the first opportunity to inspect the recently completed Stage II dam raise construction.

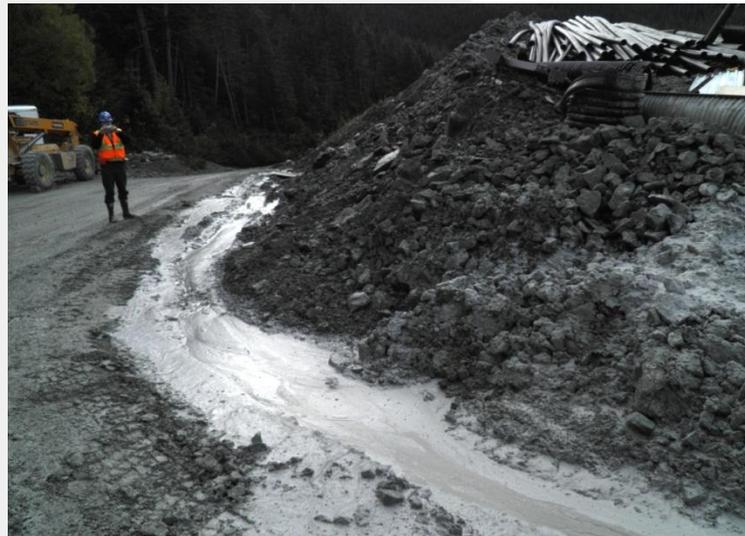
After obtaining the equipment needed for traveling underground, the team traveled through the underground portion of the mine to the Comet side, and stopped at the Comet Wasterock Pile. Sediment was flowing down the side of the road from a washout area for concrete trucks as can be seen in Figure 1. The sediment was being tracked from the washout area on the tires of trucks as they pulled away. Rip-rap size aggregate had been recently placed at the washout area to mitigate sediment tracking, and appeared to be working well.

Figure 1. Sediment flowing from the Concrete Washout Area.

- Contain the sediment flowing from the concrete washout area.
- Prevent oil from leaking from the machine in the Comet Beach shop.
- Properly dispose of the contaminated soil under the skid steer at the above ground shop.
- Place the 200 yd.<sup>3</sup> of graphitic phyllite material currently stored at the tailings treatment facility underground.
- Update the Reclamation Plan to show the current configuration of the Comet Wasterock Pile.

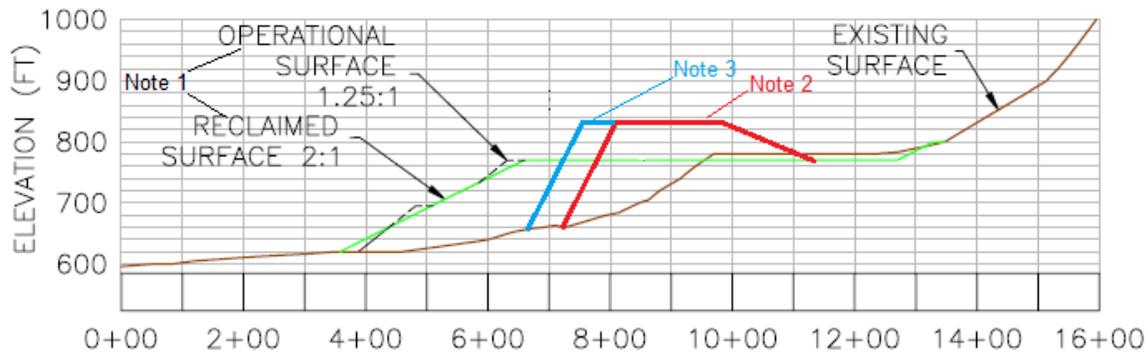
Figure 2. Not Drawn to Scale.

From the top of the waste rock pile, a large wooden spool could be seen in Ophir Creek. It appeared to have rolled down from the top of the pile after being placed. Mr. Eppers said that the spool would be removed. The Wasterock pile continues to be built in nonconformance with the Reclamation Plan (Figure 2), and the Plan should be amended to reflect the new construction design.

Note 1: Shows the planned surface at the time that the Reclamation Plan was developed.

Note 2: Actual surface as of 2-1-2012

Note 3: Actual surface as of 10-10-2012

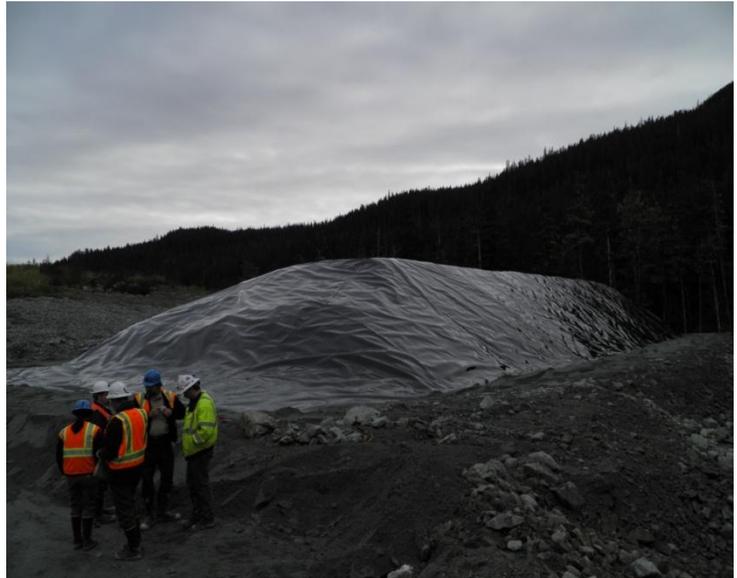
After lunch, the inspectors stopped at the North Mud Dump. Approximately 8000 yd.<sup>3</sup> of potentially acid generating graphitic phyllite was excavated during the Stage II dam raise, and has been placed in the facility. An HDPE membrane surrounds the material and can be seen in Figure 3. The membrane will help to prevent oxidation of the rock until it can be placed underground sometime in 2014.

Figure 3. Covered Graphitic Phyllite.

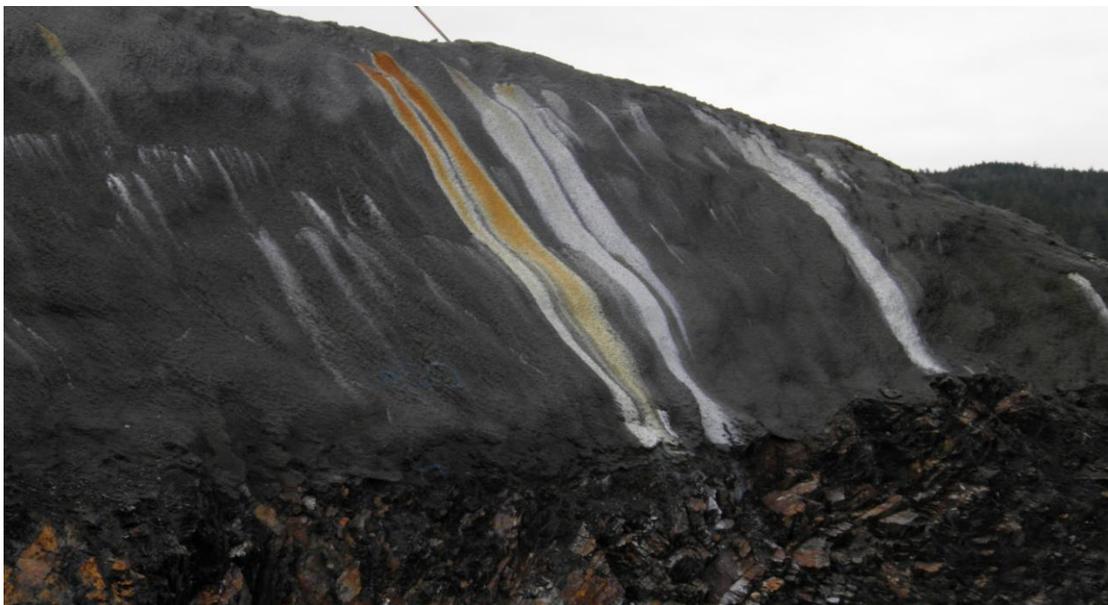
The inspection team then traveled to the Tailings Treatment Facility. Coeur had recently finished construction of the Stage II dam raise, and special attention was paid to the dam and the surrounding area. Shotcrete has been placed in and above the emergency spillway to cover a formation of potentially acid generating graphitic phyllite on the west embankment. Water with a low pH seeped through the shotcrete covering the same material during Stage I of the dam operation and produced surface staining in and above the spillway. The same type of staining is already seen on the shotcrete that was applied during construction of Stage II (Figure 4), suggesting that metals continue to leach from the water seeping through the shotcrete.

Figure 4. Staining on Shotcrete.

Currently, all water seeping through the shotcrete drains into the plunge pool at the bottom of the emergency spillway, where it is pumped to a small batch water treatment plant, treated and discharged to an infiltration gallery. It is likely that the water draining from the graphitic phyllite will require treatment after closure to meet water quality standards. The graphitic phyllite material is currently being tested for depletion rates, and an area specific

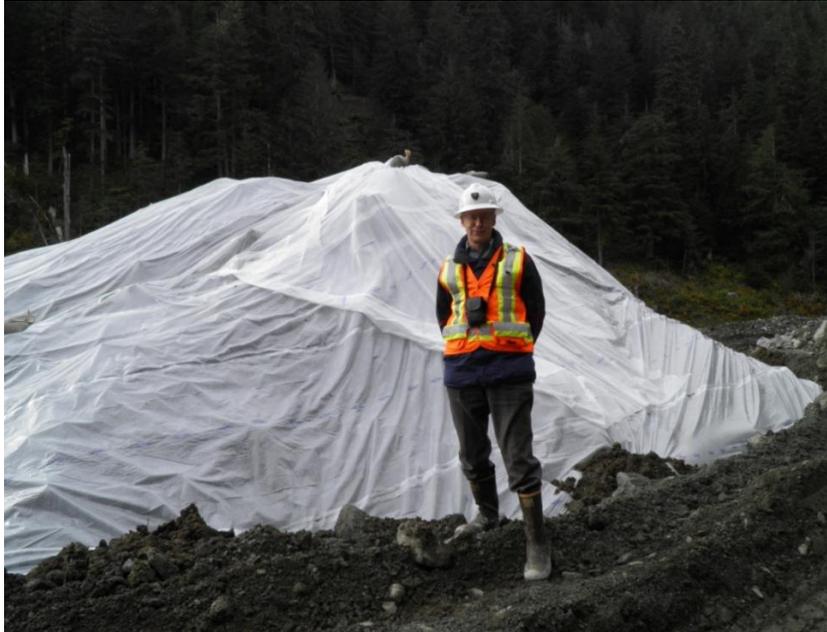
Figure 5. Covered Graphitic Phyllite

closure plan is forthcoming. Before leaving, the inspectors stopped at a pile of about 200 yd.<sup>3</sup> of covered graphitic phyllite (Figure 5) that had been removed from the dam abutment after the material in the North Mud Dump site had already been sealed beneath an HDPE membrane. The plastic cover on the material lacked sufficient weight to hold it in place. Mr. Eppers stated that more weight would be added to assure that wind could not blow the plastic off. The material is planned to be placed underground near the beginning of 2013. The next stop was at the marine facility where a Beaver floatplane was met for the ride home to Juneau.
