## February 13<sup>th</sup>, 2014 Inspection of the Kensington Gold Mine

Inspection Team:  
Curtis Caton, USFS  
Cody MacCabe, USFS  
David Wilfong, ADNR

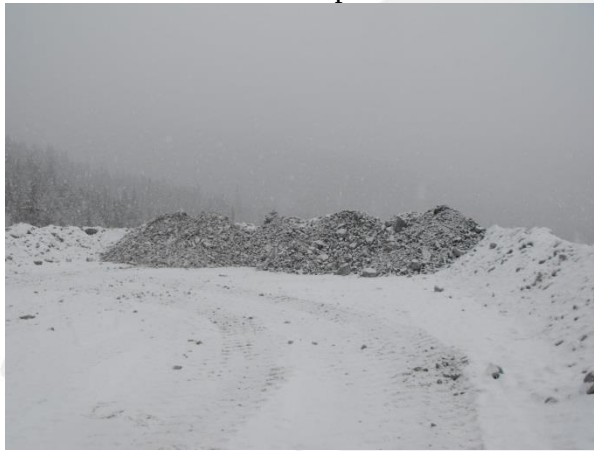
Figure 1 Looking south on the top of the Comet wasterock pile.

was poor. A few piles of waste rock were sitting at the southern end of the pile waiting to be pushed over the side (Figure 1). Coeur had recently finished a lift at the southern toe in an attempt to lessen the slope of the pile (Figure 2).

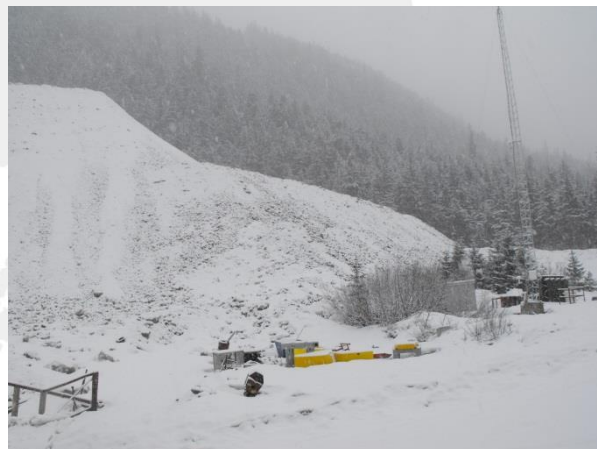
Figure 2 Lift at the south end of the wasterock pile. Looking southeast from the Comet WTP.

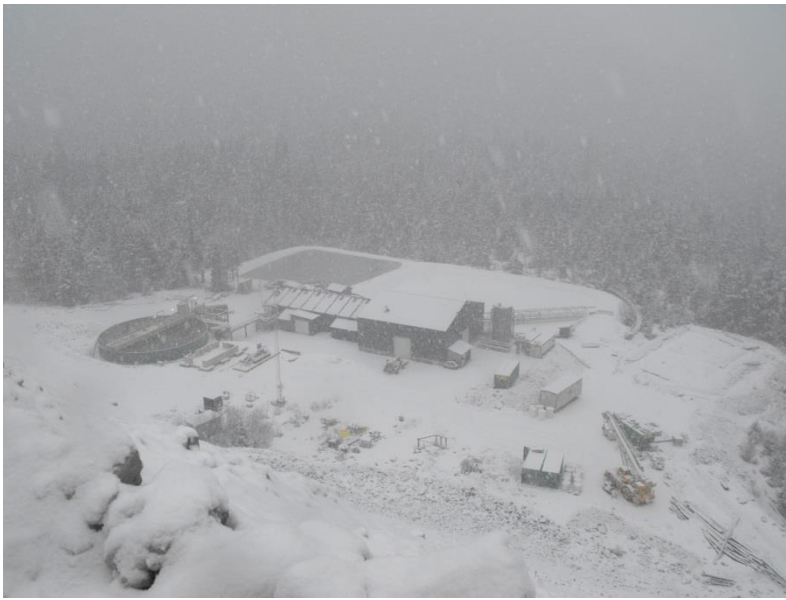
The team then drove to the Comet Wastewater Treatment Plant (Figure 3). Flow from the underground workings was approximately 800 GPM at the time of the inspection, which was relatively low due to freezing conditions. After a tour through the inside of the water treatment plant, the team moved down the trail to the distribution manifold near the outfall for the treatment plant. Past the manifold, trail

**Figure 3 Comet water treatment plant. Looking southwest from the wasterock pile.**

conditions prohibited further travel without ice cleats, so the team returned and walked around the outside of the water treatment plant. No significant issues were observed at the Comet Wasterock Pile or water treatment plant. The Comet Beach area was not visited.

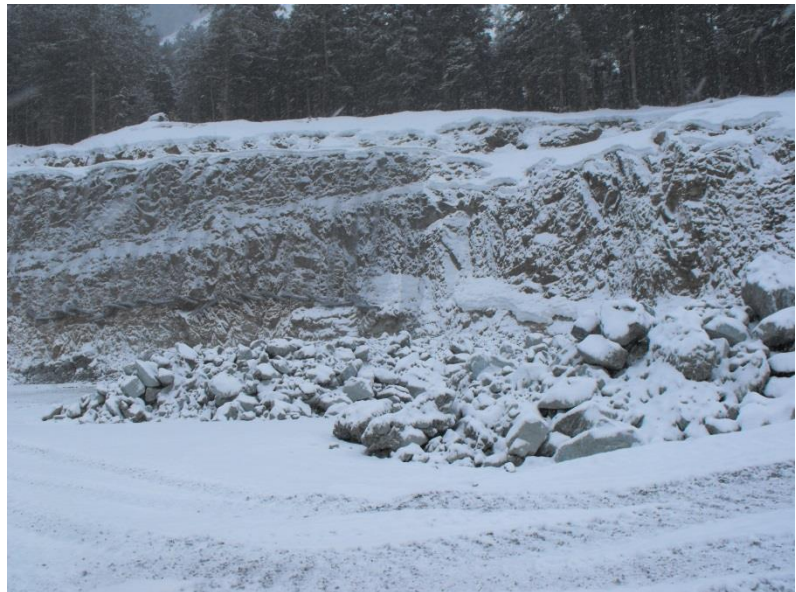
The team returned to the Jualin side of the mine and stopped at the wasterock and ore pile outside of the portal. The Jualin Wasterock Pile appeared to have grown significantly since the previous inspection that ADNR attended<sup>1</sup>. The area doubles as a storage site for the construction rock to be used for Phase III of the Tailings Treatment Facility (TTF) Dam. The only other noteworthy item observed, although not a concern, was the significant quantity of oversized ore that had accumulated (Figure 4). Occasionally, an excavator equipped with a rock breaker, fragments the oversized ore into smaller pieces that will fit through the grizzly at the opening of the crusher.

**Figure 4 Oversize ore stored near the Jualin Portal. Looking west.**

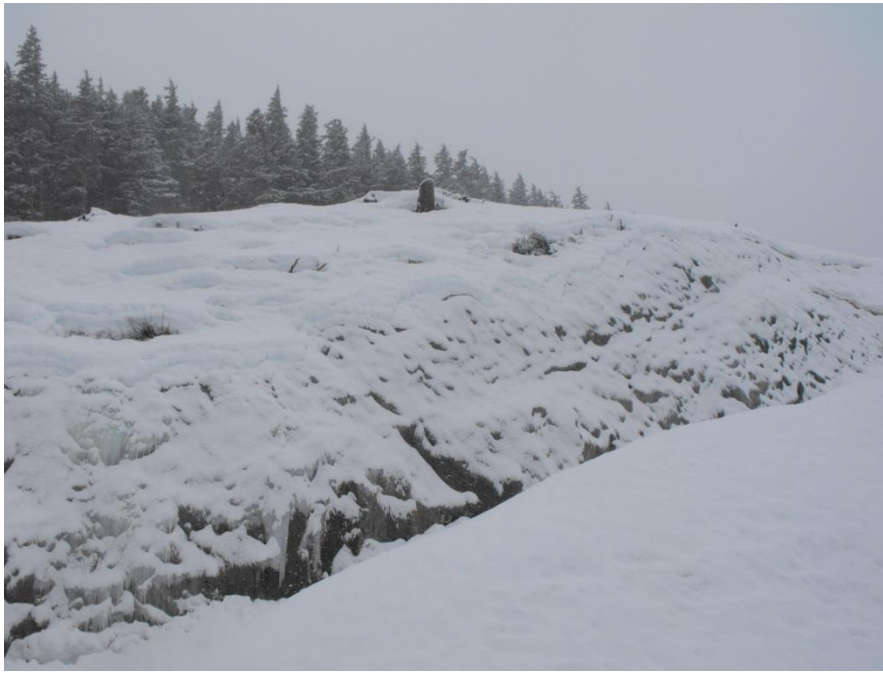
that the spillway and plunge pool had received seepage from the graphitic phyllite formation during the warming trend that had ended just a few days earlier. The shotcrete covering the graphitic phyllite was mostly free of snowpack, but was quickly being covered by the heavy falling snow. Thick icicles covered areas of the exposed bedrock, and no seepage was observed (Figure 5). The small ARD batch treatment plant was not operating at the time of the inspection. The tank used for storing seepage from the graphitic phyllite was covered with plastic, and warm air was being pumped under the cover to keep the tank from freezing. When a predetermined quantity of water fills the tank, it is pumped into the 60 gpm treatment plant where it is treated

Figure 5 Large ice formations have grown (left side of picture) due to ground water seeping and freezing near the shotcrete. Looking northwest.

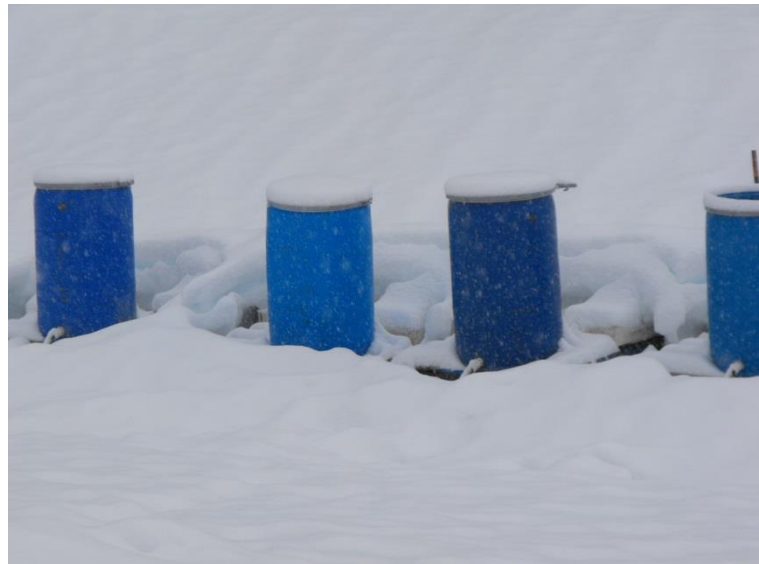
the four barrel tests had lids attached to the barrels (Figure 6) because freeze – thaw cycles were causing the barrels to overflow. Kevin stated that the lids would be removed after the spring break up.

Figure 6 Barrel tests at the north end of the TTF. Looking north.
