June 13, 2013

## June 11 Inspection of the Kensington Gold Mine

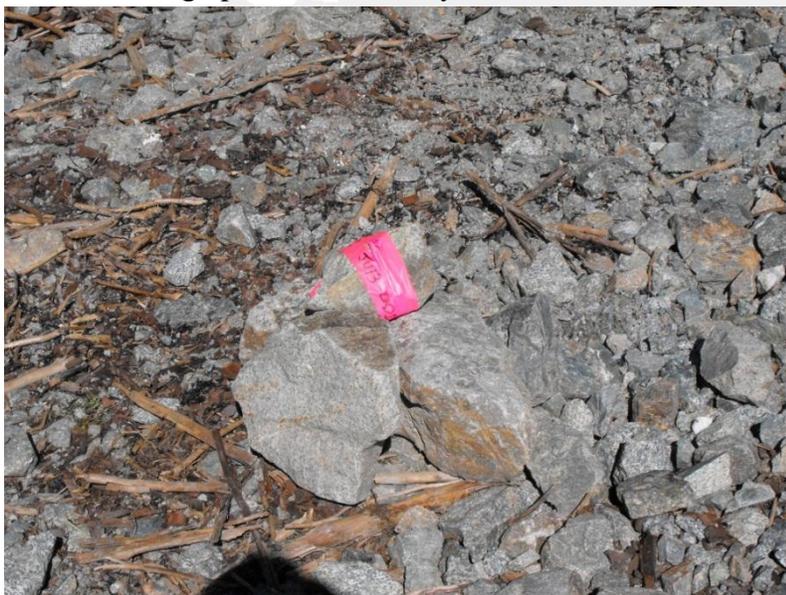
Two of the prospective drill pad sites were located on the existing Pipeline Road, and were marked by rock piles and pink ribbons (Figure 1). The Pipeline Road sites are attractive to Coeur because they are located on a prepared flat surface, and easy access for the drill rig and crews is already available. In addition, Will stated that there is historic data available from previous operations that had drilled from these same locations. After documenting that there were no

Figure 1 Rock pile and flag marking a potential drilling site on the Pipeline Road

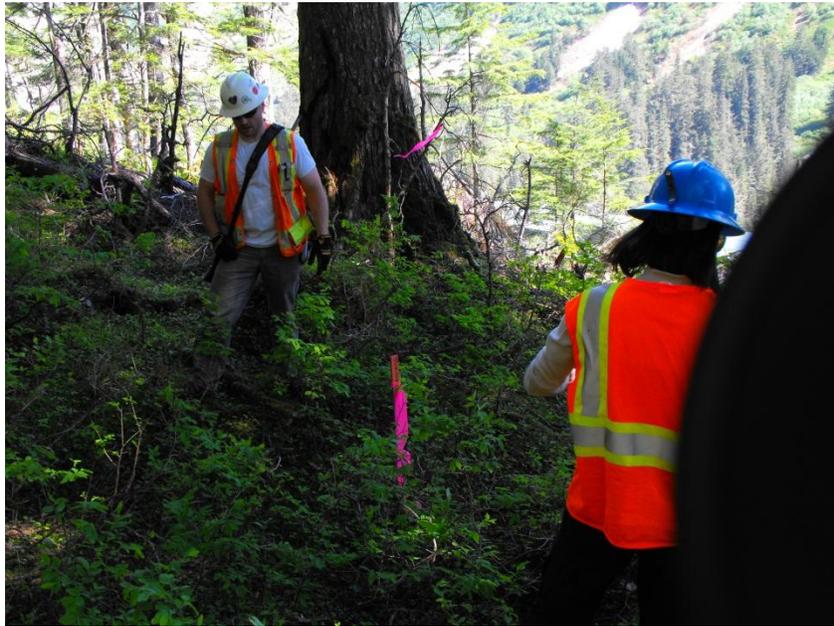
Figure 2 Stake and flag in the forest above the Mill Bench

hunger with donated blood through any exposed skin, but more than one bug died for their cause. We visited several more potential drill sites, and all were marked with pink ribbon tied to a tree, or a stake (Figure 2). One of the stakes was hard to locate as it had been knocked over, presumably by a bear. No archaeological sites were found. However, evidence of previous drilling operations, such as empty 5 gallons buckets of drill mud and cement sacks were found scattered around the area. After inspecting all of the potential drill sites, the group scrambled out of the forest, and headed back to the Kitchen and Dining Room facilities to break for lunch. Ben and Kevin met up with the rest of the team after finishing their inspection of the Tailings Treatment Facility (TTF).

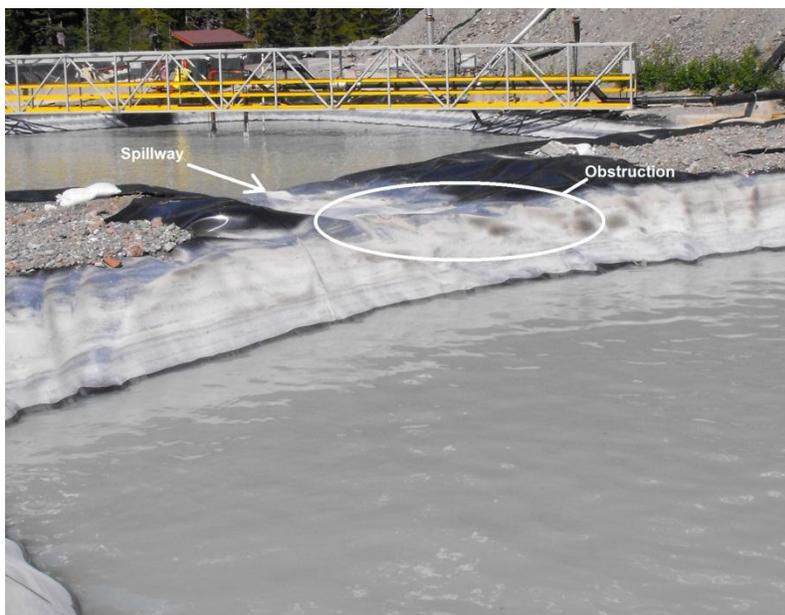
overtopped slightly during the peak flows of the spring runoff previous to this inspection. The ponds are designed so that if Pond One nears its capacity, the water will flow through an HDPE lined spillway into Pond Two. At the time of the inspection, the rate of snowmelt had subsided, and the water level in the pond lowered enough so that the cause of the overtopping was apparent.

**Figure 3 Bulged liner in the spillway**

The HDPE liner had bulged in the spillway near the rim of Pond One, effectively raising the inlet to the channel by about one foot (Figure 3). The bulged liner caused the water level in Pond One to rise higher than expected, and the turbid water flowed over the rim in at least one area. Sandbags had been placed at the point of the overtopping to hold the water back (Figure 4). There was no evidence that the small flow of water caused any erosion or structural instability to the

- Address the bridges in poor condition on the Comet Road.
- Address the blockage in the spillway running between Pond 1 and Pond 2 to ensure that water does not overtop the liner in Pond 1 during a high water event.
- Lower the level of diesel in the tank at the Comet water treatment plant, and make sure the tank does not get overfilled in the future.
- Continue to implement the approved removal plan for the acid generating material in the Tailings Treatment Facility.

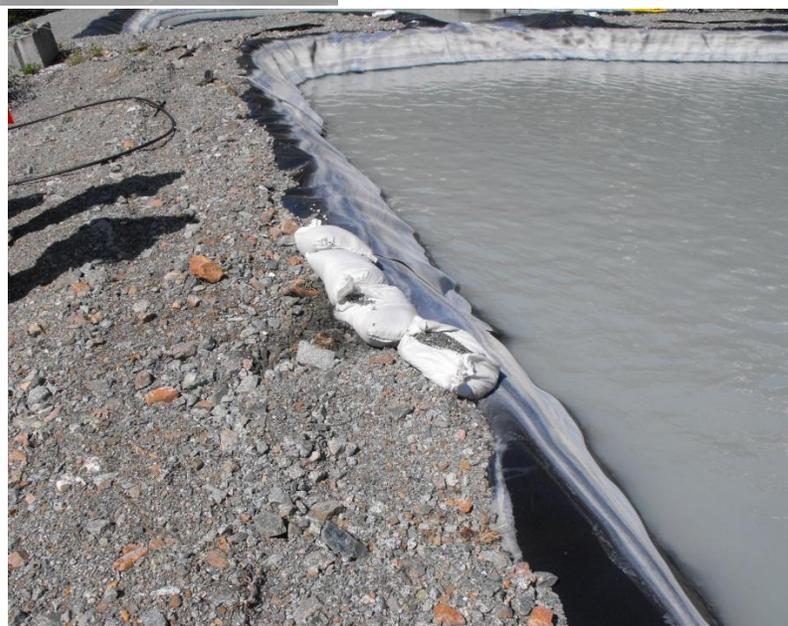
**Figure 4 Sandbags at the rim of Pond One**

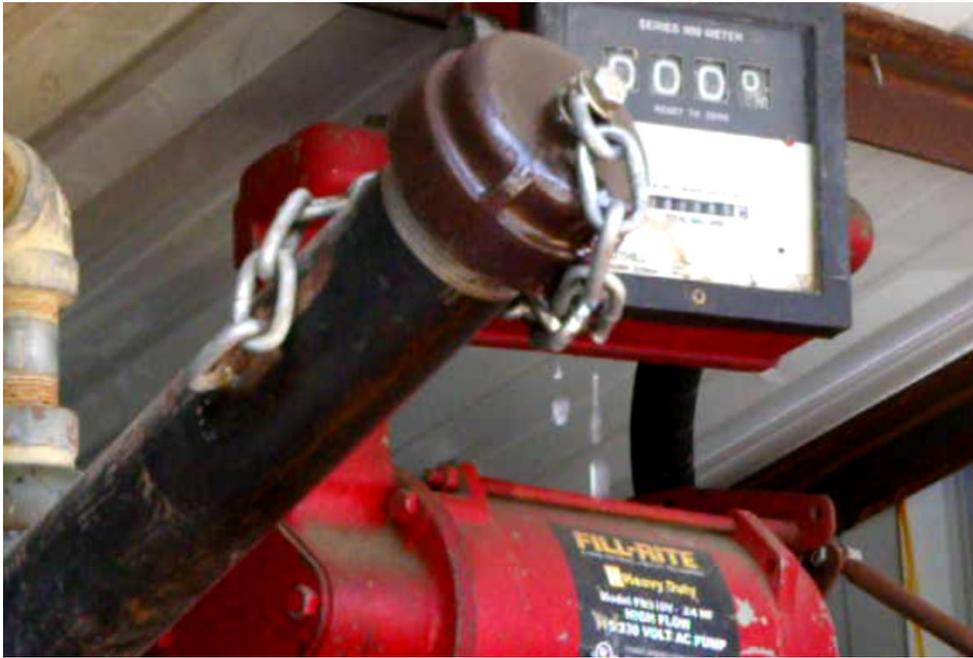
Figure 5 Diesel dripping from the fuel tank's filler neck

Before leaving the water treatment area, a leak was found at a fueling station (Figure 5). The tank had been topped off with diesel fuel earlier in the day, and when the sun began shining on the tank, the fuel may have expanded enough

to flow out the filler neck. Kevin was alerted, and oil absorbent pads were placed on the tank to soak up the dripping fuel in the interim until the fuel level could be lowered. The leaking fuel was confined in the secondary containment, and none was released into the environment. A worker at the Water Treatment Plant was asked to top off the fuel in his pickup so the level in the tank would be lowered enough to stop the leak.
