## Kensington Mine Field Inspection Report

<b>Inspection Date:</b>	April 30, 2025
<b>Time:</b>	7:00 AM to 4:00 PM
<b>Weather:</b>	Light rain. Scattered low thick broken clouds and high overcast clouds. The temperature fluctuated around 43°F.
<b>Agency Personnel:</b>	Jesse Garnett White, Carolyn Curley, Jenny March, Jonathan Kummer, and Steve Buckley
<b>Operator Contact:</b>	Peter Strow and Sierra Lammers
<b>Inspection Objectives:</b>	Site Inspection

The Department of Natural Resources (DNR) Large Mines Permitting Team (LMPT) conducted a site inspection on April 30<sup>th</sup>, 2025, at Kensington Mine for compliance with their Reclamation Plan Approval (RPA) (J20223158RPA.01) as required under AS 27.19 and 11 AAC 97.

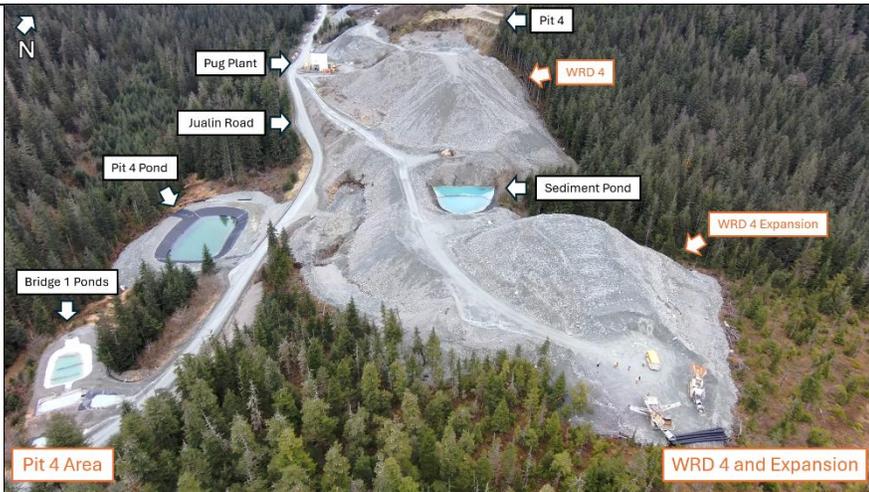
- 2.1. Ponds in the Pit 4, WRD 4, and mud dump areas (Map 1 and 4, Photos 1, 3, 5, and 7): Bridge 1 ponds, Pit 4, WRD 4, and the mud dump pond all contained water with liners that were in good condition and operating normally. We viewed Johnson Creek from Bridge 1, and the water was clear and clean (Photo 4).

Photo 1: WRD 4 and WRD 4 expansion with views of Pit 4, Pit 4 pond, Bridge 1 ponds, WRD4 sediment pond, pug plant, and Jaulin Road.

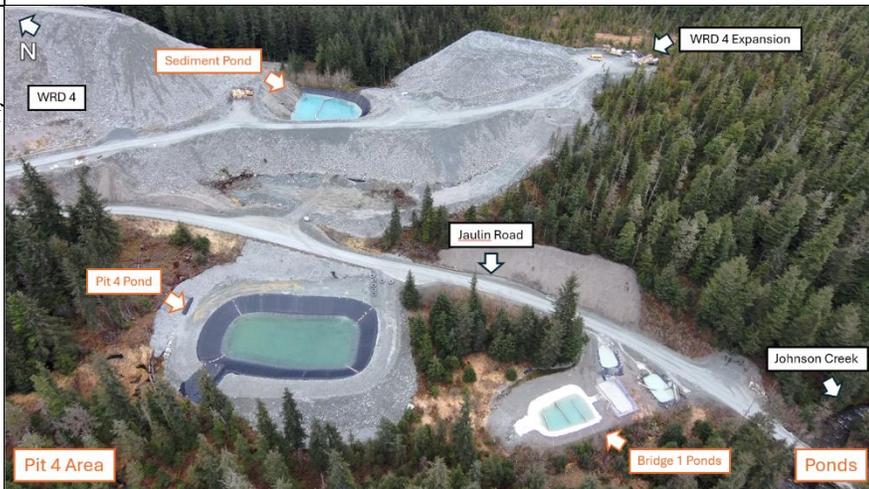
Photo 2: Pit 4 Area ponds including Bridge 1 ponds, Pit 4 pond, and WRD 4 sediment pond with views of the WRD 4 expansion, Johnson Creek, and partial view of WRD 4.

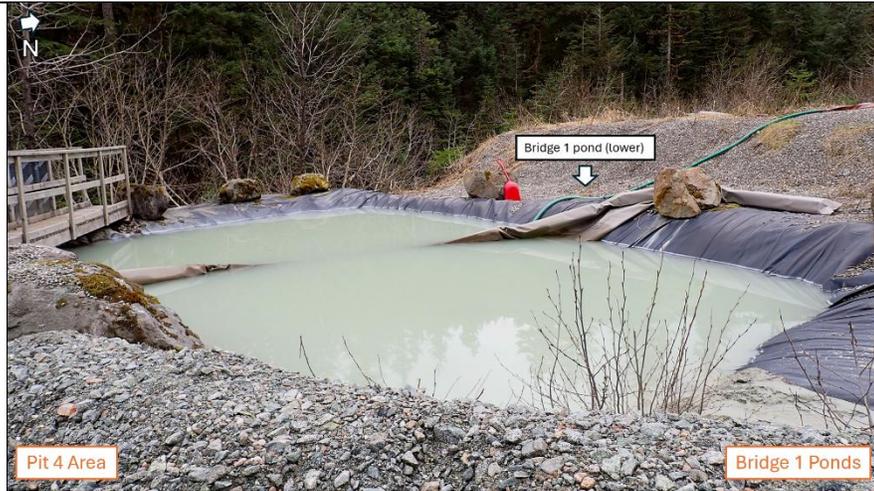
Photo 3: Bridge 1 pond (lowermost pond with respect to Jualin Road).

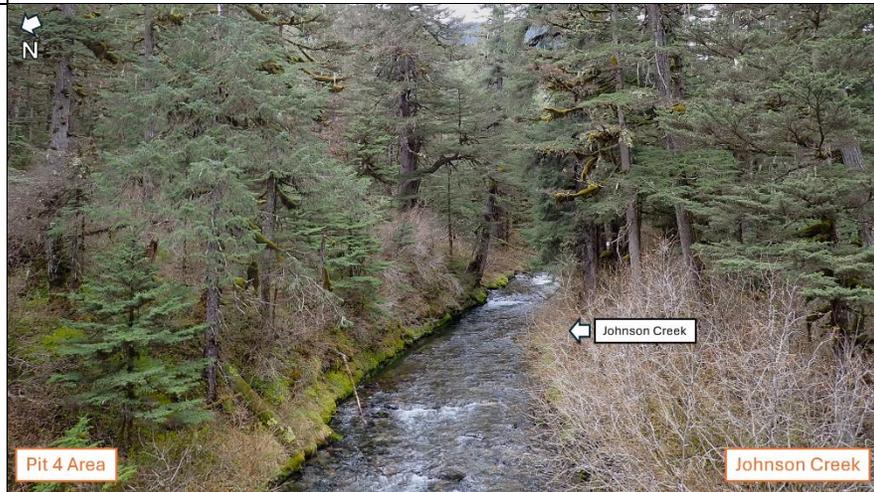
Photo 4: View of Johnson Creek from Bridge 1.

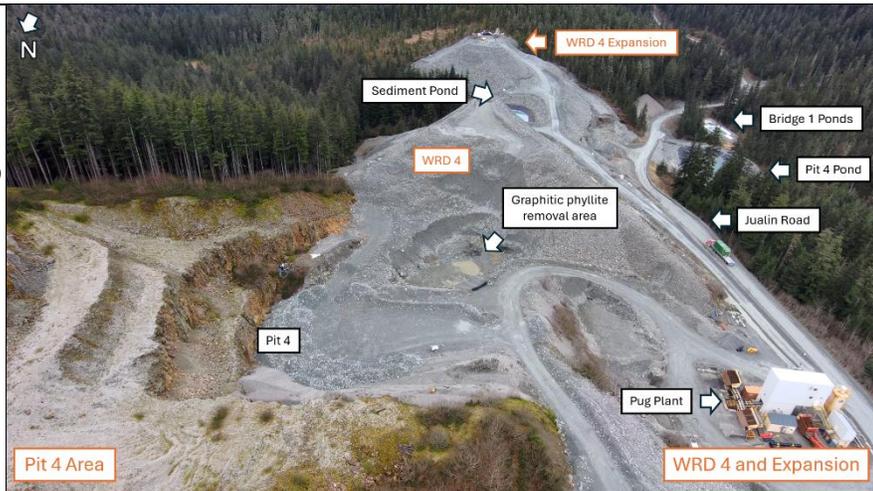
Photo 5: Pit 4 including views of WRD 4, WRD 4 expansion, graphitic phyllite removal area, pug plant, and partial views of Bridge 1 ponds, Pit 4 pond, and WRD 4 sediment pond.

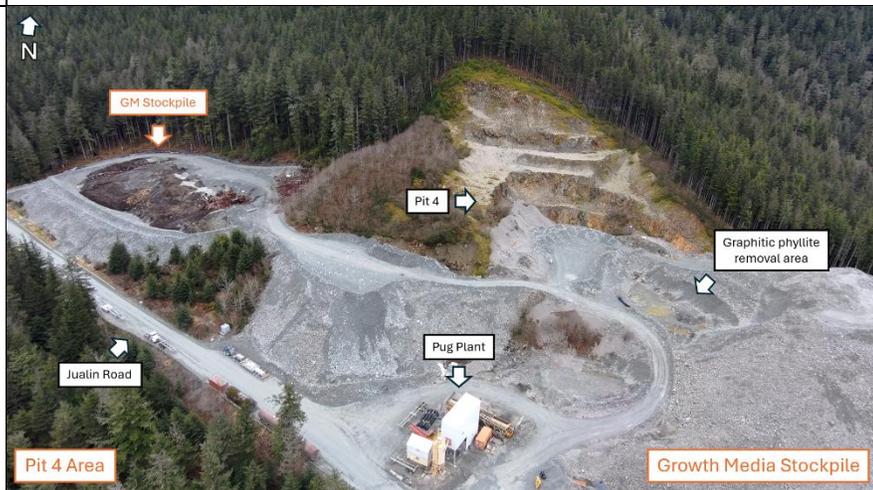
Photo 6: Pit 4 growth media stockpile with views of Pit 4, graphitic phyllite removal area, pug plant, and Jualin road.

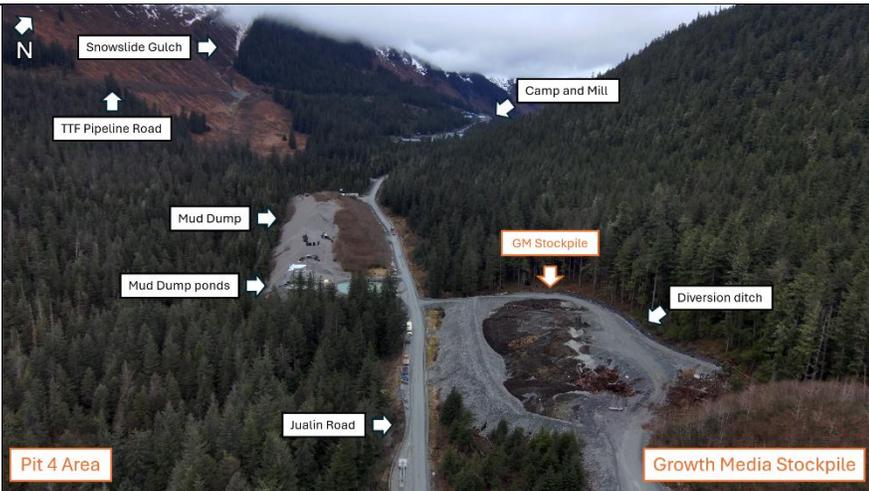
Photo 7: Pit 4 growth media stockpile, and mud dump with partial views of the mud dump ponds, Snowslide Gulch, Jualin Road, TTF Pipeline Road, camp, and mill.

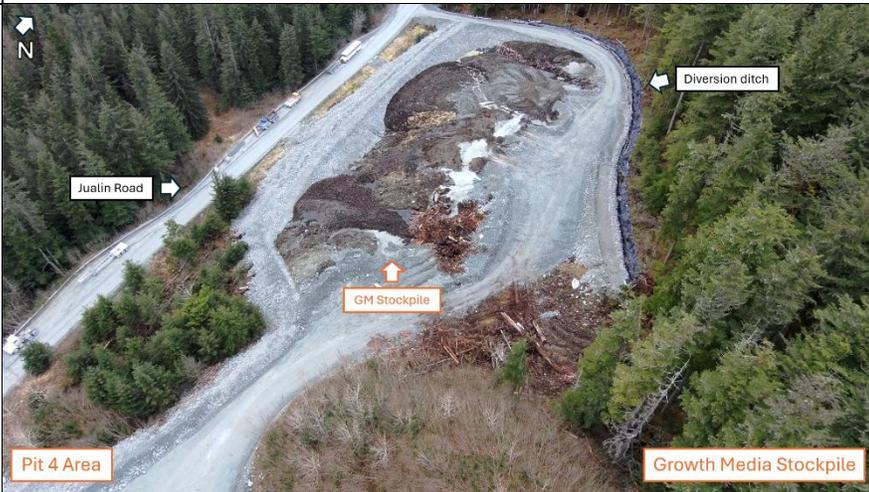
Photo 8: Pit 4 growth media stockpile.

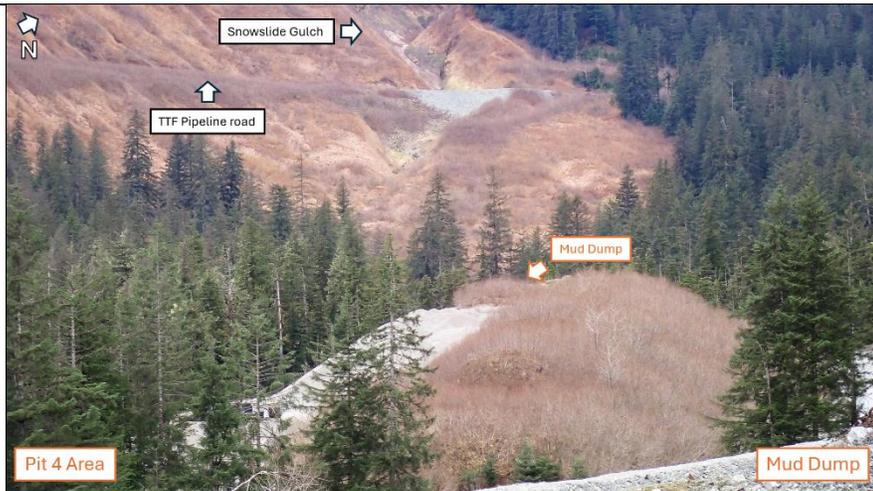
Photo 9: Partial views of Snowslide Gulch, TTF pipeline road, and mud dump from the Pit 4 growth media stockpile.

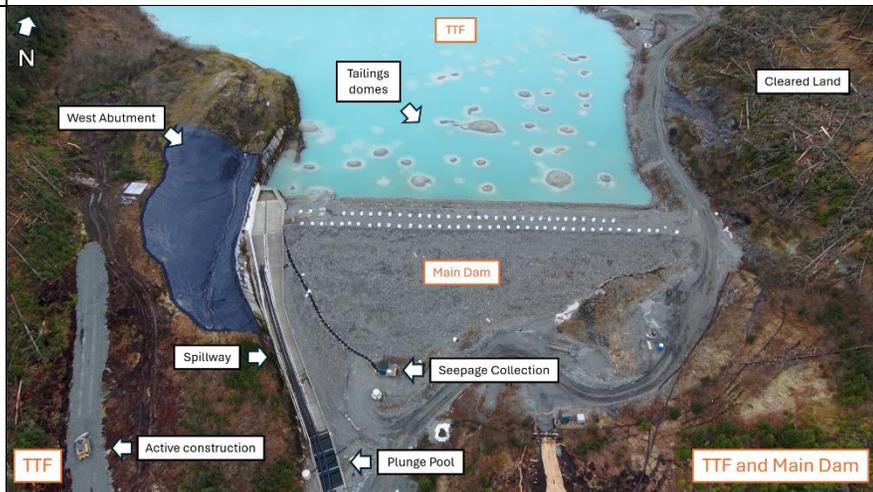
Photo 10: TTF and main dam with views of the west abutment, seepage collection, spillway chute, plunge pool, pipes to new plunge pool area, cleared land, and active construction.

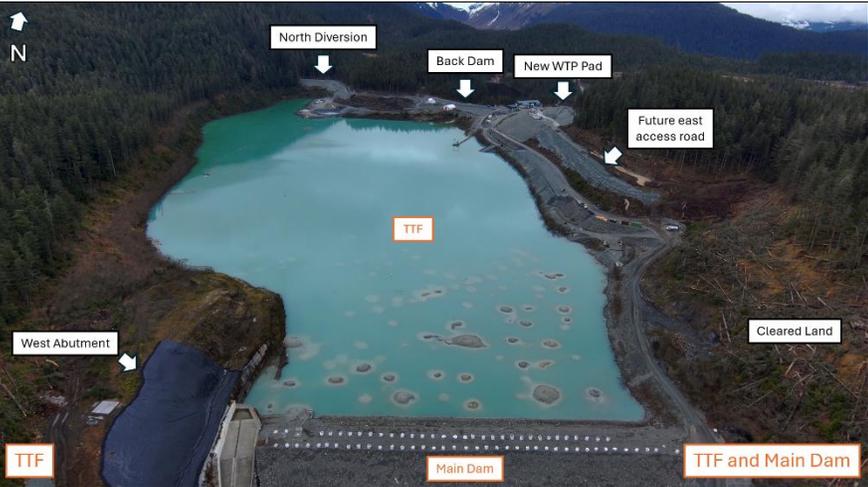
Photo 11: TTF and main dam with views of cleared land, future east access road, new WTP pad, back dam, north diversion, and partial views of the spillway chute, and west abutment.

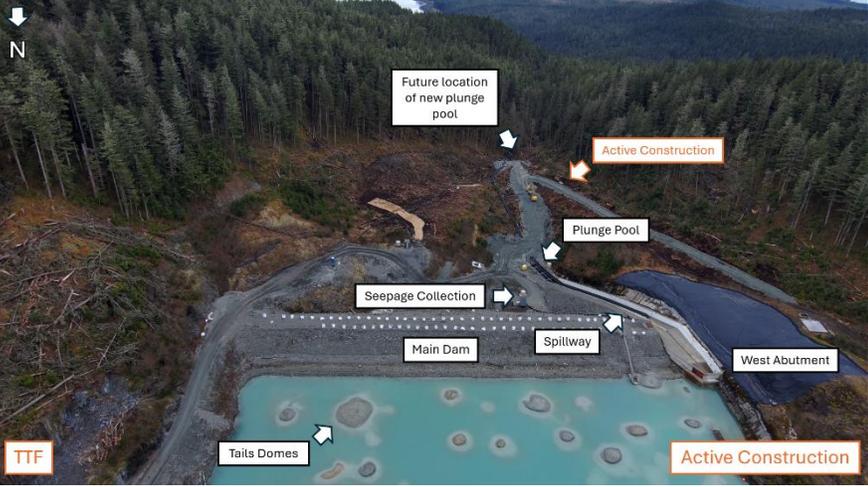
Photo 12: Active construction and cleared land below the main dam with views of the new plunge pool area, TTF main dam, west abutment, tails domes, seepage collection, current spillway chute, and plunge pool.

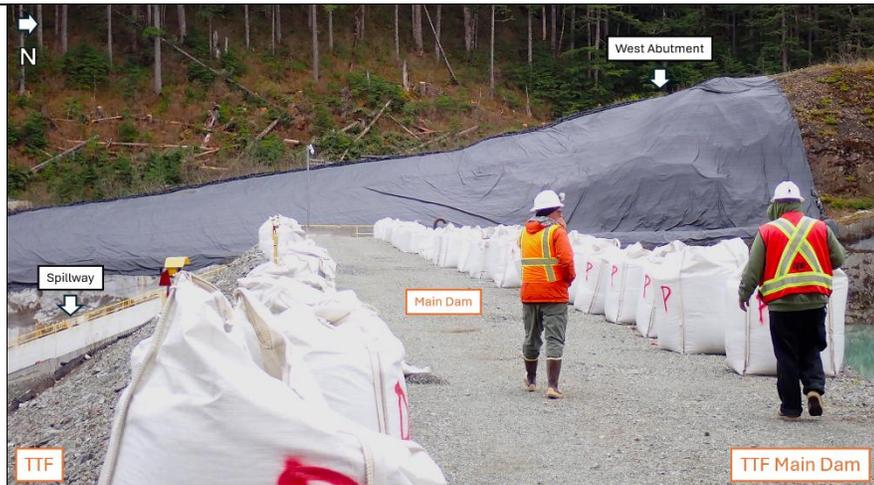
Photo 13: Top of the TTF main dam with partial views of the current spillway and west abutment.

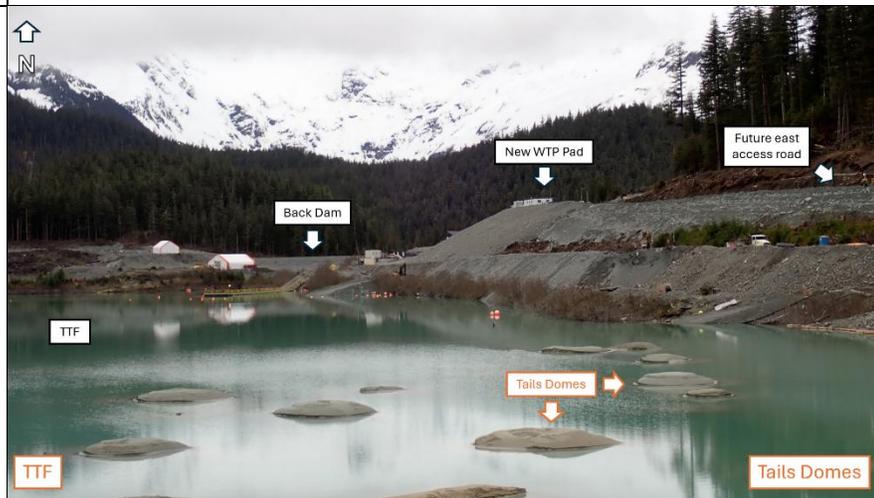
Photo 14: View from the main dam crest of the tailings domes, back dam, new WTP pad, and construction of the future east access road.

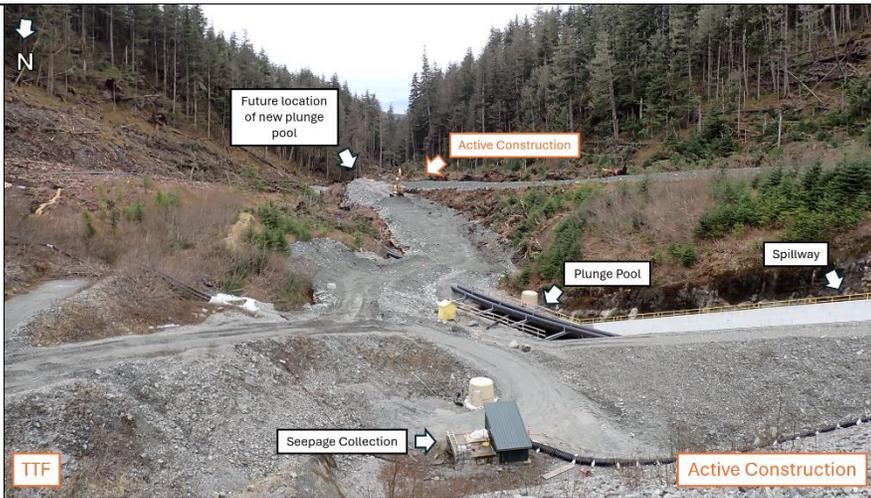
Photo 15: View of the active construction below the main dam including the spillway chute, plunge pool, seepage collection, and location of the future plunge pool.

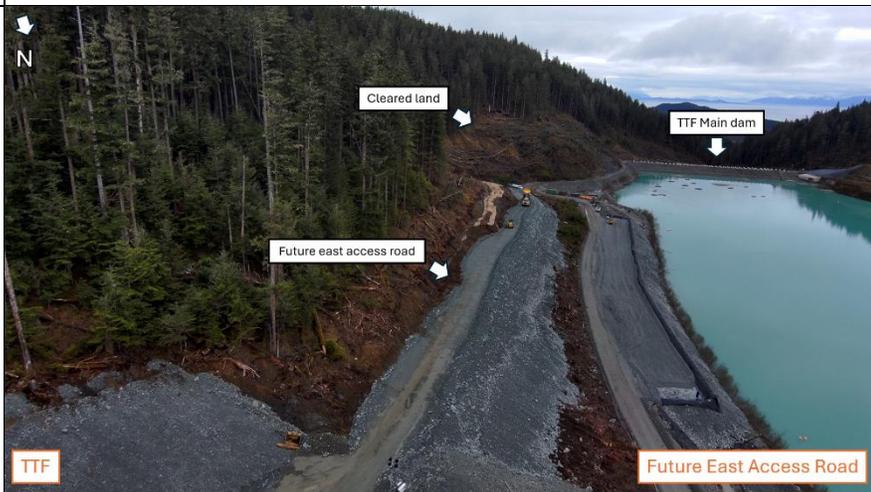
Photo 16: Future East access road with views of the TTF and main dam, active construction of the future east access road, and cleared land.

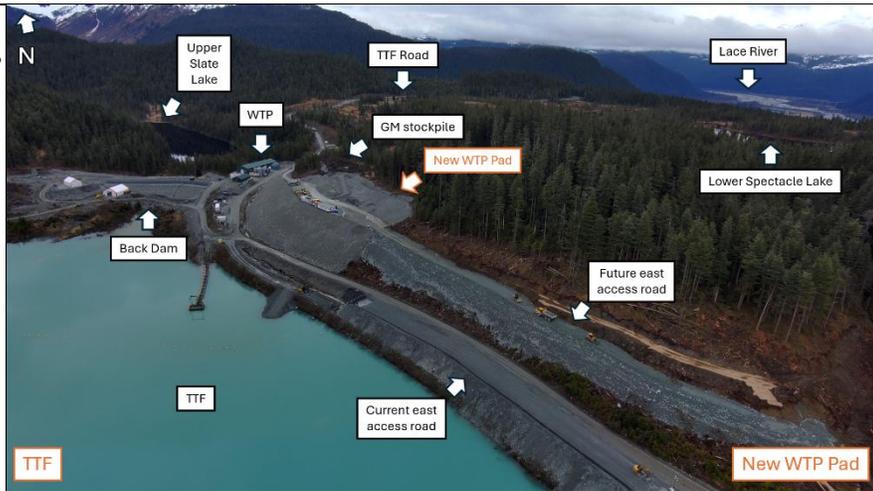
Photo 17: New WTP Pad with views the current WTP, growth media stockpile, back dam, active construction of the east access road, and partial views of the TTF road, Upper Slate Lake, Lower Spectacle Lake, and Lace River.

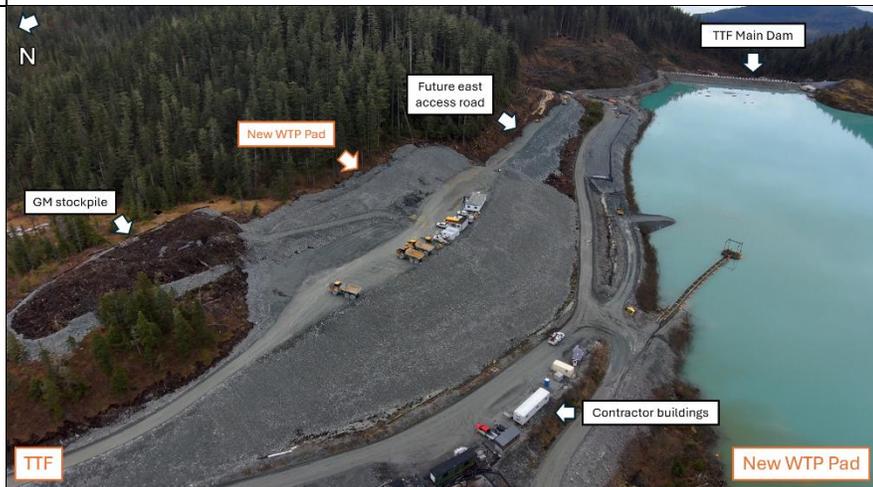
Photo 18: New WTP pad with views of contractor buildings, TTF, main dam, growth media stockpile, and active construction of the east access road.

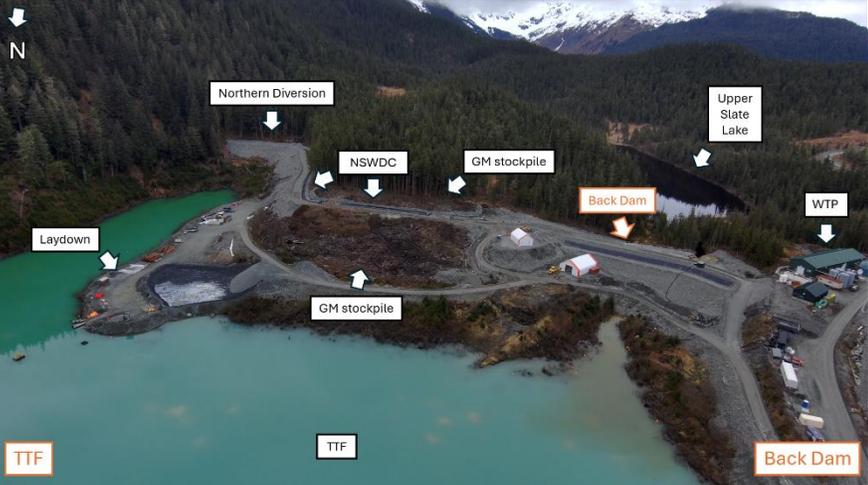
Photo 19: Back Dam, with views of the northern diversion, northern stormwater diversion channel (NSWDC), laydown yard, growth media stockpiles, tent storage structures, current WTP and contractor buildings, and partial views of Upper Slate Lake and the TTF.

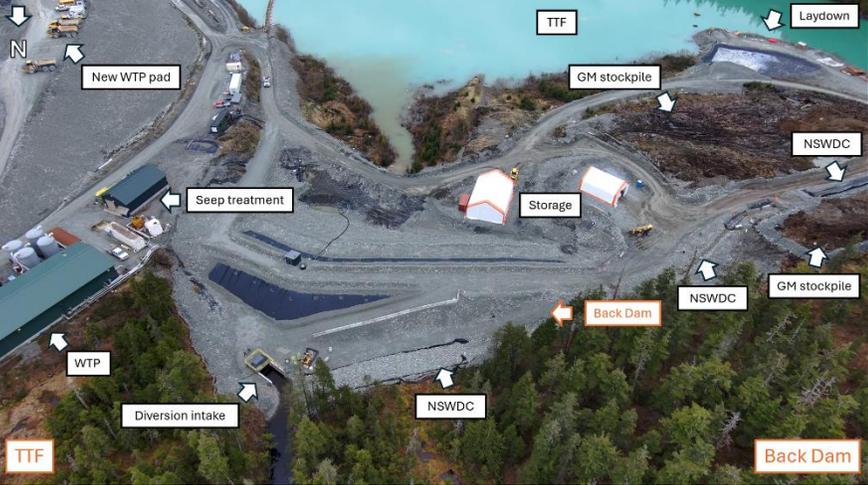
Photo 20: Back Dam with views of the growth media stockpiles, tent storage, laydown yard, NSWDC, back dam diversion intake, and partial views of the current WTP, new WTP pad, and TTF.

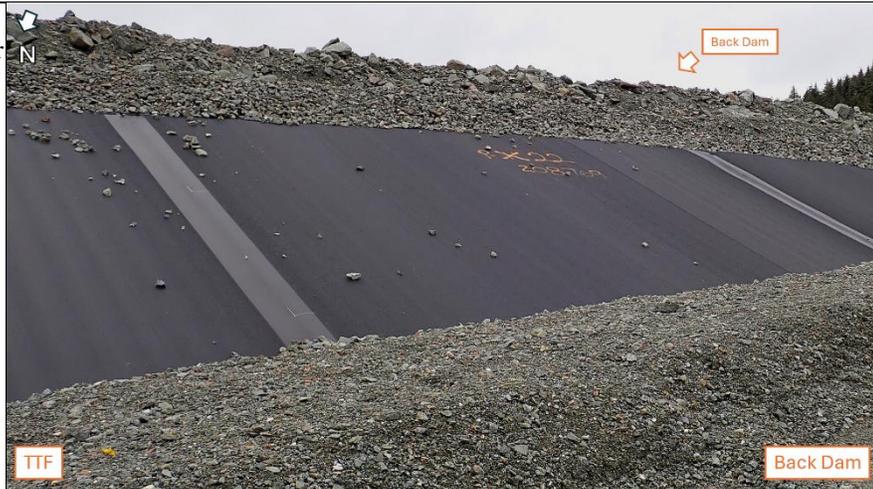
Photo 21: Center middle of the back dam. Note the liner is in good condition.

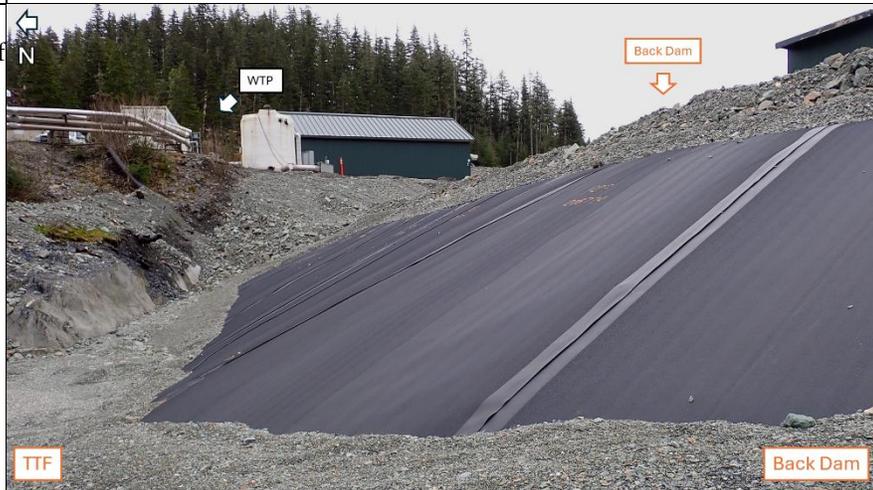
Photo 22: East side of the back dam and partial view of the current WTP. Note the liner is in good condition.

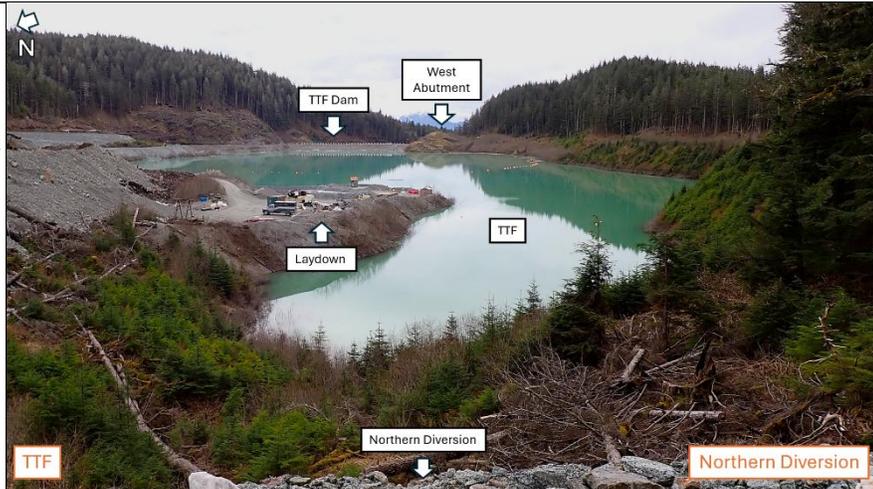
Photo 23: Northern Diversion. View of the laydown yard, TTF, main dam, and west abutment from the Northern Diversion area.

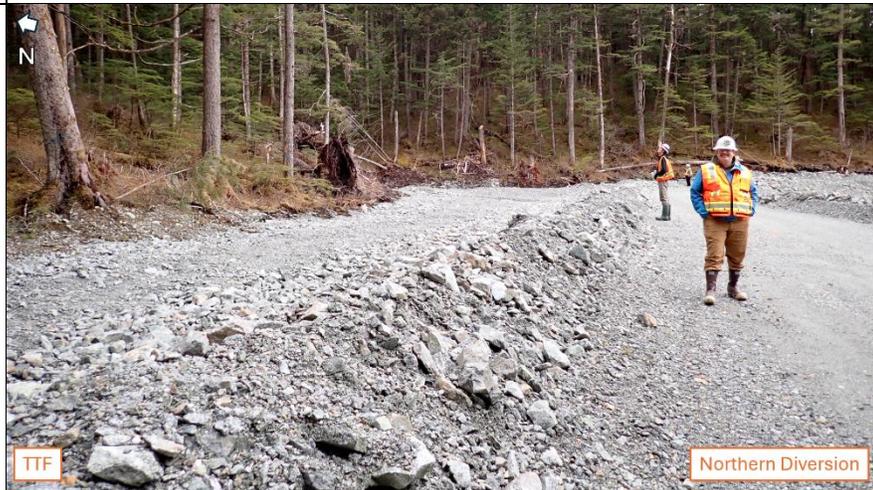
Photo 24: Northern Diversion. View of a gravel road or embankment with workers in the background.

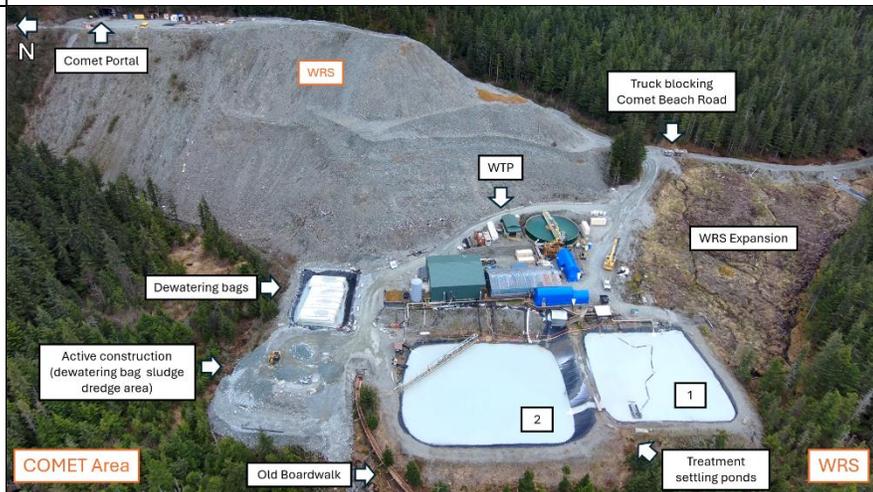
- 2.3 Comet area (Maps 1 and 6, Photos 25 through 30): Sherman Creek outfall 001 operated normally and was in good condition. The new gravel path to the outfall was not completed at the time of inspection. The old boardwalk has been decommissioned and is no longer in use. We walked through the woods on a narrow footpath to reach the outfall. The WTP ponds were full (Photo 29). Active work was occurring in the dewatering bag dredging/sludge area at the time of inspection (Photos 26, 27, and 30).

Photo 26: Comet Area with views of Comet portal, WRS, WRS expansion, WTP, treatment settling ponds 1 and 2, sediment filtration bags, and active construction (dewatering bag dredging/sludge area).

Note the articulating haul truck blocking the road to the Comet Beach facilities.

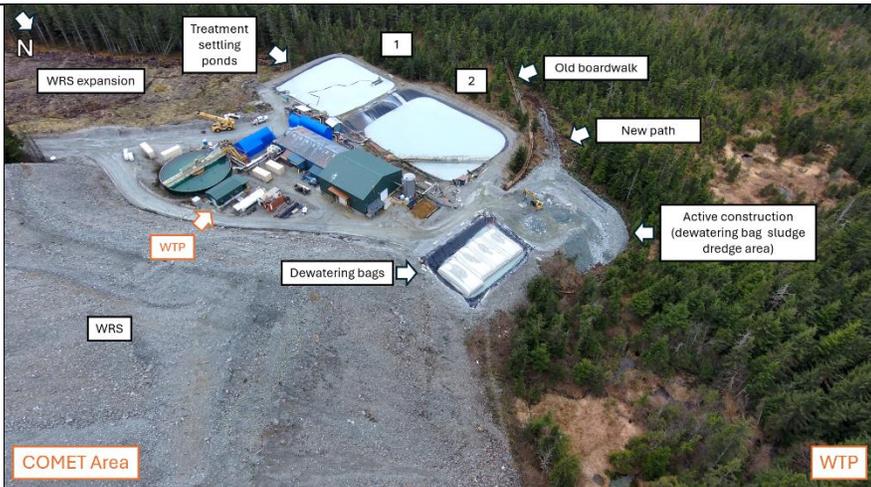
Photo 27: Comet Area. View of the WTP and treatment settling ponds 1 and 2, new footpath construction leading to outfall 001, old boardwalk footpath (decommissioned), sediment filtration bags, active construction in containment area for the dewatering bag sludge dredge area, and partial views of the WRS and WRS expansion.

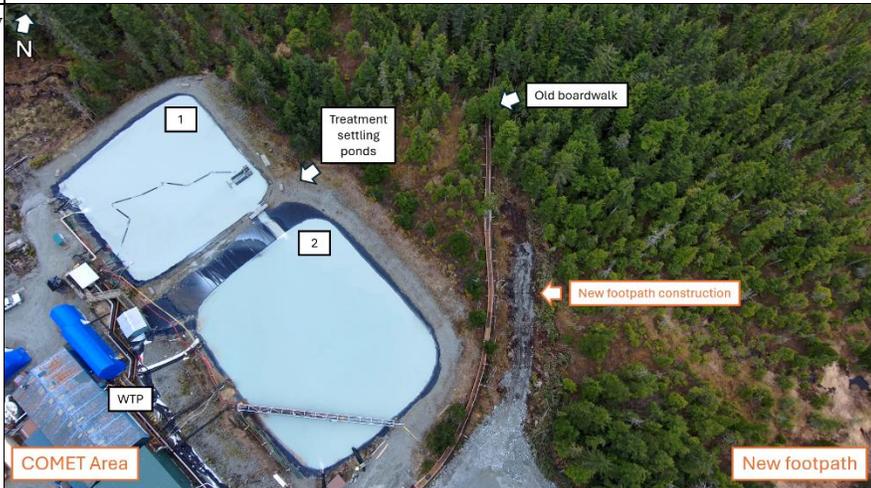
Photo 28: Comet Area. View of the new footpath construction leading to outfall 001, old boardwalk footpath (decommissioned), treatment settling ponds 1 and 2, and partial view of the WTP.

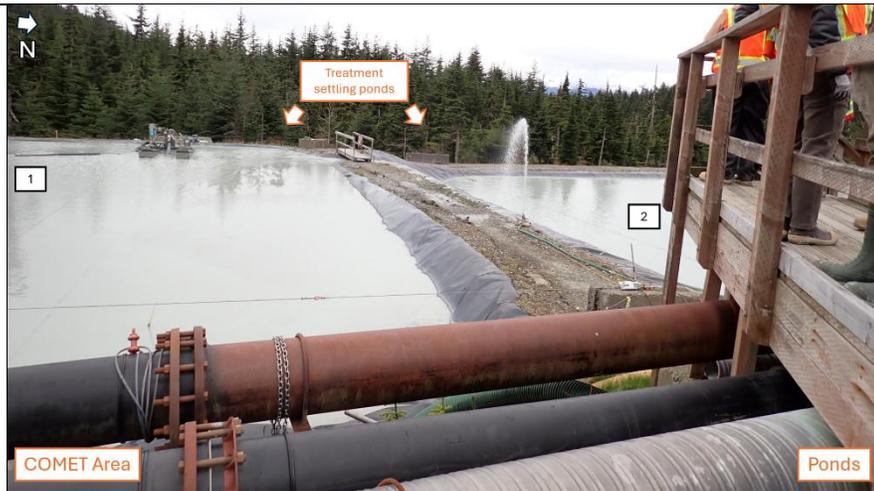
Photo 29: Comet Area WTP treatment settling ponds 1 and 2.

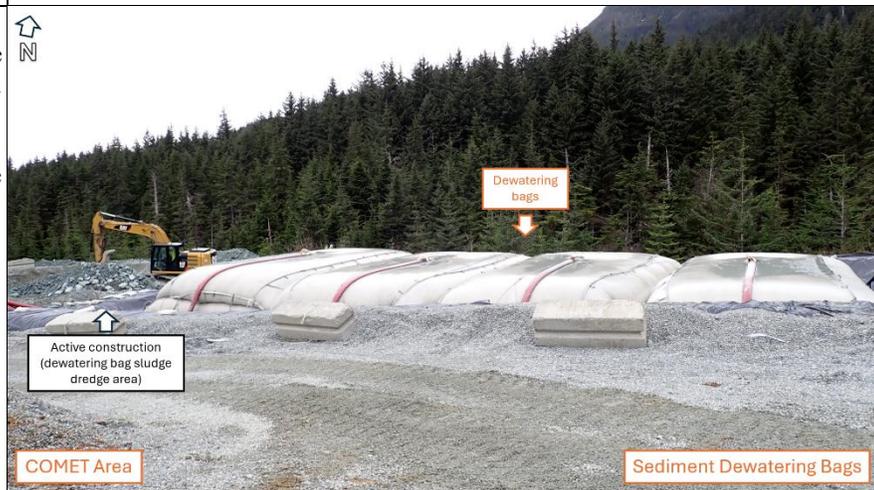
Photo 30: Comet Area WTP sediment filtration bags. The active construction area is in the containment for the dewatering bag sludge dredge area. Typically, there is one active containment cell while the other is being hauled underground for disposal and reset for continued dredging.
