Kensington Mine Field Inspection Report

Inspection Date: June 26, 2024
Time: 8:00 AM to 2:20 PM
Weather: Partly cloudy with a light breeze about 10mph with an average temperature of 60°F.
Agency Personnel: DNR: Aaron Kruse, Jesse White, and Kindra Geis
Operator Contact: Coeur Alaska: Sierra Lammers
Inspection Objectives: Site Inspection

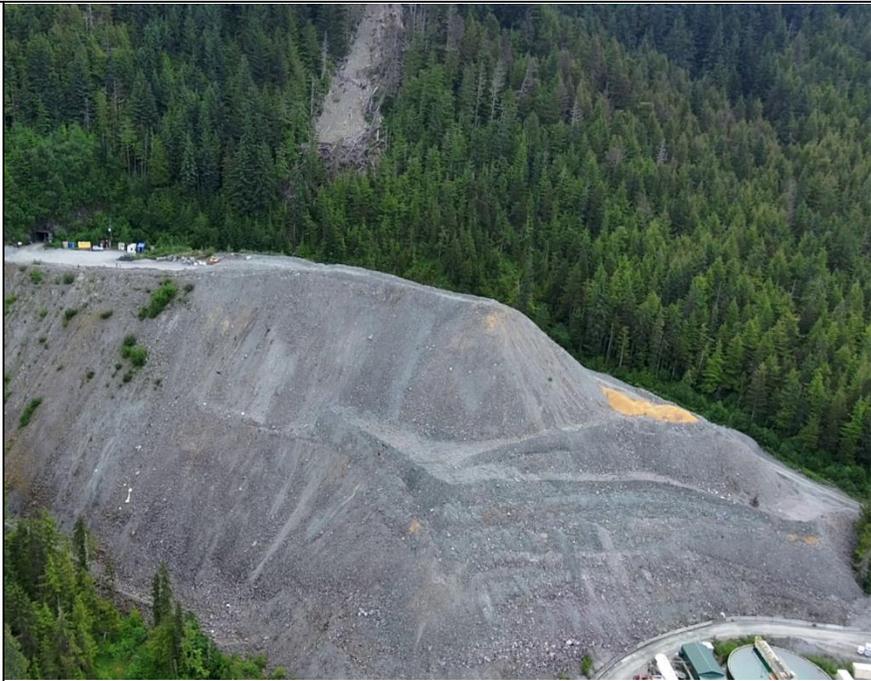
- 1.1. Comet WRS was not active at time of inspection, there was no waste rock being hauled for placement. Only a small stockpile of pebble reject from the mill was present for use as road material (Photo 1). Just south of the water treatment plant is grubbed area encompassing approximately 2 acres (Photo 2). This site will be used for a future storm water pond.

Photo 1: Comet WRS with small stockpiles of mill reject pebble just outside portal. This smaller material is primarily used in road maintenance. There is no active waste rock currently hauled.

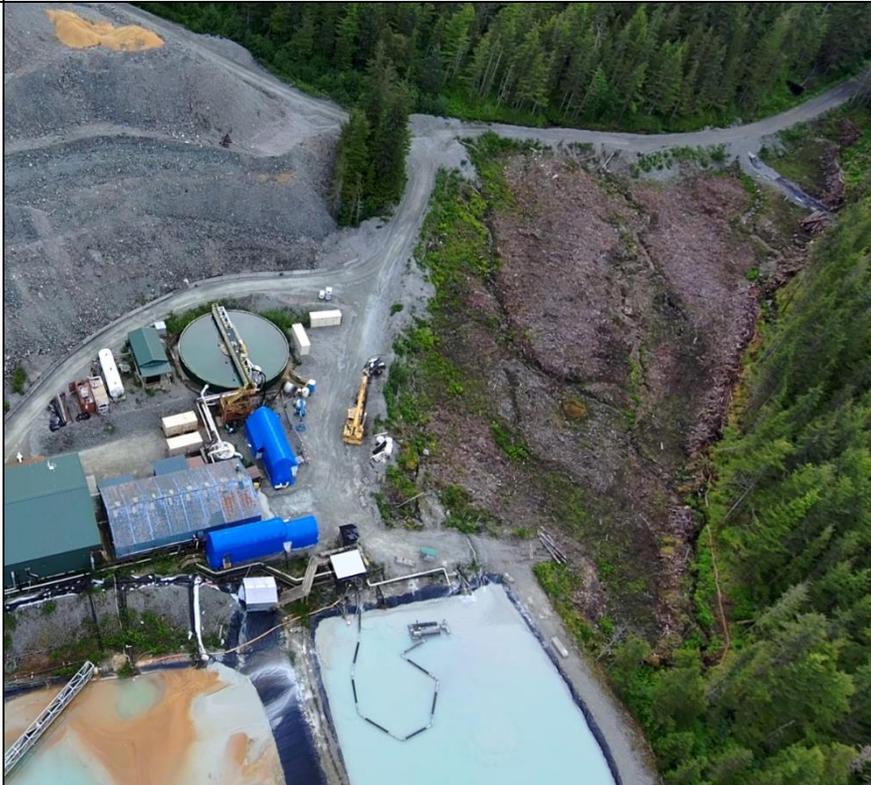
Photo 2: Right half of image is an area that has been grubbed for a future storm water pond. Below are ponds for the water treatment facility.

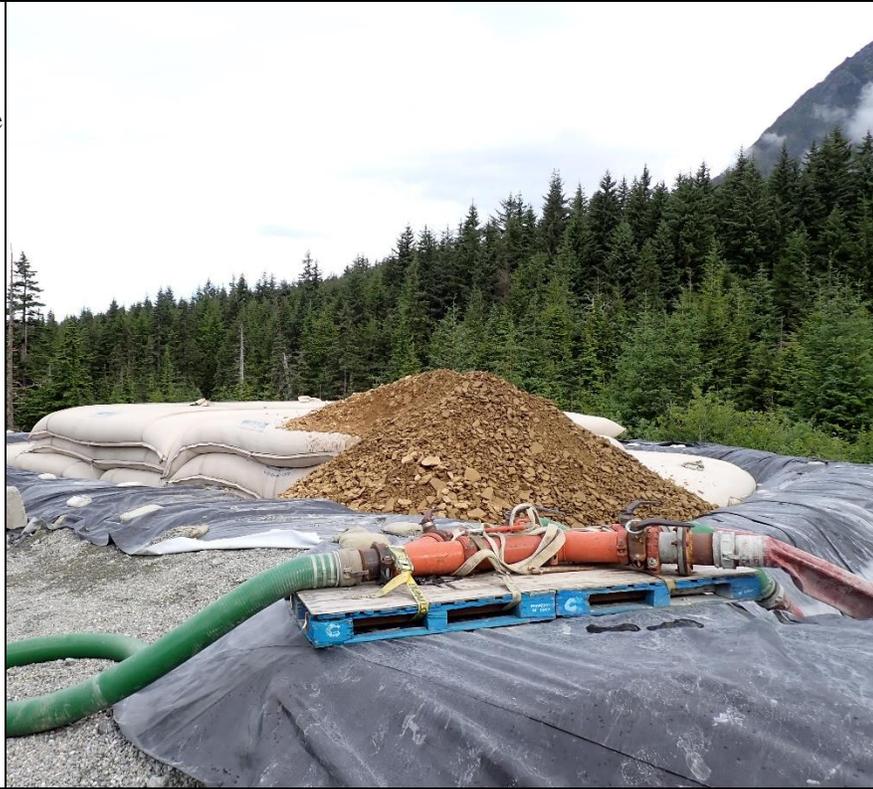
- 3.1. DNR staff observed a bladder tear with sediment cake strung about at the sediment filtration storage area next to the Comet WTP. Cleanup measures were currently under way to transport the cake into the mine for disposal (Photo 3).

Photo 3: Sediment filtration storage with one of the bladders torn open. The sediment cake will be transported underground for disposal.

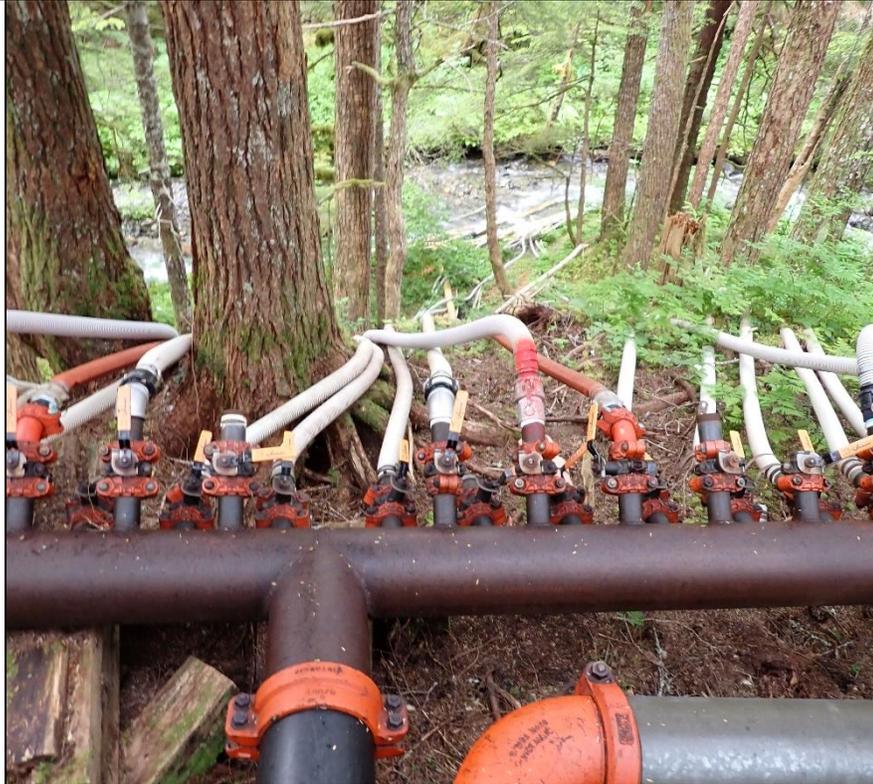
- 2.1. DNR staff observed Sherman Creek Outfall 001 and were informed there was a small increase of the White Stuff in the spring (Photo 4). Outfall 001 is monitored weekly and sampled monthly. There were no concerns noted from DNR staff.

Photo 4: Sherman Creek Outfall 001. Image is of water manifold with valved outlets into the creek.

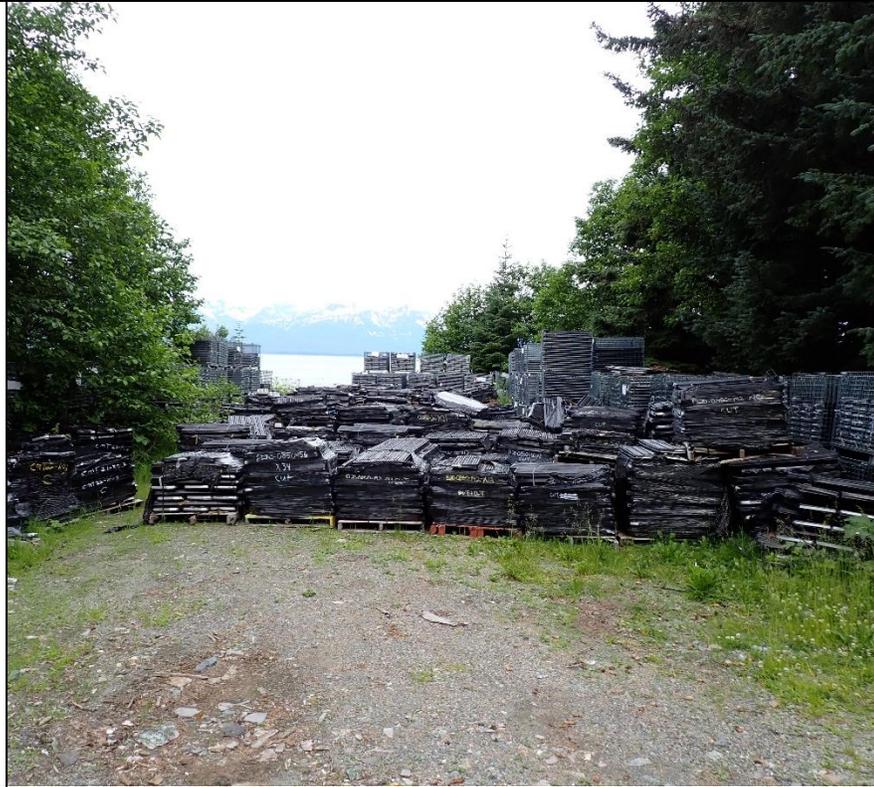
- 3.2. Comet Beach Camp is primarily used to store stacks of core boxes (Photo 5). Some are recent others are from older exploration activities. Older core stocks have degraded and fallen over. Currently cleanup efforts are taking place to remove core and debris to clean up the site.

Photo 5: Comet Beach Camp core storage yard. This area is currently being cleaned up to remove all core and debris.

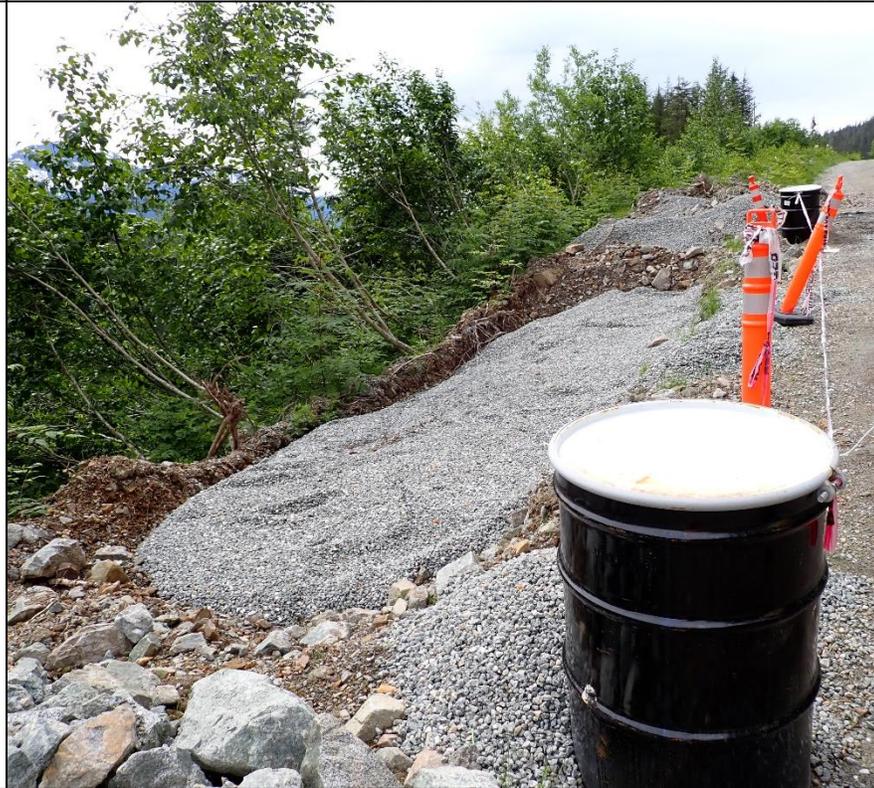
- 3.3. Earlier this spring, there was a tailings spill caused by a rupture in the tailings pipeline. The pipeline was repaired and covered with reject pebble from the mill. DNR staff inspected the site and found it to be in good condition after efforts were made to clean up the subaqueous tailings around the break and repairs were made to the pipeline (Photo 6). Cour staff continue to monitor the site weekly.

Photo 6: Location of subaqueous tailings spill along the tailings pipeline. Remediation efforts included excavation and removal of any tailings. Repair of pipeline, topped with reject pebble from the mill. This area is monitored weekly at time of inspection.

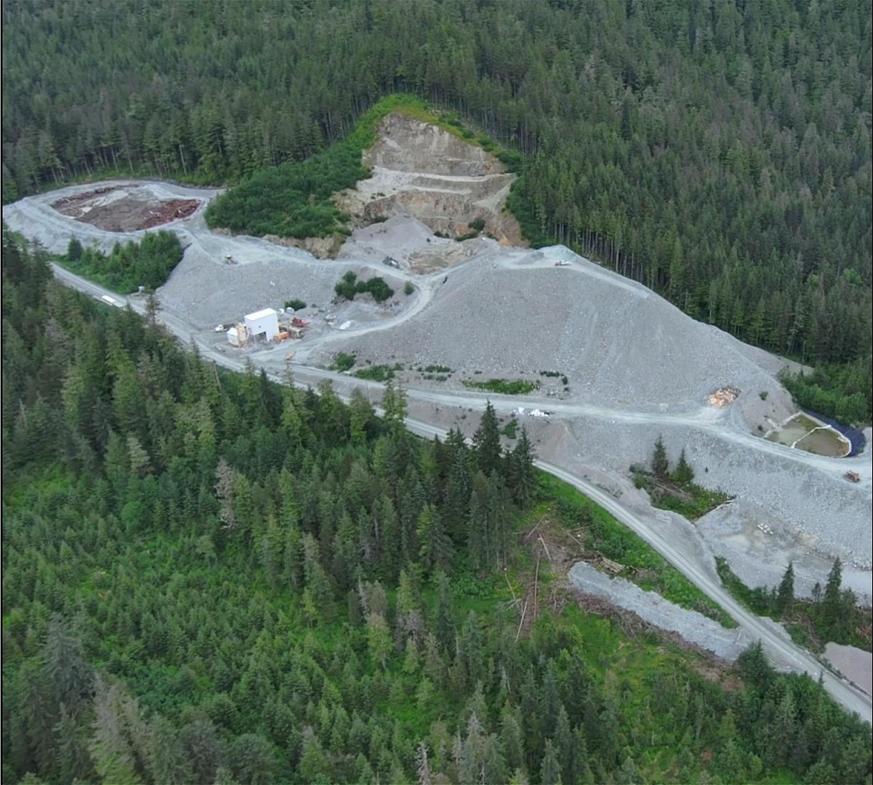
Aerial image is of Pit 4 WRS, excluding the new area of deposition. Starting on the upper left of the image is an organic stockpile. Center below highwall is phyllite storage from main dam construction. Just to the right of the highwall is an older waste rock stockpile. This area has not substantially changed since DNR's last inspection in November 2023.

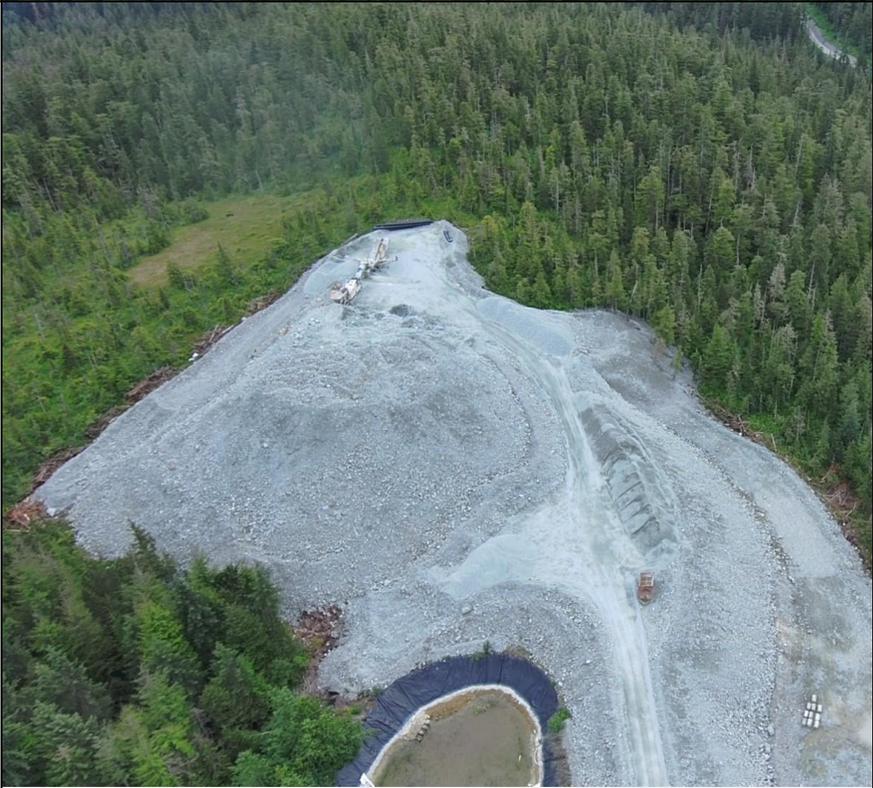
- 1.2. Pit 4 is currently the active site for storage of underground waste rock. The footprint of this site has not changed considerably since DNR's last inspection in November of 2023. However, there has been a noticeable change in volume of material placement on the southeastern portion of the WRS area (Photo 7). At the time of inspection, material from the phyllite storage area was still being excavated to be sent back into the mine to be used as backfill underground (Photo 8).

Photo 7: Pit 4 WRS area of new material deposition.

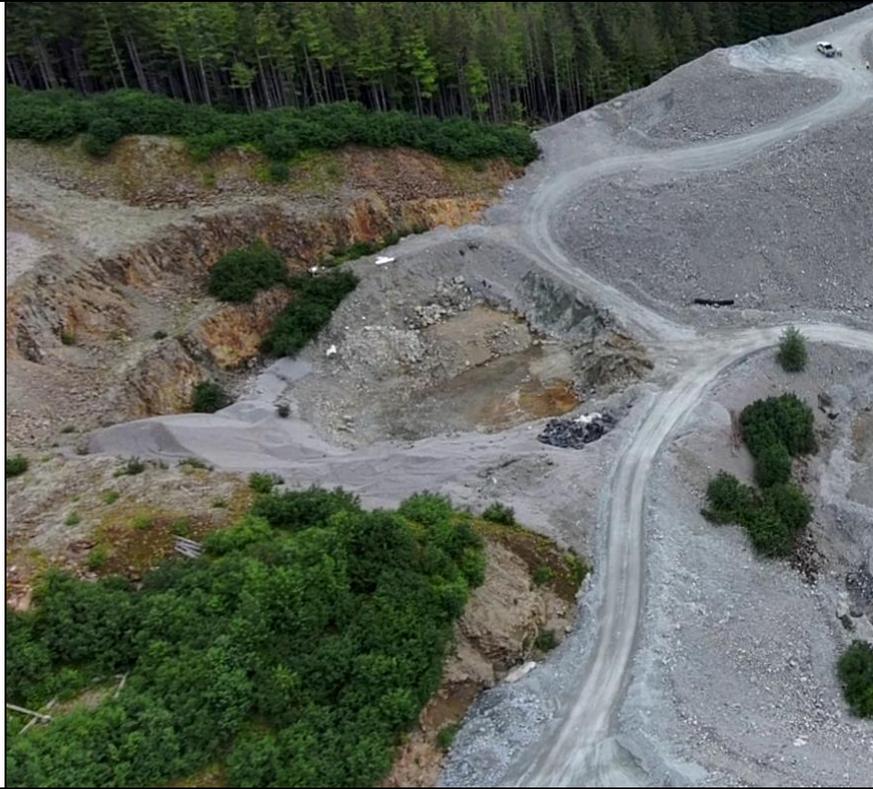
Photo 8: Phyllite storage, very little of this material is left at time of inspection. Almost all this material has been transported underground for disposal.

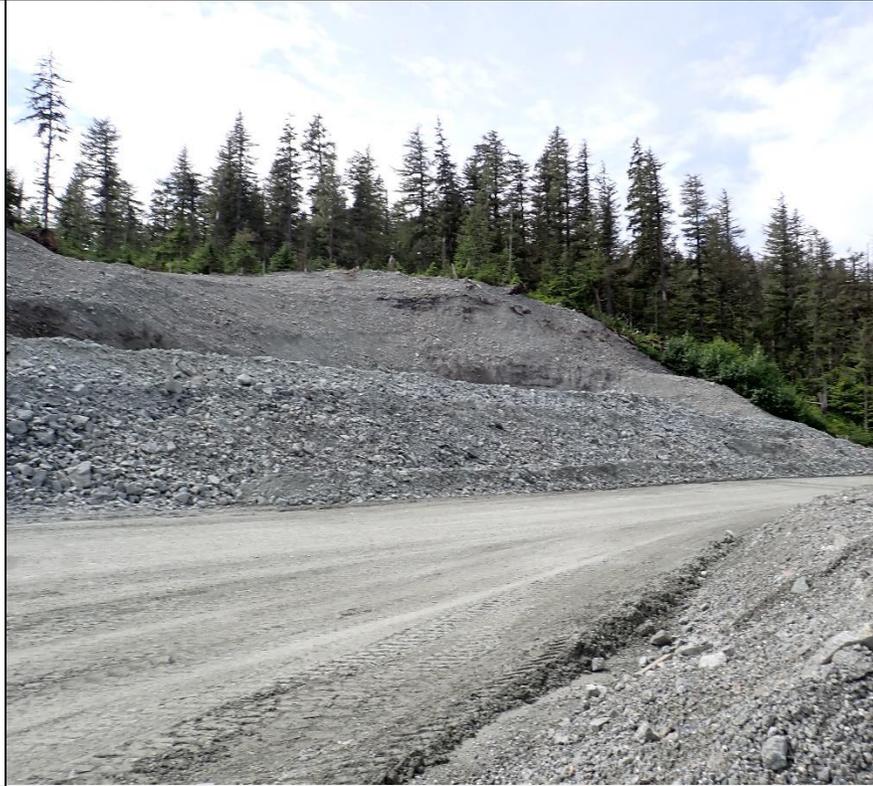
- 1.3. Pit 7 is approximately halfway between the main road by Pit 4 and the TTF. At the present time, this area is used for construction material storage. Several piles of material were documented (Photo 9): One comprised of waste rock transported from the portal pad, to be used in back dam construction and for the new pad of the water treatment plant (WTP). There were also covered piles of potentially acid generating material (PAG) and a stockpile of reject pebble from the mill (Photos 10 and 11).

Photo 9: Pit 7 waste rock storage from portal area to be used in back dam and WTP pad construction.

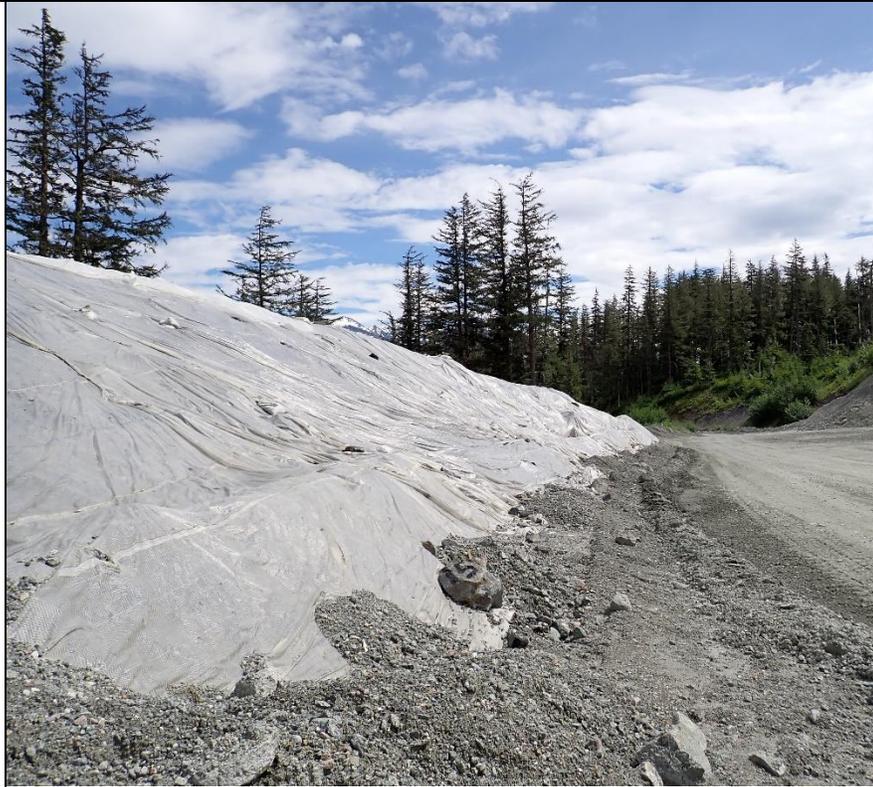
Photo 10: Pit 7 PAG covered stockpile likely from excavation of the back dam. Pile sits north along the road edge across from the main pit area.

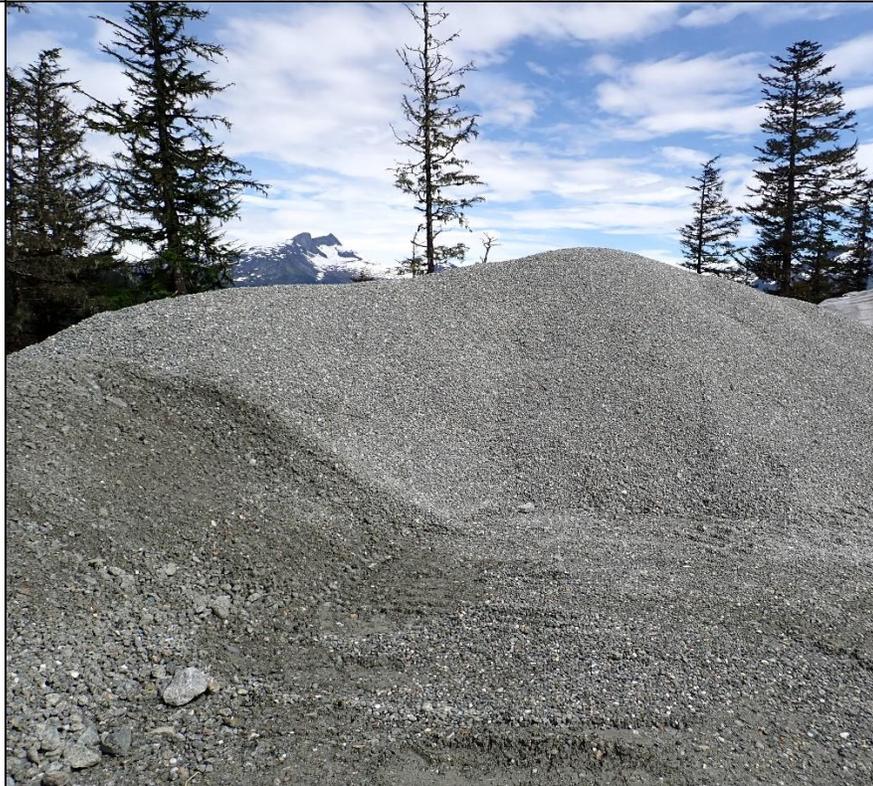
Photo 11: Pit 7 mill reject pebble stockpile located northwest of the main pit and just west of the covered PAG material.

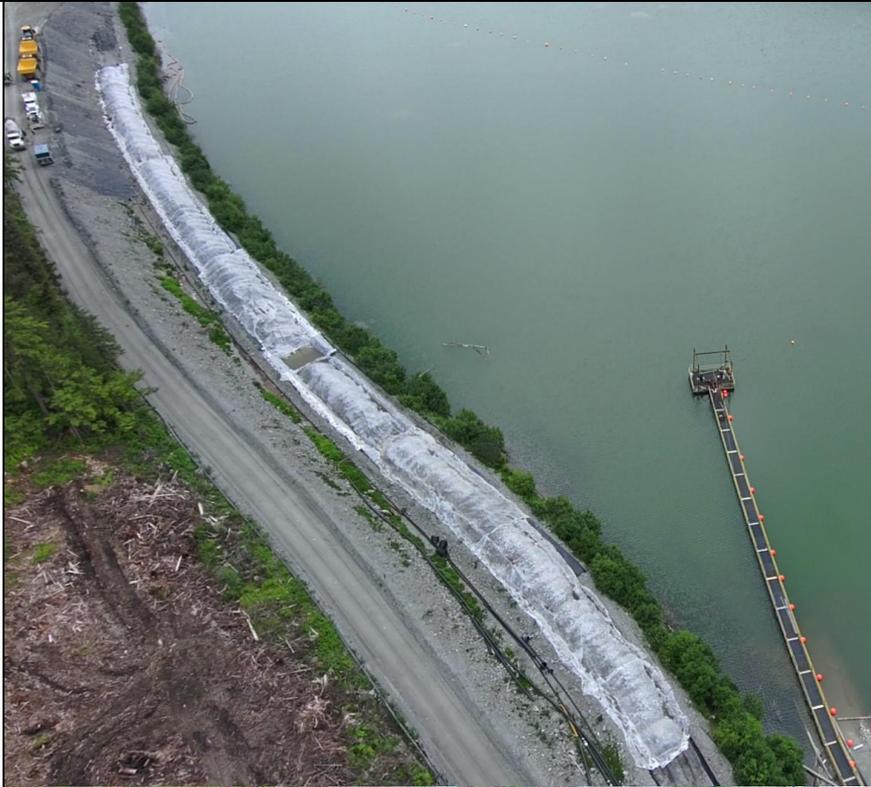
- 1.4. Along the access road of the TTF to the main dam is another PAG material storage site. This material was generated from excavation of the back dam and is properly covered for storage (Photo 12). It extends approximately 750 feet in length starting from the dock for the floating tailings barge along the main dam access road. All stored PAG will be hauled back underground within the mine for disposal.

Photo 12: Along the access road to the main dam on the east side of the TTF is covered PAG material. This material will be hauled underground for disposal.

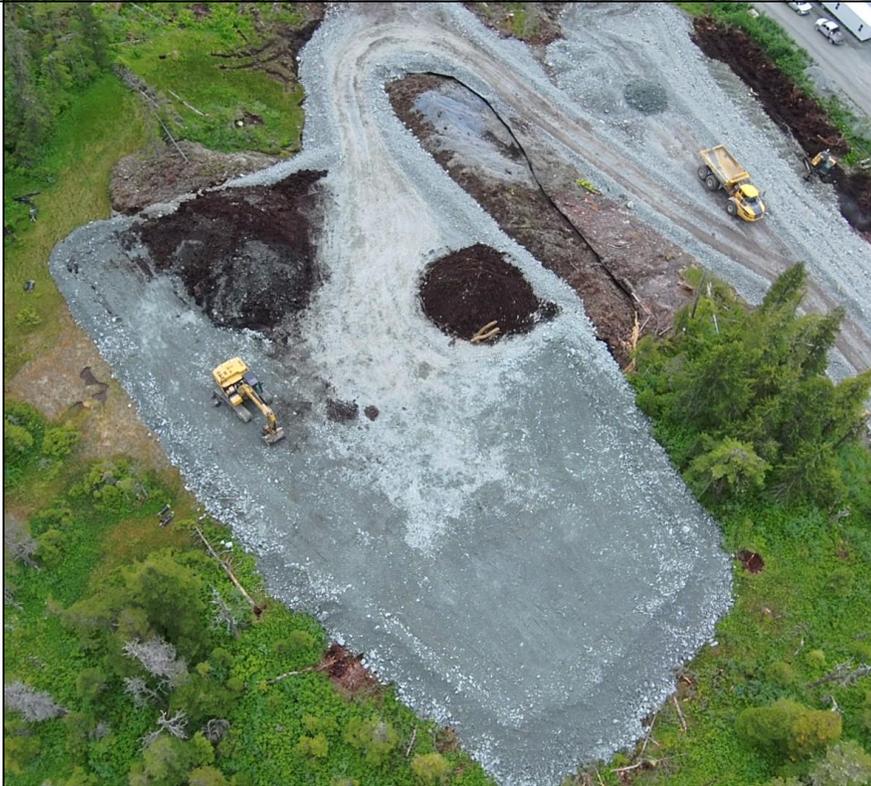
- 1.5. Just east of the current WTP for the TTF is an area that has been designated for the new WTP under stage 4a plans. This area was grubbed with active construction establishing the new pad for the WTP. At the present time an access road was in place with equipment spreading waste rock, forming the initial footprint for the WTP pad (Photo 13)

Photo 13: Area of construction for the new WTP pad. The WTP must be relocated for the dam raise outlined in the Stage 4a proposal.

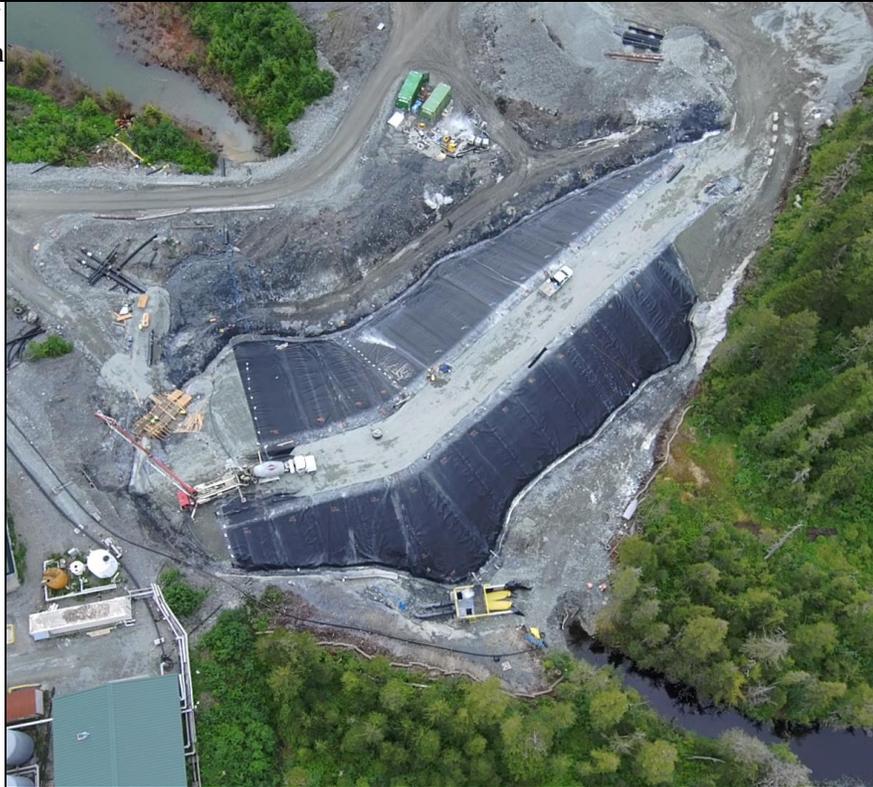
- 2.2. The construction of the back dam was at a point where it was built to its final height. Ongoing work for the welded outer liner and spillway were presently underway (Photo 14). The west ramp of the back dam is used for material storage. Some waste rock was also observed from the dam's excavation. Organic stockpiles resided within this area and will be relocated for future use (Photo 15).

Photo 14: Construction of the back dam. Left of dam is wood cribbing where spillway will be located. Outer liner is almost complete. Dam has reached its final height at time of inspection. Upper right of photo is some stockpiled construction material accessed by west ramp.

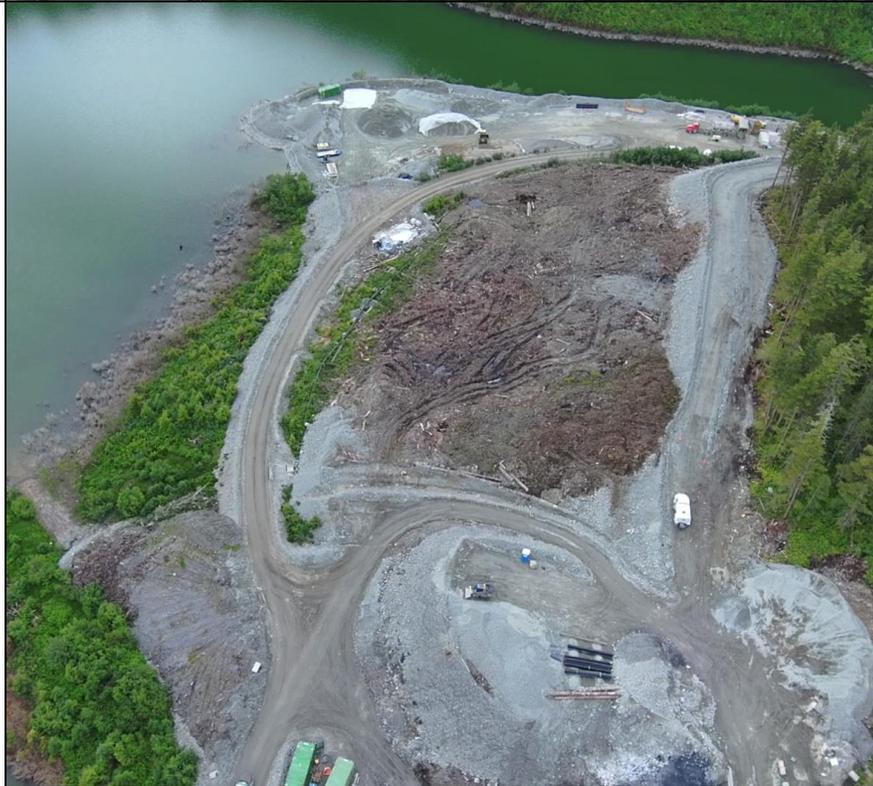
Photo 15: West ramp of back dam showing material stockpiles (background), and organics (center) with storage area for more construction material (foreground).

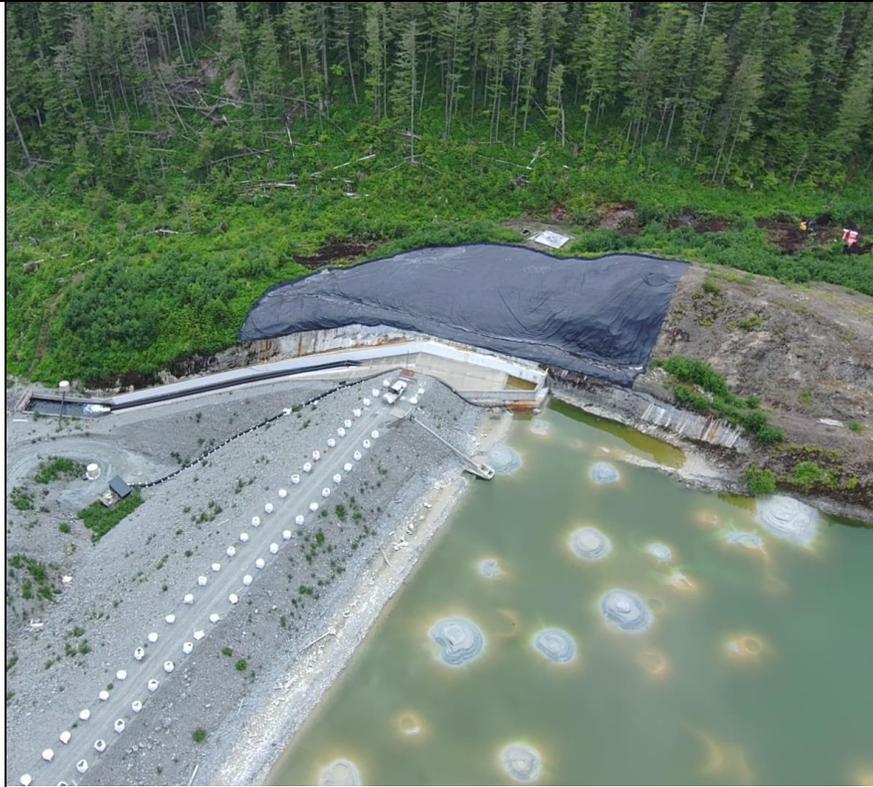
- 2.3. DNR staff also visited the main dam and its facilities along with Outfall 002. At the time of inspection, the new access road down to dam water seepage collection pump and water sampling locations was in place. Initial work for the Stage 4a spillway was underway (Photo 16) with observed disturbance, uphill, and directly west of the main dam. Water was flowing from the spillway into Outfall 002.

Photo 16: Main dam (center) with views of tailing mounds just below the water line. Some disturbance noted in the upper right of image. This will be the location for the new spillway. Liner covers exposed phyllite from dam's original excavation. Just below at the toe of the dam is the seepage pump.
