October 29, 2013 Inspection of the Kensington Gold Mine

Inspectors: Andrea Hilbert - ADEC
Pete McGee - ADEC
Allan Nakanishi – ADEC
David Wilfong – ADNR
David Schmerge – USFS

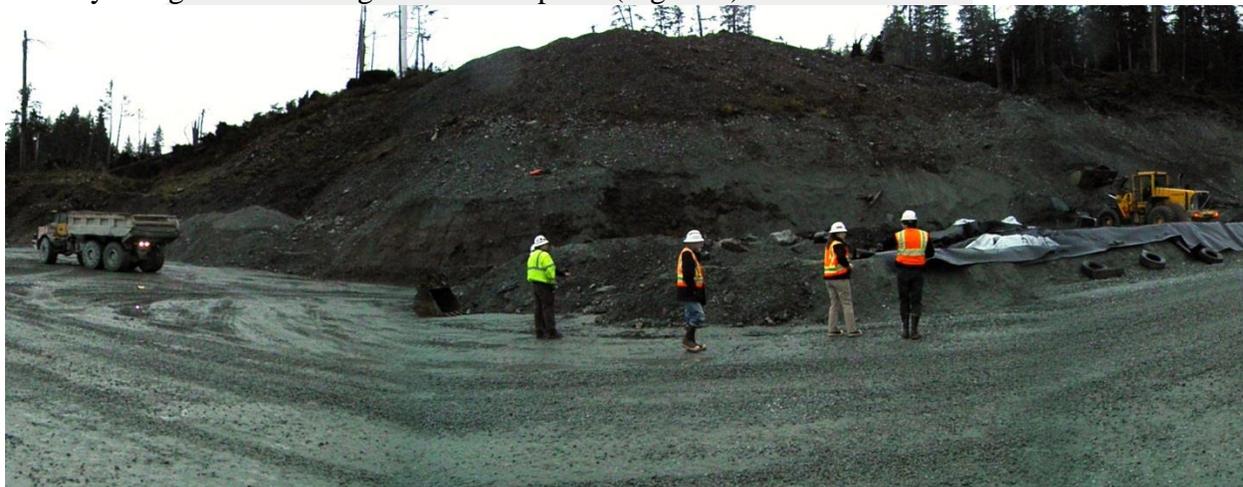
Figure 1 A front-end loader gets ready to load a 40 ton underground haul truck with graphitic phyllite.

A front end loader transfers GP to an underground haul truck, and it is driven about 3 miles to the Jualin Portal and then to a mined out stope on the 630 level where it is dumped down a raise. The raise leads to the 555 level where it is stored until it can be mixed with Portland Cement and placed into secondary stopes as cement rock fill. A sizable amount of GP had been hauled underground in the past month. While on site during the September 19, 2013 inspection, about 10,000 tons of the rock was stored in Pit 7, but during the October 29, 2013 inspection, it was estimated that less than 1,000 tons were left. Coeur had committed two 40 ton haul trucks to haul the material full time during the 12 hour day shift to ensure that all of the PAG rock got transported underground before November 15. When Kevin was asked if they would make the deadline, he stated that they were on track to finish about a week prior to the 15th.

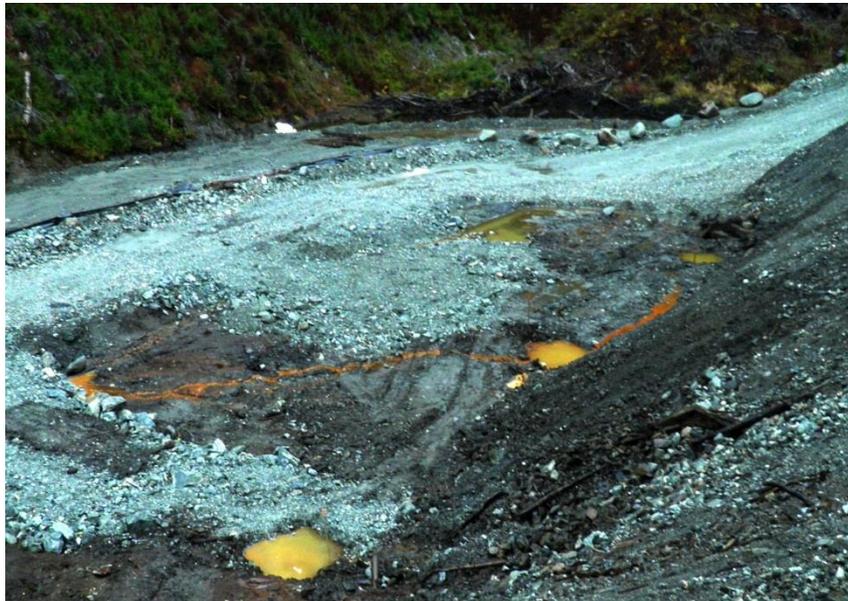
The PAG material had been mistakenly placed at the north end of the TTF as fill after being excavated from the Area around the TTF dam foundation during the Stage II raise in the summer and fall of 2012. The excavated area still showed some signs of possible ARD from one of the seeps at the toe of the pile (Figure 2). Coeur had recently excavated 200 more tons of material after

Figure 2 The middle seep was still brighter orange than the other seeps.

continued sampling showed deteriorated water quality from the middle seep. Kevin stated that the extra material showed signs of being PAG, such as orange staining. At this time it is difficult to ascertain whether the orange color at the middle seep is due to even more PAG material in the pile, or just leftover residue from the previous ARD. Despite warmer than normal temperatures this fall, the facility will inevitably be covered with snow soon, and it may the spring of 2014 before it is known if all of the PAG material has been removed. More information may be found on the ARD remediation in the 10-10-13 Inspection Report from ADNR.

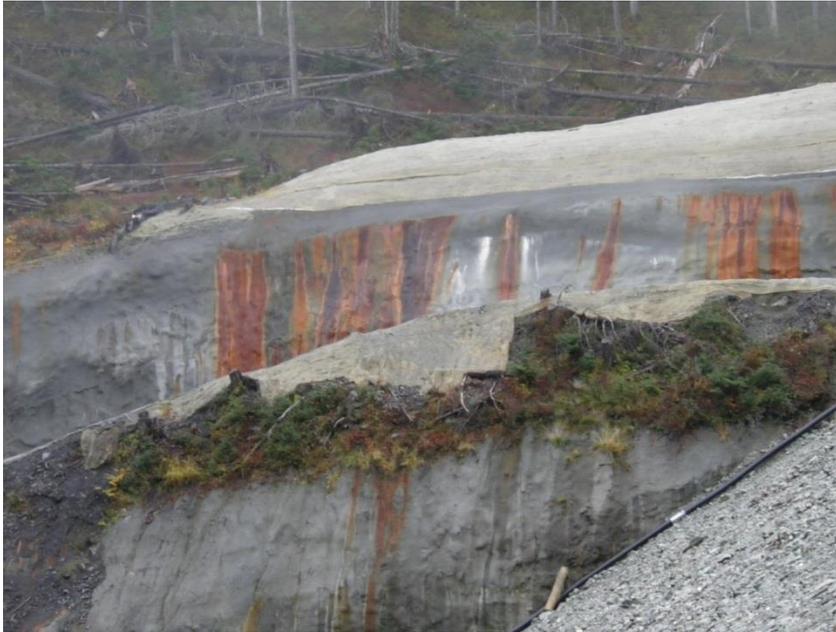
Figure 3 An invisible line has formed at the top of the emergency spillway.

The inspectors moved to the south end of the TTF and walked to the bottom of the downstream face of the dam. Low pH water continues to seep through the shotcrete in the dam's emergency spillway. A noticeable "line" has formed on the shotcrete at the top of the orange – brown stains (Figure 3). It is possible that it delineates the upper extent of the PAG graphitic phyllite geologic formation. It may be a potential tool to use this

visual reference to estimate the extent of the graphitic phyllite during Stage III of the dam construction. Staining can also be seen on the shotcrete that was placed on the embankment near the Upper Slate Lake diversion pipe outlet. More staining can be found in the gravel at the toe of the covered graphitic phyllite pile at the east end of the dam. The pile was encased with diorite to aid in the neutralization of any acid that may form. At this time, the staining is not severe enough to cause much worry, but the situation should be monitored in the future.

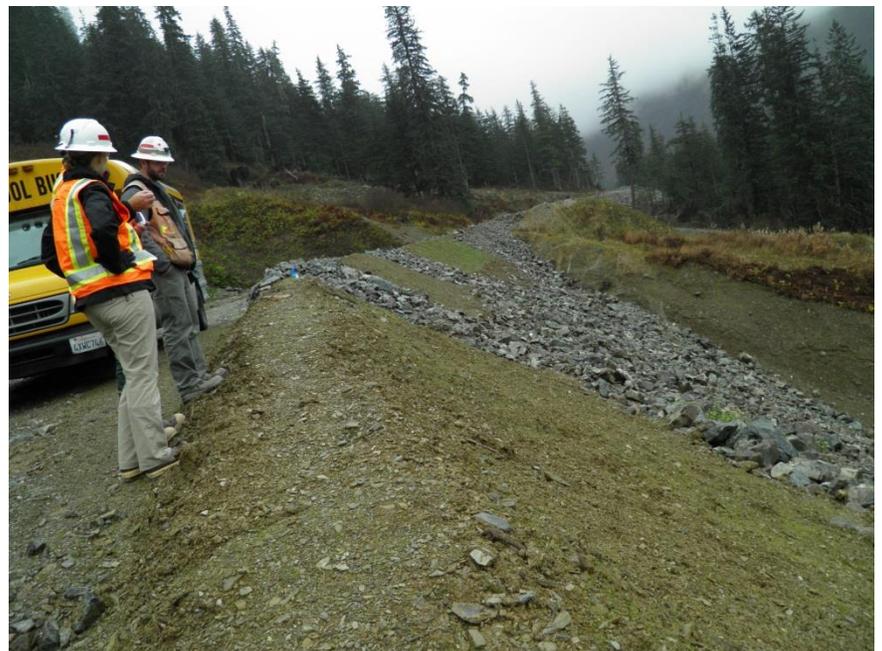
After leaving the TTF, Pete and Allan went underground to look at the GP storage, and Andrea, David and Dave went to the revegetation test plots. All three test plots continue to grow well, but the plot using fertilizer and mulch appears to be outgrowing the other two (Figure 4). The plot using the biopolymer shows a small area (~18"X18") of erosion. This is likely due to thin growth media cover. At this time, it does not appear to be leading to slope instability. The test plots will soon

Figure 4 The plot using fertilizer and mulch (in the distance) shows the best results.

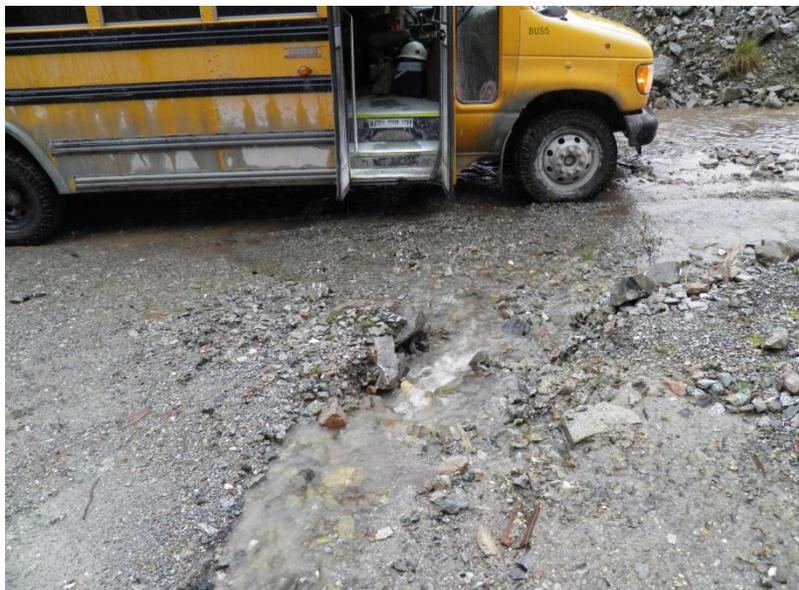
Figure 5 Heavy rain caused surface runoff on the Pipeline Road.

As the group was leaving the test plots, the bus's transmission began to slip, and when it stopped near a core drill rig, it was found that the transmission was leaking (what appeared to be several gallons) transmission fluid onto the ground. Due to the heavy rain, water was flowing down the "Pipeline" Road (Figure 5). Coeur personnel responded swiftly to the situation by laying down oil absorbent pads on the floating transmission fluid, while

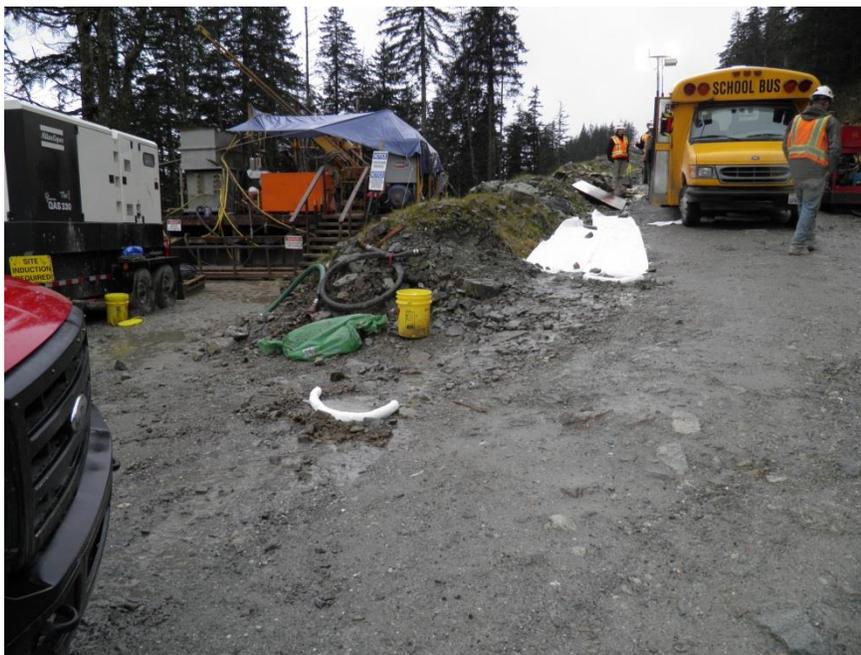
deploying oil absorbent boom across water flow paths and digging sumps to catch any contaminated water (Figure 6). The level of containment demonstrated by the responding environmental personnel (Pete Strow) confirmed a high level of training and awareness, and the response to the small spill was swift and appropriate. It appeared as though a rock may have punctured the oil pan on the transmission, causing the leak.

Figure 6 The response to the leaking oil was swift and appropriate.

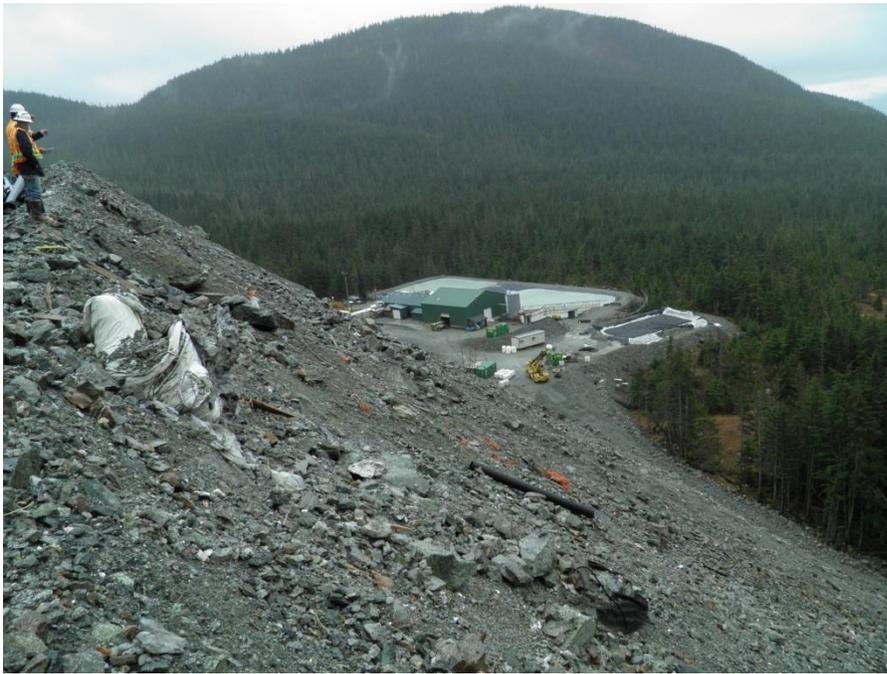
Figure 7 The Comet Water Treatment Plant from the top of the waste rock pile.

After the two smaller teams of inspectors regrouped for lunch, a new bus shuttled them to the “Comet Side” to look at the waste rock pile, and the water treatment plant (Figure 7). Both of the treatment plants were operating as the mine was dewatering about 2,000 gallons per minute. The desedimentation sumps continue to work well, and the turbidity reporting to the Comet water treatment plants is

noticeably lower than in previous years. At the base Comet waste rock pile, David and Pete walked into the woods to Ophir Creek. Kensington has been troubled by periodic water quality exceedances which may be originating in Ophir Creek. The situation is being closely monitored.

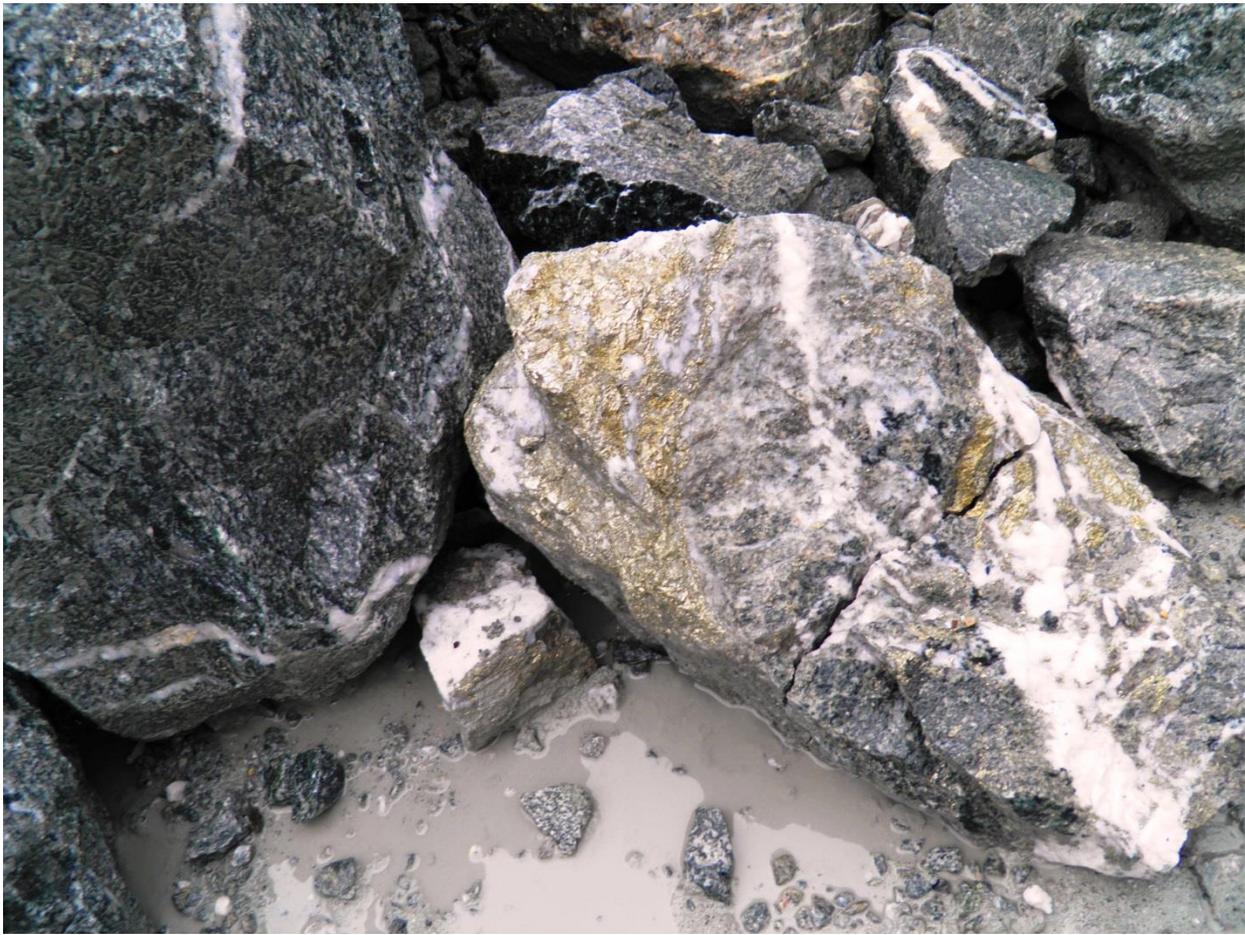
Figure 8 Gold-laden pyrite in quartz diorite at the Kensington Gold Mine.
