FIELD INSPECTION REPORT COEUR ALASKA/KENSINGTON MINE

Inspection Date: October 19, 2011, 09:00 - 14:30

Purpose of visit: Routine inspection

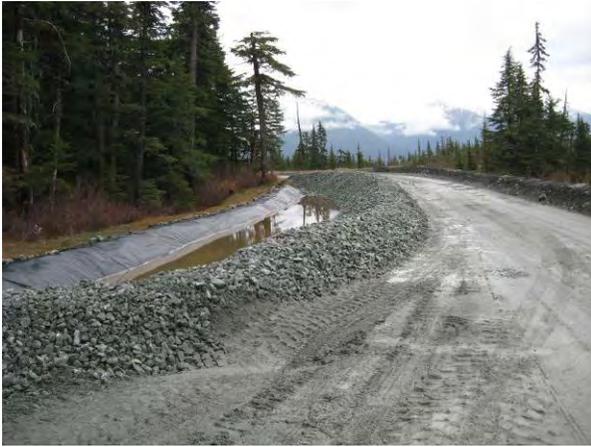
Road system: MSHA is at the site and is requiring Coeur to install berm alongside the roads; the height of the berms is to be 1/2 the height of the largest tire size used on the road. (Photo 1) Recent rains have filled stormwater ponds; these contained turbid water. In the vicinity of the maintenance area/Pit 3 a 55-gallon barrel on a pallet was noted to contain approximately 25 gallons of used oil. Kevin contacted the responsible person and was informed the barrel was in transit for disposal.

Photo 1 – rock berms beside road

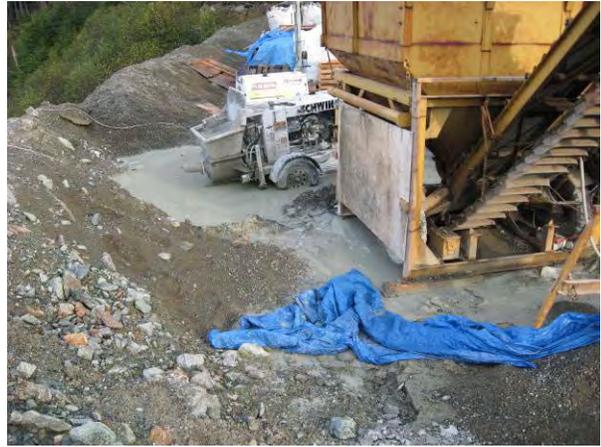
Comet area: Dewatered Pond 1 sediment was being brought to the top of the waste rock pile at the portal. Cement and mud are present at the concrete mix plant. There is no particular containment for this (Photo 2). However the majority of the liquid would be expected to percolate into the waste rock. Due to recent and heavy rain some of the material had gone down the road. This would have been captured in the ditch collection system or adjacent to the rock pile further down the road.

Photo 2 – cement slop at concrete plant

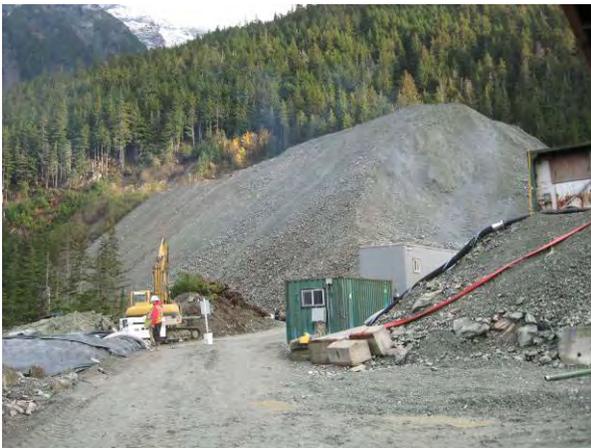
The waste rock pile toe is adjacent to Ophir Creek; the slope of the pile is 38 degrees (0.78H:1V) (Photo 3).

Ore at the lower end of the pile has been taken to the mill. Runoff from the pile has contained iron that has stained rocks a reddish/brown. This can be seen in the drainage between the rock pile and the water treatment plant.

Photo 3 – Comet rock pile

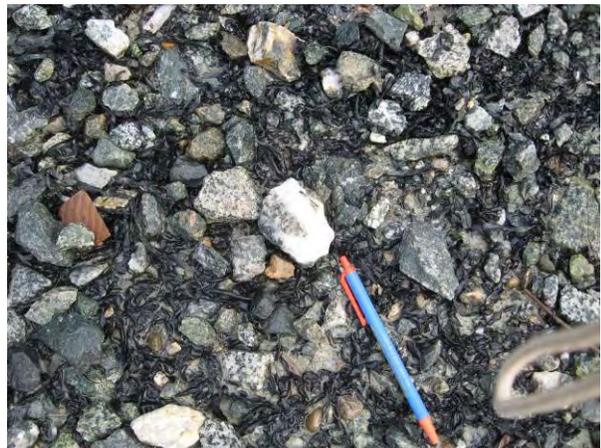
Plastic pipe is being fabricated adjacent to the treatment plant. This leaves plastic swarf on the ground (Photo 4). This swarf is to be picked up and properly disposed of at the termination of pipe fabrication in 3-4 months.

Photo 4 – plastic swarf

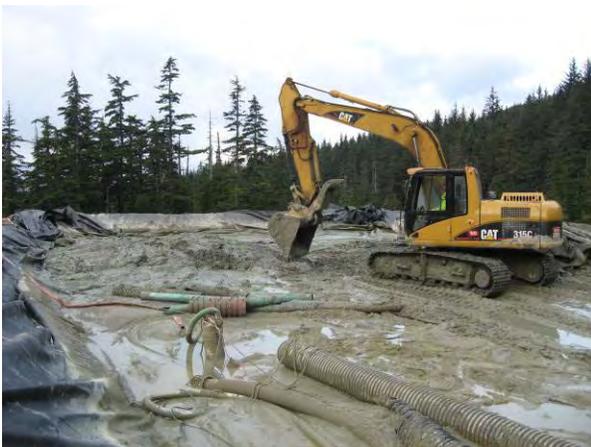
Curt Jones, the treatment plant operator, accompanied us around the primary settling ponds, Outfall 001 walkway and the exterior to parts of the treatment plant. Adjacent to the ponds sloppy pond 1 sediment from the sediment bags was being prepared for removal by truck to the top of the rock pile (Photo 5). A 60 mil liner has been placed in Pond 2 (Photo 6). A bridge is to be constructed across the corner of the pond to hold the pump. Pond 1 was in operation and seen to be partially full of sediment. The liner is to be replaced in this pond once Pond 2 is operational. Pond 1 still leaks at a rate of 3-4 gpm.

Photo 5 – dewatered Pond 1 sediment

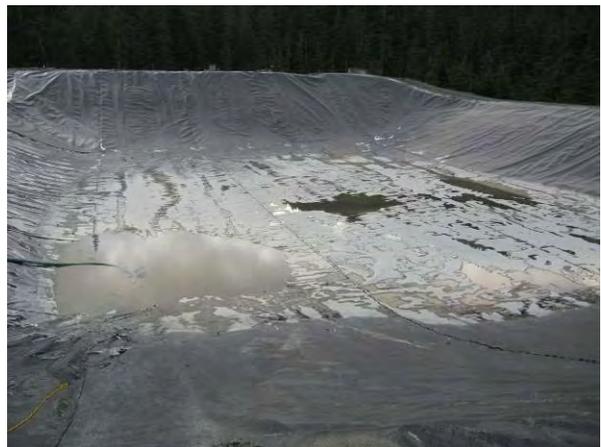
Photo 6 – Pond 2 polyethylene liner

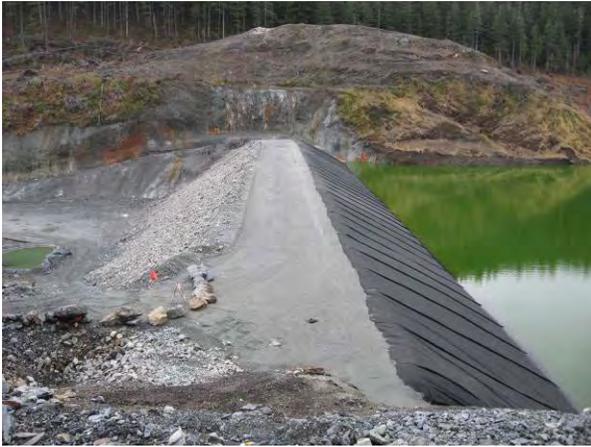
Tailings Treatment Facility (TTF): The green color from algal growth was clearly visible (Photo 7). The elevation of the water is 672.9'. The water level needs to be 668' in order to have sufficient capacity for a 200-year storm, with 2' of freeboard at the spillway. Coeur has installed the 12" pipe for the treatment plant to the plunge pool for the treatment plant discharge (Photo 8). Once put into operation the capacity of the 26" pipe will increase from 5000 gpm to almost 10,000 gpm, enabling a greater volume of water from Upper Slate Lake during a large storm event to be diverted around the tailings facility, rather than have this water enter the facility, so reducing its ability to hold the designed 200-year storm event. During an earlier storm event the water level rose 4' in 24 hours in the TTF, partly due to water from Upper Slate Lake overtopping the weir at the mid-lake bypass. The average pump back rate from the sump below the dam was 29 gpm for 6 months prior to the rainy period over the last 6 weeks, when the average pump back rate was 44 gpm.

Photo 7 – Green water in the TTF.

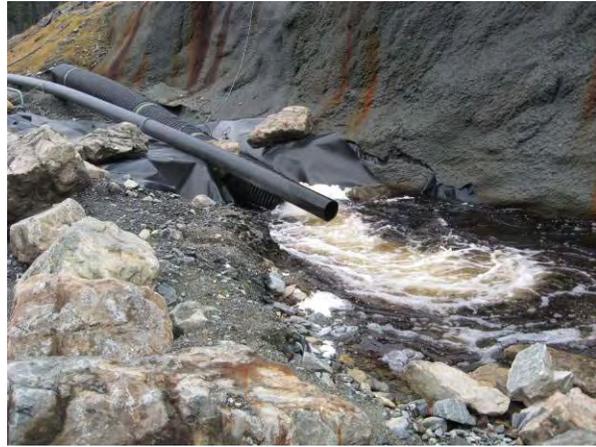
Photo 8 – 12” pipe from WTP at the plunge pool

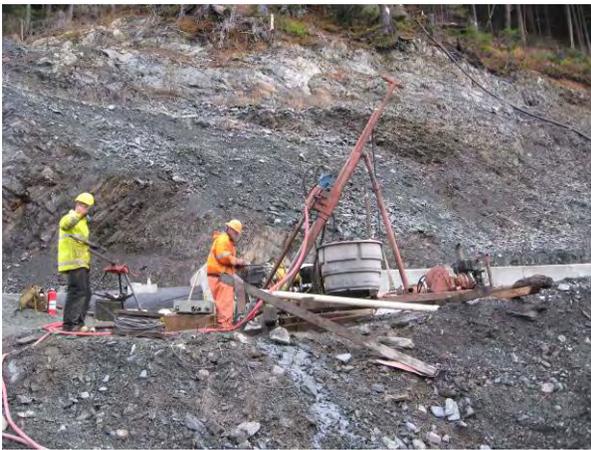
Core drilling was in progress at the dam site in preparation for the dam raise (Photo 9). The holes will go down to a depth of 100'. Water for drilling was being taken from the flume. It was pointed out to Kevin that fish from Upper Slate Lake that come down the diversion pipe may be sucked up into the drill water pump. Kevin said a screen will be placed over the intake end of the pipe to prevent this. Phase 2 of the construction will raise the dam 25'. Prior to dam construction seeps from the acid generating material that occur in shotcrete on the embankment above the flume are to have additional shotcrete placed over them per recommendations in Golder's report dated October 11, 2011.

Photo 9 – Core drill rig at the dam site
