# STATE OF ALASKA

## DEPARTMENT OF ENVIRONMENTAL CONSERVATION

### FIELD INSPECTION REPORT COEUR ALASKA/KENSINGTON MINE

**Inspection Date:** October 10, 2012, 08:30 - 15:30  
**Report Date:** October 16, 2012  
**Weather:** Fine. Temperature 50 – 60F

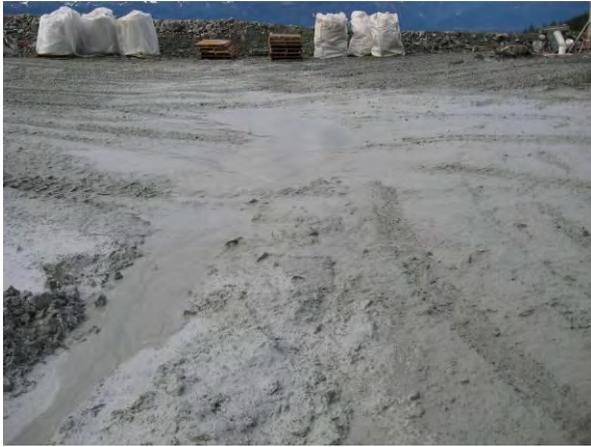
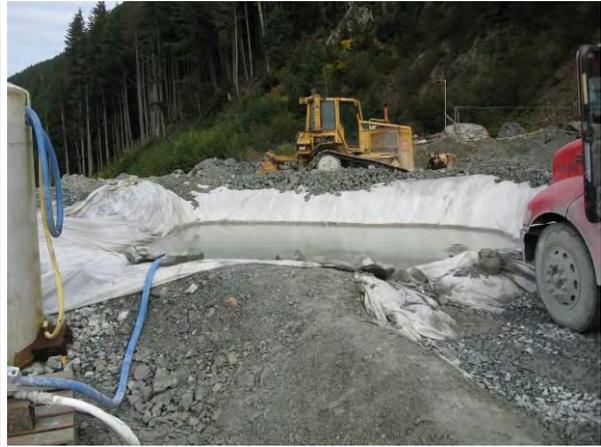
**Comet area:** Just outside the portal cement slurry is created within trucks to be taken to paste backfill areas within the mine where there are no pipes from the paste plant. There is a pond that is used for materials flushed from the trucks when they are cleaned. Recent rock had been placed to raise the truck loading area so that cement slurry was not carried out onto the main access and road system by trucks leaving the area. Prior to this the slurry had gone out onto the roaded area and was migrating down a storm water ditch beside the road. The rock platform should prevent this in the future. Kevin said they would scoop up the cement slurry that was presently on the road and migrating down the ditch. At the base of the rock pile a large wooden spool, possibly a cable spool, was seen to be sitting in Ophir Creek. Kevin said he had not seen it there before and would have it removed.

Photos 1 & 2 – Cement slurry at the Comet portal and the cement truck wash sump.

1. Clean up the cement slurry outside of containment at the Comet rock dump.
2. Clean up the oil spill under the Bobcat at Pit 3.
3. Clean up the oil under the old excavator at Comet beach, and install a capture mechanism for future leaks.
4. Provide 110% secondary containment for all chemical tanks.
5. Make sure the temporary cover over the 260 cy of graphitic phyllite material is secure and will not blow off, and overlaps such that rainwater does not reach the stored material.
6. Continue discussions and / or provide options for long-term treatment or actions for graphitic phyllite faces that will not be covered over by the Phase 3 dam construction.

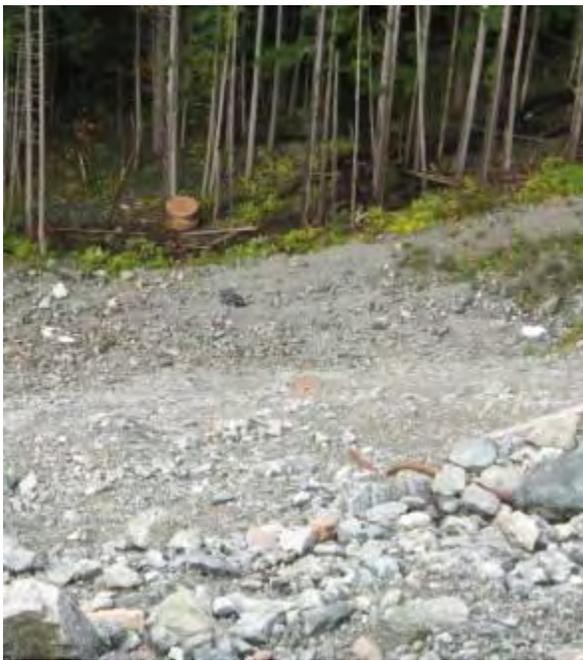
Photo 3 – Wood spool in Ophir Creek.

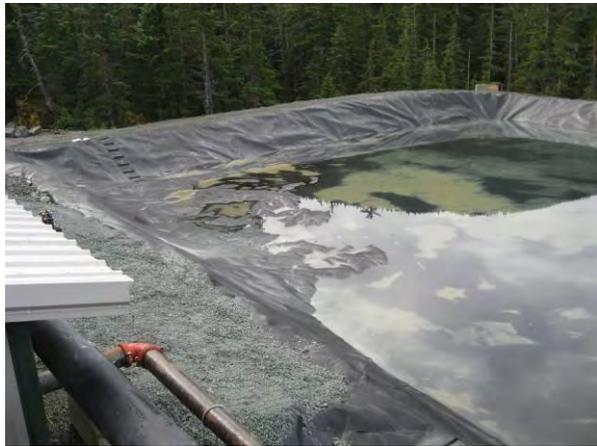
Pond 1 has been relined but was not in use at the time of the site visit. A silt curtain is to be installed and it will then be ready to be put into service.

Photo 4 – Pond 1 - relined.

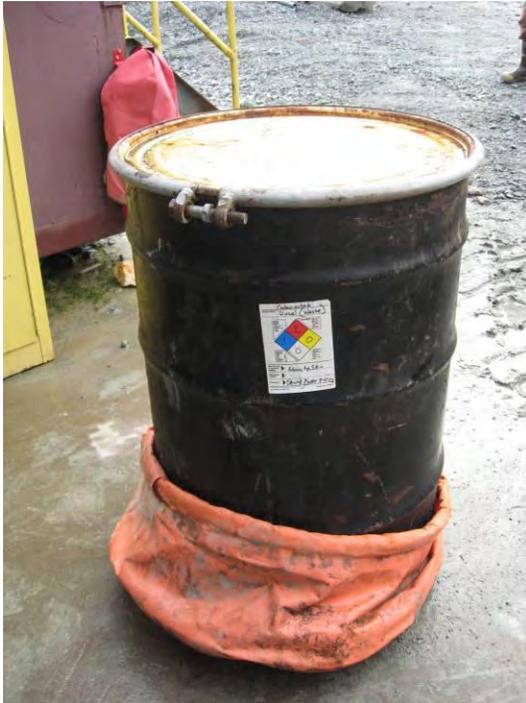
The water treatment plant was toured; secondary containment issues were discussed. Chemical tanks are now mounted on large plastic secondary containment units; these must be kept free of water in order to maintain the 110% chemical tank capacity. A drum was seen to have a low flexible secondary containment. This would not suffice for the 110% secondary containment requirement. Kevin said they would move the drum to another containment on the site.

Photo 5 – Barrel with limited secondary containment.

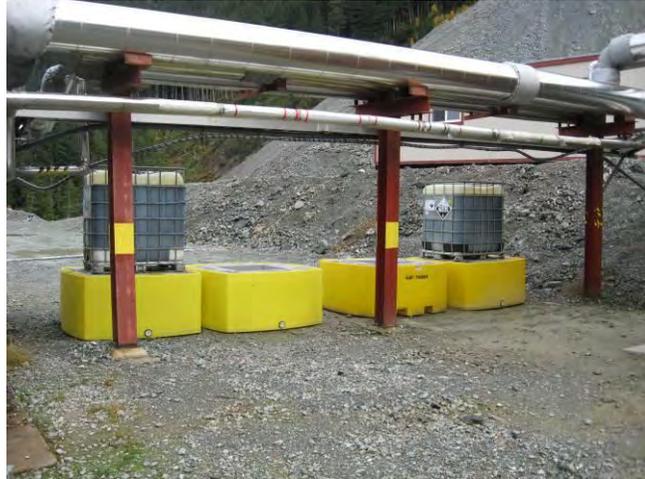
Photo 6 – Secondary containment units.

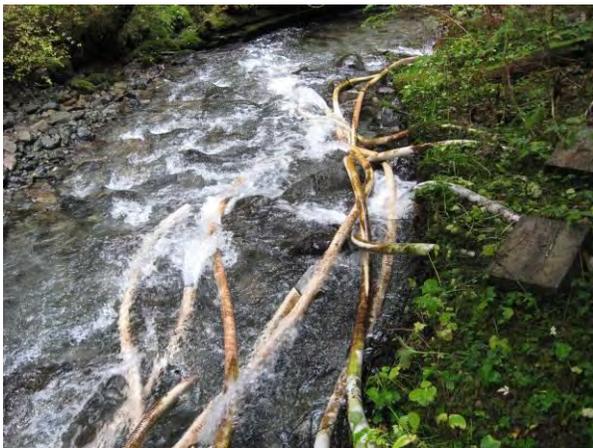
Outfall 1 was visited; it was noted that there is a new path down to the pipe diffuser system. Multiple pipes were used to minimize erosion within the stream bed.

Photo 7 – Outfall 001 to Sherman Creek.

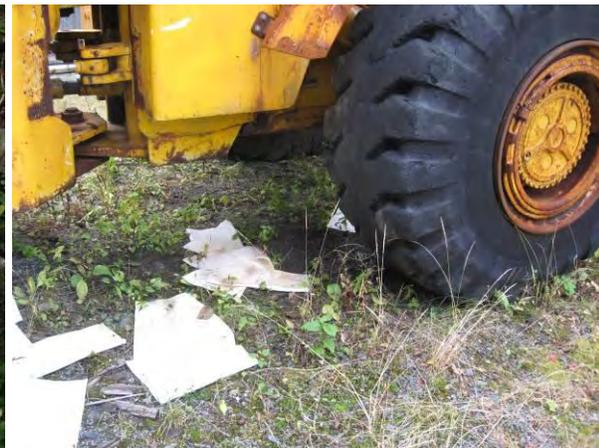
At the beach it was noted that there was a drum with an unknown substance in it (possibly a mastic) that was not in secondary containment. There is also an old loader behind the building that has had oil leaks. There are absorbent pads under the vehicle, but this does not capture all the oil. The drum will be placed in secondary containment. Oil containment will be placed under the loader to capture any future leaks.

Photo 8 – Oil beneath old excavator at Comet Beach.

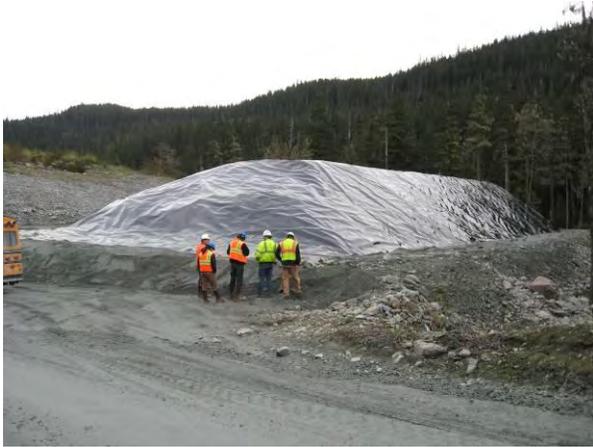
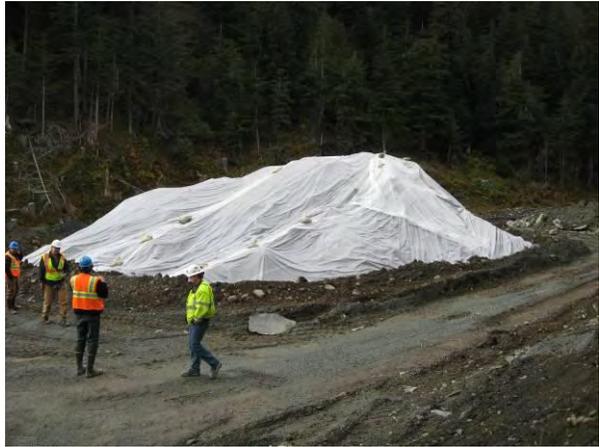
**Graphitic phyllite:** 8,000 cy of this material that was removed from the site during the Phase 2 dam raise is temporarily stored in a sealed containment at the north mud dump. This will eventually be placed underground; the plan is to place this underground in 2014. After the material was sealed an additional 260 cy was discovered during excavation for the sump at the base of the spillway. This material has been placed at the northwest end of the TTF on a liner and covered with polyethylene. Coeur intends to place this underground, encapsulated in paste and should be able to place it underground within the next few months.

Photos 9 & 10 – Graphitic phyllite at the north mud dump and the far end of the TTF.

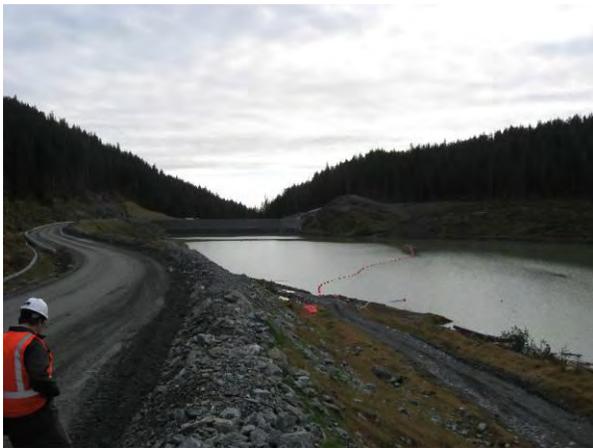
Photo 11 – TTF and raised dam.

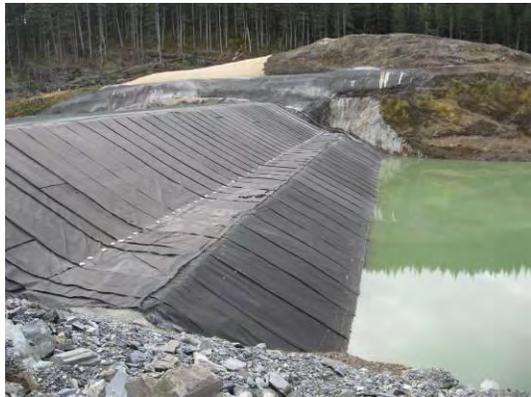
Photo 12 – Phase 2 dam raise.

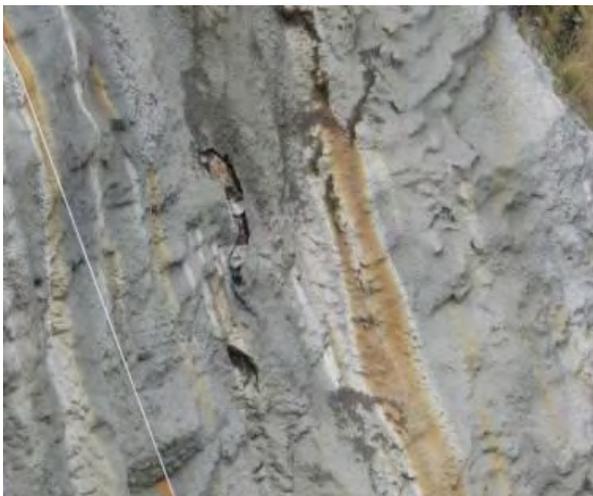
**Tailings Treatment Facility (TTF):** Phase 2 of the dam has been completed. Shotcrete applied to the graphitic phyllite walls has seeps and it appears that the cement has been dissolved in a few locations. Old shotcrete had spalled off from the rock face. Some of the shotcreted walls will be covered over when the Phase 3 raise is completed within a few years. However, what needs to be done at graphitic phyllite areas not covered by the Phase 3 dam raise needs to be discussed and agreed to by the agencies. Seepage flow into the sump at the base of the dam is at about 20-30 gpm. This water is pumped back to the TTF.

Photo 13 – Spalling shotcrete

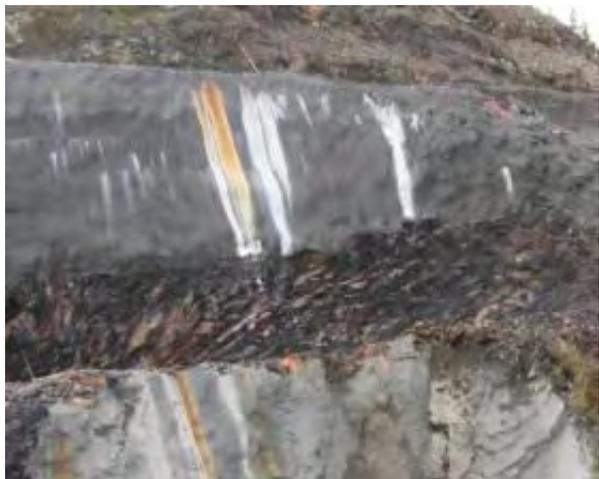
Photo 14 – Seeps on new shotcrete

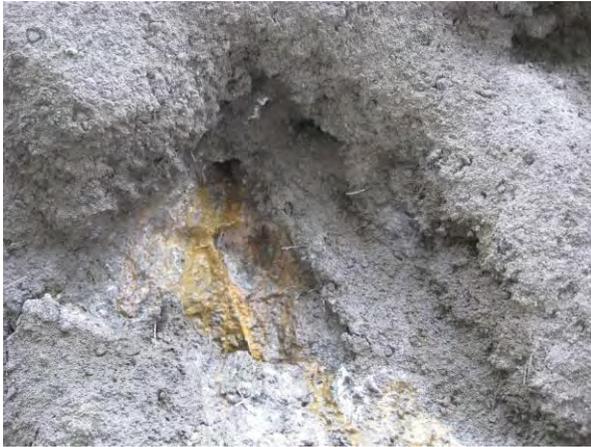
Photo 15 – Seep, possible cavity in shotcrete.

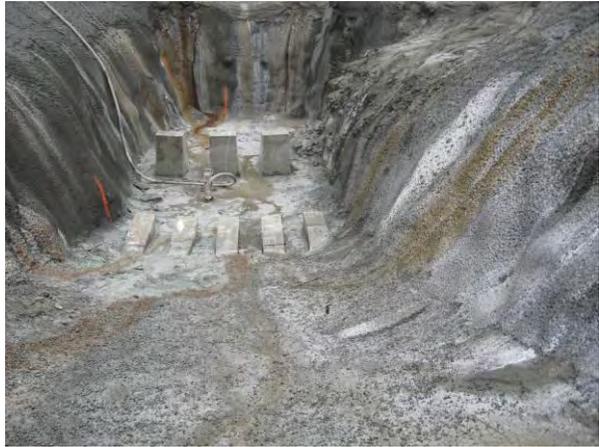
Photo 16 - Seeps at the spillway plunge pool.

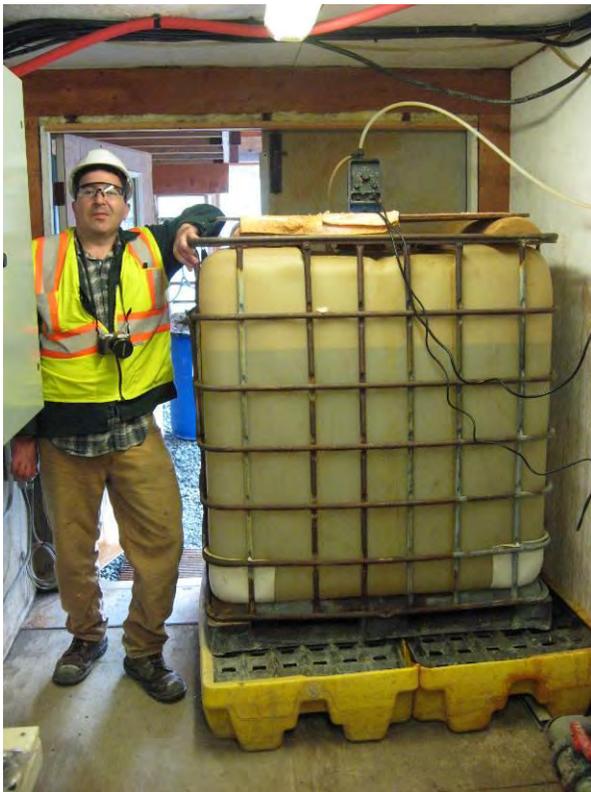
**Graphitic Phyllite Treatment Plant:** Secondary containment is required for the muriatic acid container within the plant. Kevin said he would consider making the facility secondary containment by creating a lip at the entrance and sealing the floor to capture leaks. Sludge cake

Photo 17 – Muriatic / hydrochloric acid in the graphitic phyllite WTP.

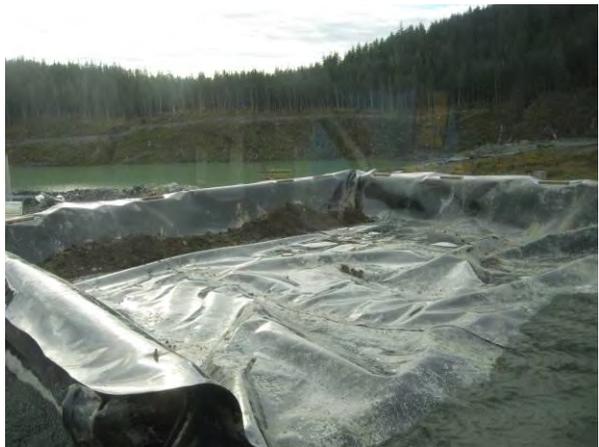
is temporarily stored in a lined containment area near the TTF water treatment plant. It is suggested that a cover be kept over this to prevent loss of sludge cake by the containment filling with water or by the cake becoming sloppy when it is time to transfer it to the underground paste facility.

Photo 18 – Filter cake from graphitic phyllite WTP.

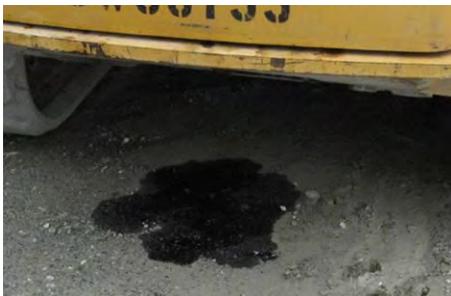
**Pit 4 (also known as Pit 3):** Vehicles are maintained at this site. Adjacent to the road a parked bobcat was seen to have been leaking oil onto the road. This was pointed out to Kevin and he said they would have it cleaned up.

Photo 19 – Oil beneath the Bobcat at Pit 3.
