October 1, 2014

## The October 1, 2014 Inspection of the Kensington Gold Mine

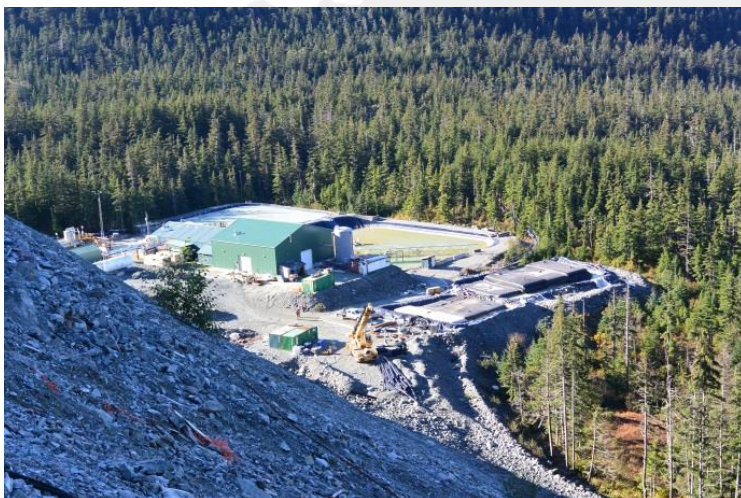
Figure 1 The Comet Water Treatment Plant as seen from atop the Comet Wasterock Pile.

After emerging from the Comet Portal and parking the truck, the team walked across the double berms to the west side of the Comet Wasterock Pile for an overview of the Comet Wastewater Treatment Plant (WTP) (Figure 1). The double berms designed to prohibit dumping of permitted waste off the west side of the pile are working well. There was a moderate flow in Ophir Creek, and the stream bed was clear of debris.

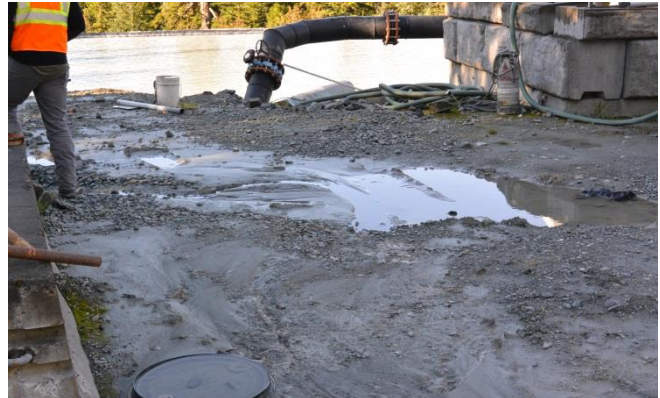
mine was being delivered to Pond One at a rate of about 1300 Gallons Per Minute (GPM) during our visit. A slight preferential flow path could be seen in the gravel laydown area draining into Pond One (Figure 2). Water draining from the access road likely uses the path only during heavy rain events, and the path leads directly into Pond One where the water would be treated. At the time of the inspection there was no cause for concern that the preferential flow path would erode further into the gravel pad.

Figure 2 A preferential flow path draining into Pond One.

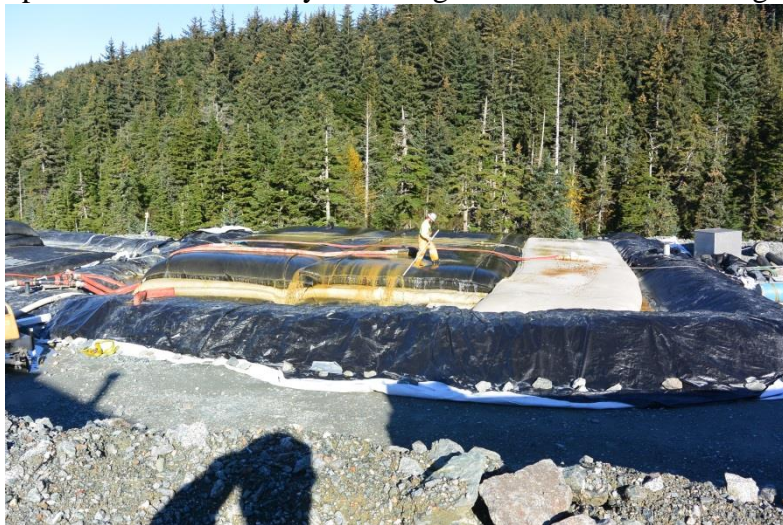
Figure 3 Dewatering bags inside lined containment.

from the bottom of the pond as a slurry, and pumps it into a large porous bag contained inside a lined containment cell (Figure 3). The water is pushed through the pores in the bag, and all but the smallest of particles settle to the bottom of the inside of the bag. The water that exfiltrates from the bag is light brown, and a noticeably different color from the steel gray water contained in the ponds. The water from the sedimentation bags is collected in the lined containment area, and pumped back to the pond. When

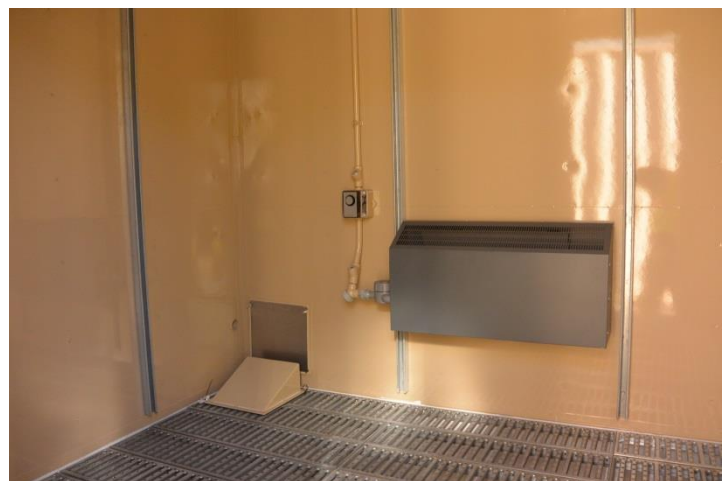
Figure 4 Inside of a new 20 foot container. Note the integrated secondary containment, heater and floor vent.

Two new 20 foot long containers were sitting empty near the treatment plant (Figure 4). These elaborate containers feature integrated secondary containment, onboard heating, and built in ventilation. The approved POO states that all hydrocarbons and hazardous liquids must be stored in secondary containment. Kevin stated that these containers will be used to store reagents for the water treatment plant that are susceptible to freezing.

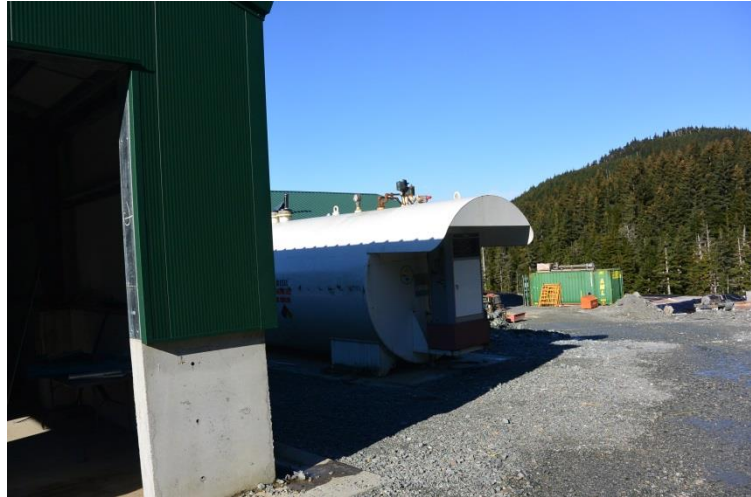
Figure 5 New building and fuel tank.

Since the last inspection performed by ADNR, a 660 square foot concrete and steel building had been built, and a new fuel tank was placed between the WTP and wasterock pile. Both the tank and building have been sited on concrete foundation pads (figure 5). The new tank can hold 10,000 gallons of diesel fuel, and will be used mainly to fuel a 1.2 megawatt backup generator that will be housed in the adjacent new building and diesel heaters in the surrounding buildings.

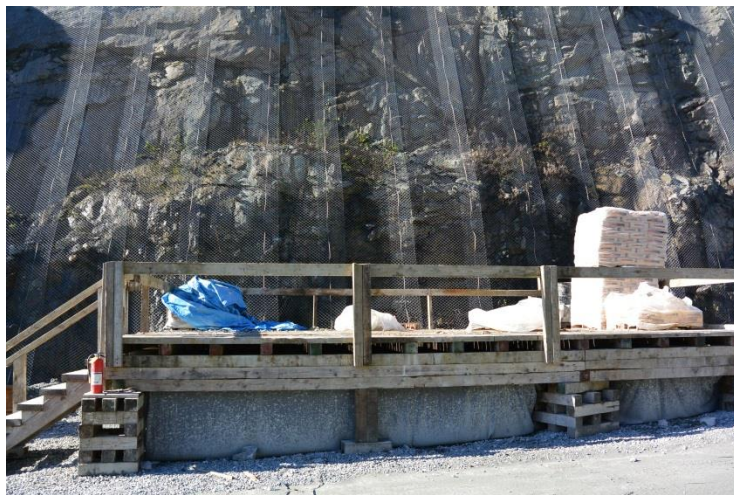
Figure 6 Site of the proposed new portal.

site of the proposed new portal (Figure 6). The portal, if built, would access a previously unknown ore reserve. It would be built on the existing Mill Bench, upon patented claims within the current disturbance footprint. The portal would be about the same size as the existing Jualin Portal (approximately 18' diameter), and would lead to an estimated 8000' decline. The newly discovered ore body is slightly different from the currently mined ore.

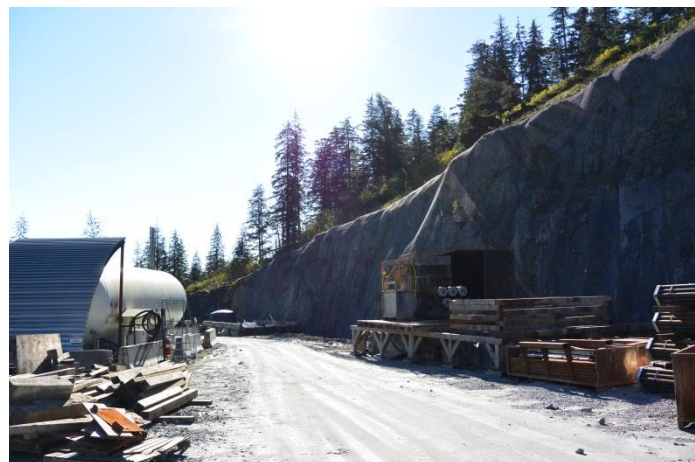
Figure 7 High wall and propane tank.

Limited space is available on the Mill Bench, and a propane tank (Figure 7) used to fuel the portal heaters in winter will need to be relocated to accommodate the haul trucks entering and exiting the portal. The loaded haul trucks will drive around the lower side of the mill, up to the existing portal area, where they will dump ore onto the existing ore pad, or wasterock on the existing Jualin Wasterock Pile.

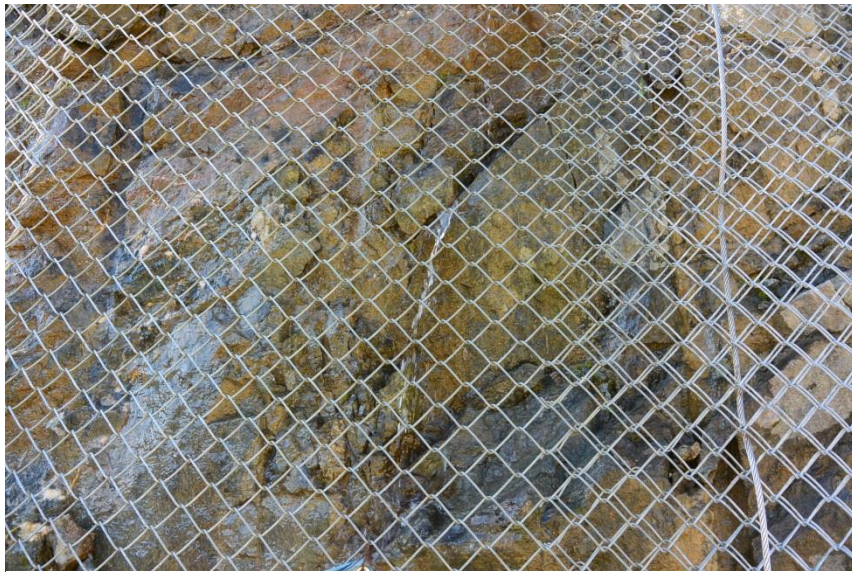
Figure 8 Water seeping from a crack in the high wall.

Water could be seen seeping from the high wall near the location of the proposed portal (Figure 8). Several hundred gallons per minute of water is expected to be encountered infiltrating into the proposed decline. Coeur will attempt to limit the amount of seeping water by pressure grouting flow paths wherever possible. Water from the workings would be collected, pumped to an existing sump near the Jualin Portal, and then pumped to the Comet WTP for treatment.

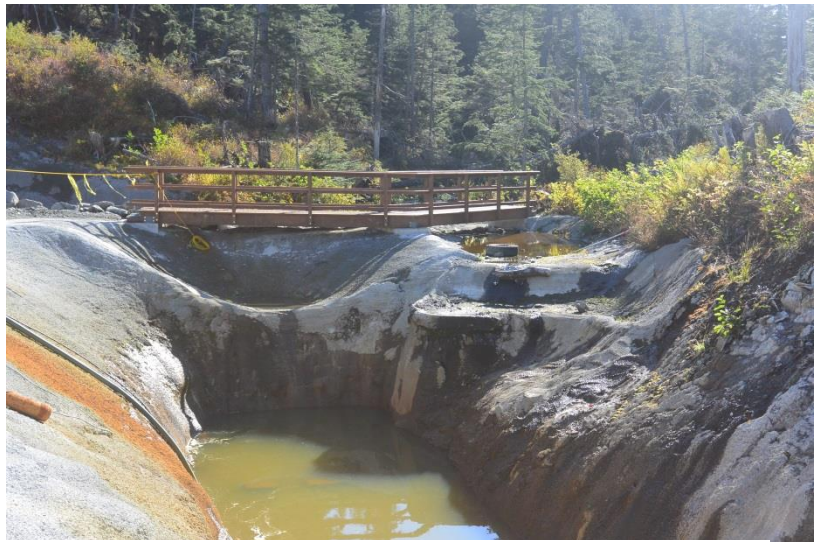
Figure 9 New walkway leading to a water quality monitoring site.

After breaking for lunch, the inspection team drove to the Tailings Treatment Facility (TTF), and moved downstream of the dam. A new walkway had been built since the previous inspection (Figure 9). Kevin stated that the walkway was installed to make it safer to travel to the water sampling point on the East Fork of Slate Creek required by the Quality Assurance Project Plan and Fresh Water Monitoring Plan. The remaining exposed area of the original emergency spillway for Stage One of the TTF Dam has been filled in with diorite (Figure 10). The old

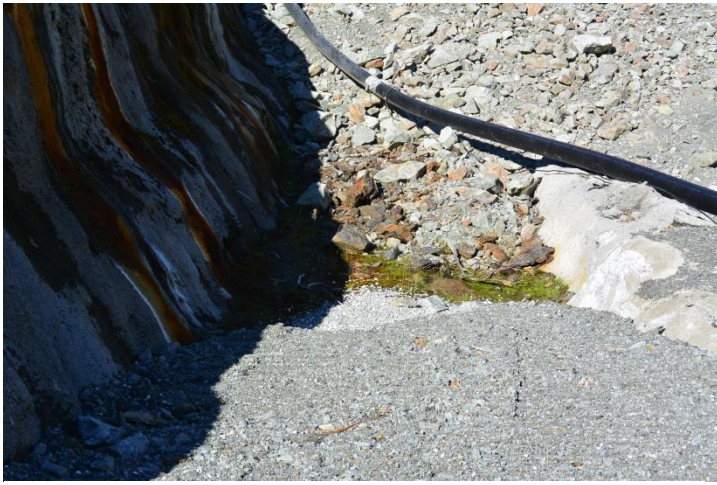
Figure 10 Filled Stage One Emergency Spillway.  
upstream of the TTF Dam.

spillway still collects Acid Rock Drainage (ARD) seepage from the shotcrete covered graphitic phyllite formation. Any collected ARD will infiltrate through the porous, crushed diorite containing a high amount of carbonate. The carbonate will help to neutralize acidic drainage before it reaches a sump at the bottom of the now filled spillway where it is collected and pumped to the small ARD Treatment Plant below the dam. The treated water is then discharged into an infiltration gallery just

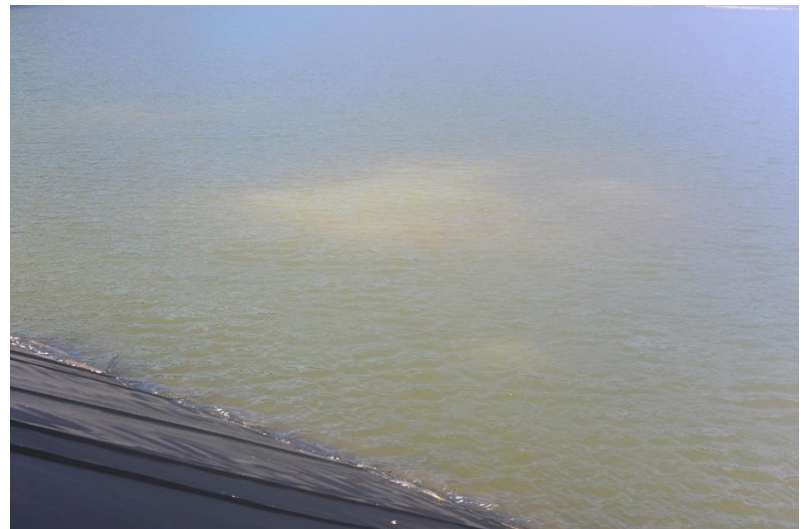
The team moved to the crest of the dam, where we observed several light colored areas that marked the crests of several mounds of tailings that had been deposited on and near the upstream face of the dam (Figure 11). Section 3.5 of the approved POO states that a minimum of 9 feet of water will be maintained above the tailings during operations. It is estimated that a cover of 4-6 feet of water was atop the tailings at the time of this inspection. The depth of the cover is not a safety concern, and the height of the water cover will increase as precipitation increases during the rainy autumn season.

Figure 11 A mound of tailings with a shallow cover of water.

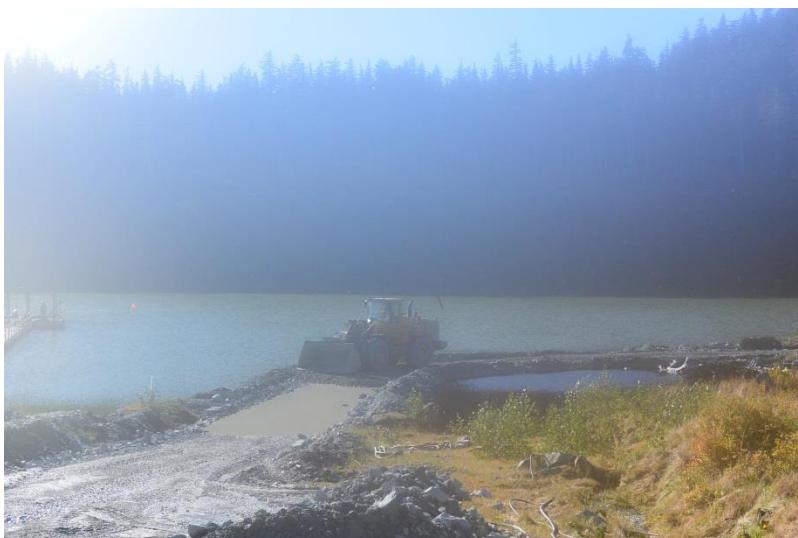
The inspectors traveled north to the road that accesses the site of the barrel tests. The test site was only accessible by foot because a low area of the access road had become inundated by the rising level of water in the TTF. A loader was actively placing fill on the inundated roadbed (Figure 12). Kevin stated that a new road alignment may be needed so that consistent road access to the test area is maintained.

Figure 12 A loader raising the elevation of the road bed. The haze is caused by a fogged up camera lens.
