INSPECTION REPORT: KENSINGTON GOLD MINE

Tongass National Forest Minerals Group
8510 Mendenhall Loop Rd
Juneau, AK 99801
(907) 789-6275 – office
(907) 586-8808 – fax

Date of Inspection: Tuesday, March 1, 2016
Date of Report: Wednesday, March 10, 2016
USDA Forest Service Inspector: Richard Dudek

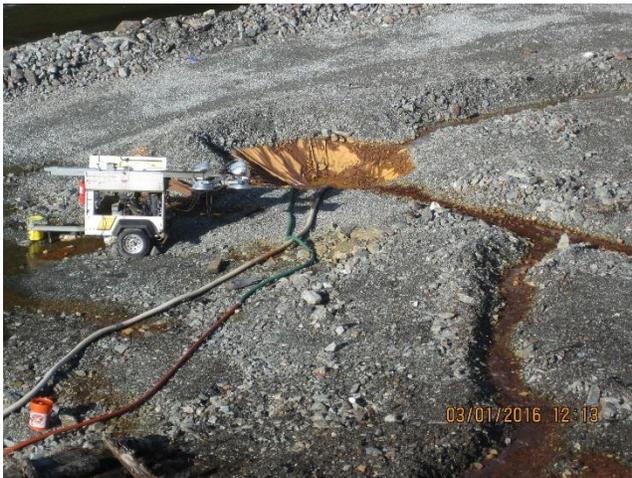
Photo 1. Northern TTF ARD catchment.

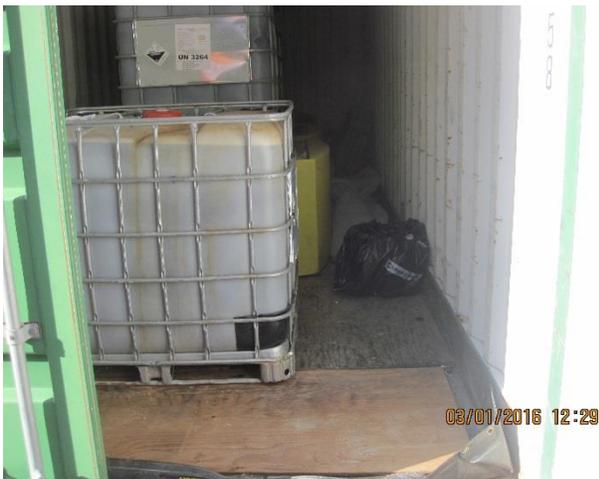
During the inspection of the treatment plant's storage containers. A storage container used for storing treatment plant chemicals needs minor improvements for the secondary containment (Photo 4).

Photo 4. Slight improvements are needed secondary containment at the TTF WTP.

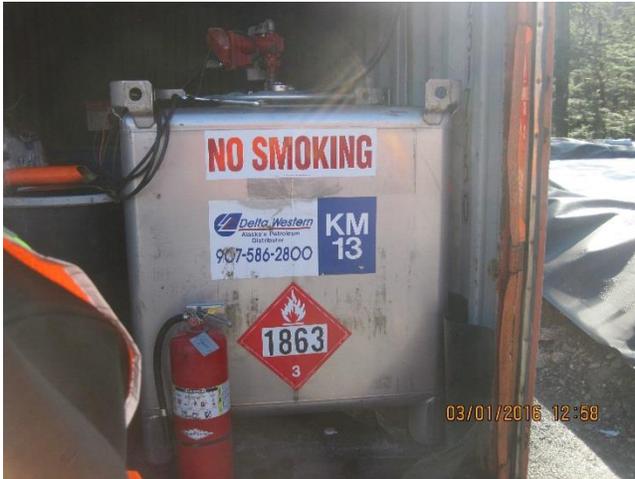
A storage container used for storing aviation fuel needs slight improvements for the secondary containment (Photo 5). Coeur Alaska's **2012 Plan of Operations** for fuel will be stored in a lined secondary containment (page 83). Also at this site, another USFS inspector observed was a large tear in the poly-liner covering for a GP stockpile (Photo 6).

Photo 5. Fuel container's secondary containment front section needs slight improvements for capturing spills.

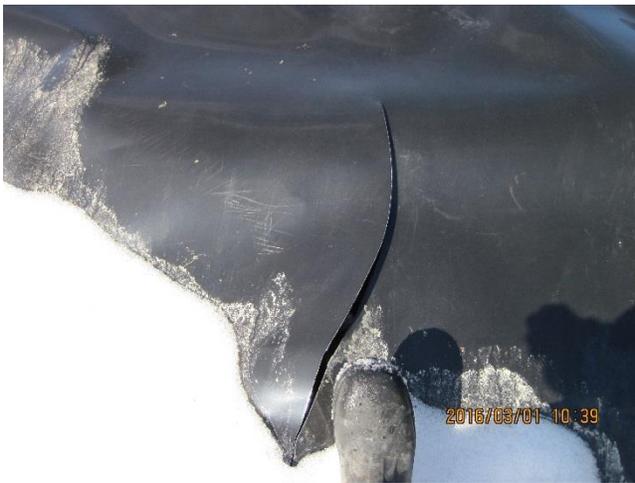
- Helipad fuel tank not in secondary containment.
- A tear in a poly-liner containment for GP at the Mud Dump.

Photo 6. A tear in a GP poly-liner cover at the Mud Dump

- Sherman Creek Outfall
- Repair the liner on GP stockpile located at the Mud Dump

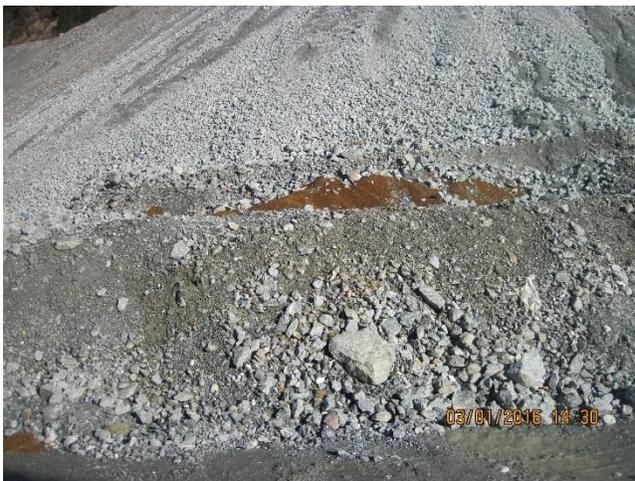
The water treatment plant's byproduct materials (e.g. filter press cakes) are also stored into the development pile (Photo 7). This complies with **Section 4.2.4 of the 2012 BMP** plan for the treatment of waste disposal to assure against any discharge of contaminants flowing into navigable waters.

Photo 7. Byproducts (filter press sediments) stored within the Comet development pile

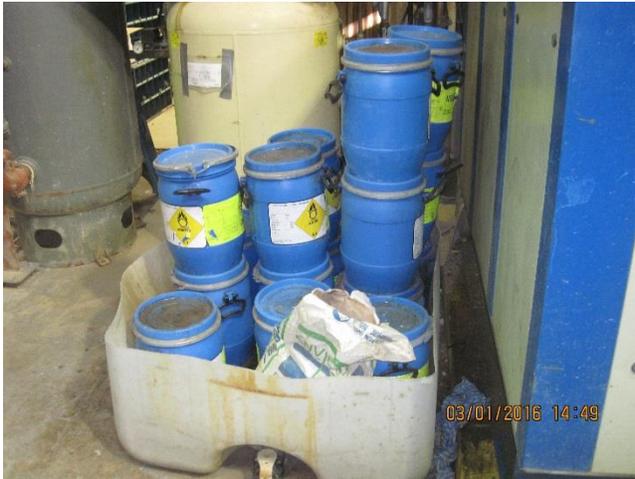
Outside and inside the water treatment plant, good housekeeping practices comply with **Table 4-1 of the 2012 BMP** plan (Photo 8).

Photo 3. Empty containers properly stored and out of the walkway at the Comet Water Treatment Plant.

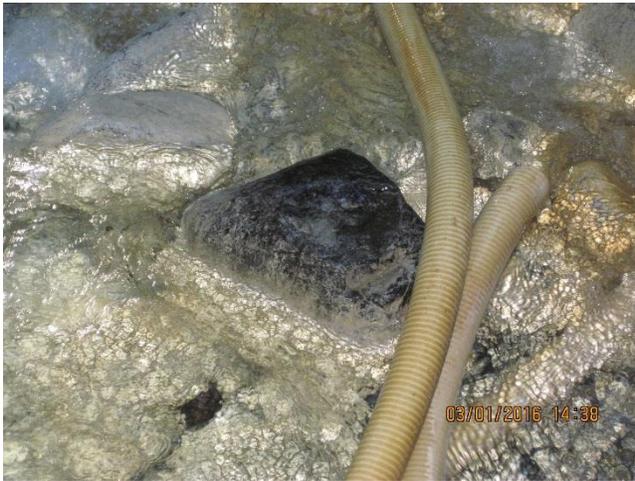
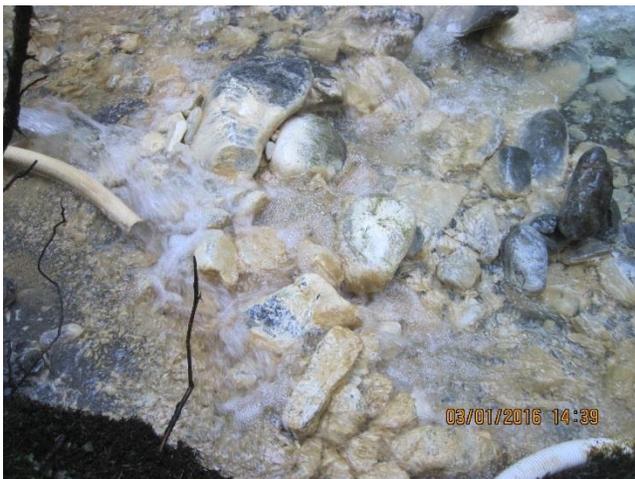
The white material at the Sherman Creek outfall has persisted since September 2014 (Photos 9-10). Coeur Alaska has been placing clean rocks near the Outfall to monitor the white material overtime.

Photo 4. Sherman Creek Outfall, white material covering rocks in the streambed.

Photo 5. White material coating to rocks in the streambed at Sherman Creek.
