INSPECTION REPORT: KENSINGTON GOLD MINE

Date of Inspection: Thursday, May 18, 2016
Date of Report: Friday June 10, 2016
USDA Forest Service Inspector: Richard Dudek

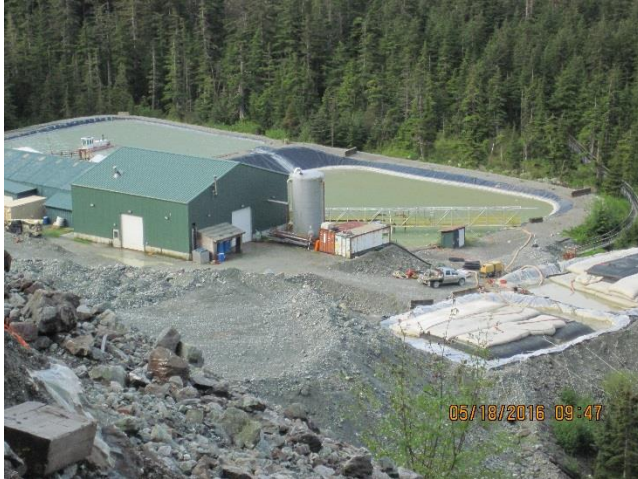
Coeur began expanding the south-west section of the Comet Development Pile in early 2016. During the site visit, it was observed that additional development (waste) rock had been added to the toe expansion (Photos 1-2).

Photo 1. Comet Development Pile's toe expansion.

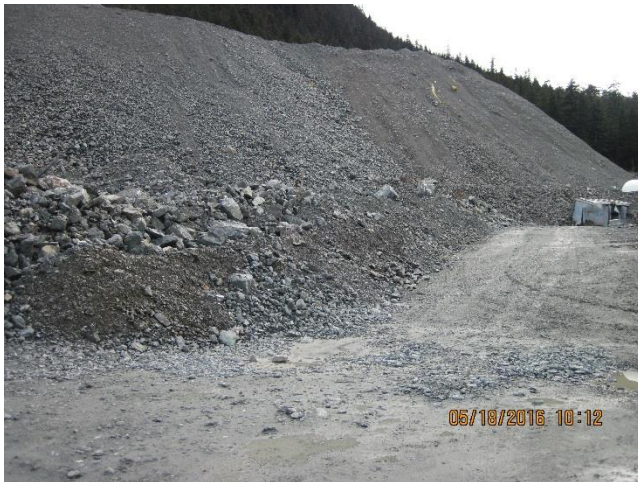
Photo 2. The base of the Comet Development Pile's toe expansion.

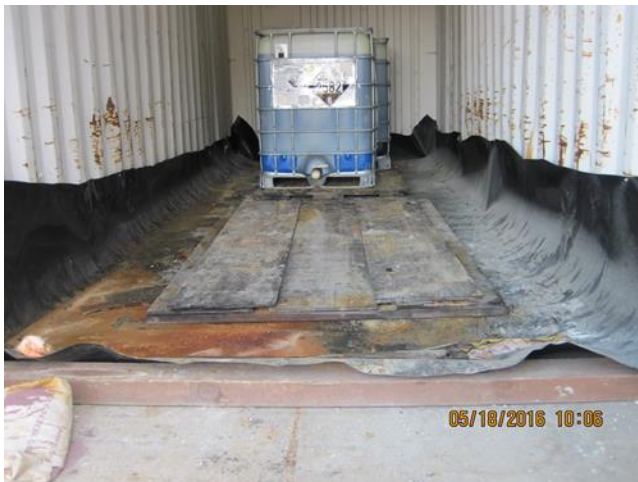
The Comet Water Treatment Plant's storage containers were clean and all chemicals and petroleum products were properly stored within secondary containment (Photo 3).

Photo 3. Comet Water Treatment Plant storage container.

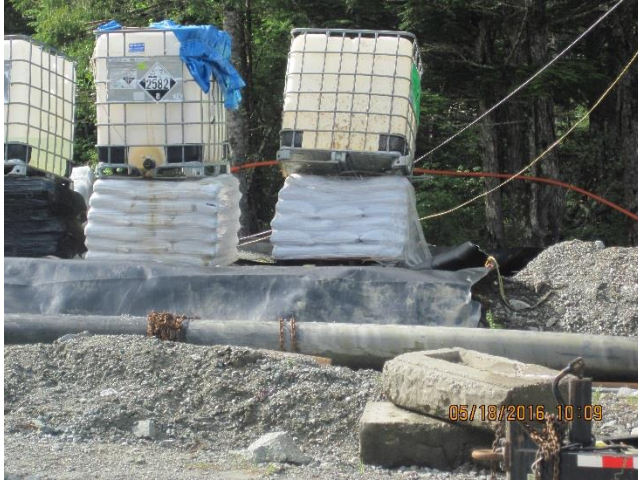
The empty totes (Photo 4) stored at the Comet water treatment plant are triple rinsed and used for backup in the event that a full tote is punctured. In the event of a puncture, the chemicals from the damaged tote are pumped into the backup tote.

Photo 4. Emergency backup totes stacked on palletized media sand.

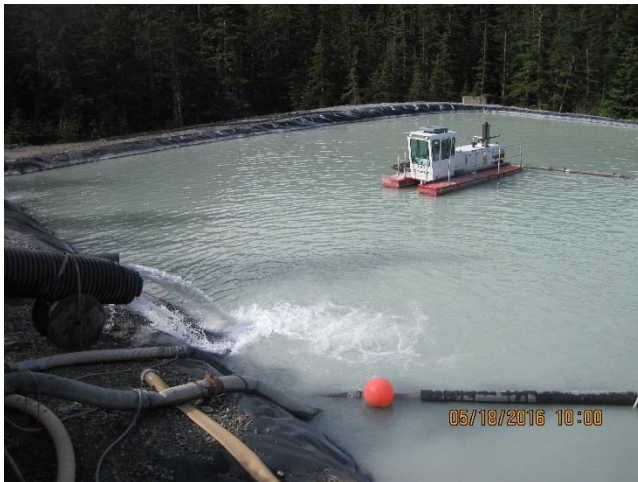
Photo 5. Suction dredging process underway at Pond-1 of the Comet Water Treatment Plant.

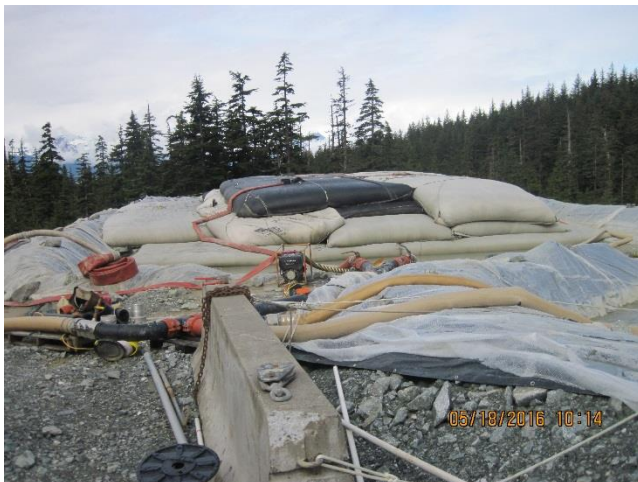
Photo 6. Dewatering bags used for removing sediments from water.

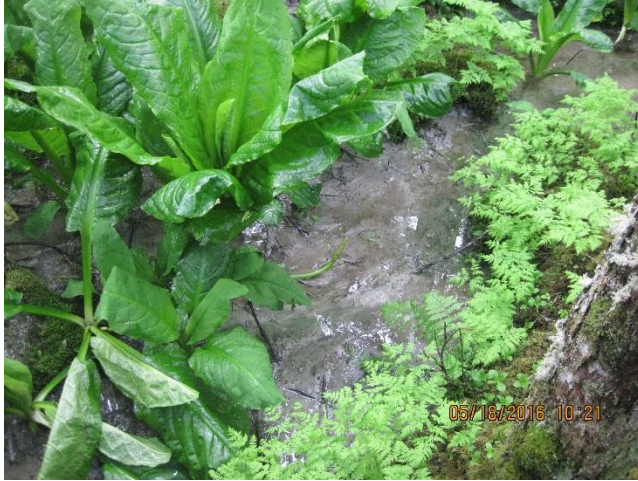
Just down gradient from the water treatment plant, sediments had reached the forest duff near the Sherman Creek Outfall walkway (Photo 7). The cause was due to a diversion ditch behind the Comet water treatment plant became overwhelmed during a high storm event (Photo 8). Coeur has plans to make the diversion ditch larger thereby increasing its effectiveness, and will continue to perform regular maintenance.

Photo 7. Sediments deposited onto the forest duff due to a washed out diversion ditch.

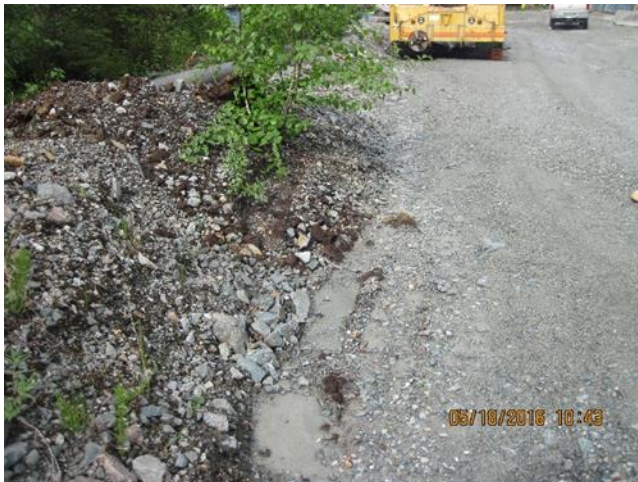
Photo 8. Image of the washed out diversion ditch behind the Comet Water Treatment Plant.

- **Mud Dump: Small tear in GP liner.**
- **Sherman Creek Outfall: Leaky hose needs to be replaced at the outfall.**
- **Comet Water Treatment Plant: Diversion ditch needs to be reconstructed.**

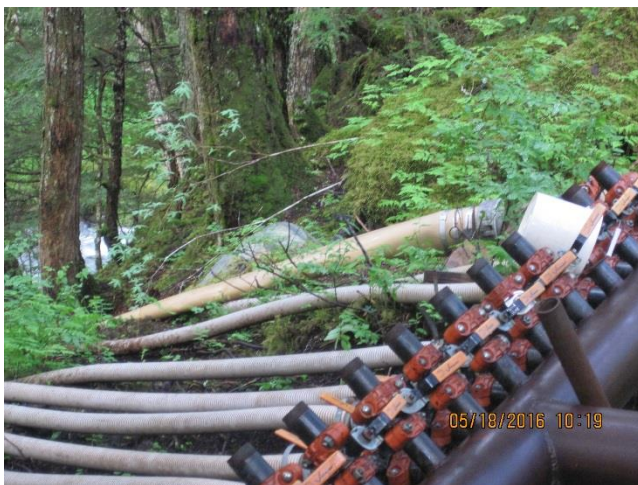
A leak in one of the outfall hoses (Photo 9) was documented in April 2016, and was still present. Coeur is aware of this problem and ordered eight new hoses to replace the older hoses. This repair should be made as soon as possible. Below the leaking hose, white material appeared to be settling onto the ground (Photo 10). The presence of white material suggests that white material is still present and not completely removed at the Comet Water Treatment Plant.

Photo 9. Sherman Creek Outfall gravity fed water lines.

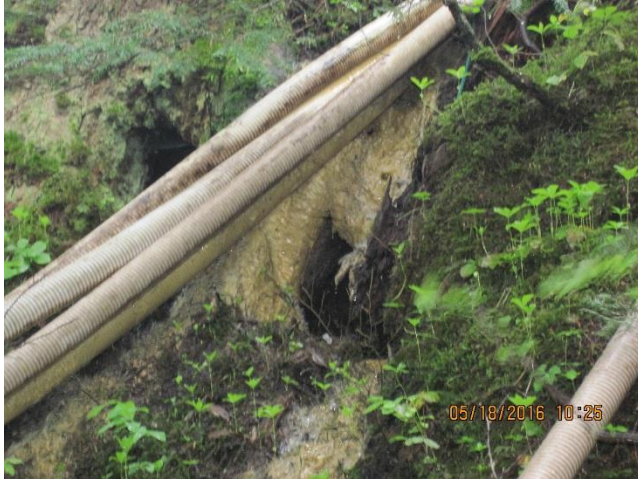
Photo 10. White material was present below the leaking outfall hose.

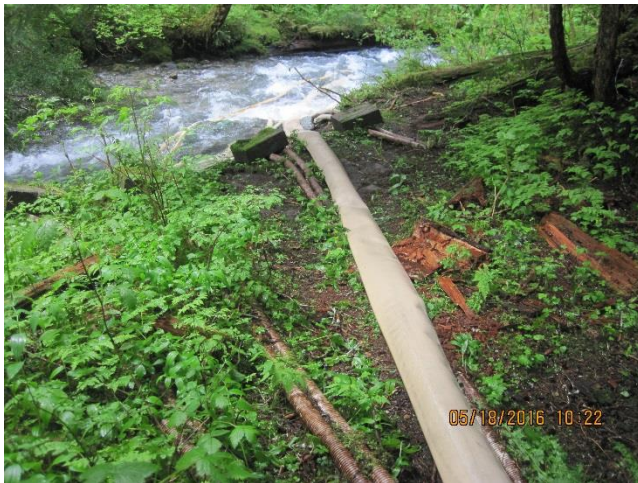
To reduce backpressure concerns at the treatment plant, Coeur Alaska has replaced one of the existing corrugated water lines in the outfall with a collapsible water line (Photo 11) in order to increase the outflow of water, and reducing backpressure from the plant.

Photo 11. Collapsible water line at the Sherman Creek outfall.

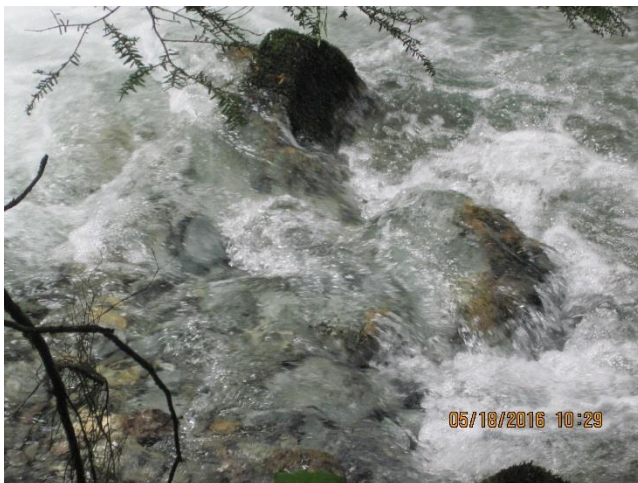
The White material in Sherman Creek has been observed and interpreted as having come from mucking an underground sump. During this inspection, little to no white material was observed either in the streambed (Photo 12-13) or at the mouth of the Sherman Creek at Comet Beach (Photo 14). The lack of white material may be a result of the high discharge from recent storm events.

Photo 12. Zoomed in image of Sherman Creek streambed.

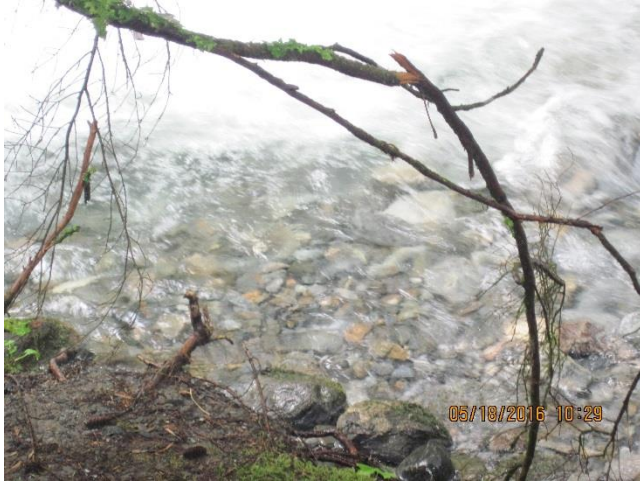
Photo 13. Sherman Creek Streambed had trace amounts of white material.

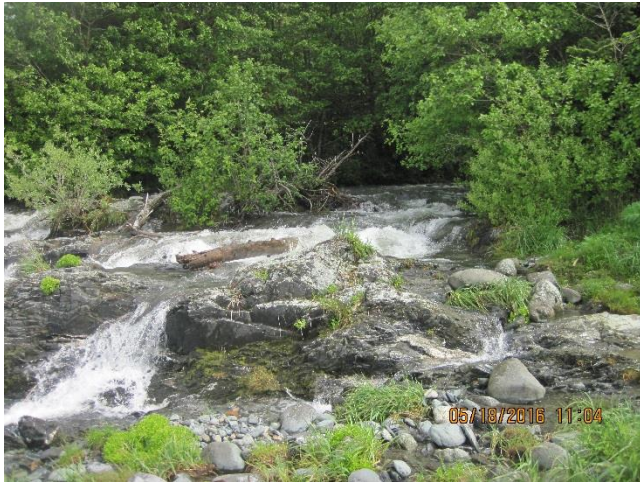
Photo 14. The mouth of Sherman Creek at Comet beach.

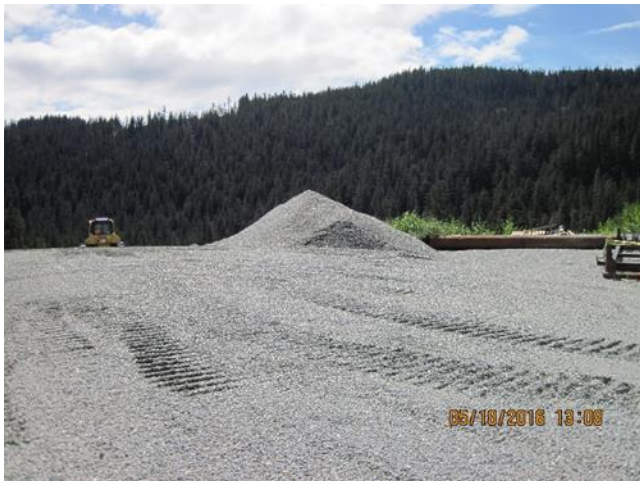
Pit 4 is an active site where reject rock is stockpiled from the Jualin mill processing (Photo 15). The reject rock is sent through an x-ray sorter for rock economic potential. The reject rock that has gone through

Photo 15. Pit 4 X-ray sorter reject rock stockpile.

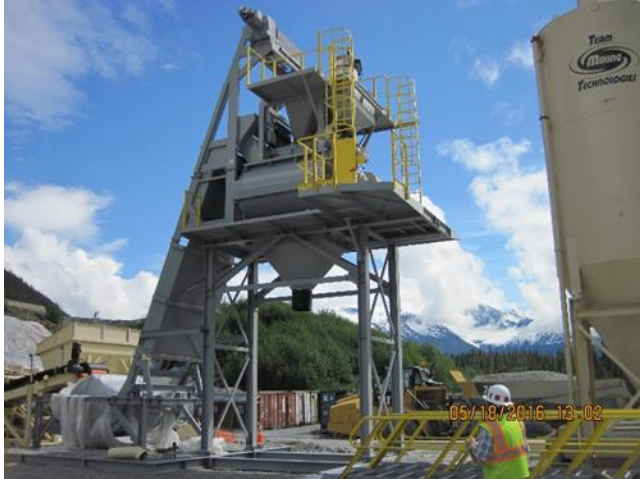
The Pug Plant is still not operational; Coeur is still waiting for electrical components needed for operating the plant. The timeline for the Pug Plant to be operational is sometime in June.

Photo 16. Pug Plant at Pit 4 is not online.

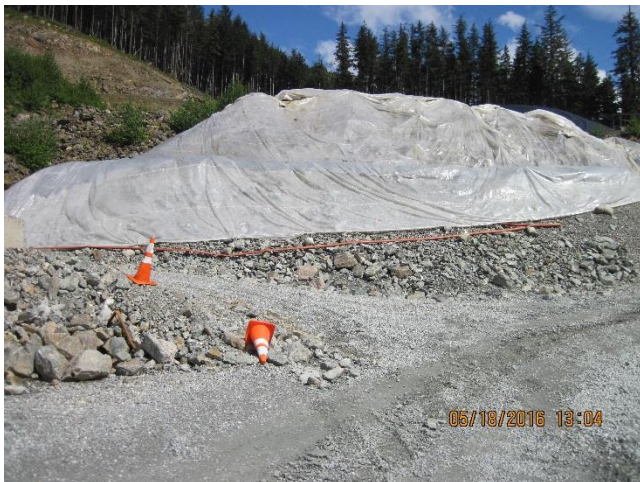
the x-ray sorter and is considered non-economic rock is designated as “x-ray sorter reject rock”. This rock is stockpiled at pits 1-3, and will eventually be used as road base material or shipped off site and used as construction aggregates. The graphitic phyllite (GP) material (Photo 17) stockpiled at Pit 4 will be sent to the Pug Plant (Photo 16) where it will be mixed with cement and used as backfill in the underground mine stopes.

Photo 17. GP material covered with a poly liner at Pit 4.

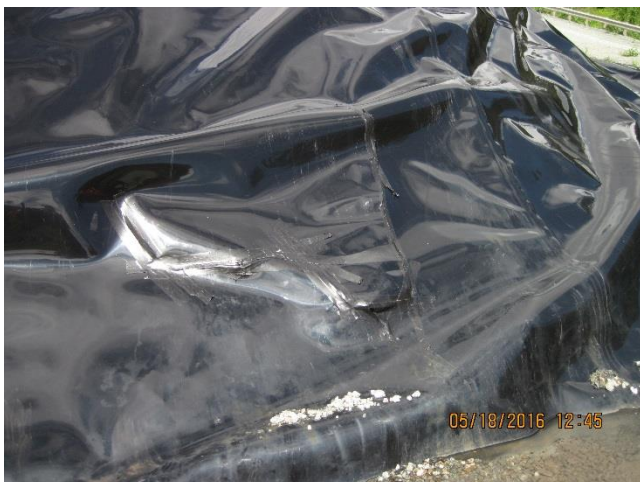
During an USFS inspection in February 2016, a tear was observed in a liner used for covering GP material. This observation was documented in the report as an “ACTION ITEM”. Since the last report, the tear has been repaired (Photo 18) however, during the most recent inspection a small puncture (Photo 19) was observed and reported to Coeur Alaska’s Environmental Manager.

Photo 18. Repaired liner for GP material at the Mud Dump.

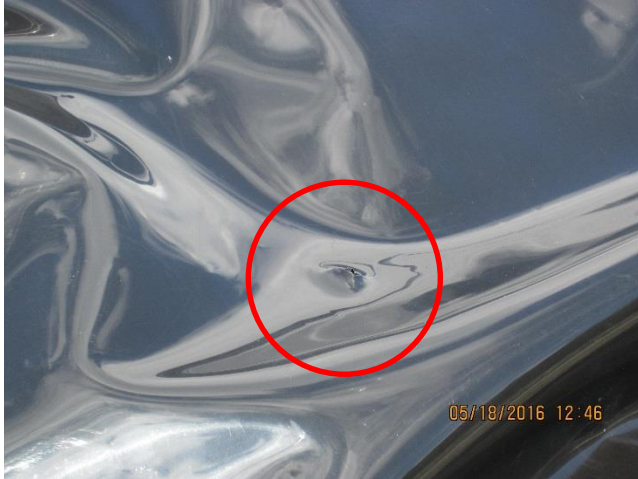
Photo 19. Puncture in a liner used for covering GP material at the Mud Dump.

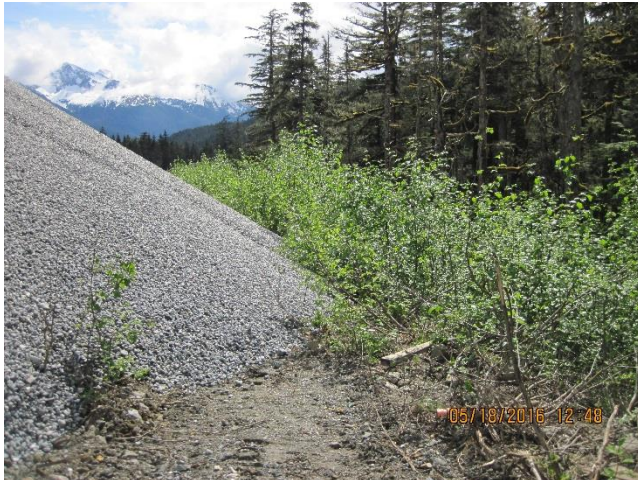
Prior to this inspection, there was a discussion as to whether or not an X-ray sorter reject rock stockpile was slumping into Forest Service lands (Photo 20). However, after further investigation, it was determined that this stockpile was still within the private land boundaries.

Photo 20. X-ray sorter reject rock stockpile at the Mud Dump.

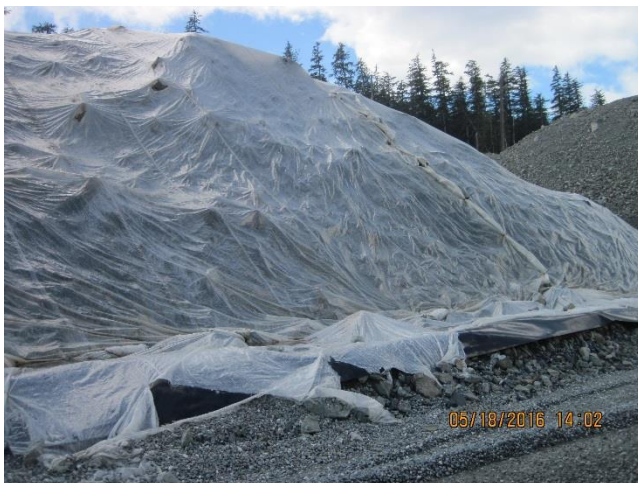
Currently inactive and in order, Pit 7 has a large amount of GP (graphitic phyllite) material stockpiled there (Photo 21). Coeur Alaska eventually plans to use the stockpiles as underground backfill. The GP rock will be mixed in cement at the Pug Plant, and used as backfill in the underground mine stopes.

Photo 21. GP material stockpiled at Pit 7.

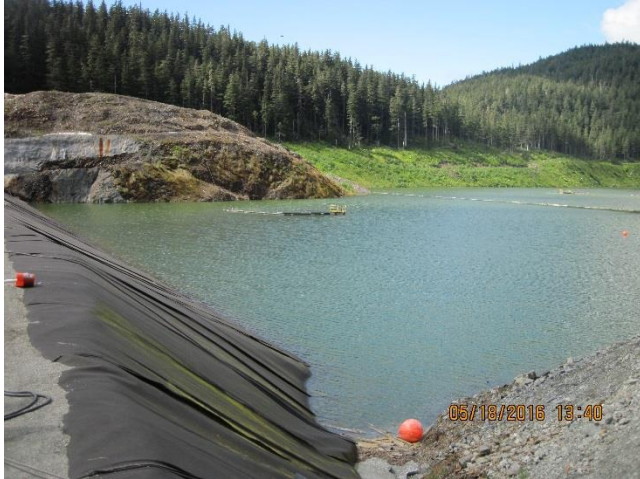
There were no tailings observed above the water in the TTF during the inspection (Photo 22). The water level for the TTF was 697.1 feet and below the allowable limit. Water in the TTF has been steadily dropping over the days prior to this inspection.

Photo 22. TTF dam and Lower Slate Lake.

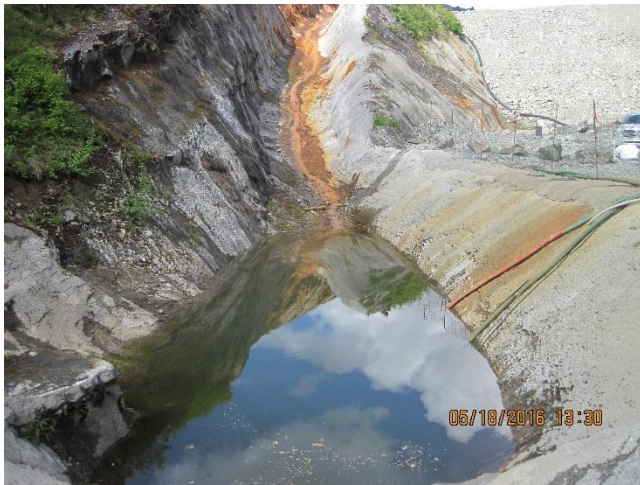
The TTF dam plunge pool’s water level (Photo 23) was high during the site visit. Coeur Alaska’s Environmental manager stated this is not a significant concern. The reason why the water level was high in the dam’s plunge pool was due to the sump’s float level was raised four inches. This was done to prevent ice cover from disrupting the intake pipe in the plunge pool. Overall, this is a good idea to ensure that the intake pipe is properly working during the winter months.

Photo 23. TTF dam spillway and plunge pool.

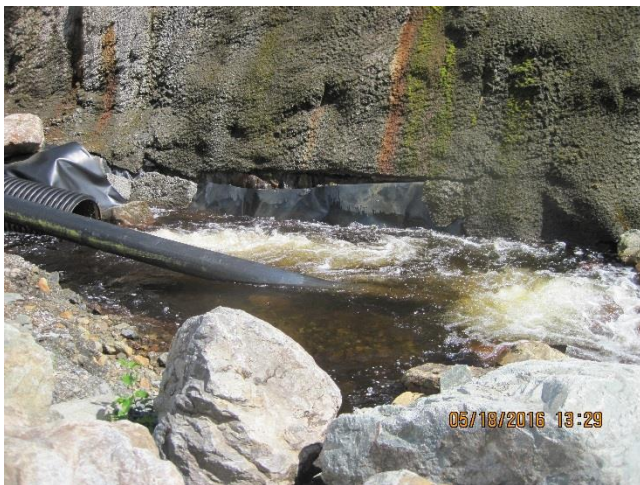
Photo 24. Upper Slate lake bypass and TTF water treatment plant plunge pool.
