## INSPECTION REPORT: KENSINGTON GOLD MINE

Tongass National Forest Minerals Group  
8510 Mendenhall Loop Rd  
Juneau, AK 99801  
(907) 789-6275– office  
(907) 586-8808 – fax

Date of Inspection: Wednesday July 6, 2016  
Date of Report: Thursday July 28, 2016  
USDA Forest Service Inspector: Richard Dudek

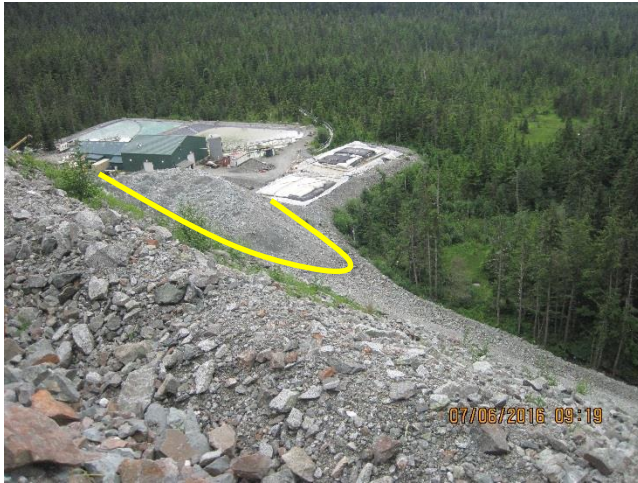
Coeur Alaska began expanding the South-West section of the toe in early 2016 (Photos 1-2). Coeur Alaska continues to add waste rock to the expansion pile.

**Photo 1. The area within the highlighted line is the location for the Comet development pile toe expansion.**

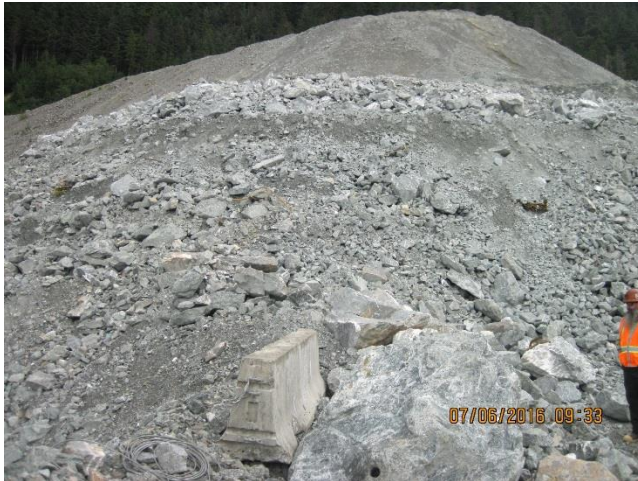
**Photo 2. Comet development pile South-West toe expansion.**

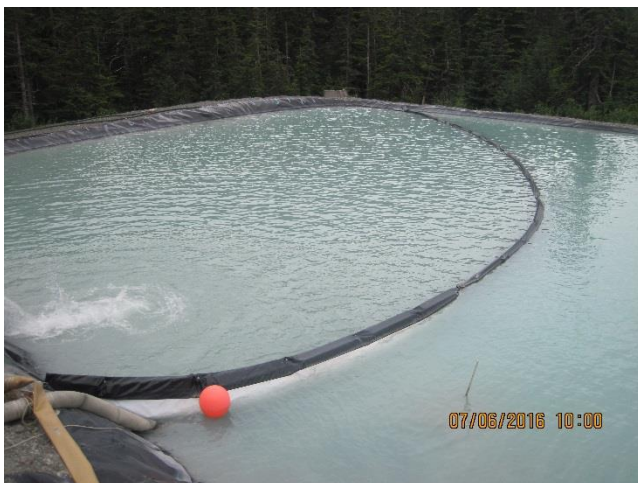
The Comet water treatment plant is currently treating approximately 900 gallons of water per minute. During this inspection, both Pond-1 and Pond-2 were actively receiving influent water (Photos 3-4). It was observed and documented that white residue was on the liner of Pond-1 (Photo 5).

**Photo 3. Pond-1 with a silt curtain for sediment area reduction.**

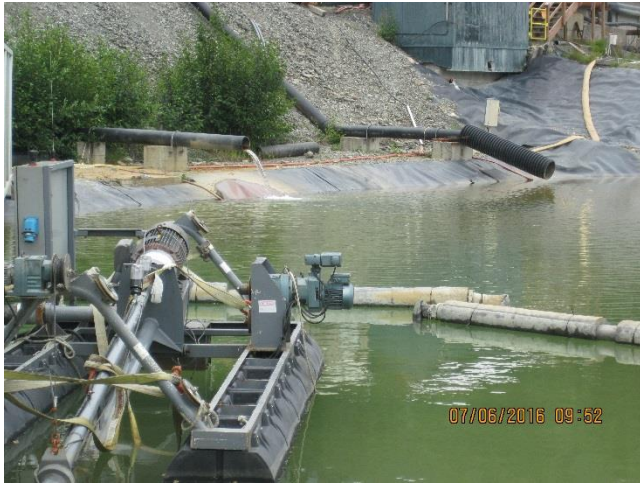
**Photo 4. Pond-2.**

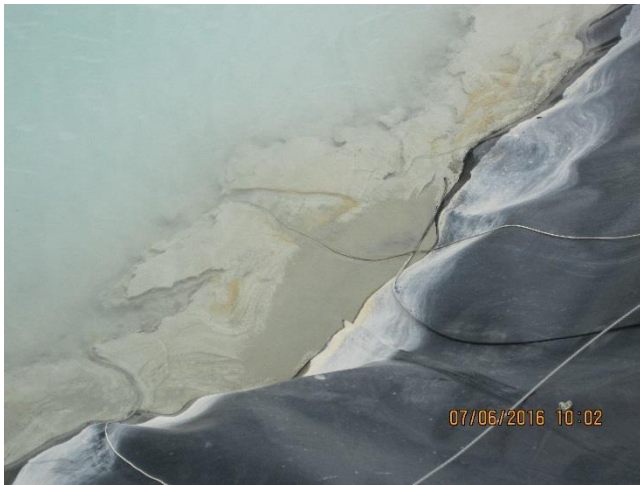
**Photo 5. Pond-1 liner with white material.**

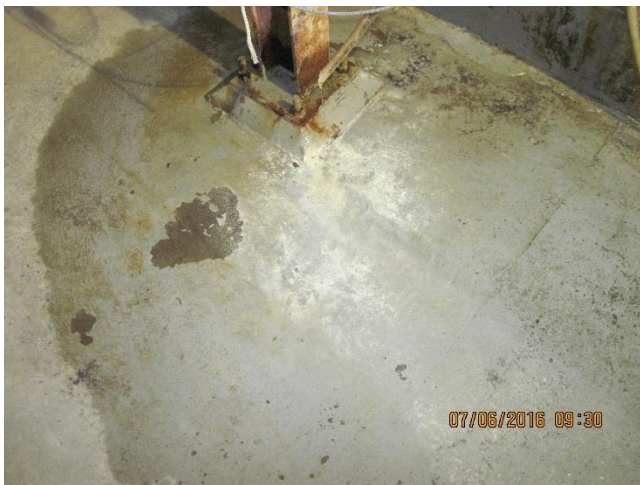
Inside the Comet water treatment plant, white material was observed on the sealed non-porous concrete floor (Photos 6-7). Coeur is currently bench testing different flocculants and coagulants for removing the white material during the water treatment process. The bench test control at the Comet water treatment plant is a 55-gallon barrel filled with rocks and water used for monitoring white material binding to rocks (Photo 8). Different flocculants and coagulants are also being tested at the underground triple sumps to help the white material settle out of solution.

**Photo 6. White material buildup observed on the sealed nonporous concrete floor.**

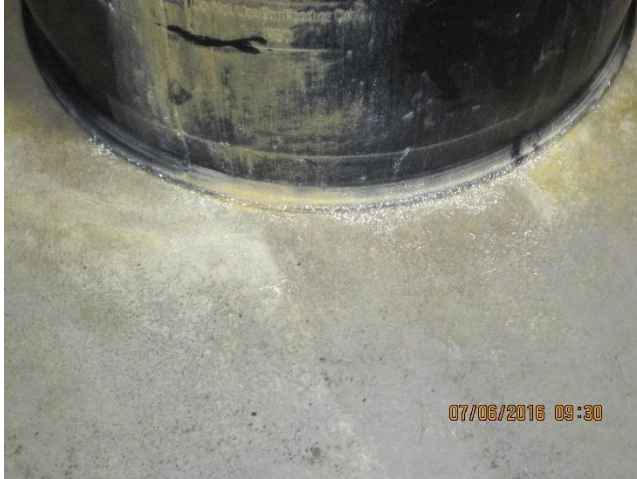
**Photo 7. White material on the concrete floor of the Comet water treatment.**

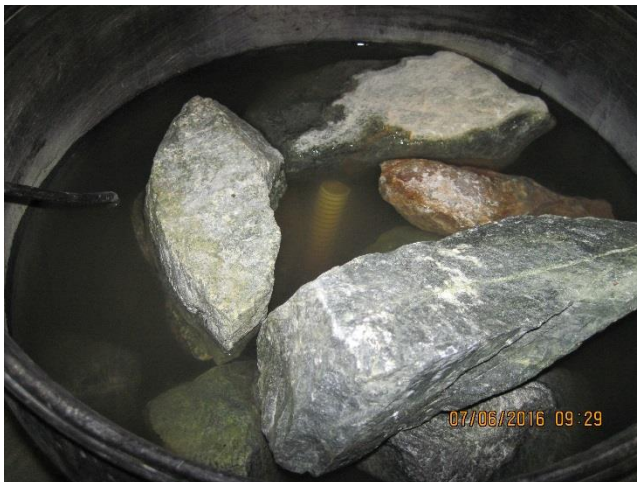
**Photo 8. Control test for white material removal.**

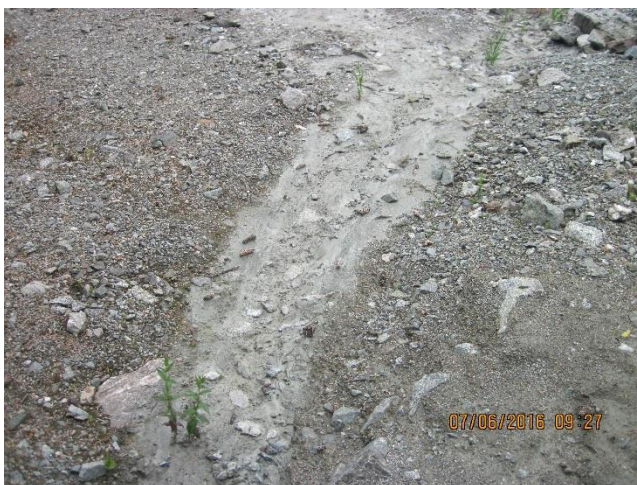
A diversion ditch behind the Comet water treatment plant needs additional improvements for storm water conveyance (Photos 9-10).

**Photo 9. Diversion ditch behind the Comet water treatment plant.**

- **Comet water treatment plant: improvements to stormwater diversion ditch**
- **White Material at Sherman Creek Outfall**
- **Pit 4: Graphitic Phyllite (GP) stockpile liner requires repairs to tears and/or adjustment to ensure GP material is not exposed.**

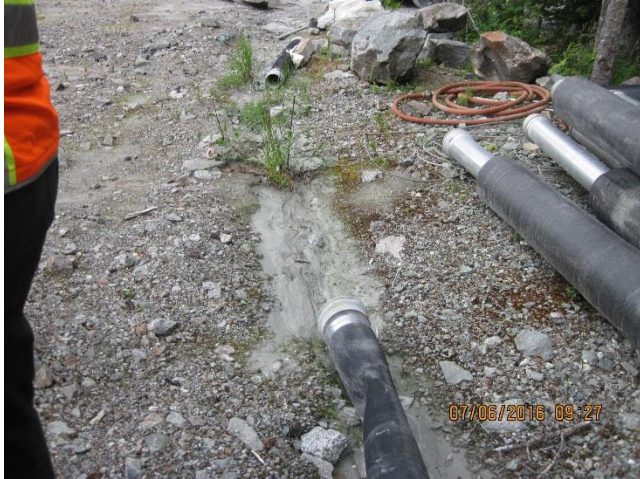
**Photo 10. Diversion ditch located behind the Comet water treatment plant.**

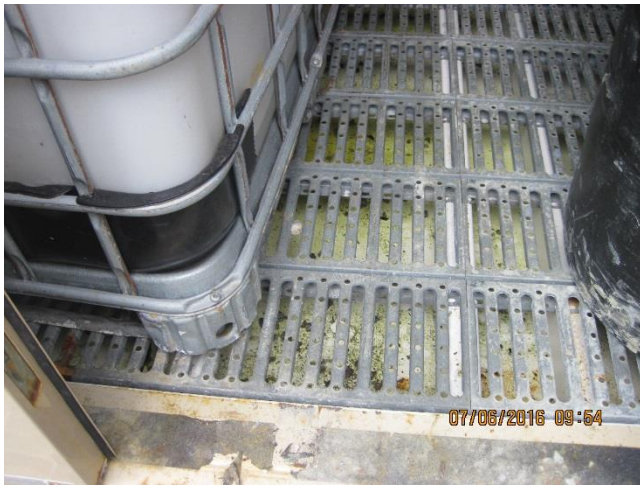
All chemicals and petroleum products are stored within secondary containment (Photo 11).

**Photo 11. Storage container with secondary containment.**

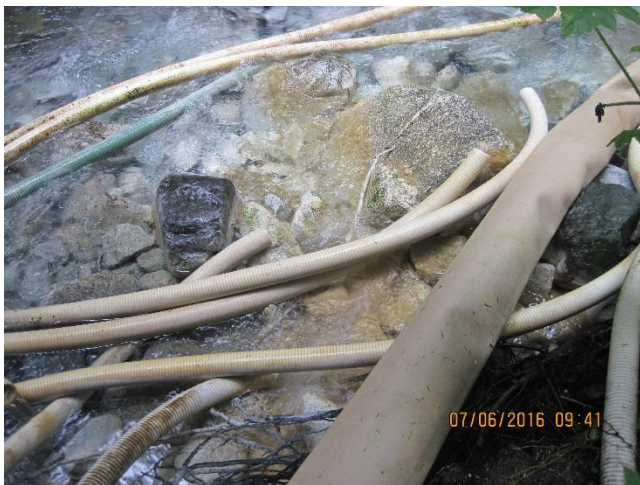
White material was again observed in Sherman Creek (Photos 12-14) during this inspection. Approximately 10 gallons of soil/white material that accumulated under the leaky outfall hose was removed and disposed of within the Comet development pile (Photos 15-16). However, additional white material was observed under other outfall hoses (Photo 17). No white material was observed at the mouth of Sherman Creek (Photos 18-19).

**Photo 12. White material coating rocks within Sherman Creek bed**

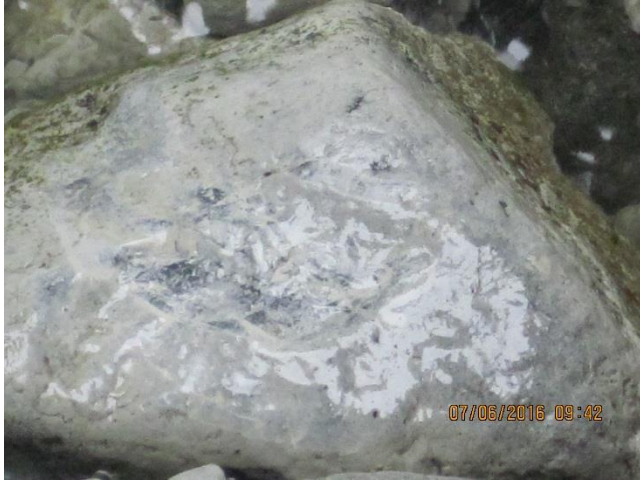
**Photo 13. Zoomed image of white material covering a rock in Sherman Creek.**

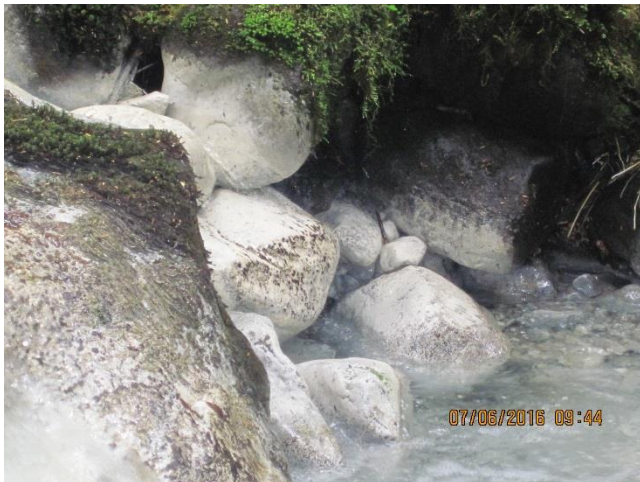
**Photo 14. White material in Sherman Creek.**

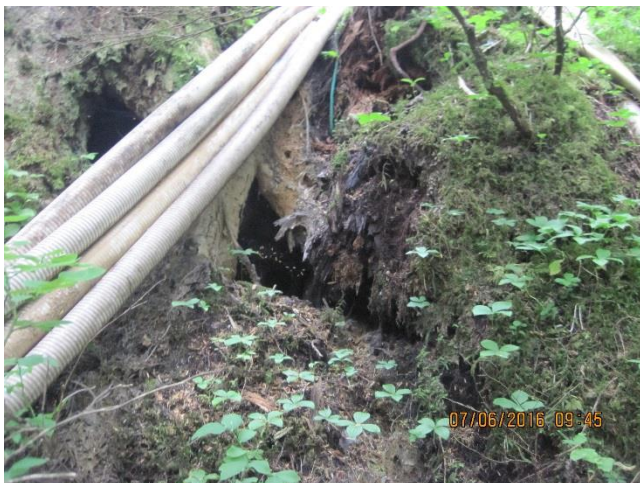
**Photo 15. Approximately 10 gallons of Soil and White material was removed.**

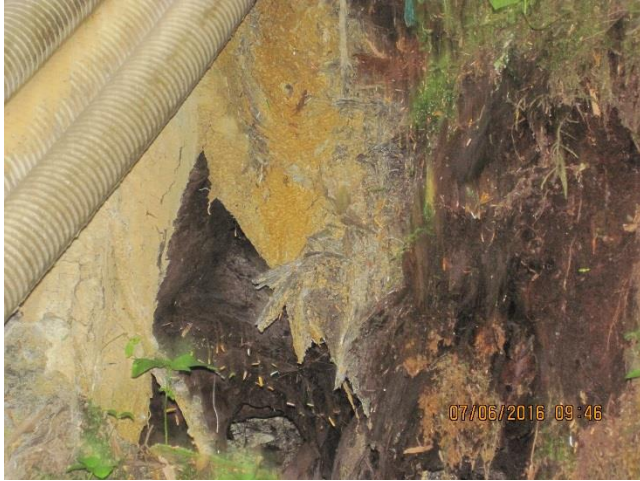
**Photo 16. Zoomed in image showing most of the white material removed.**

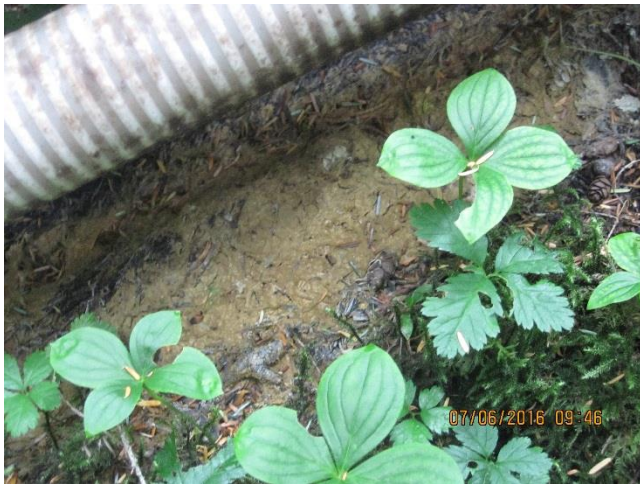
**Photo 17. White material observed under other outfall hoses.**

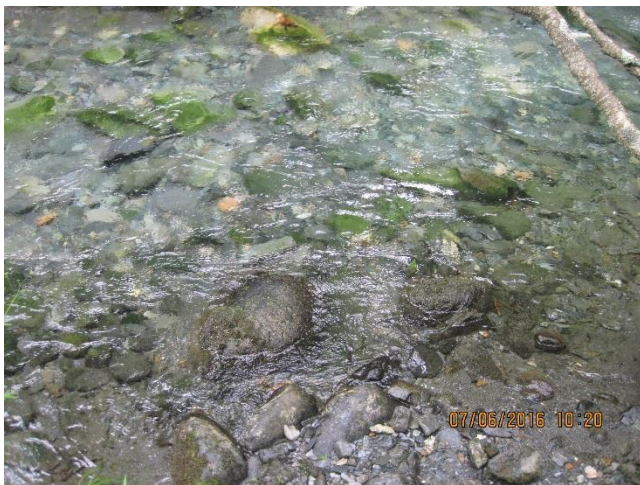
**Photo 18. Comet beach/Sherman Creek.**

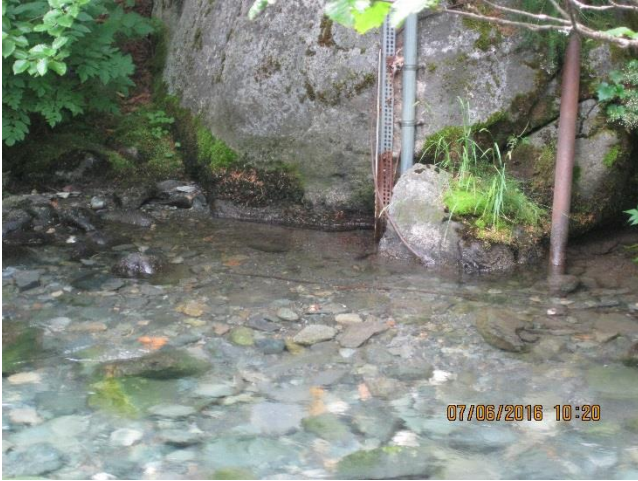
**Photo 19. Comet Beach/Sherman Creek no white material observed.**

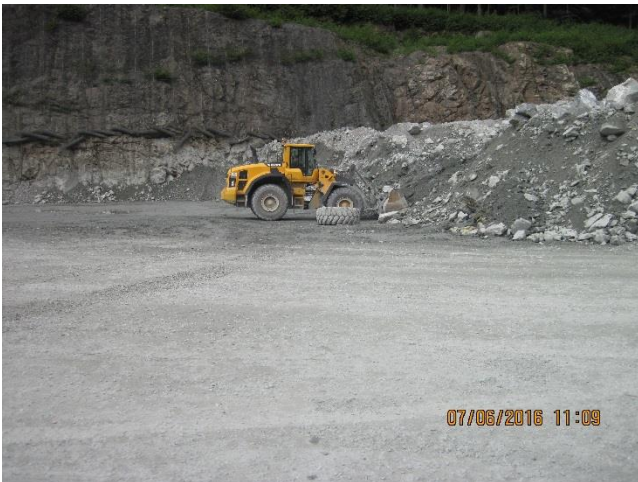
The Jualin ore pad was active with front-end loader transporting ore rock to the crusher for mineral processing (Photo 20).

**Photo 20. Front-end loader translocating ore rock to the Jualin mill.**

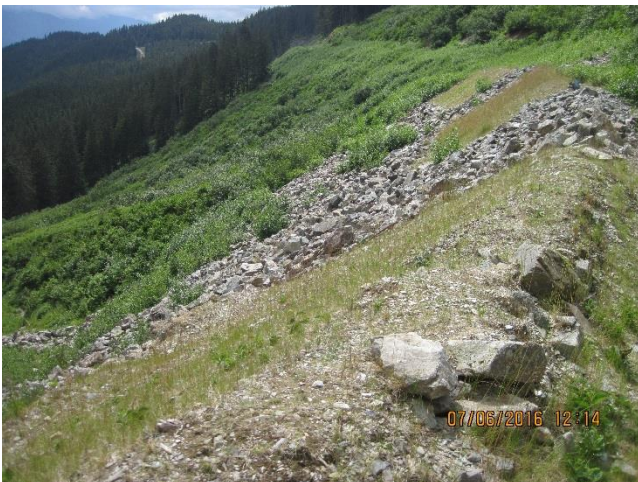
The three waste rock revegetation test plots (Photo 21) were developed as a quantitative approach to monitor growth potential of native plant species (Reclamation plan Appendix 1). The same seed mixture was applied to all three plots, however the soil amendments differ for each plot. Plot-1 is a fertilizer, mulch mixture, Plot-2 is a seed only application, and Plot-3 is a seed and biopolymer application. The three reclamation test plots did show grass was germinating. Further review of the test plots by plant specialists from the agencies is necessary to evaluate their success.

**Photo 21. Three reclamation test plots.**

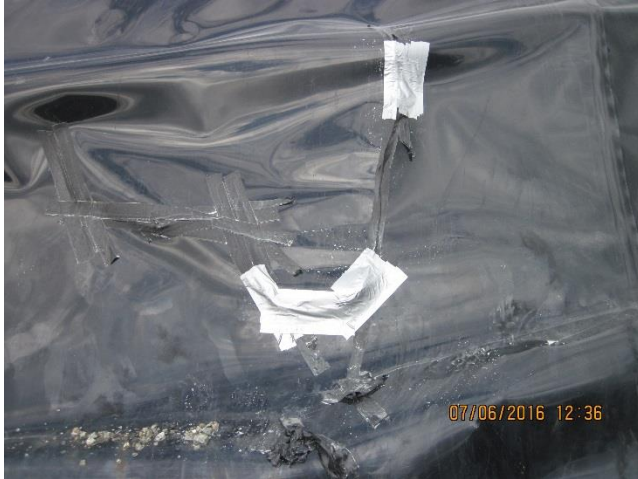
The tears in the Graphitic Phyllite (GP) liner, documented in the 06/08/2016 inspection report, have been repaired (Photo 22). The site was tidy and in order.

**Photo 22. Mud Dump GP liner repaired.**

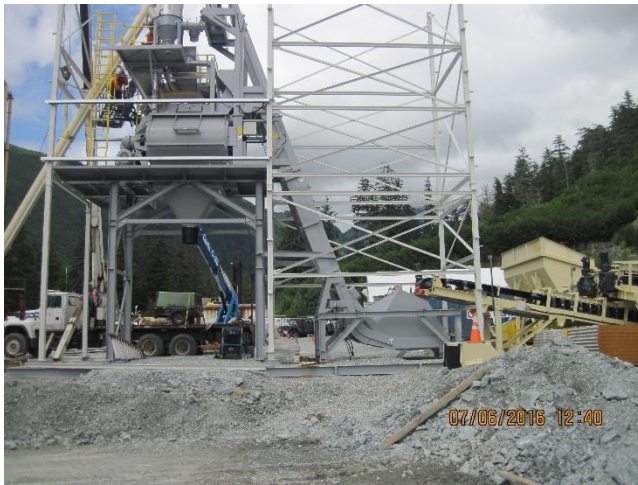
Coeur Alaska is currently adding more structural steel for the Pug plant to help compensate for snow load (Photo 23). The GP stockpile liner is in need of repair. There were two tears observed towards the bottom left side of the stockpile, a top right section of the liner was partially uncovered with GP material exposed (Photo 24). Pit 4 is also the location for the x-ray sorter, which is used to reclaim mineralized pebble reject. The total amount of pebble reject that has gone through the x-ray sorter is 70,110 short tons. The total amount of reclaimed mineralized rock from the x-ray sorter is 5,219 short tons. The reclaimed mineralized rock is sent to the Jualin mill for processing. The x-ray reject rock that is still below the cutoff for the economic grade, is used for access road base material or shipped off site.

**Photo 23. Plug plant structural steel construction.**

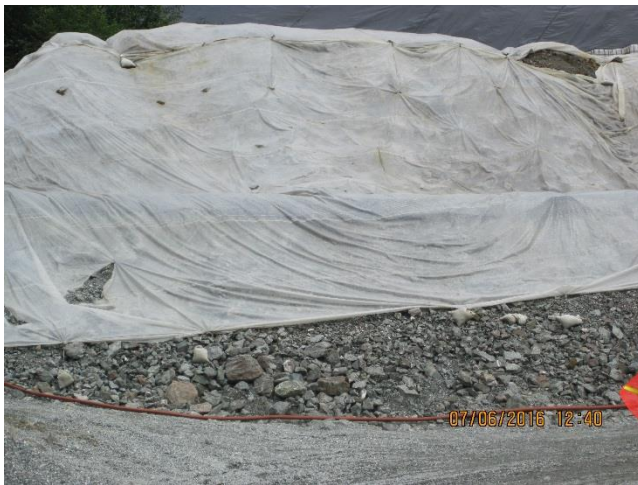
**Photo 24. Pit 4 GP liner tears and a section of the liner partially uncovered.**

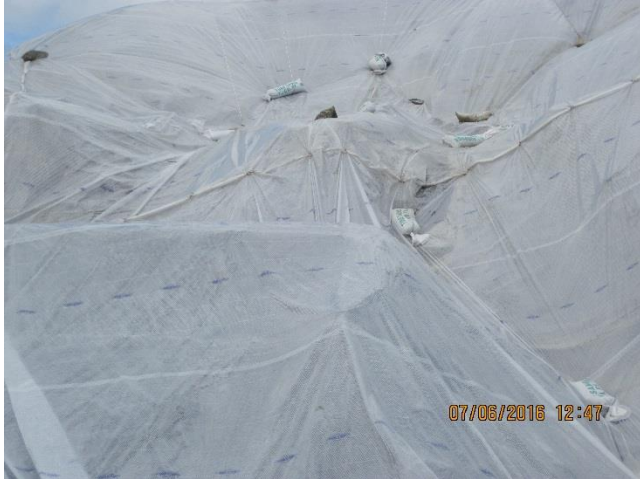
The liner for a GP material stockpile that was partially uncovered, which was documented in the last inspection report on 06/08/2016, has been fixed (Photo 25). The site was tidy and in order.

**Photo 25. Pit 7 GP liner repaired.**

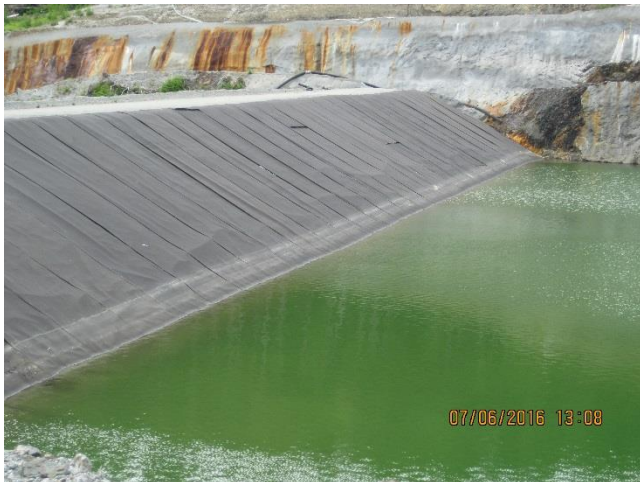
The water level for the TTF was 694.3 feet (Photos 26-27). However, an area of apparently shallow water cover was identified. It was documented from the previous inspection on 06/08/2016, that below the TTF dam, a liner for GP material was partially uncovered. The liner has been re-aligned and is now covering the exposed GP rock (Photo 28).

**Photo 26. TTF water level is 694.3 feet.**

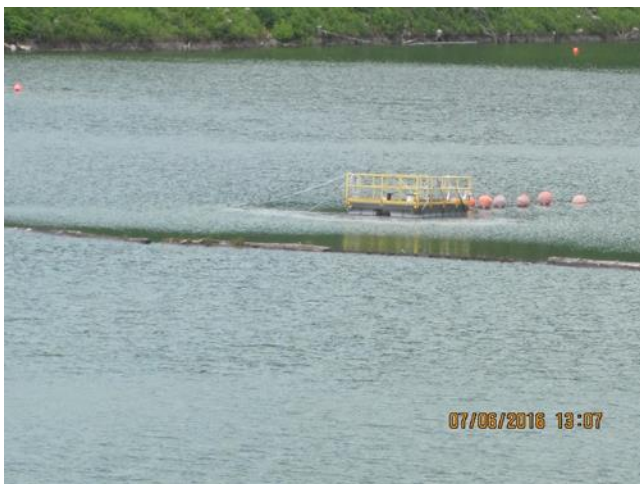
**Photo 27. TTF tailings placement barge.**

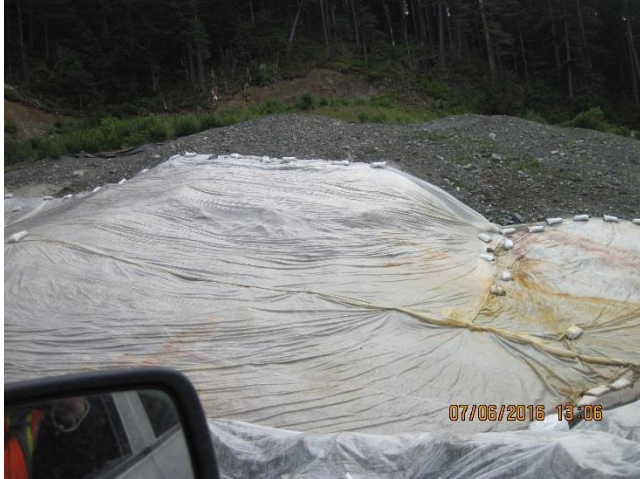
Photo 28. TTF GP material cover.

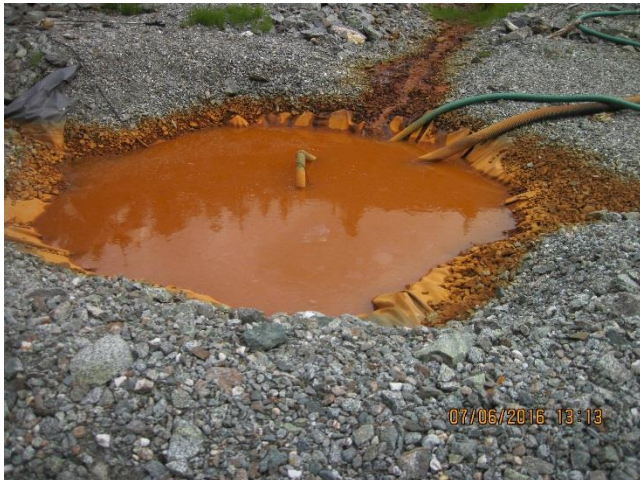
At the northern section of the TTF, acid rock drainage (ARD) (Photo 29) was being pumped to the first of two holding tanks. The ARD is transported to the seep plant where it undergoes treatment and piped to the infiltration gallery near the TTF. The sludge waste collected during the ARD treatment process is used as underground backfill material. The pH for the ARD is approximately 7.0-7.5. The concern is not with the pH levels, but with the high levels of heavy metals (Cadmium, Manganese, and Iron) in the water.

Photo 29. Zoomed in image of an ARD catchment at the northern section of the TTF.

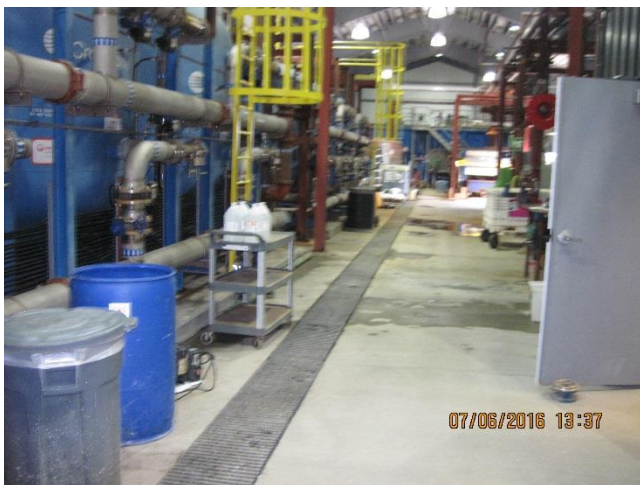
At the time of inspection, the TTF water treatment plant was treating 1150 gallons of water per minute (Photo 30). The water treatment plant facility was tidy and in order. All outside storage containers for chemicals and petroleum products are also stored in appropriate secondary containment (Photo 31).

Photo 30. TTF water treatment plant.

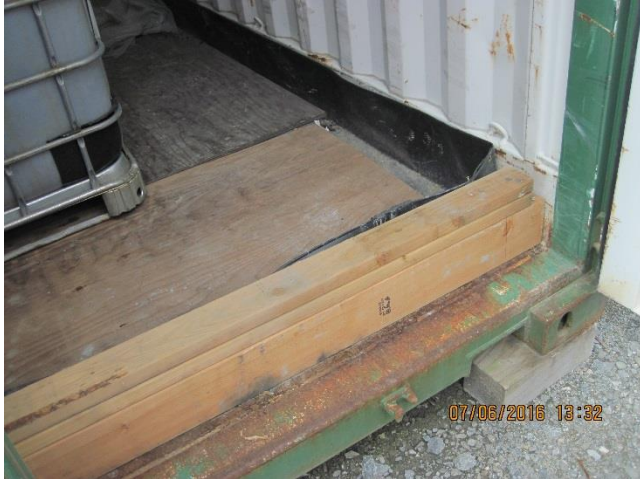
**Photo 31. TTF water treatment plant.**

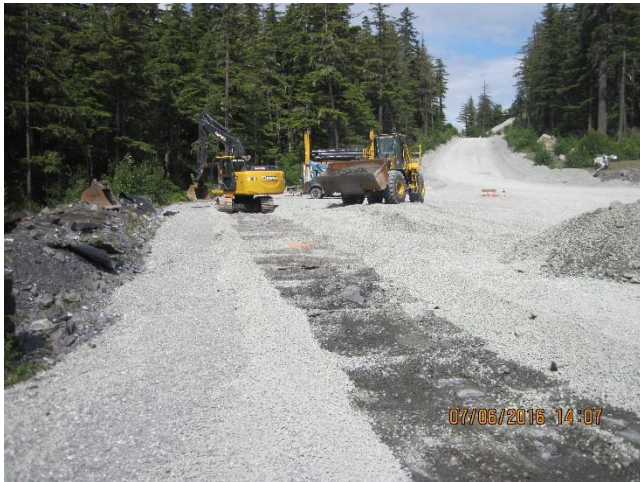
Contractors have begun excavating the area for the fuel depot location (Photos 32). Since the July 6, 2016 inspection, Coeur Alaska has decided not to modify the construction. The fuel depot will be constructed with a liner under the facility and the fuel tanks placed on compacted gravel. This is the approved construction design stated in the Record of Decision for the 2014 Kensington Fuel Depot Environmental Analysis (EA).

**Photo 32. New fuel depot location.**
