INSPECTION REPORT: KENSINGTON GOLD MINE

Date of Inspection: Thursday September 15, 2016
Date of Report: Tuesday September 27, 2016
USDA Forest Service Inspector: Richard Dudek

Ranger District: Juneau Ranger District
Weather Conditions: Clouds with rain. Temperature: High 50's °F.

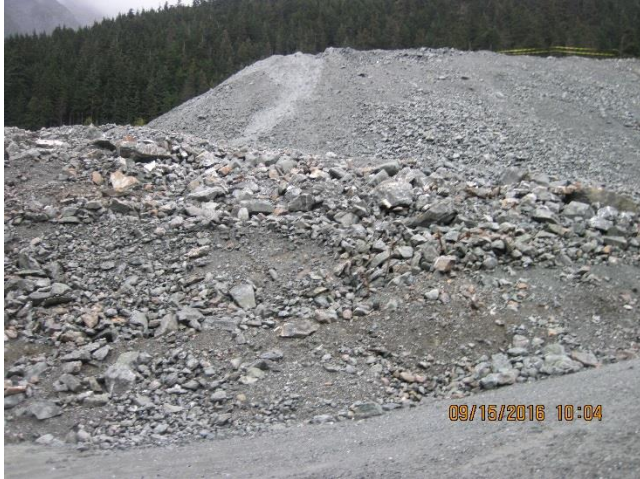
Coeur Alaska continues to deposit development rock at the south-west toe (Photo 1).

Photo 1. Comet development pile toe expansion.

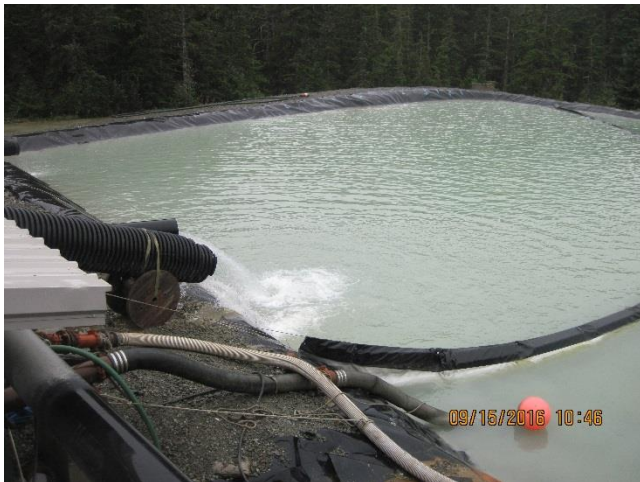
During the inspection, the Comet water treatment plant was treating approximately 1,600 gallons of water per minute (gpm). Pond-1 and Pond-2 (Photos 2-3) were actively receiving mine-site water. Coeur Surface operations have recently installed a silt fence and trench, behind the Comet water treatment plant to enhance stormwater runoff to Pond-1 (Photo 4). All chemicals and petroleum products were properly stored within secondary containment (Photo 5). Active dredging of Pond-2 was occurring during the inspection. A hose associated with the dredge and sediment dewatering bags was malfunctioning, and quickly repaired by Coeur personnel on request from inspectors.

Photo 2. Comet water treatment plant Pond-1.

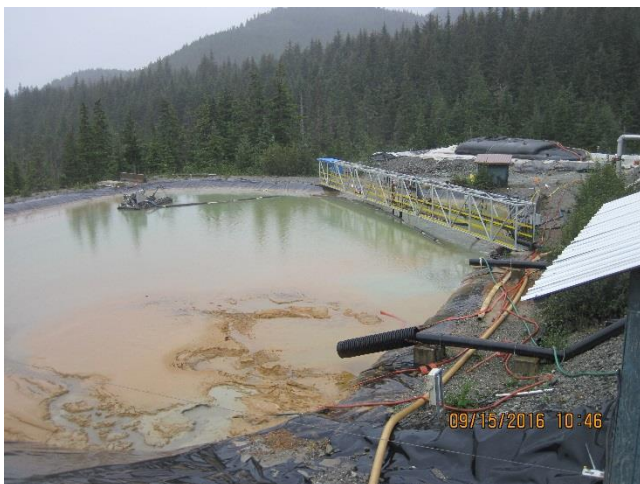
Photo 3. Comet water treatment plant Pond-2.

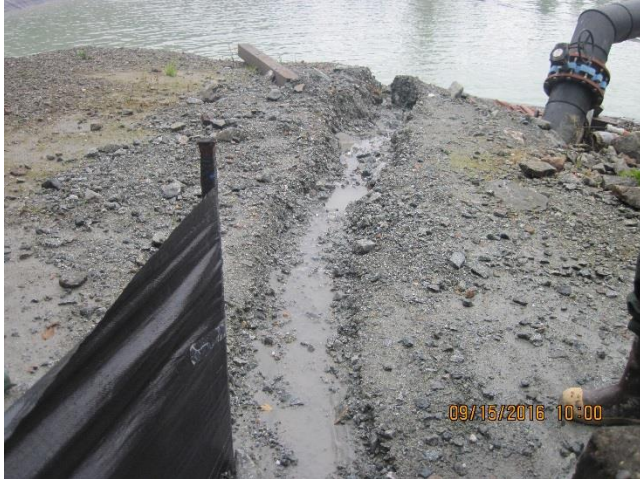
Figure 4. Silt fence and trench for conveying stormwater runoff to Pond-1.

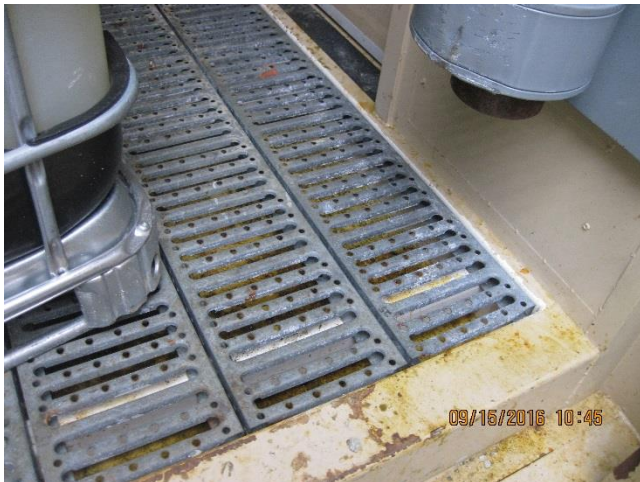
Photo 5. Comet water treatment plant storage container.

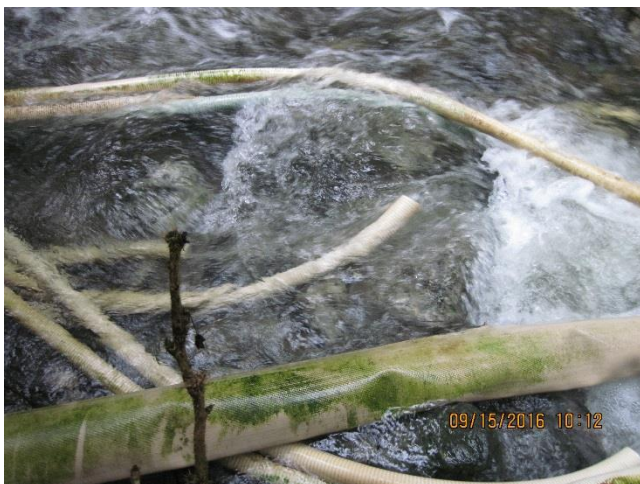
Due to increased flows in Sherman Creek, the white material was not observed throughout the creek bed (Photos 6-7). Kevin Eppers, Environmental Manager for Coeur Alaska, stated that a dewatering bag was installed near the underground 445 level sump is to filter turbid water and trap the sediment. Coeur anticipates this additional mitigation might reduce impacts from the white material. The Forest Service will continue to monitor the white material presence at Sherman Creek Outfall. Coeur Alaska continues to bench test different flocculants and coagulants at the underground triple sumps (Comet adit).

Photo 6. Sherman Creek Outfall (Outfall 001).

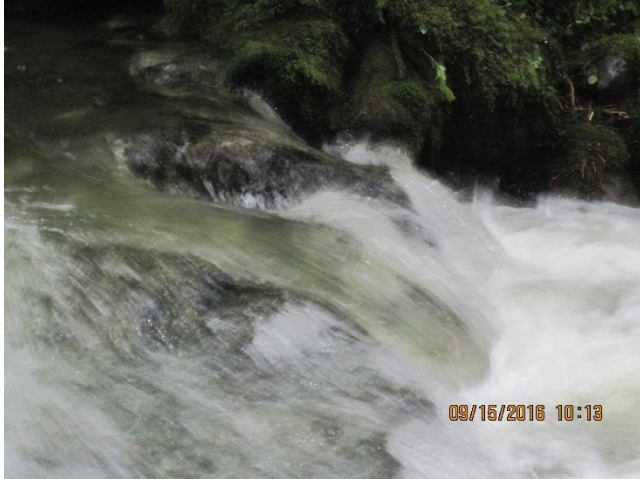
Photo 7. Increased precipitation have increased the flow rates for Sherman Creek.

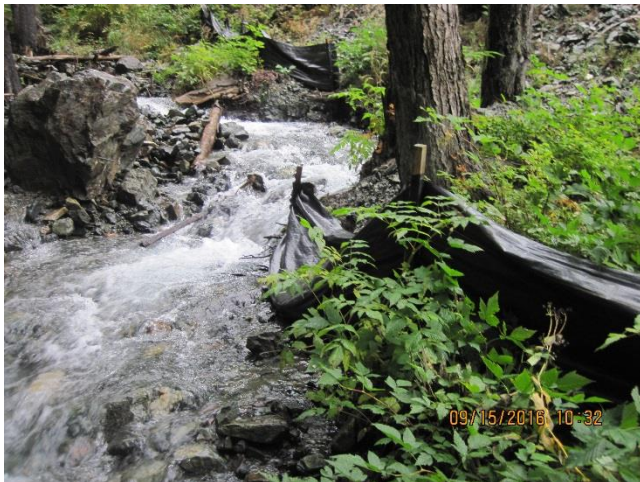
In the 08/04/2016 inspection report, it was documented that Ophir Creek had migrated and undercut the silt fencing, resulting in a section of silt fencing crossing the creek. Since the inspection the section of silt fencing has been removed (Photo 8). Ophir creek's migration towards the Comet Development pile caused the crossing over of the silt fencing. Coeur plans to place riprap at the cut bank section of the creek to help reduce erosion (Photo 9).

Photo 8. A section of silt fencing crossing Ophir Creek has been removed.

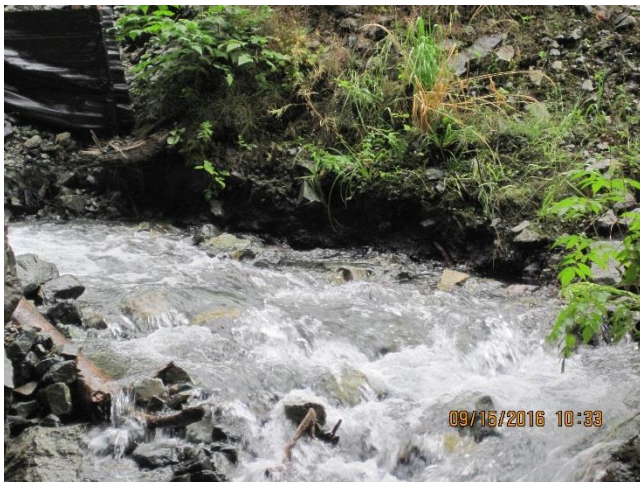
Photo 9. A section of Ophir Creek is migrating towards the Comet Development pile.

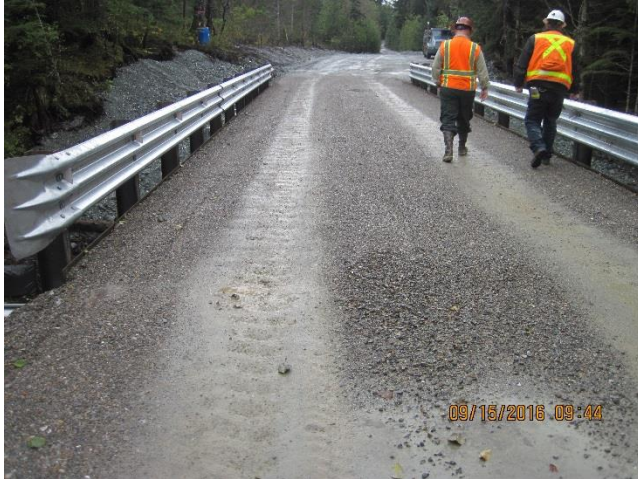
The Forest Service approved bridge replacement (2016 Comet Road Bridge Work Plan) for two prefabricated steel bridges along the Comet access road. The Lower Sherman Creek Bridge is completed (Photos 10 -12). The Upper Sherman Creek Bridge abutments (Photo 13-14) are complete. The Forest Service approved the felling of trees for the construction of the two bridges.

Photo 10. Lower Sherman Creek Bridge for the Comet access road is installed.

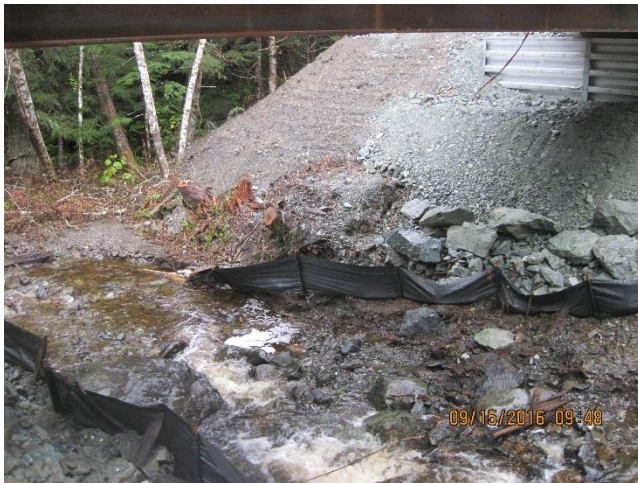
Photo 11. Riprap and silt fencing installed along both bridge abutments (Lower Sherman Creek).

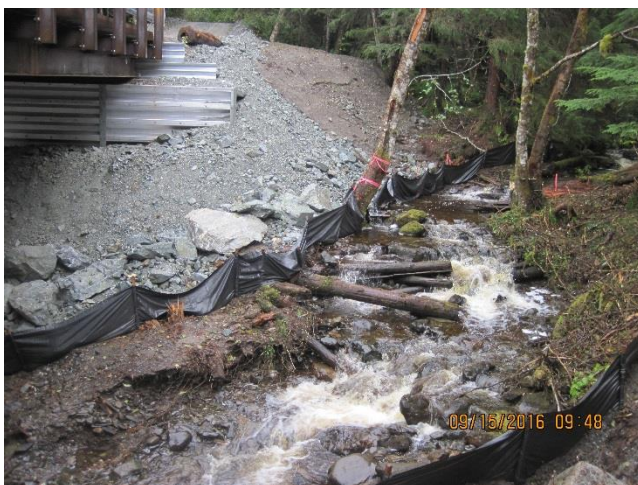
Photo 12. Silt fencing installed to capture stormwater runoff entering upstream of Lower Sherman Creek.

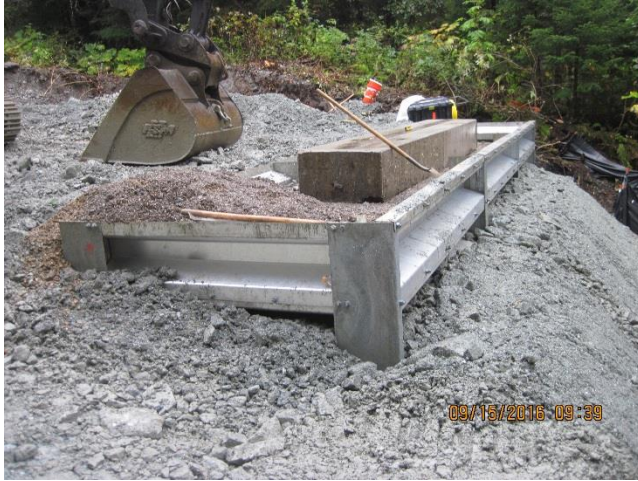
Photo 13. Image shown 1 of 2 upper Sherman Creek bridge abutments have been installed.

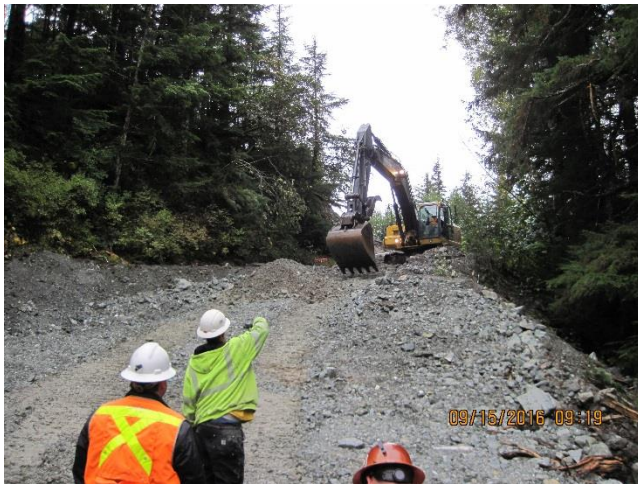
Photo 14. Image shown is 2 of 2 upper Sherman Creek Bridge abutment.

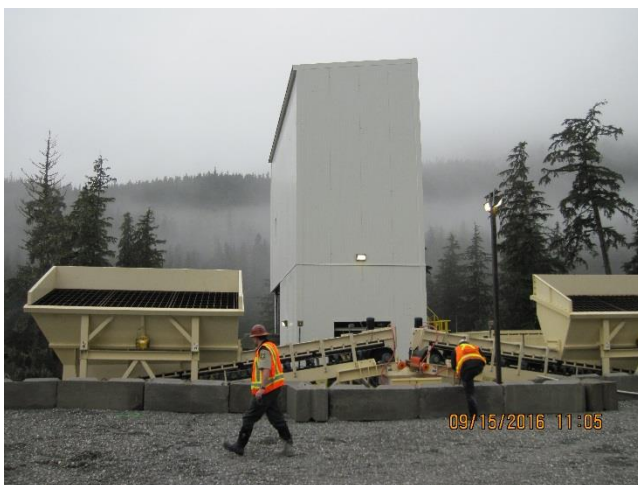
The construction for the Pug plant is completed and is currently in the testing phase (Photo 15). The pug plant will mix graphitic phyllite (GP), cement, and x-ray reject rock. The mix will be disposed of as backfill for the underground stopes. Coeur Alaska recently submitted a proposal to the Forest Service and State agencies for construction of a waste rock stockpile at pit 4 (Photos 16). The Forest Service and State agencies are currently reviewing this proposal.

Photo 15. Pug plant at Pit 4.

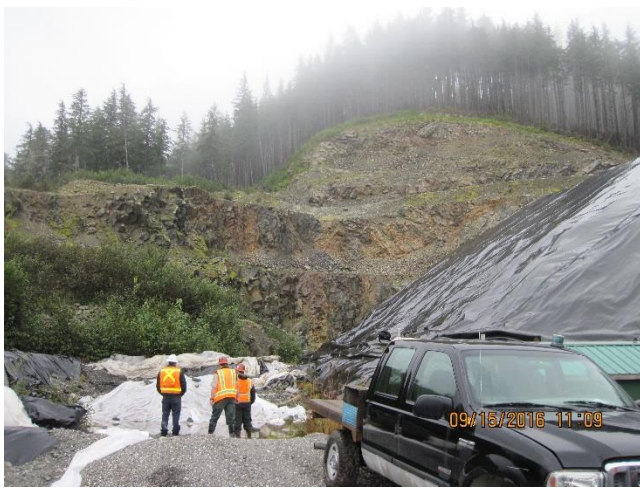
Photo 16. The proposed area at Pit 4 for waste rock storage.

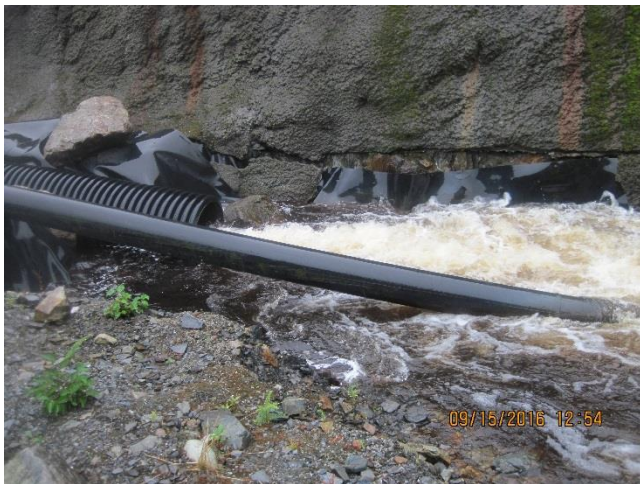
Photo 17. TTF spillway and Slate Creek bypass.

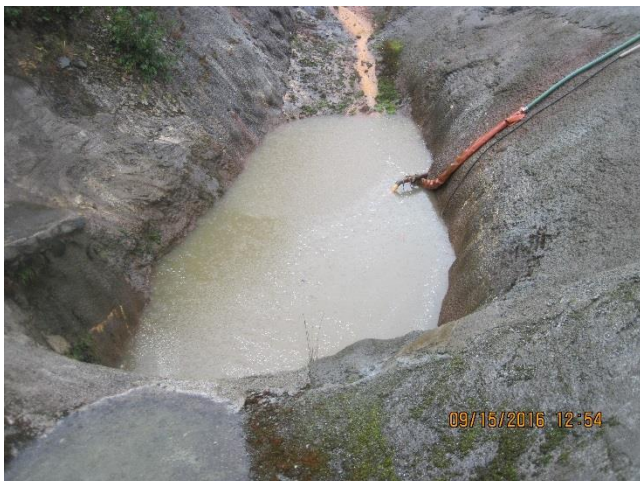
Photo 18. TTF dam spillway/plunge pool.

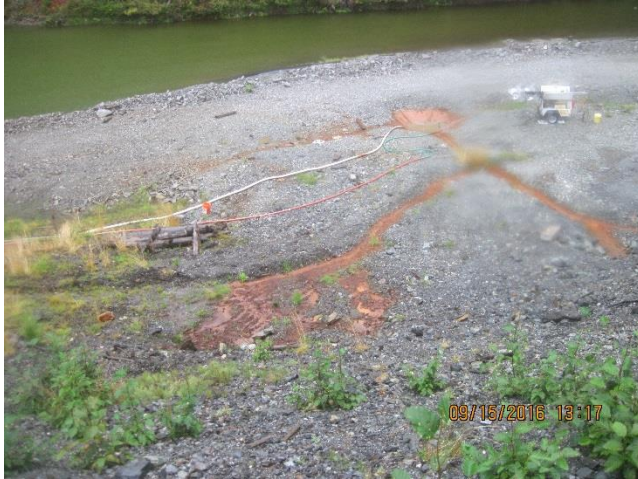
Photo 19. Northern TTF ARD catchment.

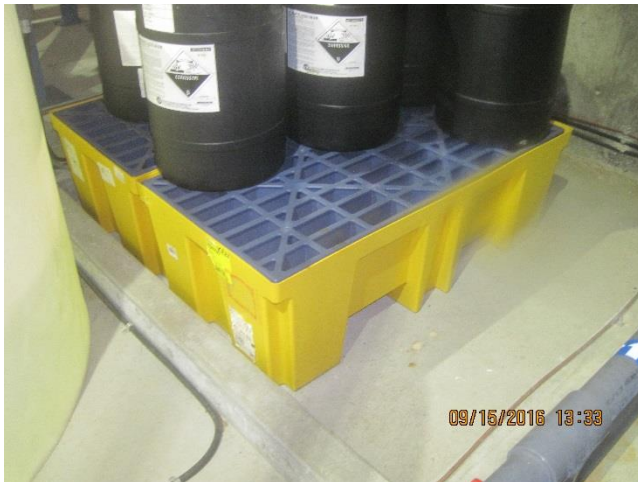
Photo 20. TTF seep plant's secondary containment for chemicals.

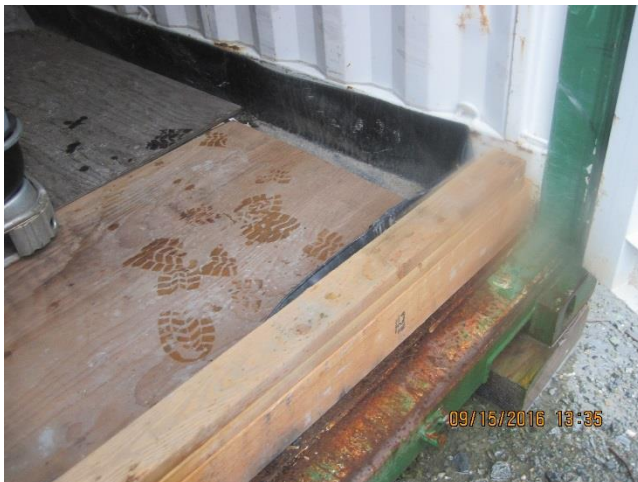
Photo 21. TTF water treatment plant storage container with secondary containment.

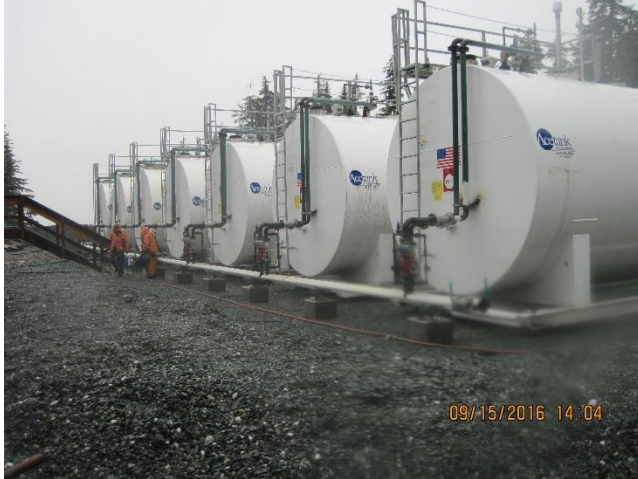
Photo 22. Seven fuel tanks installed.

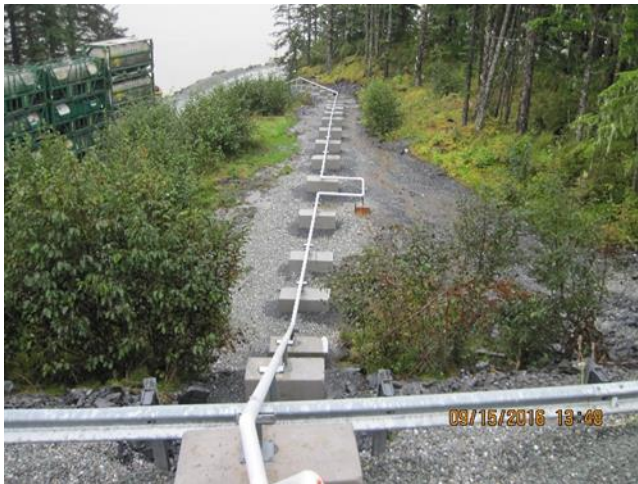
Photo 23. The fuel transfer pipeline installed from the Kensington port to the fuel depot.

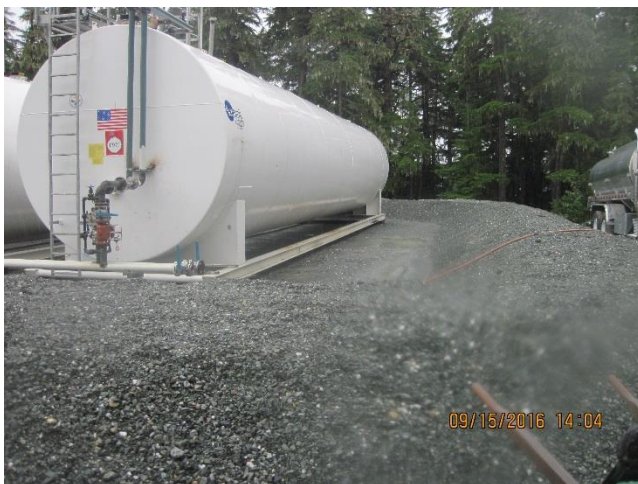
Photo 24. Crushed X-ray reject rock used to construct the berms and gravel layer.

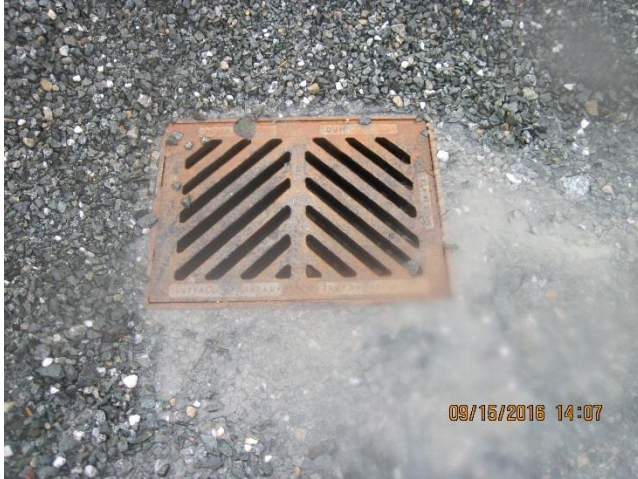
Photo 25. Stormwater drain in fuel depot.

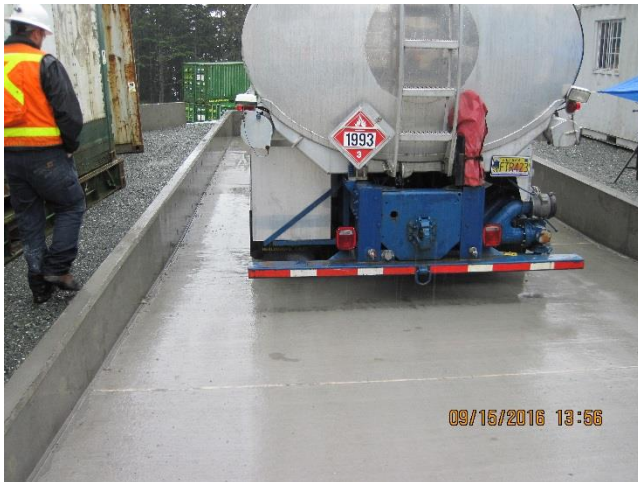
Photo 26. Fuel depot concrete fueling pad.

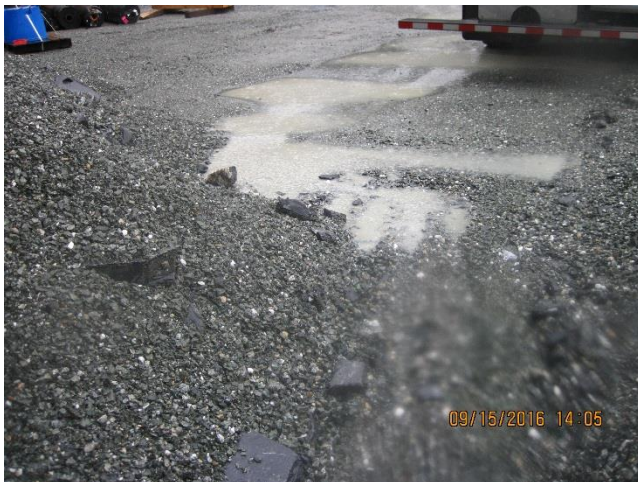
At the north section of the fuel depot, stormwater was ponding and forming flow paths in the gravel parking area (Photo 27). On the south section of the depot, the drainpipe for stormwater needs to be lengthened to avoid undercutting under the concrete walkway (Photo 28).

Photo 27. Stormwater ponding and flow paths formed in the gravel parking area of the fuel depot.

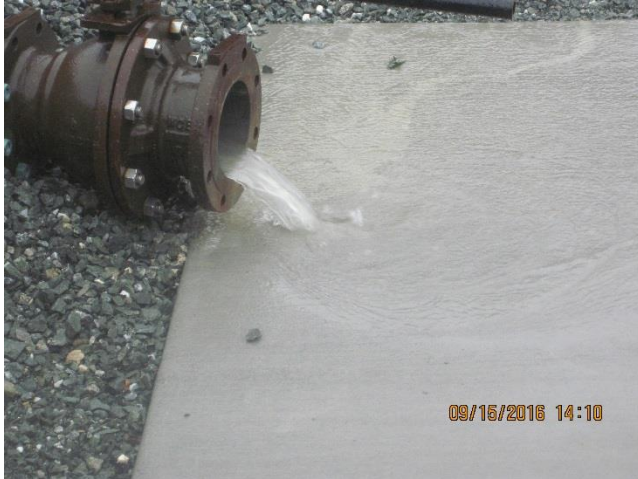
Photo 28. Stormwater drain needs extend out past the fuel depot's concrete walkway.

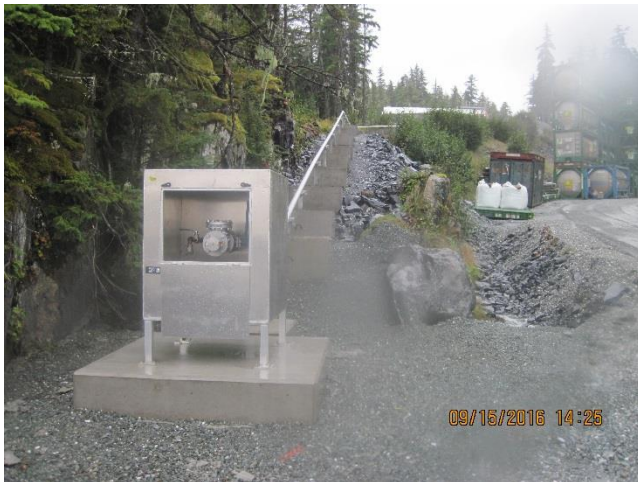
Photo 29. Fuel transfer pipeline from the Kensington port to the fuel depot.

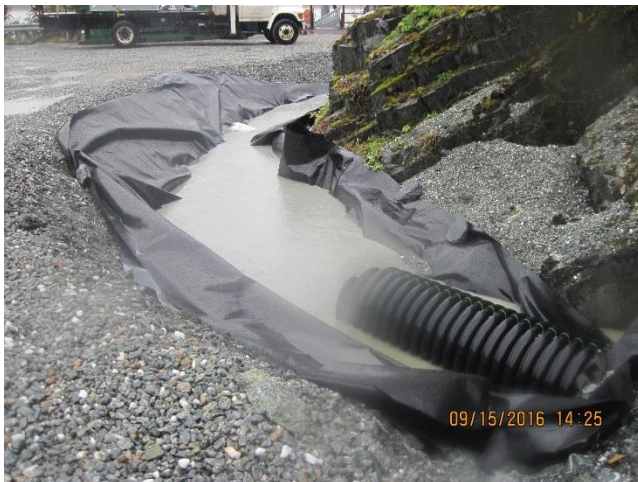
The fuel transfer line from the port to the fuel depot is installed (Photo 29). The improved sump and rock check dam, located at the Kensington Port, were properly functioning with the additional improvements required in the Fuel Depot Decision Notice (Photo 30-31). The sump and rock check dam should to be frequently monitored, and maintained by Surface operations. The 2016 BMP plan, Table 4-3, requires site-wide preventative maintenance for sumps and other structural BMP's need to be cleaned when the sediment capacity is greater than fifty percent.

Photo 30. Kensington port lined sump collecting stormwater runoff.

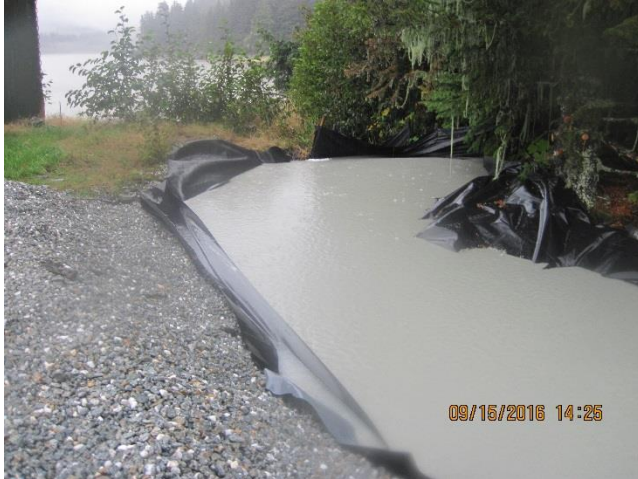
Photo 31. The sump and silt fencing should be frequently monitored at the Kensington port.
