INSPECTION REPORT: KENSINGTON GOLD MINE

Date of Inspection: Thursday October 27, 2016
Date of Report: Thursday November 10, 2016
USDA Forest Service Inspector: Richard Dudek

Ranger District: Juneau Ranger District

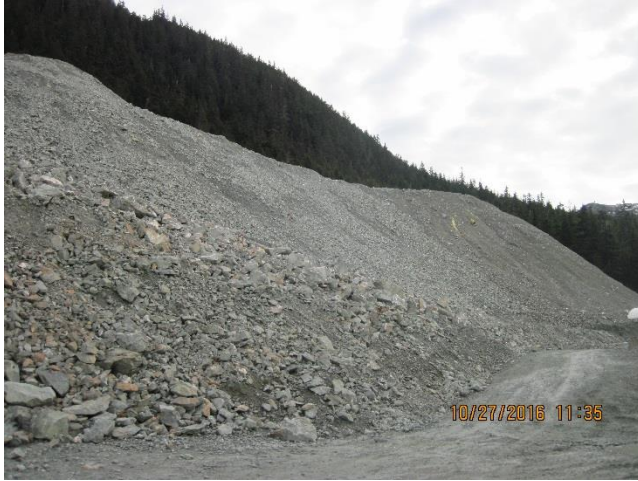
Coeur Alaska continues to deposit development rock at the south-west toe (Photo 1).

Photo 1. Comet development pile south-west toe extension.

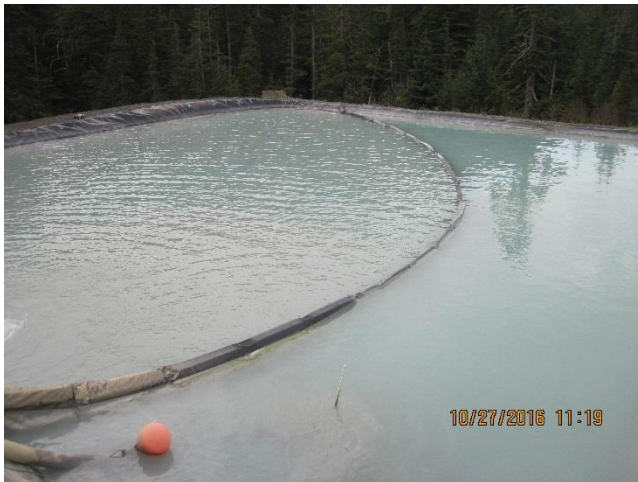
Photo 2. Comet water treatment plant, Pond-1.

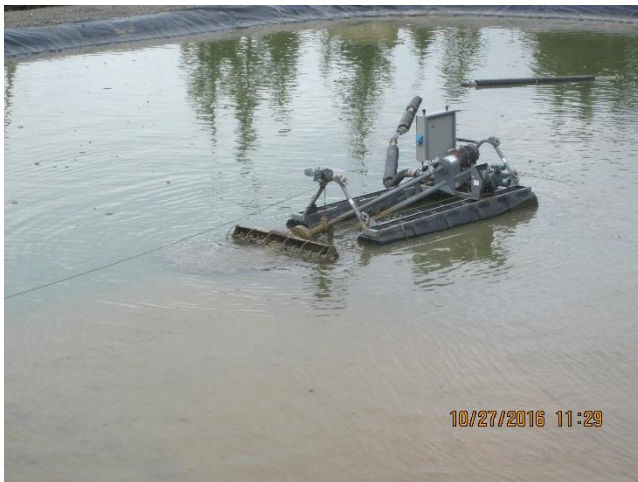
Photo 3. Comet water treatment plant, Pond-2.

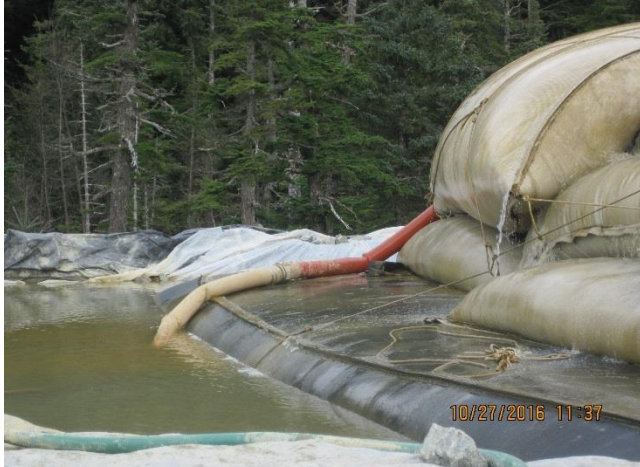
Photo 4. Sediment dewatering bags at the Comet water treatment plant.

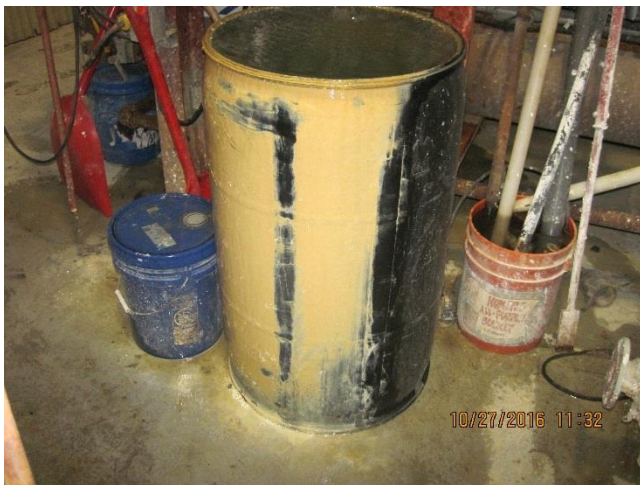
Coeur Alaska continues using a barrel that is filled with rocks and overflowing with treated mine-site water (Photo 5). The barrel is used for monitoring the accumulation rate of white material adhering to the rocks.

Photo 5. The barrel is used for monitoring rate of accumulation of white material.

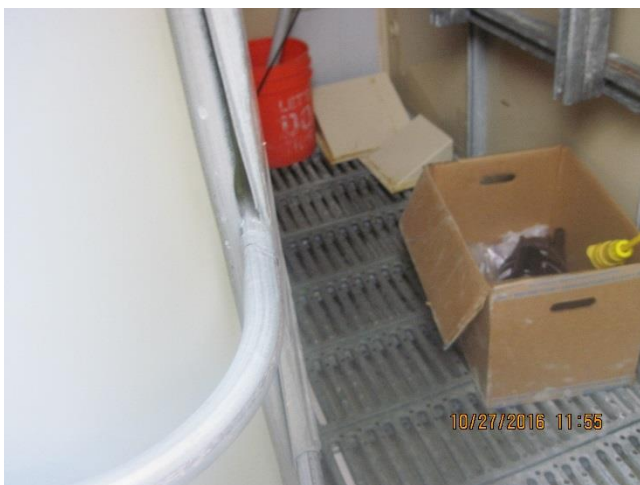
A storage container for the water treatment plant was tidy, and all liquid chemicals were stored within secondary containment (Photo 6).

Photo 6. A storage container with secondary containment.

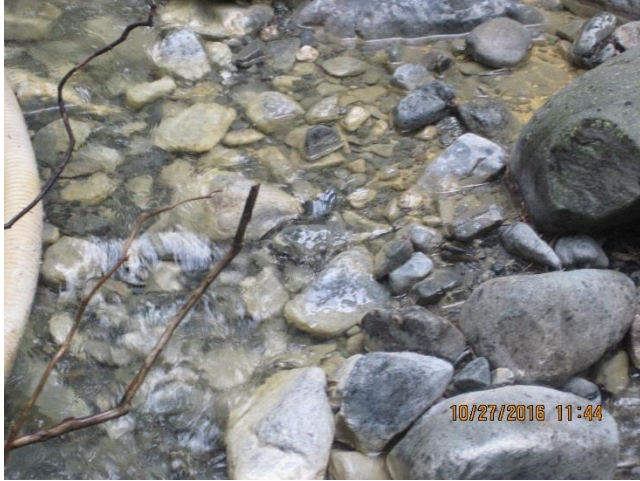
White material was observed in Sherman Creek (Photo 7). In a previous report from 09/15/2016, Coeur Alaska stated that a dewatering bag was installed near the underground 445 level sump as an additional mitigation for removing white material. Coeur Alaska anticipated this would reduce the amount of white material prior to entering the Comet water treatment plant settling ponds. The success for this mitigation will be determined by the reduction of white material in the outfall. Coeur Alaska is currently testing new coagulants and flocculants to help settle out white material out of solution.

Photo 7. White material observed in Sherman Creek.

Sherman Creek Outfall: Visual observations for white material in Sherman Creek.

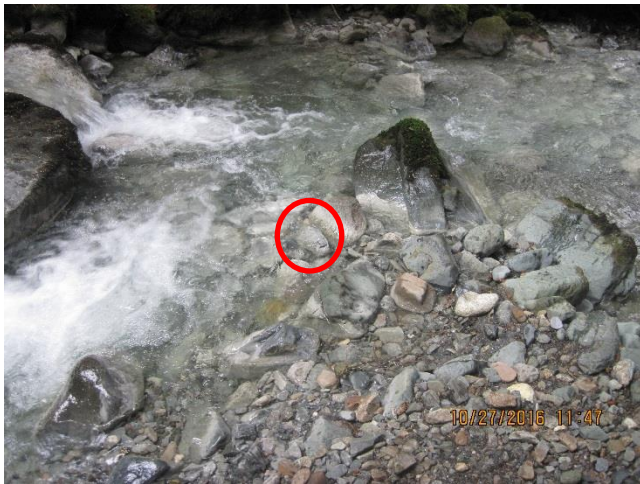
Coeur Alaska personnel recently placed a clean rock in Sherman creek (Photo 8) for monitoring accumulation of white material in the creek bed. The USFS will continue to monitor this location for white material in Sherman Creek.

Photo 8. The rock encircled is a recently placed clean rock used for white material observations.

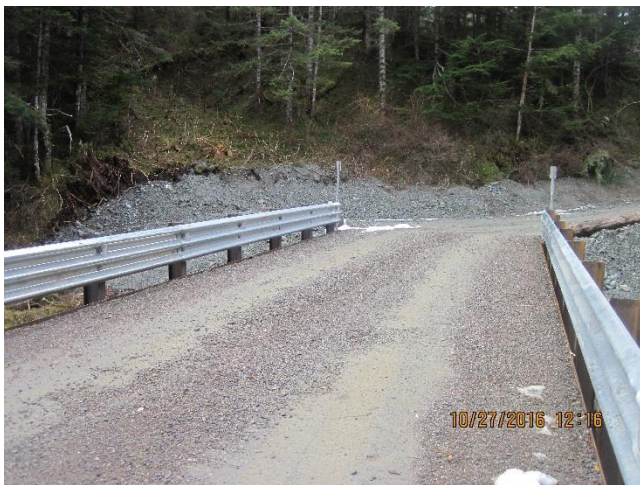
Photo 9. Upper Sherman Creek Bridge.

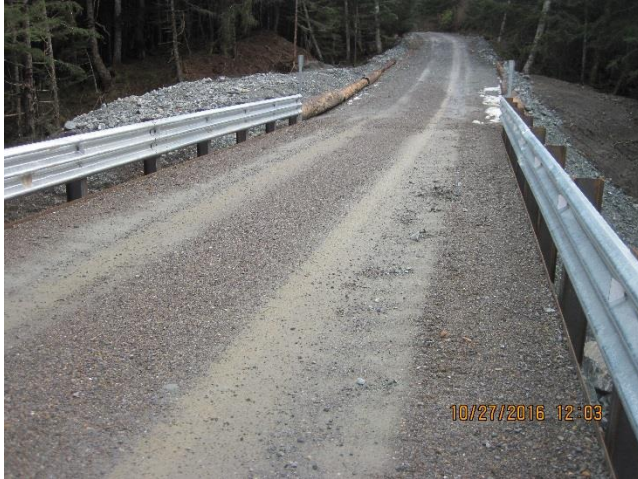
Photo 10. South fork Sherman Creek Bridge.

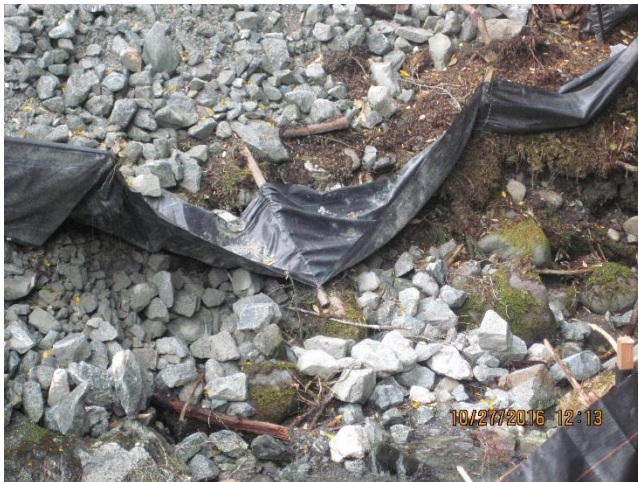
The Forest Service approved the replacement of two wood stringer bridges with two prefabricated steel bridges. The installation of the two steel fabricated bridges crossing Upper Sherman Creek (Photo 9), and the south fork of Sherman Creek (Photo 10) is complete. There are sections of silt fencing at the Upper Sherman Creek Bridge that need immediate repairs (Photo 11). Rocks and woody debris have pushed over and/or torn through sections of silt fencing (Photo 12).

Photo 11. Upper Sherman Creek Bridge silt fencing pushed over.

Upper Sherman Creek Bridge: The damaged sections of silt fencing repaired and/or replaced.

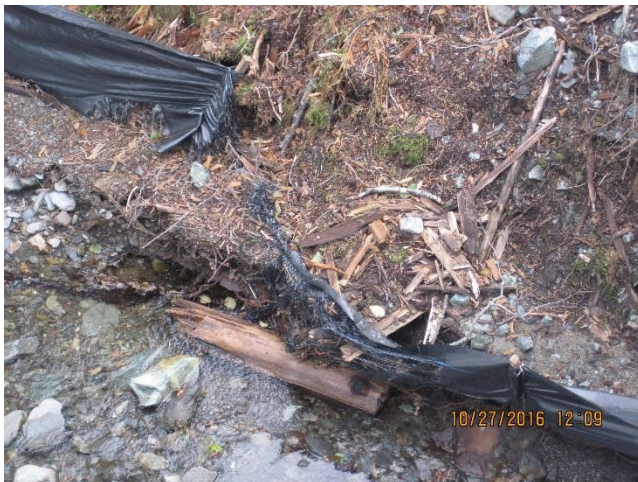
Photo 12. Upper Sherman Creek Bridge silt fencing is torn.

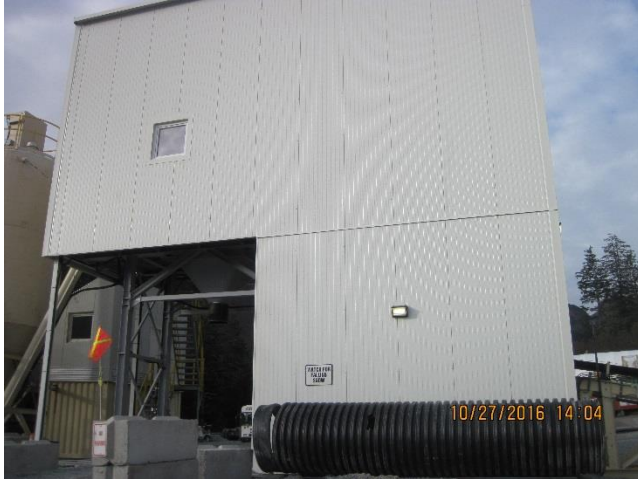
Photo 13. Pug plant at Pit 4.

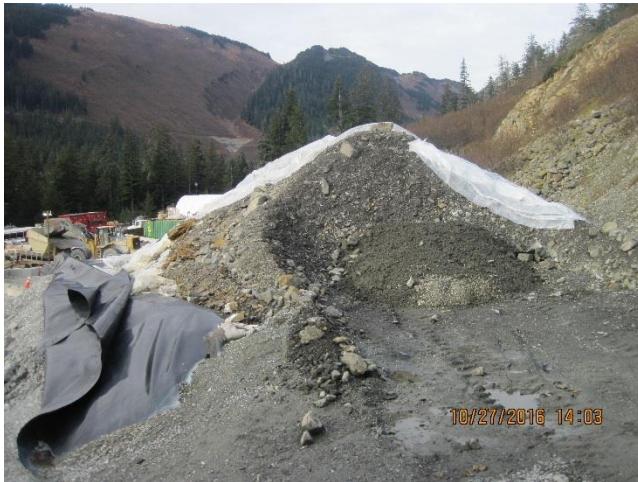
Photo 14. Temporary GP stockpile at Pit 4 is currently being utilized as aggregate for the Pug plant.

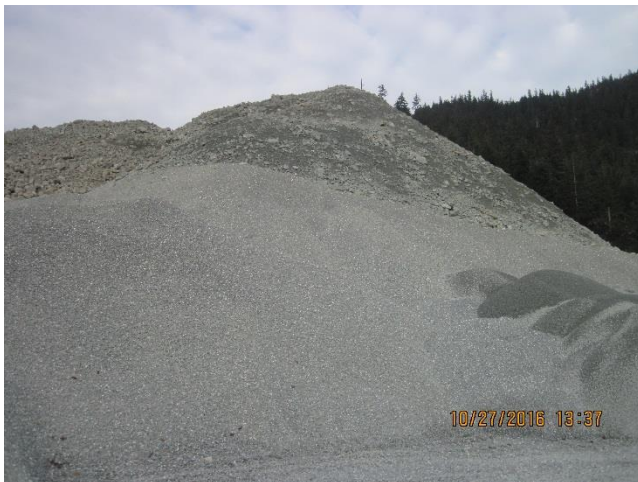
Photo 15. Waste rock and pebble reject rock storage at Pit 4.

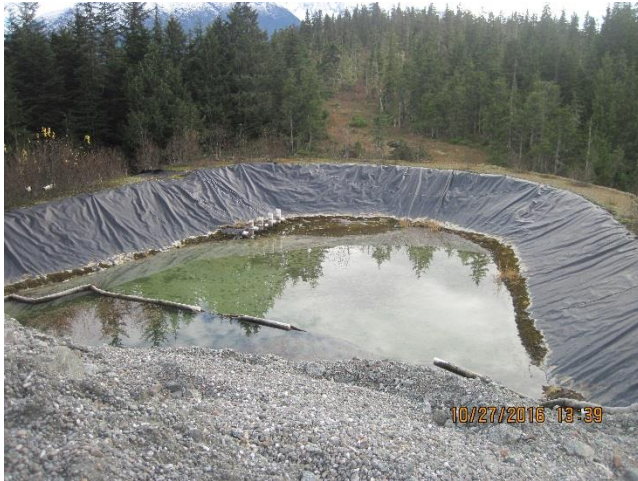
Photo 16. An existing settling pond at Pit 4 will collect stormwater runoff from the waste rock pile.

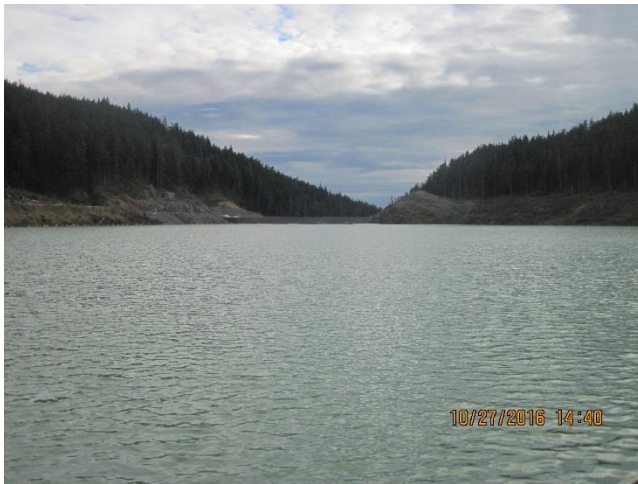
The water level for the TTF (Photo 17) was 695.9 feet. Coeur Alaska will be installing a water agitator in the TTF dam plunge pool (Photos 18-19) to keep ice from forming and jamming the transfer pipe from the dam plunge pool to the seep plant.

Photo 17. Coeur Alaska's TTF.

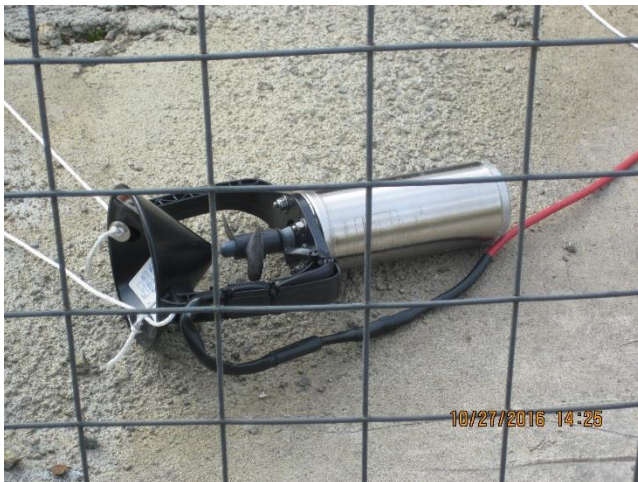
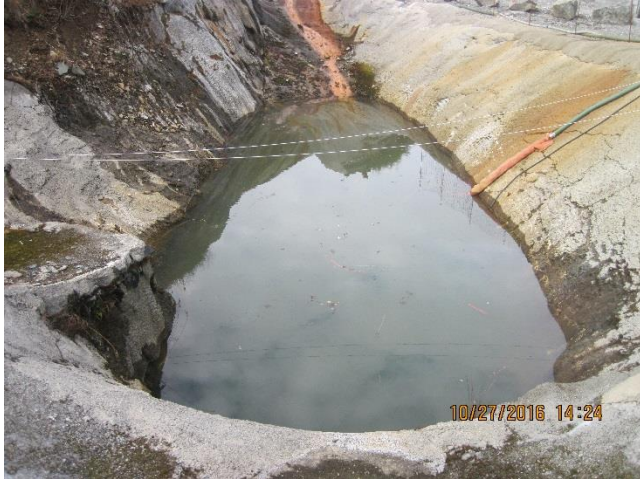
Photo 18. A water agitator at the TTF dam plunge pool.

Photo 19. The TTF dam plunge pool.

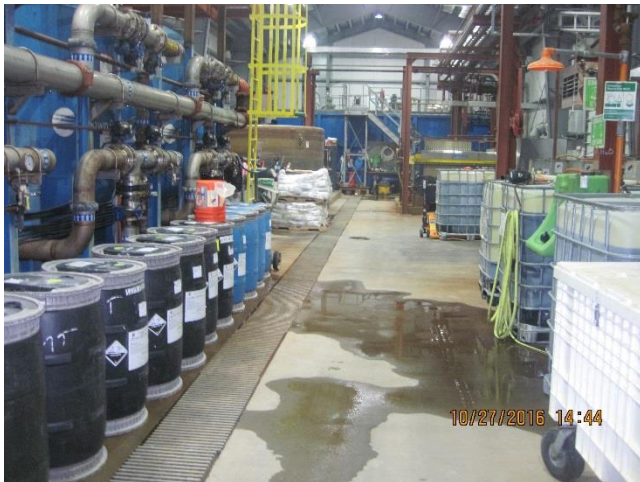
Photo 20. The TTF water treatment plant

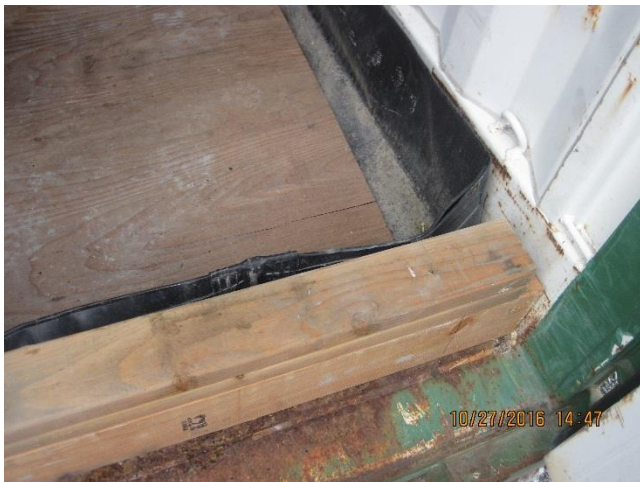
Photo 21. TTF storage containers with secondary containment.

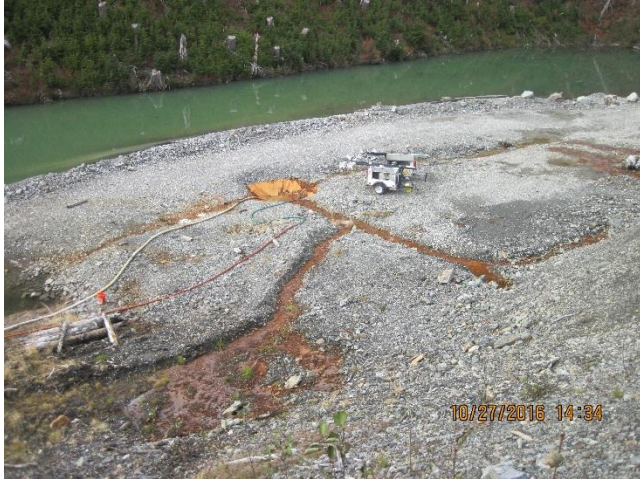
At the northern section of the TTF, acid rock drainage (ARD) continues to seep into an ARD catchment (Photo 22). The concern with the ARD is due to Aluminum and Manganese levels exceed the Alaska water quality standards (AWQS); the pH for the ARD is approximately 7.5. The ARD seepage undergoes treatment at the seep plant and is discharged into the infiltration gallery adjacent the TTF. Solids filtered during the treatment process are disposed of as underground backfill.

Photo 22. Northern TTF, ARD catchment.

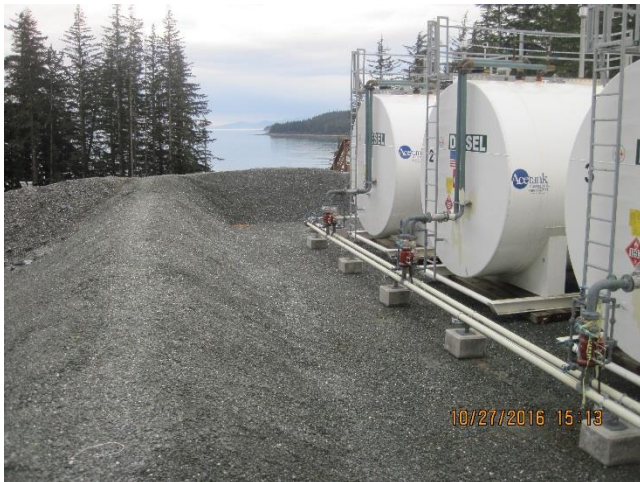
Photo 23. Seven 50,000-gallon double walled fuel tanks.

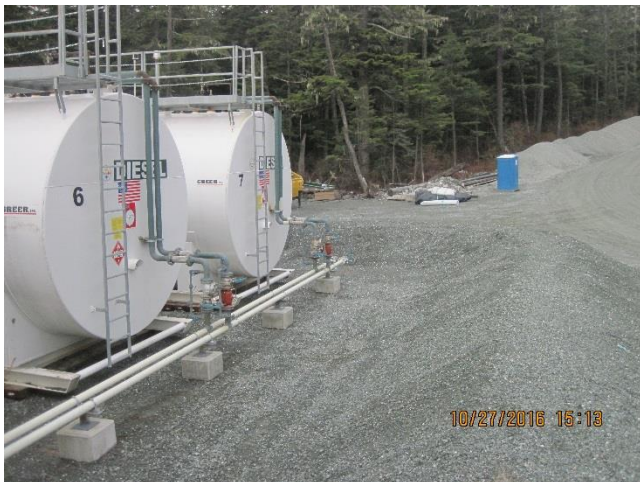
Photo 24. Fuel tanks are placed on a HDPE lined and bermed gravel bed.

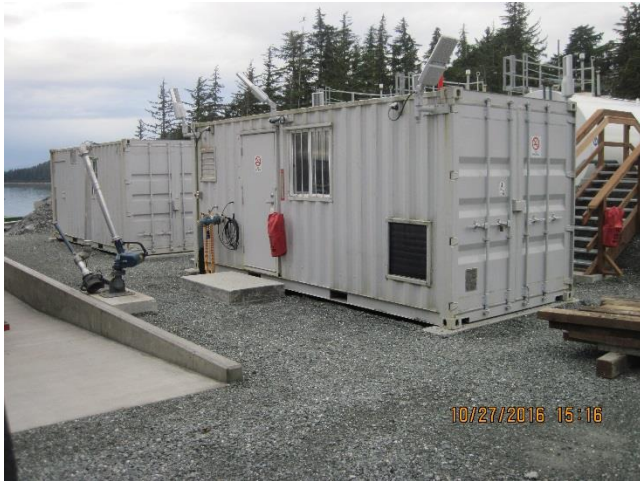
Photo 25. The fuel depot pumping station will transfer fuel from the tanks to a fuel truck.

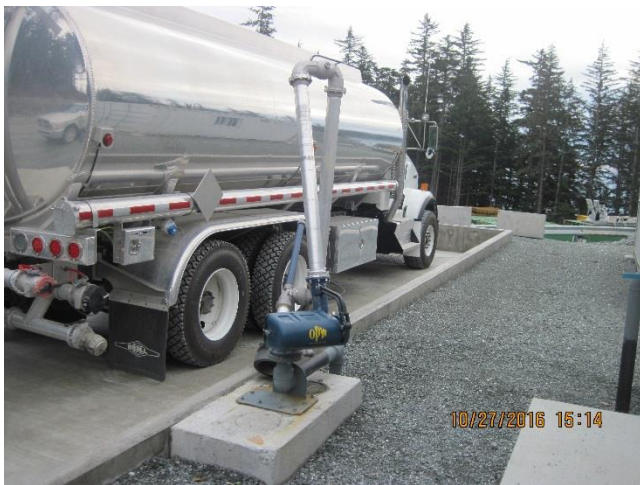
Photo 26. Kensington fuel truck parked on a concrete pad at the fuel depot.

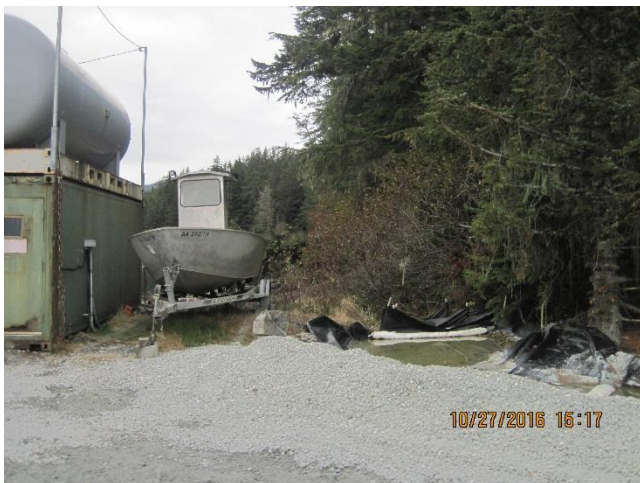
Photo 27. 18-foot skiff for will be used to deploy an oil containment boom in the event of a spill.

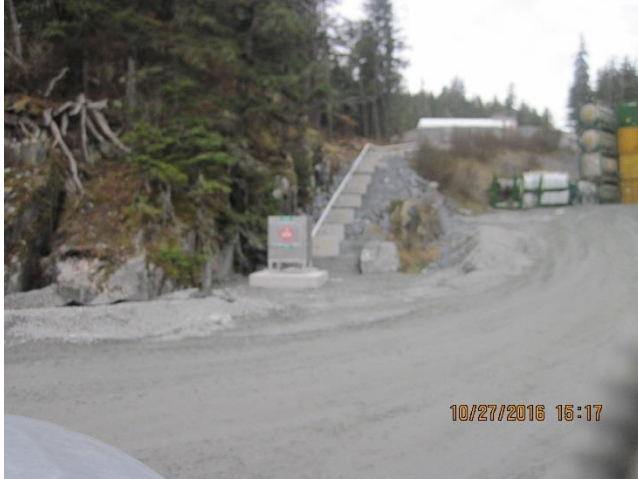
Photo 28. The Kensington port fuel transfer pipeline.
