INSPECTION REPORT: KENSINGTON GOLD MINE

Date of Inspection: Thursday, December 29, 2016
Date of Report: Thursday, January 5, 2017
USDA Forest Service Inspector: Edward Gazzetti

This inspection focused primarily on a diesel spill first reported by Coeur on December 26.

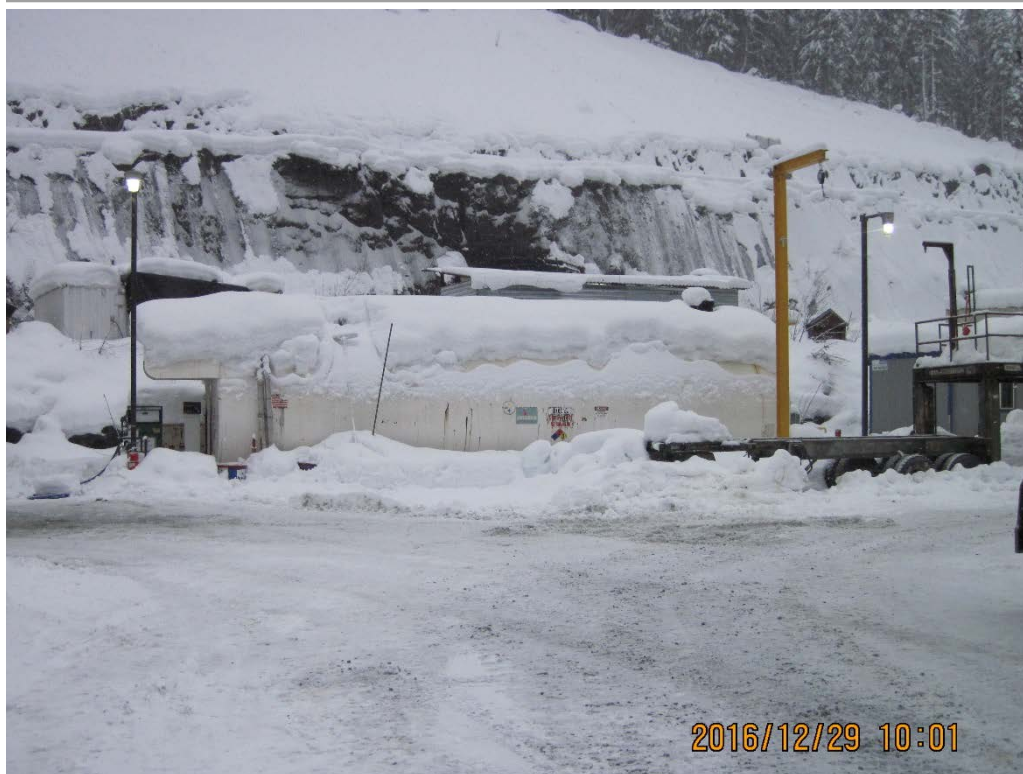
Photo 1. 30,000-gallon “day tank”. Isotainers are placed on the rack (trailer) located on the right side of this photo during refueling. Fuel flows through a filter before entering the day tank.

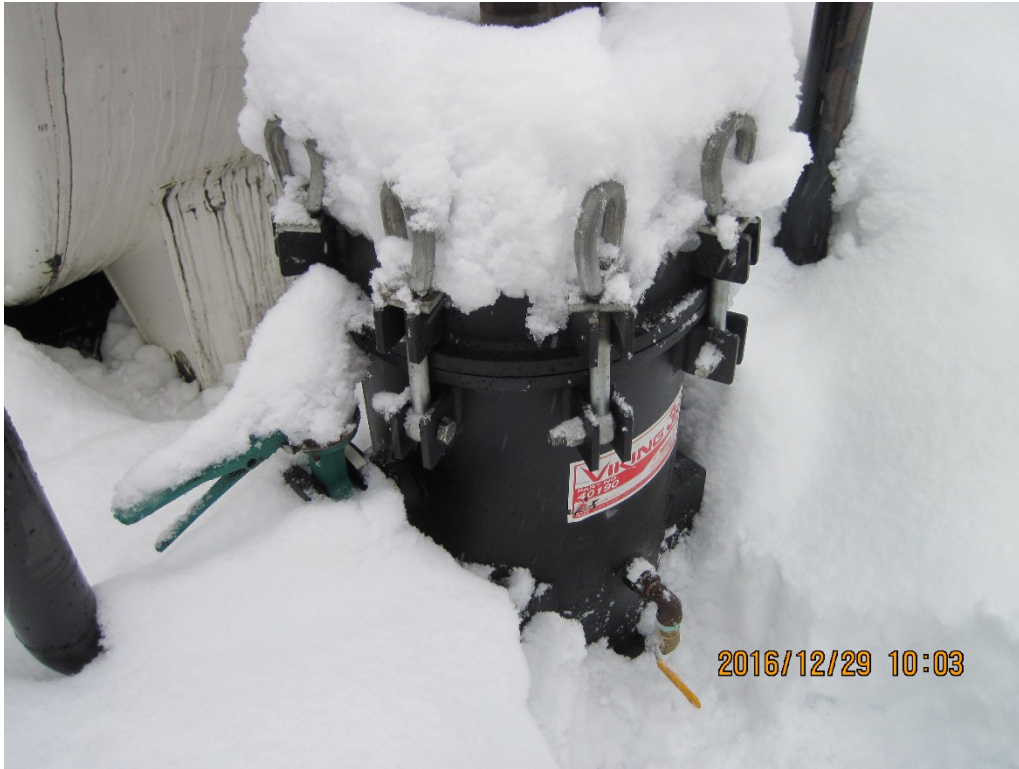
Photo 2. During refueling, diesel from the isotainer flows through this filter, located on the back of the day tank.

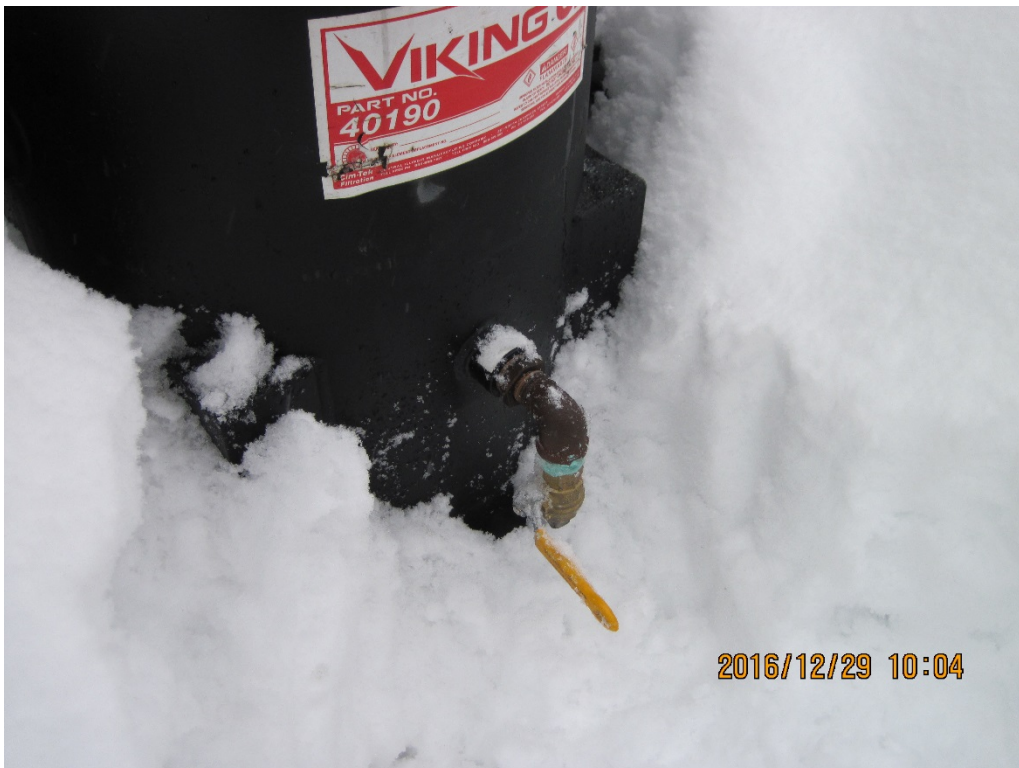
Problem: Ball valve turned to the “open” position.

Photo 3. Ball valve on the filter was in the “open” position, allowing diesel to escape from the filter during refueling. The valve has since been plugged and the orientation of its handle has been changed to prevent falling snow/ice from opening it.

Resolution: To prevent a repeat of this spill, Coeur Alaska has inserted a plug into the ball valve and has changed its orientation to prevent falling objects (like snow and ice) from opening it.

Action Item: Coeur Alaska will develop a written procedure for the filter’s maintenance to highlight the plug’s purpose and to ensure it stays in place.

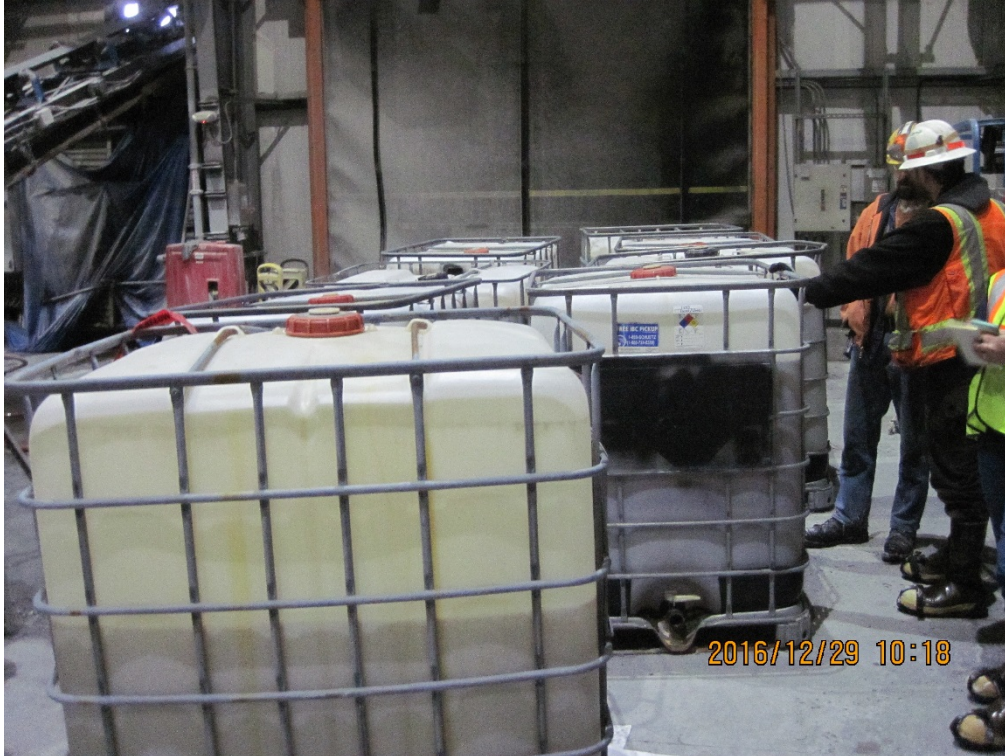
OWS and lift station: The OWS’s function is to separate spilled diesel and stormwater collected by the day tank’s concrete containment area. When functioning properly, the OWS isolates oil (diesel) and an adjacent lift station pumps recycled water into the Mill for use in the tailings thickening process. It appears the OWS was filled with ice and, therefore, not functioning during the spill event. Consequently, the spilled diesel flowed into the lift station, which pumped it into the Mill. On December 26, Coeur Alaska reported collecting an estimated 860 gallons of diesel from the lift station (Photo 4). On December 29, Coeur Alaska revised that estimate to 160 gallons, stating that the 860 gallons was mostly water.

Photo 4. Eight totes filled with a water/diesel mixture captured and removed from the lift station. As the mixture separated, mine personnel adjusted their spill estimate from ~860 gallons to ~160 gallons. Coeur Alaska expects to capture more diesel from the OWS and lift station.

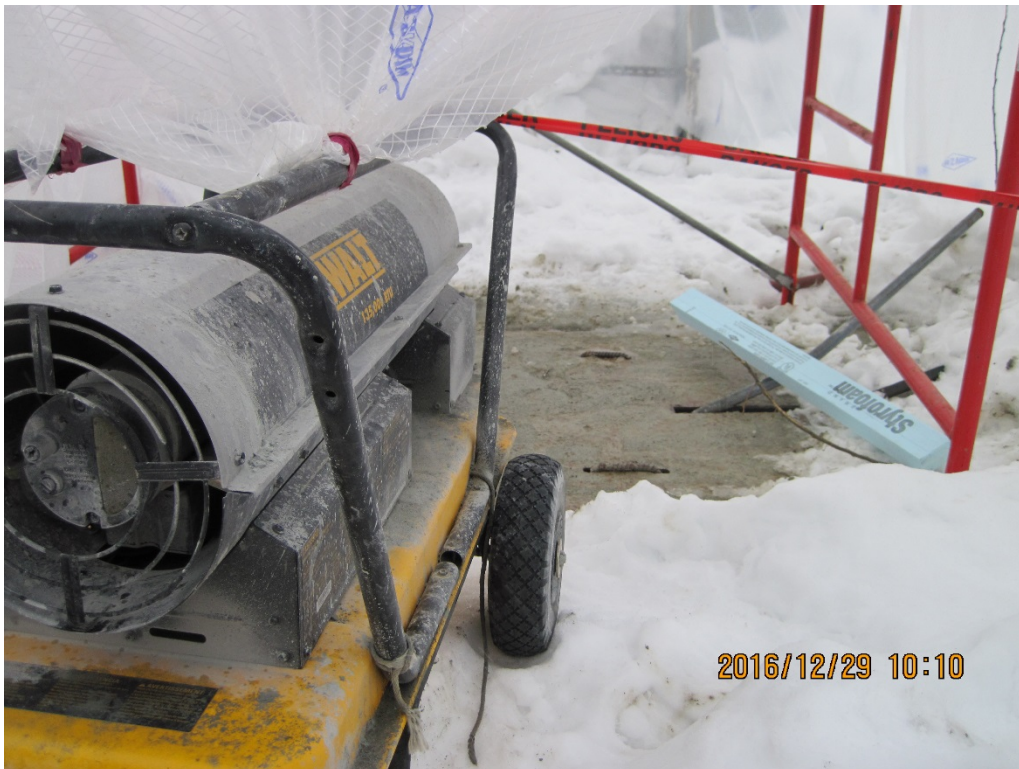
Coeur Alaska personnel have since turned off the lift station to prevent additional diesel from entering the Mill and are defrosting the OWS (Photos 5 & 6). Once defrosted, crews will remove all remaining diesel and water from the OWS and lift station.

Problem: OWS not properly maintained. Water within the OWS tank froze, rendering it inoperable.

Photo 5. Defrosting the oil/water separator (OWS). The OWS is a metal tank in a concrete container located beneath the recently exposed cover on the ground. Ice filled the OWS, rendering it inoperable.

Resolution: Coeur Alaska is defrosting and cleaning the OWS and lift station.

Action Items: Create a written schedule for OWS maintenance. Defrost OWS and keep it free of ice. Remove diesel from OWS, lift station, and associated pipes.

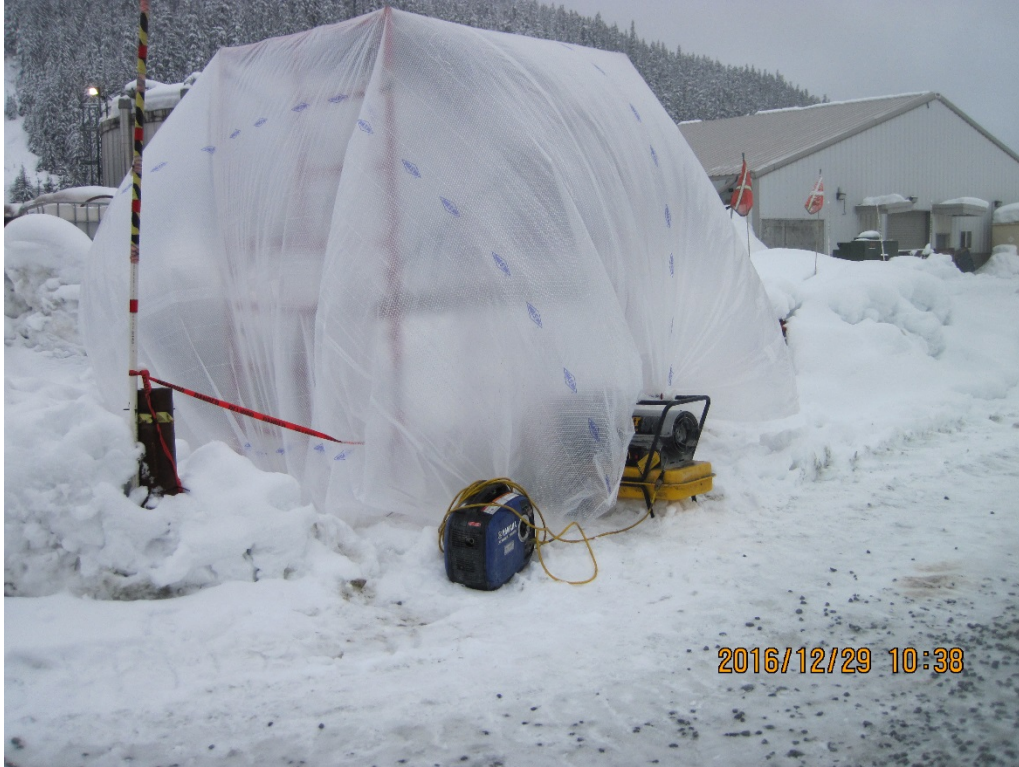
Photo 6. Defrosting the OWS. Crews assembled a tent around the OWS to speed up the defrosting process. During the spill, the OWS was frozen and multiple feet of snow covered the ground.

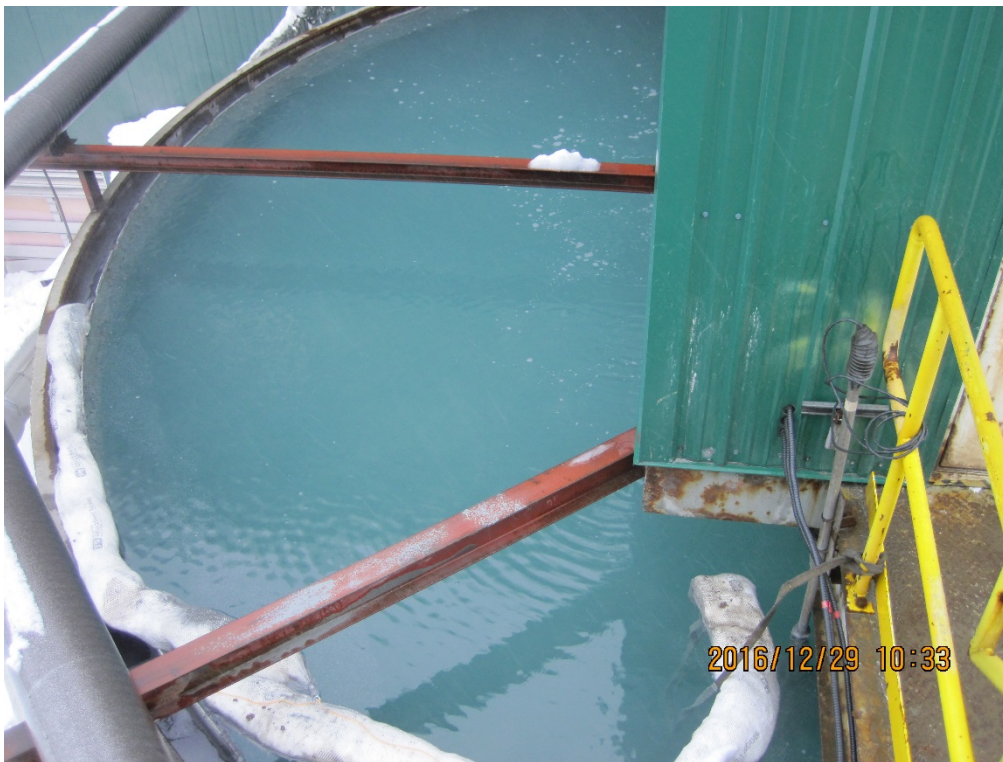
Tailings thickener tank: Coeur Alaska personnel noticed a sheen on the tailings thickener tank on December 22 and immediately placed containment booms on the surface to prevent the spread of diesel to the TTF and underground paste plant (Photo 7).

Photo 7. Tailings thickener tank. Coeur Alaska crews placed oil containment booms on the surface of the tank to contain and capture diesel. Crews originally spotted a sheen on the tank on December 22.

Follow-up: Continue to check thickener tank and its containment boom for signs of diesel

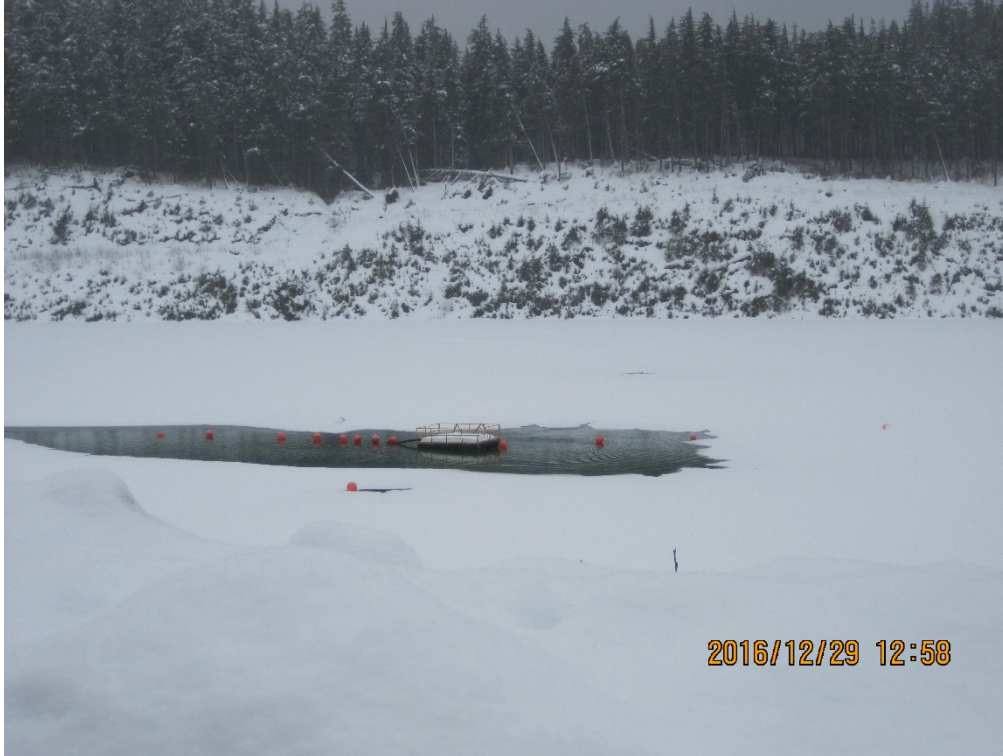
Tailings discharge to the TTF at the tailings barge, which is currently located towards the northern end of the facility (Photo 8). Surface agitation caused by the movement and placement of relatively warm tailings keeps a small area around the barge and pipeline free of ice. A water reclaim barge located on the southern end of the TTF (near the dam) pumps water to the TTF Water Treatment Plant, which is not equipped to treat hydrocarbons (Photo 9). Agitators on the reclaim barge keep a small area around it ice-free. These two locations (the small areas around the barges) are the only places on the TTF without ice cover and are, therefore, the most likely places within the TTF to observe potential diesel contamination. As of December 29, no sign of diesel contamination has been noticed anywhere at the TTF. Coeur Alaska has equipped the TTF with oil containment booms as a precaution.

Photo 8. TTF tails barge. Agitation caused by the movement and placement of relatively warm tailings keeps a small area around the barge free of ice, thus providing a window to observe a sheen if diesel discharges into the TTF.

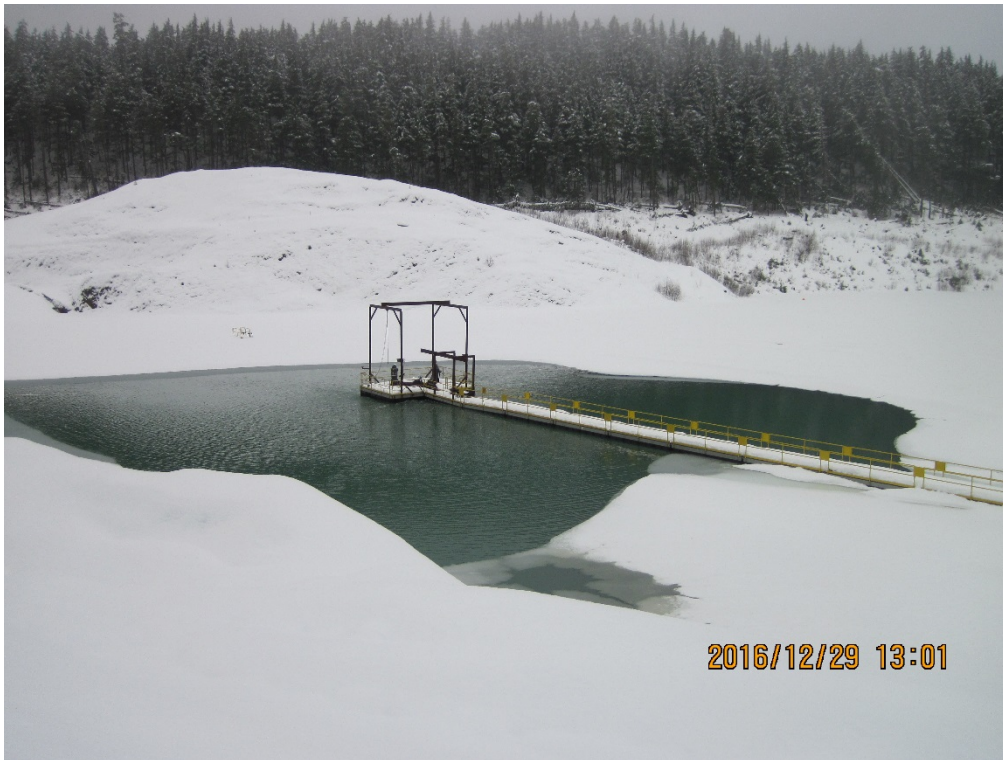
Photo 9. TTF water reclaim barge. Located about 100 meters south of the tailings barge, the reclaim barge pumps water to the TTF Water Treatment Plant. Agitators on the barge keep the surrounding area ice-free and provide another window to observe potential sheens.

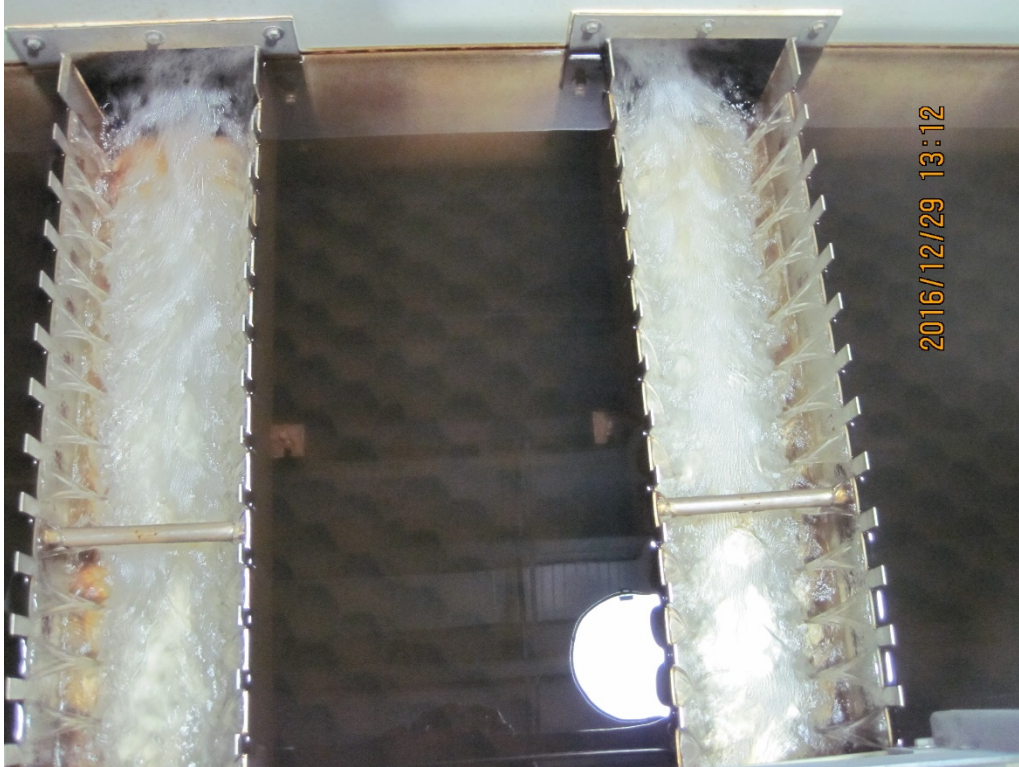
Coeur Alaska personnel regularly check the clarifier tank within the TTF Water Treatment Plant and have placed a containment boom at its outlet as a precautionary measure (Photos 10 & 11). The open top of the clarifier tank provides a good point within the treatment process to observe potential diesel contamination. As of December 29, operators have observed no signs of diesel in the clarifier tank or on the boom. Crews will replace the boom regularly and check it for diesel.

Photo 10. Looking down into the TTF Water Treatment Plant clarifier tank. Operators frequently check the tank for signs of diesel contamination.

Follow-up: Regularly check clarifier tank and containment boom for signs of diesel until TTF ice cover thaws and its surface inspected. Inspect TTF and shore at first reasonable opportunity. If diesel is present, contain and collect it immediately.

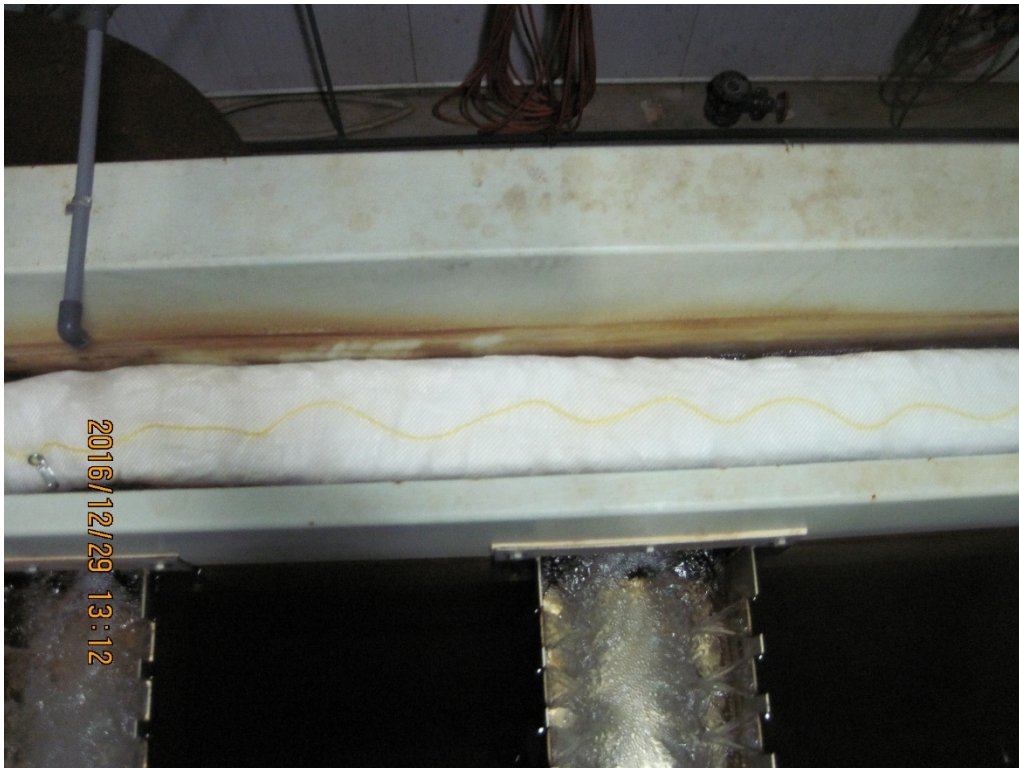
Photo 11. Although no sign of diesel has been observed at the TTF, Coeur Alaska crews placed an oil containment boom at the clarifier tank outlet to catch potential contamination. Crews will change the boom regularly and checked it for diesel.

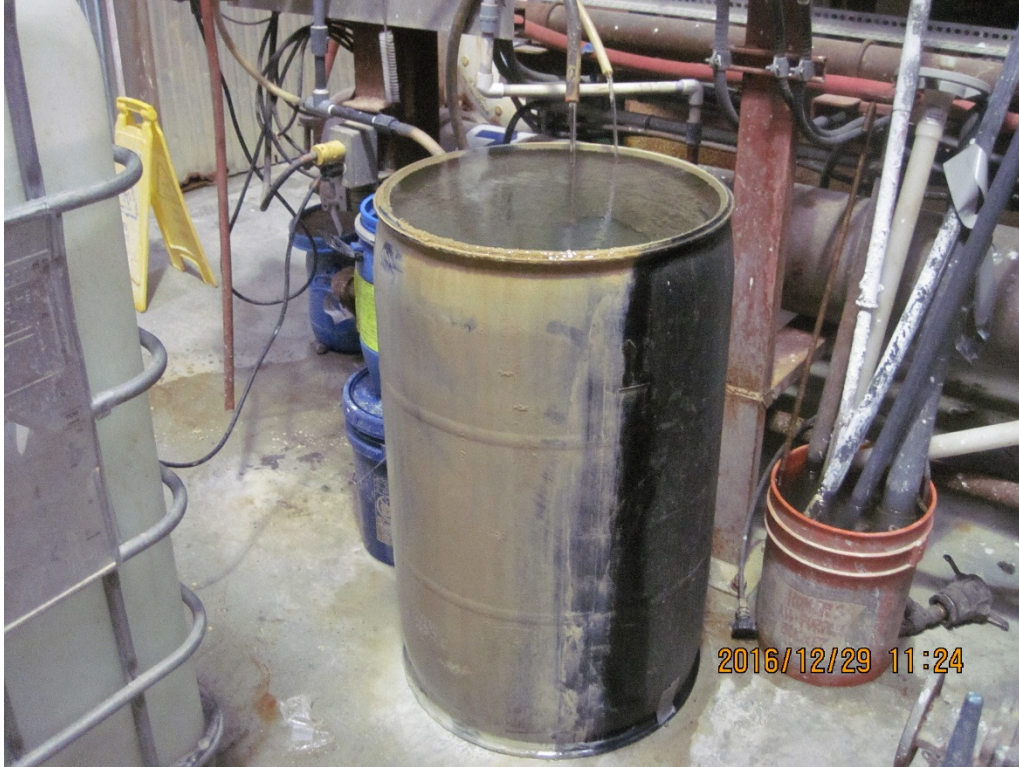
Recent snowfall prevented us from inspecting Sherman Creek Outfall 001 for the presence of “white material” on the streambed. However, a barrel used to indicate the occurrence of “white material” flowing through the Comet Water Treatment Plant suggests the material is still present (Photo 12). While this inspection did not determine whether there was more or less “white material” on the streambed compared to previous inspections, it is clear that “white material” continues to discharge into Sherman Creek.

Photo 12. Indicator barrel inside the Comet Mine Water Treatment Plant suggests “white material” moves through the plant and discharges into Sherman Creek at Outfall 001.
