INSPECTION REPORT: KENSINGTON GOLD MINE

Date of Inspection: Wednesday February 8, 2017
Date of Report: Thursday February 23, 2017
USDA Forest Service Inspector: Richard Dudek

This inspection included the Access roads, Kensington mill area, Comet Development Pile, Comet water treatment plant, Sherman Creek Outfall, TTF area, and the Fuel Depot.

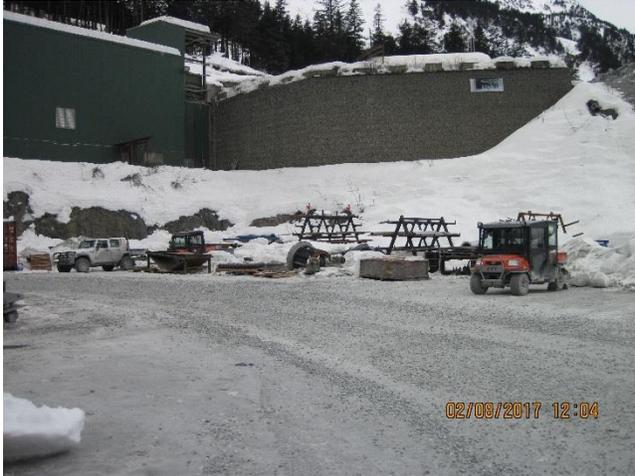
Coeur Alaska has submitted plans to the Forest Service, and other State of Alaska agencies, to replace their old generators with 4 new turbine generators. The current 7 generators used for supplying power to the mine, are near their 10-year operating life. The 4 new turbine generators will be located near the Mill (Photo 1). Additional structures will also be relocated near the 4 new generators.

Photo 1. Near the mill is the location for the new turbine generators.

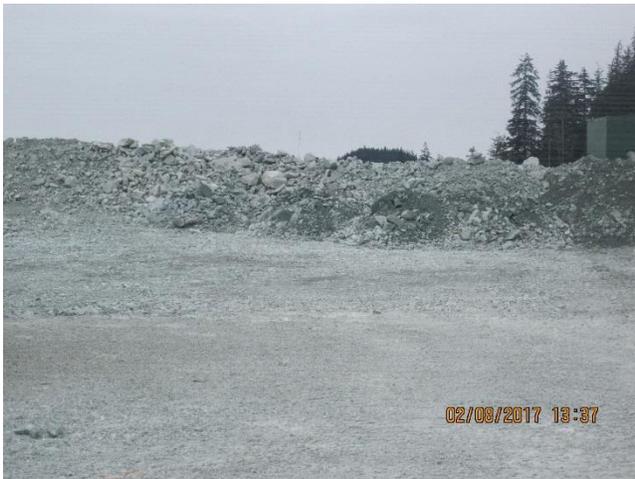
Coeur Alaska continues to deposit waste rock at the Kensington development pile (Photo 2).

Photo 2. Kensington Development pile.

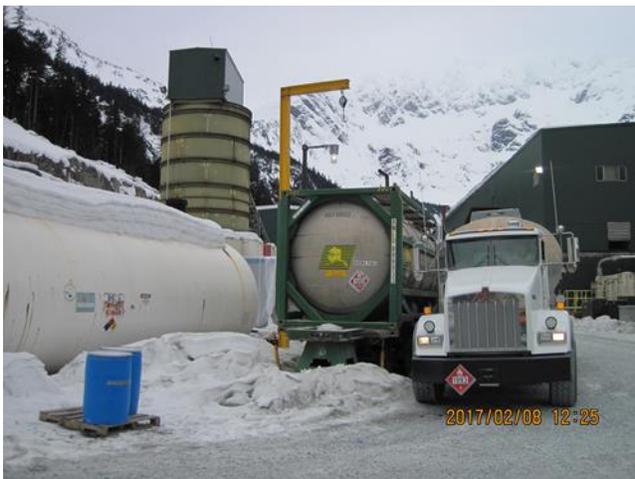
A fuel truck was refueling the 30,000 gallon "day tank" (Photo 3). The fuel depot now supplies the fuel for the mine.

Photo 3. Refueling at the 30,000 gallon Day Tank.

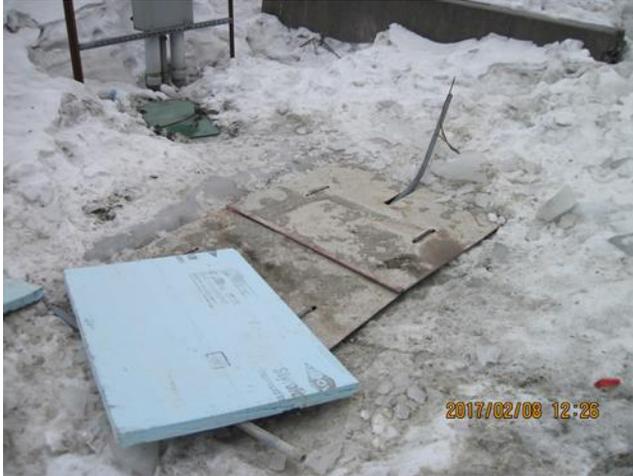
Coeur Alaska personnel continue to frequently monitor the oil/water separator (Photo 4) for frozen water.

Photo 4. Oil/water separator located near the 30,000-gallon day tank.

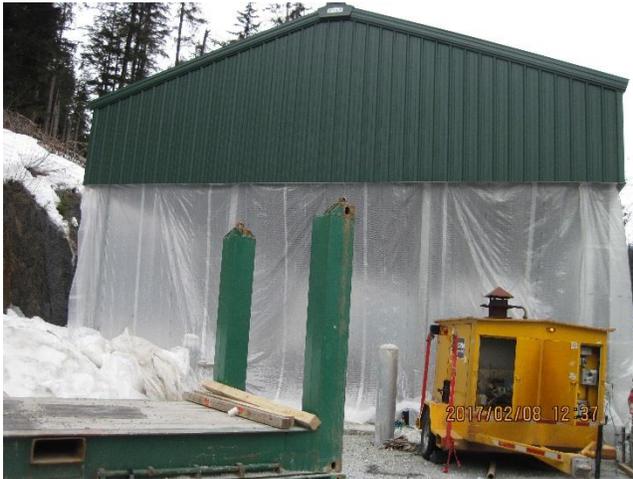
Contractors are currently constructing a cold storage warehouse for chemicals used in the water treatment plant (Photo 5). During the site inspection, the concrete floor in the storage facility was being poured.

Photo 5 . Kensington warehouse area construction for a cold storage facility for chemicals.

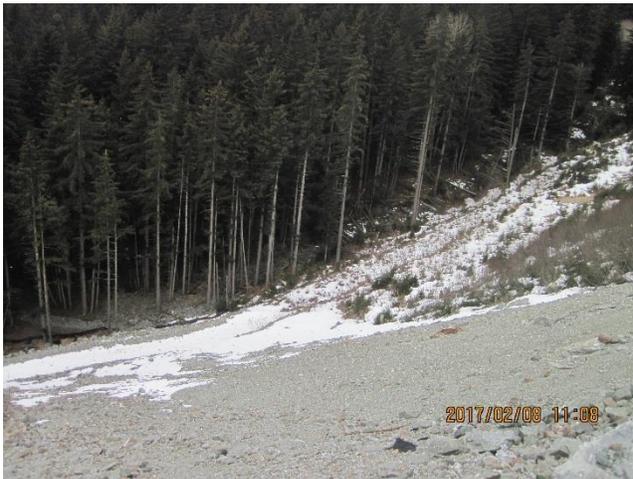
During this inspection, this site was inactive and no haul trucks were depositing waste rock (Photo 6).

Photo 6. Comet Development pile.

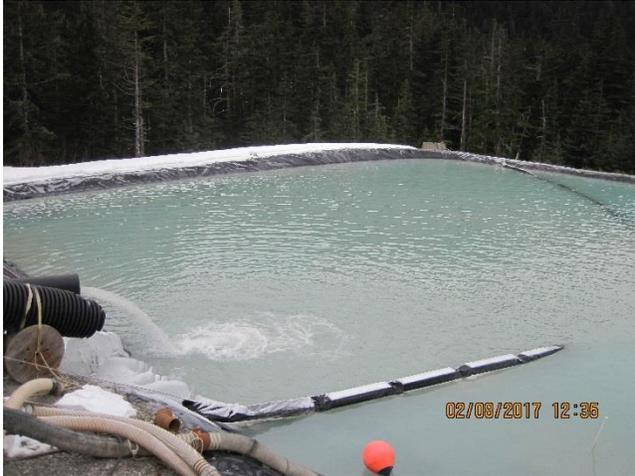
Pond-1 (Photo 7) was receiving mine site water, and Pond-2 was mostly frozen over. The water treatment plant was treating 900 gallons of water per minute (gpm). Coeur Alaska has started weekly monitoring of the test barrel used to measure the white material in the treated mine site water (Photo 8). Coeur Alaska continues to bench test different coagulants and flocculants that will remove white material out of solution. The water treatment plant was tidy and in order (Photo 9).

Photo 7. Comet water treatment plant Pond-1.

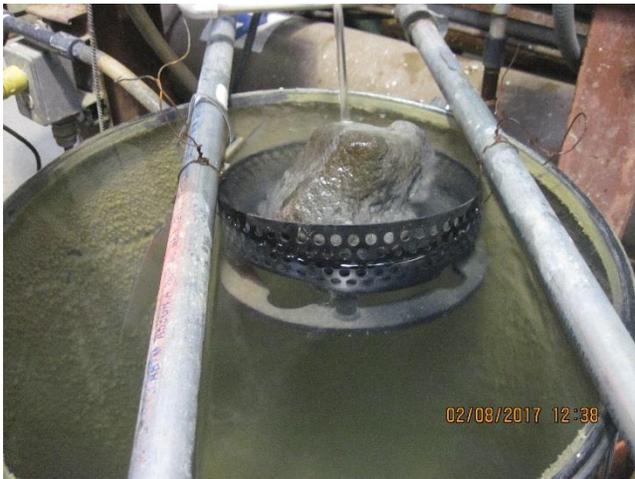
Photo 8. A rock is suspended above the barrel for monitoring white material accumulation.

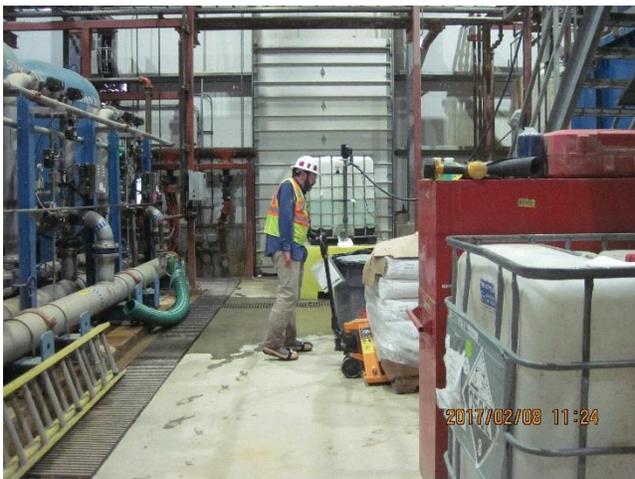
Photo 9. Comet water treatment plant.

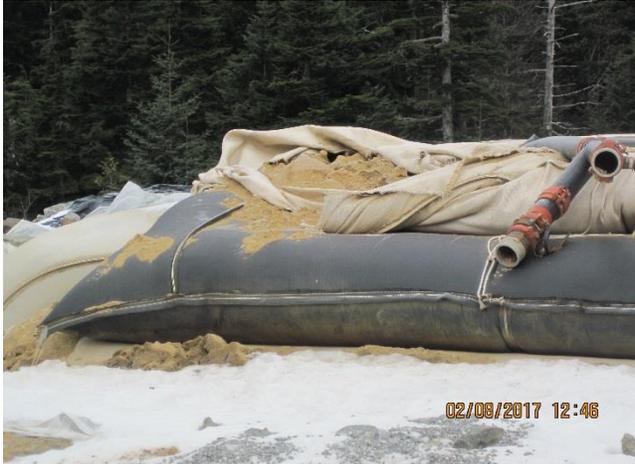
A dewatering bag is torn (Photo 10) and will be replaced once dredging operations begin.

Photo 10. Dewatering bag is torn and will be replaced when dredging begins at Comet.

Dewatering bag replaced once dredging begins at Comet.

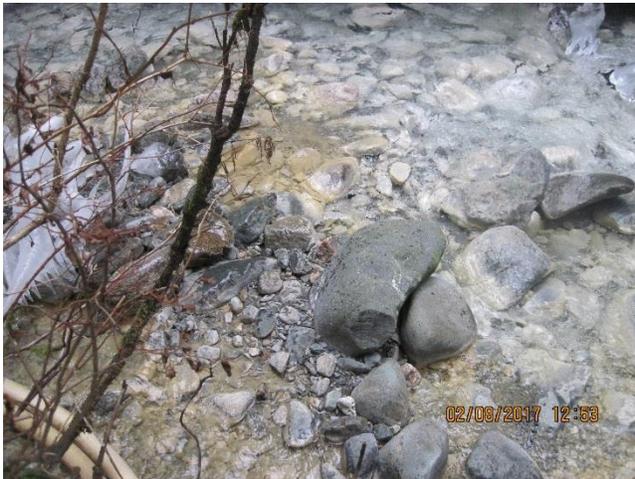
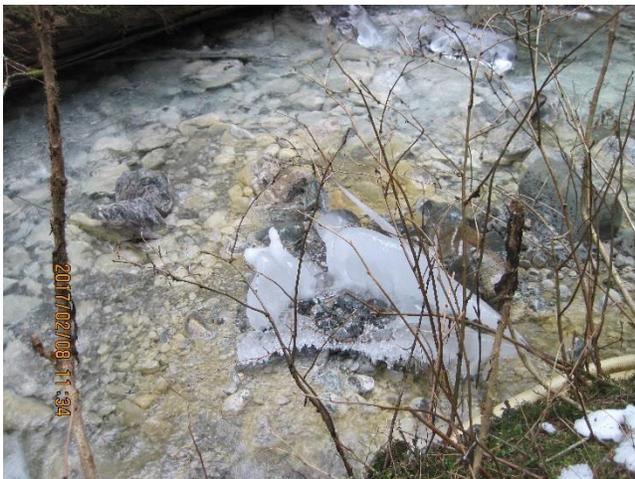
White material continues to precipitate in the creek (Photos 11-12). Coeur Alaska is still using a dewatering bag, near the underground 445 level sump, to help remove white material prior to it entering the Comet water treatment plant. Coeur Alaska personnel are still using a clean rock to monitor white material accumulation in the creek bed.

Photo 11. White material in Sherman Creek image 1 of 2.

Photo 12. White material in Sherman Creek image 2 of 2.

Sherman Creek Outfall white material accumulation in the creek bed.

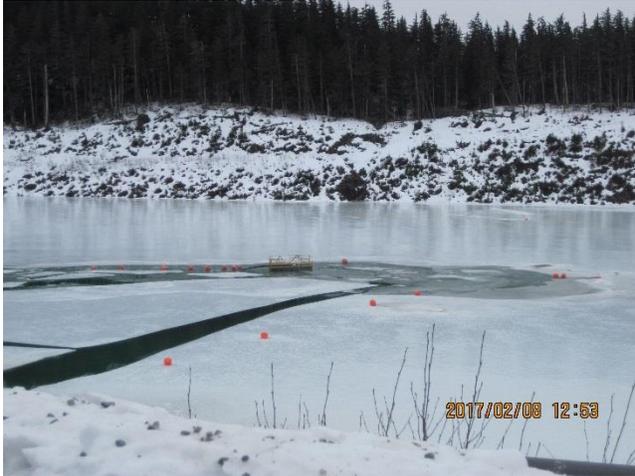
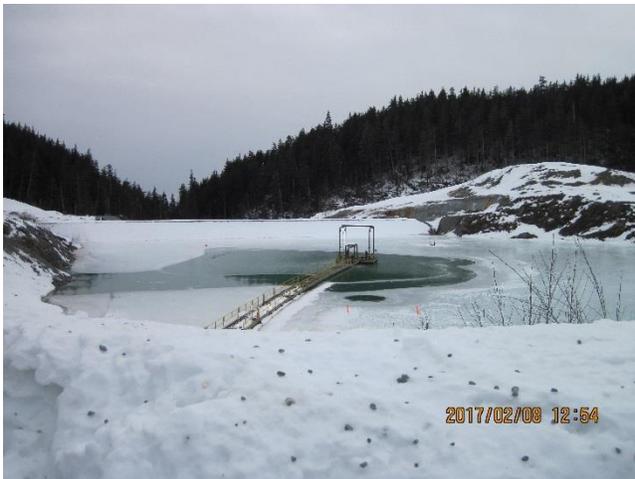
The water level for the TTF was 697 feet and was mostly frozen over (Photos 13-14). The water treatment plant was treating 600 gallons of water per minute (gpm).

Photo 13. TTF tailings barge.

Photo 14. TTF water reclaim barge.

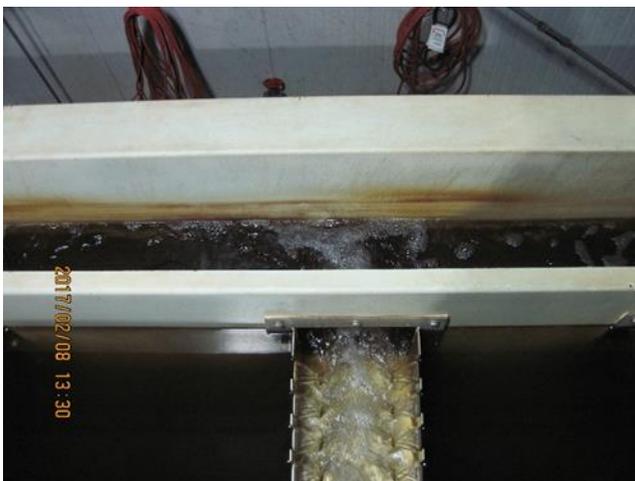
On December 22, 2016, a fuel spill occurred at the Mill's 30,000-gallon "day tank" and diesel fuel was observed in the tailings thickener tank. There is a possibility that fuel made its way from the mill and

into the TTF. The water reclaim barge located in the TTF, routes water back to the mill and to the water treatment plant. When diesel fuel was observed at the mill, personnel at the water treatment plant placed an oil containment boom in the outlet of the water clarifier (Photo 15). A containment boom was put in place because the plant is unable to treat water for hydrocarbons. Coeur Alaska personnel should keep an oil containment boom in the outlet until the ice cover thaws in the TTF, and the surface is thoroughly inspected for fuel.

Photo 15. TTF water treatment plant's clarifier outlet.

Sherman Creek Outfall: white material continues to precipitate in the creek.
Place an oil containment boom in the TTF's water clarifier outlet.

Oil containment boom is placed in the TTF's water treatment plant's clarifier outlet.

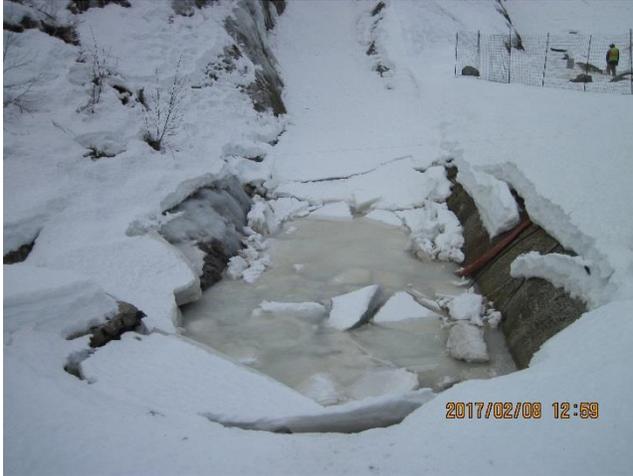
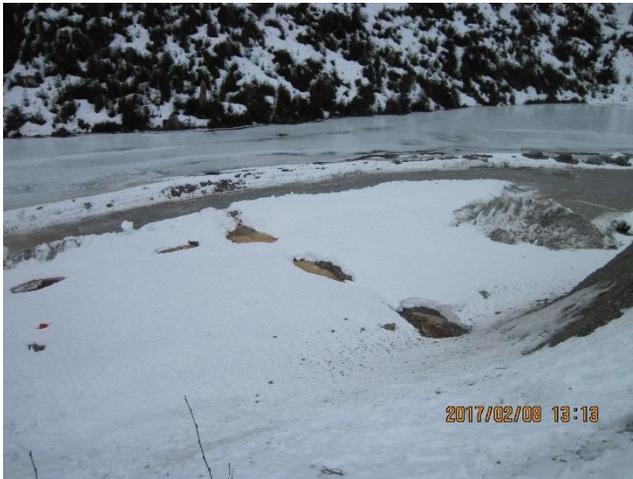
The Seep plant was in active due to the snow and ice covering the acid rock drainage (ARD) catchments (Photos 16-17).

Photo 16 .TTF dam plunge pool. The ARD is routed to the Seep Plant.

Photo 17. Northern TTF ARD catchment.

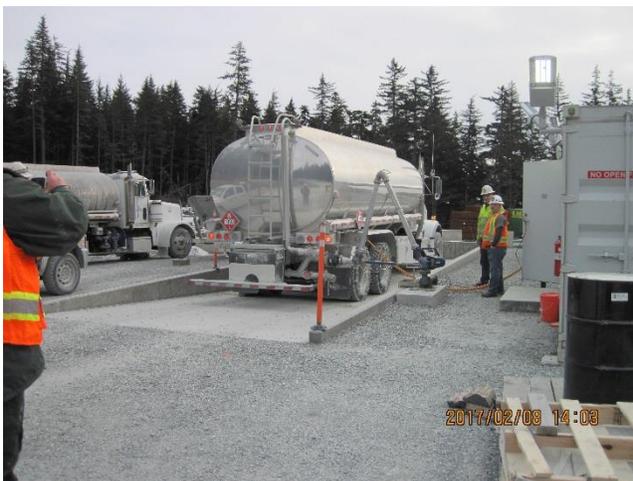
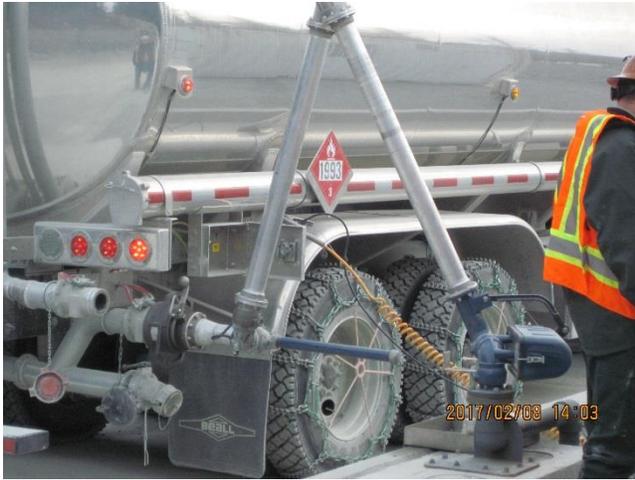
The fuel depot is online; a refueling truck was filling up to transfer fuel (Photos 18-19). Two isotainers will remain on site for the next several weeks as Coeur Alaska transitions away from using isotainers as fuel storage.

Photo 18. Fuel Depot refueling truck pad.

Photo 19. Fuel transfer truck receiving fuel from the depot.

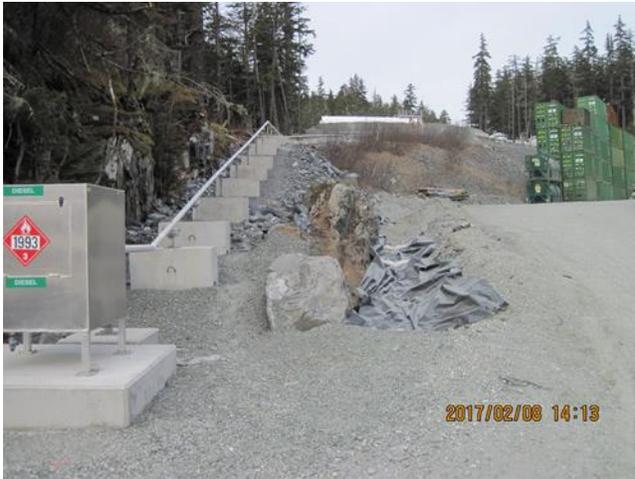
The fuel header at the port (Photo 20) had no indications of a fuel spill during fuel transfer. The sump for stormwater runoff was mostly frozen over (Photos 21-22).

Photo 20. Kensington port marine header.

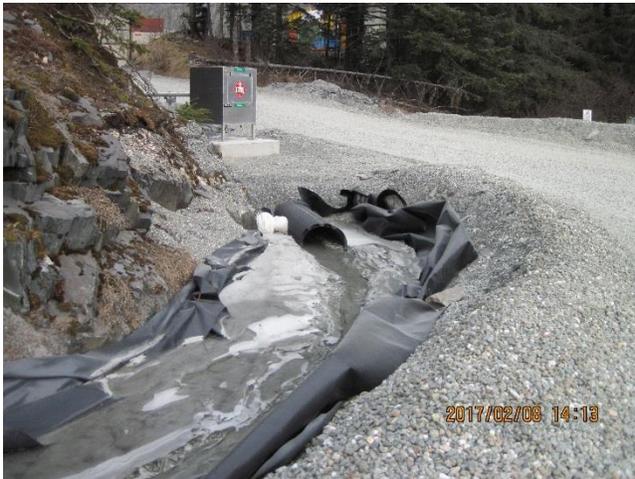
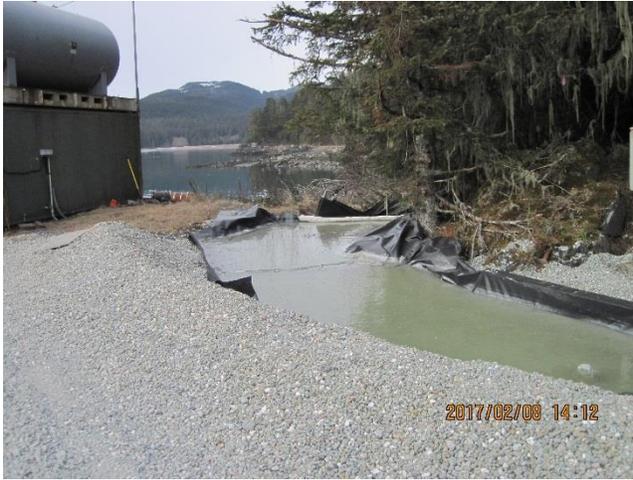
Photo 21. Stormwater runoff in the drainage ditch is mostly frozen over image 1 of 2.

Photo 22. Stormwater runoff drainage ditch image 2 of 2.
