INSPECTION REPORT: KENSINGTON GOLD MINE

Date of Inspection: Wednesday March 22, 2017
Date of Report: Wednesday April 5, 2017
USDA Forest Service Inspector: Richard Dudek

This inspection included the Access roads, Comet Development Pile, Comet water treatment plant, Sherman Creek Outfall, Kensington warehouse, TTF area, Fuel depot, and the Kensington port.

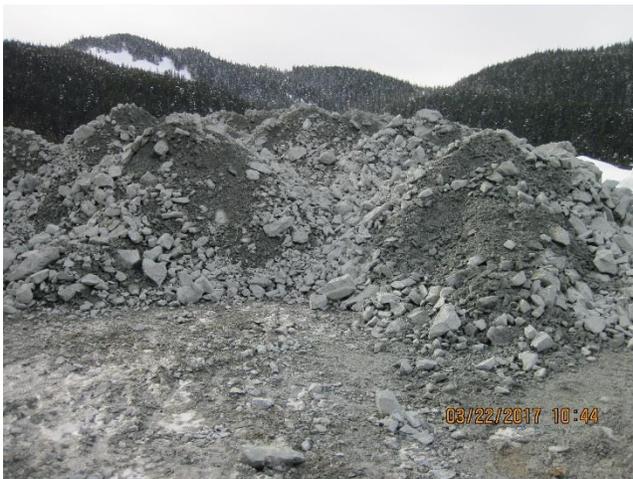
Waste rock from the Raven adit was recently deposited at the southern end of the development pile (Photo 1). The upgraded brass board shelter (Photo 2) is equipped with a communication system for underground blasting crews.

Photo 1. Raven adit development rock (waste rock).

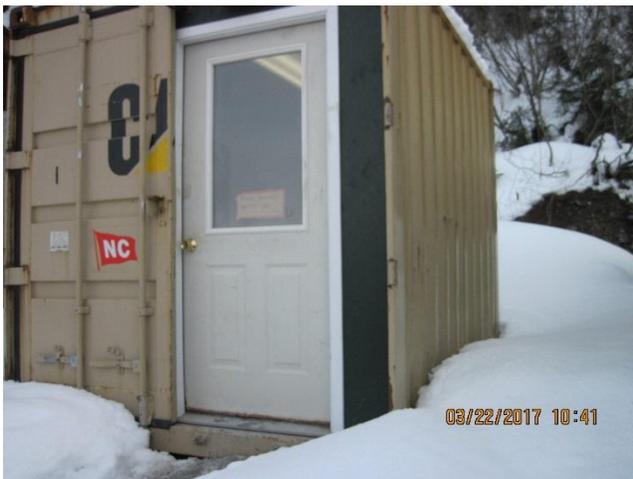
Photo 2. The new brass board shelter.

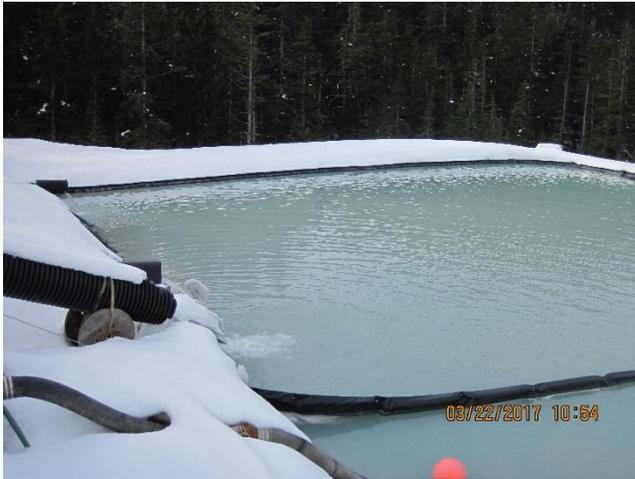
The Comet water treatment plant was treating 700 gallons of water per minute (gpm). Pond-1 was receiving mine site water, and Pond-2 was inactive (Photos 3-4). Coeur Alaska continues weekly monitoring of the test barrel to measure white material accumulation in the treated mine site water (Photo 5).

Photo 3. Comet water treatment plant Pond-1.

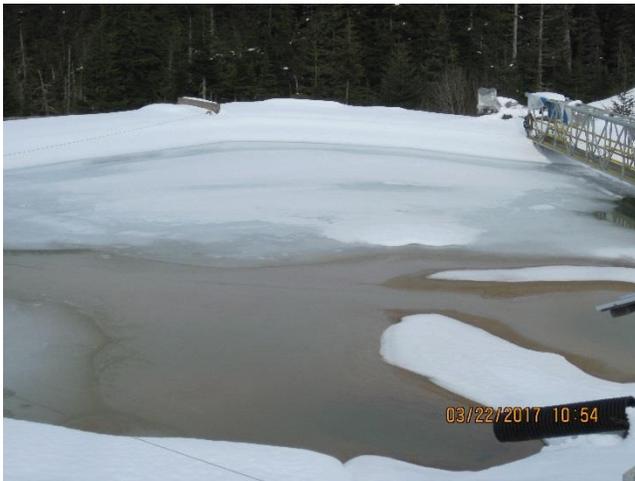
Photo 4. Comet water treatment plant Pond-2.

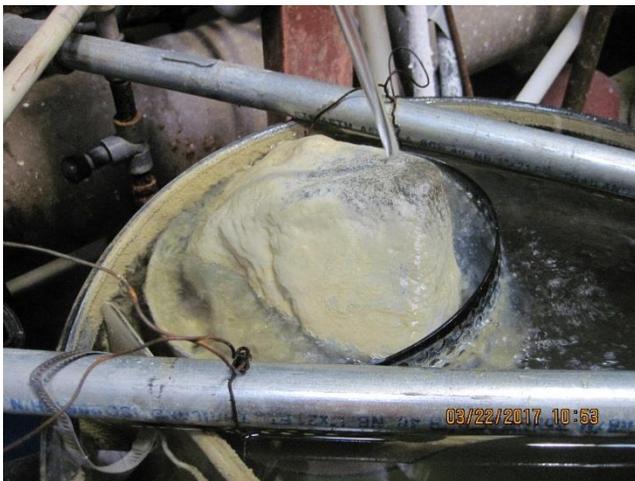
Coeur Alaska continues to bench test different flocculants and coagulants for precipitating white material out of solution. The Comet water treatment plant was tidy and in order.

Photo 5. A rock used for monitoring white material accumulation at the Comet water treatment plant.

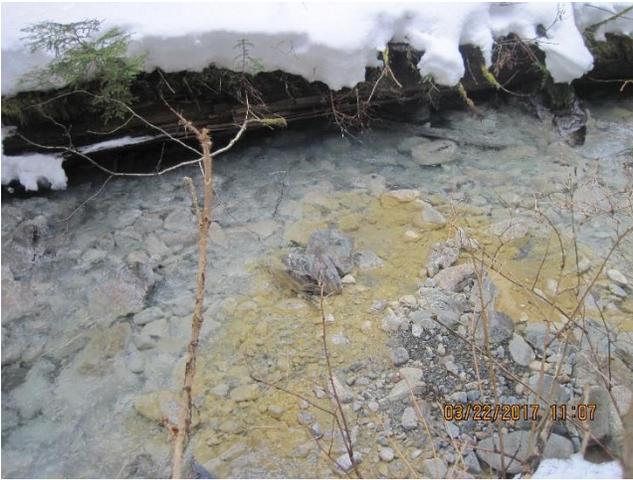
Sherman Creek outfall white material continues to precipitate in the creek.
Keep an oil containment boom in the TTF water treatment plant clarifier's outlet until the TTF's surface can be thoroughly inspected for fuel sheening.

White material continues to precipitate in the creek bed (Photos 6-7). Coeur Alaska is still using a dewatering bag, near the underground 445 level sump, to help remove white material prior to the water treatment process. In conjunction with the barrel tests, Coeur Alaska personnel continue testing different flocculants and coagulants for removing white material out of solution in the triple underground sumps.

Photo 6. White material continues to accumulate in Sherman Creek outfall 001 (Image 1 of 2).

Sherman Creek will have continued observations for white material accumulation.
TTF water treatment plant's clarifier outlet continues to have an oil containment boom.

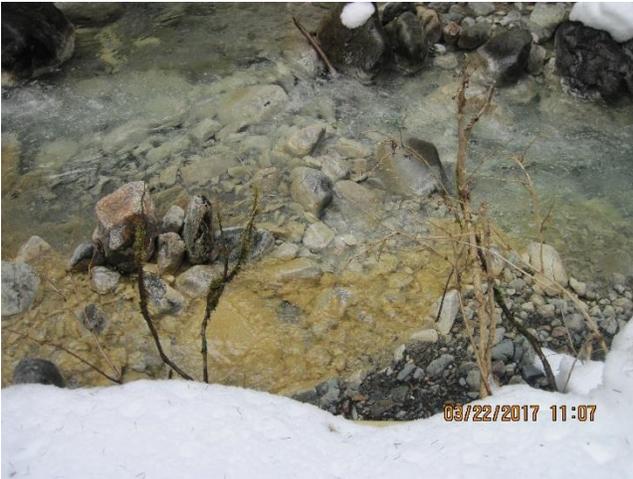
Photo 7. White material in Sherman Creek outfall 001 (image 2 of 2).

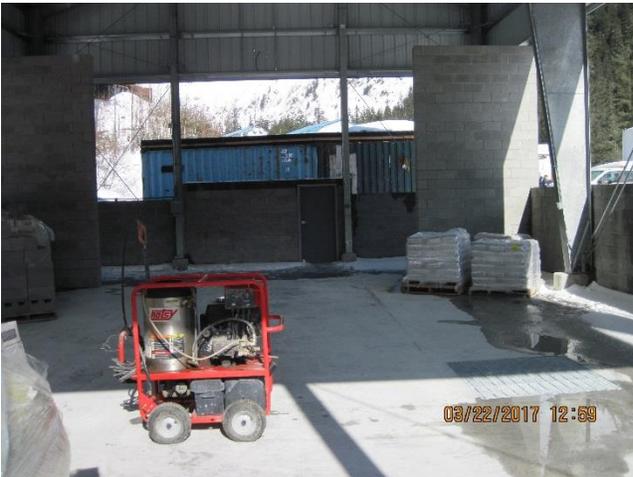
The construction for the cold storage warehouse is near completion (Photo 8). Chemicals used for the water treatment process will be stored in this facility.

Photo 8. Coeur Alaska's cold storage facility for chemicals used for water treatment.

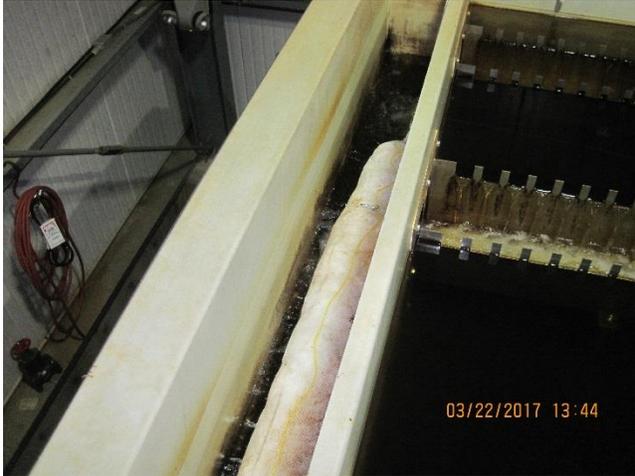
A fuel spill occurred at the Mill's 30,000-gallon "day tank" on 12/22/2016. There is a possibility that fuel made its way into the TTF. The water reclaim barge located in the TTF, routes water back to the mill and to the water treatment plant. The water treatment plant does not treat water for hydrocarbons. Therefore, an oil containment boom will remain in place in the water clarifier's outlet (Photo 9) until the ice cover thaws in the TTF, and the surface is thoroughly inspected for fuel sheen.

Photo 9. Oil containment boom.

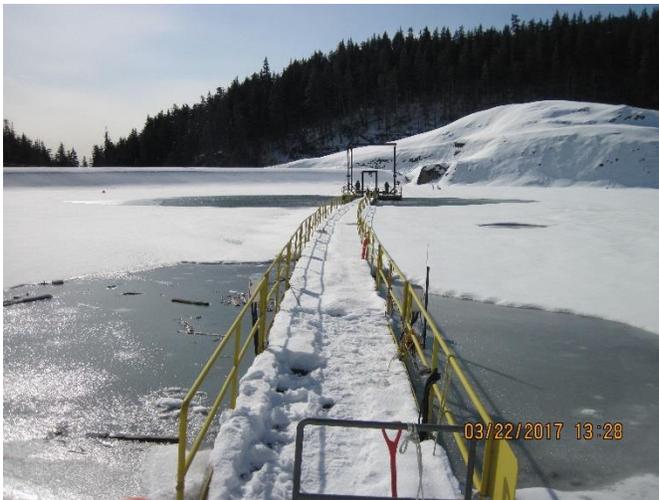
The water level for the TTF was 697.8 feet (Photo 10). The TTF water treatment plant was treating 550 gallons per minute (gpm). The reclaim water returning to the mill was 185 gallons per minute (gpm). The TTF water treatment plant was tidy and in order (Photo 11). All petroleum and chemicals were properly stored with secondary containment (Photo 12).

Photo 10. The TTF water reclaim barge.

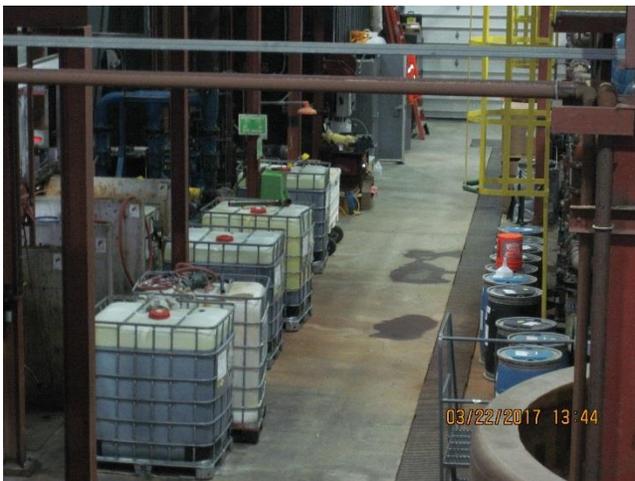
Photo 11. TTF water treatment plant.

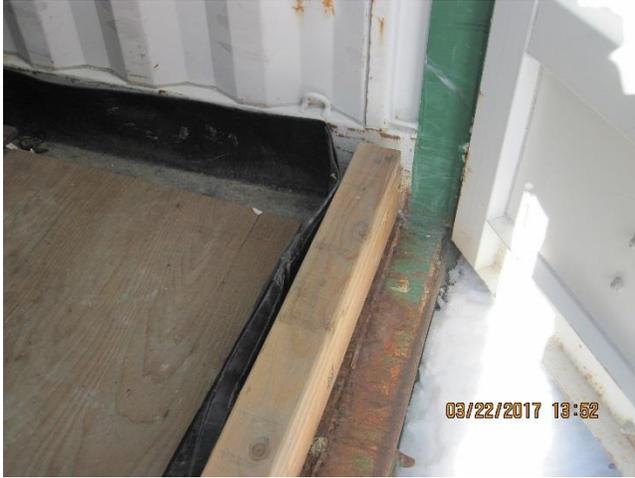
Photo 12. A TTF water treatment plant storage container with secondary containment.

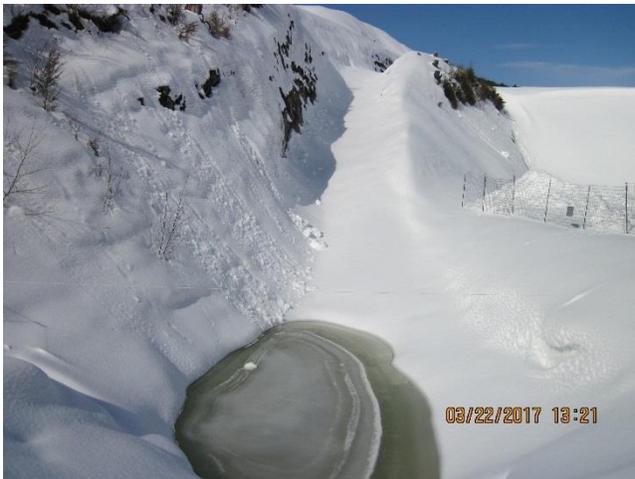
The seep plant was inactive due to the acid rock drainage (ARD) catchments are covered in snow and ice (Photos 13-14).

Photo 13. TTF dam plunge pool.

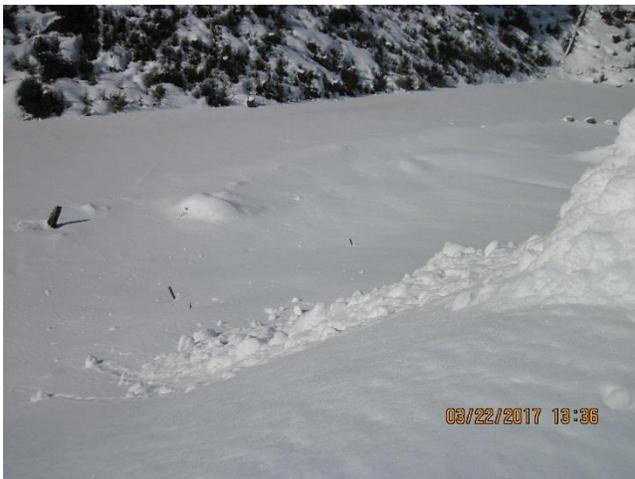
Photo 14. Northern TTF ARD catchments covered in snow.

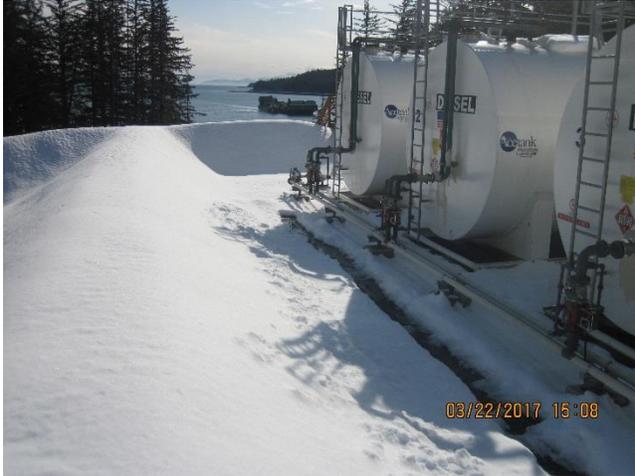
The fuel depot is online and supplying fuel for the mine site (Photo 15). There were no fuel drips or sheening observed on the concrete refueling pad (Photo 16).

Photo 15. Kensington fuel depot.

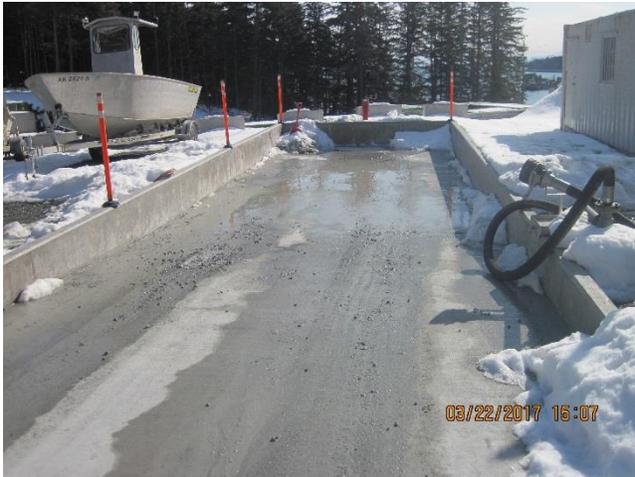
Photo 16. Fuel depot's refueling pad.

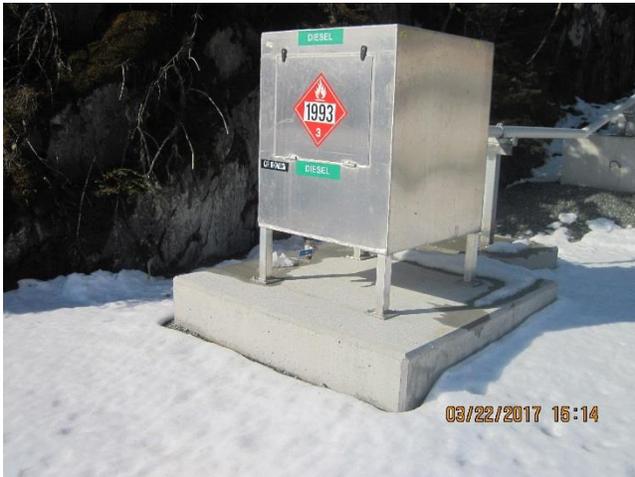
No fuel drips were observed on the marine fuel header's concrete foundation (Photo 17). The stormwater runoff drainage ditch was covered in snow (Photo 18).

Photo 17. Kensington port marine fuel header.

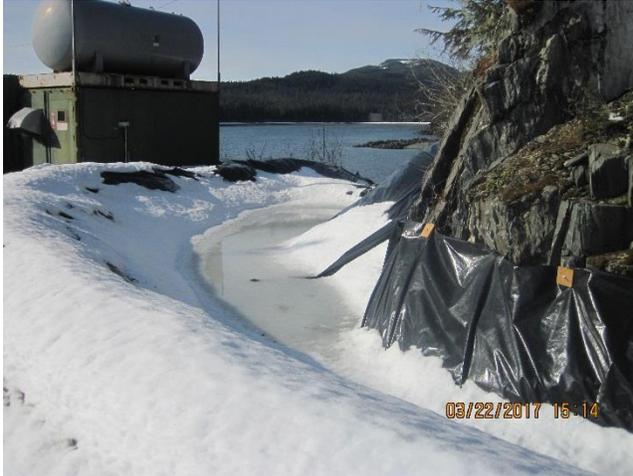
Photo 18. Kensington port drainage ditch.
