August 8, 2013

June 25 and July 16, 2013 Inspectors: David Schmerge – USFS
David Wilfong – ADNR

July 29, 2013 Inspectors: David Schmerge – USFS
Jill Weitz – ADEC
David Wilfong – ADNR

Inspections of the Kensington Gold Mine

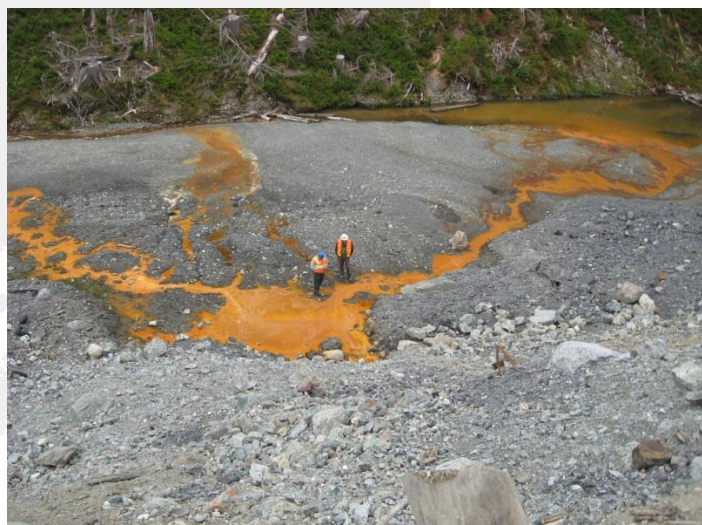
Figure 1 Staining due to metals leaching from low pH water.

Some of the acid generating graphitic phyllite material was mixed with other fill for unknown reasons during last summer's construction of the second stage of the downstream dam raise, and placed into a non-lined area of the TTF. Water quality tests showed that the resulting drainage from the area contained high levels of metals and a low pH as seen in Figure 1.

the area, and the entire volume of fill had to be excavated and placed in containment to avoid any future releases of water with poor quality.

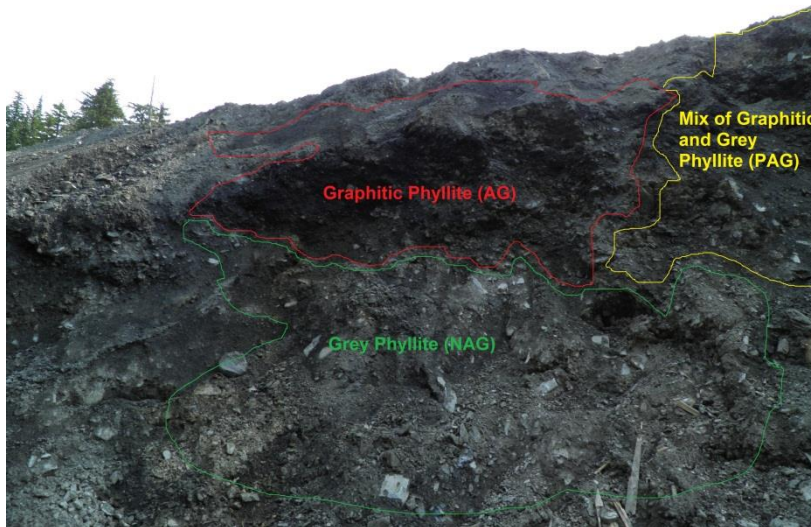
Figure 2 Outlines are for reference only and are not an accurate representation of the location or dissemination of the graphitic phyllite.

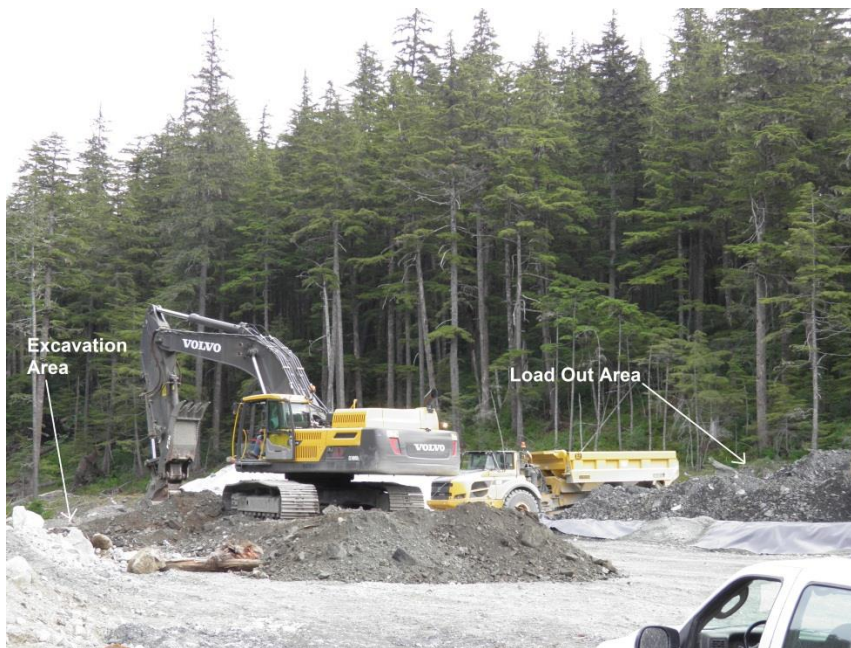
Figure 3 Equipment used to load and haul the graphitic phyllite.

During the June 25th inspection, a Volvo EC480DL Excavator was actively digging material from the embankment and placing it into a lined load out area. From there, it was loaded into one of two Volvo A30F 30 ton articulating underground haul trucks.

June 25 inspection, and the removal procedure had begun (Figure 3). Water management is a key component of mitigating the effects of the ARD. While the effects of the drainage are limited to the containment of the TTF, the Lower Slate Lake Water Treatment Plant (WTP) is not designed to treat ARD. A small ARD treatment plant that manages the effluent from the graphitic phyllite deposit is located at the south end of the TTF. Water is collected in ponds, sumps and caissons at the north end of the TTF, collected and pumped into an HDPE lined storage pond in a central location. When the storage pond is full, it is pumped into a tanker truck, and hauled to the ARD treatment plant. On July 16, an electric sump-pump was transferring water from a small natural drainage up to the ARD collection pond, but the hose was damaged and leaking as can be seen in figure 4.

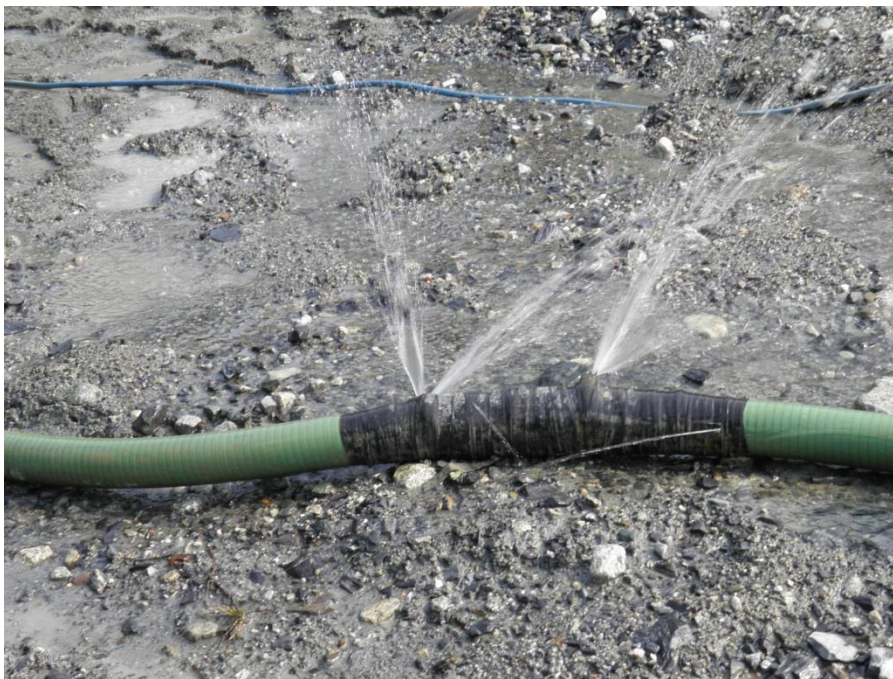
Figure 4 The hose had been mended, but the repair was insufficient.

The substantial head pressure in the hose caused the leak to diminish the flow to the top of the hill, and the flow into the ARD pond had slowed to a trickle. The low pH water flowing from the damaged hose returned to the pond in which it came from where it was collected and pumped back into the leaking hose. Kevin was alerted to the problem. During the July 29 visit, it was noted that that the hose

had been properly repaired, and the pond had been pumped nearly dry. It was apparent that the re-repaired hose had been effective in moving the poor quality water up the hill where it could be properly managed. Also noted during the July 29 inspection was the construction of a third HDPE lined containment cell in Pit 7 (Figure 5). Two smaller containment cells at the same location were filled to capacity. Substantial progress had been made on the construction of the third cell. The subgrade had been prepared, the HDPE liner welded, and a sandy gravel layer had been placed on top of the liner to reduce the risk of the 30 ton haul trucks causing damage to it.

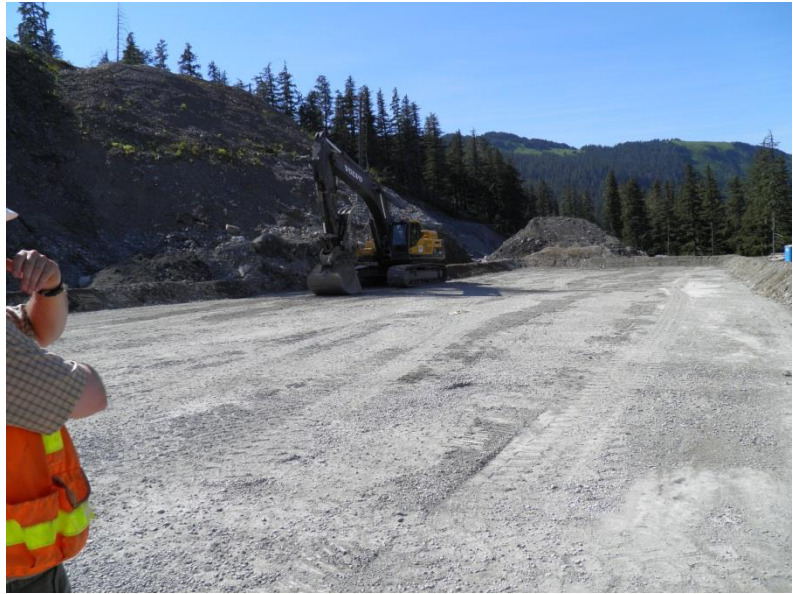
Figure 5 Containment cell near completion.

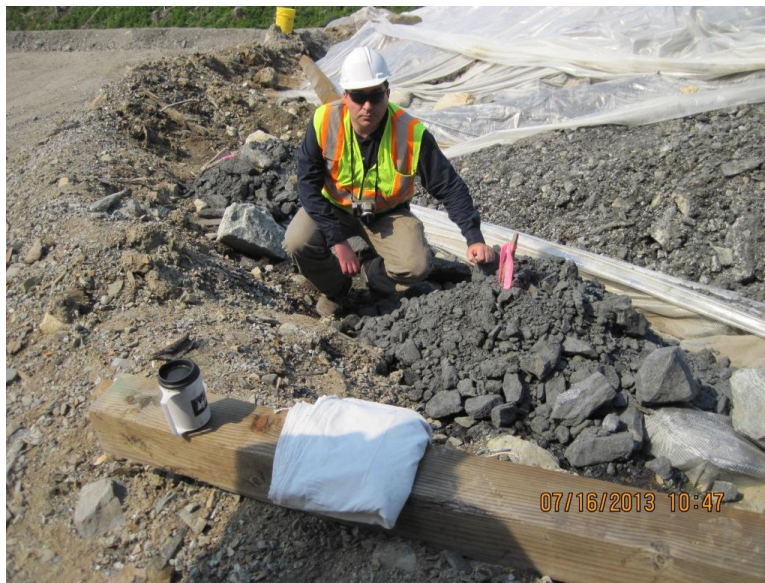
Figure 6 Segregated pile of graphitic phyllite. The large pieces are to be used for testing.

confirmed in the lab using LECO analysis equipment. As can be seen in in Figure 6, the Piles were well graded, with particle sizes including riprap size chunks and smaller. I expressed my concern that since the humidity cell tests were not producing the expected results due to the small particle size, it was possible that the small particles in the piles may have skewed the results of the barrel tests. After consulting with Golder, the large chunks were separated out and the fines were washed from them, and only the large pieces would be used in the long term barrel tests.

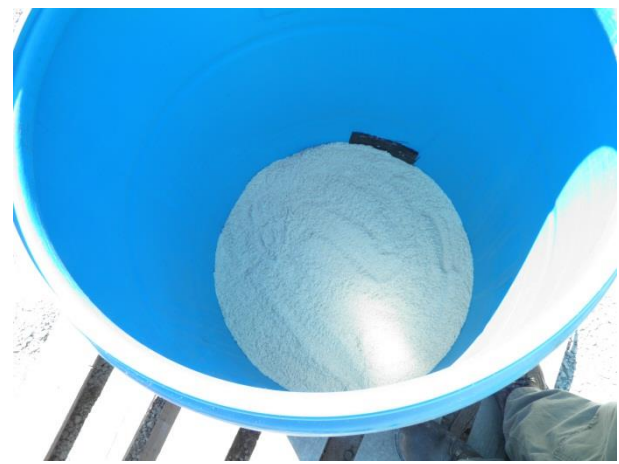
Figure 7 Outlet covered with geotextile at the bottom of the barrel. About 2 more inches of sand was added.

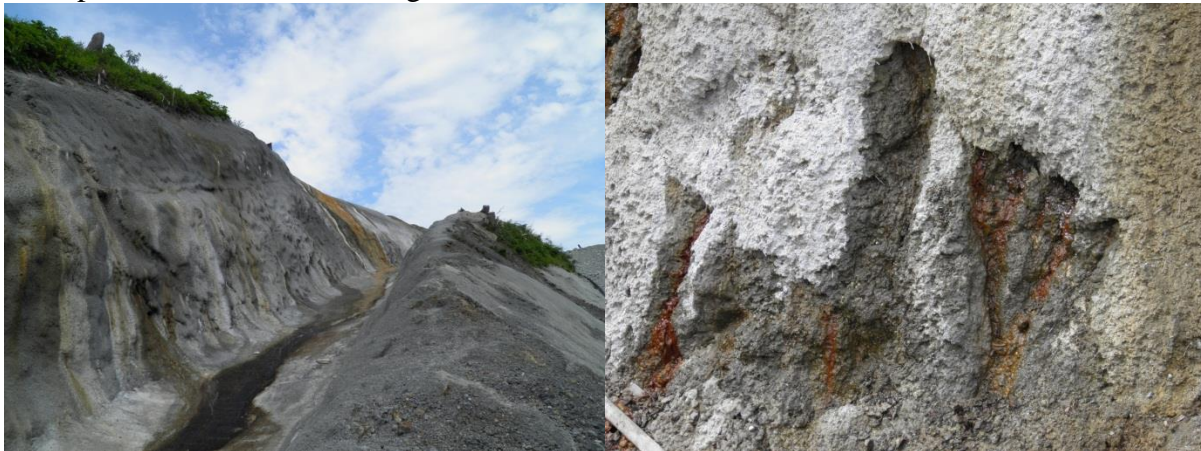
Figure 10 Spillway and shotcrete covering the GP. Low pH water seeping through the shotcrete is eroding it.

In areas of thin or no cover, contact water is exfiltrating through the shotcrete, and draining into the spillway. It flows down the spillway and collects in the plunge pool where it is pumped to a batch ARD water treatment plant. The low pH water reacts with the carbonate in the shotcrete and is actively deteriorating the areas around the seeps. The eroding shotcrete allows the seeps to widen allowing more water to exfiltrate. It is unclear how or if the higher flow rates affect the quality of contact water.

The shotcrete was intended to limit infiltration and exfiltration of oxygen and water into the GP formation, consequently minimizing the production of ARD. It is difficult to gauge how effective the application of shotcrete has been in this role. A dialogue between the agencies and Coeur Alaska has been opened in the past to discuss whether or not the application of shotcrete would be the best alternative at closure. The discussion should be taken up again before the third (final) stage of the dam is built.

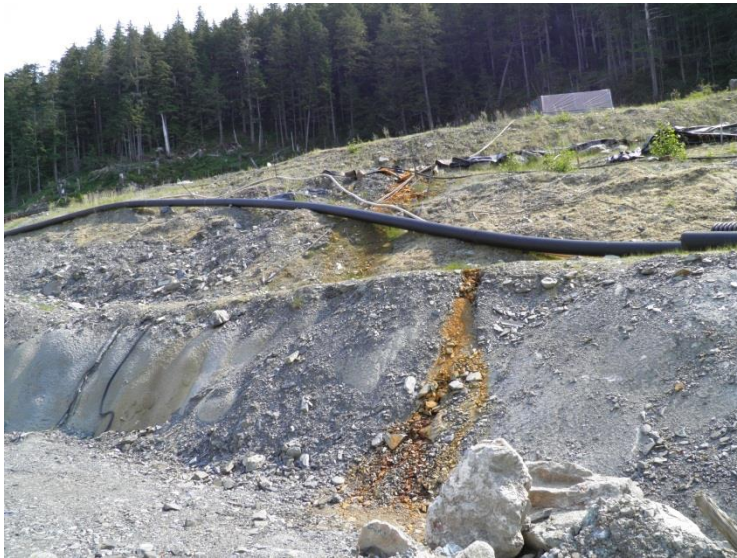
Figure 11 Staining beginning to show near the east end of the dam.

Light staining is beginning to appear on the east side of the dam (Figure 11). The same graphitic phyllite that was uncovered on the west side was excavated on the east side during the initial construction of the dam. Diorite wasterock was placed in the area to neutralize any acid that may be produced by the disturbed GP, because diorite can have a carbonate content of up to 40 kg CaCO₃/ton¹. The staining has not been noted on the east side of the dam on previous inspections. It may be possible that the buffering capacity of the diorite is nearing its end, and low pH effluent with high metals concentration is

surfacing. This is a concern as the only systems in the area to prevent the water from entering Slate Creek are pump-back wells. This area needs to be closely monitored.

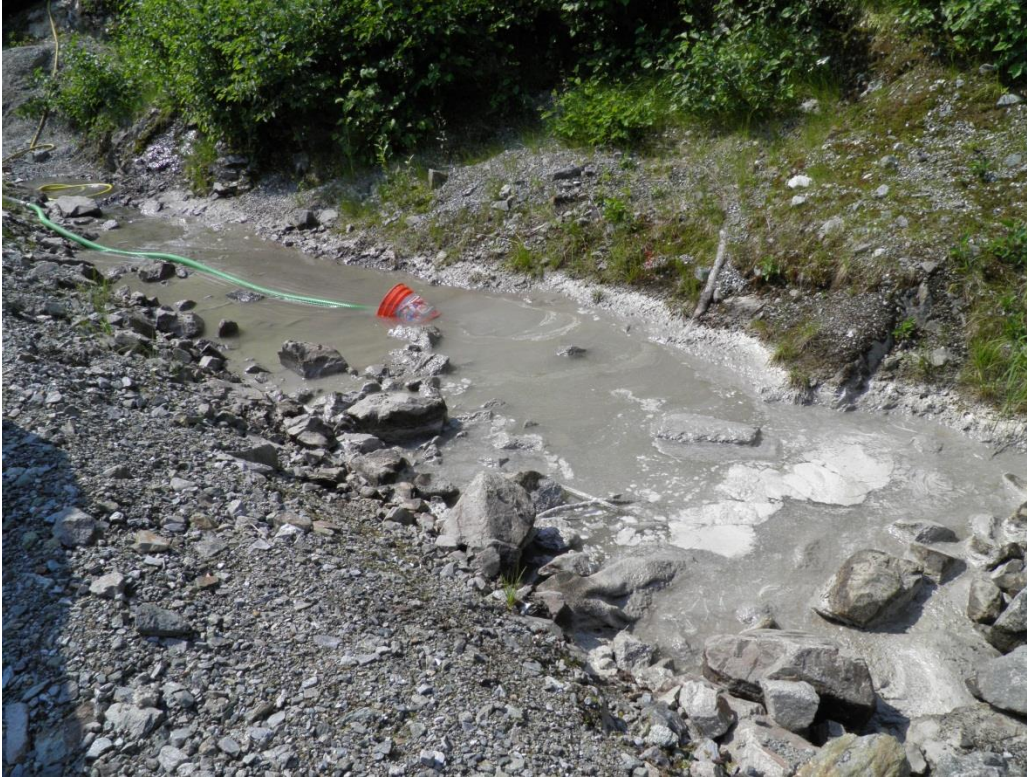
Several surface exploration sites had been chosen by Coeur for the 2013 season. The sites were located both on USFS managed land, and private property. During the June 25 inspection, a core drill rig was positioned directly over a runoff ditch that flowed directly into Johnson Creek. The surface drilling plan of operations (POO) states that no drilling will occur within 200 feet of flowing water, and a pre-shift checklist states that drill water is not to be within 200 feet of flowing water. With the positioning of the drill rig, it was impossible to keep sediment out of the ditch, and hence straight into Johnson Creek. Coeur was alerted to the problem during the inspection, and again during a regular meeting several days later.

Figure 13 Before the culvert was installed.

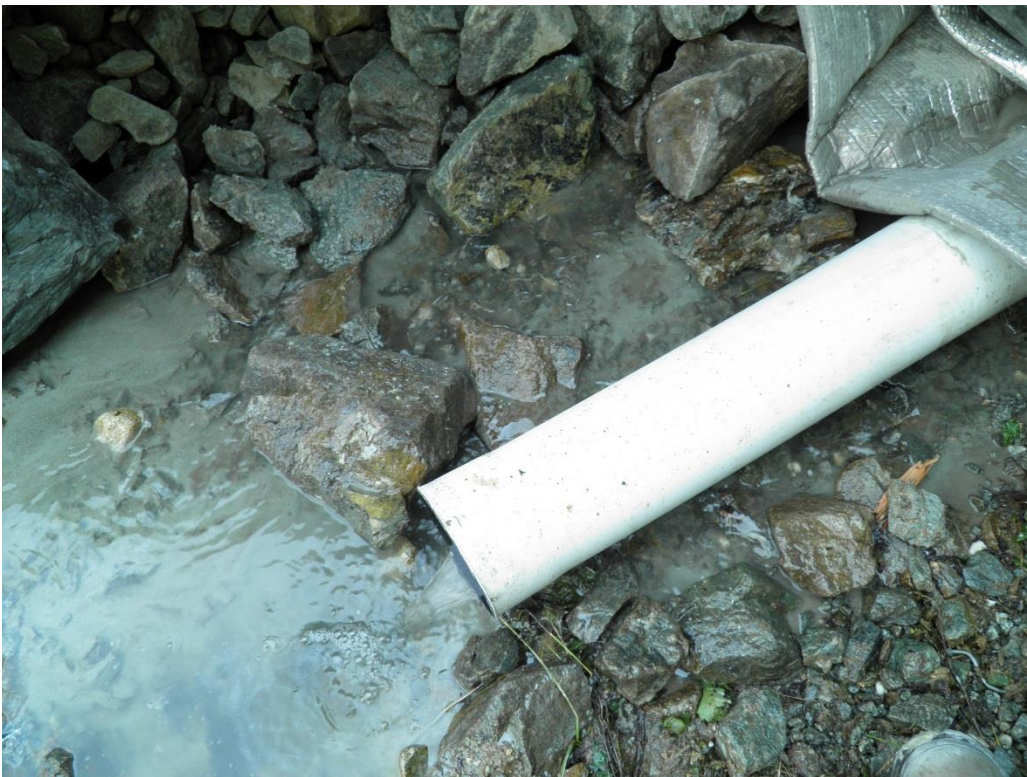
During the next visit, the drill rig was still positioned above the ditch, but a culvert had been installed under the drill so any drill cuttings that escaped containment did not travel downstream. It was not a perfect solution, but it seemed to markedly cut down the turbidity in the ditch. Before and after photos can be seen in Figure 13 and 14.

Figure 14 After the culvert was installed.

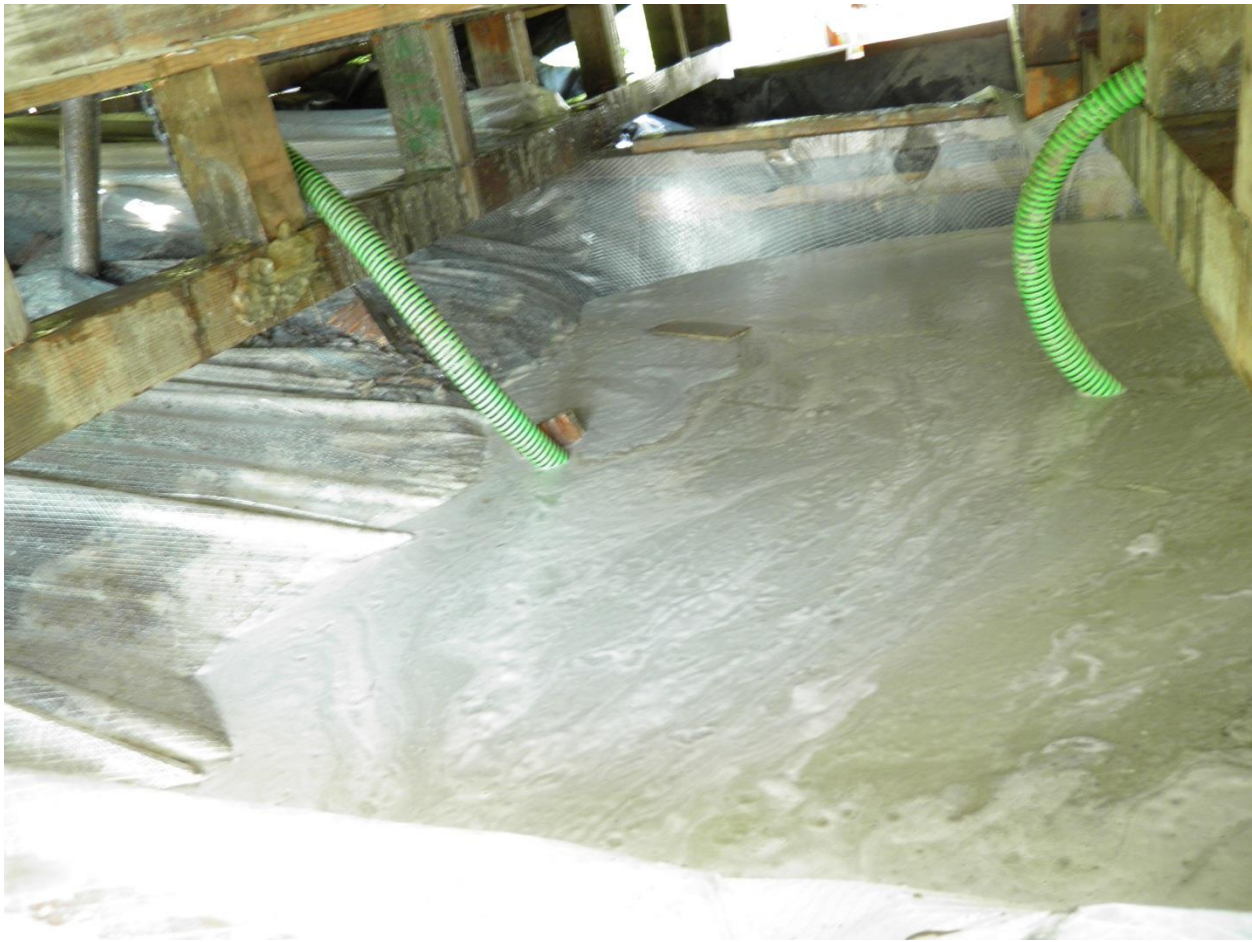
Figure 15 The thin layer of plastic separated the drill water and the ditch directly below.
