INSPECTION REPORT: KENSINGTON GOLD MINE

Tongass National Forest Minerals Group
8510 Mendenhall Loop Rd
Juneau, AK 99801
(907) 789-6276 – office
(907) 586-8808 – fax

Date of Inspection: Thursday June 17, 2021
Date of Report: 06/24/2021
USDA Forest Service Inspector: Casey Loofbourrow

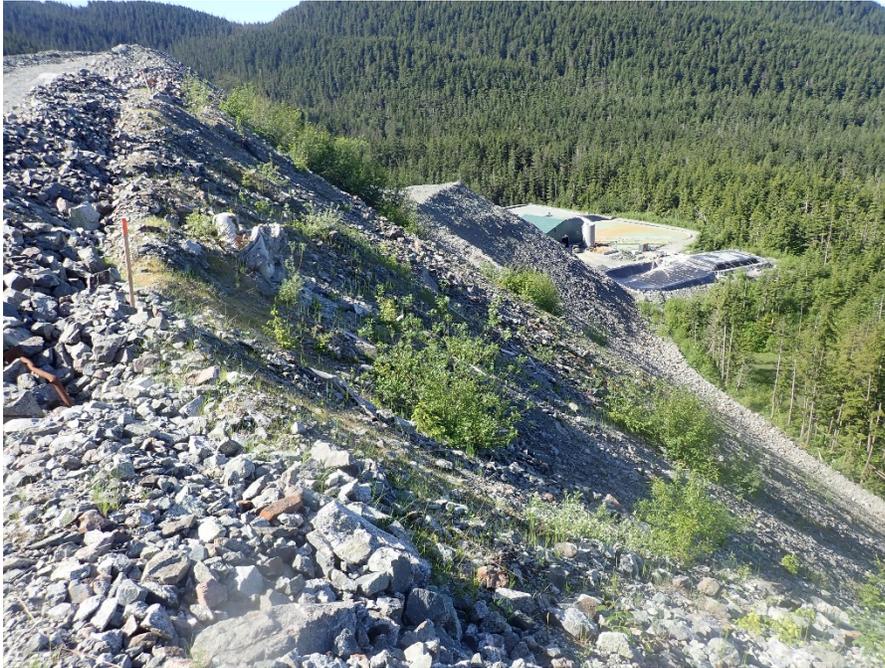
No additional waste rock has been added to the pile since the previous inspection and the slopes of the Comet waste rock storage area appear stable (Photos 1-2).

Photo 1. Comet Development Pile looking south.

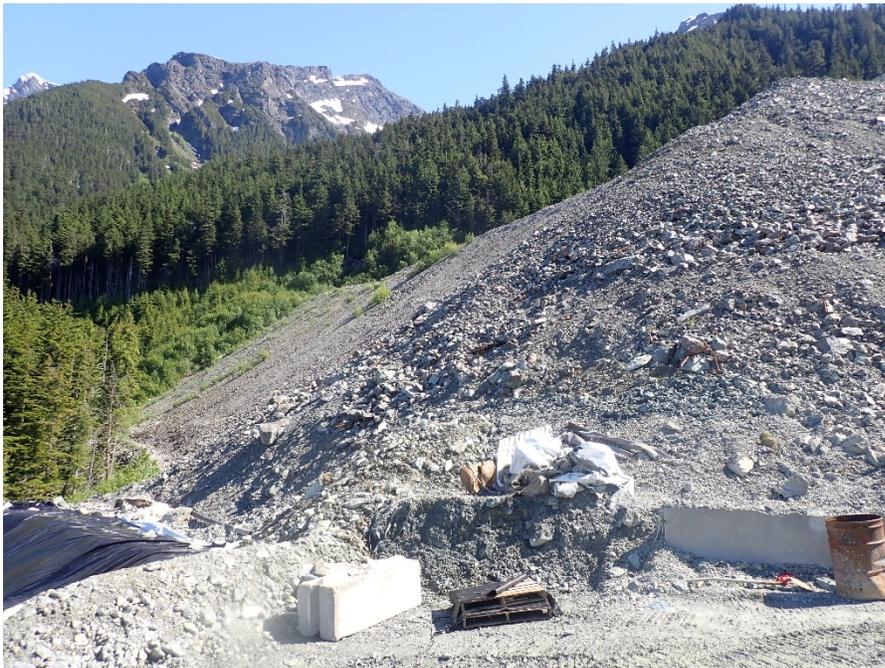
Photo 2. Comet Development Pile looking north.

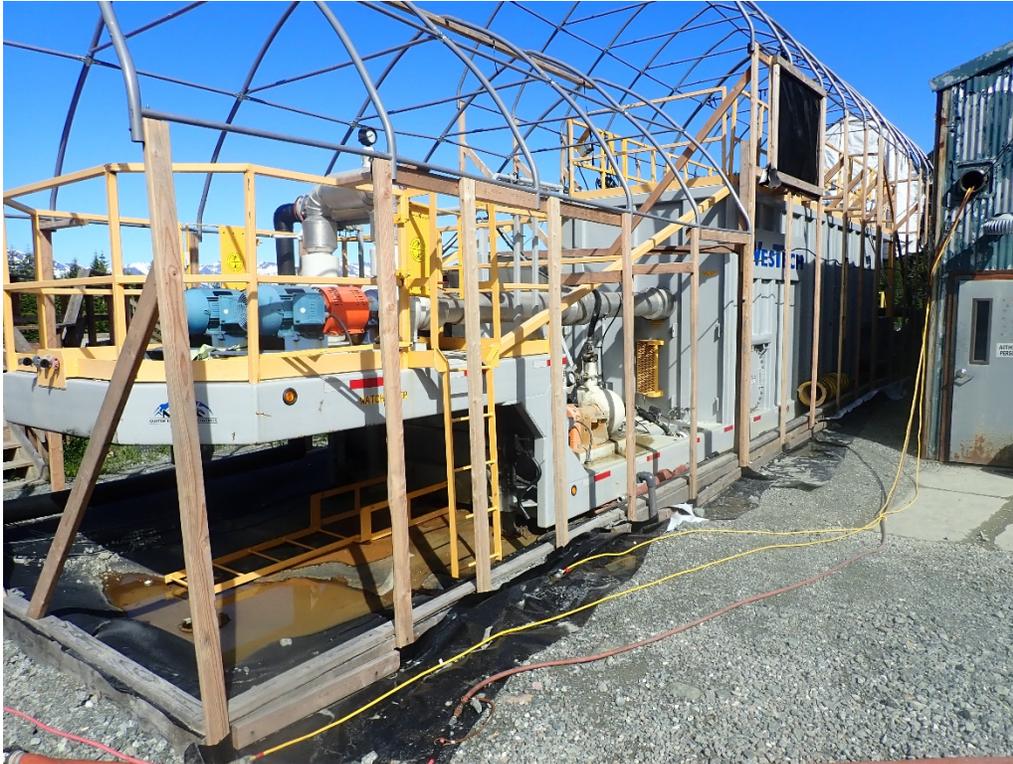
The CWTP was treating approximately 2,794 gallons per minute (gpm). Ponds 1 and 2 were in good condition and functioning as designed. Sensor calibration was occurring at the time of inspection, so pH, turbidity, and temperature of effluent were not available. The mobile water treatment plant, referred to as plant 2.5, was treating approximately 332 gpm (Photo 3).

Photo 3. Mobile water treatment plant, referred to as plant 2.5.

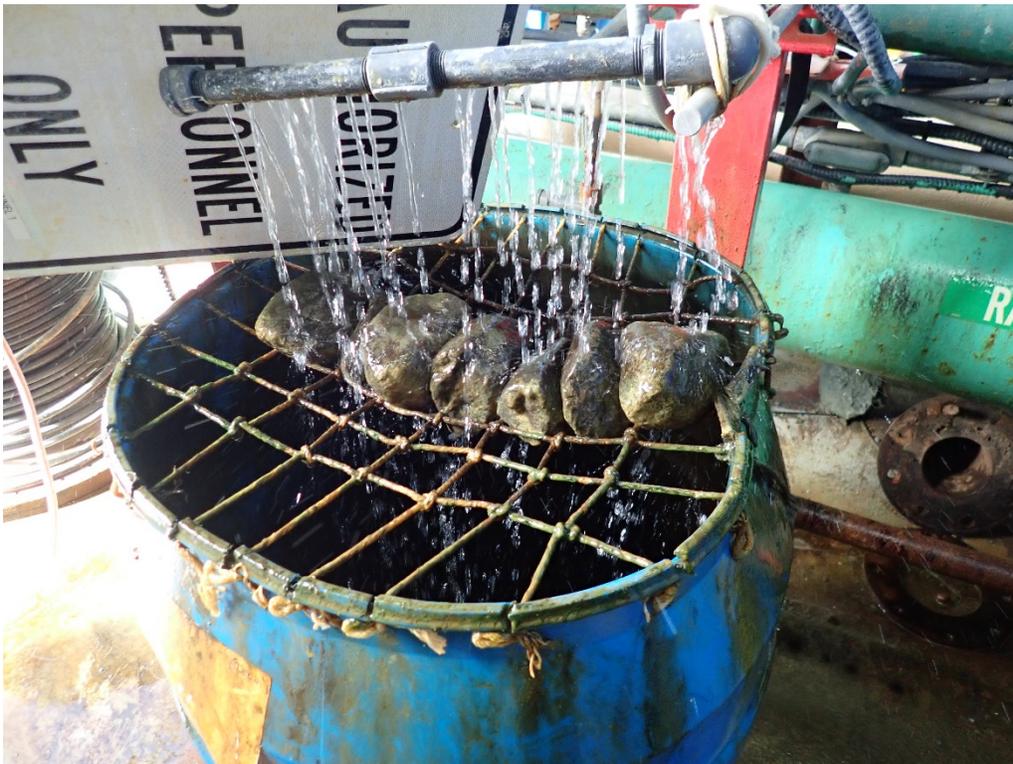
White material was not observed on the test rocks used for monitoring in the CWTP (Photo 4).

Photo 4. Test rocks for white material accumulation in CWTP.

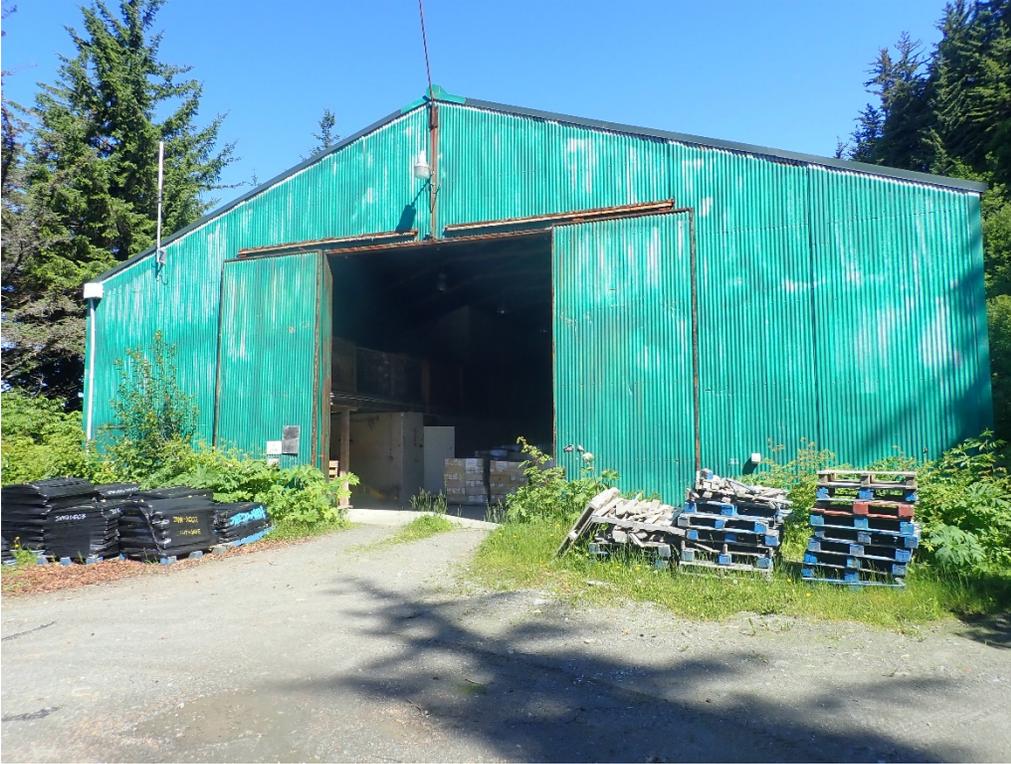
The core storage facility at comet beach was orderly (Photo 5).

Photo 5. Core storage shed at Comet Beach.

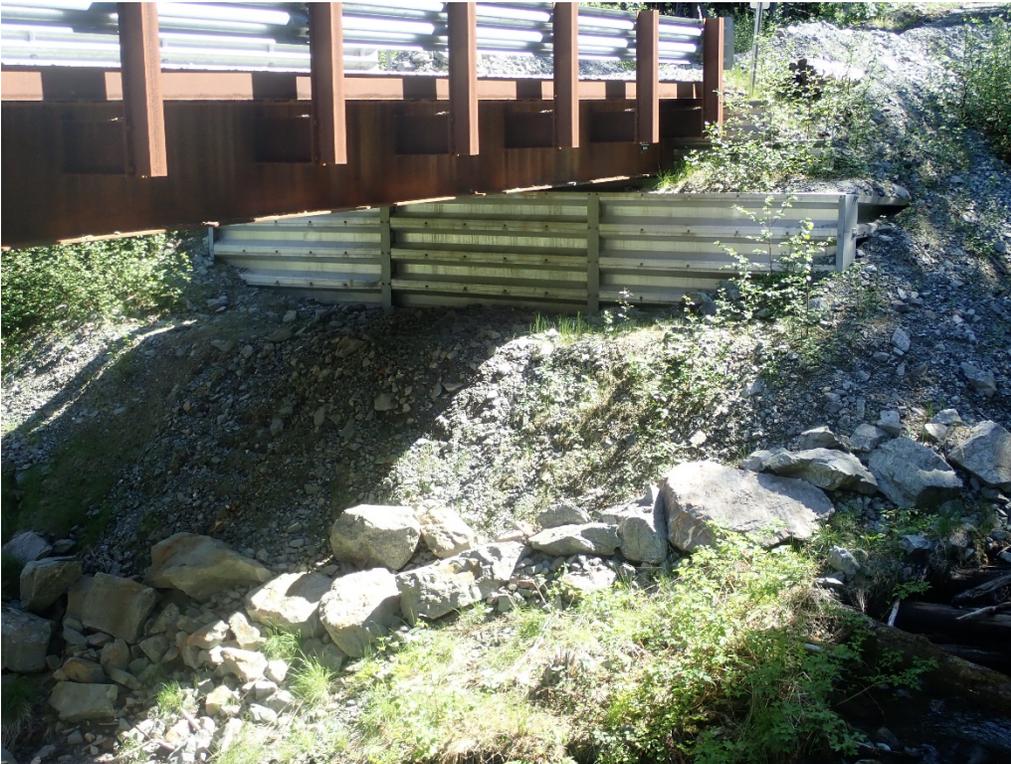
No Name Creek Bridge and abutments were in good condition with no evidence of erosion or sedimentation (Photo 6).

Photo 6. No Name Creek Bridge abutment.

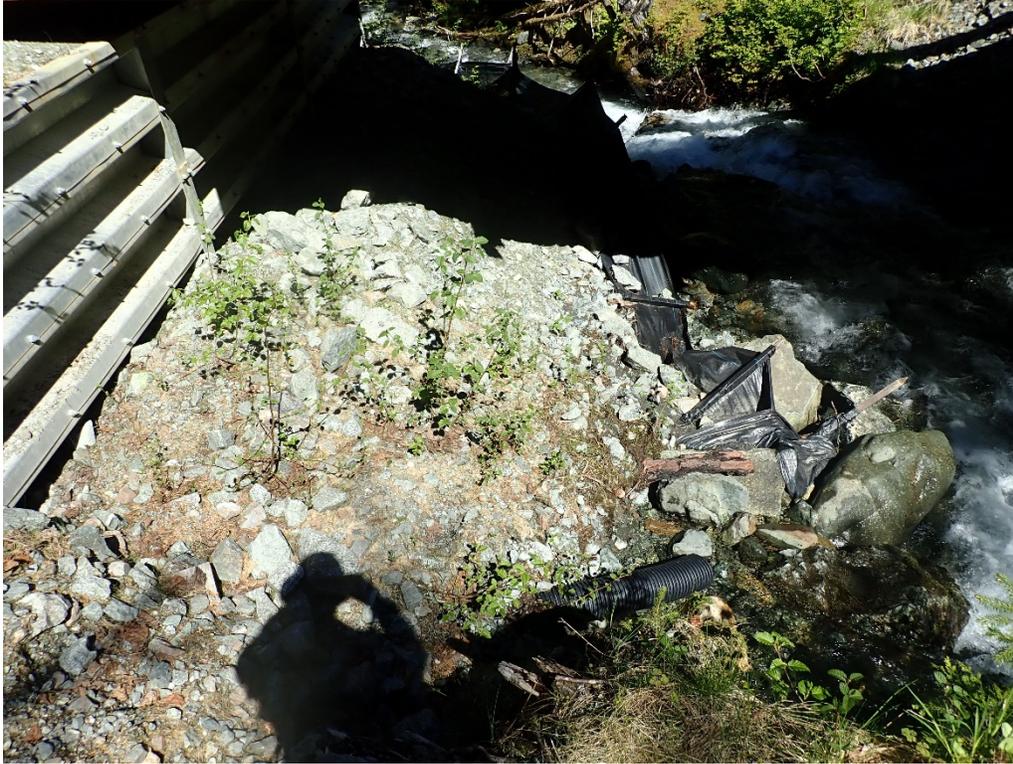
ACTION ITEM 182-1: Sherman Creek Bridge downhill side abutment silt fencing is in disrepair. This should be replaced or removed if no longer needed.

ACTION ITEM 182-1: Sherman Creek Bridge downhill side abutment silt fencing is in disrepair (Photo 7). This should be repaired or removed.

Photo 7. Sherman Creek Bridge abutment with silt fencing in disrepair.

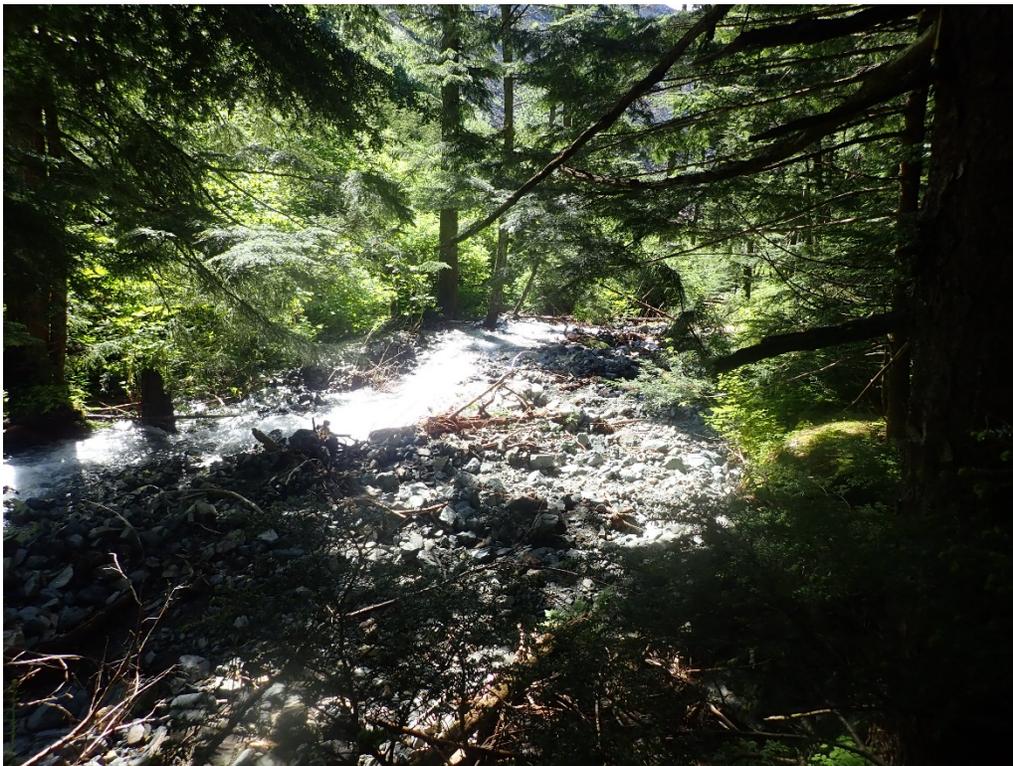
Ophir creek experienced high flows during the December 2020 storm event resulting in the migration of the active stream channel at locations below the toe of the Comet Development Pile (Photos 8-9). The changes to the stream channel were not mapped during this site visit but will likely occur during future visits. The active stream channel is currently migrating away from the Comet Development Pile.

Photo 8. Ophir Creek showing stream channel migration and large cobble bedload from Dec 2020 storm.

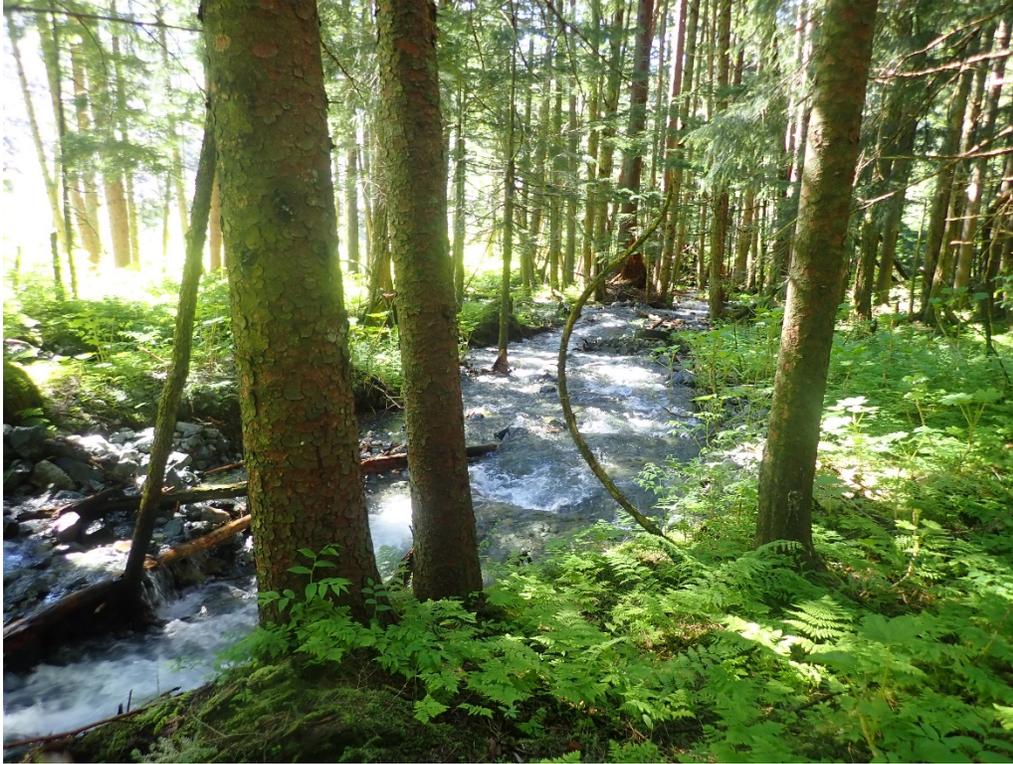
Photo 9. Ophir Creek stream channel migration.

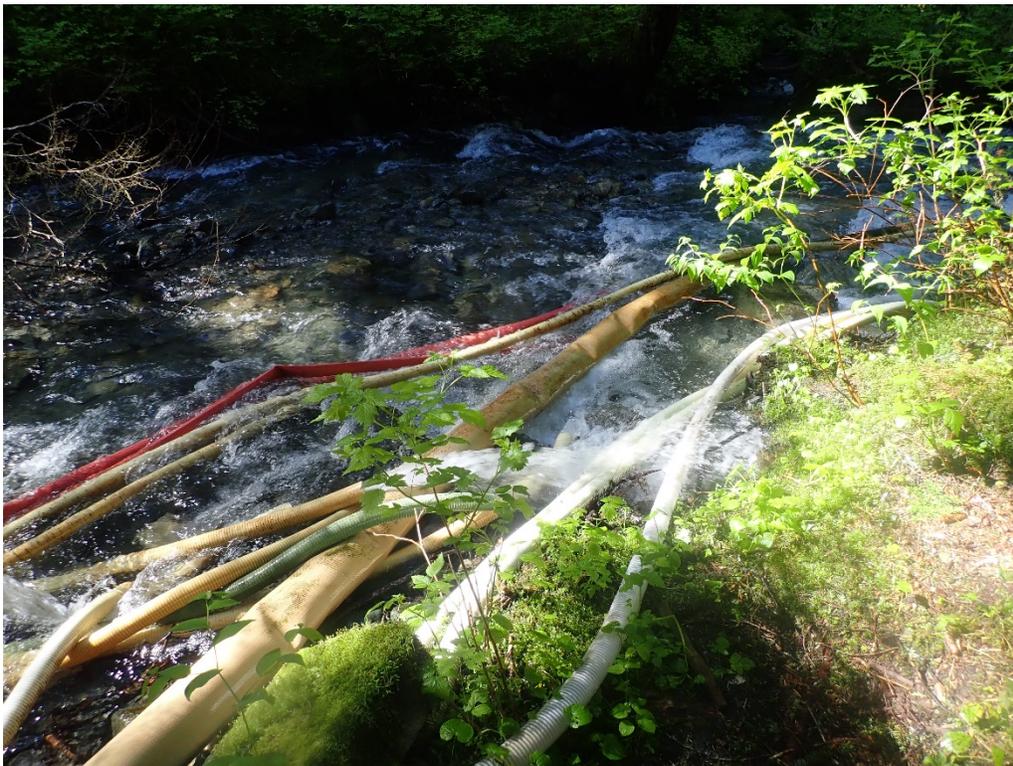
White material was not observed on the substrate in Sherman Creek (Photos 10-11). In the underground workings Z-Clear 129 continues to be added to seepage water at the lowermost sump. This coagulant is used in an attempt to remove flocculants and polymers used as underground drill additives that Coeur suspects contribute to the white material intermittently observed at the Sherman Creek Outfall.

Photo 1. Sherman Creek outfall absent of white material.

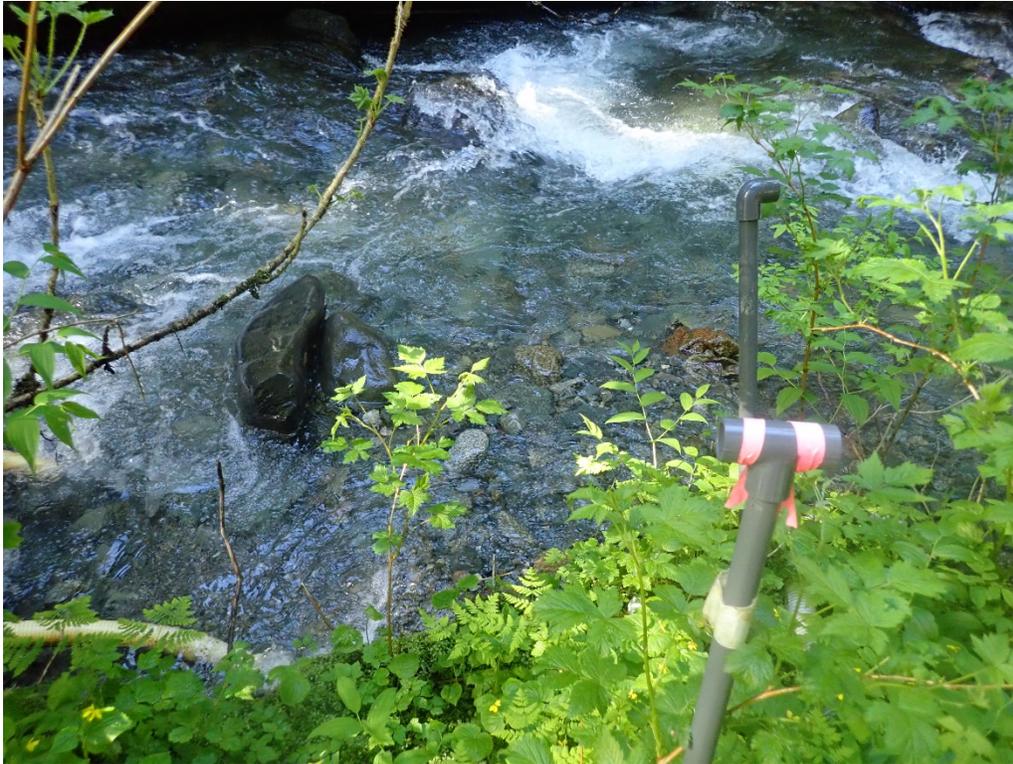
Photo 2. Sherman Creek outfall with white material absent in substrate.

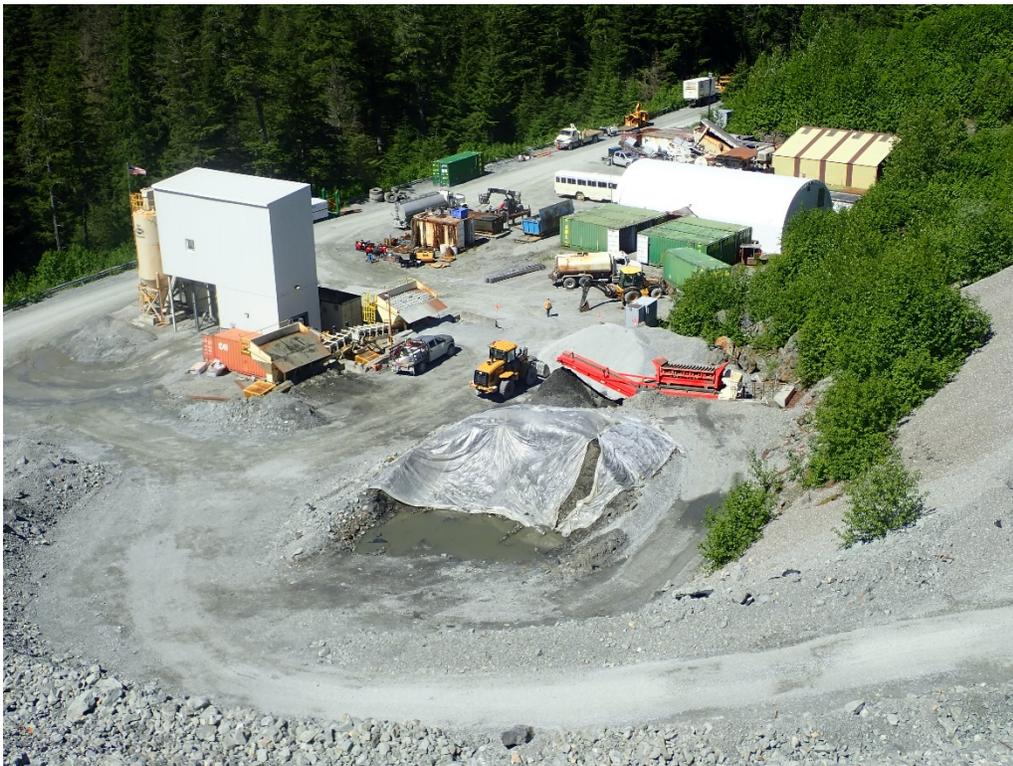
The pug plant was not operating at the time of inspection but has been operating intermittently this season (Photo 12). The pug plant is used to mix ARD-generating graphitic phyllite with concrete in preparation for underground backfill and storage to prevent impacts to surface resources.

Photo 3. Pit 4, Pug Plant, and graphitic phyllite stockpile.

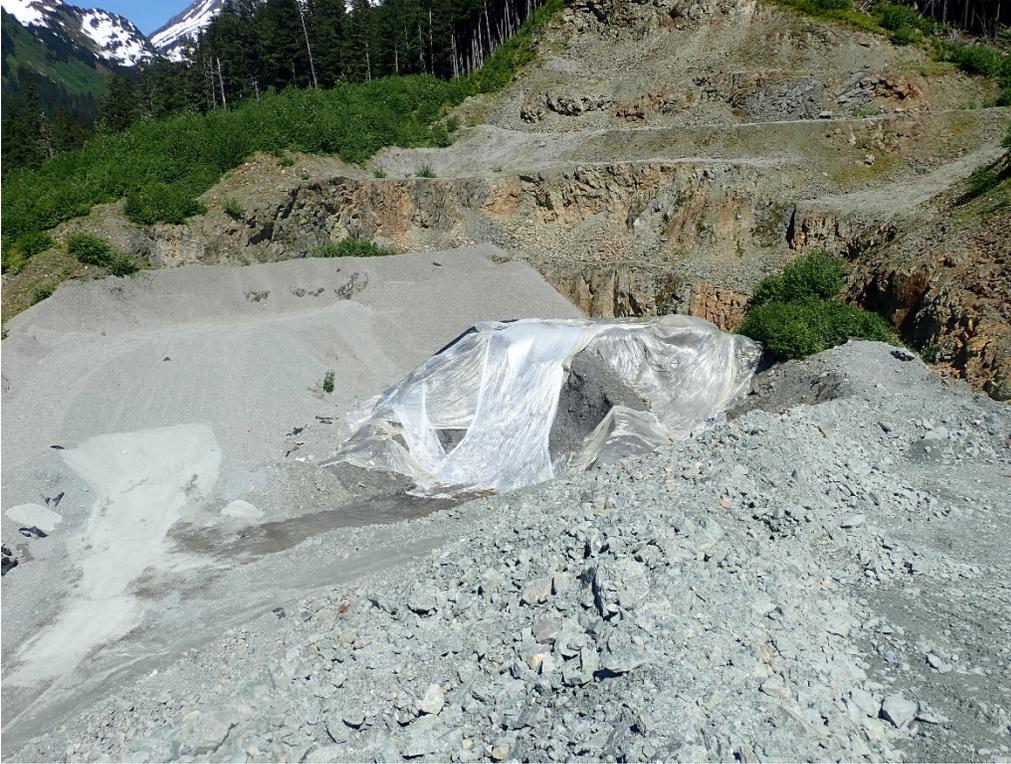
ACTION ITEM 182-2: Graphitic phyllite stockpile at Pit 4 requires covering.

ACTION ITEM 182-2: Graphitic phyllite stored at this location is to be in covered and lined containment to manage ARD when pug plant operations are not active. The upper liner intended to prevent rainwater from contacting the stockpile was partially displaced and requires attention (Photo 13).

Photo 4. Graphitic phyllite stockpile at Pit 4 that requires covering with impermeable liner.

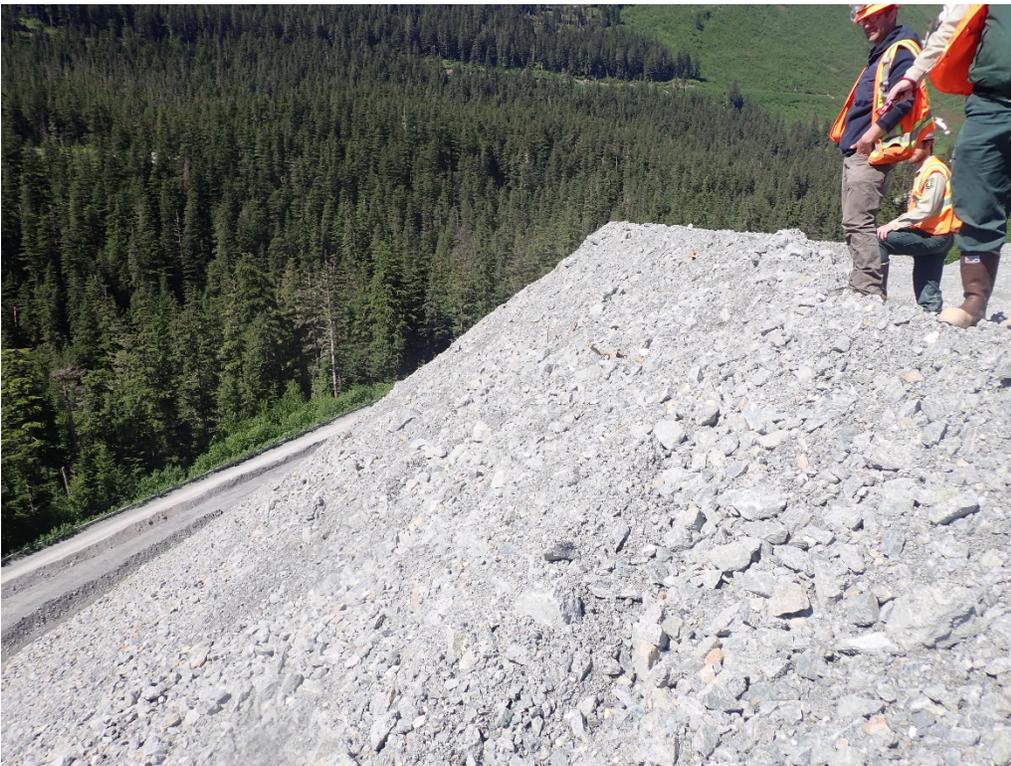
The waste rock stockpile at this location appeared stable (Photo 14). The Pit 4 Pond and liner appeared in good condition (Photo 15).

Photo 5. Waste rock pile at Pit 4.

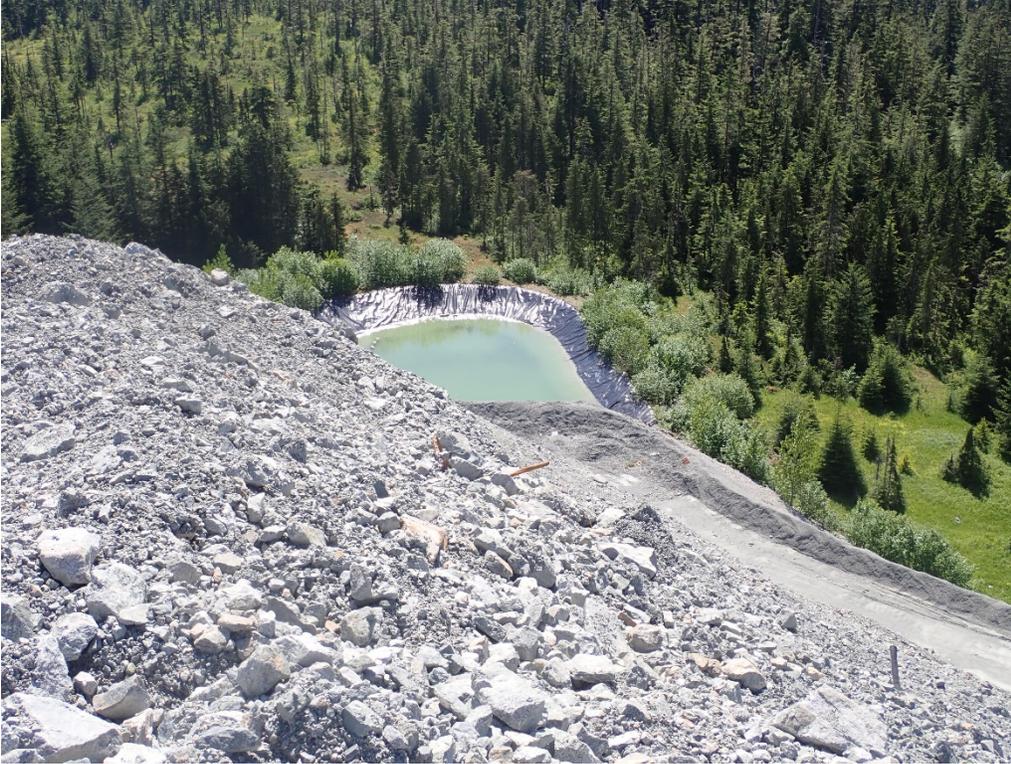
Photo 6. Pit 4 pond below waste rock stockpile.

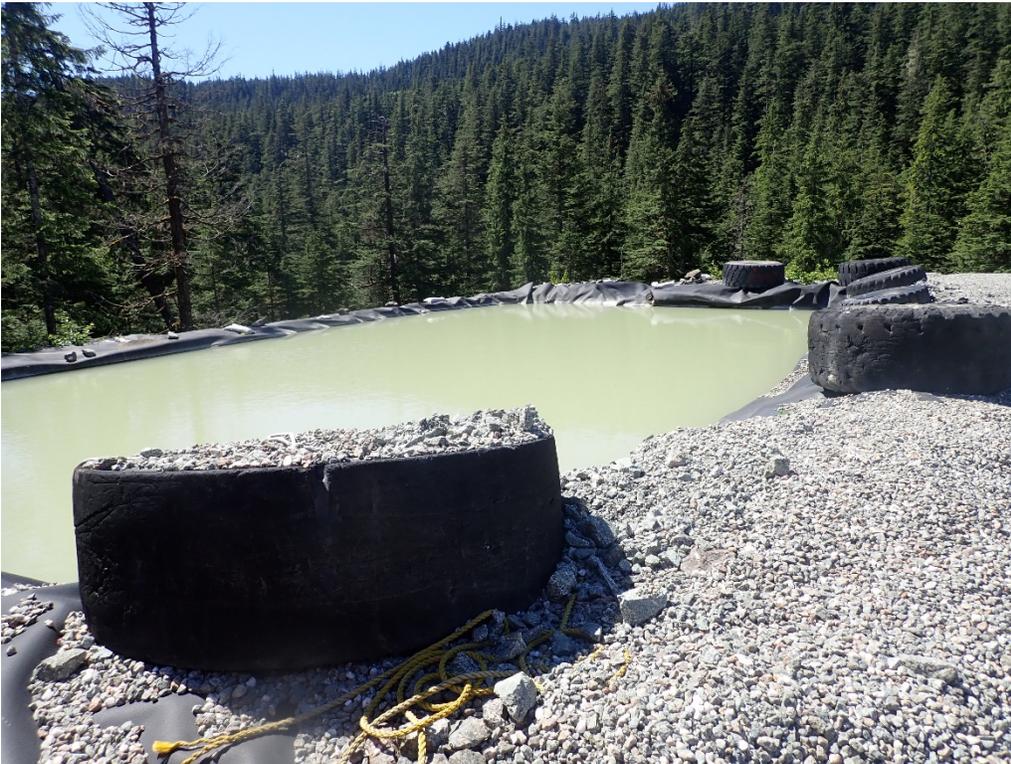
Access road sediment management ponds known as Bridge 1 Pond and Heli Pond were inspected and appeared to be functioning as intended (Photos 16-17)

Photo 7. Bridge 1 Pond.

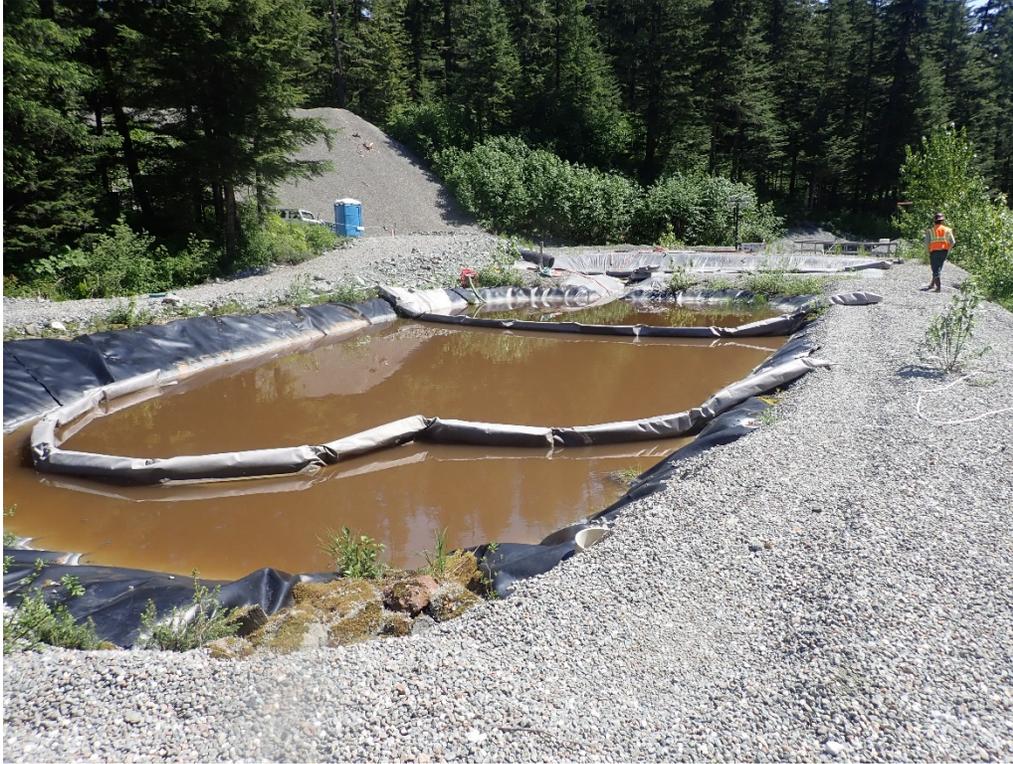
Photo 17. Heli Pond.

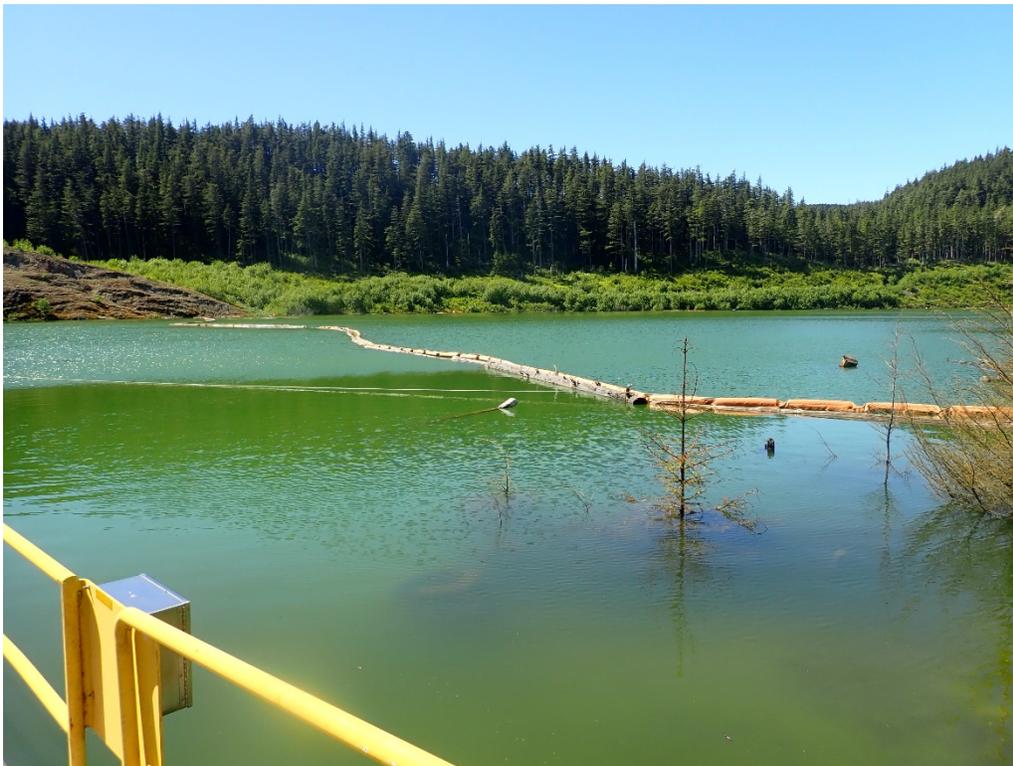
The TTF's recorded water level was 716.25 feet. Tailings placement was occurring in the northwest area of the TTF. A new log boom was installed to prevent debris from accumulating against the face of the dam (Photo 18).

Photo 18. Improved log boom across TTF to prevent debris from accumulating against dam face.

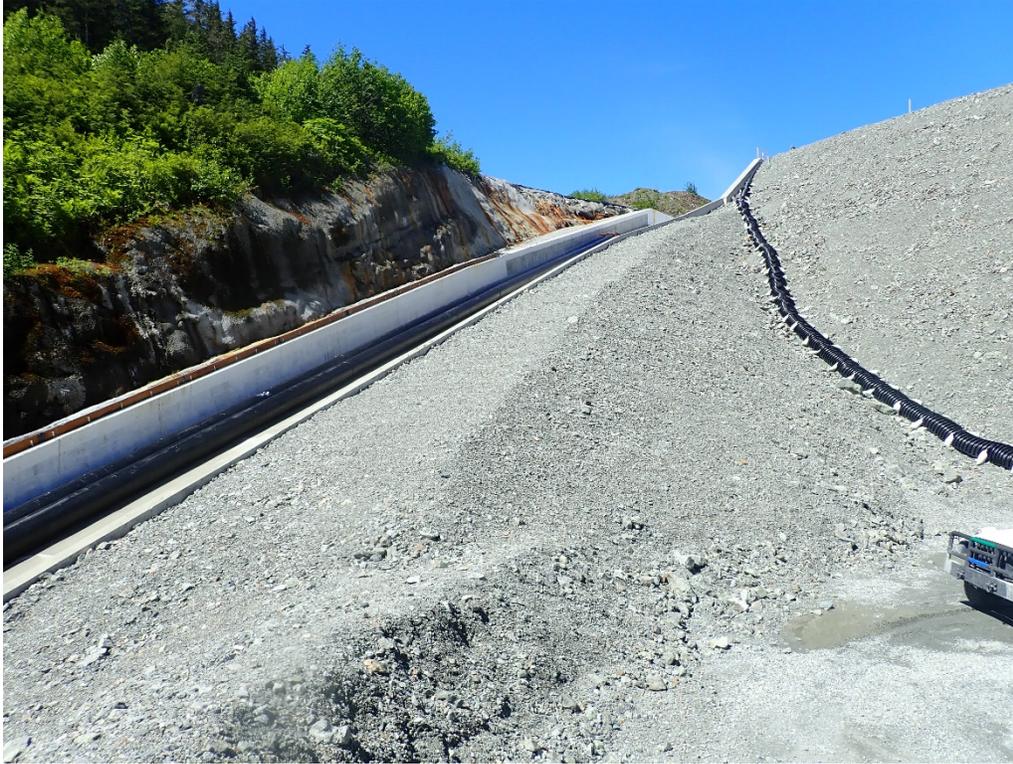
The TTF dam spillway was functioning as intended and free of debris (Photo 19). The acid rock drainage (ARD) diversion sill appeared to be preventing seepage of ARD into the dam spillway (Photo 19).

Photo 19. TTF Dam Spillway.

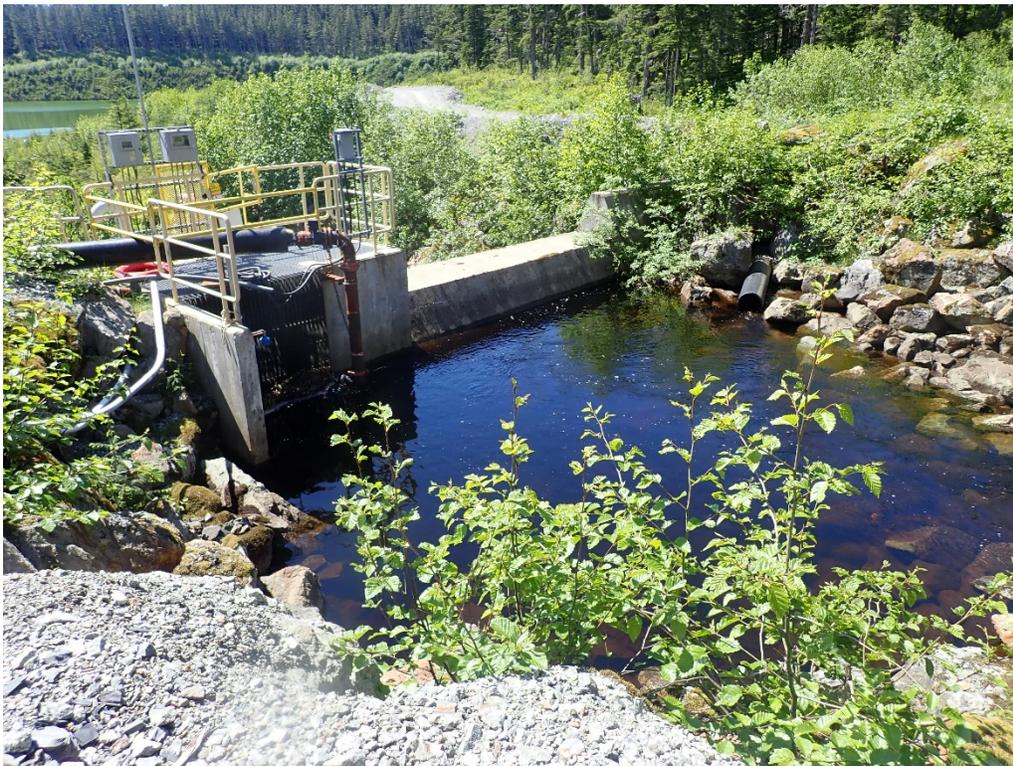
ACTION ITEM 182-3: The screen for the Upper Slate Lake diversion pipeline intake has accumulated debris that requires removal.

ACTION ITEM 182-3: The screen for the Upper Slate Lake diversion pipeline intake has accumulated organic debris that requires removal (Photo 20).

Photo 20. The screen for the Upper Slate Lake diversion pipeline intake that has accumulated organic debris that requires removal.

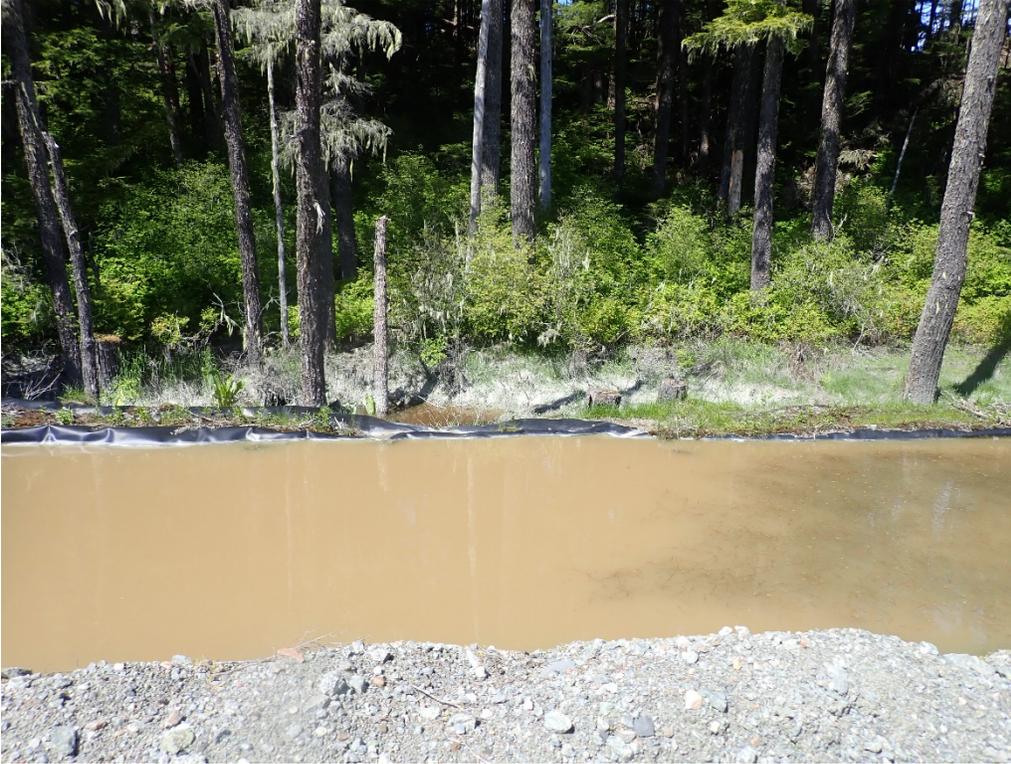
The settling pond near the alpine area of the TTF spur road appeared to be functioning. This BMP was listed as an action item from the previous inspection. However, high flows from increased precipitation has allowed turbid water to overflow the settling pond and discharge into the environment. This area will be continued to be monitored for effectiveness of the BMP (Photo 21).

Photo 21. Site of previous action item, showing sediment being effectively settled from stormwater before discharge.

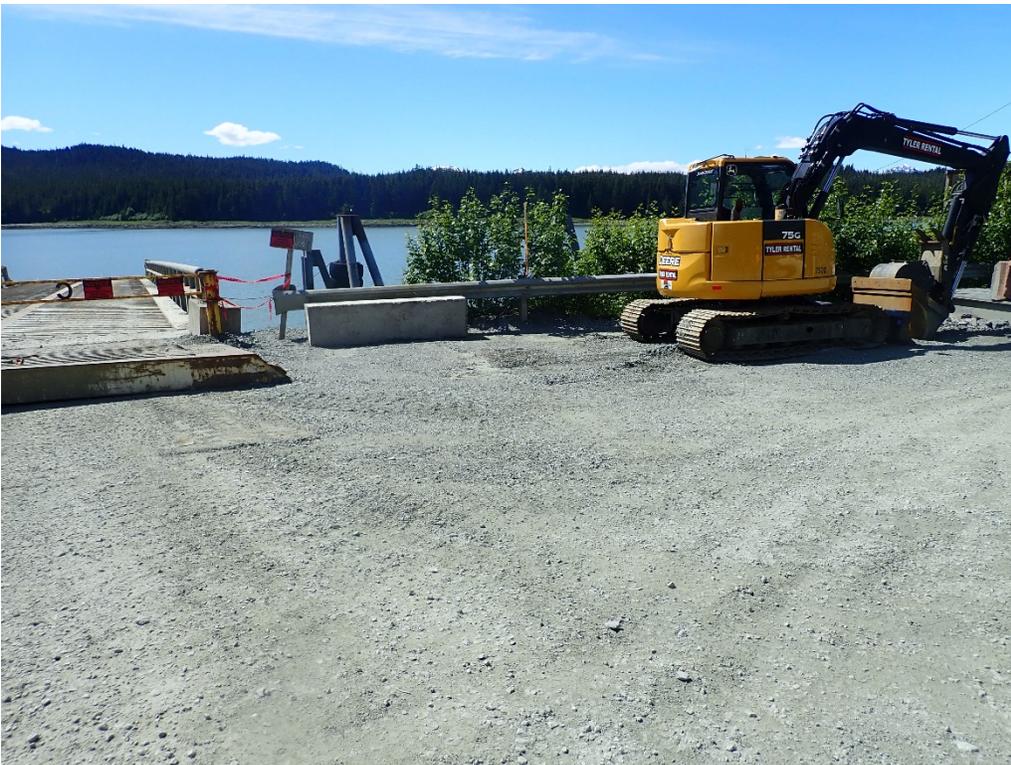
All contaminated sediments from the fuel spill, that occurred April 18, 2021, has been removed from the marine port facility. Coeur excavated contaminated materials and completed testing to confirm the full extent of the spill had been addressed, and the site has been backfilled (Photo 22). There is still a small amount of contaminated material temporarily stockpiled at Pit 1 awaiting containers to be used to ship to an approved disposal facility out of state (Photo 23).

Photo 22. Backfilled site where fuel-contaminated soil had been excavated.

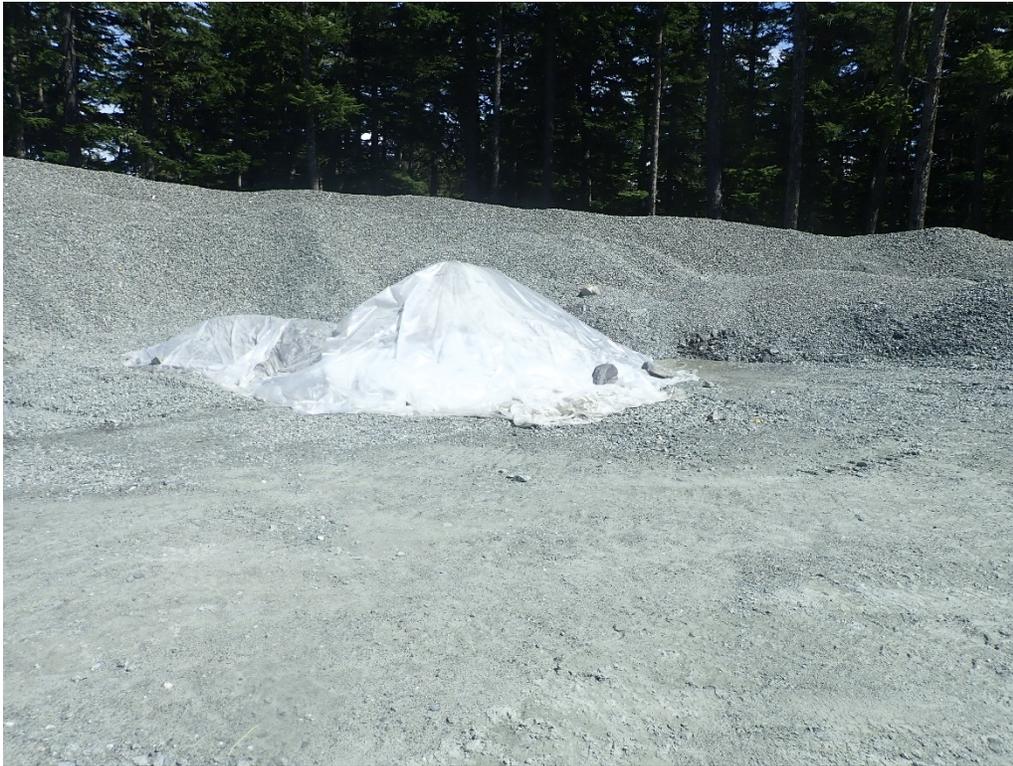
Photo 23. Remaining contaminated soil from marine terminal fuel spill.

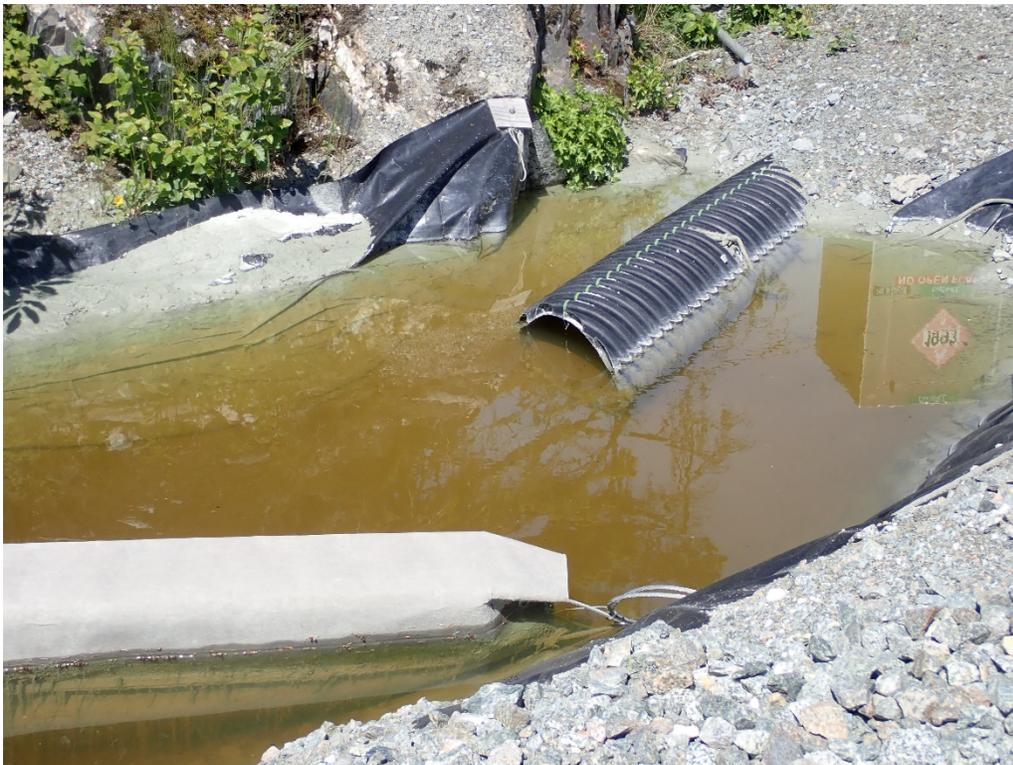
An action item from the previous inspection was to clean accumulated sediment from a culvert connecting sediment sumps, and this has been accomplished (Photo 24).

Photo 24. Site of previous action item showing culvert has been cleared of sediment.

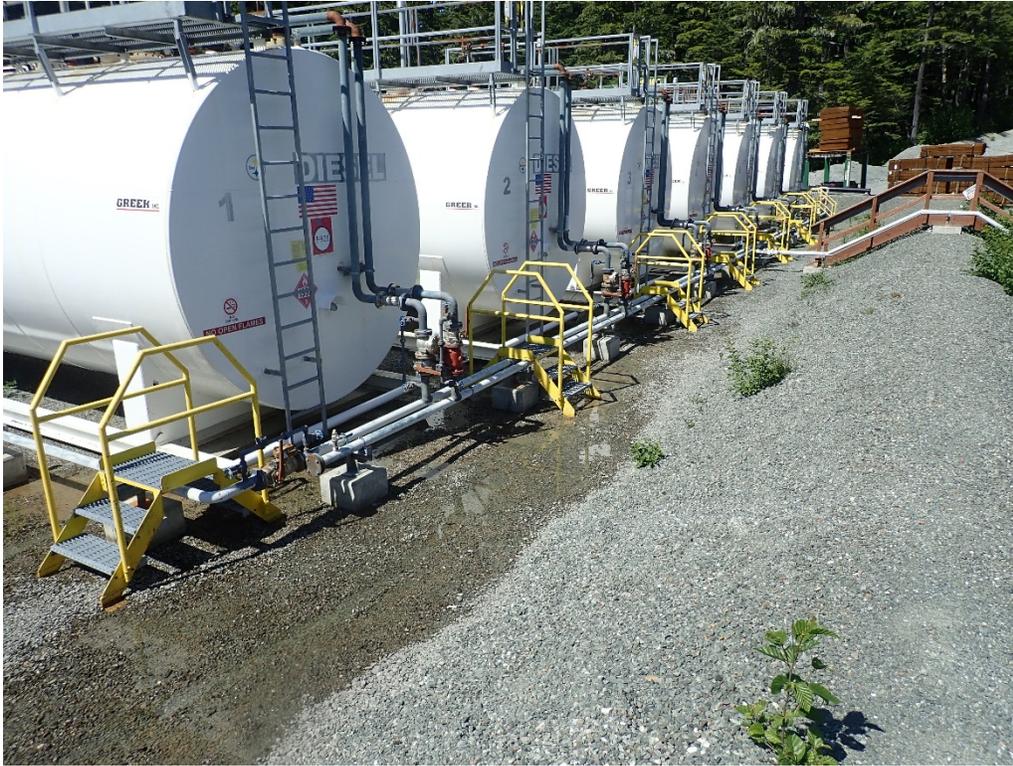
The tank farm, fueling bay, and fuel transfer header appeared in good condition and free of spills (Photos 25-27)

Photo 25. Fuel Depot.

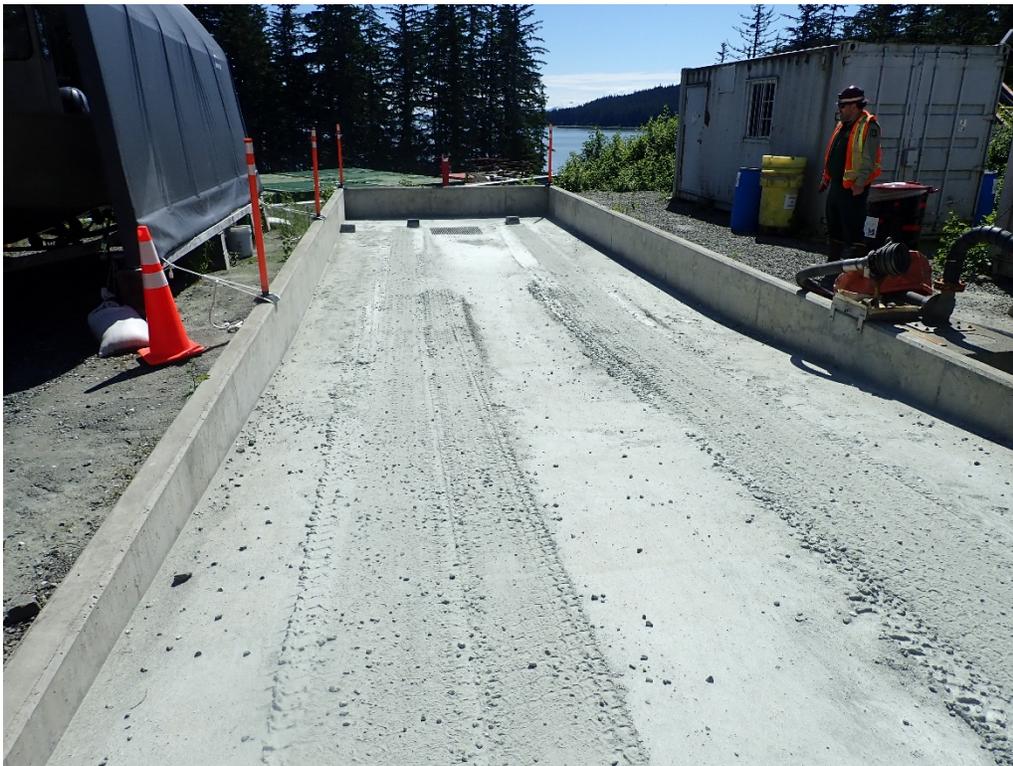
Photo 26. Fueling bay.

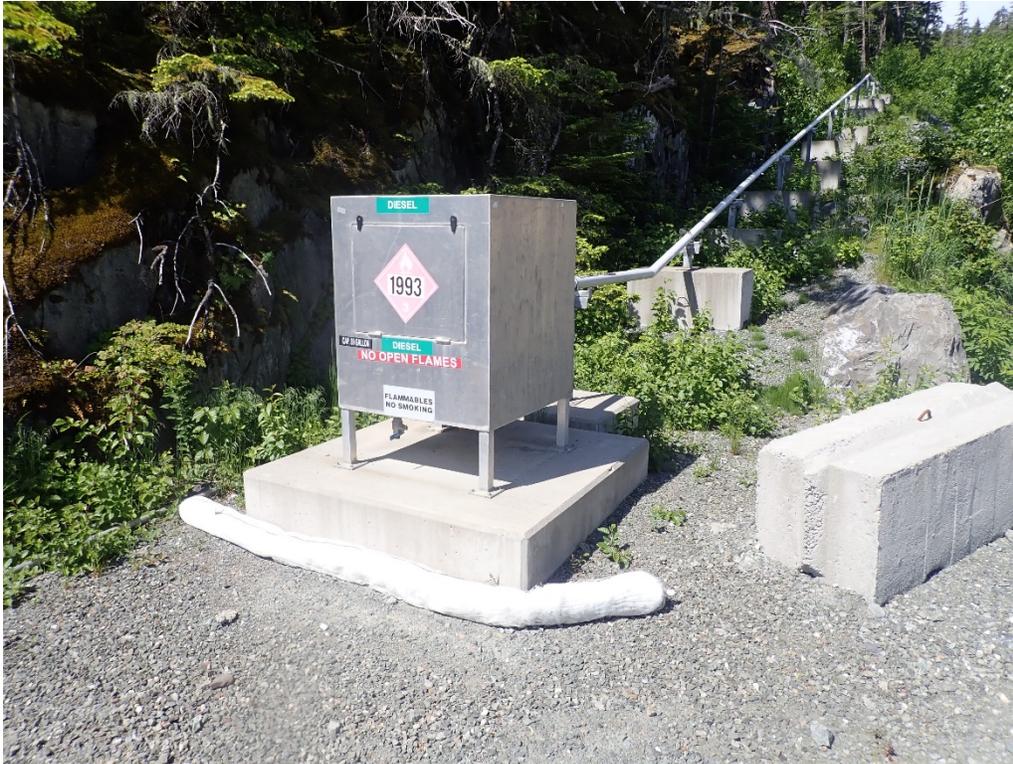
Photo 27. Fuel transfer header.
