INSPECTION REPORT: KENSINGTON GOLD MINE

Tongass National Forest Minerals Group
8510 Mendenhall Loop Rd
Juneau, AK 99801
(907) 789-6276 – office
(907) 586-8808 – fax

Date of Inspection: Wednesday August 18, 2021
Date of Report: Thursday, September 2, 2021
USDA Forest Service Inspector: Richard Dudek

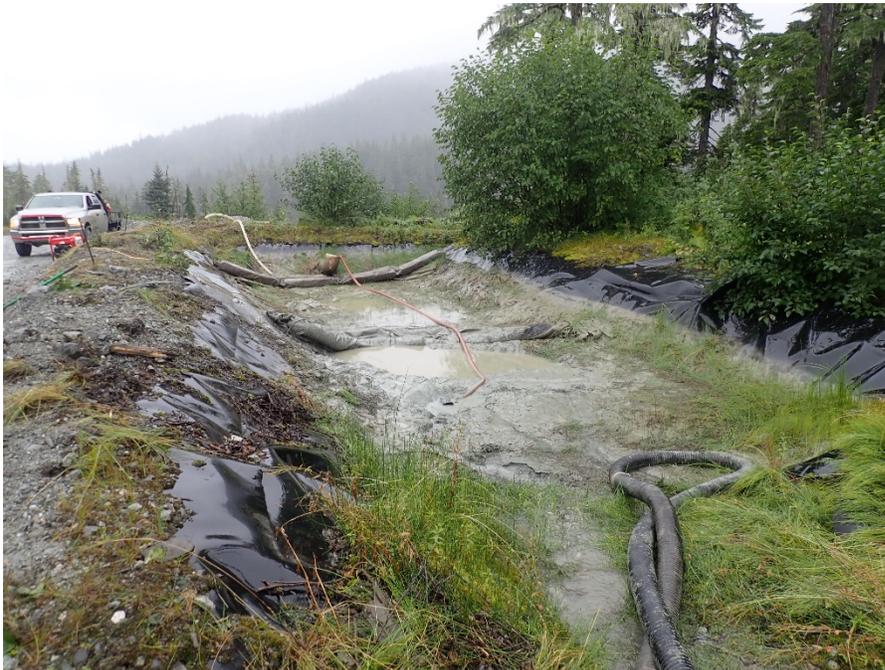
The access roads were in adequate condition (2016 BMP Plan; Table 4-4). Surface Operations were in the process of removing sediments with a Vacuum truck from the Spur Road settling ponds (Photos 1-2).

Photo 1. A Spur Road settling pond recently mucked out.

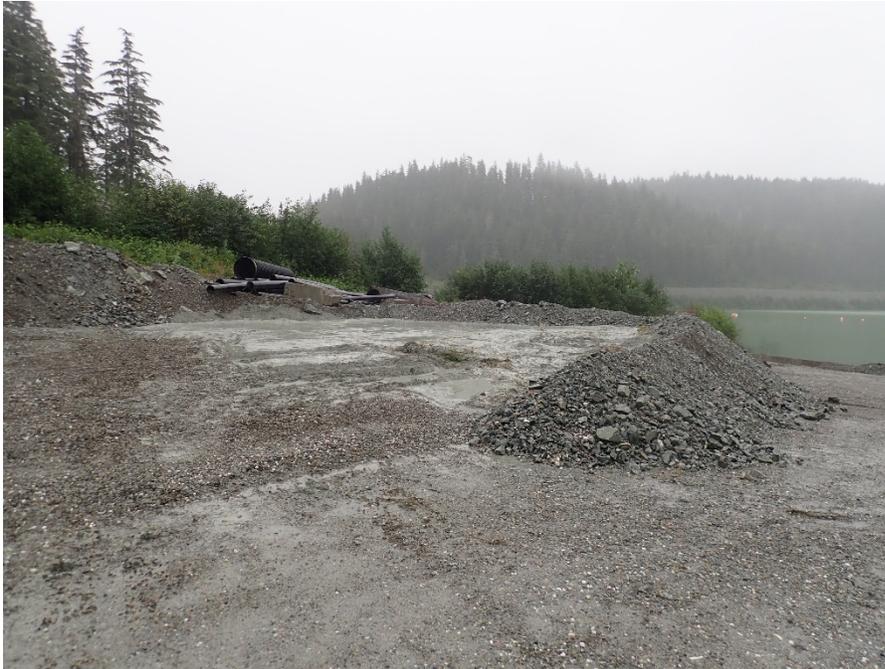
Photo 2. The muck from the Spur Road settling ponds is currently being staged in the northern TTF lay down.

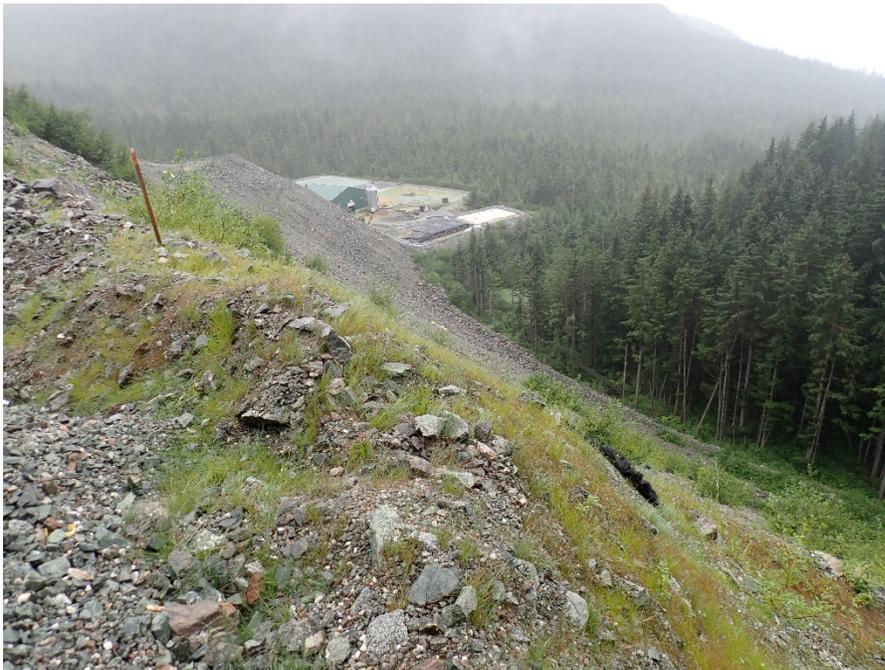
The slopes of the Comet waste rock storage area appear stable (Photo 3-4).

Photo 3. The Comet development pile.

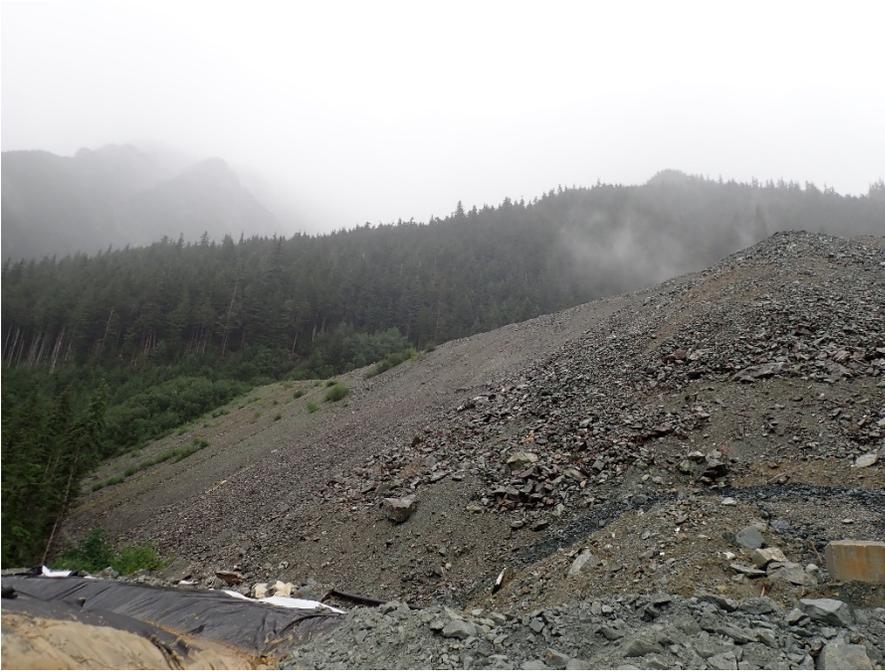
Photo 4. The Comet Development Pile viewed from the Comet water treatment plant.

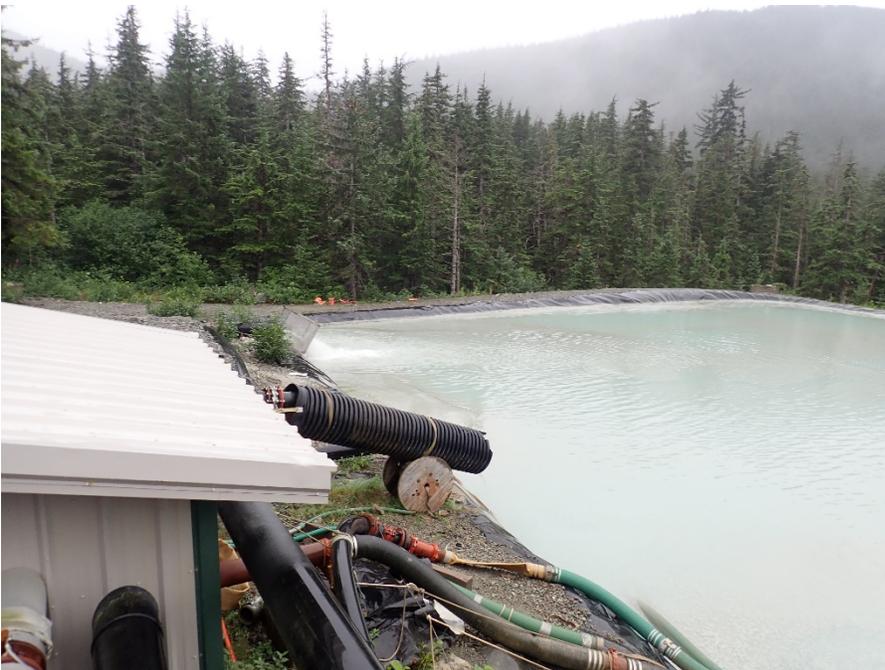
The CWTP was treating approximately 2,187 gallons per minute (gpm). Pond 1 (Photo 5) was receiving mine site water and functioning as intended. At time of this site inspection, CWTP personnel were in the process of dredging Pond 2 (Photos 6). The dredging process takes about two to three weeks. The mobile water treatment plant (CWTP plant 2.5) was online and treating water from the underground mine.

Photo 5. Pond-1 receiving mine site water.

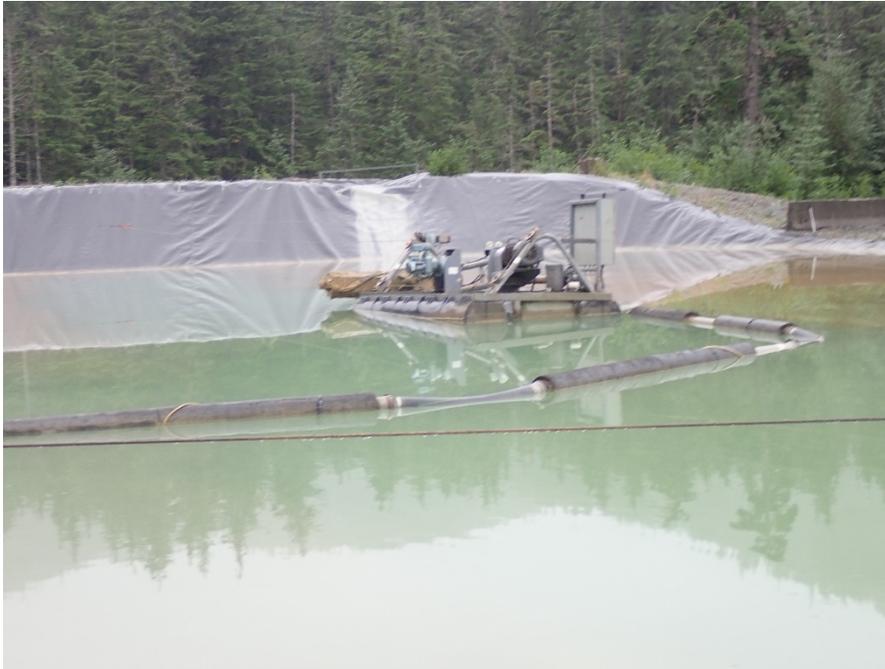
Photo 6. Dredging taking place at Pond 2.

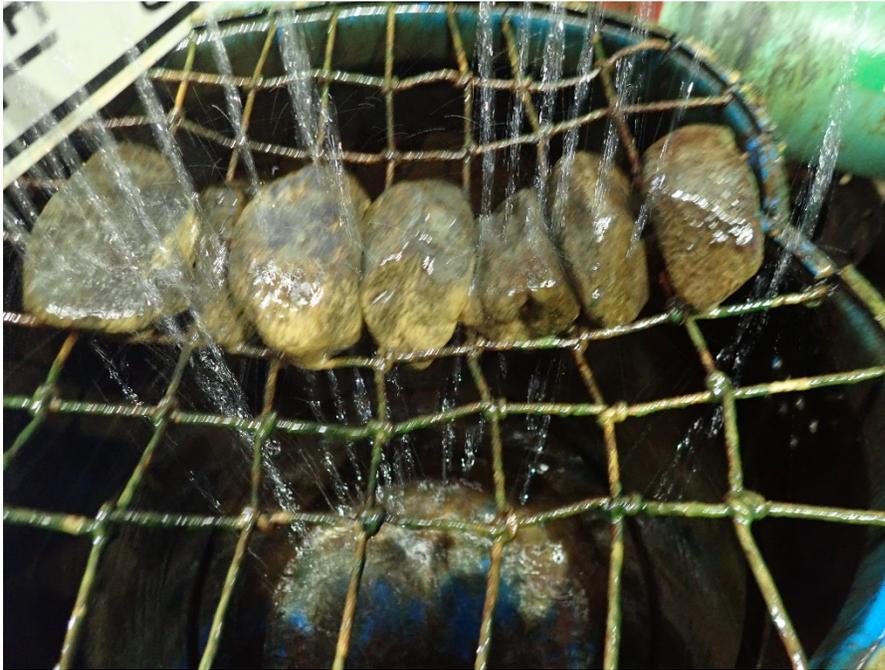
White material was not observed on the test rocks used for monitoring in the CWTP (Photo 7).

Photo 7. Test rocks used for monitoring white material.

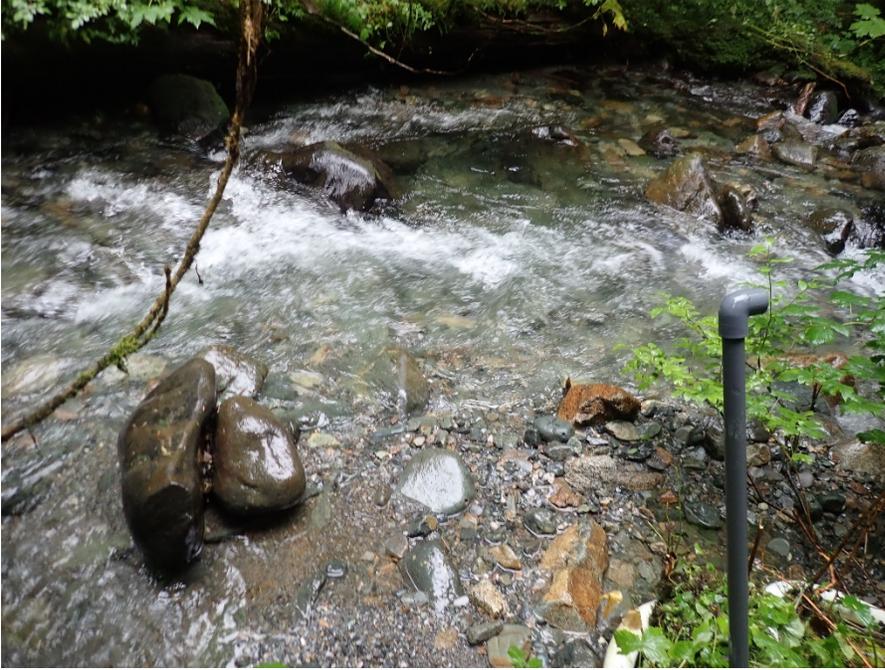
White material was not observed in Sherman Creek (Photo 8).

Photo 8. Sherman Creek (outfall 001).

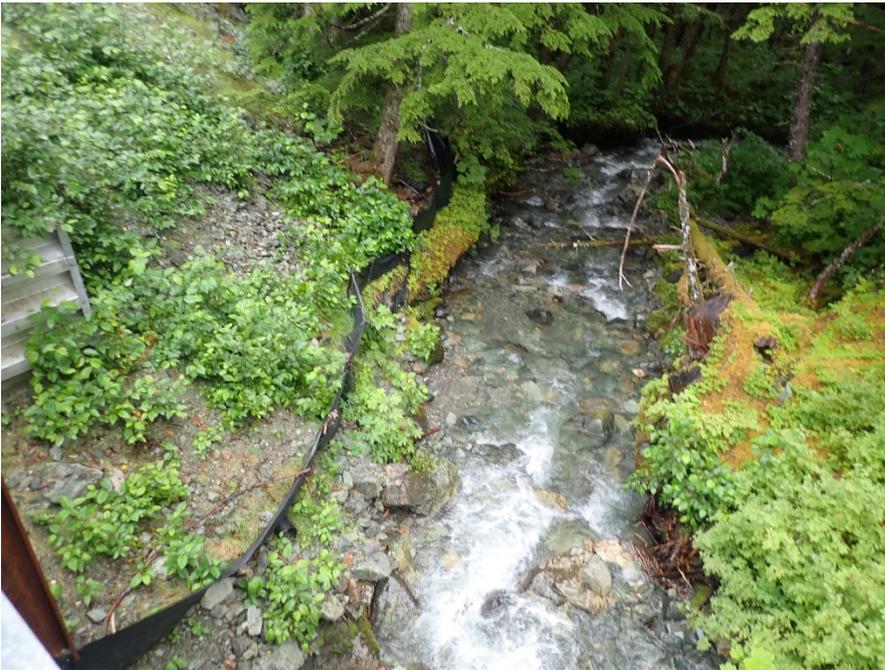
Surface Operations recently installed new silt fencing along the bridge abutments (Photo 9).

Photo 9. New silt fencing installed along the Sherman Creek Bridge abutments.

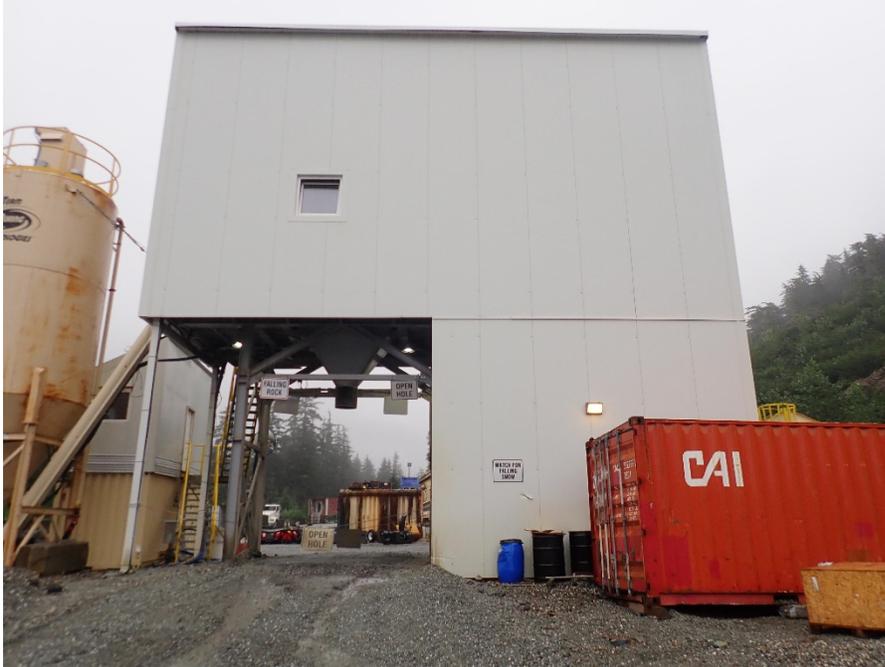
The pug plant was not operating at the time of inspection due to no available haul trucks to use that day (Photo 10).

Photo 10. Pug plant at Pit 4.

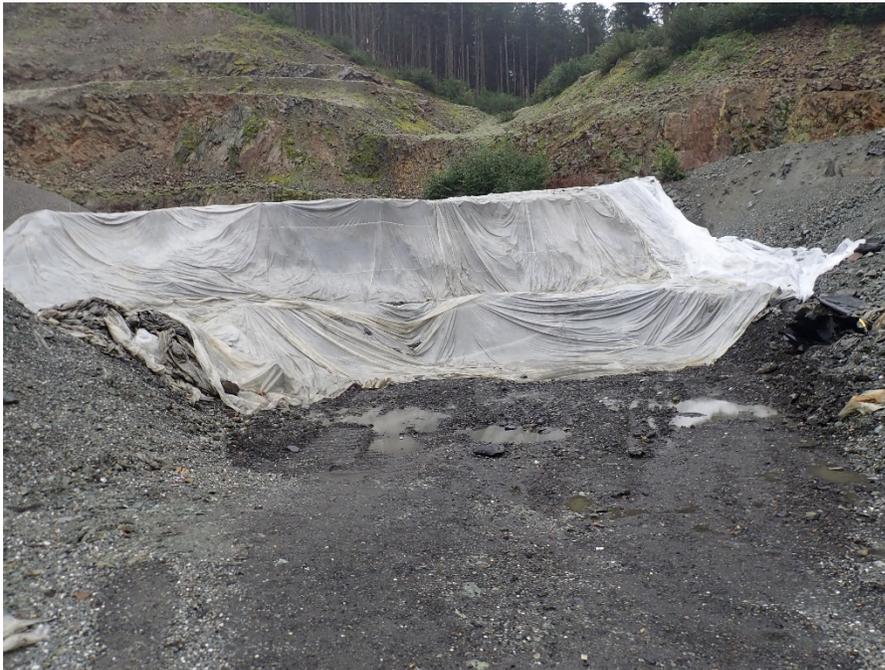
| ID | Action Item | Status |
|---|--|--|
| 182-2 | Graphitic phyllite stockpile at Pit 4 requires covering. | Resolved. The Stockpile is covered and protected from wind gusts (Photo 11). |

The graphitic phyllite (GP) pile (Photo 11) at Pit 4 was completely covered to prevent ARD generation.

Photo 11. The GP pile at Pit 4 is covered to prevent the potential ARD generation.

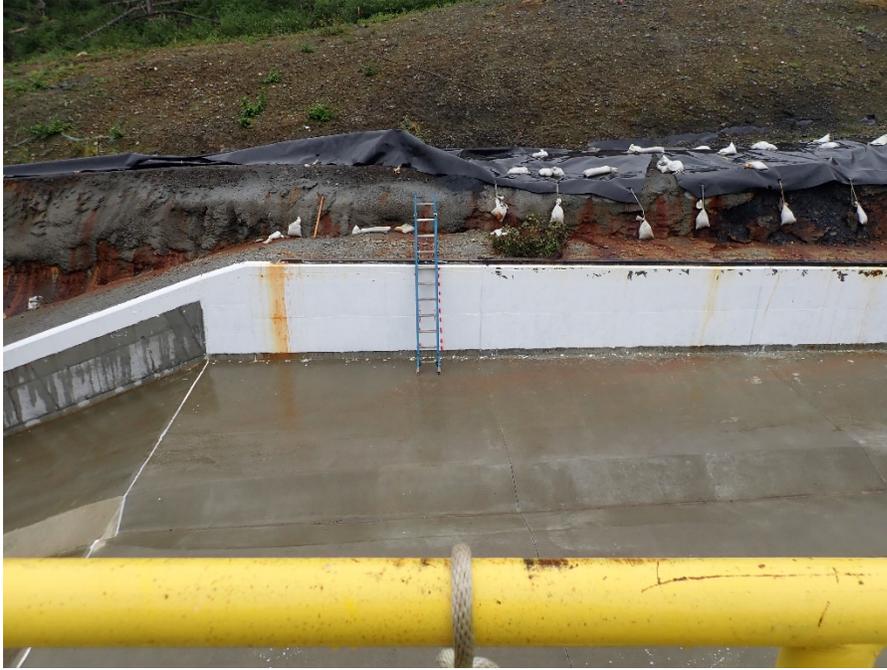
The TTF dam spillway was functioning as intended and free of debris (Photos 12-13).

Photo 12. TTF spillway wall.

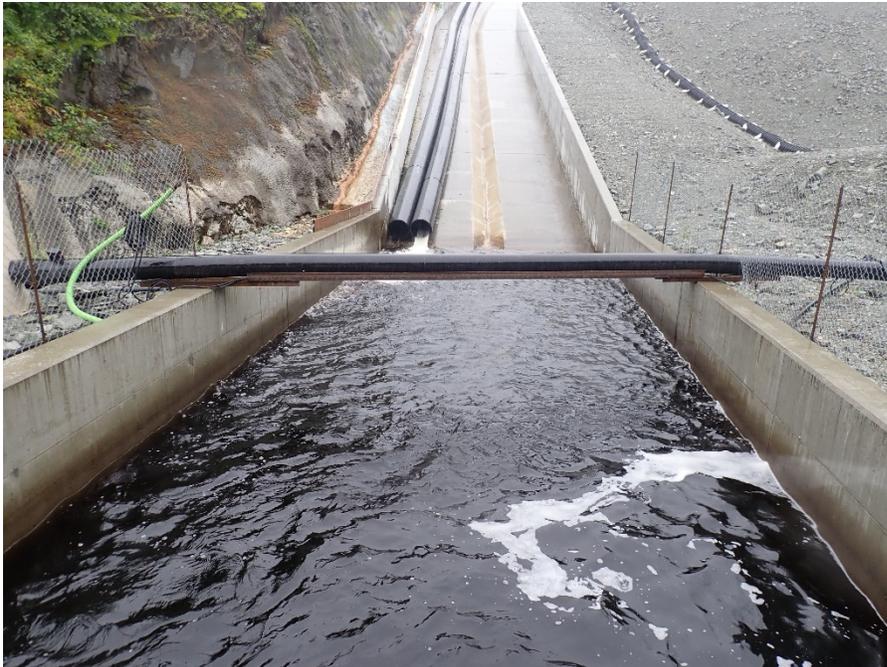
Photo 13. TTF spillway, Spillway plunge pool, and Upper Slate Lake (USL) bypass.

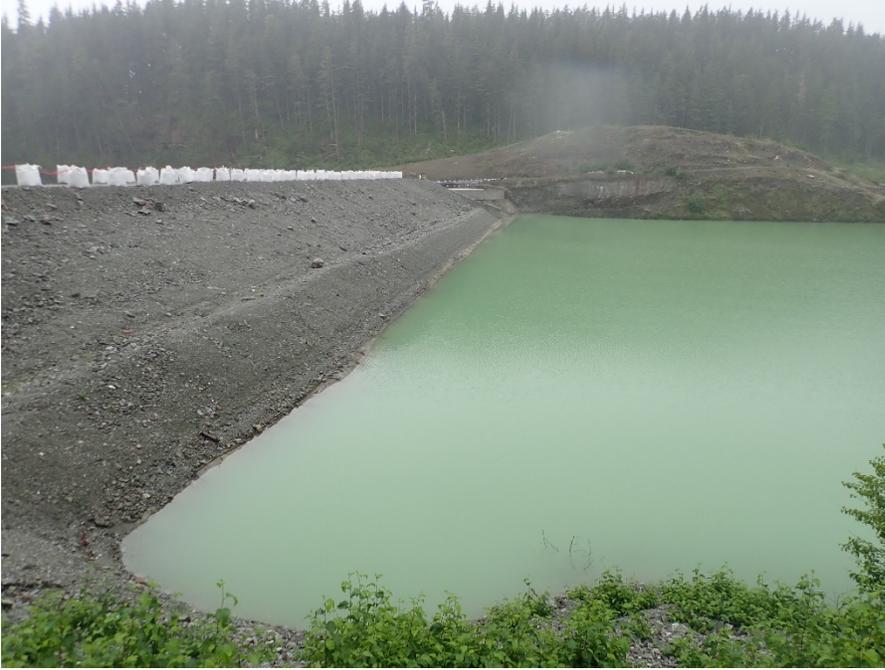
| ID | Action Item | Status |
|---|--|--|
| 183-3 | Remove log from face of TTF dam. | Resolved. The log has been removed from the dam's face (Photo 14). |

No debris was observed at the face of the TTF dam (Photo 14).

Photo 14. TTF Dam face. No debris touching the dam's face.

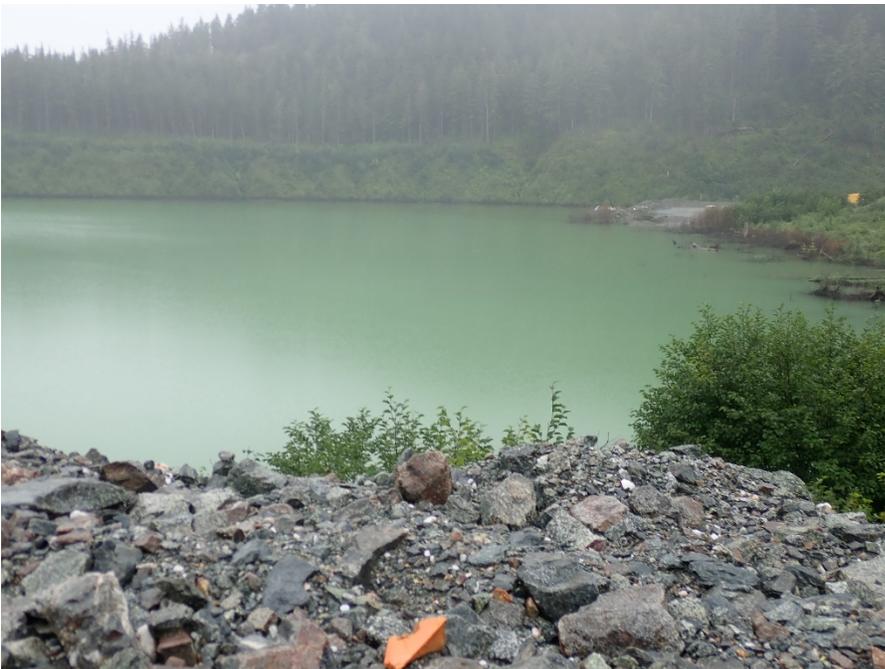
| ID | Action Item | Status |
|---|--|--|
| 183-1 | Investigate the light color spots within the TTF and 9-foot water cover. | Resolved. No light areas were observed. (Photo 15). |

During the inspection of this location. No light-colored spots were observed in the TTF (Photo 15). TTF personnel checked the northern TTF area for light spots. No light spots were found at the locations noted by the Forest Service in the previous inspection report. TTF personnel will be conducting a bathymetry survey in early September.

Photo 15. No light-colored spots were observed. Light color could indicate that tailings are not covered by 9-feet of water.

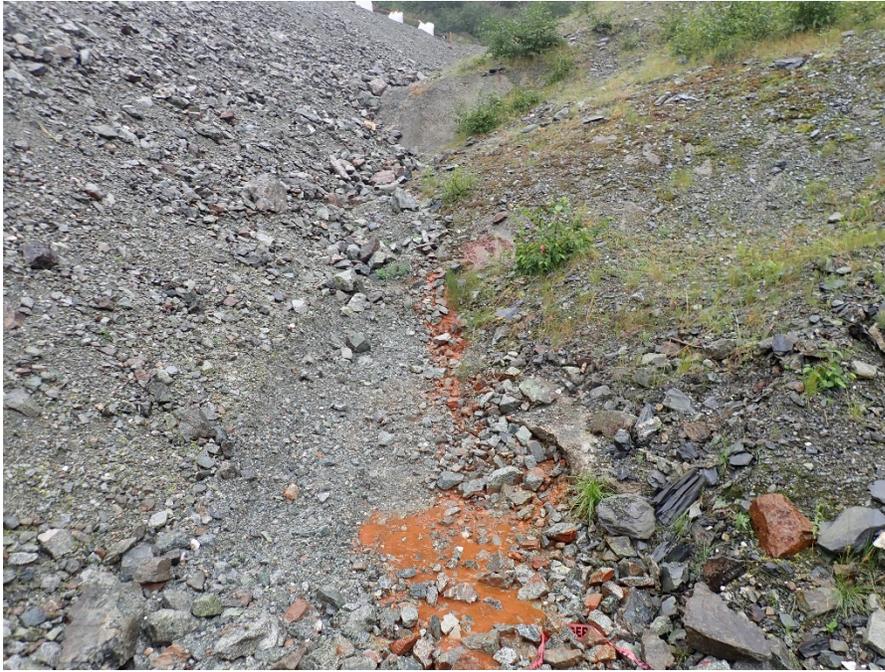
| ID | Action Item | Status |
|---|--|--|
| 183-2 | ARD at the TTF SE abutment. | Pending. Once the application of concrete is completed at the TTF spillway wall, the contractors will |

| | | apply concrete to the SE abutment. |

Photo 16. ARD seepage observed below the dam. The source is from a partially exposed outcrop of graphitic phyllite (GP).

The acid rock drainage (ARD) observed below the dam will be covered with shotcrete once contractors finish the TTF spillway wall work (Photo 16). This area is contoured so that any potential ARD seepage will flow directly into an ARD sump.

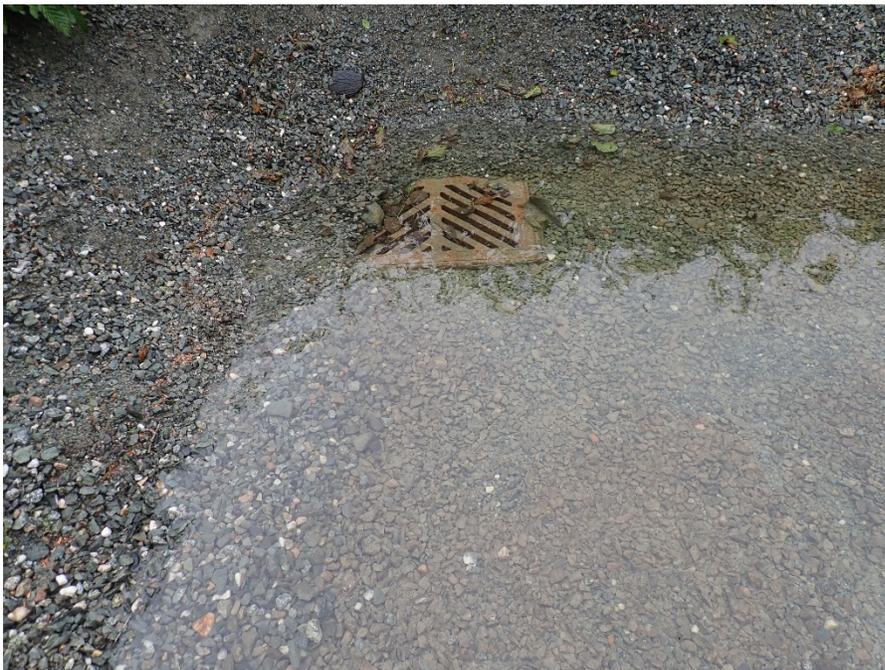
The fuel depot and re-fueling pad were in good condition and free of spills (Photos 17-18).

Photo 17. No fuel sheen was observed inside the fuel depot pad.

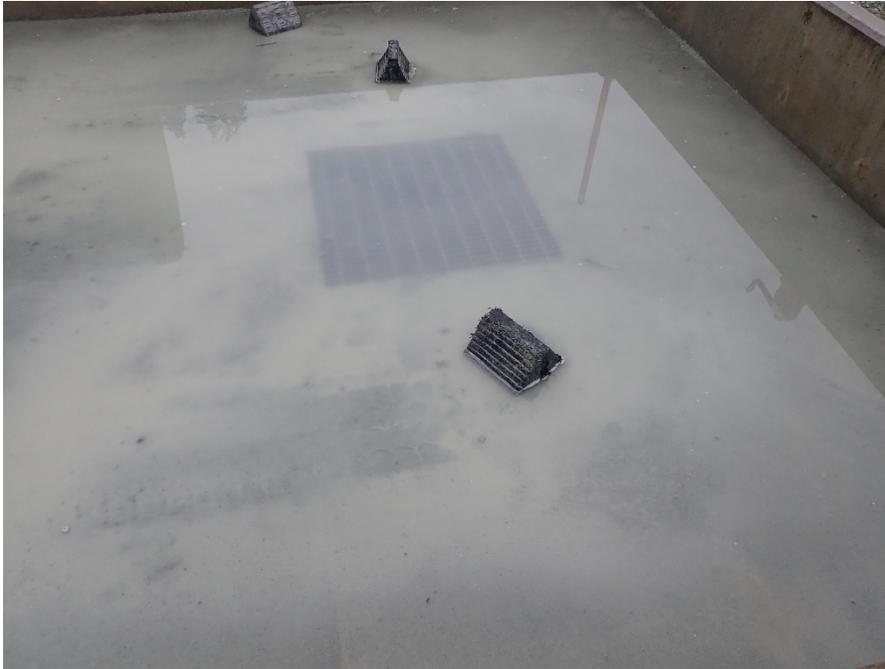
Photo 18. There were no signs of leaks at the refueling pad.
