## INSPECTION REPORT: KENSINGTON GOLD MINE

Date of Inspection: Thursday, November 18, 2021  
Date of Report: Tuesday, December 12, 2021  
USDA Forest Service Inspector: Casey Loofbourrow

Sites visited during the inspection included: access roads, Comet Development Pile, Comet Water Treatment Plant (CWTP), Sherman Creek Outfall 001, Pit 4, the Tailings Treatment Facility (TTF) area, the Slate Cover marine facility, and the Fuel Depot.

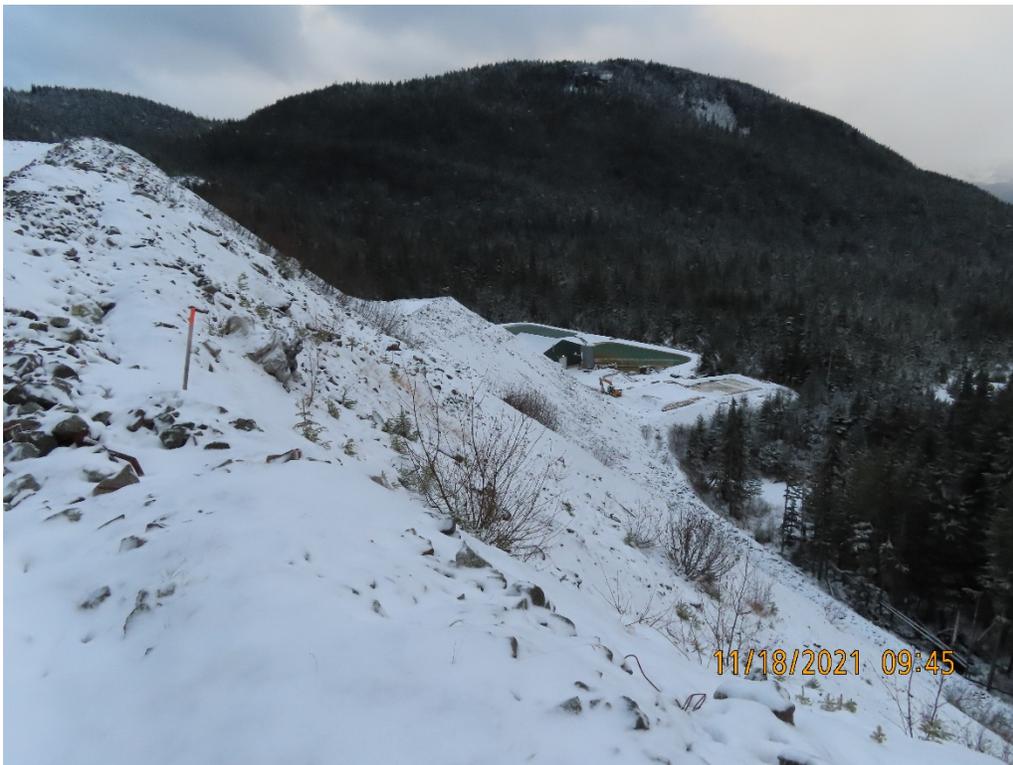
The slopes of the Comet waste rock storage area appear stable (Photos 1-2).

**Photo 1. Comet Waste Rock Stockpile from above.**

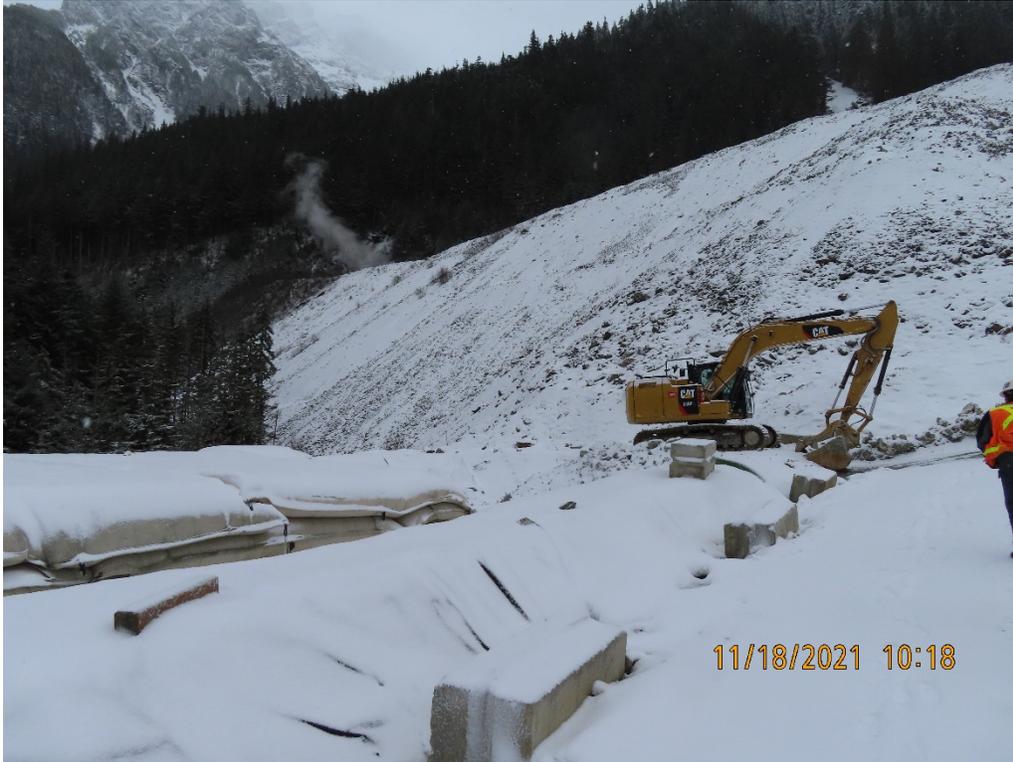
**Photo 2. Comet Waste Rock Stockpile from below.**

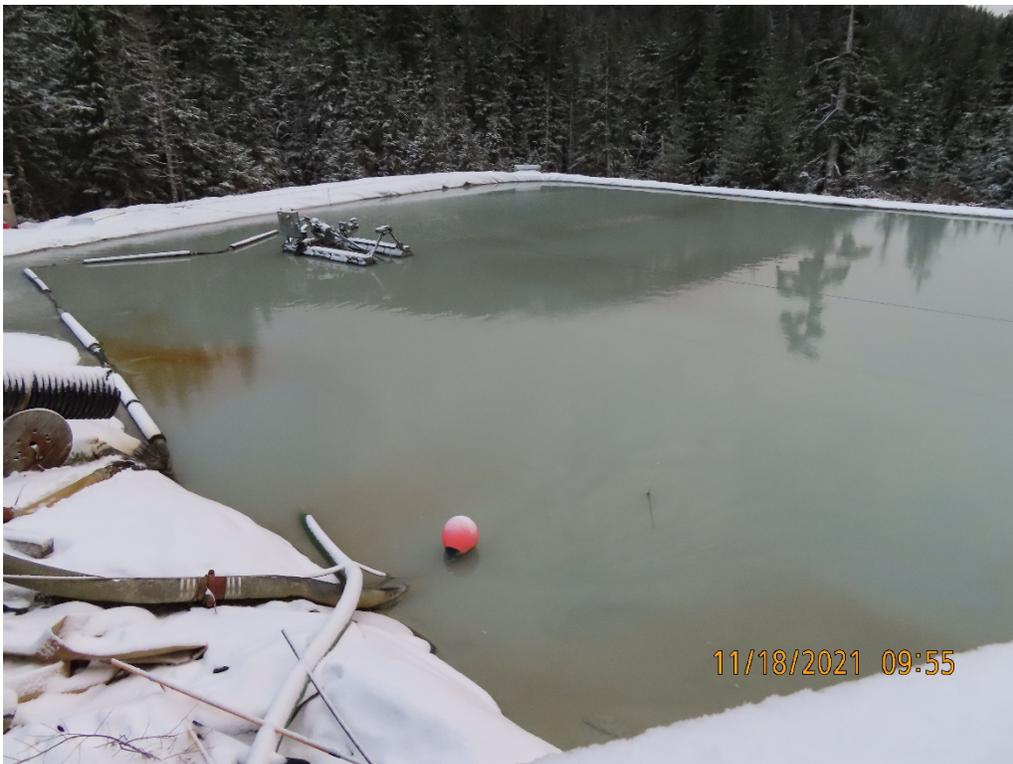
The CWTP was treating approximately 1976 gallons per minute (gpm). Ponds 1 and 2 were receiving mine site water and functioning as intended (Photos 3-4). The mobile water treatment plant (CWTP plant 2.5) has been idled and winterized (Photo 5).

**Photo 3. Comet Water Treatment Plant Pond 1.**

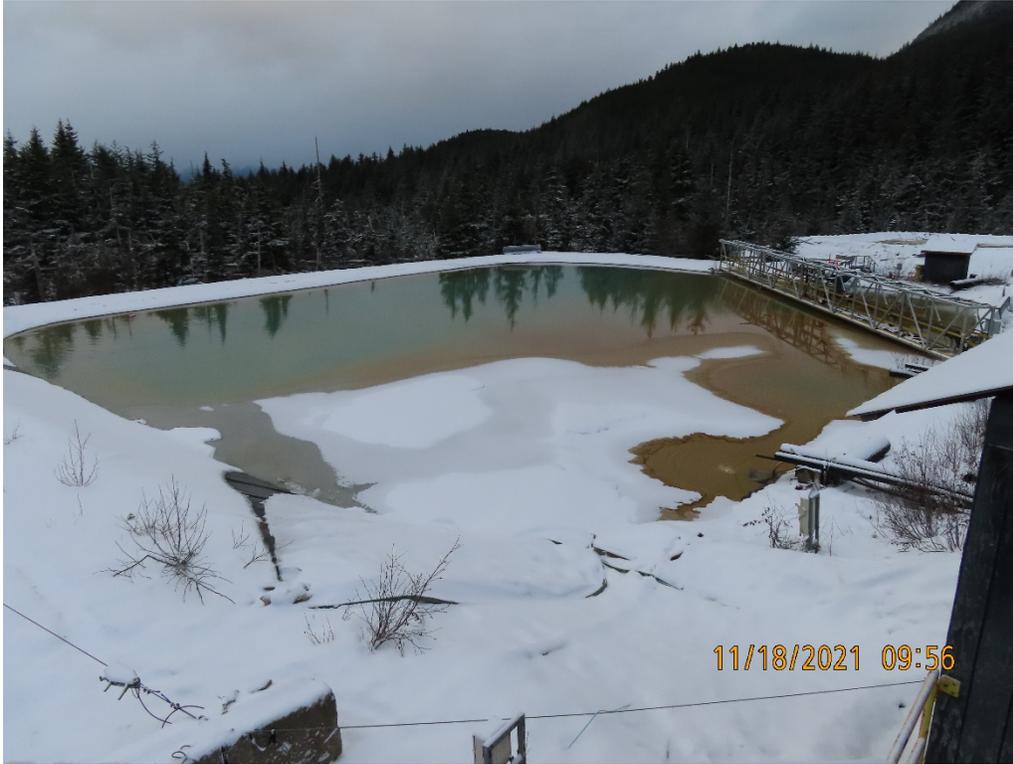
**Photo 4. Comet Water Treatment Plant Pond 2.**

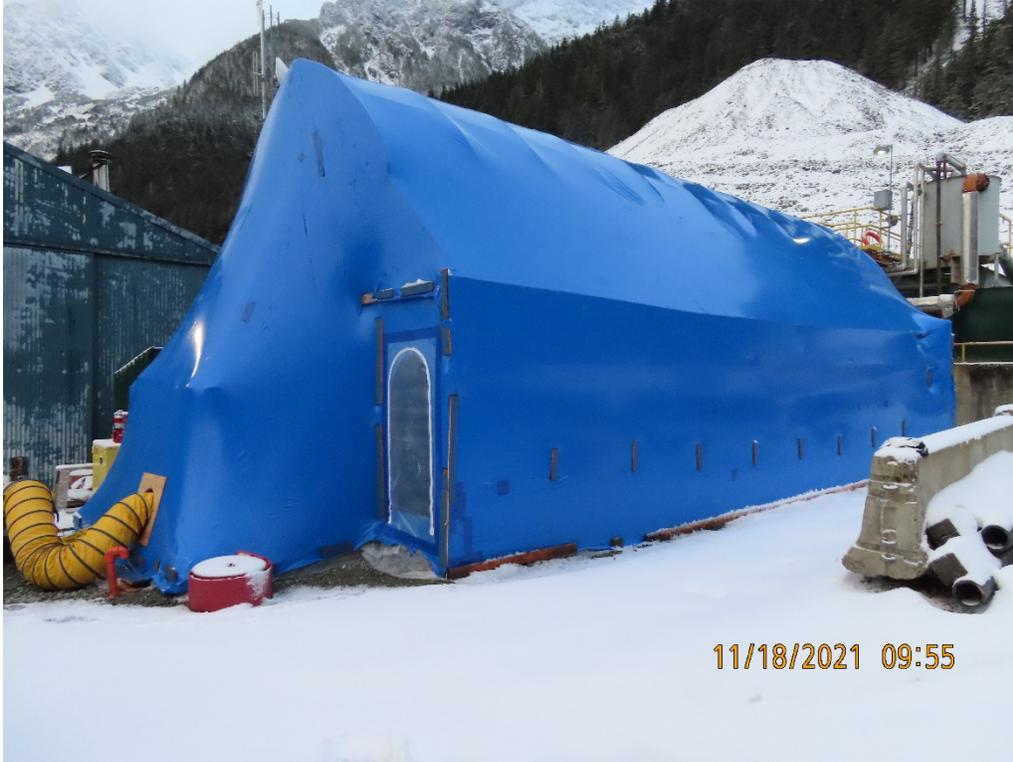
**Photo 5. Comet Water Treatment Plant 2.5.**

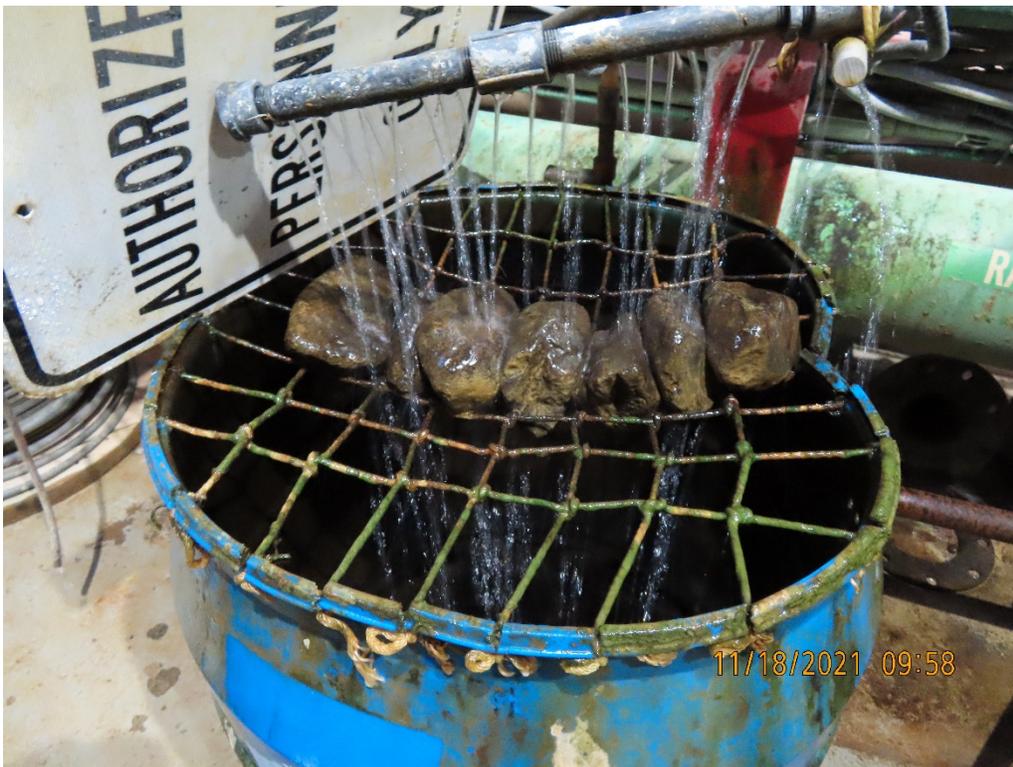
White material was not observed on the test rocks used for monitoring in the CWTP (Photo 6).

**Photo 6. Test rocks in the Comet WTP used for monitoring for white material.**

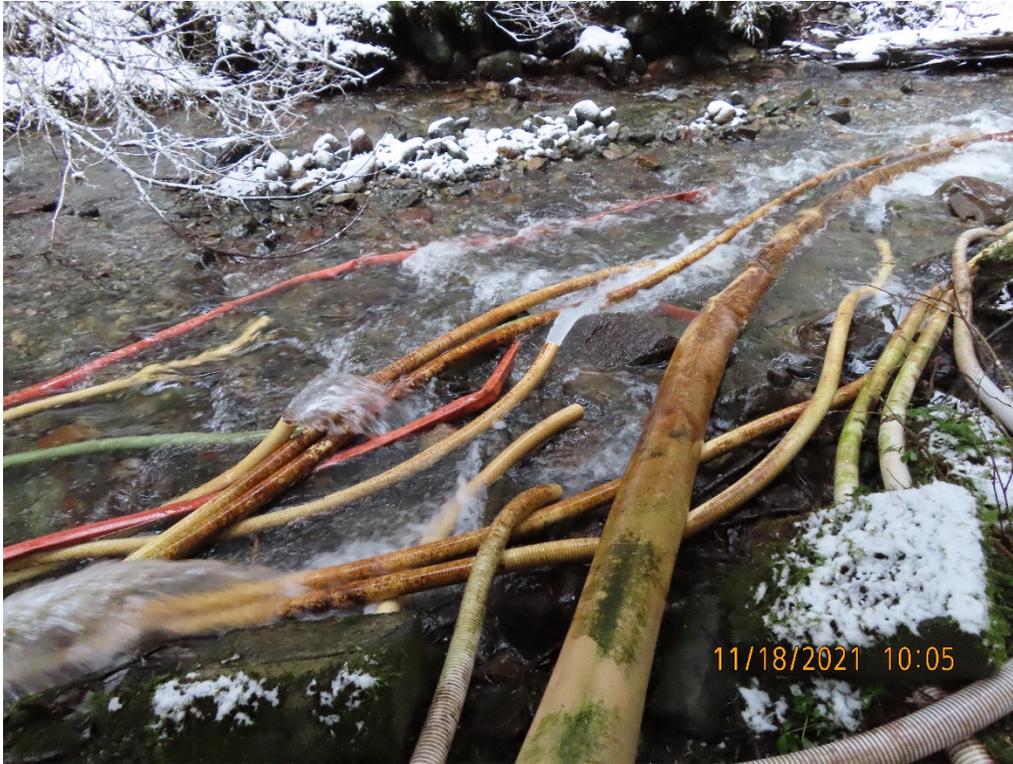
White material was not observed in Sherman Creek at Outfall 001 (Photo 7).

**Photo 7. Sherman Creek Outfall 001.**

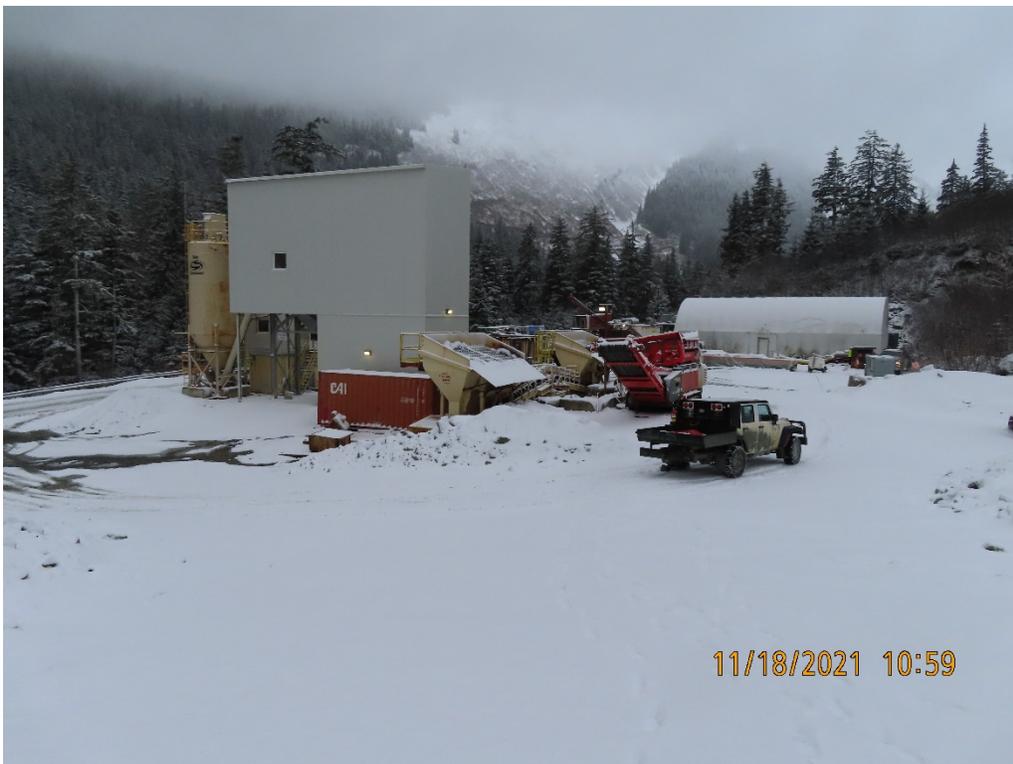
The pug plant has ceased operation for the winter (Photo 8). Exploration drilling is currently being performed at this location on patented land (Photo 9).

**Photo 8. Idle Pug Plant at Pit 4.**

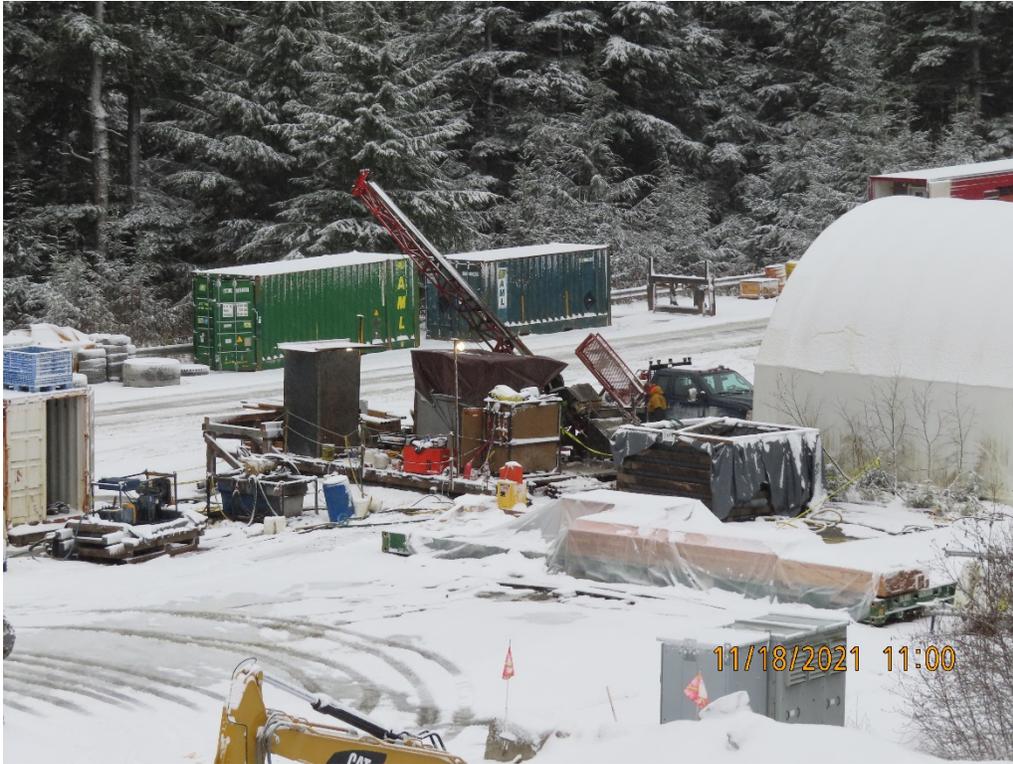
**Photo 9. Drill Rig adjacent to Pug Plant performing exploration diamond core drilling.**

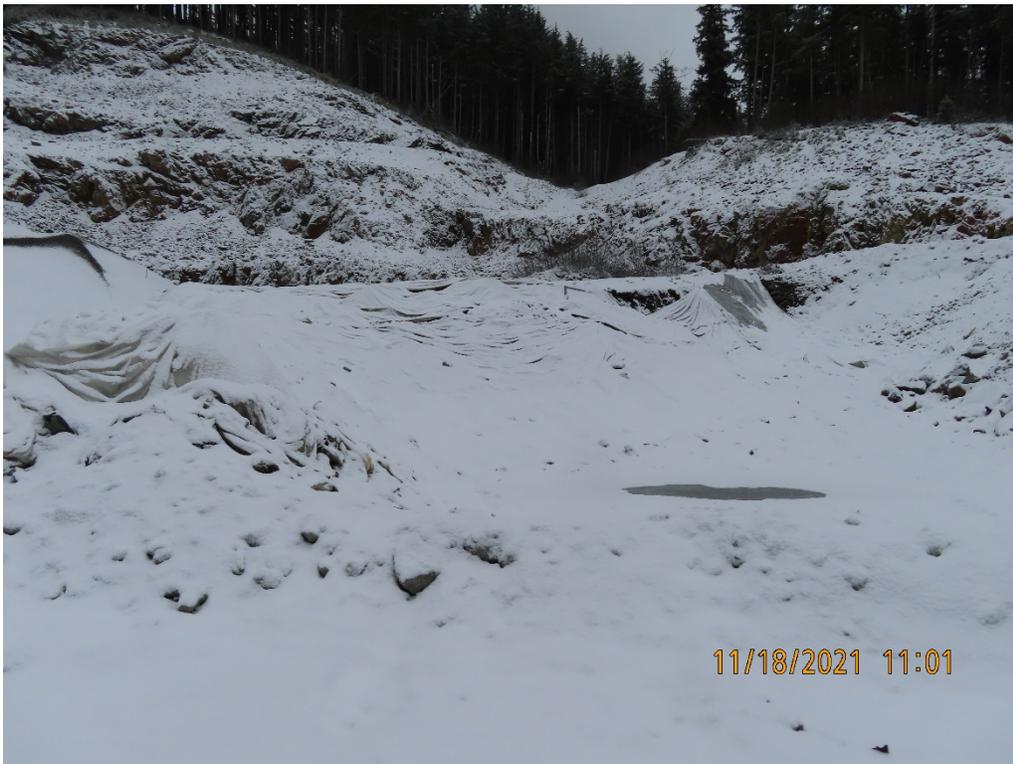
**185-1:** The graphitic phyllite (GP) stockpile at Pit 4 was not adequately covered to prevent rainwater infiltration and potential ARD generation.

**New action item 185-1:** The graphitic phyllite (GP) stockpile at Pit 4 was not adequately covered to prevent rainwater infiltration and potential ARD generation (Photo 10).

**Photo 10. Graphitic phyllite stockpile at Pit 4.**

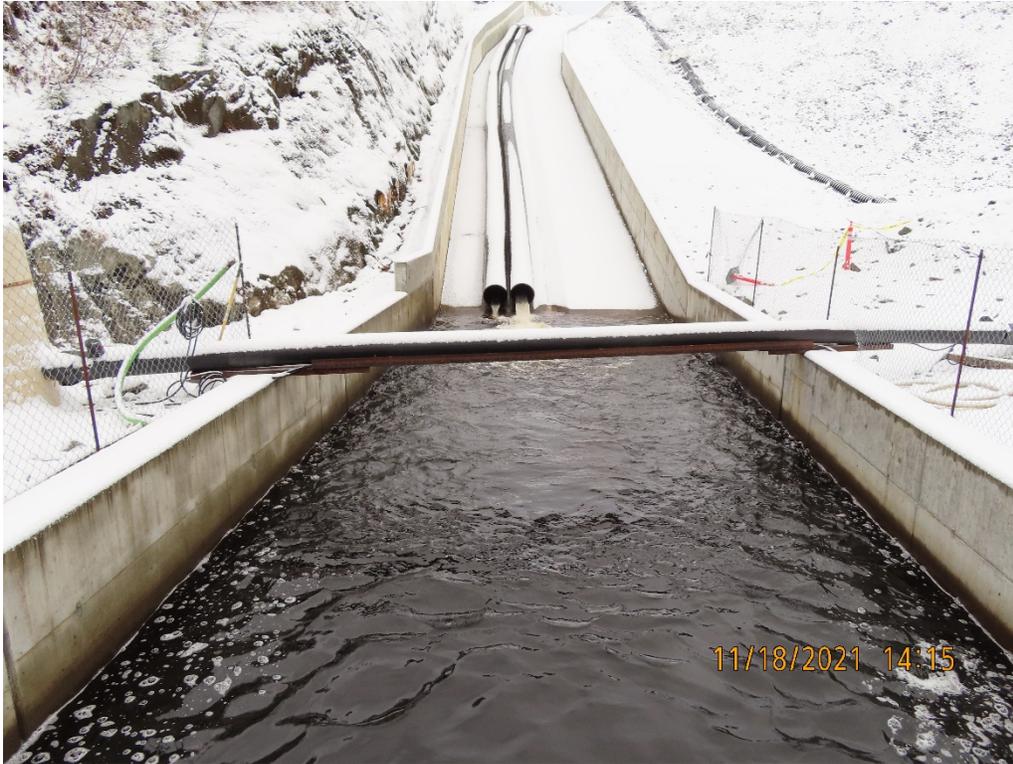
The TTF dam spillway was in good condition and free of debris (Photos 11).

**Photo 11. Spillway and diversion pipeline outfall.**

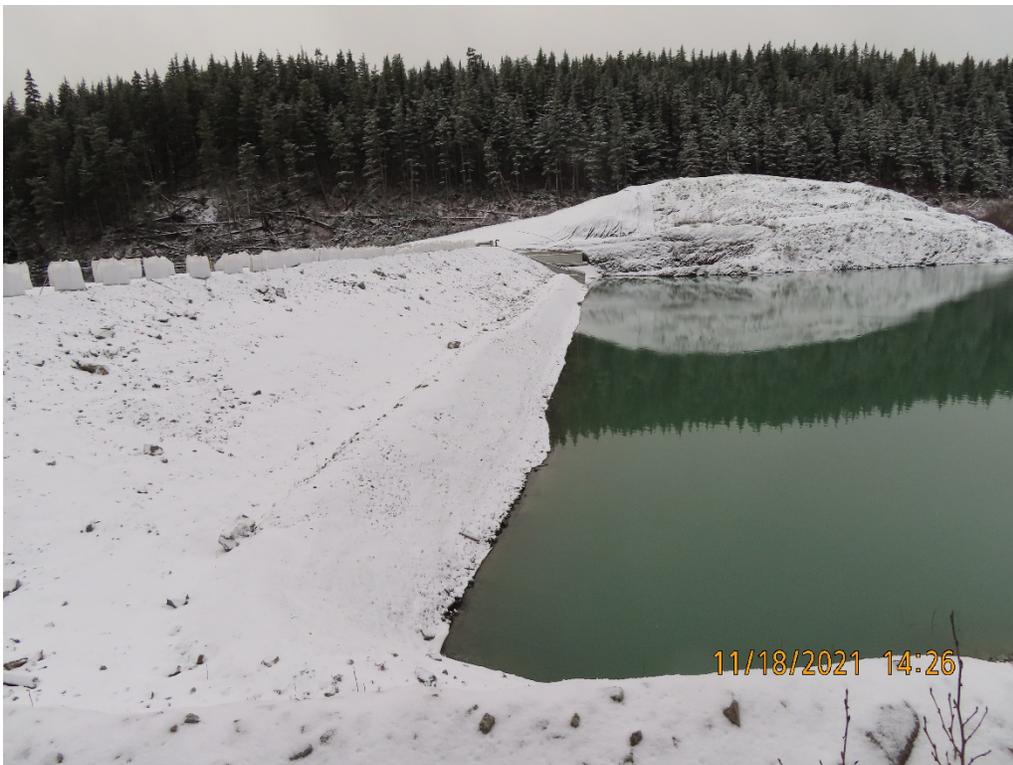
No debris was observed against the face of the TTF dam (Photo 12).

**Photo 12. Face of TTF Dam free of debris.**

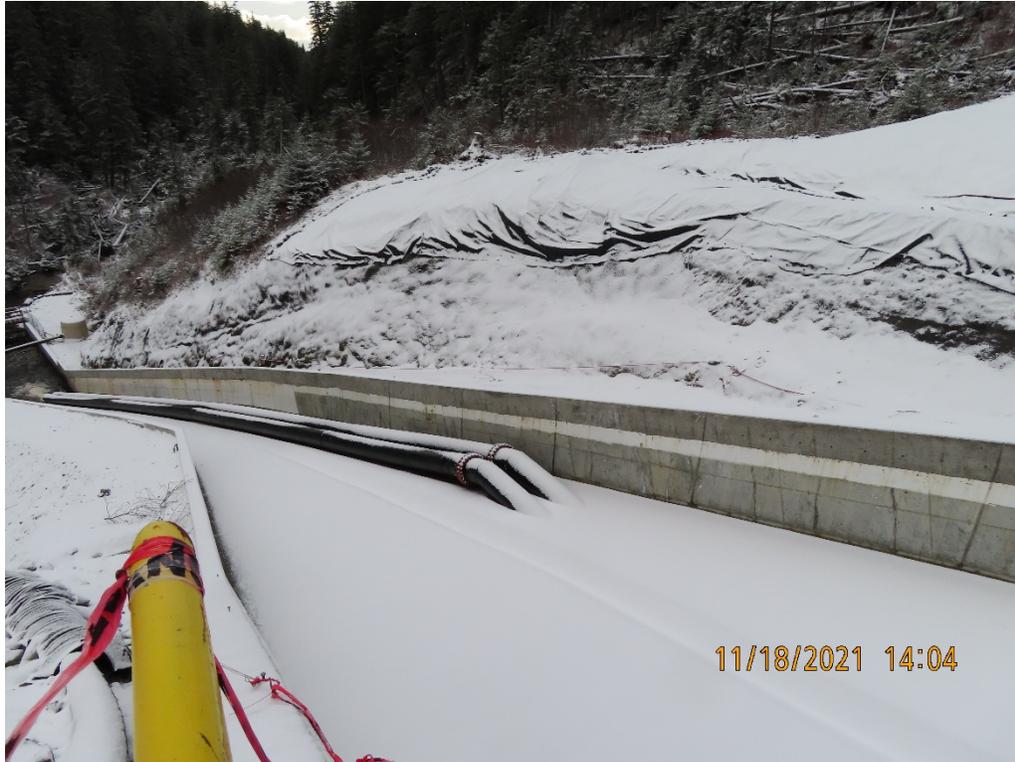
Contractors have completed construction of a two-foot concrete raise above the spillway (Photo 13). The bedrock at this location is ARD-generating graphitic phyllite, and the purpose of the raise is to prevent ARD from entering the spillway. Contact and seep water from the graphitic phyllite will be diverted to the sump at the base of the dam where it is collected and pumped to the Seep Treatment Plant. Coeur plans to install a handrail along the new raise to facilitate safe inspection and maintenance. Additionally, an impermeable liner has been installed over the exposed graphitic phyllite to reduce precipitation infiltration and ARD generation (Photo 13).

**Photo 13. Two foot raise along spillway (darker colored above white painted concrete) and liner above graphitic phyllite outcrop.**

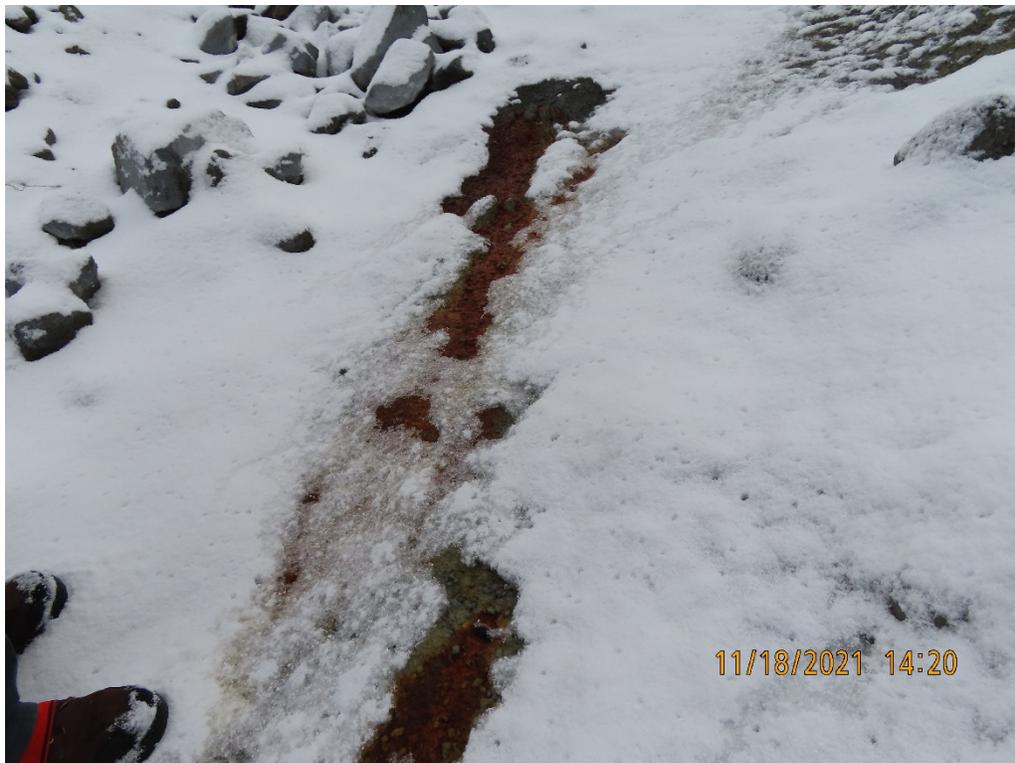
ID	Action Item	Status
183-2	ARD seepage at the TTF SE abutment.	<b>Pending.</b> Shotcrete was applied to this area, but visible ARD seepage was occurring at the time of inspection (Photo 14). Coeur will reapply shotcrete when conditions allow.

**Pending action item 183-2:** The ARD seep observed below the TTF dam in the previous two inspections was covered with shotcrete. However, ARD seepage continues and will require additional application of shotcrete (Photo 14). Coeur tested the water at this seep and found it to be slightly acidic and containing metals. The application of shotcrete is performed out of an abundance of caution; the seep

collection sump at the base of the dam is designed to capture water that includes this seep, where it is transported to the Seep Treatment Plant.

**Photo 14. ARD seep below east side of TTF Dam.**

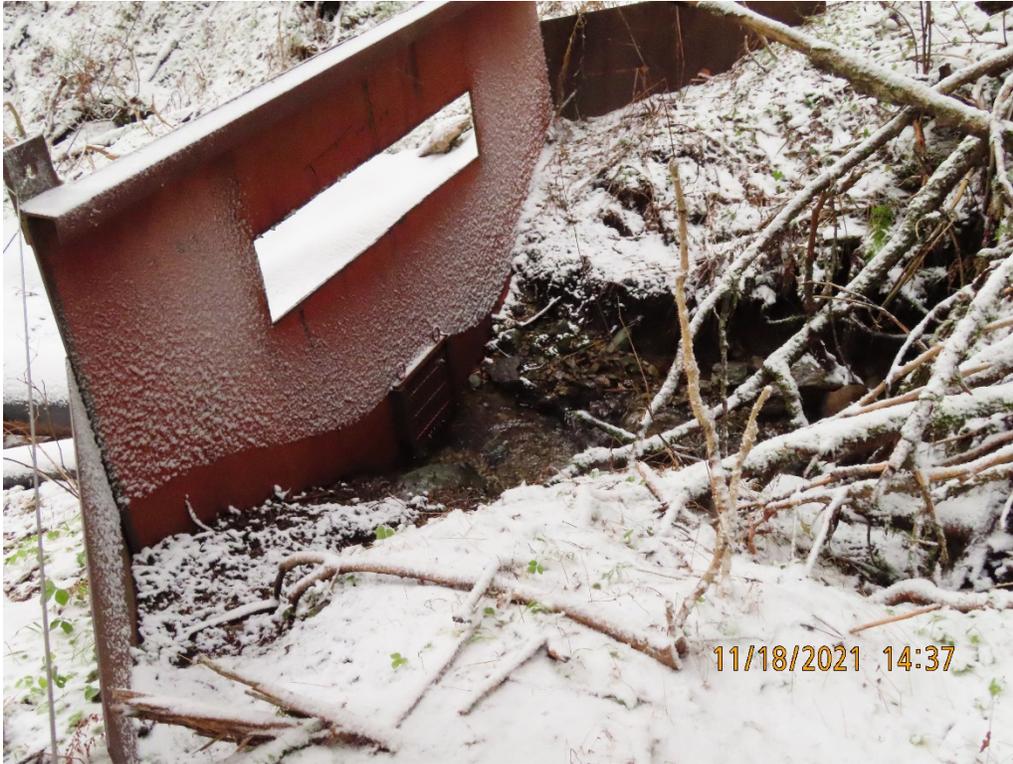
The structures that capture flow from the two small drainages that feed the Northwest Diversion Pipeline were inspected and found to be operating effectively and capturing flow (Photos 15-16).

**Photo 15. Northwest drainage diversion structure.**

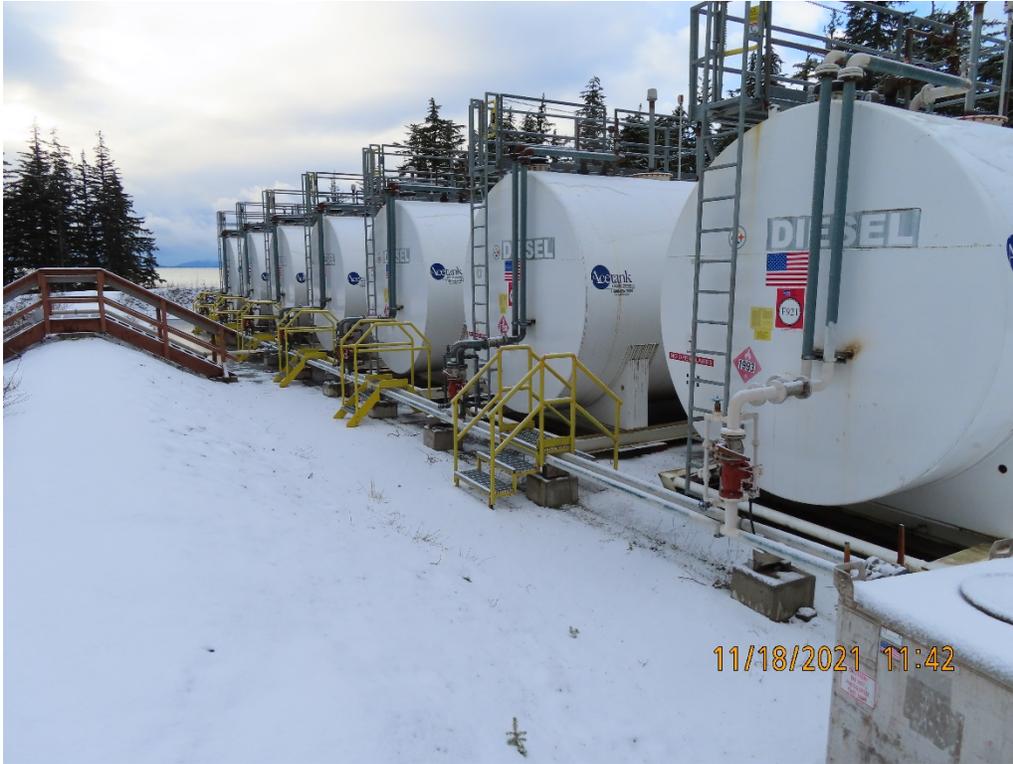
The fuel depot and re-fueling pad were in good condition and free of spills (Photos 17-18).

**Photo 17. Fuel Depot**

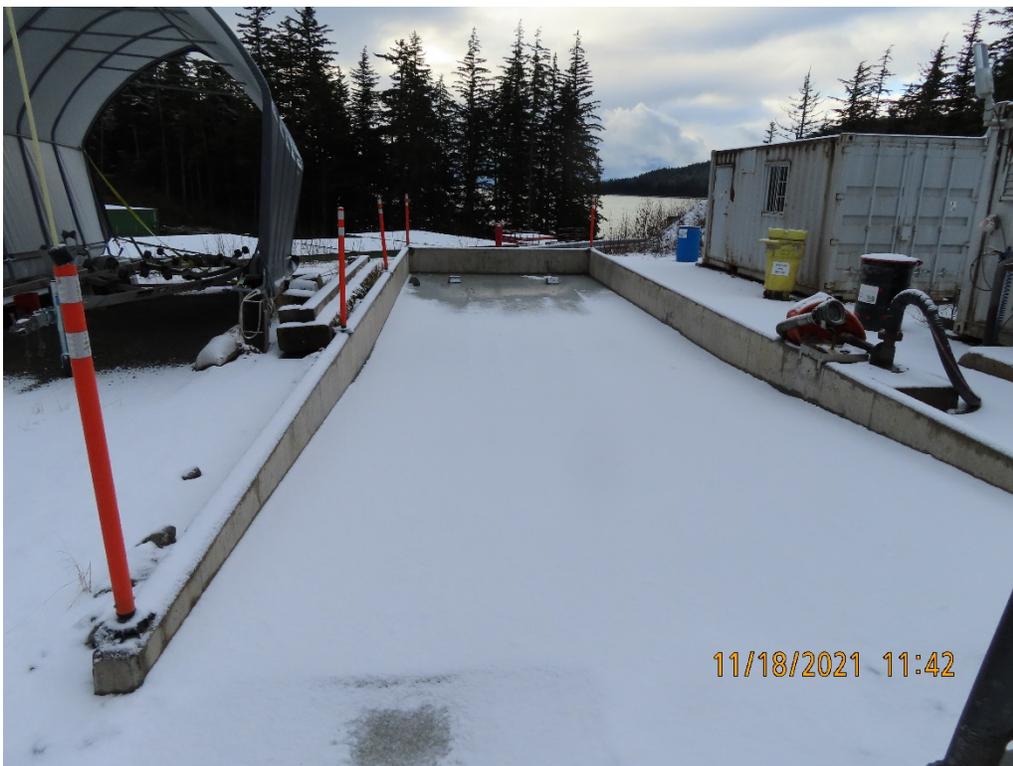
**Photo 18. Refueling pad.**

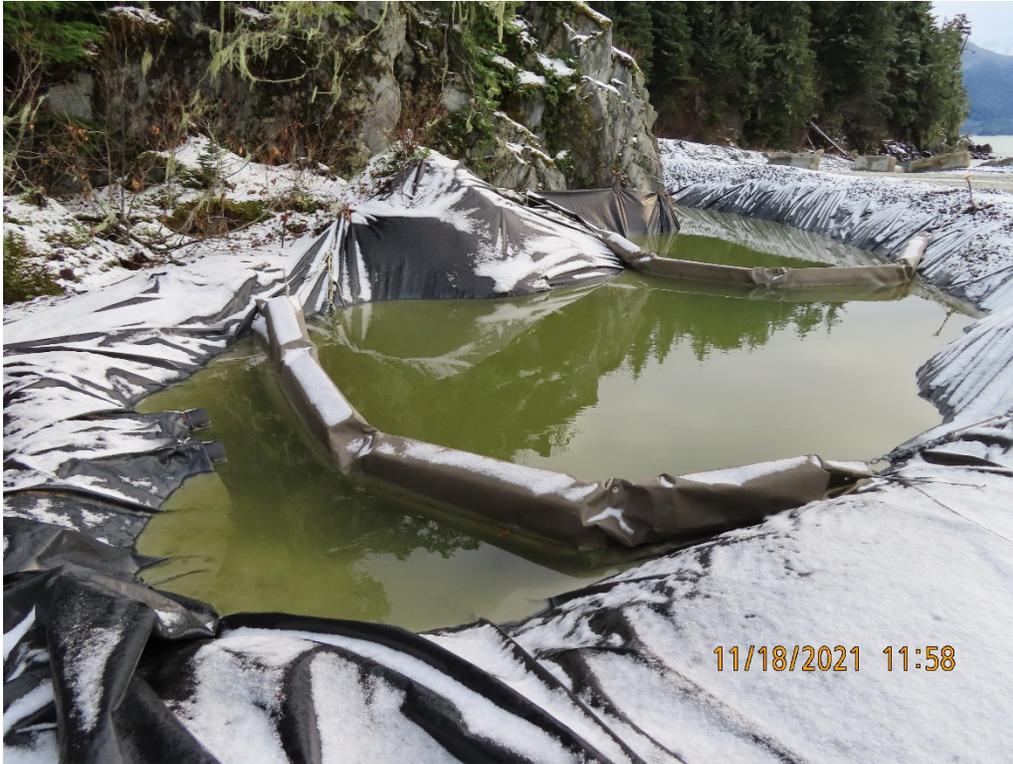
The sediment sumps at the marine facility appeared to be functioning as intended and preventing sediment release to Slate Cove (Photo 19). “Floc Blocks” are being used at this location (Photo 20). These are blocks of flocculant that slowly release into the water and facilitate the settling of very fine sediment particles.

**Photo 19. Sediment ponds adjacent to dock facility.**

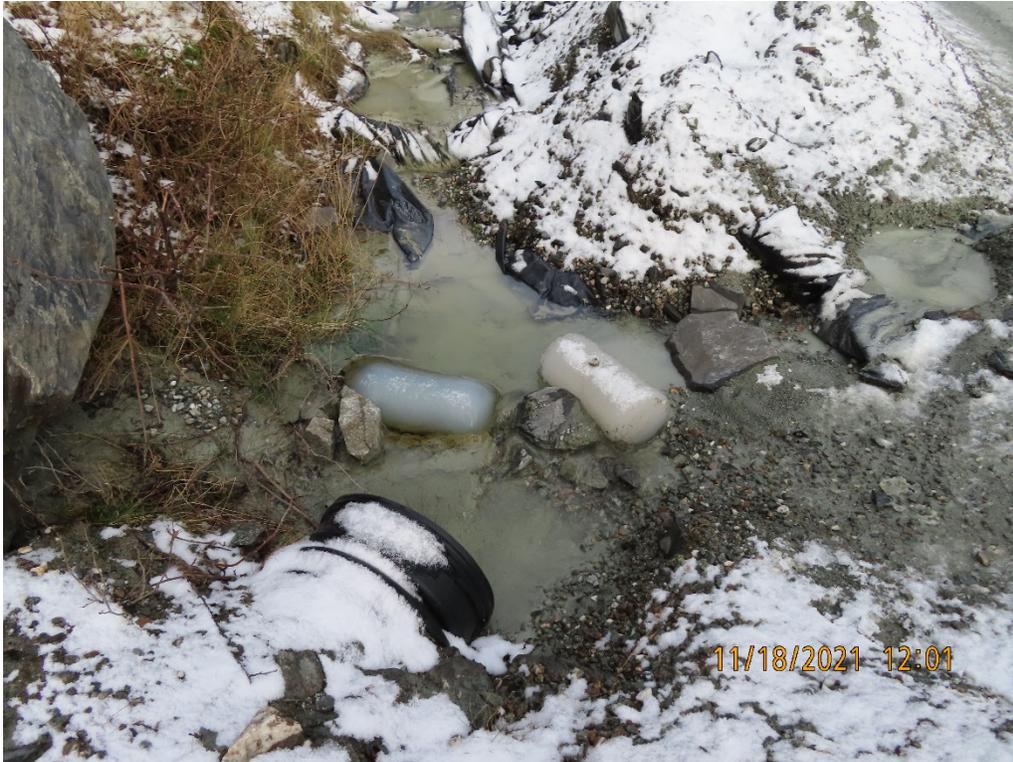
**Photo 20. Slow-release flocculant blocks used to facilitate fine sediment settling.**
