INSPECTION REPORT: KENSINGTON GOLD MINE

Tongass National Forest Minerals Group
8510 Mendenhall Loop Rd
Juneau, AK 99801
(907) 789-6276 – office
(907) 586-8808 – fax

Date of Inspection: Wednesday, August 24, 2022
Date of Report: September 7, 2022
USDA Forest Service Inspector: Casey Loofbourrow

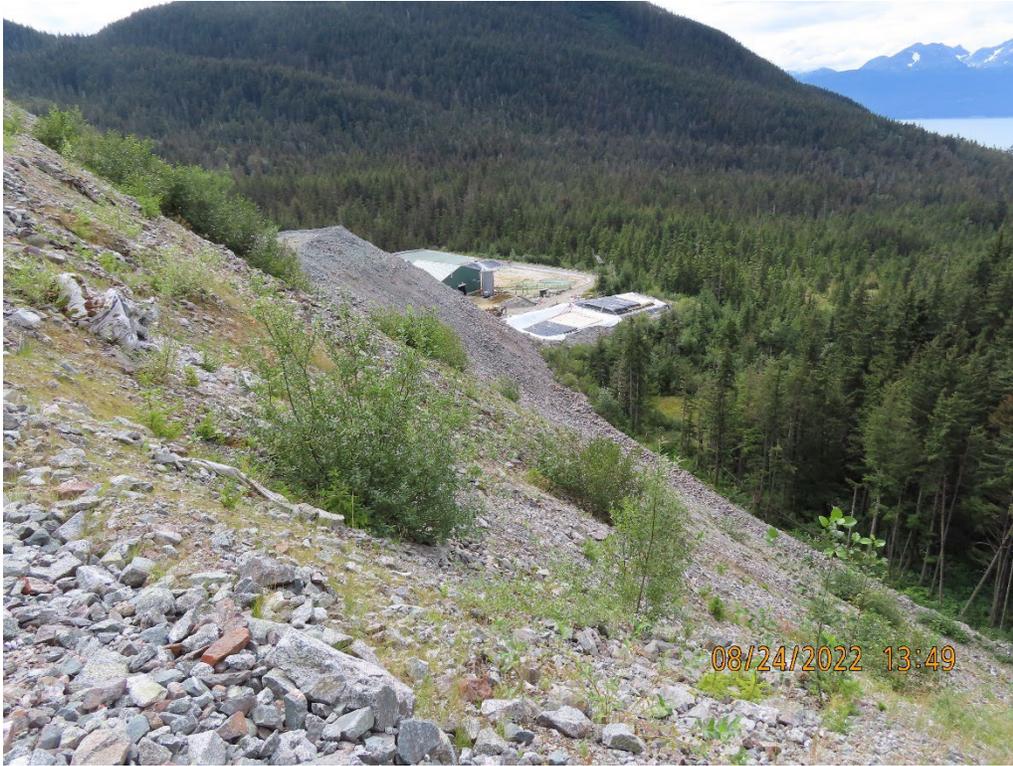
The slopes of the Comet waste rock storage area appeared stable (Photo 1). There has been no recent waste rock placement at this site.

Photo 1. Comet waste rock storage area.

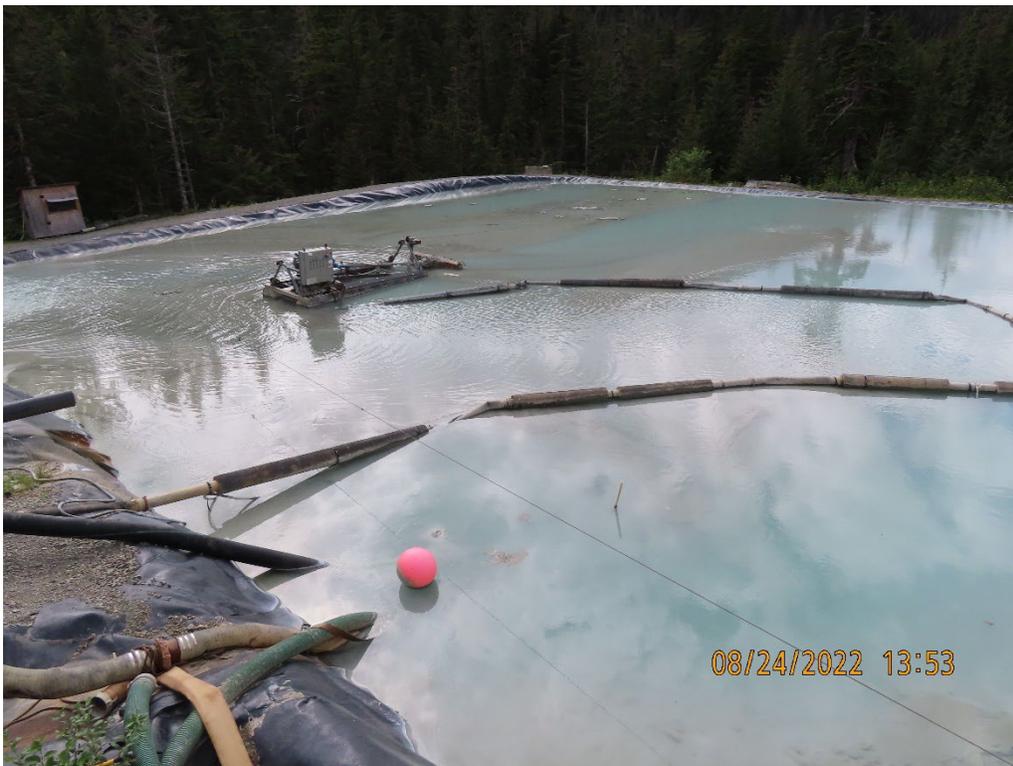
The CWTP treatment rate was approximately 2600 gpm. A dredge was located in Pond 1 (Photo 2), and Pond 2 had been largely emptied of water to assess the sediment quantity and the potential need for additional dredging (Photo 3).

Photo 2. Comet Water Treatment Plant (CWTP) Pond 1.

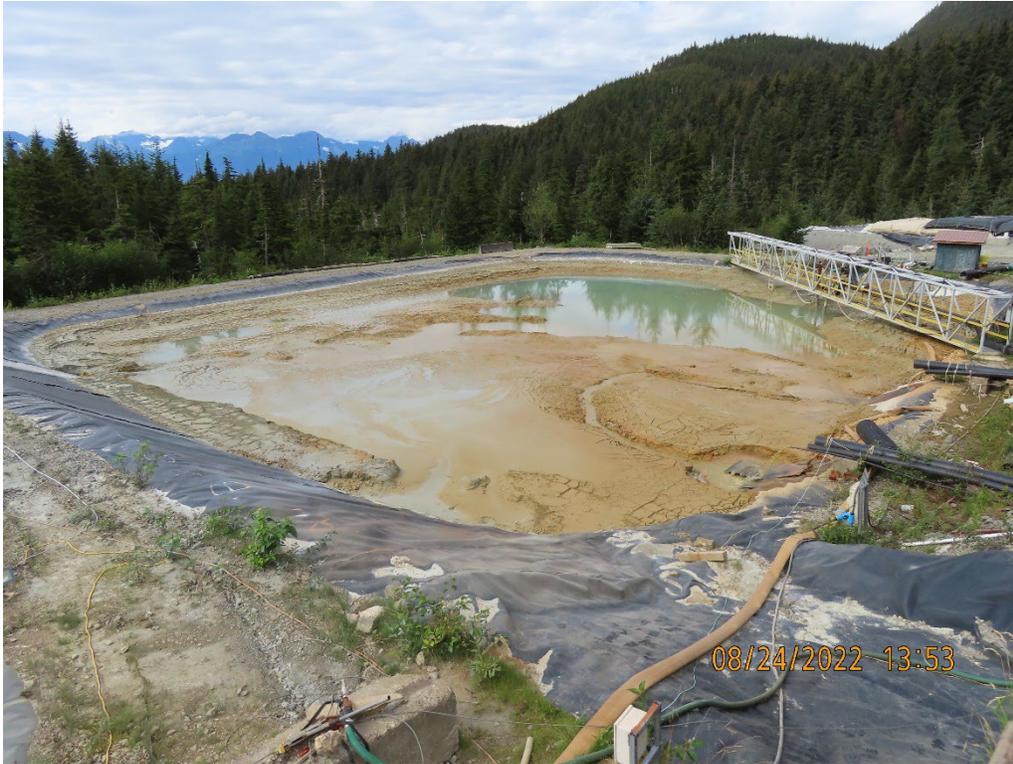
Photo 3. CWTP Pond 2.

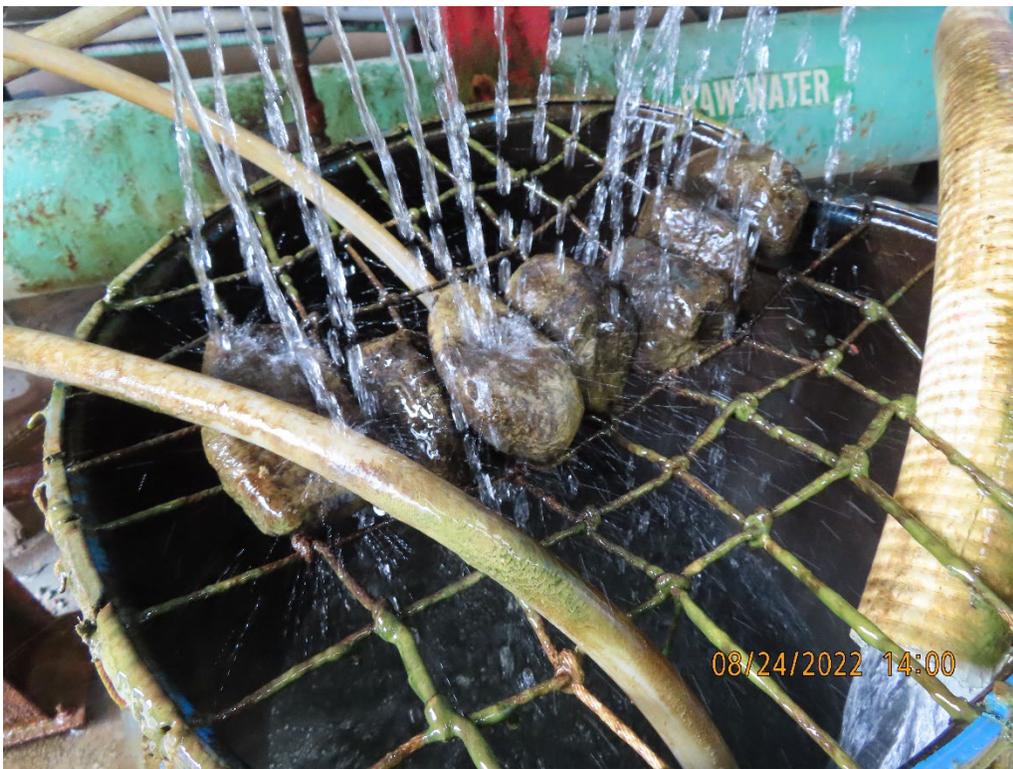
White material was not observed on the test rocks used for monitoring in the CWTP (Photo 4).

Photo 4. CWTP white material test rocks.

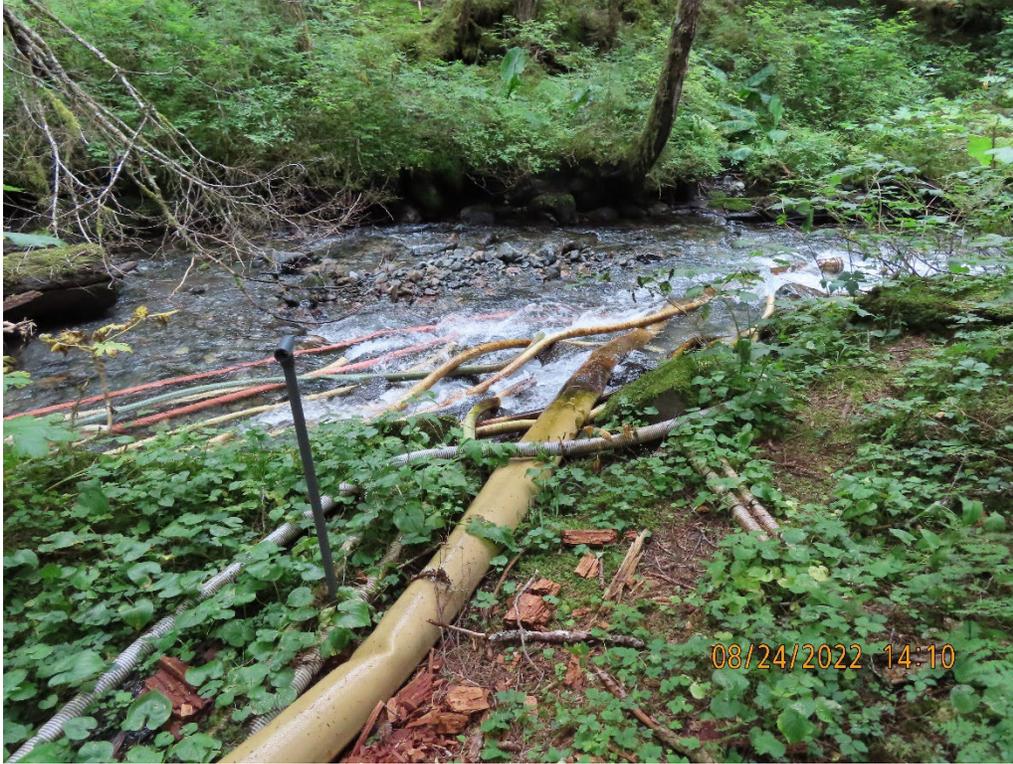
No white material was observed at Outfall 001, where treated water from the CWTP is discharged (Photo 5).

Photo 5. Sherman Creek Outfall 001.

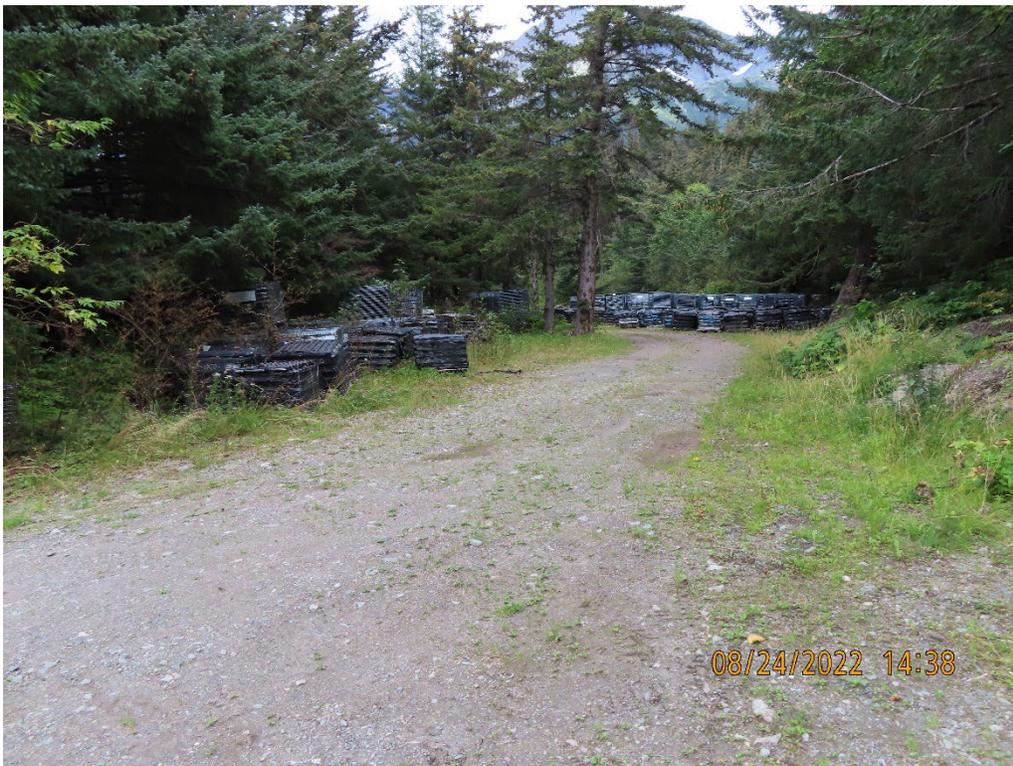
The core storage area at the Comet Beach was in orderly condition (Photo 6).

Photo 6. Comet Beach core storage area.

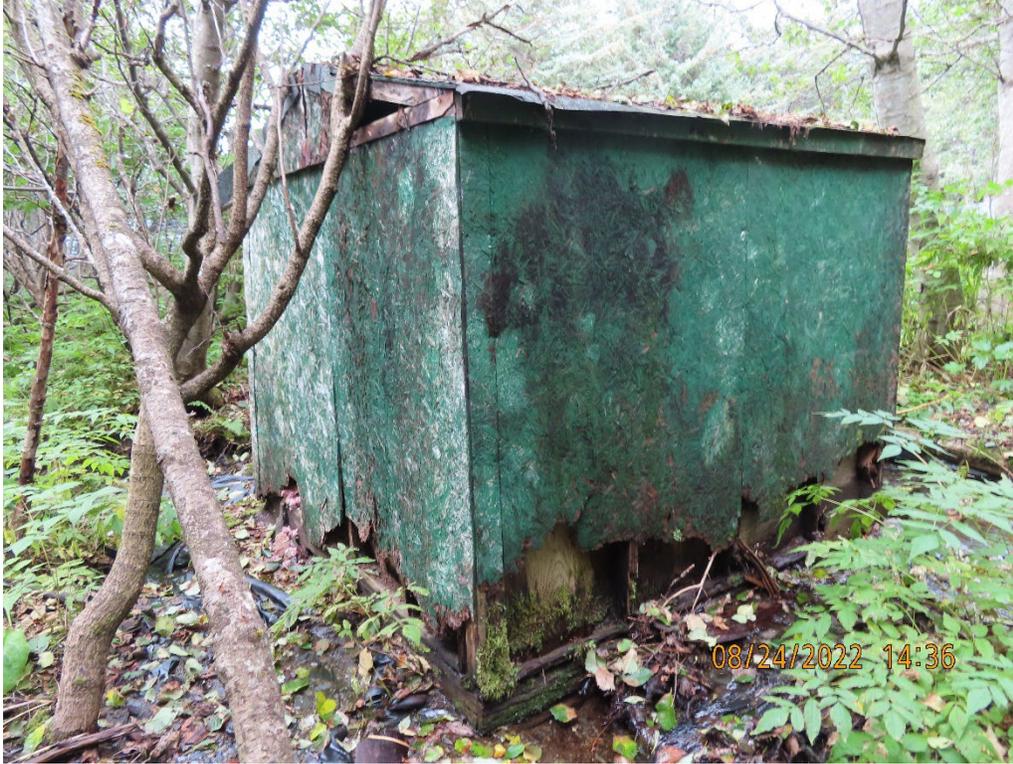
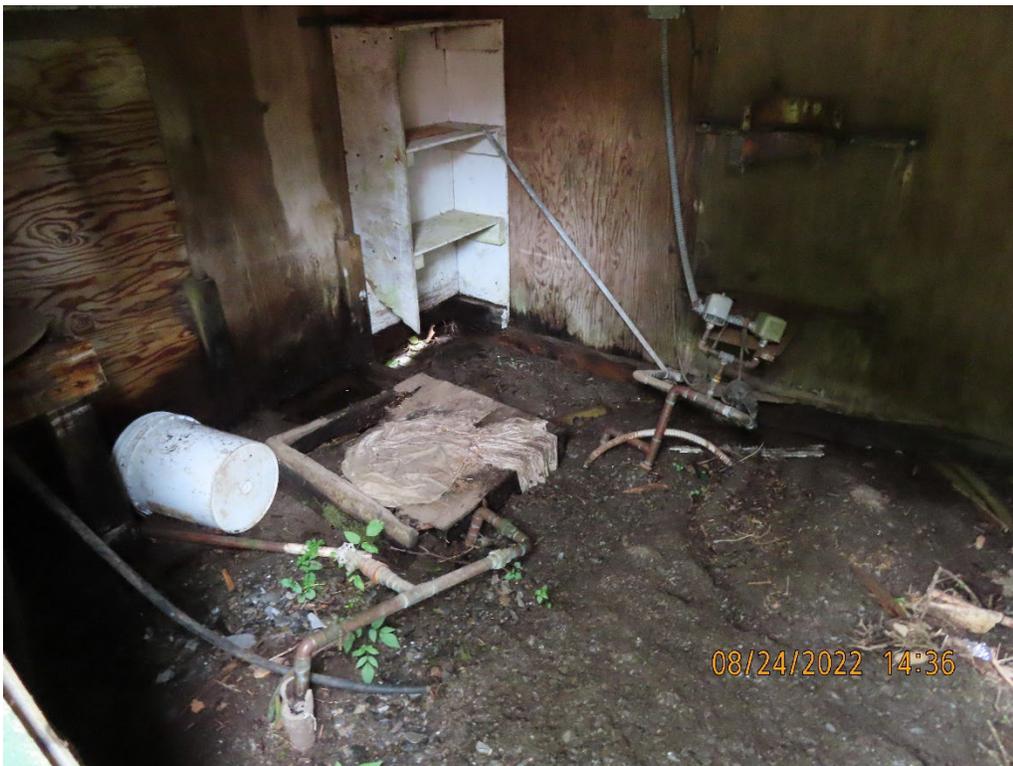
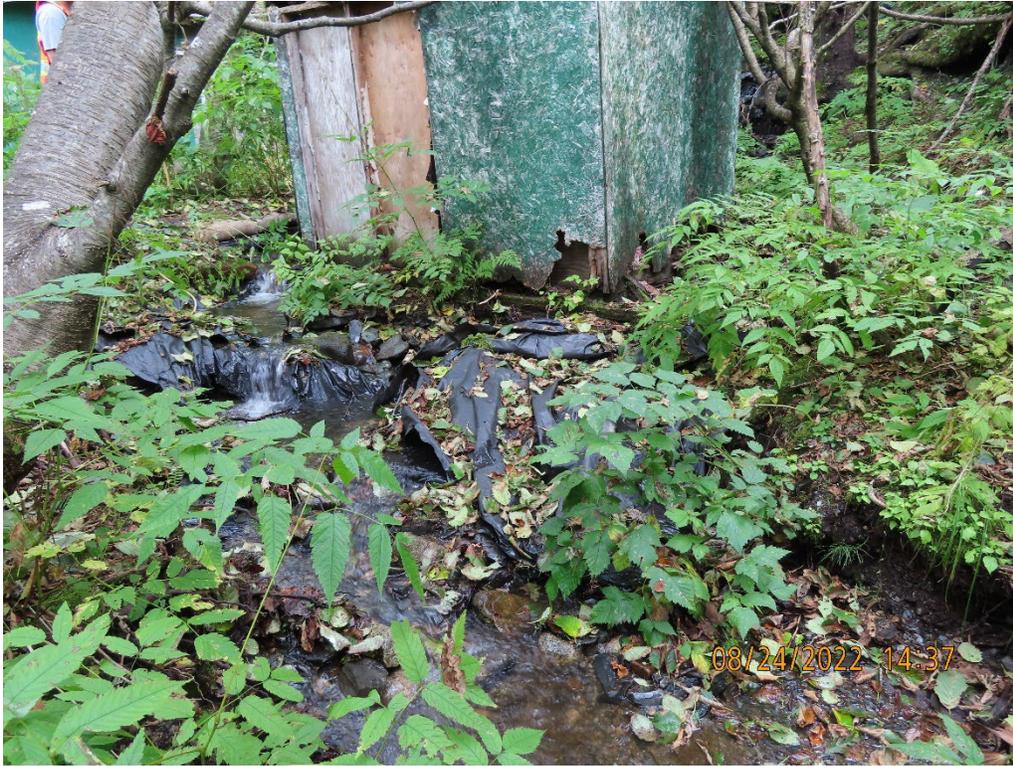
A disused water intake structure present within the stream channel of an unnamed fish-bearing creek by the historic cabin near the south extent of the Comet Beach facilities was documented (Photos 7-9). This structure has been recommended for removal by USFS aquatics staff to improve fish passage. Mr. Strow estimates the structure is no more than 30 years old. A USFS archaeologist will determine whether the structure may be removed.

Photo 7. Disused water intake structure on unnamed stream near Comet Beach.

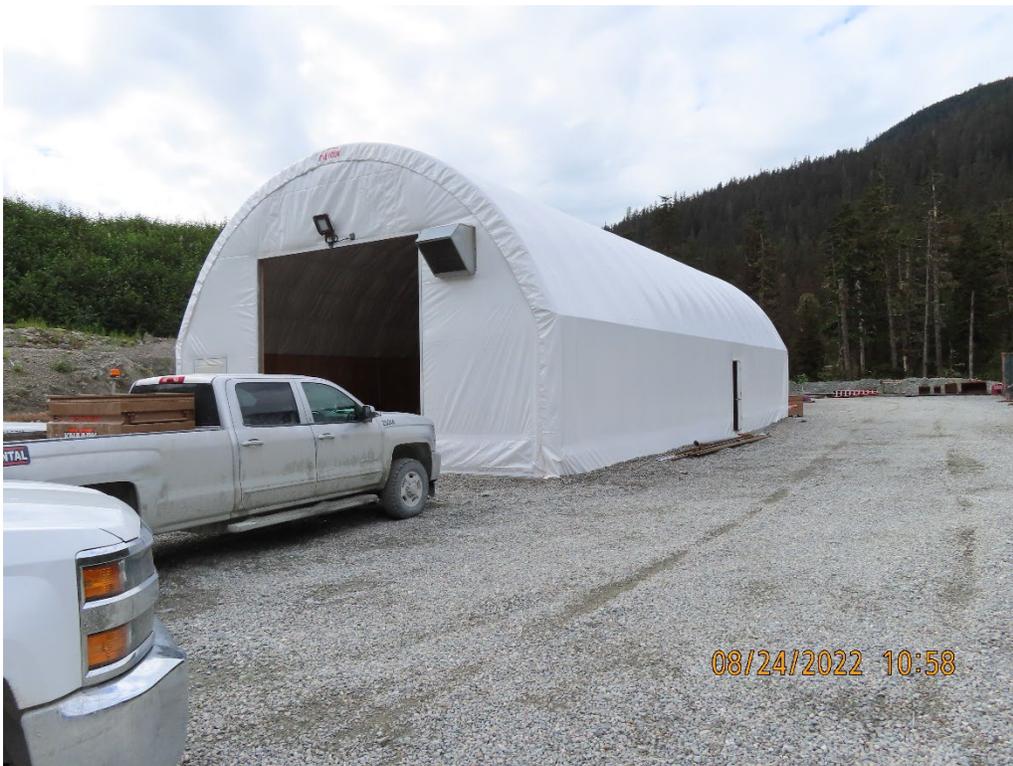
The surface equipment shop has been relocated from Pit 4 to the north end of the Mud Dump (Photo 10).

Photo 10. Surface equipment shop relocated from Pit 4 to the Mud Dump.

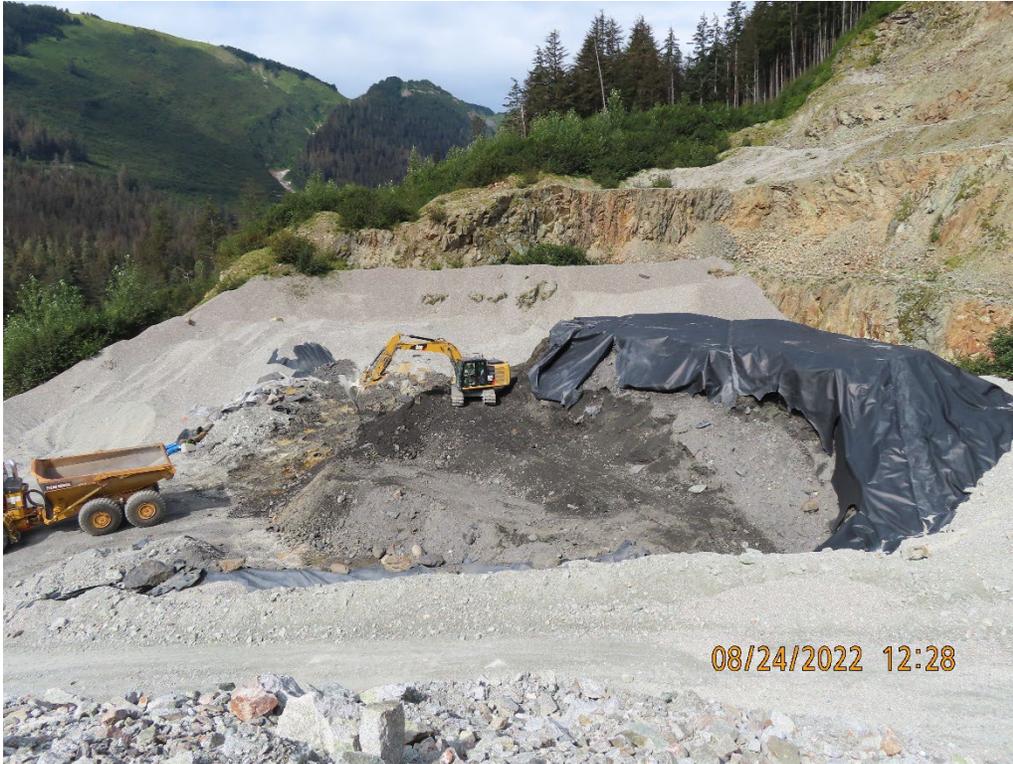
The Pug Plant was operational and processing graphitic phyllite stockpiled in Pit 4 (Photo 11) for underground backfill.

Photo 11. Graphitic phyllite stockpile at Pit 4.

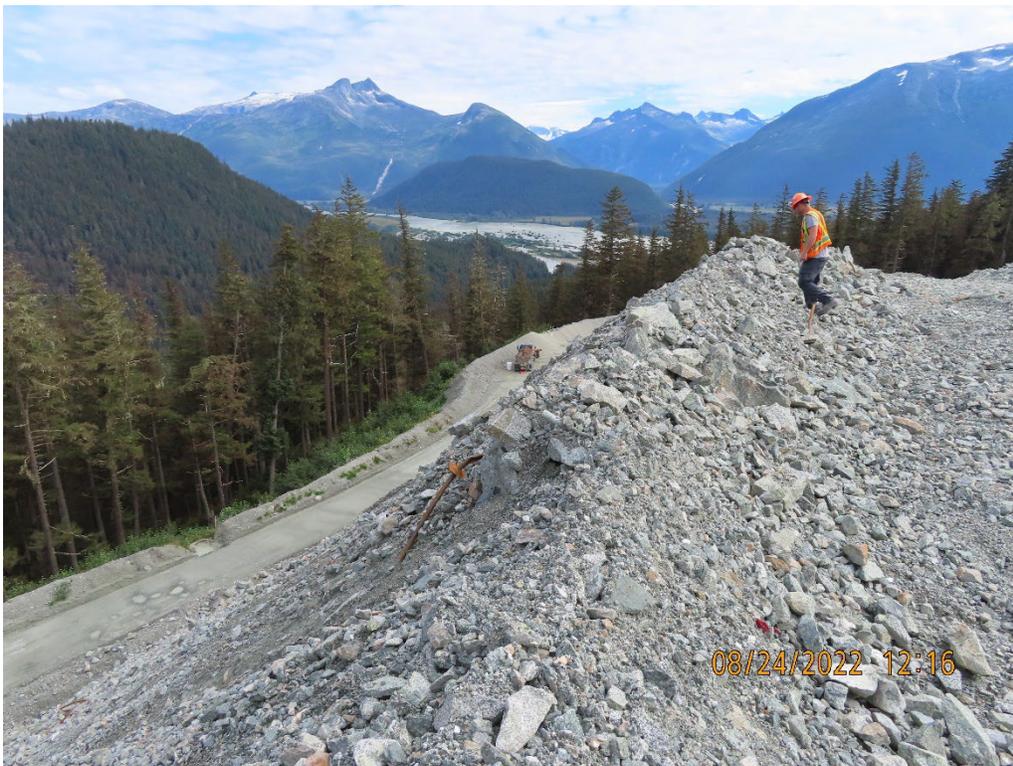
Coeur continues to transport and store waste rock at Pit 7 (Photo 12). Coeur intends to use this material as fill for POA1 Stage 4 dam construction.

Photo 12. Looking from top of waste rock stockpiled at Pit 7 down to the TTF access road.

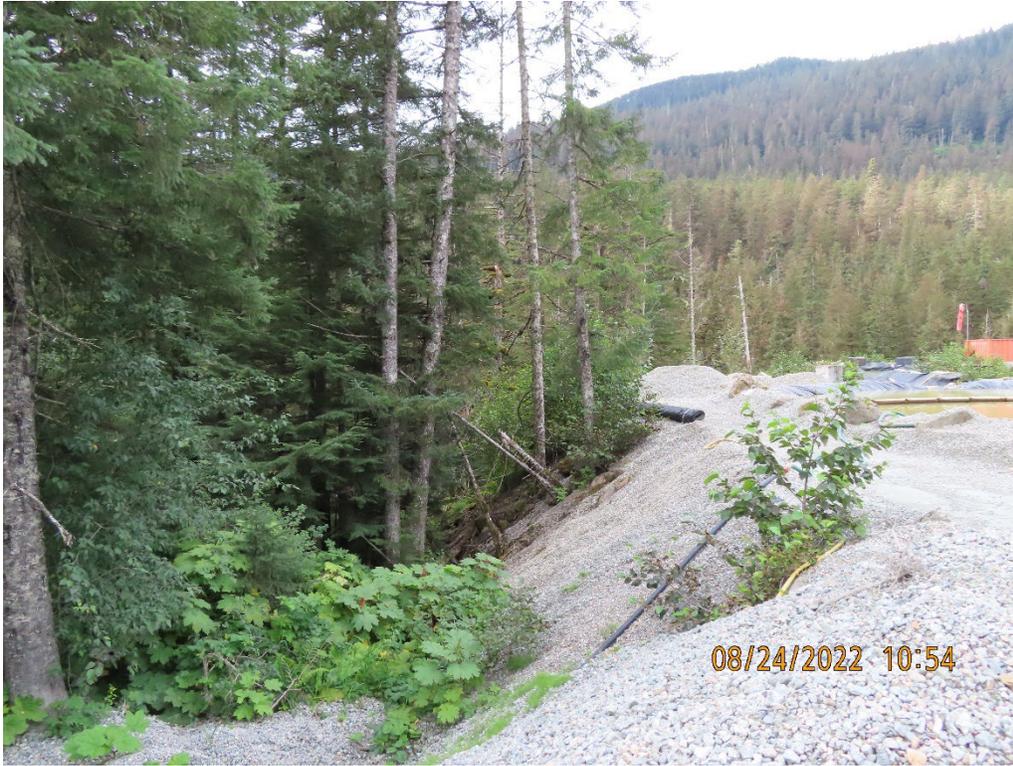
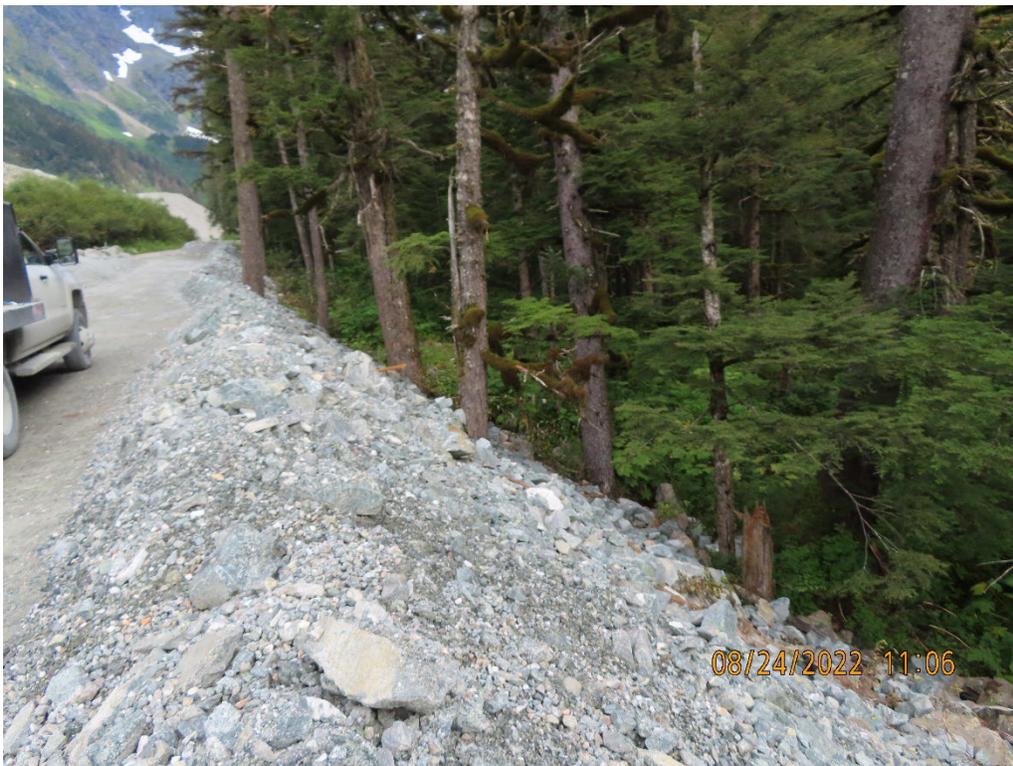
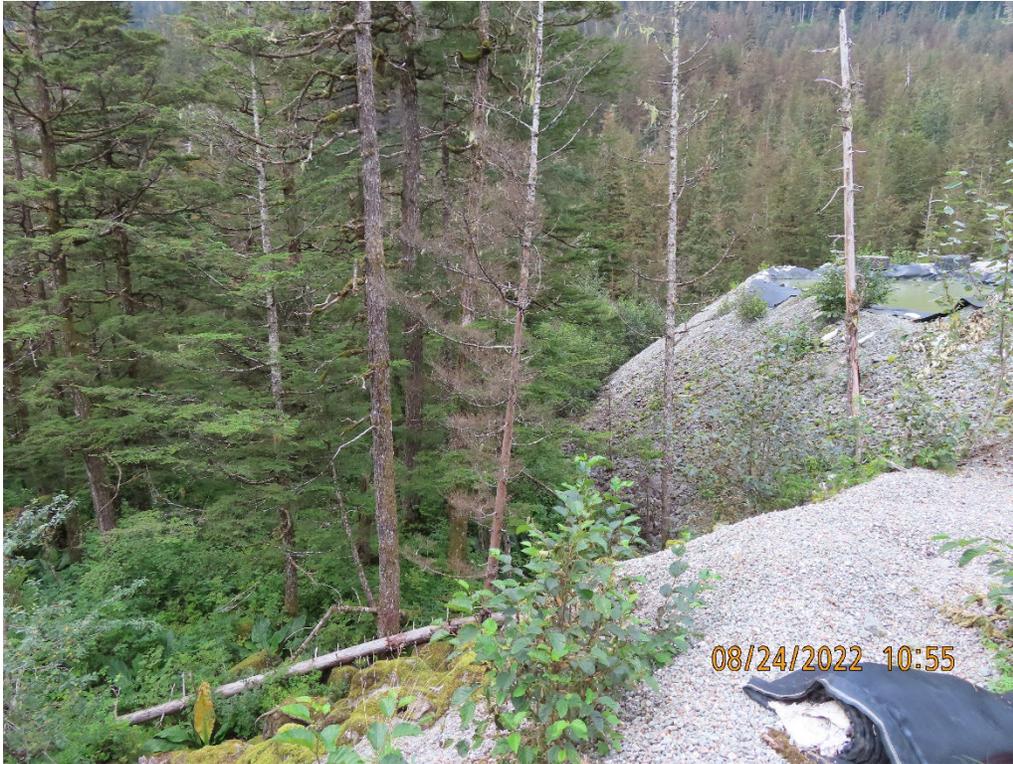
A recent inspection by consulting engineers recommended removal of trees within the slopes of stormwater retention ponds classified as class III dams by the State of Alaska Dam Safety Program, to ensure the stability of these facilities. These include the Camp Ponds, Wolf Ponds, and the Mud Dump Ponds (Photos 13-15). These trees are within permitted disturbance boundaries, so their removal is allowable as a regular maintenance activity.

Photo 13. Trees to be removed from Class III dam stormwater retention ponds.

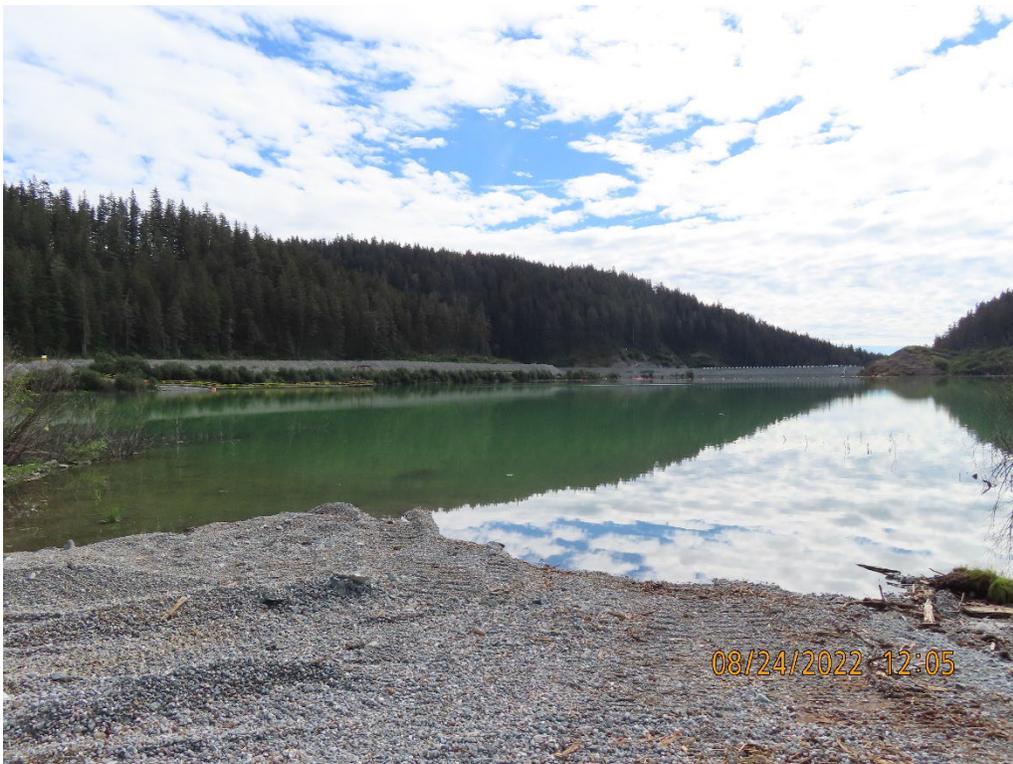
The water level for the TTF (Photo 16) was 715.4 feet.

Photo 16. TTF looking from north laydown area towards dam.

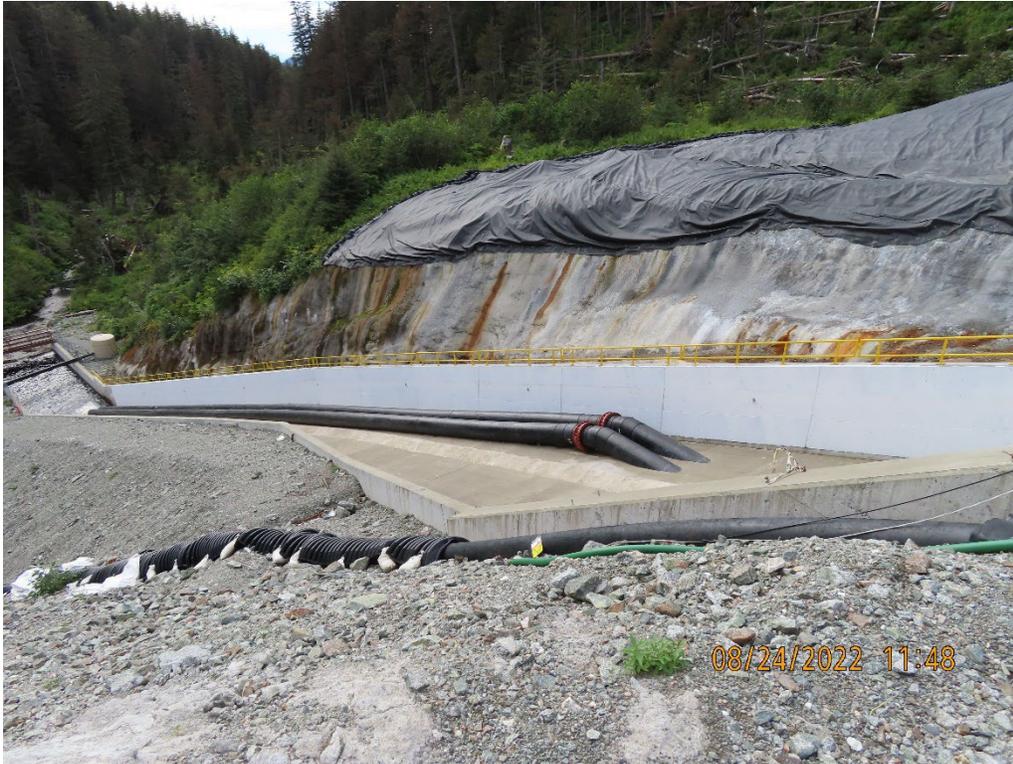
The TTF dam spillway appeared in good condition and there was no visual indication of ARD seepage reaching the spillway (Photo 17). The face of the dam was free of debris (Photo 18).

Photo 17. TTF dam spillway.

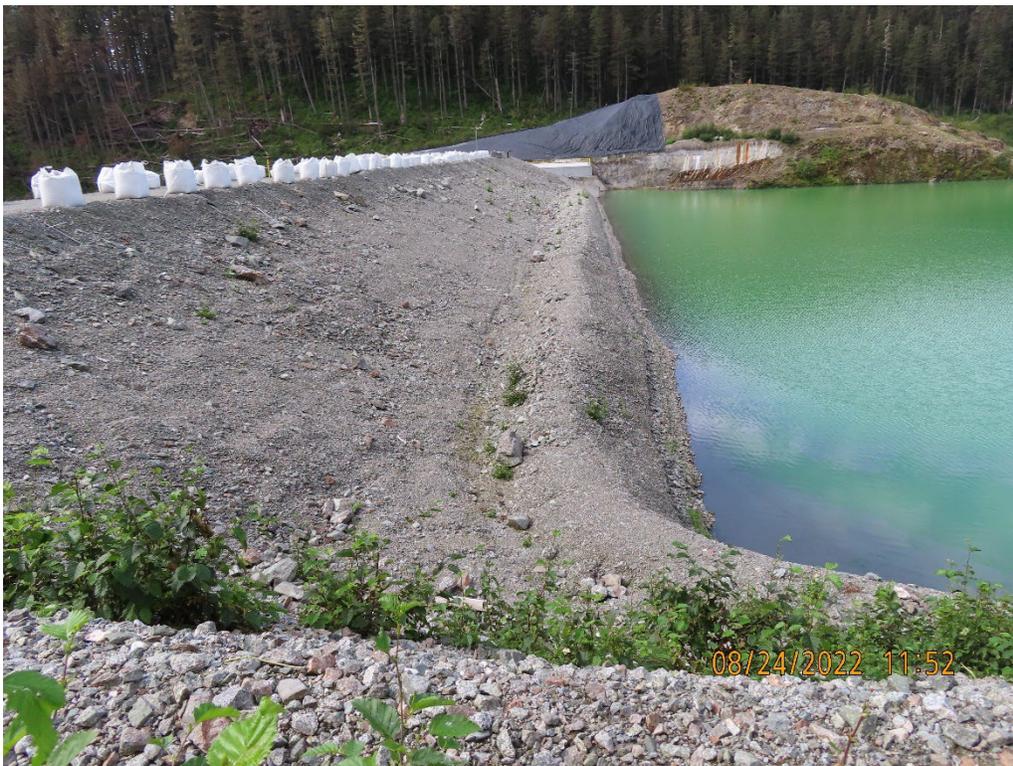
Photo 18. TTF dam face.

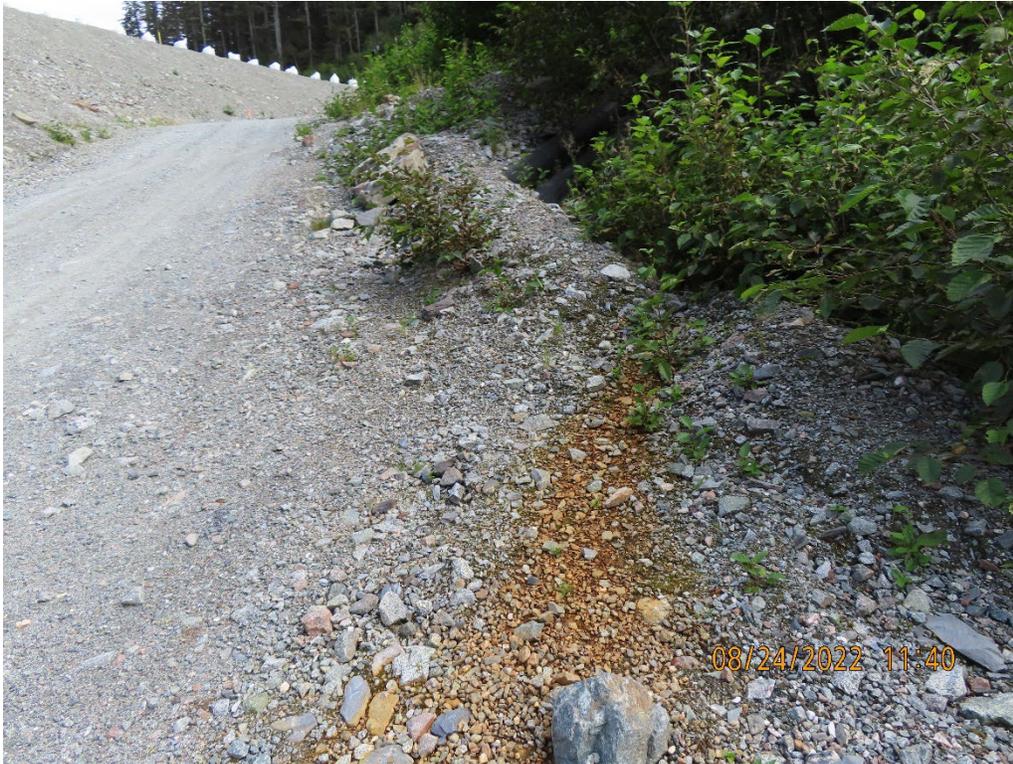
NEW ACTION ITEM 191-1: Adjacent to and running across the lower TTF dam access road, reddish staining from a seepage is present. The source appears to be the area above the Upper Slate Lake diversion outlet (Photo 19). Due to the presence of ARD-generating graphitic phyllite, groundwater in this vicinity is captured in wells and transported to the ARD seepage treatment plant. On September 7, 2022, Coeur provided a photograph of containment they have constructed to capture this seep (Photo 20), from which surface water is routed to the seepage treatment plant. Additionally, Coeur has collected water quality samples for which results have not yet been received. Preliminary field sampling indicates the seep may not be ARD, as the pH is above 7.0. This location will be monitored, and water quality testing results summarized, in a subsequent inspection report.

Photo 19. Seepage staining adjacent to lower TTF dam access road.

NEW ACTION ITEM 191-1: Staining on the TTF dam lower access road will be investigated to determine source and if additional mitigation measures are necessary.

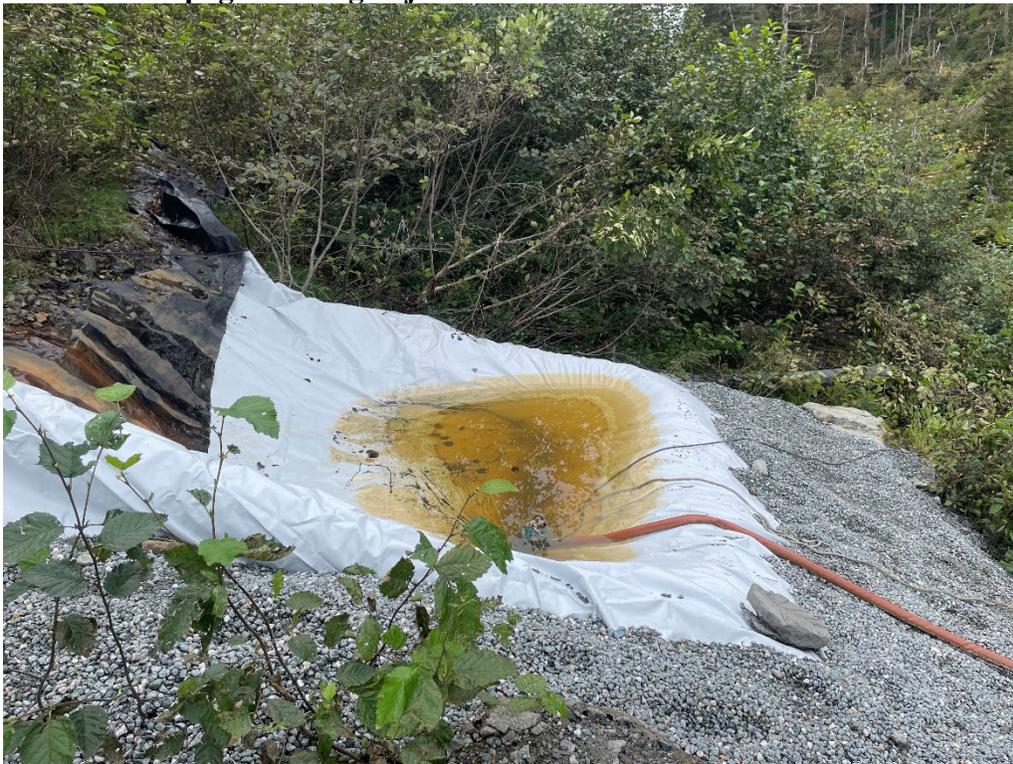
Photo 20. Seepage collection sump constructed by Coeur following the inspection (photo courtesy of Coeur, provided September 7, 2022).

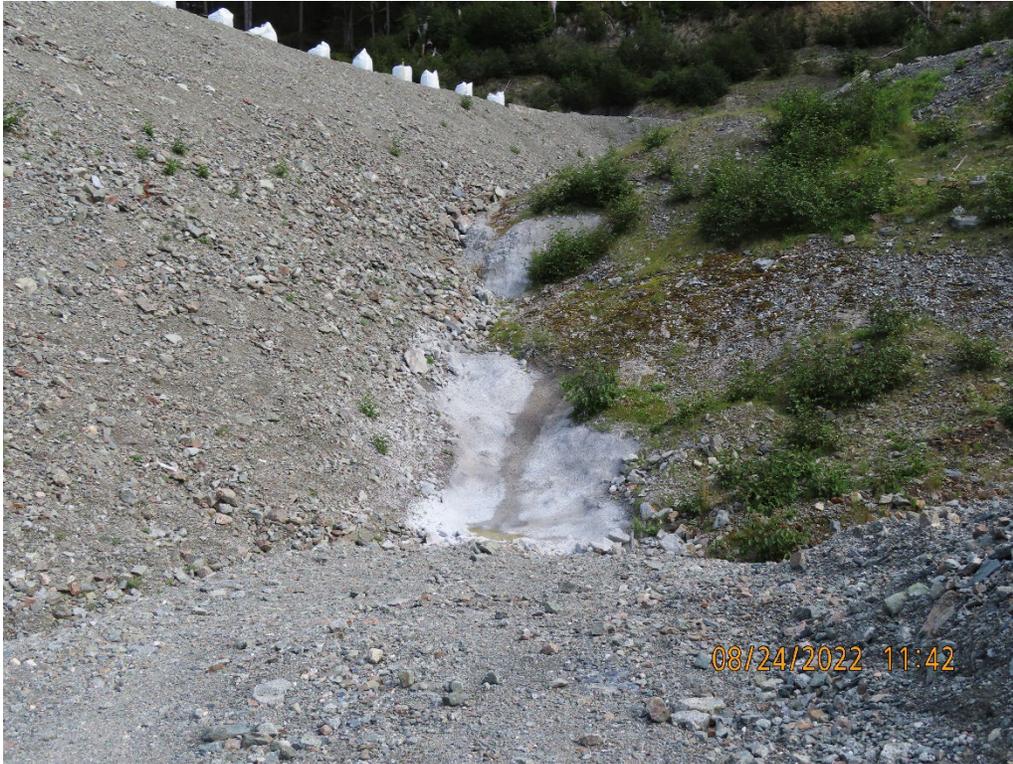
The site of a previously documented ARD seep along the east TTF dam abutment appears to have been suitably addressed by covering with shotcrete (Photo 21).

Photo 21. Shotcrete covering previously observed ARD seep by east TTF dam abutment.

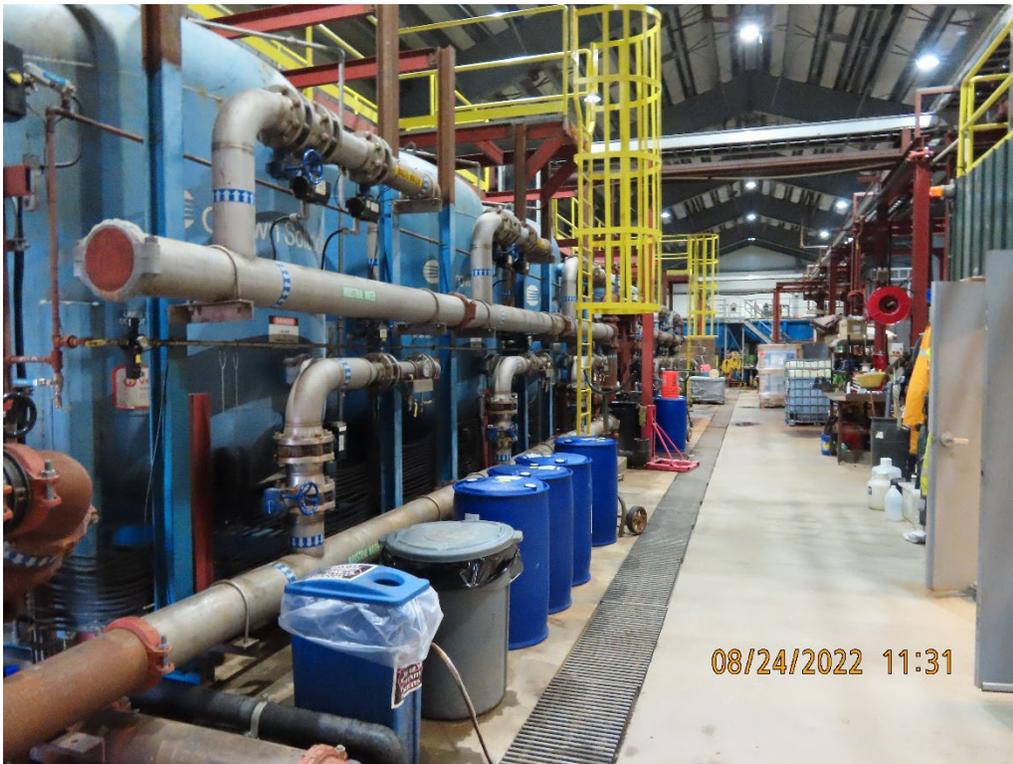
Good housekeeping practices were observed inside the TTF water treatment plant (Photo 22, Appendix 4g BMP plan; Table 4-1). The TTF water treatment plant was treating 815 gpm, and the water discharged to Outfall 002 measured 7.44 pH and .239 NTU.

Photo 22. TTF water treatment plant interior.
