Inspection Report: Kensington Gold Mine

Tongass National Forest, Minerals Group 8510 Mendenhall Loop Road Juneau, Alaska 99801 (907) 789-6276 – office (907) 586-8808 – fax Date of Inspection: Tuesday, September 17, 2013
Date of Report: Friday, October 18, 2013
USDA Forest Service Inspector: David Schmerge

Ranger District: Juneau Ranger District

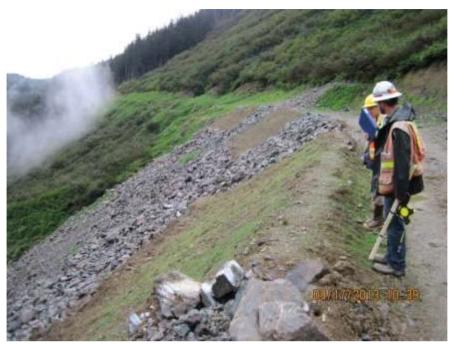
Grass is germinating in each of the three reclamation test plots at Snowslide Gulch (photo 01). There is some apparent erosion in the biopolymer test plot where the subgrade has become exposed (photo 02). Kevin believes that this is not an accurate picture, and that there has been minimal erosion in this location. If Kevin is correct, then an insufficient amount of topsoil was used at this site. The approved Reclamation Test Plot Plan states, "a minimum of one-foot of stockpiled topsoil will be placed and distributed over each area," and the Forest Service approval letter states, "the topsoil should be evenly spread such that after settlement, it meets the required depth of at least one foot."

Photo 01. Grass has germinated in each of the three reclamation test plots at Snowslide Gulch. The near plot was planted with fertilizer and mulch, the middle plot was just seed, and the far plot with biopolymer.

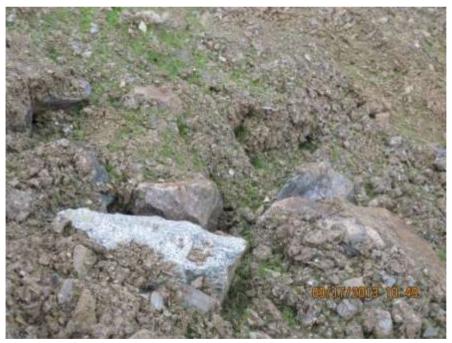
Photo 02. Some erosion is occurring in the biopolymer test plot where the subgrade has become exposed.

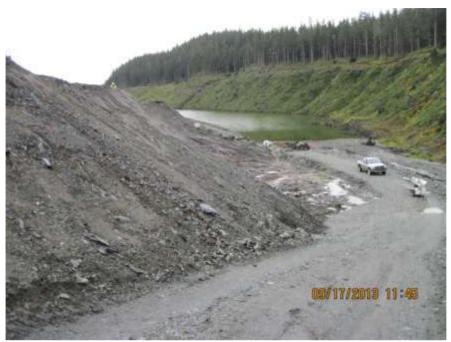
About 14,000 tons of the graphitic phyllite (GP) have been excavated at the Tailings Treatment Facility (TTF) this summer (photo 03), but ARD is still occurring at the site (photo 04). The pH at one of the seeps (photo 05) and at the sump (photo 06) was about 5. The pH at the north end of Lower Slate Lake (photo 07) was about 6, and at the northwest pond (photo 08) it was about 5.5.

Photo 03. About 14,000 tons of graphitic phyllite have been excavated from the north end of the TTF this summer. Lower Slate Lake is in the background.

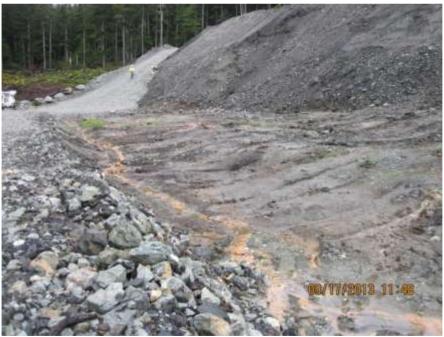
Until recently, water quality at the site was improving, but on September 3 water quality noticeably deteriorated (table 1). The Tailings Treatment Facility ARD Remediation Plan (ARD Plan) contains a list of required corrective actions and a timeline for their completion. The ARD Plan requires the GP to be excavated by July 16, and DEC approved an extension of this deadline to August 7. Kevin stated that Coeur believes that all the GP at the site has been excavated, and that the present ARD is a residual that has not yet been flushed out of the system. However, Coeur has not presented evidence that supports this conclusion. Kevin stated that he believes the ARD remediation is satisfactory because the ARD seepage is contained and is being treated in the ARD treatment plant, and that the current BMP's are adequate to prevent impact to surface waters and the TTF. However, due to the continued poor water quality, there is reason to doubt that all the graphitic phyllite has been completely removed. Until the water quality meets the Alaska water quality standards, the ARD remediation plan is in effect and all GP needs to be removed. Alternatively, the ARD remediation plan needs to be revised and approved.

Photo 04. Acid rock drainage is still occuring at the base of the site where the graphitic phyllite was excavated.

- 1. The Forest Service will provide Coeur with a letter approving the agreed upon modifications of the Reclamation Test Plot Plan.
- 2. Coeur should provide the Forest Service with evidence that supports Coeur's opinion that all the graphitic phyllite has been excavated from the stockpile. If Coeur cannot provide this information, then a meeting with the Forest Service and DEC should be scheduled as soon as possible to discuss the necessary next steps to remediate the ARD.
- 3. If Coeur still wants to pursue a dye tracer study at the north end of the TTF, then Coeur should provide the Forest Service with a written proposal that follows the protocols in the 2 dye tracer documents that I provided.
- 4. Coeur should secure the field test cells with a fence as soon as possible.

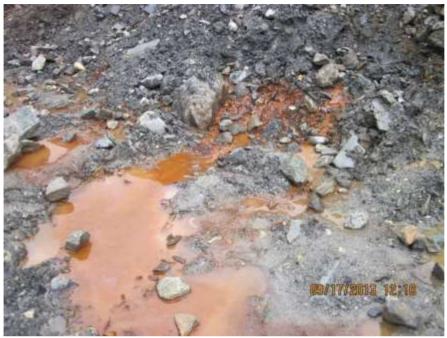
Photo 05. The pH of this ARD seep was about 5.

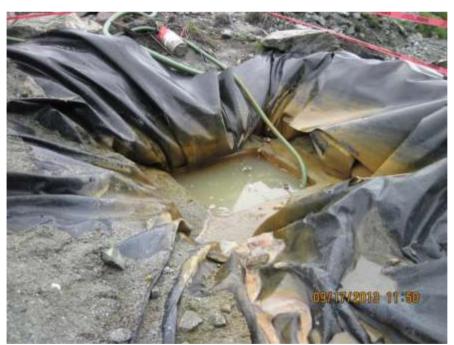
Photo 06. The pH at the sump was about 5. Water in the sump is being pumped to an ARD containment pond, and then sent to the GP water treatment plant.

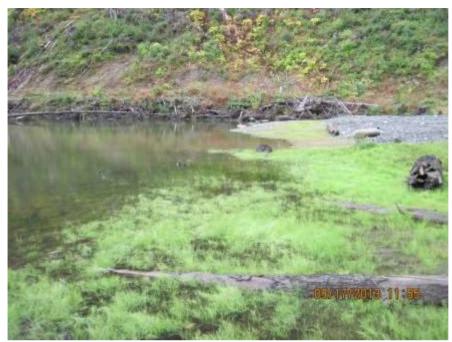
Photo 07. The pH at the north end of Lower Slate Lake was about 6.

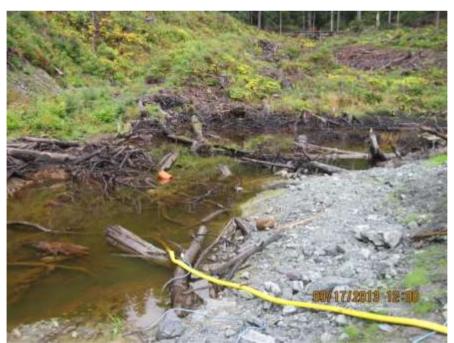
Photo 08. The pH at the northwest pond was about 5.5. Water is being pumped from the pond to the ARD containment pond.

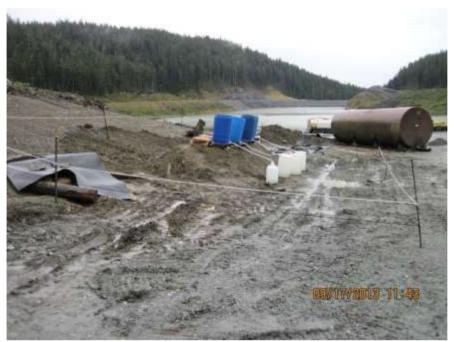
The GP field test cells have not yet been secured with a fence (photo 09) as required by the approved Scope of Work for Construction and Operation of Field Test Cells. Kevin questions the authority of the Forest Service to require Coeur to install a fence. The Forest Service has the authority to enforce the Plan of Operations and supplemental plans under 36 CFR 228.4(d). For large mines such as Kensington, the Forest Service recognizes that supplemental plans may be necessary to cover significant surface disturbances not covered by the initial Plan of Operations. The excavation of the graphitic phyllite has been a significant surface disturbance not covered by the initial Plan of Operations, and numerous supplemental plans have been needed to address the issue. The Scope of Work for Construction and Operations of Field Test Cells is a supplemental plan that was approved by the Forest Service on May 31, 2013. In section 3.2.1 of the approved scope of work, it states, "the selected site should be in a secure area with limited access that can be fenced off and left undisturbed for the life of mine, so that a long-term test

Photo 09. The field test cells have not been secured with a fence as required. It is important that this area not be disturbed for the life of the mine.

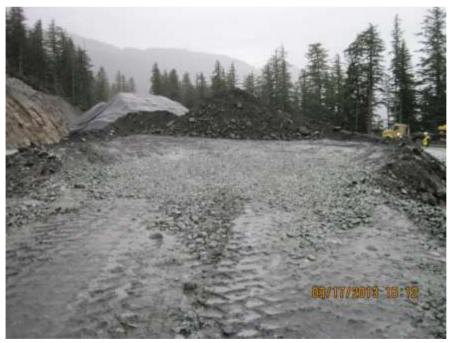
The GP at Pit 7 is being hauled underground. A temporary containment cell that was full during my last visit on August 21, is now nearly empty (photo 10). There are 2 additional temporary containment cells at pit 7 that are full and temporarily covered. The ARD Plan requires the GP to be underground by the end of September. Coeur is behind schedule to achieve this, but Kevin and Ken both stated that they believe that they can get all the GP underground by the end of October. With a little luck, all the GP will be underground before the first snow fall. In the event that some of the GP has to be stored above ground during the winter, several drainage sumps have been constructed to capture any seepage (photo 11).

Photo 10. The GP from the cell in the foreground is being hauled underground. The two cells in the background are covered, but not sealed.

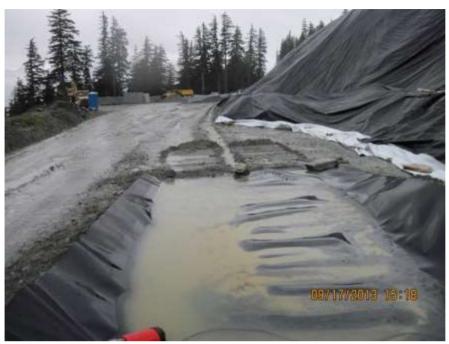
Photo 11. Drainage from the storage cells at pit 7 is directed to the sump in the foreground.
