December 29, 2014

December 18th Inspection of the Kensington Gold Mine

This report covers the December 18th, 2014 inspection of the Kensington Gold Mine. The multiagency inspection team (team) consisted of David Wilfong from the Alaska Department of Natural Resources (ADNR), and Curtis Caton and Matthew Reece from the United States Forest Service (USFS). The team was accompanied by Pete Strow from Coeur Alaska (Coeur) for the entire duration of the inspection. Transportation to and from the mine was provided by a USFS chartered Ward Air Cessna floatplane. The purpose of the trip was to conduct a general inspection, with an emphasis on visiting the recently approved surface exploration pads and the proposed site of the fuel tank farm and supporting pipeline needed to fill the tanks. Due to the short winter days, the team limited the inspection to the Kensington "side" of the mine.

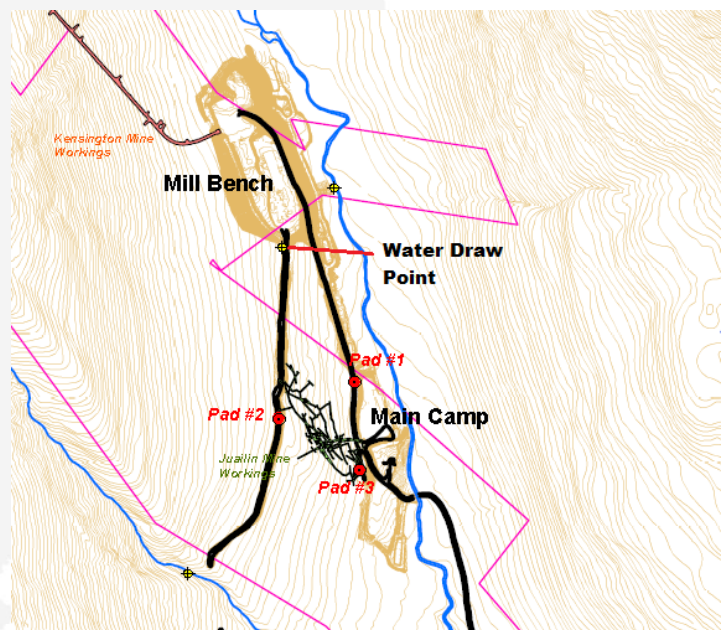
Figure 1 Exploration pad sites, and water withdrawal points.

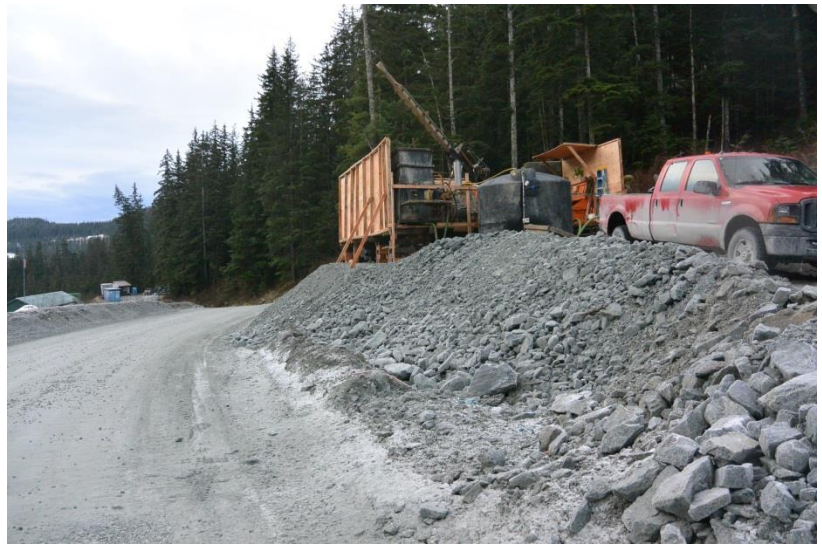
When the team arrived at the drill pad, drilling operations were actively occurring. Drilling ceased for a short time for a site induction and safety briefing. The drill pad was neat and clean, and no safety or environmental concerns were observed. It was noted that this was a very elaborately built drill pad with 10 foot tall walls on three sides. The walls were intended to dampen the sound coming from the 24 hour per day operation of the drill rig, as the main bunkhouse for the miners was about 100 yards away. Drill make-up water was pumped through a steel reinforced, flexible hose from a permitted draw point about 1150 feet away on the Mill Bench as shown in Figure 1.

Figure 2 Surface exploration drill pad.

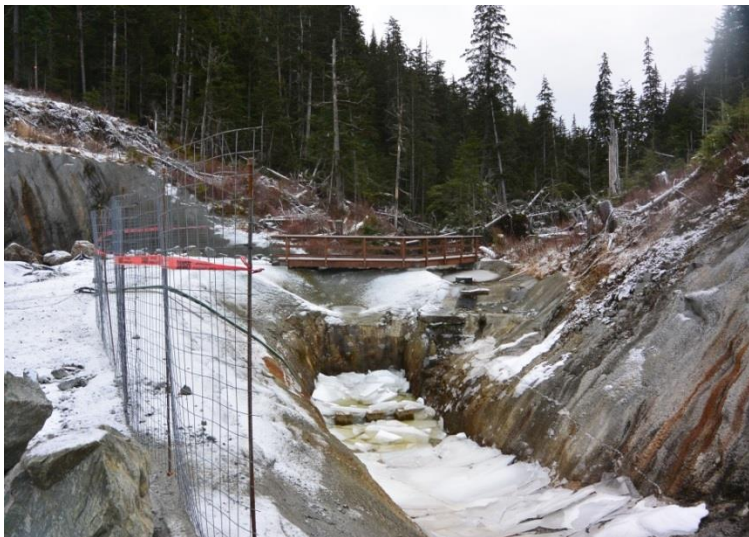
Figure 3 Plunge pool. Note the new guarding.

The team left the drill site, moved to the Tailings Treatment Facility (TTF), and drove to the downstream face of the TTF Dam. Additional guarding has been placed around the emergency spillway plunge pool (Figure 3) to satisfy a Mine Safety and Health Administration (MSHA) requirement. MSHA had determined that the extra guarding may prevent the possibility of drowning in the 3-6 inches of water in the plunge pool (frozen over in Figure 3). The water level is maintained by a pump and a float activated switch. When present, plunge pool water is pumped to a holding tank near the small water treatment plant (WTP). The water is then

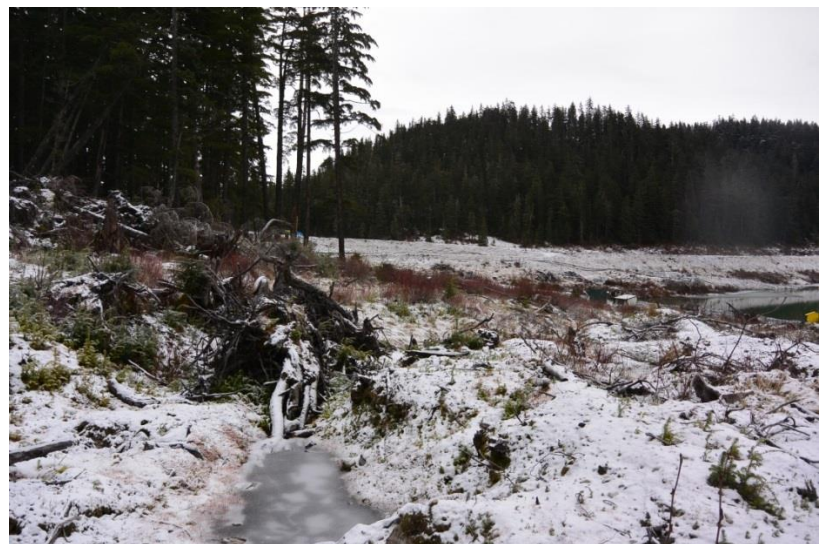
Figure 4 The new access road will be constructed in this area.

is constructed with geochemically inert wasterock from the mine. The newly constructed road will require revisions to the BMP Plan, part of the Plan of Operations. The Reclamation Plan will need to be updated with a written narrative and figures that describe the position of the new road alignment, but the Reclamation Cost Estimate should not change as the rising water will reclaim the old alignment, and new road will be the same length and will use a very similar construction design and material. The surface of the TTF was partly clear of ice at the time of the inspection, with most of the ice occurring at the south end, near the dam (Figure 5).

samples from May until December. The inspectors climbed the small hill behind the barrel tests to walk along the future access road alignment in Parcel 25 (Figure 4). The access road needs to be realigned due to the rising water in the TTF which threatens to inundate the old road. The USFS, ADNR, and Alaska Department of Environmental Conservation (ADEC) all agree that the old roadbed could be reclaimed in place. However, Coeur has the option to recycle the material from the old roadbed to build the new road alignment. The old road alignment, like the future alignment,

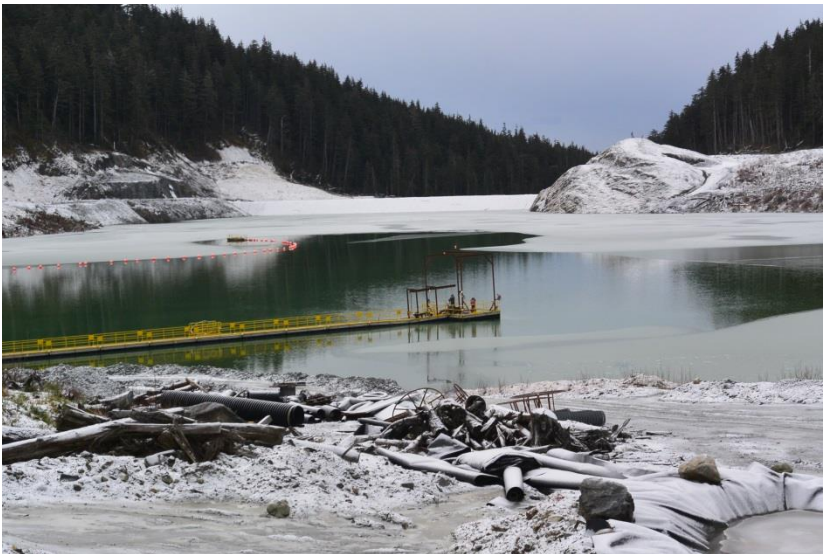
Figure 5 The TTF was partially frozen over.

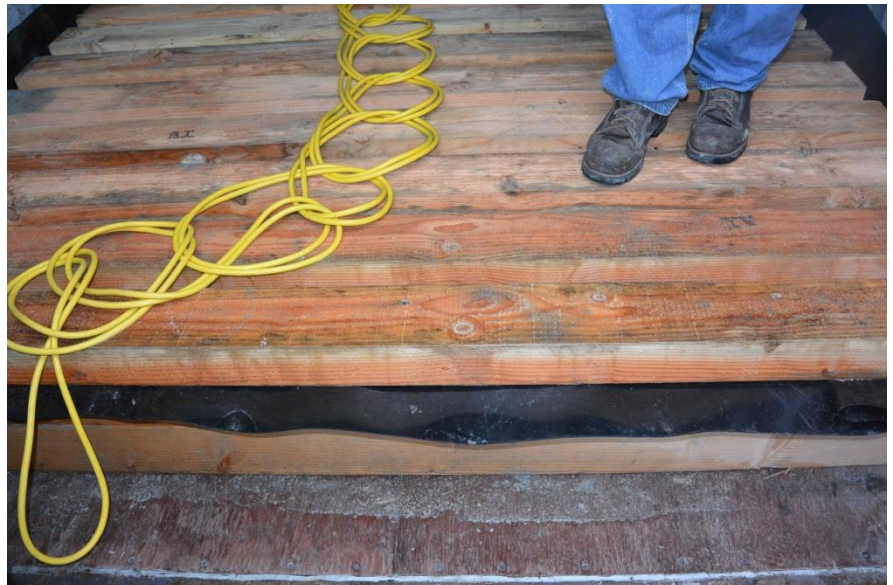
Figure 6 Internal secondary containment designed and constructed by Pete Strow. A very robust design.

for use at the Comet Water Treatment Plant. This type of container provides a more efficient manner of storing chemicals that are prone to freezing in Alaska's cold weather. Coeur has begun building a more robust design of internal secondary containment in their existing containers (Figure 6). The design utilizes heavy timbers to form a rectangular perimeter around the inside of the container which is lined with a High Density Poly-Ethylene (HDPE) liner. A second layer of heavy timbers sandwiches the HDPE in place, leaving a rectangular reservoir below. The timbers have sufficient spacing to allow chemicals to pass to the lower reservoir should a leak occur. A forklift with a telescoping boom will likely be used to insert and remove totes from the container. This in-house design will eliminate rain filled containment, and is more efficient use of space than the "SAF-TAINER" individual tote containment.

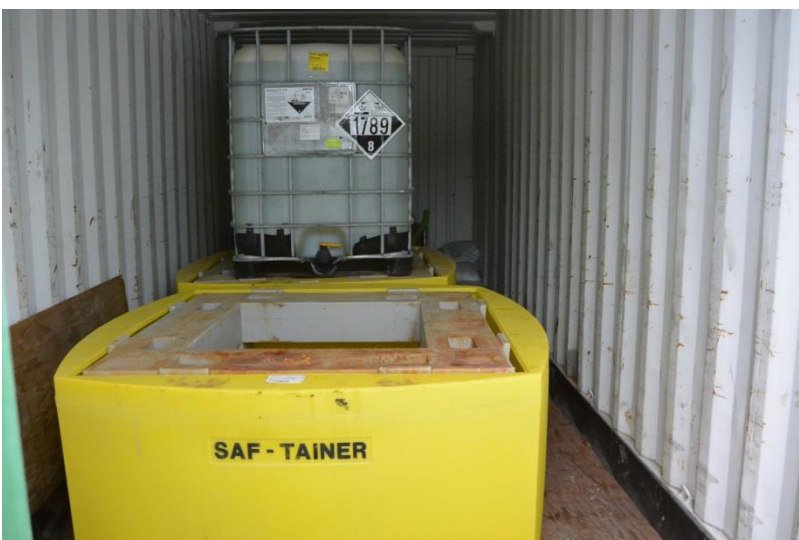
Figure 7 Internal, individual secondary containment for muriatic acid.

The inspectors traveled to the TTF Water Treatment Plant and walked around its exterior. Coeur has begun using internal secondary containment (Figures 5 and 6) for the safe storage of chemicals used at the WTP. The external secondary containment was prone to filling up with rain water, having equipment run over it, and tearing due to opening and closing the doors, rendering the containment ineffective. Coeur purchased a 20 foot container with prefabricated self-containment, heating, and ventilation

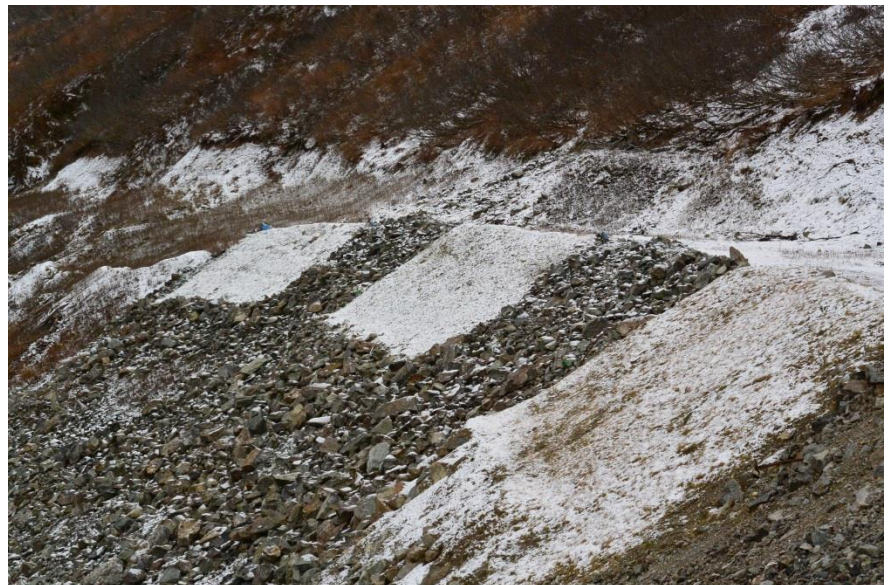
After lunch, the team moved to the vegetation test plots (Figure 7) on the "Pipeline Road". The road is used mainly to access the test plots, but also is used for exploration drilling. The road is rough, but easily passable in a vehicle with good ground clearance. The test plots were covered with a light dusting of snow, and appeared to be done growing for the season. The three plots were constructed using soil with significant amounts of sand and gravel, but little organic material. They are all constructed on a slope with a rip-rap like sub-base material, and are well drained. Plot #1(A) was treated with fertilizer, urea and mulch (Closest plot in the photo). Plot #2(B) utilizes no soil amendment, while Plot #3(C) is treated with a biopolymer designed to promote soil stability and plant growth. All three plots were planted using an approved upland seed mix at a rate of approximately 43 pounds of seed per acre. The plots were planted in July 2013, and they initially experienced rapid growth. By the end of the growing season in 2013, Plot #1 showed more than 50% ground coverage, and quantitative monitoring ensued. But, the growth seems to have slowed significantly during the growing season of 2014, and when quantitative monitoring began in July 2014, it was found that Plot #1 did not show the 50% coverage required, and qualitative monitoring resumed. By the end of the growing season, none of the plots showed 50% ground coverage by the planted vegetation.

Figure 8 The revegetation test plots.

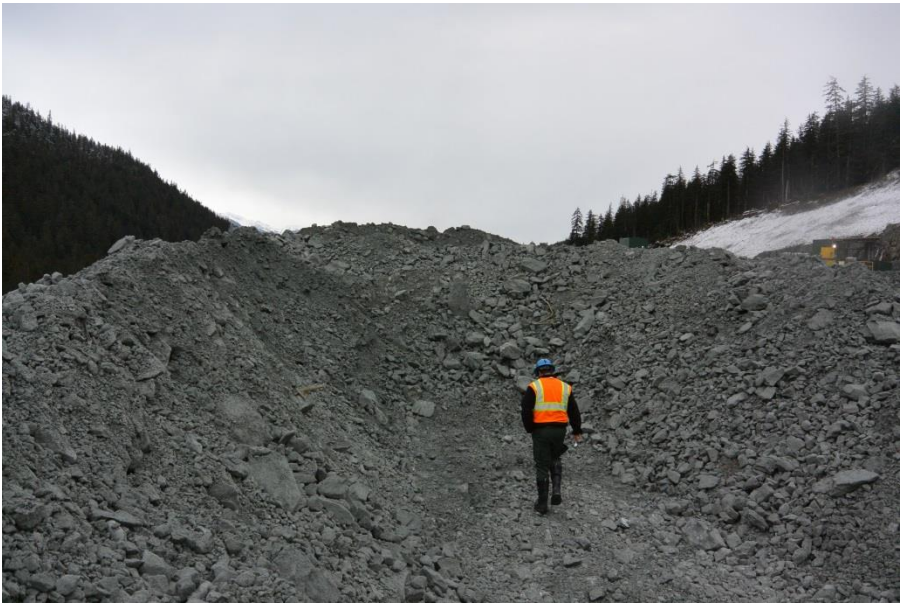
The team moved on to the top of the Jualin wasterock pile (Figure 9). Pete mentioned that the mine was running low on areas to place wasterock. Kensington mainly places wasterock in two different areas (piles). Both piles are located near the portal on their respective sides. One pile is on the Comet side of the mine, and the other pile is on the Jualin side of the mine. Lately, Coeur has opted to place most of the produced wasterock on the Jualin side to stockpile it for use in the construction of Phase 3 of the TTF Dam. The wasterock will be sorted according to size using a portable screen plant and placed in the earthen dam according to the construction specifications approved by the ADNR Dam Safety office. The construction of the third and final raise of the dam at the TTF, scheduled for the summer of 2015, will use a sizable amount of the available wasterock, and the size of the pile will diminish.

Figure 9 The pile is beginning to be pushed south toward the camp.

Because the toe of the Jualin wasterock pile is nearing the disturbance boundary set by the Forest Service, the pile cannot be pushed further northward. The wasterock pile is now being built to the south along the east side of the Mill Bench access road. To prepare the ground's surface for

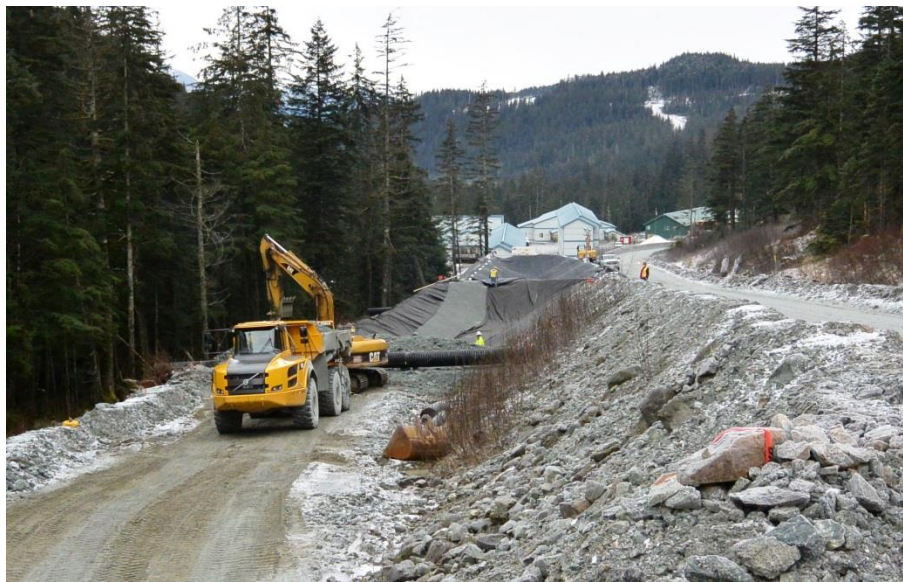
Figure 10 Construction of two new storm water runoff ponds was nearly complete.

the disposal of waste rock, Coeur needs to reposition two storm water settling ponds. Construction of new settling ponds was underway, and nearly complete (Figure 10) at the time of the inspection. The settling ponds are used to reduce or remove the sediment from storm water runoff, and will be placed about 200 yards south of the old ponds. The new ponds use the same design as the old ponds, with a sandy

bedding material underlying geotextile fabric and an HDPE liner. The HDPE and geotextile liners will be removed from the old ponds, and will be buried beneath wasterock as approved in the Reclamation Plan.

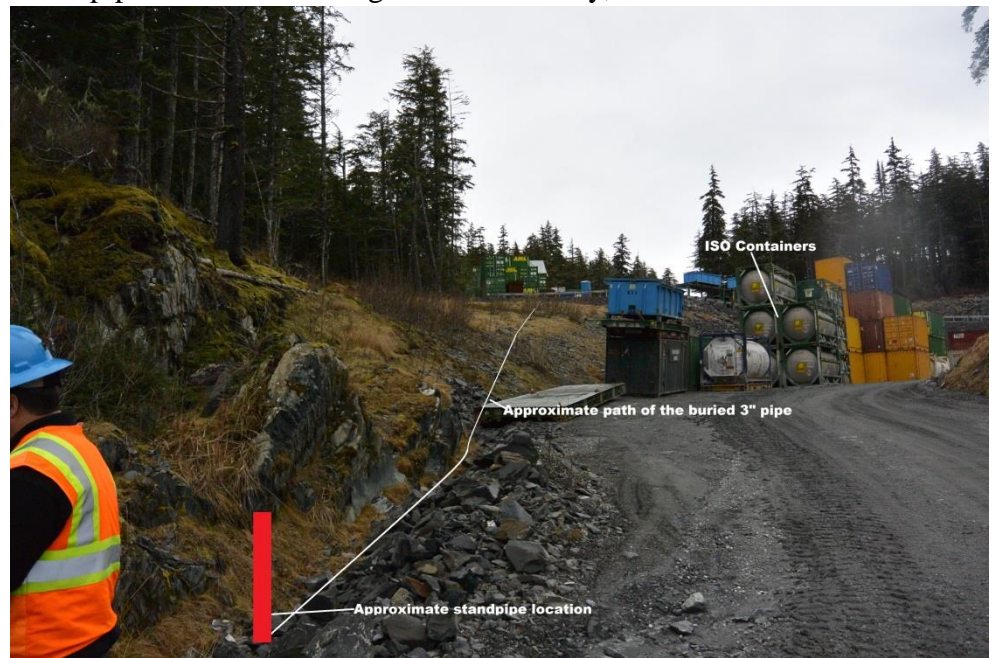
The inspection team left the mine area, and was shuttled down to Slate Creek Cove to look at the area of the proposed fuel tank farm. The USFS has determined that it will prepare an Environmental Assessment under NEPA for the proposal. The tank farm would consist of seven 50,000 gallon self-contained fuel storage tanks, and a 3" pipe will connect the tanks to the barge landing. The pipe will be buried where possible, and connected to a standpipe near the bottom of the road in a safe location. The approximate path that the buried pipe would take if approved, and the estimated location of the standpipe can be seen in Figure 11. Currently, the mine's fuel is transported in International Standardization Organization (ISO) tank containers from a barge to a landing area up the road, and stacked three high. When needed, a container is removed from the stack, loaded on a truck, and hauled up the road to the main fuel tank near the mill.

Figure 11 The approximate path the buried 3" pipe will take to the proposed tank farm. Note the ISO containers next to the road.
