June 17, 2014

## The May 27, 2014 Inspection of the Kensington Gold Mine

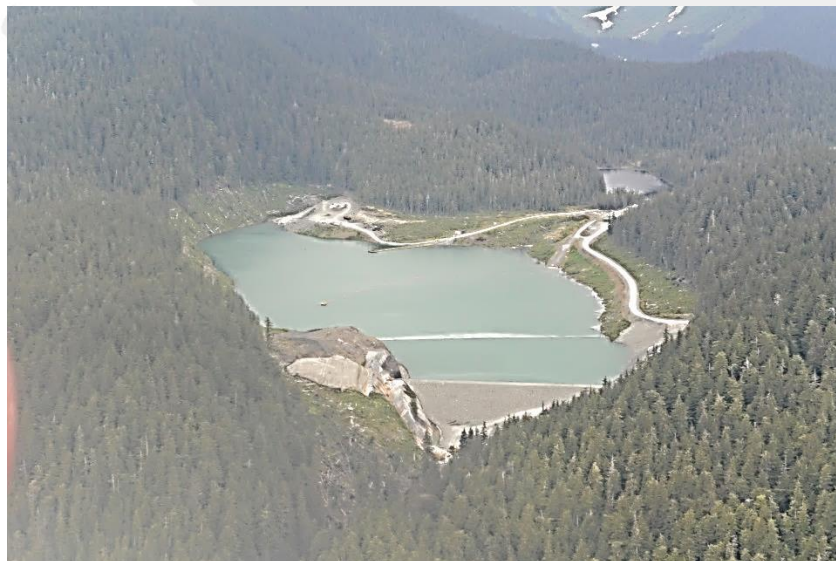
Figure 1 Aerial view of the Tailings Treatment Facility.

Before landing in Slate Creek Cove, the floatplane circled over the Tailings Treatment Facility, and then over flew the Comet waste rock pile and Water Treatment Plant (Figures 1 and 2). The mine looked clean and orderly from the air. After circling back to Slate Creek Cove, the team offloaded onto the beach and greeted Kevin Eppers, who was waiting for the plane, and then loaded into a pickup for the short drive to the camp

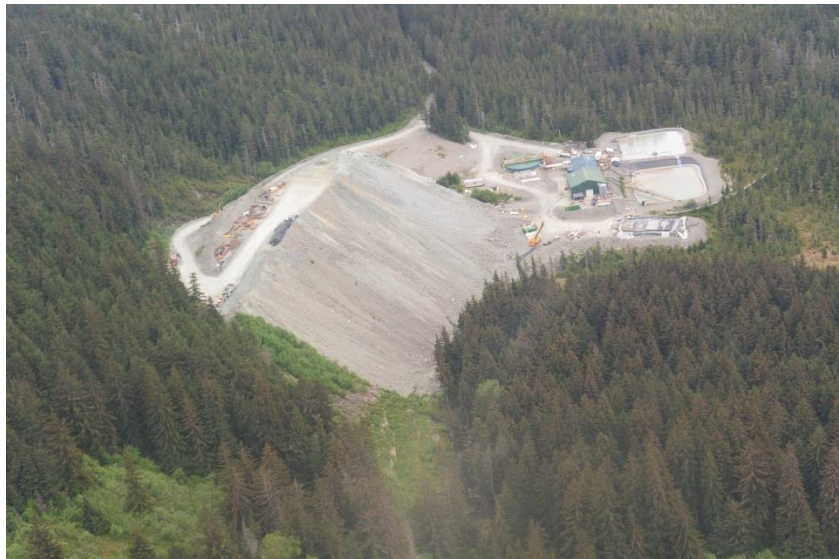
Figure 2 Aerial view of the Comet waste rock pile and water treatment plant.

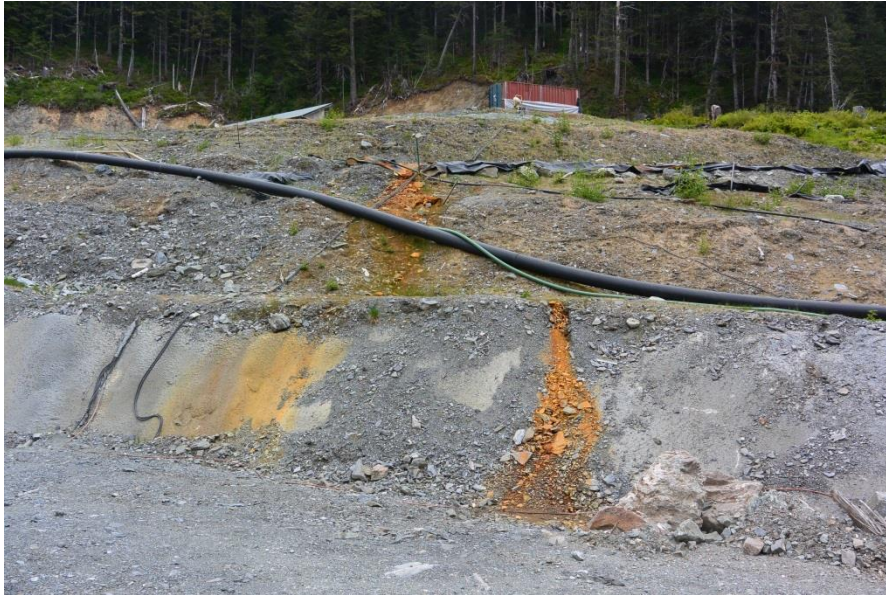
The inspectors were driven to the Lower Slate Lake Tailings Treatment Facility (TTF). The access road to the Tailings Facility was in good condition and appeared to have survived well through the milder than normal Alaska winter. The team stopped below the TTF Dam and walked around the area on foot. The localized staining visible on the lower eastern embankment below the dam appears to be worsening with time (Figure 3).

The orange staining has been mentioned in previous inspection reports (August 8, 2013<sup>11</sup>, October 29, 2013), and is likely being generated due to the graphitic phyllite that was buried below the east end of the dam. The Potentially Acid Generating (PAG) material was buried during the initial construction of the dam after being encountered during the excavation of the dam abutment. The buried material was surrounded by a diorite “shell” containing a high carbonate content. The diorite was intended to neutralize any acid produced by the buried

Figure 3 Orange staining below the Tailings Treatment Facility Dam.

graphitic phyllite, but the orange staining may indicate that some acid rock drainage is seeping from the pile. The buried graphitic phyllite will eventually be excavated and hauled underground when room becomes available.

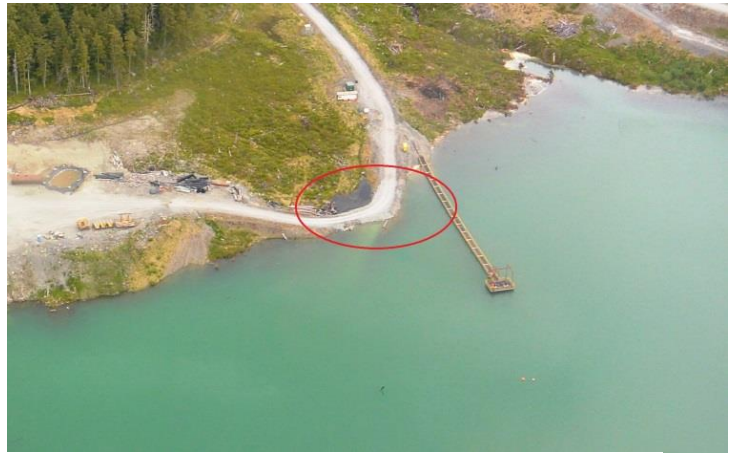
The inspectors drove to the north end of the TTF and visited the barrel test site and the area where PAG graphitic phyllite had been accidentally placed more than a year before. The access road to the barrel test area had been reconstructed due to rising water levels during the spring runoff. The new road follows the same alignment, but fill had been placed at the lowest elevation to ensure that the road was not inundated by the rising waters (Figure 4).

Figure 4 Filled road bed area.

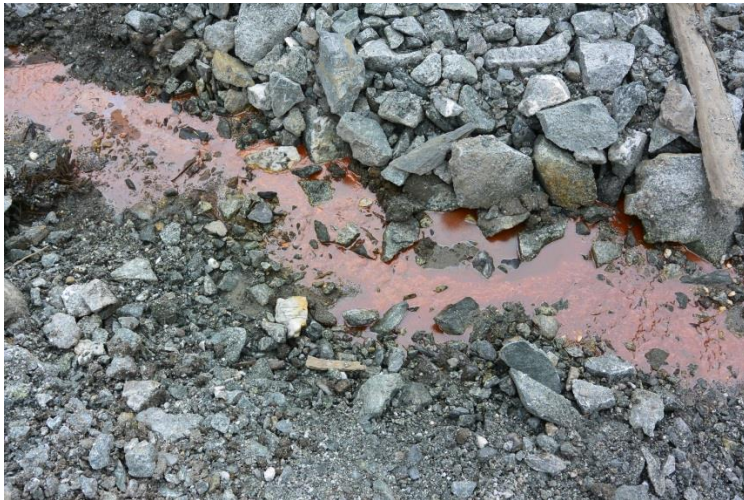
Figure 5 The discoloration in this seep appeared to be the result of organic decomposition and digestion by iron bacteria.

A closer look at the toe of the pile revealed that orange staining could be found in several areas. However, it is believed that much of the staining may not have been as a result of Acid Rock Drainage (ARD). Upon closer inspection, the far south seep revealed a floating scum and rainbow sheen indicative of iron bacteria (Figure 5). The majority of the discoloration is likely due to the natural function of anoxic iron bacteria breaking down organic material in the original topsoil stockpile that was placed in the area during the original construction of the TTF dam. Field tests show a near neutral pH and low conductivity from the south seep. However, the middle seep continues to show that some parameters do not meet permit requirements<sup>2</sup>, hence the small additional amount of excavated material.

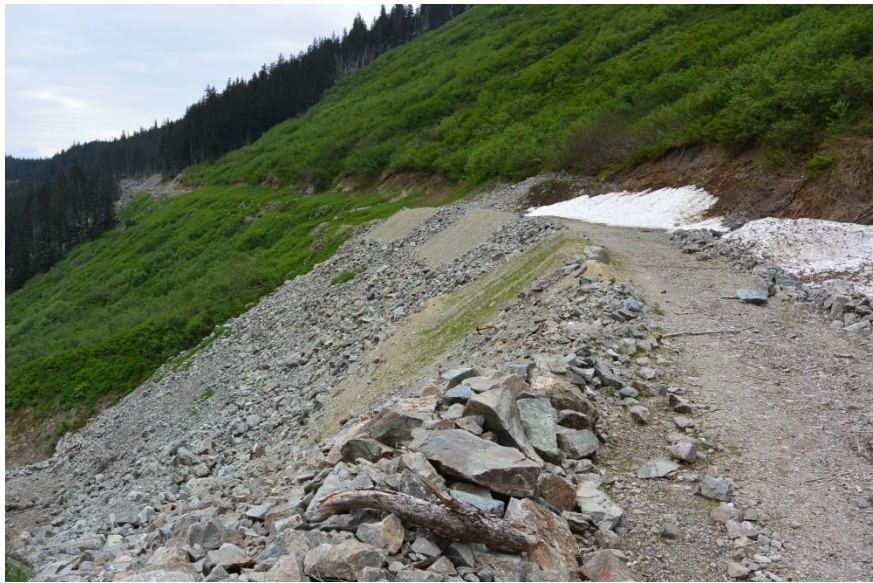
Figure 6 Revegetation Test Plots

The team then moved on to the Revegetation Test Plots located along the Pipeline Road (Figure 6). The test plots survived the spring breakup well. No major rills, gullies, or other serious erosion features were observed. The lush grass that had been emerging at the end of the 2013 growing season had disappeared, however new growth was observed in the plot that contained fertilizer and mulch (closest plot in Figure 6). The other two plots, one containing a biopolymer and the other with no soil amendment, contained very little new plant growth, but it was still early in the growing season.

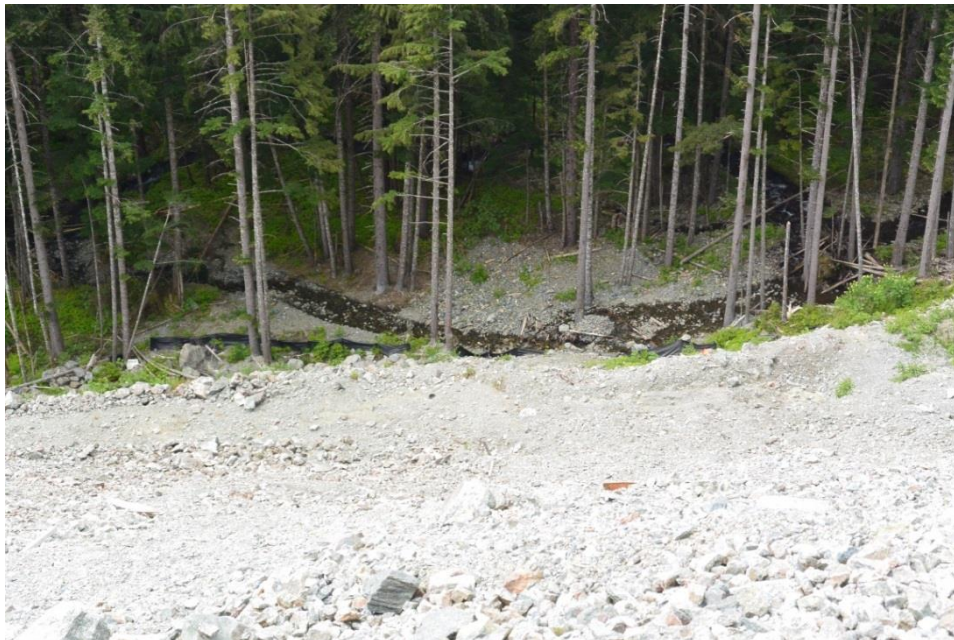
Figure 7 The silt fence running between the Comet Wasterock Pile and Ophir Creek was partially buried.

rolled into the now flowing Ophir Creek. However, the silt fence at the bottom of the pile, designed to reduce the sediment flowing into Ophir Creek was in disrepair (Figure 7). The top of the pile was being used to store mine equipment, and was clean and tidy.

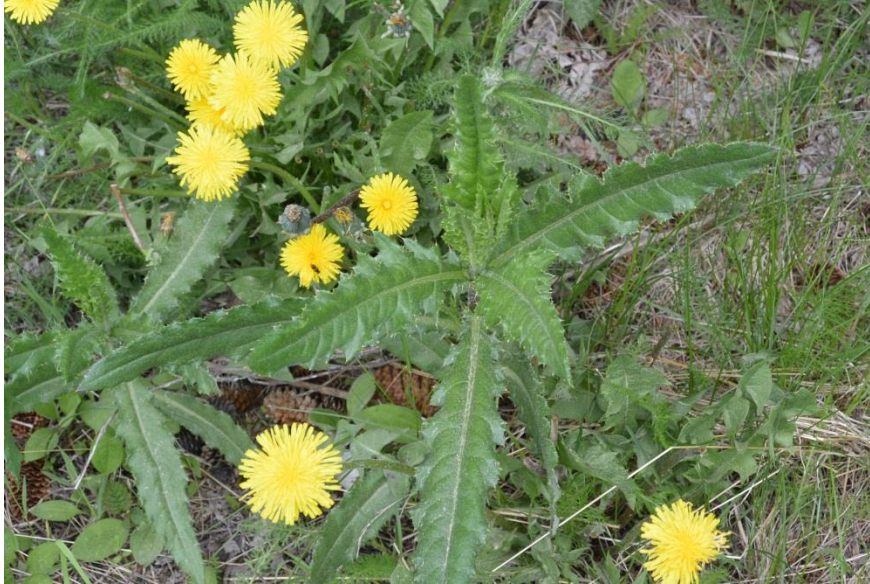
After leaving the pile, the inspectors moved to the Comet Water Treatment Plant. The flow of mine water to the plant was high (~2300 gpm) due to the recent spring breakup. The water was being pumped into both Pond One and Pond Two, and was quite silty despite the use of the sumps in the mine, likely due to the high rate of flow. After a quick walk around the outside of the treatment plant, the inspectors moved to the Comet Beach area. Near Comet Beach, Canada Thistle plants were discovered (Figure 8). The area was known to contain the invasive weed in

Figure 8 Canada Thistle.

the past. The Kensington Mine is attempting to eradicate the invasive plant, and is evaluating options to do so.
