DIVISION OF MINING, LAND & WATER
Mining Section
Northern Office

Mahn Choh Inspection Report

Inspection Date: September 20, 2023

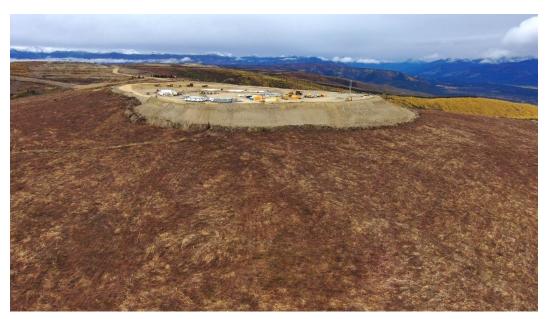
Main Infrastructure Site: The Main Infrastructure Site (MIS) (Photos 1 and 2) is southwest of the Water Treatment ponds. The layout contains Cat Rental Power portable generators, fuel tanks, Kiewit and Kinross administration buildings and trailers, WTP Storage and Operations Area, numerous connex containers, Rent-A-Cans, and parked light-duty vehicles and heavy machinery. Three concrete foundations have been built on the MIS for Mine Drill and 777 Maintenance. Vegetation around the entire MIS has been removed and graded.

Photo 2: Drone imagery of the Mahn Choh Main Infrastructure Site. View to the south.

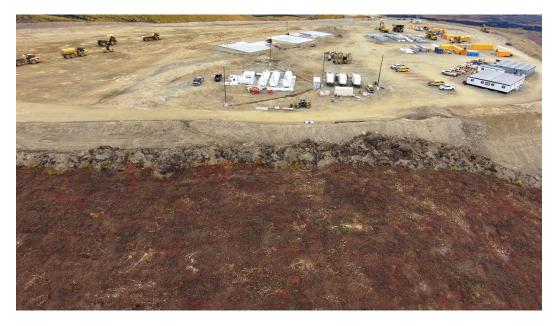
Photo 2: Drone imagery of the Mahn Choh Main Infrastructure Site. View to the west.

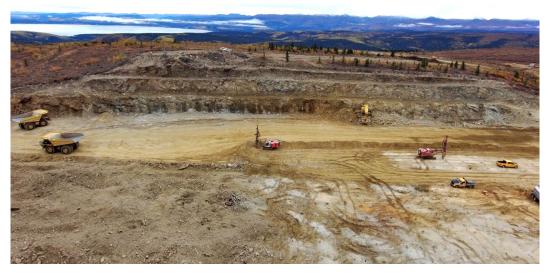
South Pit: The South Pit (SP) (Photos 3 and 4) is north of the Main Waste Rock Dump (MWRD). It was in its initial phase at the time of inspection. Drilling rigs and truck and shovel operations were working on and removing the fourth bench of waste rock overburden. A CAT 6030 hydraulic crawler excavator was actively loading 777 haul trucks that were transporting waste rock to the Main Waste Rock Dump.

Photo 3: Drone imagery of the Mahn Choh South Pit. View to the southeast.

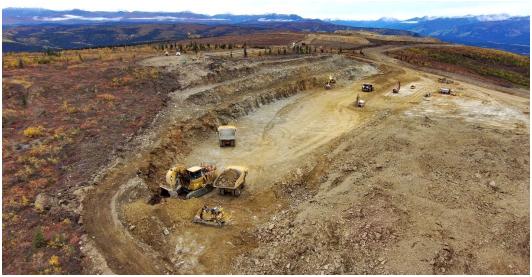
Photo 4: Drone imagery of the Mahn Choh South Pit. View to the south.

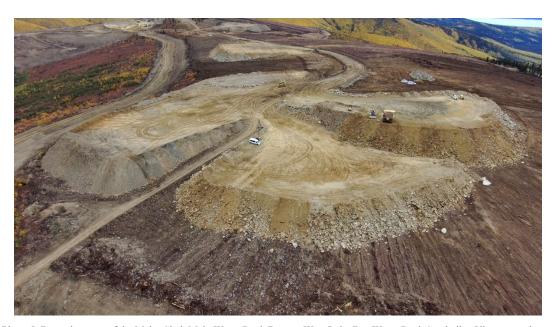
Main Waste Rock Dump: The MWRD (Photos 5 and 6) is located south of the South Pit. Blended non-acid generating material (NAG) and blended low-sulfur waste rock will be placed in the MWRD. The west lobe dry waste rock stockpile is temporary and consists of both NAG with stockpiles of metal leaching (ML) and potentially acid generating (PAG) waste rock, all of which will be relocated to the South Pit at end of mining. Vegetation around current MWRD has been removed and graded for WRD expansion.

$Photo \ 5: \ Drone \ imagery \ of \ the \ Mahn \ Choh \ Main \ Waste \ Rock \ Dump \ - \ West \ Lobe \ Dry \ Waste \ Rock \ Stockpile. \ View \ to \ southeast.$

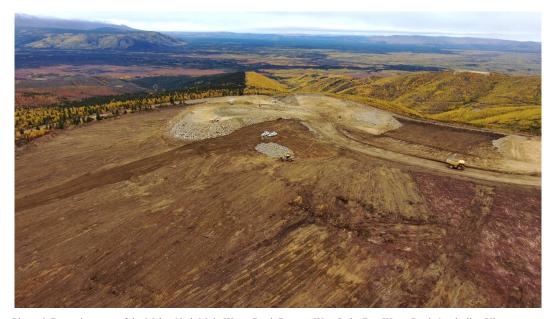
Photo 6: Drone imagery of the Mahn Choh Main Waste Rock Dump - West Lobe Dry Waste Rock Stockpile. View to west.

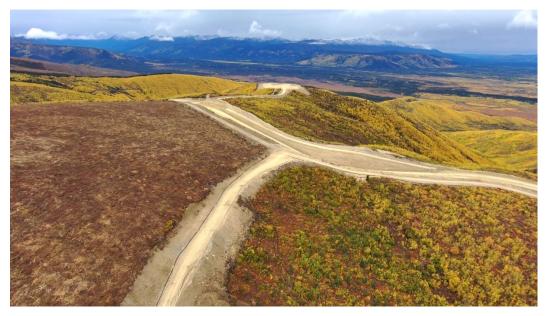
Explosives Storage Area: The Explosives Storage Area (ESA) (Photos 7 and 8) is located west-southwest of the MIS. At the time of inspection, the explosives silo foundation was in its initial construction phase. The pads circumference was surrounded by organic stockpile.

Photo 7: Mahn Choh Main Explosives Storage Area. View to the southwest

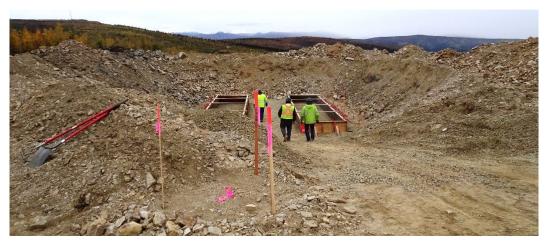
Photo 8: Mahn Choh Main Explosives Storage Area. View to the south.

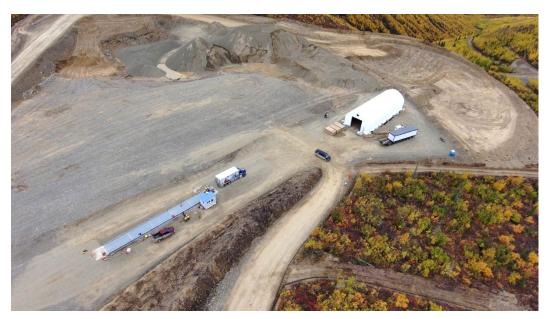
Ore Loadout Area: The Ore Loadout Area (OLA) (Photos 9 and 10) is northeast of the MIS. It consists primarily of a gravel pad that at the time of inspection was being expanded to the west-southwest. Mine trucks will dump ore onto lined stockpile pads for transfer into the highway ore hauling trucks. There is a scale-house and scales for weighing the loaded highway ore trucks, room for numerous parked mine trucks, a highway truck shop, washroom module/trailer, office trailer, and parts laydown areas. At the time of inspection, the OLA contained large temporary stockpiles of gravel placed by Keiwett contractors.

Photo 9: View of Mahn Choh Ore Loadout Area.

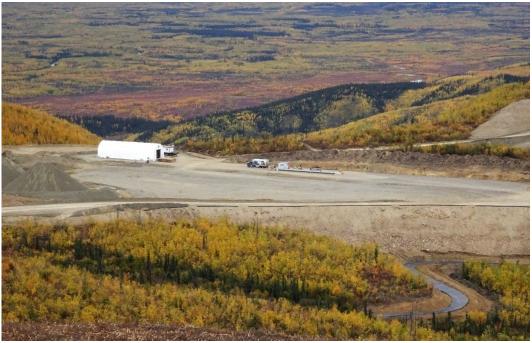
Photo 10: View of Mahn Choh Ore Loadout Area. View to the north.

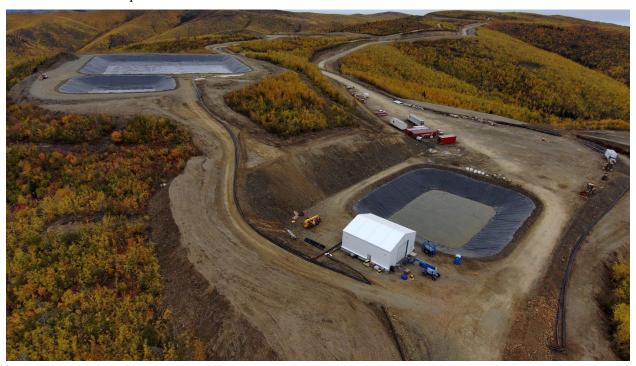
Water Treatment Ponds: The Water Treatment Ponds (WTP) (Photo 11) are northeast of the MIS. All contact water sources are to be captured and conveyed via perimeter ditches surrounding the mine infrastructure and redirected (pumped) from the retention basins (North Ditch Lined Pond, North Ditch Transfer Pond, and South Ditch Lined Pond) and piped to the Open Treatment Pond, Brine Pond, and Untreated Water Pond. All the ditches, and ponds are lined and bermed.

The Brine Pond and Untreated Water Pond are lined and bermed. Note the material site under construction at the top center of Photo 11.

Photo 11: Mahn Choh Water Treatment Ponds. View to the northeast.
